Corrosion of Stainless Steel in Fire Protection Systems

| Report's title Stainless steels used in fire protection systems | |
| Project name Palovesiputkiston tutkimus | Project number/Short name PALOMIC |
| Keywords stainless steel, fire protection system, pitting corrosion, MIC | Report identification code VTT-R-01556-08 |

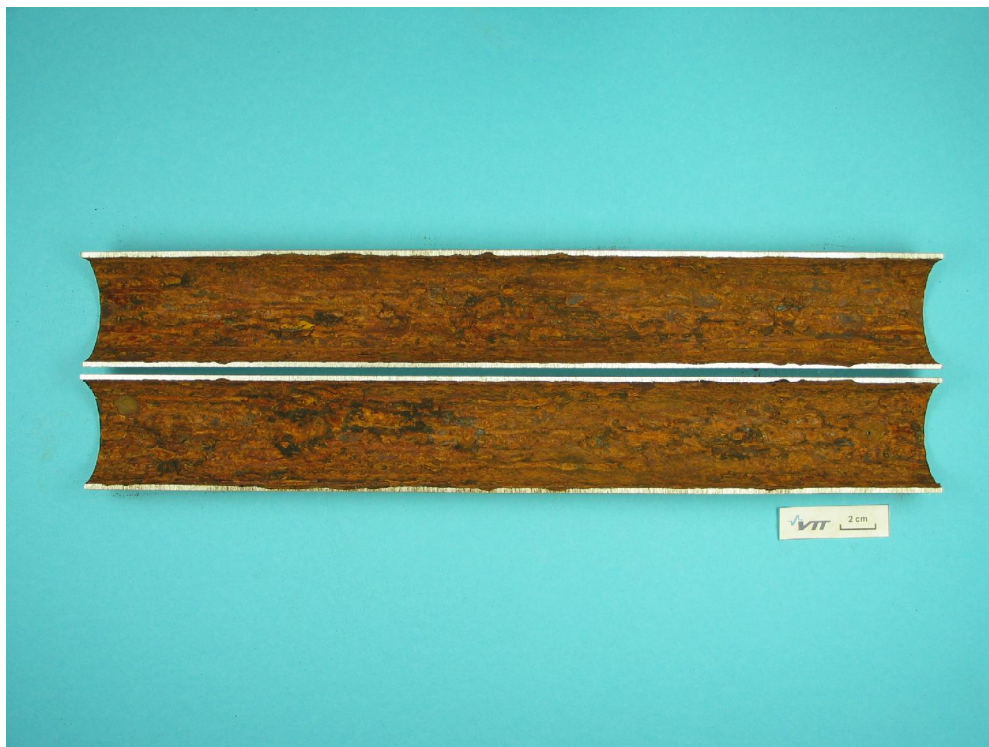
Figure 1. A piece of carbon steel pipe taken from a fire extinguishing system of a stainless steel factory after 20 years of use.

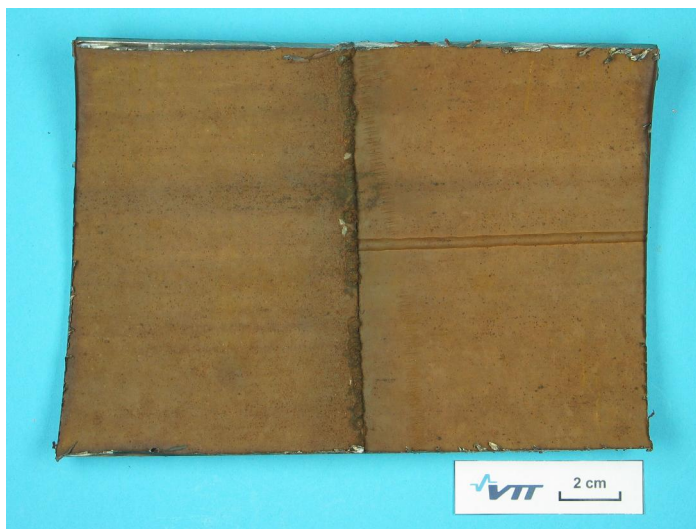
Figure 2. Inner surface of sample 1.

The brown deposit area of sample 1 was found to contain iron (Fe), oxygen (O), carbon (C) and chromium (Cr) as main components as well as manganese (Mn), nickel (Ni), silicon (Si), aluminum (Al), calcium (Ca), sulfur (S) and phosphorus (P), Table 2, page 21. The corroded area contained besides the elements mentioned already also titanium (Ti) and molybdenum (Mo). The amount of chromium and nickel were higher at the corrosion area than on the uncorroded surface, Table 2. Iron, chromium and nickel are the main components of stainless steel, so main parts of these originate from the stainless steel. Also part of the manganese, molybdenum and silicon originates from the material and the rest of these as well as aluminum, calcium, sulfur and phosphorus originate from the environment (water).

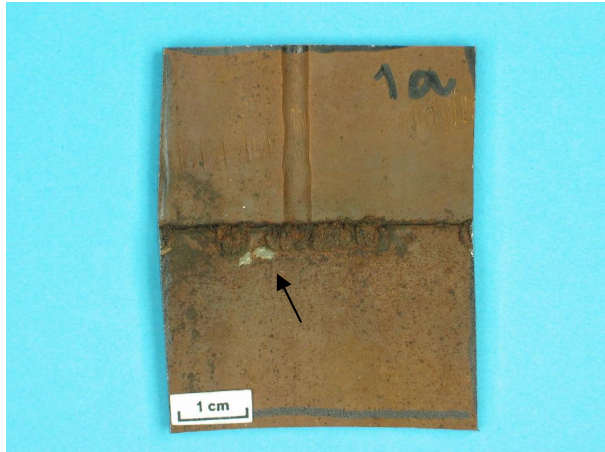
Figure 3. Starting pitting (an arrow) on the heat affected zone of a weld of sample 1.

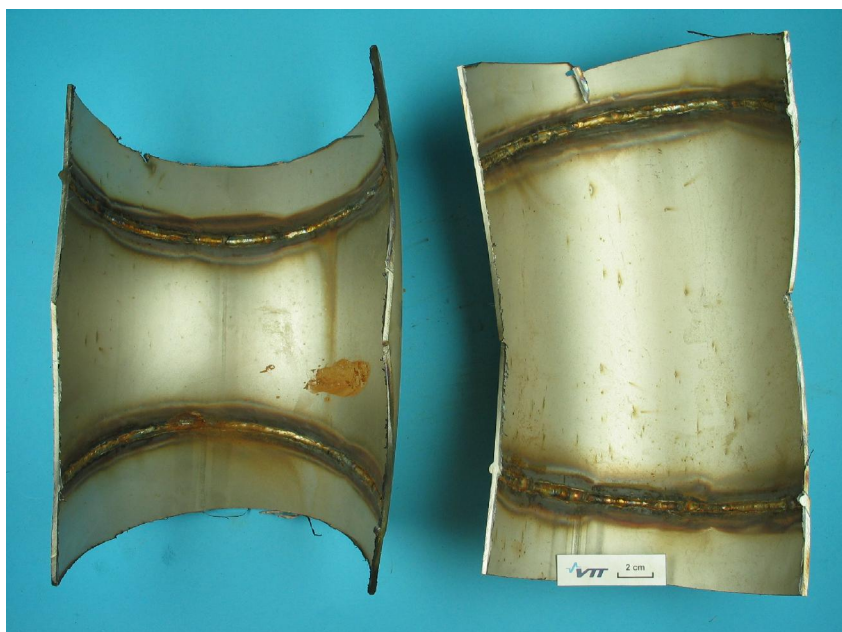
Sample no. 2 did not have a continuous brown deposit layer as sample 1. Instead reddish brown deposit could be seen surrounding the corrosion areas on the heat tint areas as well as some deposits on the inner surface close to the weld, Fig. 4 and 5. Very strong heat tint colors (dark brown and blue) could be seen surrounding the field welds of this sample.

Figure 4. The inner surface of sample no. 2.

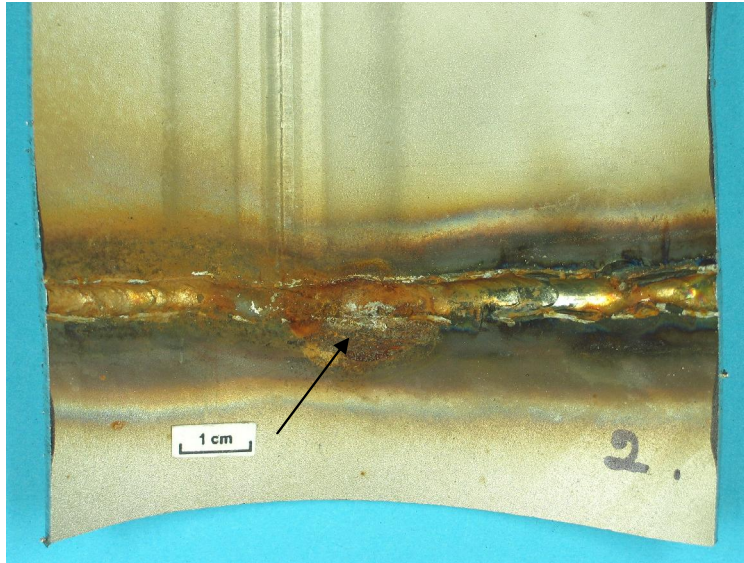
Figure 5. A closer look to the weld area with pitting corrosion (an arrow).

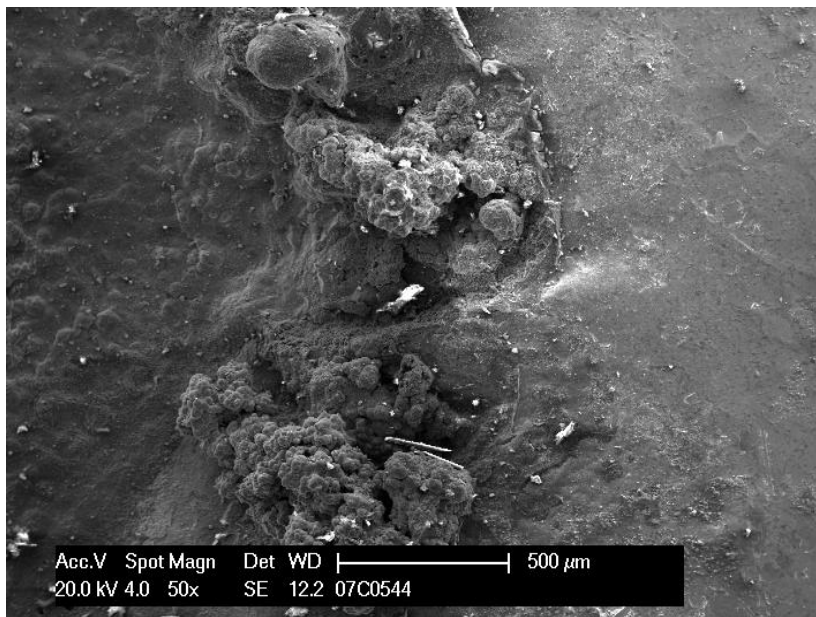
A piece of this sample (Fig. 5) was further divided for studies with SEM/EDS and to prepare a metallographic cross section of the failure area. SEM-examination revealed corrosion products (Fig.6) close to the several small openings of pits (Fig.7).

Figure 6. Corrosion products on the heat affected zone of a weld of sample no. 2. SEM-figure.

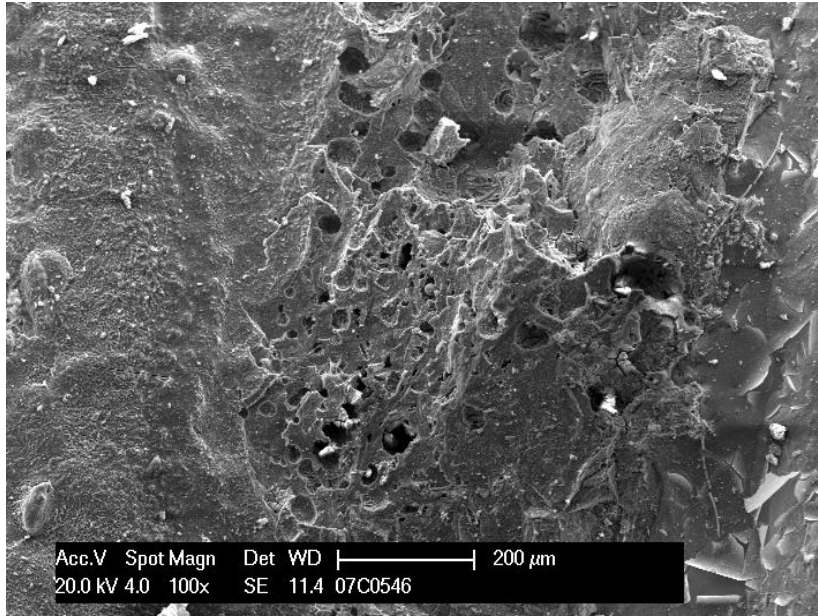
Figure 7. The corroded area of heat affected zone of sample no. 2. SEM-figure.

According to the EDS-analysis the corroded area was found to contain besides the main components iron, carbon and oxygen, also nickel, chromium, manganese, zinc (Zn), titanium (Ti), sulfur (S), chlorine (Cl) as well as sodium, calcium, potassium, silicon and aluminum, Table 2, page 21. Zinc, carbon, part of manganese, titanium, chlorine indicating the chlorides, sodium, sulfur and potassium originate from the water.

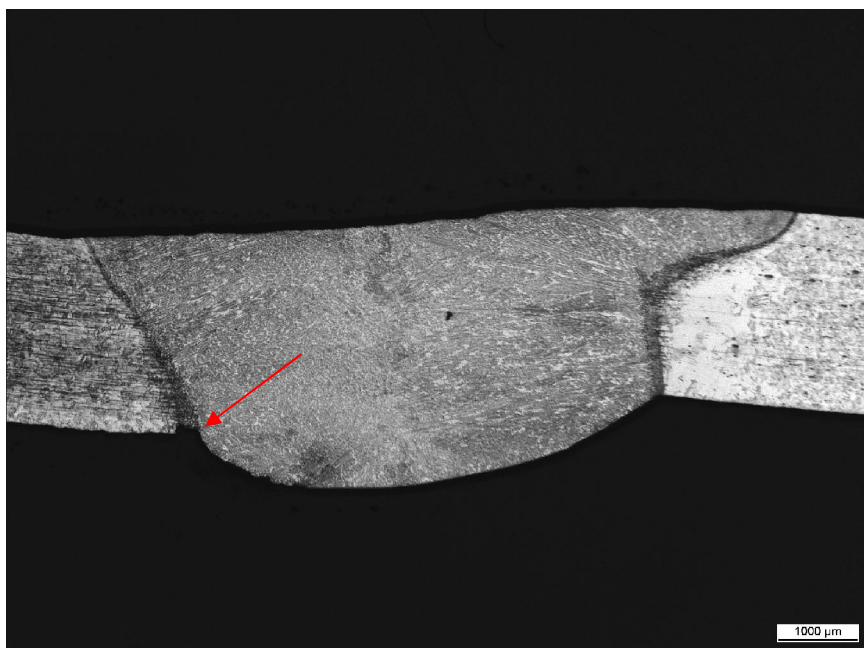
The cross section prepared from the failure area first revealed only a small opening of a pit adjacent to the weld at heat affected zone (Fig. 8). When the grinding was continued, it could be seen that corrosion had proceeded deeper inside the pipe, Fig. 9.

Figure 8. A small opening of a pit on the inner surface of the sample no. 2.

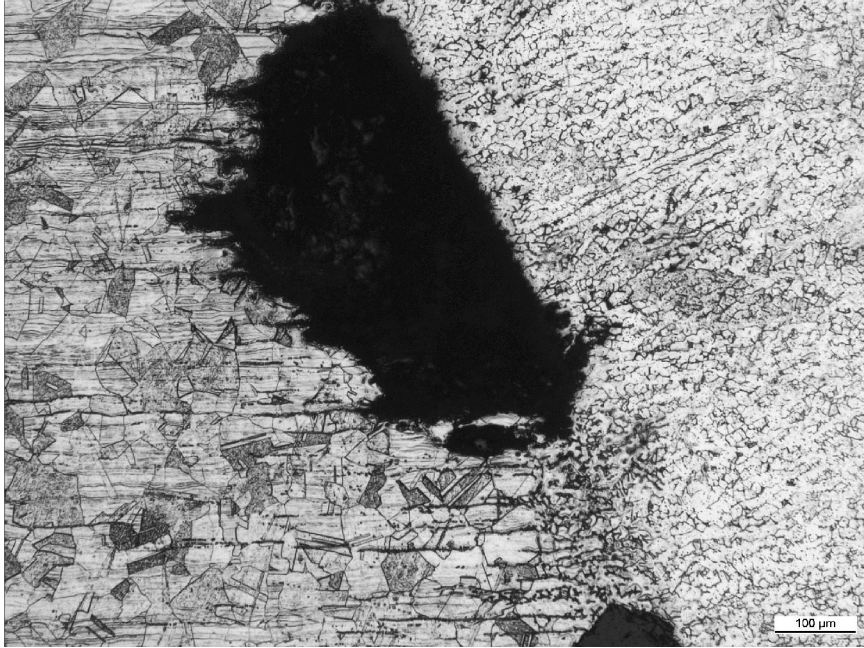
Figure 9. A corrosion pit growing along the heat affected zone (fusion line) of a weld of sample no. 2.

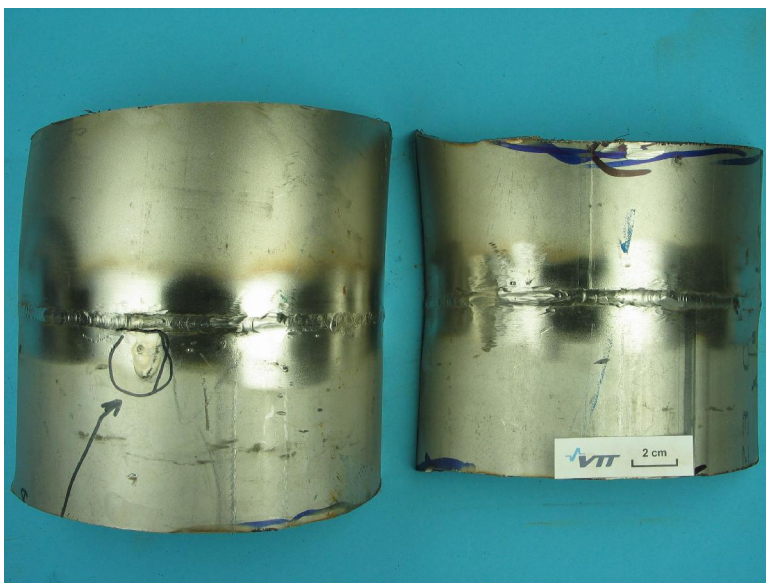
Sample no. 3 had a perforated pit, which could be seen on the outer surface of sample 3, Fig. 10. The outer surface was other wise clean and only a little brown deposit was seen under the stereomicroscopic study. On the contrary on the inner surface of sample 3 there was a lot of reddish brown deposit on and close to area with perforated pit, Fig. 11 and 12. Also in this sample dark colors (brown and dark blue) of heat tint were seen.

Figure 10. A perforated pit marked with an circle and an arrow on the outer surface of sample no 3.

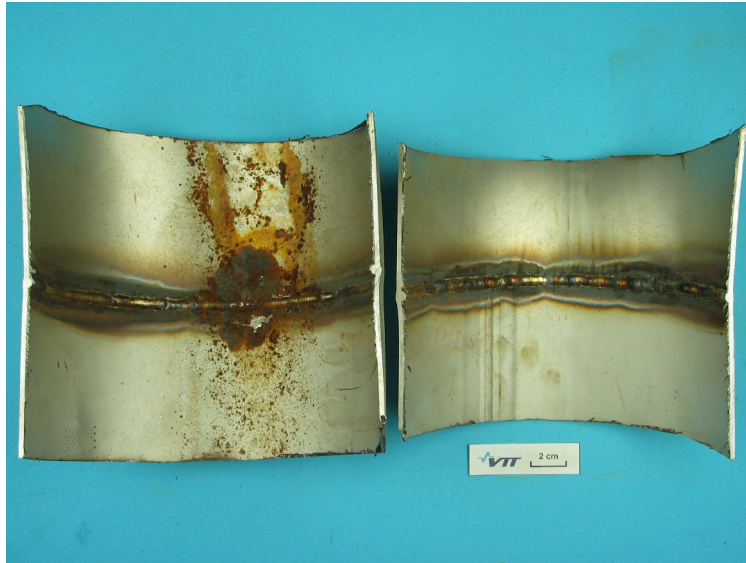
Figure 11. The inner surface of sample no. 3.

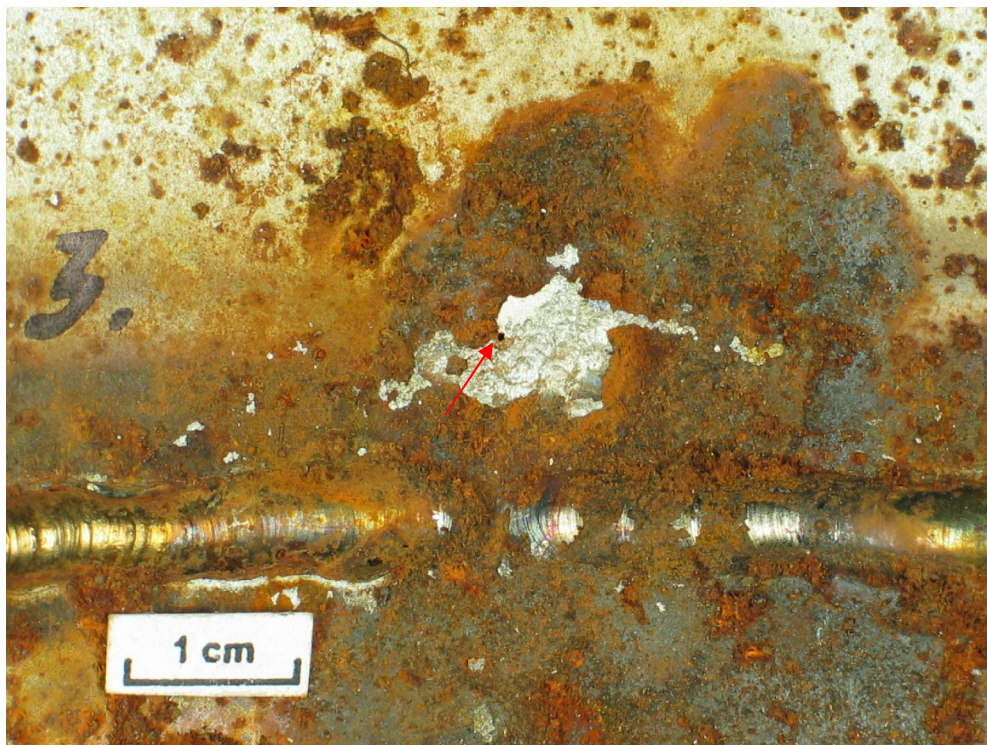
The red brown deposit on the inner surface contained partly also some small metallic particles, which might be originating from the cutting the samples. After carefully removing some of the deposit, a shiny corroded area was revealed, Fig. 13. The red brown deposit was found to contain besides the main components; iron and oxygen, also carbon, manganese, sulfur and titanium among others, Table 2, page 21. Sulfur and manganese as well as copper was detected on the corroded shiny area. Phosphorus and sulfur were detected in the pit. Manganese and sulfur were detected also on the non-corroded area of the inner surface of sample no 3.

Figure 12. An opening of a perforated pit surrounded by corroded shiny area on the inner surface of sample no. 3.

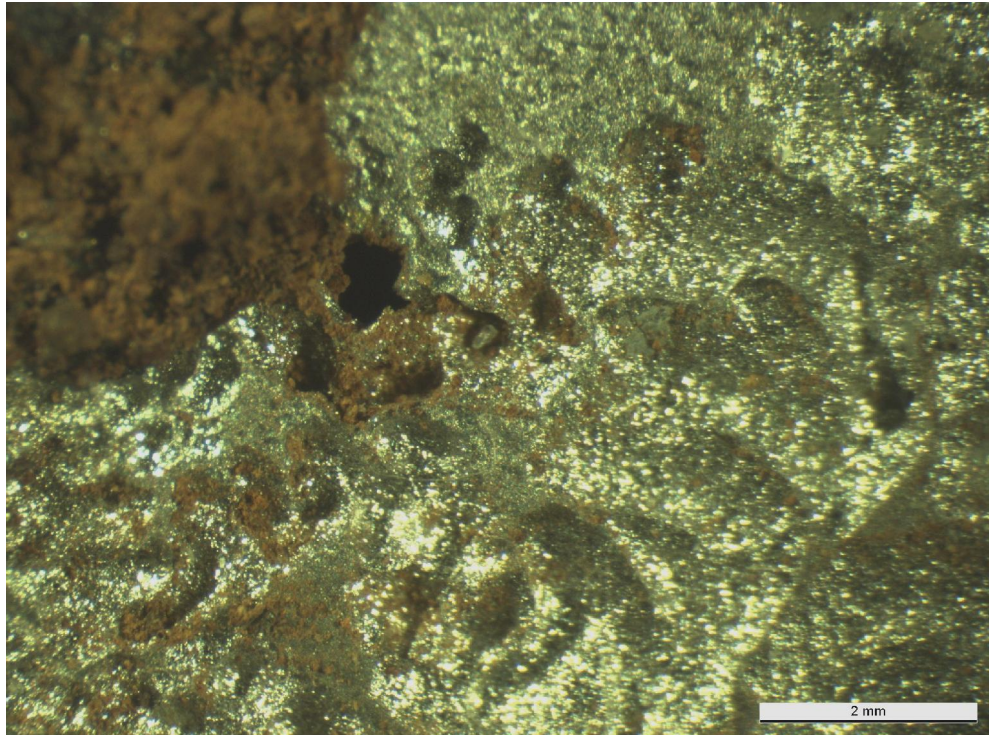
Figure 13. A closer look to the corroded area on the heat affected zone of a weld on the inner surface of sample no. 3.

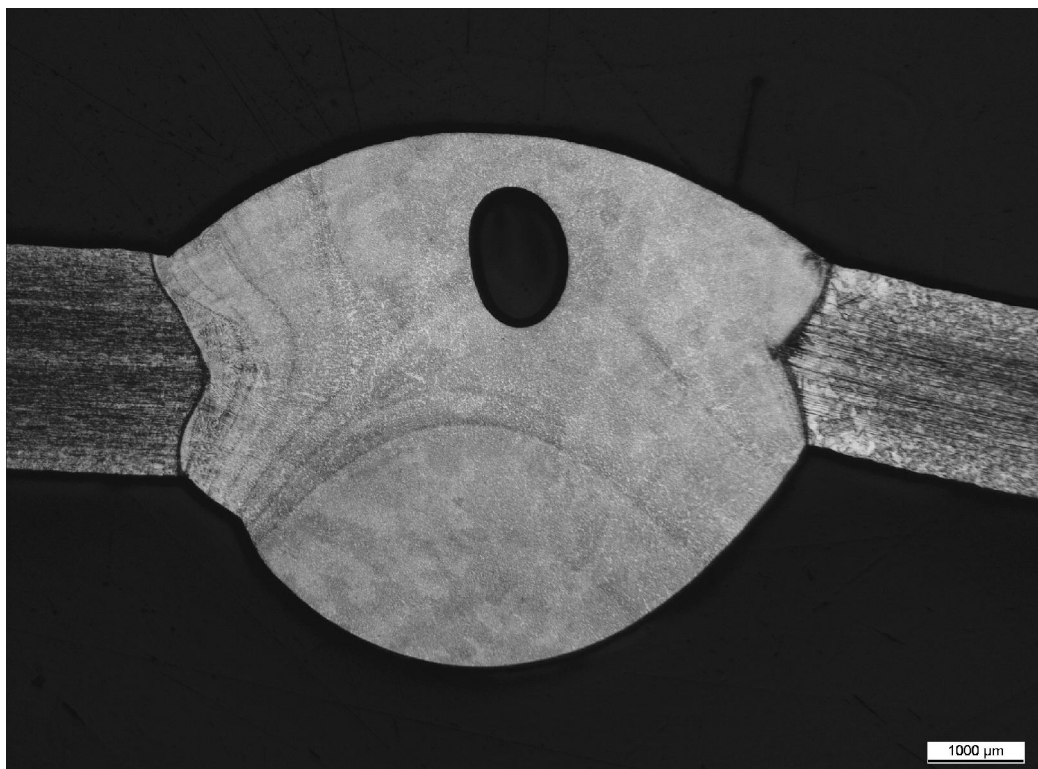
A cross section was prepared from the area close to the perforation. From this cross section it could be detected that in this sample the weld had one gas pore, Fig. 14. A small pit could be seen on the base material (under the heat tint area) close to the perforated area, Fig. 15 as well as one on the fusion line (not seen in this figure).

Figure 14. A pore in the weld of sample no. 3.

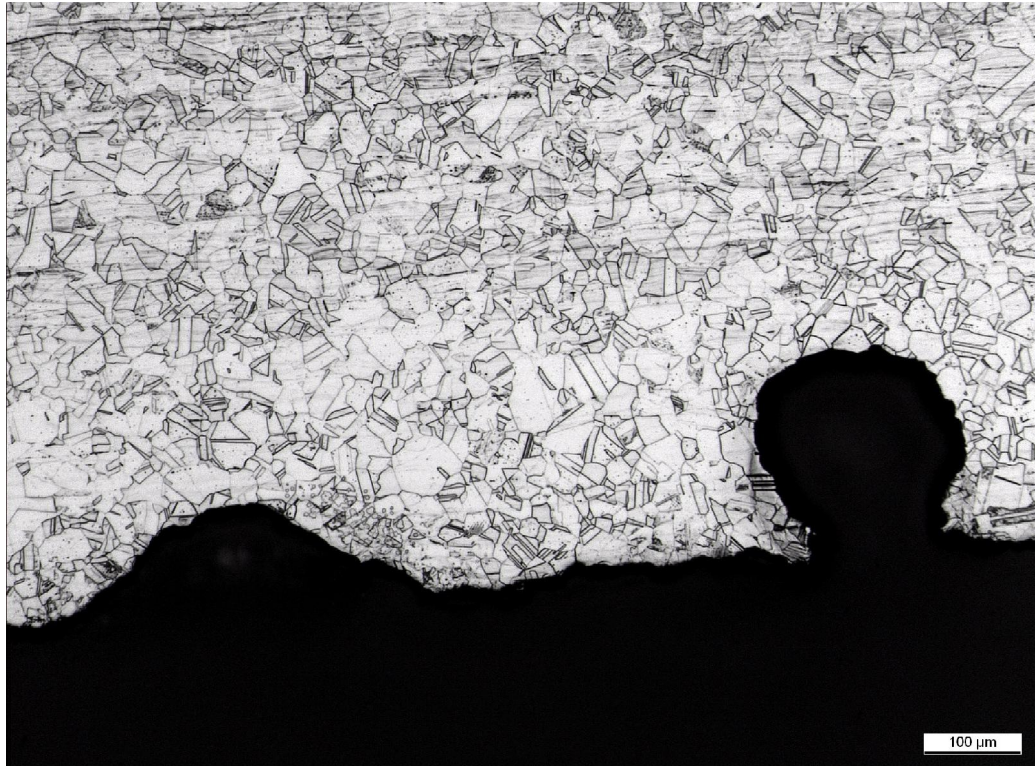
Figure 15. Corrosion on the inner surface of stainless steel pipe sample no. 3.

The metallographic examination did not reveal any abnormalities in the microstructure of this sample and the microstructure was considered to be normal austenitic structure (Fig. 15).

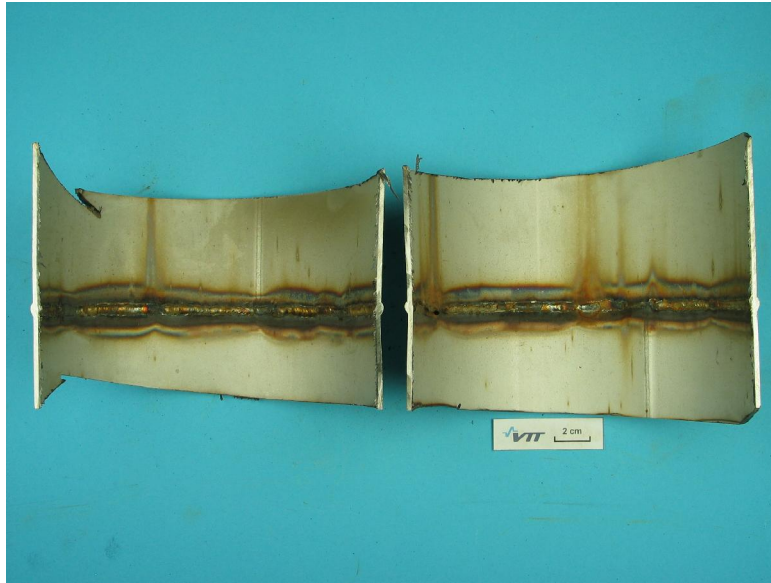
Sample no. 4 was clean on the outer surface without any signs of perforation. The examination of the inner surface, Fig. 16 revealed again very dark heat tint colors and several small pits on the heat affected zone, Fig. 17 and 18.

Figure 16. The inner surface of sample no. 4.

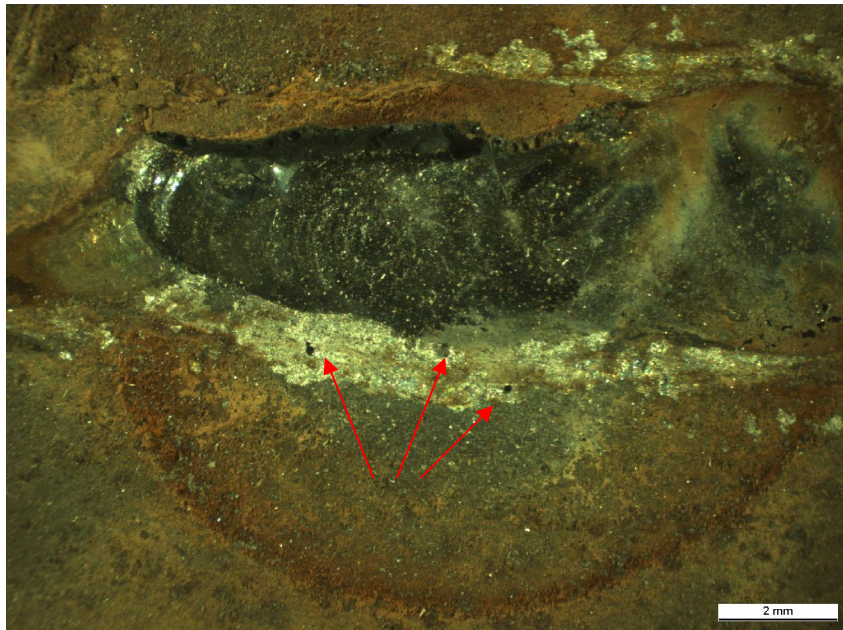
Figure 17. Pits (marked with arrows) on the heat affected zone of a weld on the inner surface of sample 4.

In sample 4 the fusion line of the weld was partly shiny and small pit holes could be seen on those areas. The weld was uneven and partly incomplete. In Fig. 17 a ring with remains of corrosion products can be seen, which is a typically seen on pitting corrosion cases of stainless steels in natural waters. The amount of deposit was low and probably most of the corrosion products were removed during the removal and transporting of sample.

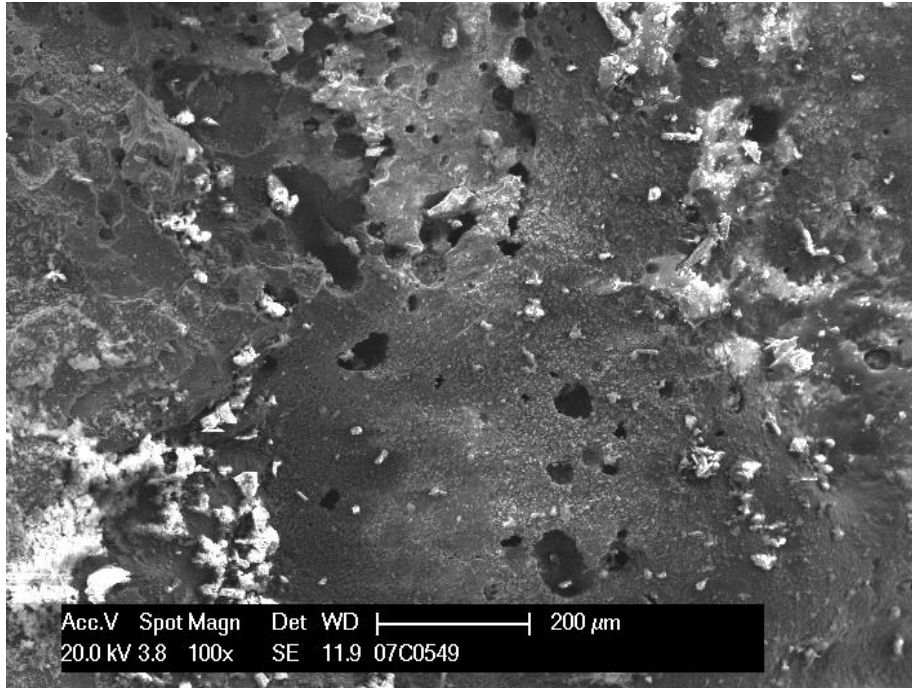
Figure 18. Corrosion pits on the heat affected zone of the weld of sample 4. SEM-figure.

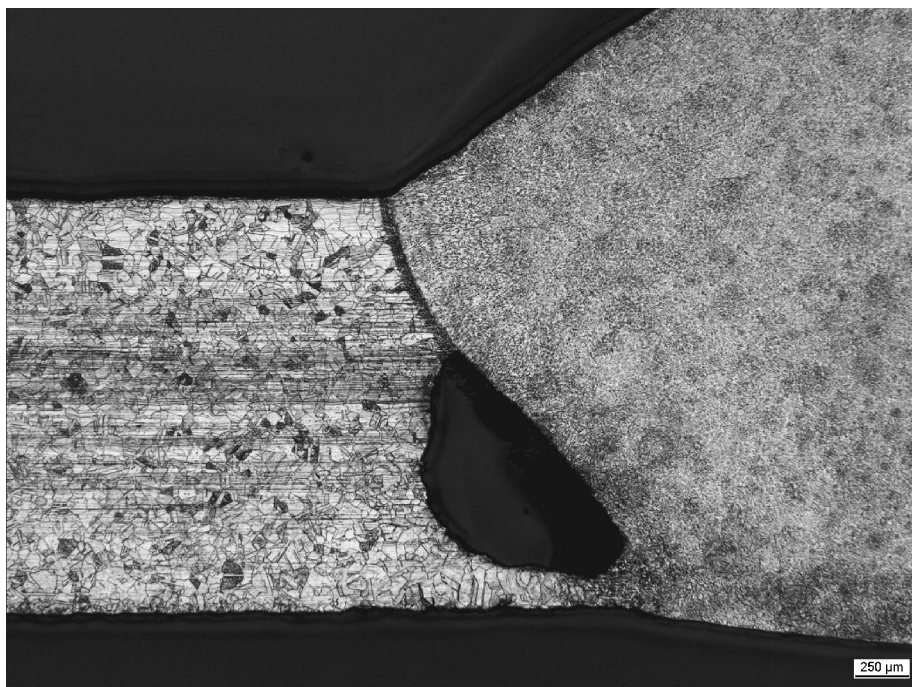
A cross section from the failure area shows an example of a large pit in the heat affected zone, Fig. 19.

Figure 19. A large pit in the heat affected zone of sample 4.

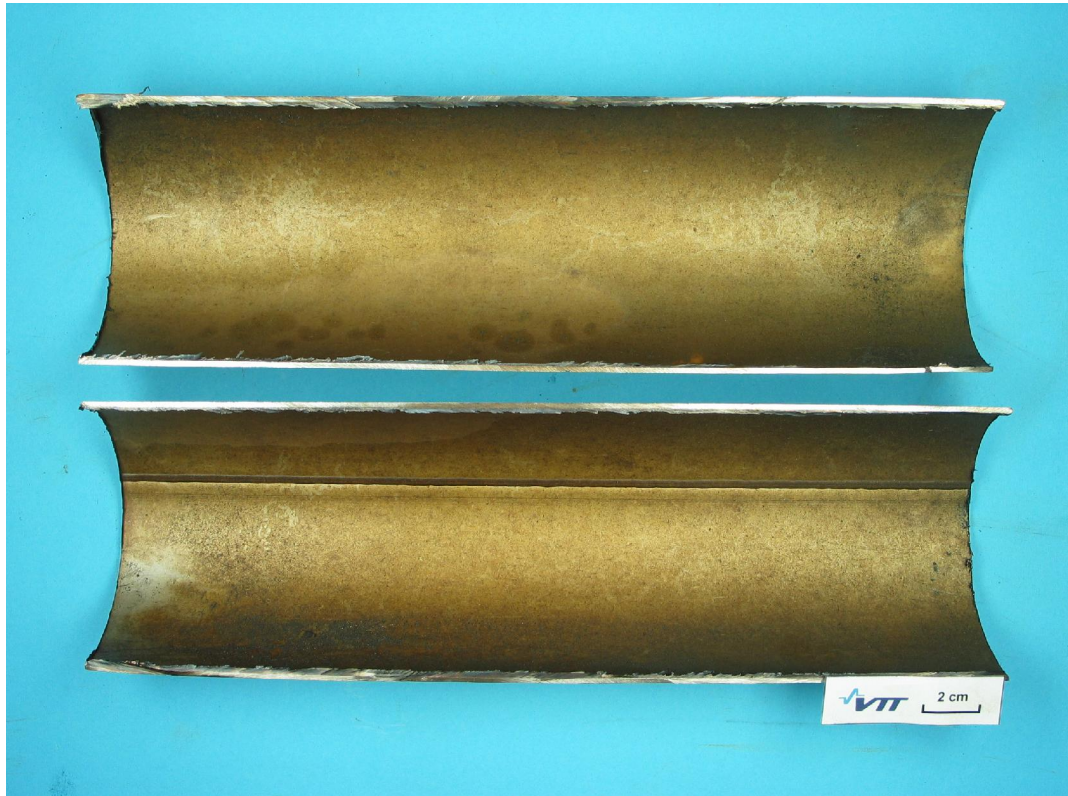
Sample no. 5 containing factory made weld, was taken from the hot rolling mill fire protection system (FPS). In this sample no corrosion could visually be seen, Figure 20. No heat tint areas were seen on this sample. No failures have been detected in this fire protection system, although field welds have been made also with manual metal arc welding, like in the FPS of the cold roll mill.

Figure 20. The inner surface of sample 5 taken from the hot rolling mill FPS.

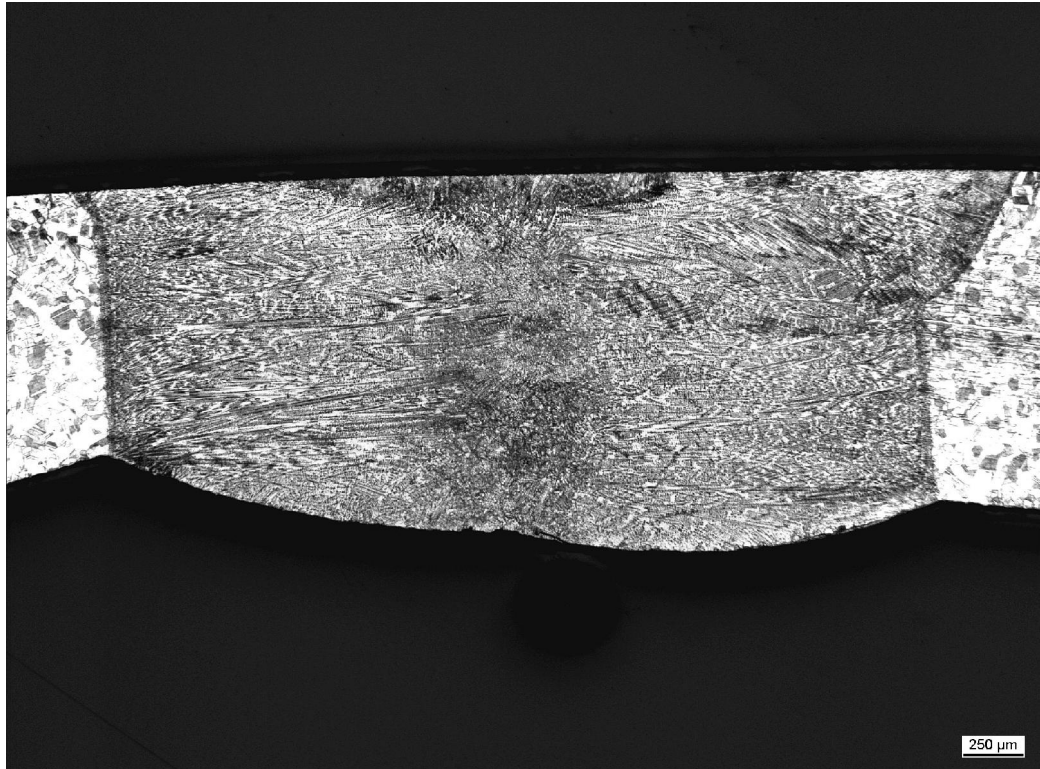
A cross section performed from the weld area revealed a normal microstructure of the pipe material and a good quality weld seam, Figure 21. With a higher magnification some starting, negligible corrosion could be seen in the weld on the inner surface of the pipe, Figure 22.

Figure 21. A cross section of the weld of sample no. 5.

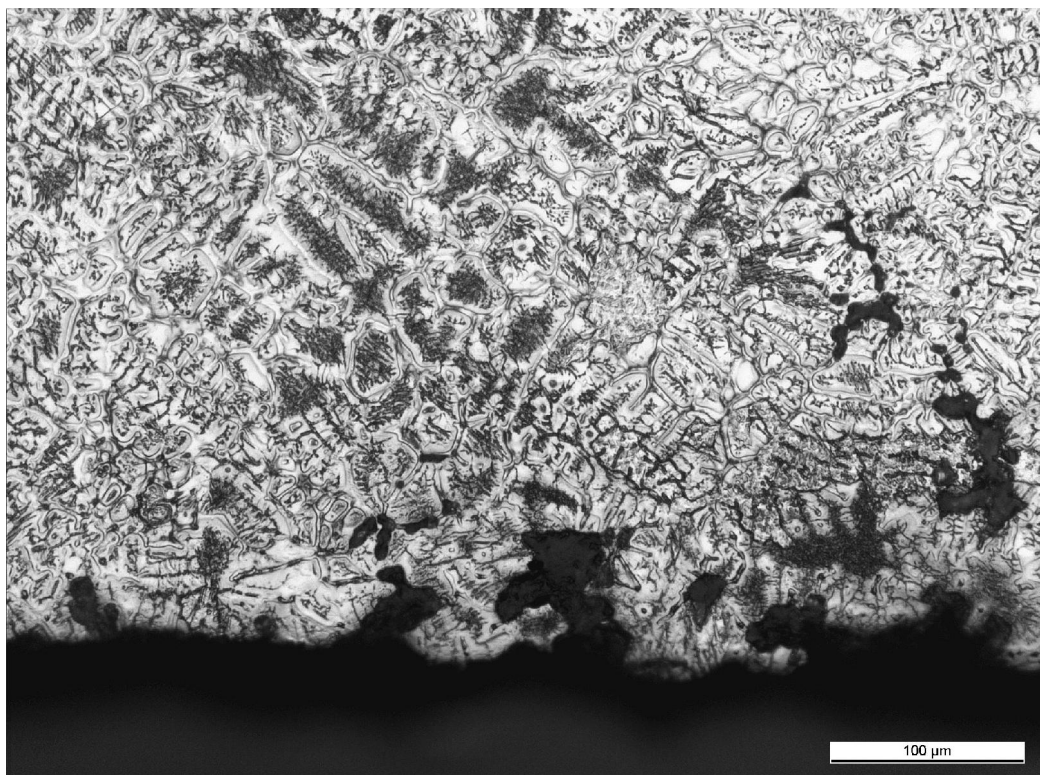
Figure 22. A closer look to the weld area with incipient corrosion.

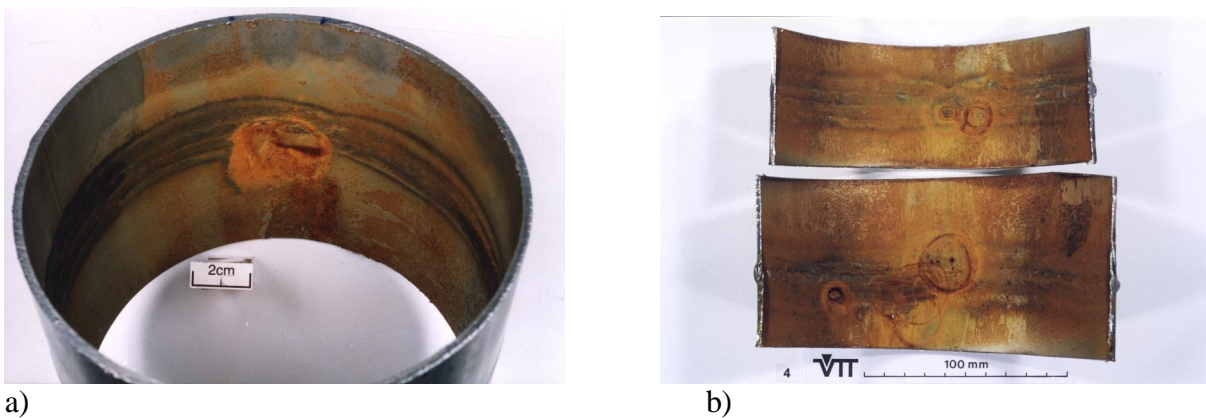
Visual inspection of the pipe sample revealed two perforations on the outer surface of the sample. These perforations situated at the heat affected zone close to the fusion line of the weld. A plenty of reddish brown deposit was seen on the opposite inner side (Fig. 23a). Similar reddish brown deposits and deposit rings were observed on the inner surfaces of type EN 1.4301 stainless steel removed from the fire extinguishing system later on (Fig. 23b). Typically the openings of the pits were very small but having large subsurface cavities (Fig. 24). The chemical compositions of these type EN 1.4301 stainless steel samples were according to the specifications in ASTM standards except for some of the samples having less than 18 % Cr (17 and 17.7 %). The microstructure of both materials was normal austenitic structure. Pits were typically situated close to or in girth site welds. There were clear signs of oxidation of heat affected zone (heat tints) but no other clear signs of welding defects on the failure areas.

Figure 23. a) Reddish brown deposit seen on the inner surface of stainless steel type EN 1.4401 pipe section removed from the fire extinguishing system b) deposit rings surrounding pits on the welded areas of stainless steel type EN 1.4301 pipe samples removed later from the same fire extinguishing system.

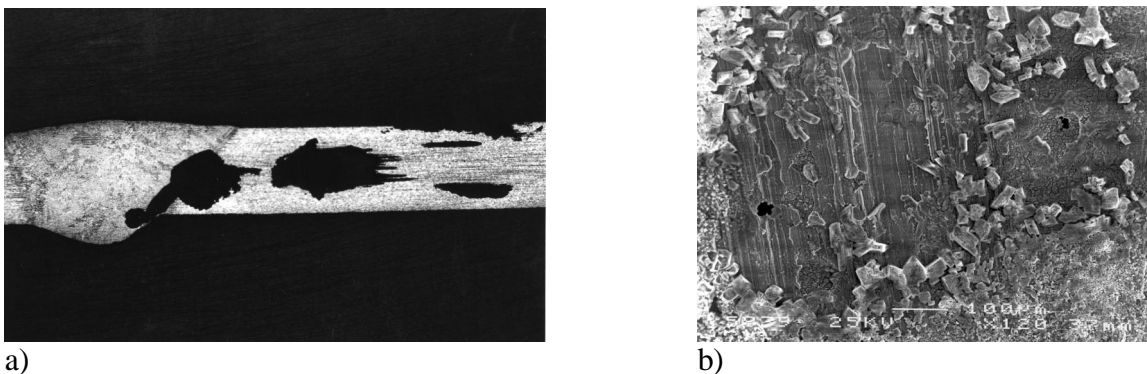
Figure 24. a) An optical micrograph of a through wall, mainly subsurface pitting corrosion in EN 1.4401 type of stainless steel after two years service in fire extinguishing water b) Two small openings of pits revealed on the inner surface of stainless steel EN 1.4301 after corrosion products were removed by pickling.

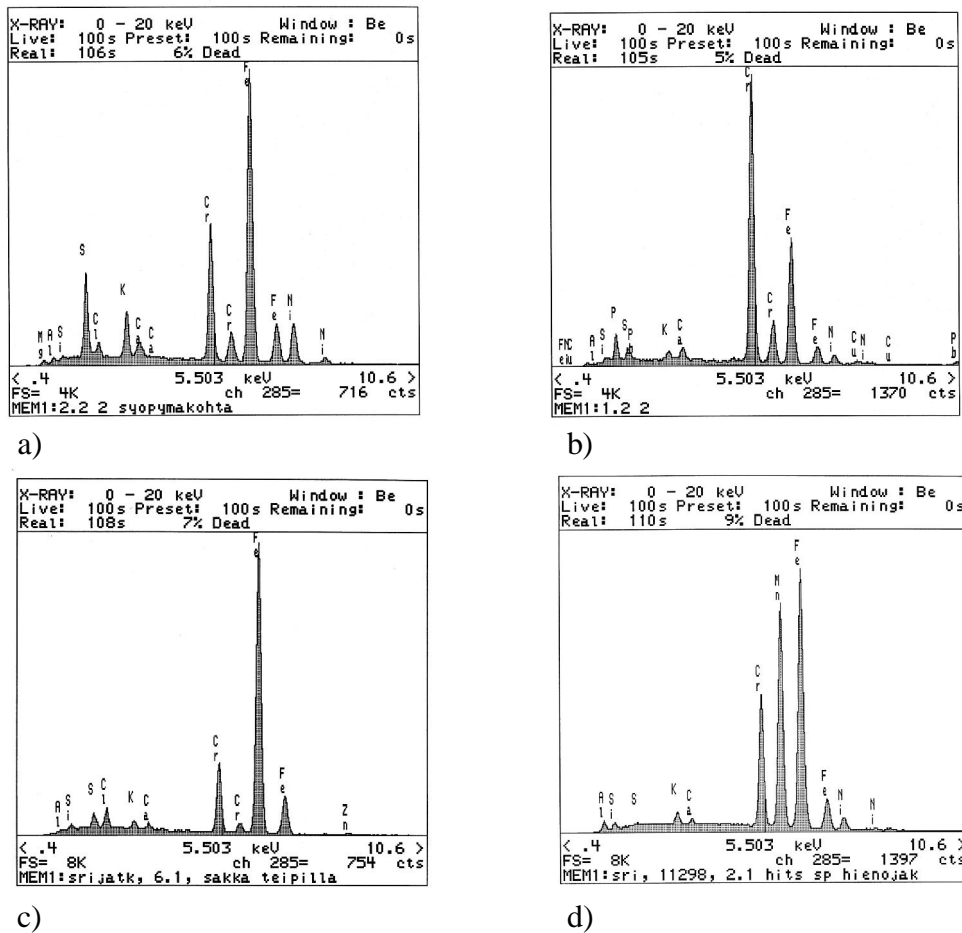
The pits were typically surrounded by dark brown circular deposit ring and the inner surfaces were most of the times covered with thin rather smooth layer of yellowish brown deposit. Sulfur and occasionally also high amounts of manganese as well as small amounts of phosphate were detected on the deposits in or surrounding the pits (Fig. 25). These elements are often found in the cases of MIC.

Fig. 25. EDS-analysis performed a) and b) from a pitted area on the inner surface of type 304 stainless fire extinguishing pipe, c) from a dark deposit removed from the surface of a weld, d) from the deposit covering the inner surface containing a transversal weld.

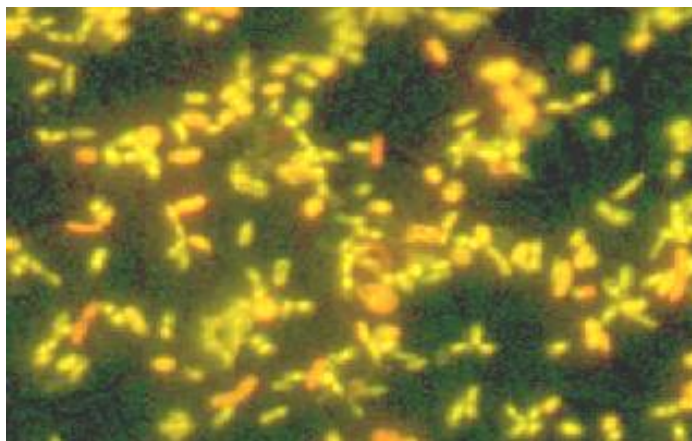
The presence of iron bacteria (bacteria growing on ferrous sulfide medium) was verified from the sample delivered to the laboratory under the water taken simultaneously from the fire extinguishing system under consideration. The amount of heterotrophic aerobic bacteria both in this sample as well as in the water taken simultaneously from the system was rather high (4.3×10^5 and 2.4×10^5 cfu/ml respectively). A plenty of individual rod-shaped bacteria as well as cell aggregates and starting biofilm formation on the stainless steel coupons incubated 6 d in iron bacteria culture medium could be seen under the epifluorescence microscopy, Fig.26.

Figure 26. A plenty of bacterial cells and starting biofilm formation in the deposit analyzed from the failure area on the inner surface of fire extinguishing pipe [22].
