Finland's Emerging Alkali-Aggregate Reaction Problem?

Hannu Pyy
Lic. (Tech), Senior
Research Scientist
VTT Technical Research
Centre of Finland
P.O. Box 1000
FI-02044 VTT, Finland
hannu.pyy@vtt.fi

Erika Holt
Ph.D., Senior Research
Scientist
VTT Technical Research
Centre of Finland
P.O. Box 1000
FI-02044 VTT, Finland
erika.holt@vtt.fi

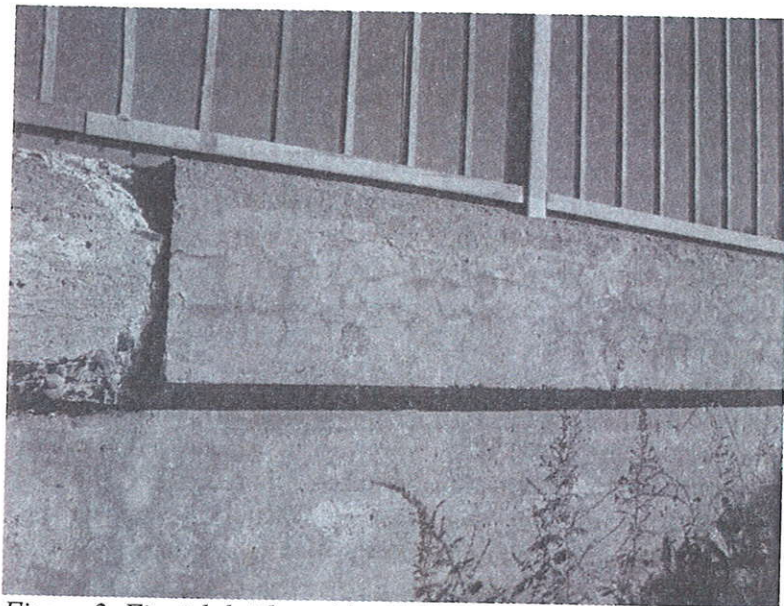
Figure 2. Finnish bridge with side beam having signs of AAR.

AAR in Finnish structures has been investigated at VTT by the use of petrographic thin section microscopy. Such studies have been integrated with studies of in-service structures for 25 years. It is during the past 10 years that AAR has been identified in about 10 bridges from various locations around Finland (Figures 1 and 2). This represents about 2 % of all concrete durability assessments by thin-section microscopy on bridges done at VTT in the past 10 years. In these cases the level of damage varies from low to high. Often the role of AAR has been smaller than the role of other damaging forces. In 2 – 3 of these cases, AAR has played a major role. In these cases initial thin section studies gave a warning about high levels of AAR and a heavier damage than was recognized on site. The studies were completed with additional thin section studies, where strong AAR was found on the bridge decks. Bridge decks are more favoured to AAR than other structures (like columns), because of the use of de-icing salts and occurrence of rain that pools on the decks.

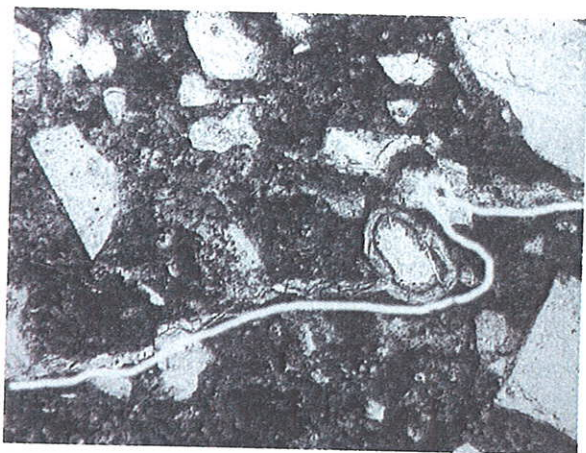
The appearance of AAR has been seen in thin section studies as a gel in the interfacial transition zone between the cement paste and aggregate, as well as in gel filling in cracks running from the reacted aggregates as a result of expansion and as cracked aggregates (Figure 3). The appearances are in-line with international guidelines [1]. During one petrographic study at VTT, it was even possible to see clear AAR gels coming out from the cored concrete surface a few days after the samples were taken.

Figure 3a. Cracks and AAR gel in concrete (marked with yellow) from a Finnish bridge.

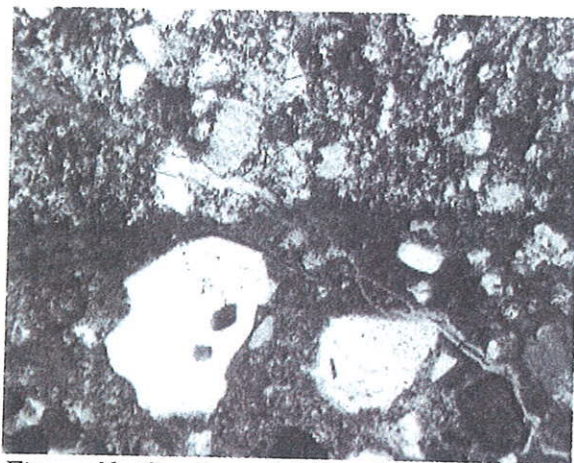
Figure 3b. Cracks and AAR gel in concrete from a Finnish paper mill.

In addition to bridges, AAR has also been found in other Finnish structures. For instance, AAR has been seen in industrial indoor structures where the conditions are favoured, i.e. the temperature is high (even 30-40 °C) and the relative humidity is high. In the case of a Finnish swimming pool and in a paper mill (Figure 3b), the concrete structures have been wet during the use or manufacturing processes respectively.
