(S)TEM analysis of OFP copper CT-tested in S containing groundwater

Authors: Janne Pakarinen

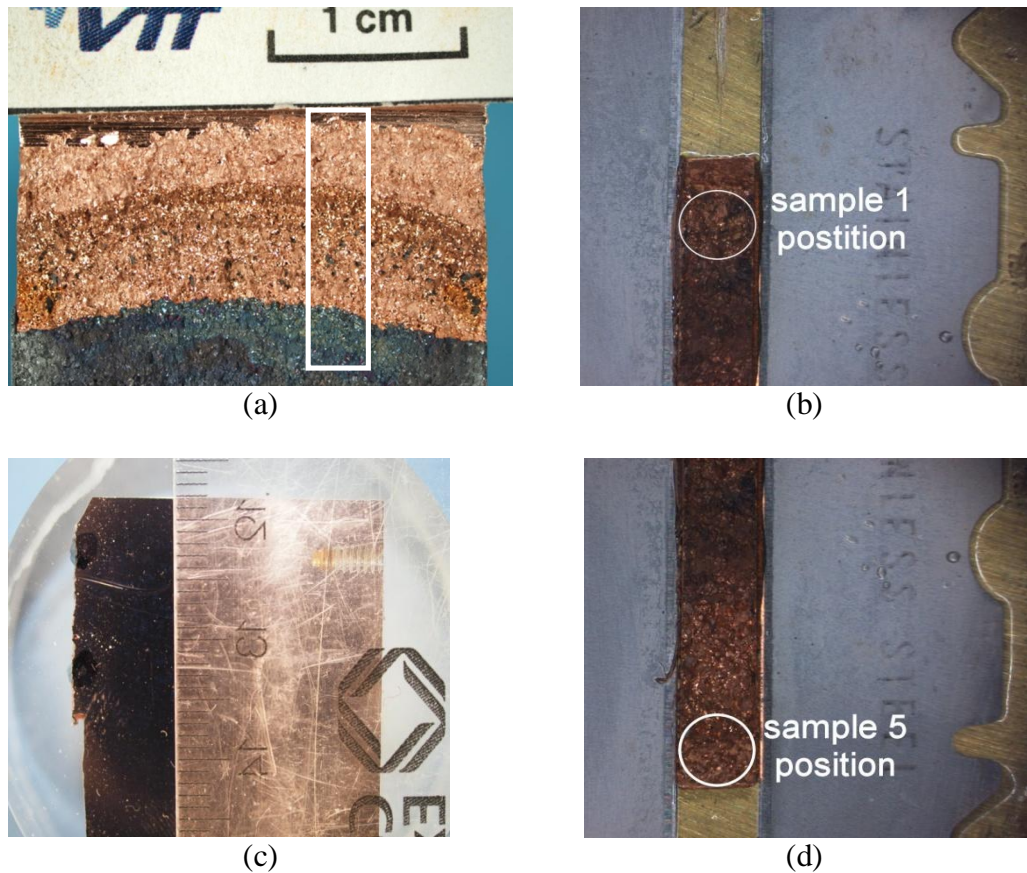
Fig. 1. Macro images of the examined sample. The fracture surface and side view of the C- sample are shown in (a) and (c), while the positions of TEM specimens CuHa1 and CuHa5 are shown in (b) and (d). The white box in (a) shows the approximate position of which samples were punched. The white circles in (b) and (d) are 3 mm in diameter.

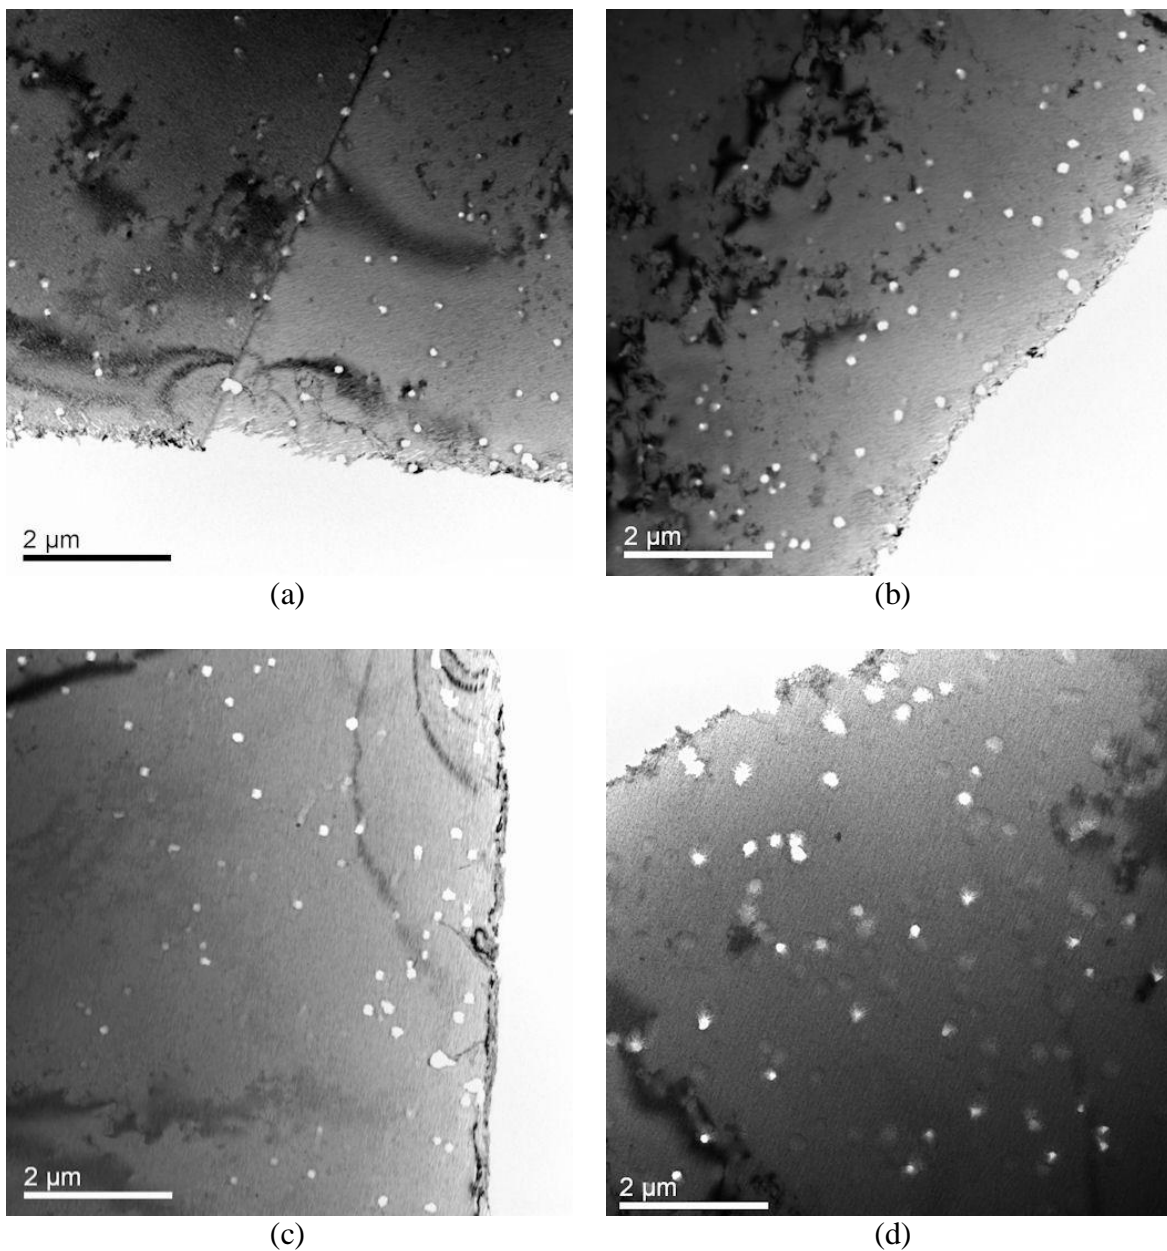
The general appearance of the examined samples Ref3 and Ref4 is shown in Fig. 2. Most distinctly, all the examined samples showed a large amount of holes that were most likely a consequence of particles dropping out during the electrolytic polishing procedure. There was no evidence that the amount of holes would have been larger at the grain boundaries as compared to the matrix.

Fig. 2. General appearance of Ref 3 [(a) and (b)] and Ref 4 [(c) and (d)]. The matrix showed a varying distribution of apparent inclusions that were fallen off during electrolytic

polishing of specimens.

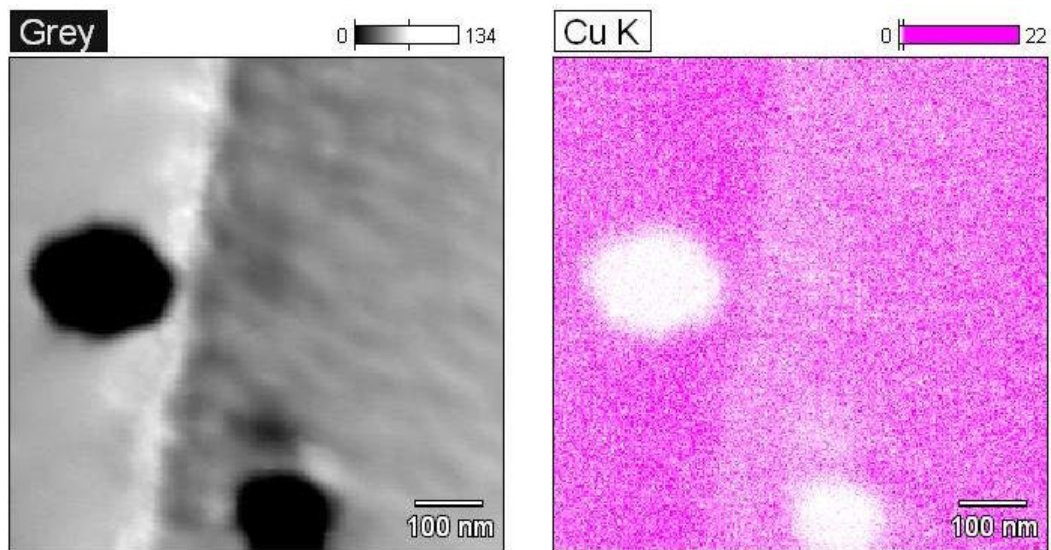
To verify that the holes did not contain any impurities, STEM-EDS maps from the location of fallen particles was done. As shown in Fig. 3 indeed, there were no impurities at the fall out locations. Notice that the reverse contrast between Figs. 2 and 3 is due to STEM images taken in high-angle annular dark field (HAADF) mode. HAADF contrast is especially sensitive to changes in elemental composition. The linear vertical feature in Fig. 3 is a grain boundary, and the contrast variation between the two grains is due to different lattice orientations. The size of the particles was a couple of hundred nanometers.

Fig. 3. STEM-EDS map of a region in Ref3 where couple of inclusions have fallen off from the matrix.

As is also noticed from Fig. 3, the grain boundary did not show any significant signs of segregated elements, although according the experience it would be difficult to see low concentration in a STEM-EDS map. Further examination on grain boundaries were made by using spot analyses.

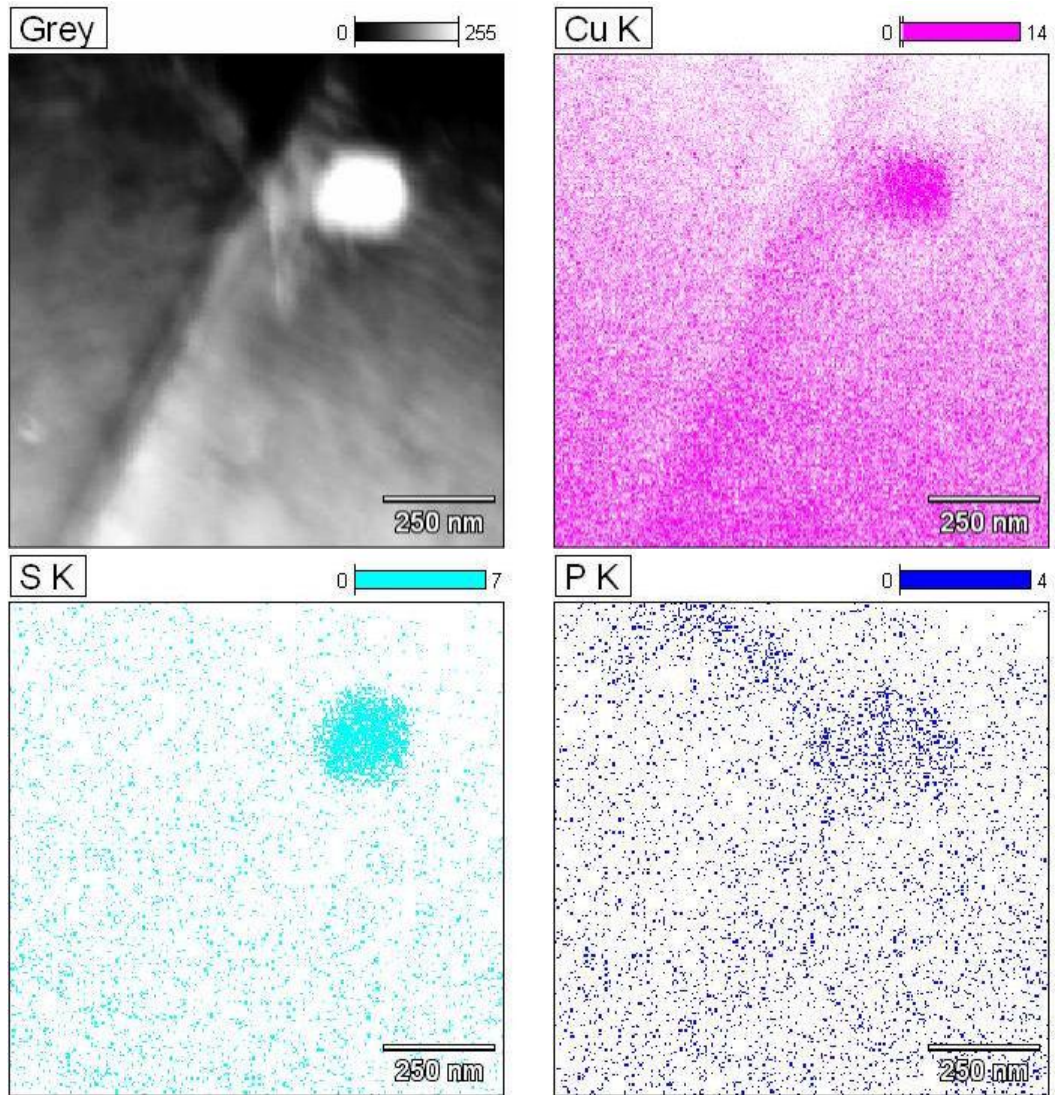
Fig. 4. Particle in Ref 3 foil edge. Clear signs of Cu, S and P detected by STEM-EDS.

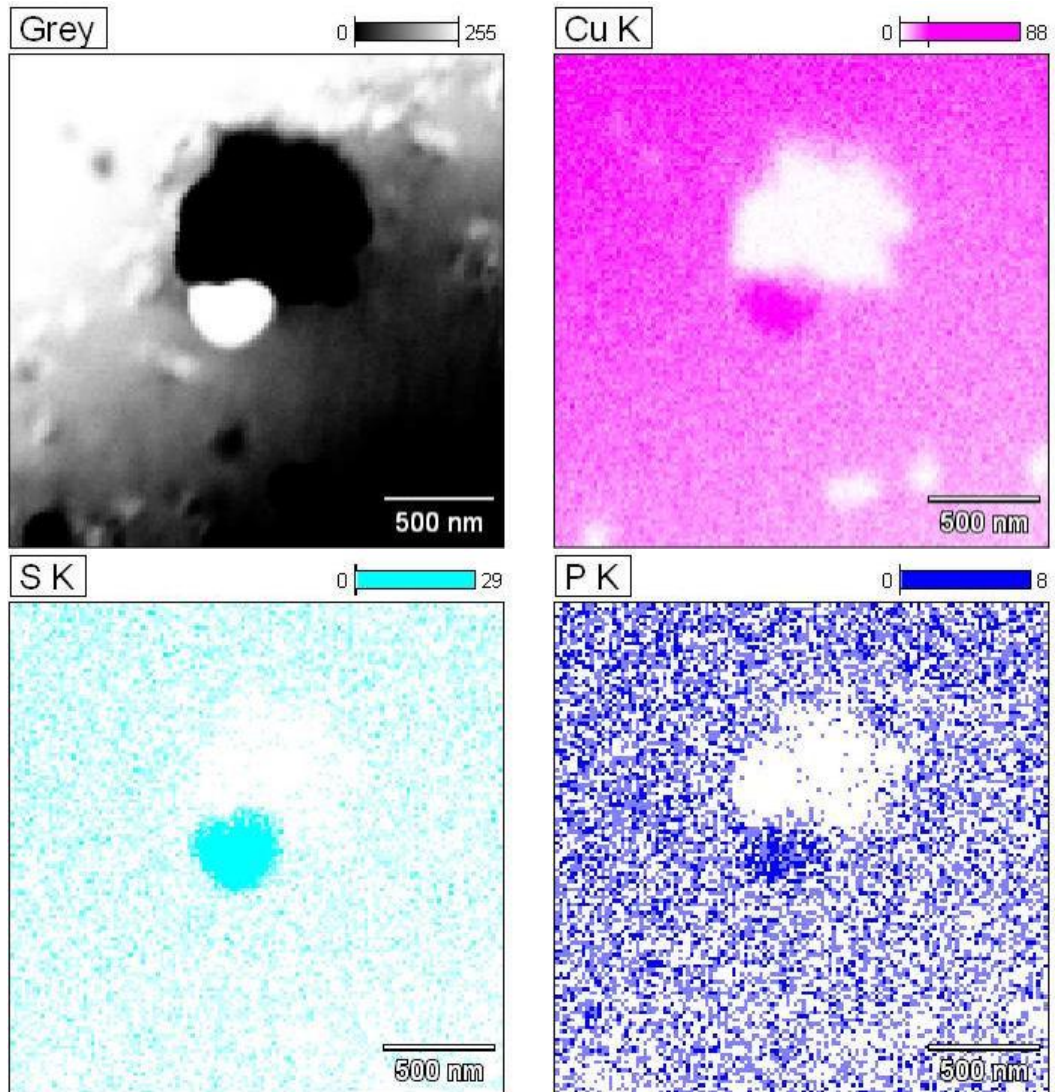
Fig. 5. Particle sitting at the edge of the hole in Ref 4. The particle clearly contains S and some P.

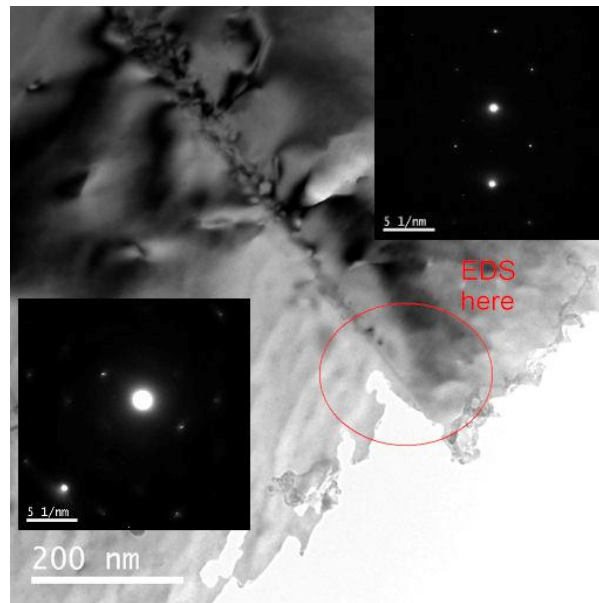
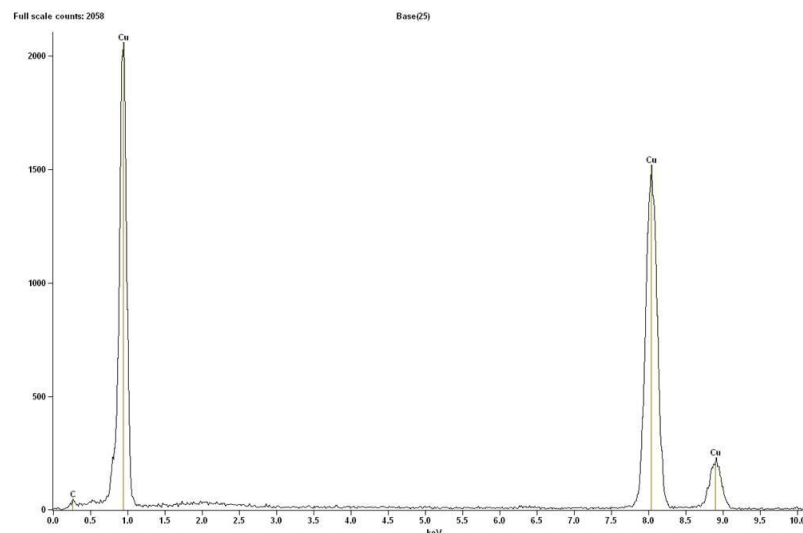
Several grain boundaries of the reference samples were examined by using spot analyzes. Fig. 6 shows one of the analysed GBs. Selected area diffraction (SAD) patterns from the neighbouring grains show that there's a difference in crystal orientation, as expected. EDS spot analyses from the region shown inside the red circle in Fig. 6 did not show any impurities at the GB. A representative EDS spectrum shown in Fig. 6 (b) contains only a weak peak from C contamination and clear emissions related to Cu.

Fig. 6. Grain boundary analyzed by using a small probe and EDS. (a) shows the examined region, while (b) shows a representative EDS spectrum (nothing but Cu and C contamination present) from the GB.

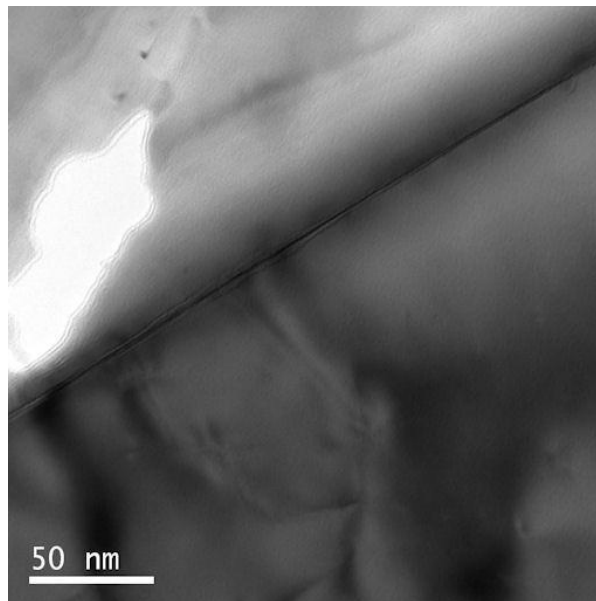
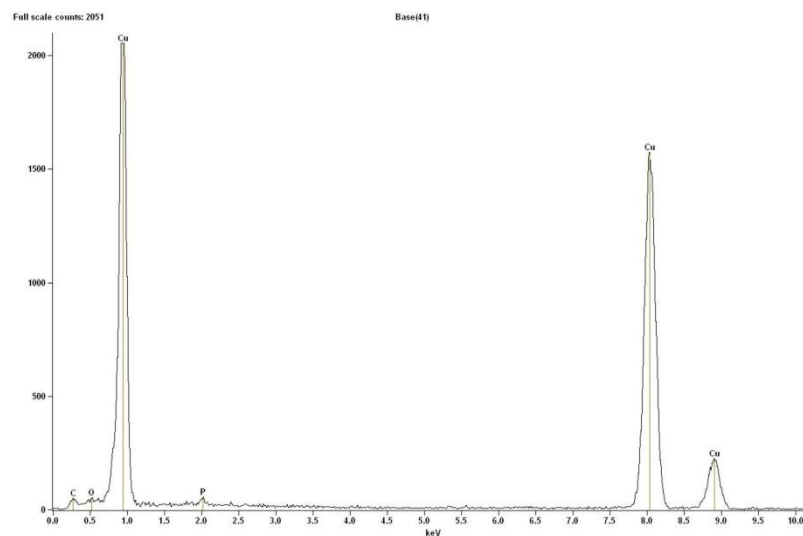
Another grain boundary of Ref7 showed a weak but observable signal of phosphorus on the grain boundary. The amount of phosphorus ranged from 0.5 to

1 % wt. The examined region as well as one of the obtained EDS spectra is shown in Fig. 7.

Fig. 7. Another grain boundary analyzed by using a small probe and EDS. (a) shows the examined region, while (b) shows a representative EDS spectrum.

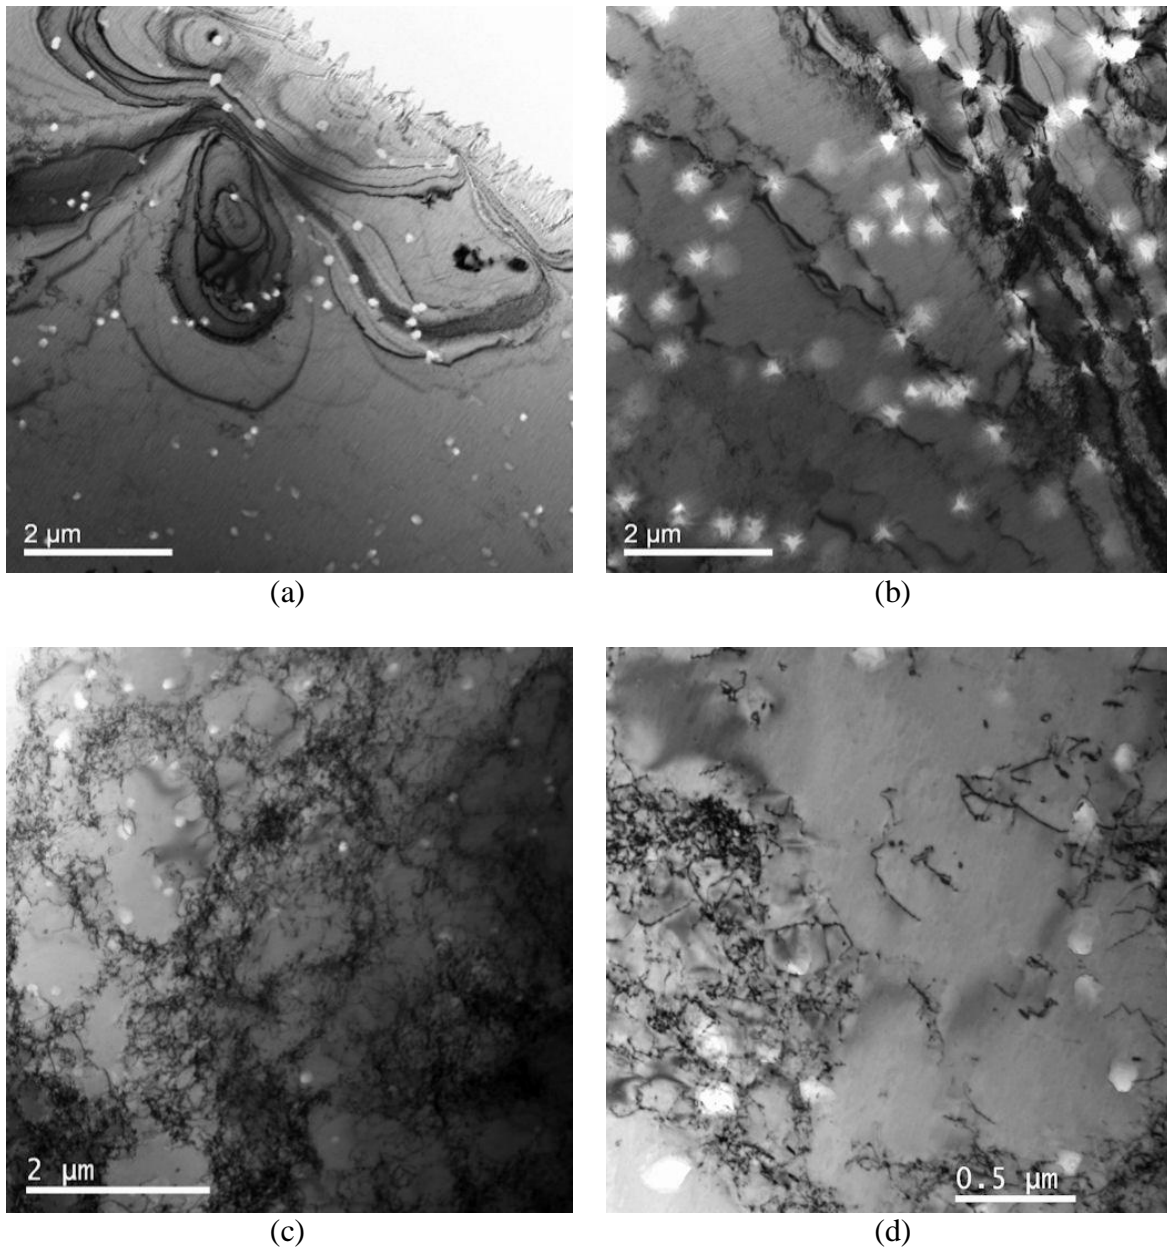
Specimens for CuHa1 and CuHa5 were fabricated from the proximity of the fracture surface of the CT-sample, as described earlier in Section 2. Specimen CuHa1 was from the first fractured region, while CuHa5 was from the last fractured region. The general appearance of the microstructures in CuHa1 and CuHa5 closely resembled that observed in the reference samples. A large amount of holes was found as a consequence of apparent falling out of particles from the matrix.

Fig. 8. General appearance of the matrix showed a varying distribution of apparent particles that fell out during electrolytic polishing of the specimens.

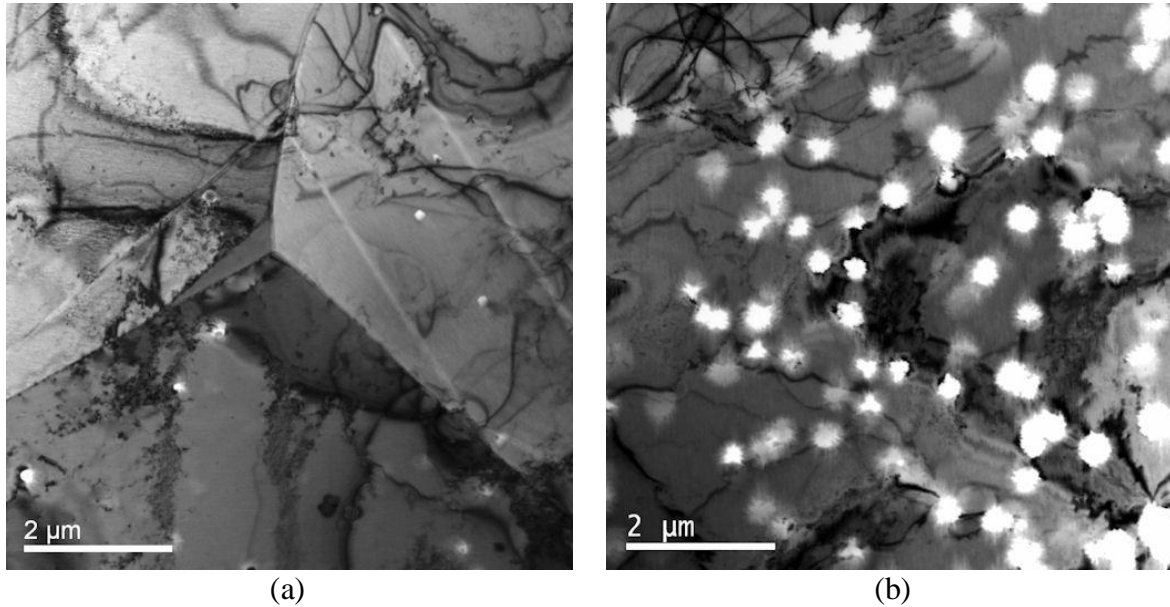
As compared to the reference samples, the general impression was that locally some of grains were filled with a larger number of holes/particles, while other grains showed lower density. A comparison between two separate regions from CuHa1 is shown in Fig. 9.

Fig. 9. The amount of holes/particles showed large variation between different regions of CuHa1.

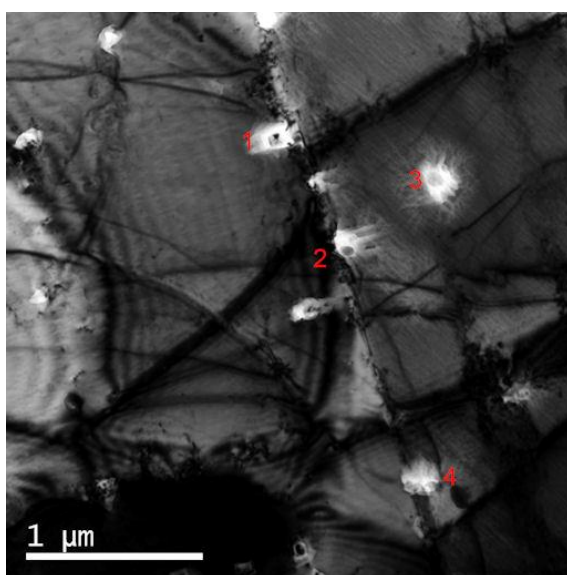
Again, some residual particles were found in the CuHa1 and CuHa5 samples from the edges of the holes left from larger particles falling out. Point analyses from CuHa1 in Fig. 10 show that the particles are composed of high amount of S, but at these points P was not detected. Some of the precipitates are on the grain boundary, but there's no clear trend in that behavior. In addition to S containing precipitates, some triangular features containing Cl were found from CuHa1. The EDS location and the triangular appearance of the Cl containing feature are shown in Fig. 11. Similar S rich particles were found from CuHa5 sample, but Cl containing features were not found.

#	Cu wt%	S wt %	P wt %
1	balance	23.3	-
2	balance	7.3	-
3	balance	3.8	-
4	balance	5.4	-

Fig. 10. EDS point analyses and results from CuHa1. The precipitates clearly contain S. No traces of P were found.

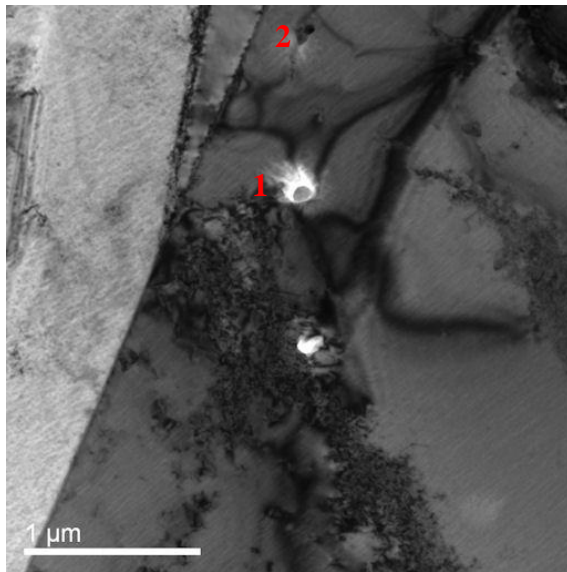
#	Cu wt%	S wt %	Cl wt %
1	balance	17.1	-
2	balance	-	3.6 - 6.7

Fig. 11. EDS point analyses and results from CuHa1. The lower precipitate clearly contains S, while Cl was found from the upper feature. No traces of P were found.

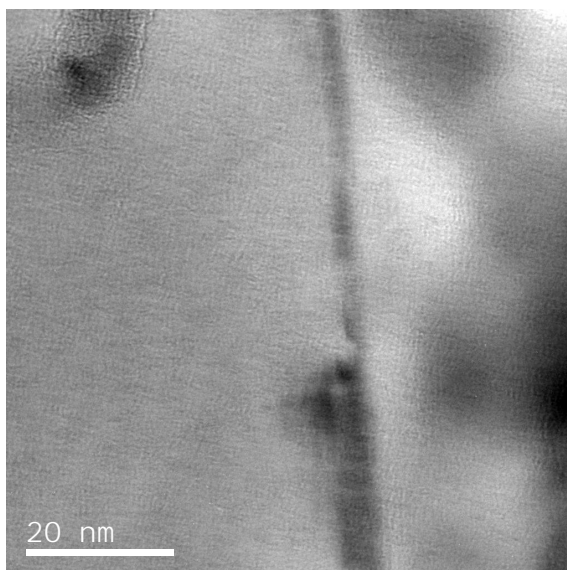
Several grain boundaries of CuHa1 and CuHa5 were examined by using EDS spot analyses. The analysis revealed that the grain boundaries contained small amounts of P but no S, as was also noticed in the reference samples. As an example, one GB of CuHa5 is shown in Fig. 12 with EDS results.

#	Cu wt%	P wt %
1	balance	0.8
2	balance	0.8
3	balance	0.6
4	balance	0.4
5	balance	0.1
6	balance	1.6
7	balance	0.6
8	balance	0.6
9	balance	1.2
10	balance	0.5
11	balance	0.8
12	balance	0.3
13	balance	0.5
14	balance	-
15	balance	0.2

Fig. 12. EDS point analyses and results from CuHa5 grain boundary.

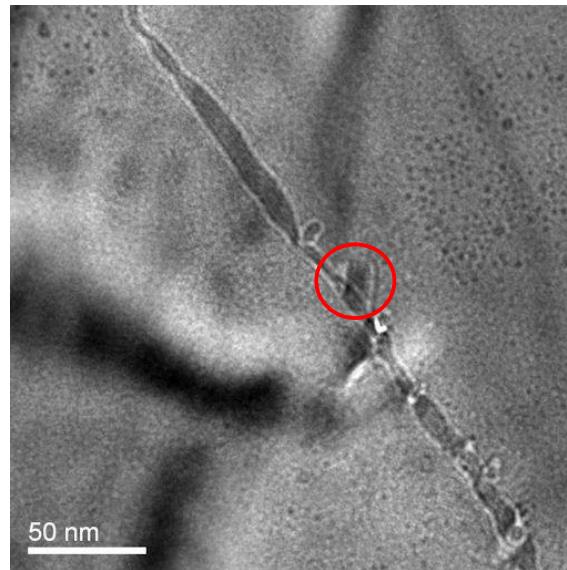
Although most of the boundaries did not show any unfamiliar features, one grain boundary of CuHa1 was clearly filled with some corrosion product, as shown in Fig. 13 with EDS results.

#	Cu wt%	S wt%	Cl wt%	P wt%	K wt%	Cr
1	balance	6.1	1.1	0.5	0.3	3.3
2	balance	2.7	0.9	0.5	0.3	1.6
3	balance	6.2	0.9	0.4	0.2	3.4
4	balance	7.0	0.4	0.3	0.1	3.5
5	balance	0.1	0.3	0.2	0.1	-
6	balance	0.1	0.9	0.3	0.3	-
7	balance	-	1.8	1.6	0.4	-
8	balance	0.2	0.8	0.3	0.2	-
9	balance	0.1	0.7	0.4	0.1	-
10	balance	-	0.8	0.3	0.2	-
11	balance	0.1	0.7	0.3	0.3	-
12	balance	0.1	0.6	0.5	0.3	-
13	balance	-	0.5	0.2	0.2	-
14	balance	-	0.7	0.1	0.2	-
15	balance	0.1	0.8	0.3	0.2	-
16	balance	-	1.1	0.3	0.2	-

Fig. 13. EDS point analyses and results from CuHa1 grain boundary, which clearly was filled with some corrosion product. Locations 1 – 4 are from the circled particle. All the other particles are from the grain boundary. Most notably, there is a S rich particle on the boundary (# 1 -4) and Cl is found everywhere.

Grain boundaries have been proposed to be the major diffusion path of S to the copper matrix under applied stress in S containing environment. In the present study, one grain boundary clearly contained corrosion product with Cl and other elements possibly originating from the groundwater.
