IGSCC IN A BWR STEAM LINE AFTER 30 YEARS OF OPERATION

Ulla Ehrnstén, Juha-Matti Autio¹ and Petra Holmstrom²

ABSTRACT

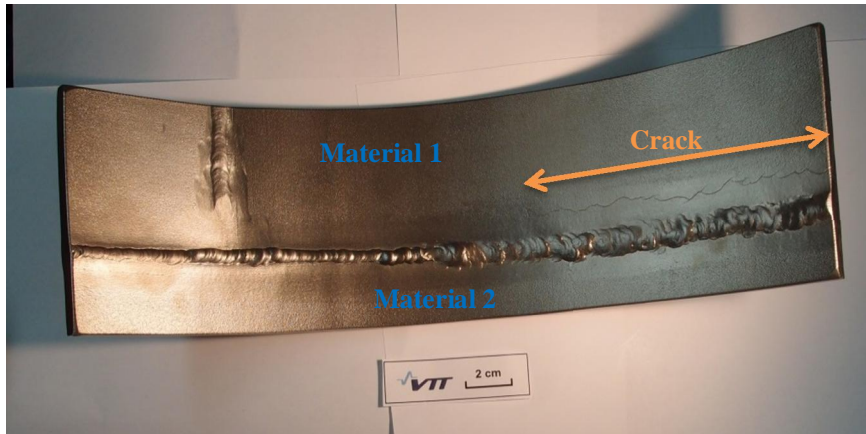
The visual inspection revealed that the pipe with the leak was a (axially) welded pipe (material 1), while the pipe on the other side of the assembly weld was a seamless pipe (material 2), Figure 1. An about 15 mm long crack was observed at a distance of about 8 – 11 mm from the fusion line in material 1, Figure 2. The crack extended up to the cut surface, so only a part of the crack was located in the investigated pipe section. The width of the root of the assembly weld was larger at the location of the crack than elsewhere, obviously as a consequence of the performed re-welding due to the weld defects observed during the assembly welding. A few millimeter long crack was observed next to the cut surface also in material 2. This crack was at a distance of about 8 mm from the fusion line.

Figure 1. Photograph of the pipe section with a leak in material 1.

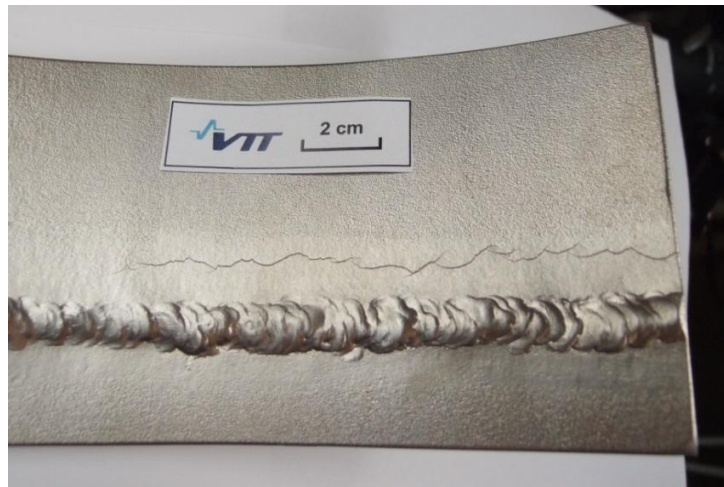
Figure 2. Close-up of the crack causing the leak in material 1.

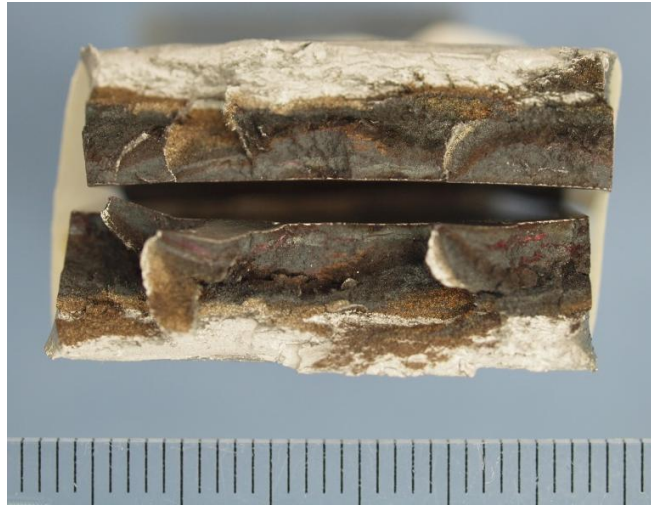
The macroscopic crack in material 1, causing the leak, comprise of several cracks which have coalesced into one, see Figure 3, showing that initiation has occurred at several locations at almost the same distance from the fusion line. The cracking mode is intergranular, with a very small amount of transgranular cracking, Figure 4.

Figure 3. Photograph of the fracture surface of a part of the crack in material 1.

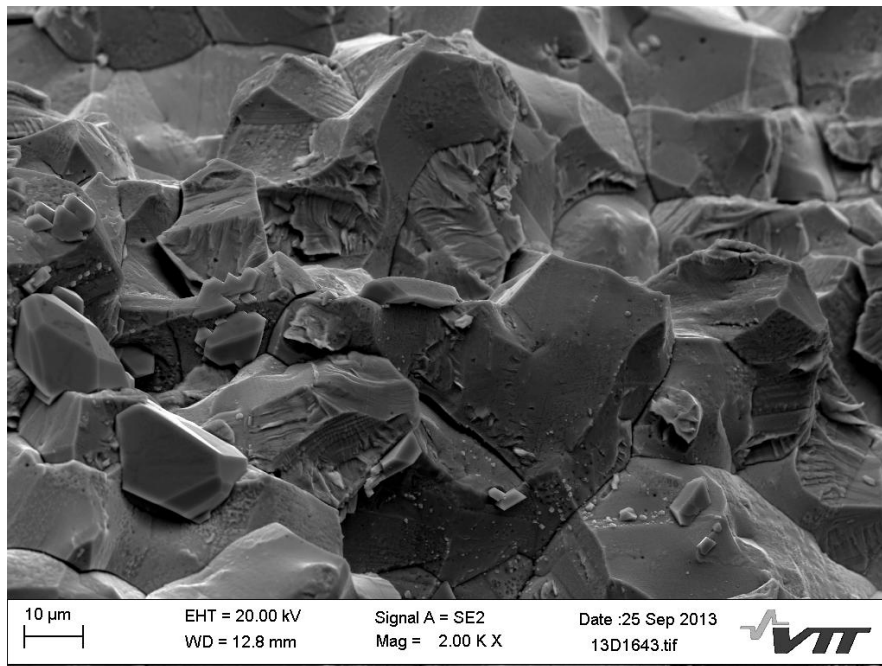
Figure 4. Mainly intergranular cracking of the crack causing a leak in material 1.

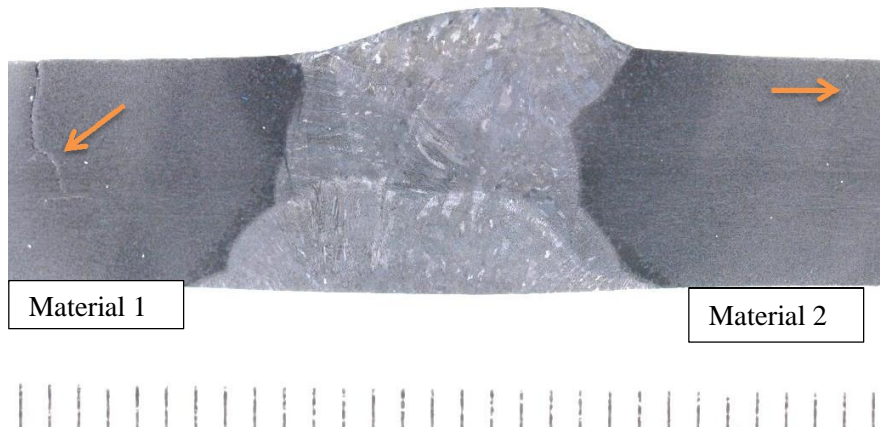
The microstructure of the base materials 1 and 2 is austenitic with a small amount of δ -ferrite. The microstructure of the weld next to the macroscopic crack shows that the weld has not been welded continuously, Figure 5, but re-welding has been performed, in line with given information. This was not

Re-welding during the assembly of the pipe section has obviously resulted in higher than typical (without re-welding) residual stresses. The mis-alignment, observed next to the cracked region cause high stresses, and may be the reason for the initial defects in the weld requiring re-welding during the assembly. Further, thinner wall thickness (here 8 mm) compared to thicker, typical for primary piping (~20 mm) results in higher residual axial stresses [7].

Figure 5. Macrograph of a cross-section, showing cracks both in materials 1 and 2, as indicated with arrows.

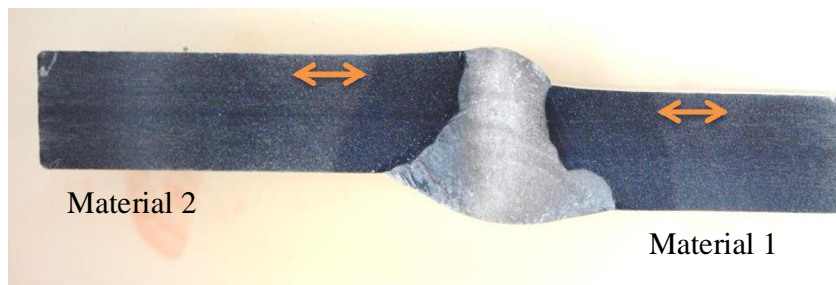
seen in a cross-section outside the crack, showing that the re-welding had been performed only to a part of the circumference, as also the width of the root indicated. However, in this cross-section a mis-alignment between the two pipes is obvious, Figure 6.

Oxalic acid etching of a cross-section close to the cracked region, but still outside it, revealed grain boundary attack, indicating sensitization, Figure 9, only between about 6 and 12 mm from the fusion line, Figure 6. The DL-EPR measurements, measured from slices cut parallel to the fusion line, Figure 10, showed a maximum degree of sensitization at a distance of 6 mm from the fusion line, Figure 11.

Figure 6. Macrograph of a cross-section close to the cracked region after oxalic acid etching. A clear mis-alignment between the pipes is seen. The region where grain boundary attack was observed in the two materials is indicated in the picture.

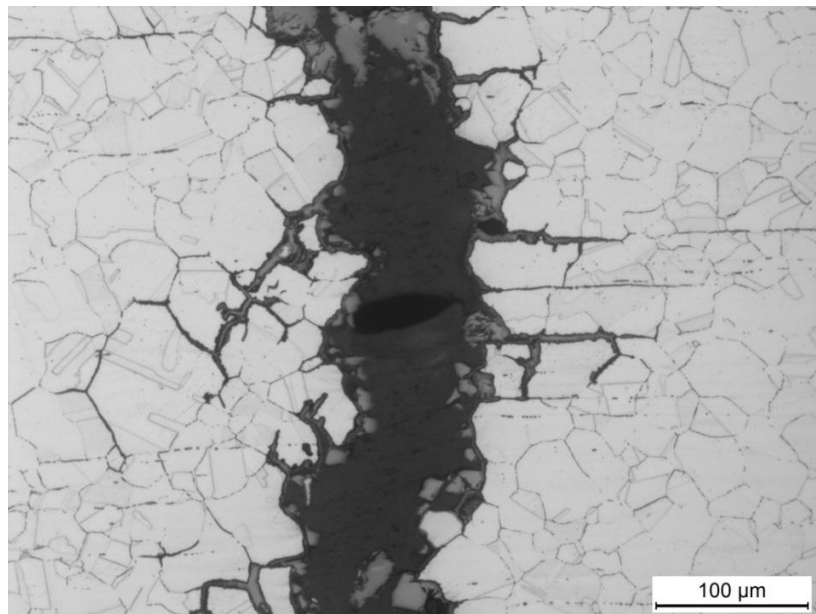
The macroscopic crack in material 1 is intergranular and mainly only slightly branched, Figure 7. Close to the crack tip in the investigated cross-section, i.e. at about 60% depth (4.6/7.6mm), the crack grows locally parallel to the pipe surface, i.e., almost perpendicular to the main crack growth direction, Figure 8, in both directions from the main crack. This part of the crack grows along a δ -ferrite stringer, after which cracking continues intergranularly in the austenitic material, perpendicular to the surface. Indications of sensitization in the form of pits at the grain boundaries, obviously from carbides removed from the grain boundaries during specimen manufacturing were observed next to the crack. Similar observations were observed in material 2, i.e., the short crack was intergranular and indications of sensitization were observed next to the crack. The grain size was slightly larger in at the location of the crack compared to either side further away from the crack.

Figure 7. Intergranular cracking in material 1.

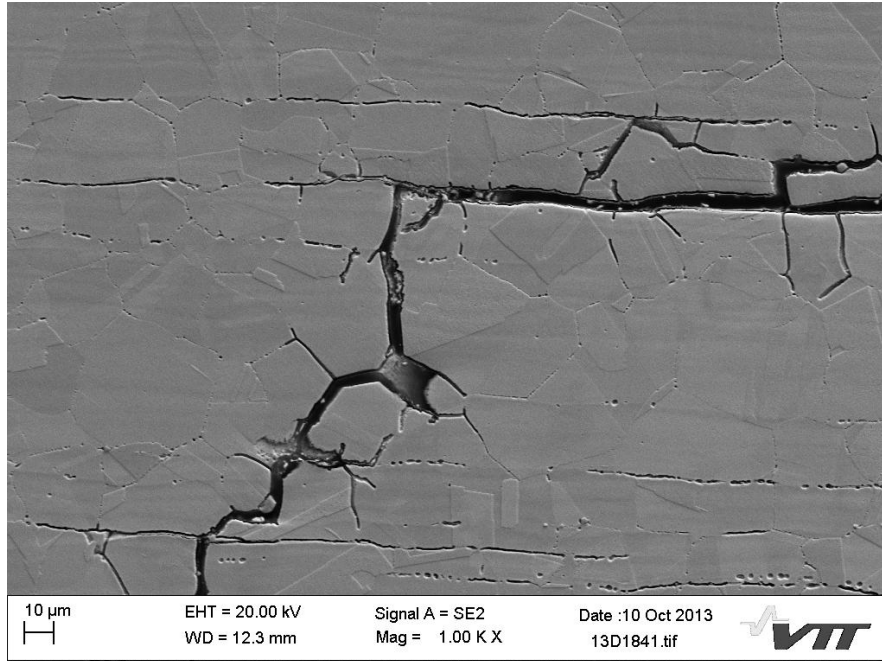
Figure 8. Locally, the intergranular crack grows along a δ -ferrite stringer.

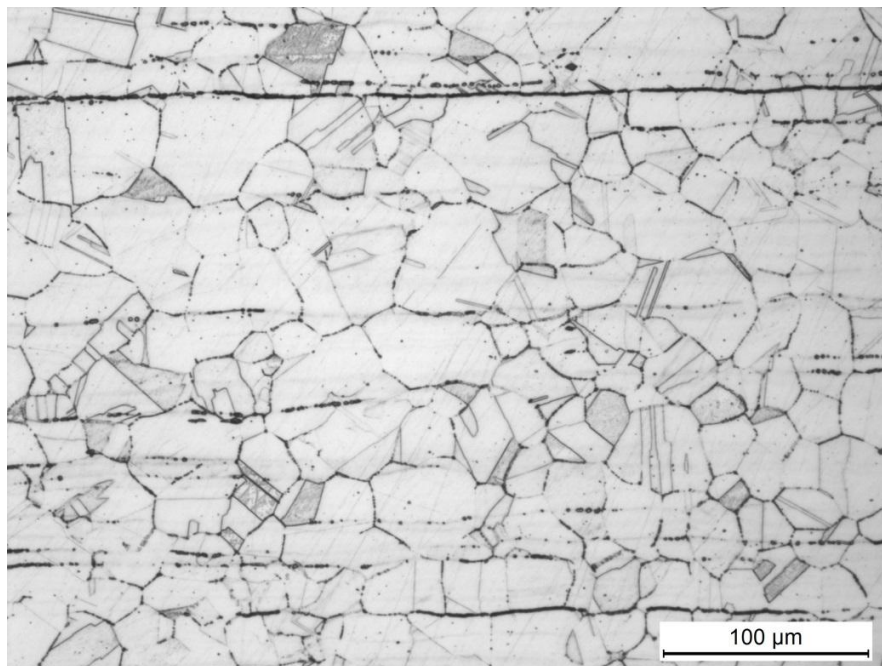
Figure 9. Microstructure of material 1 after oxalic acid etching showing grain boundary attack, which, however, is not fully continuous.

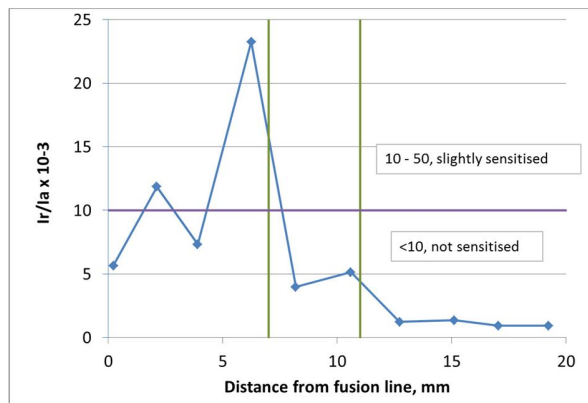
Figure 11. DL-EPR results as a function of distance from the fusion line. The vertical lines indicate the region with cracking.
