## TEM microstructures of copper following three different EAC tests

Authors: Wade Karlsen, Janne Pakarinen

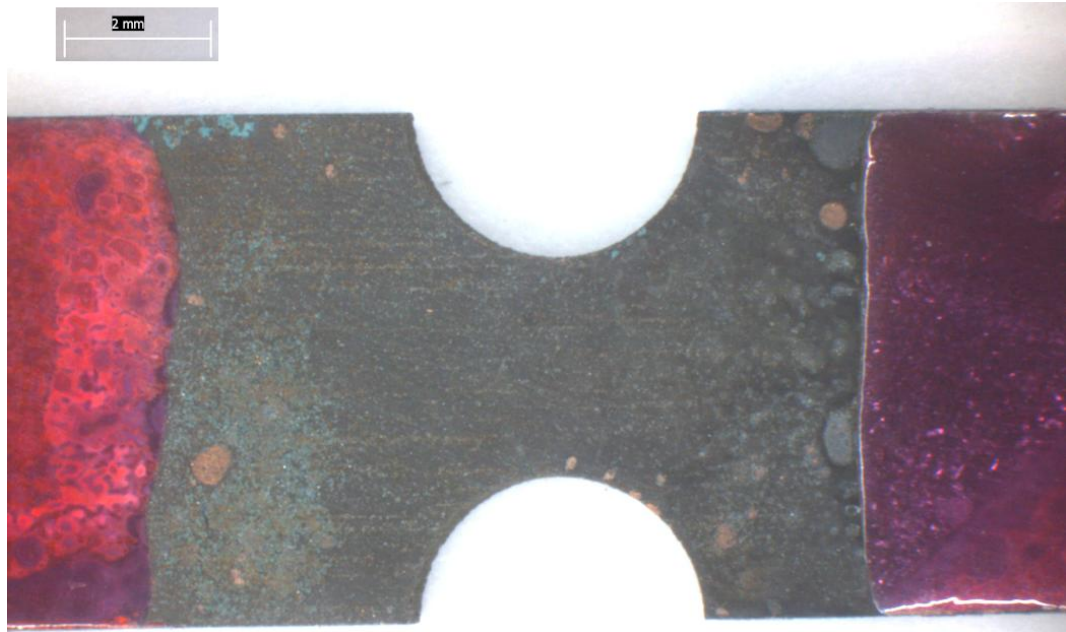
A few stereomicroscope images were available of the test bars before TEM specimen extraction commenced. As shown in Figure 5, when loaded by only 50 MPa, the surface of the specimen had turned black. As shown in Figure 6, when loaded to 250 MPa some corrosion product and pitting were visible on the surface, though the test bar was still mostly copper coloured. Finally, as shown in Figure 7, at 320 MPa some features appeared on the specimen which could be interpreted to be cracks, despite occurring outside of the gauge region. A higher magnification image of those features is shown in Figure 8.

*Figure 5: Stereomicroscope image of bar Cu5, which had been tested at a constant load of 50 MPa.*

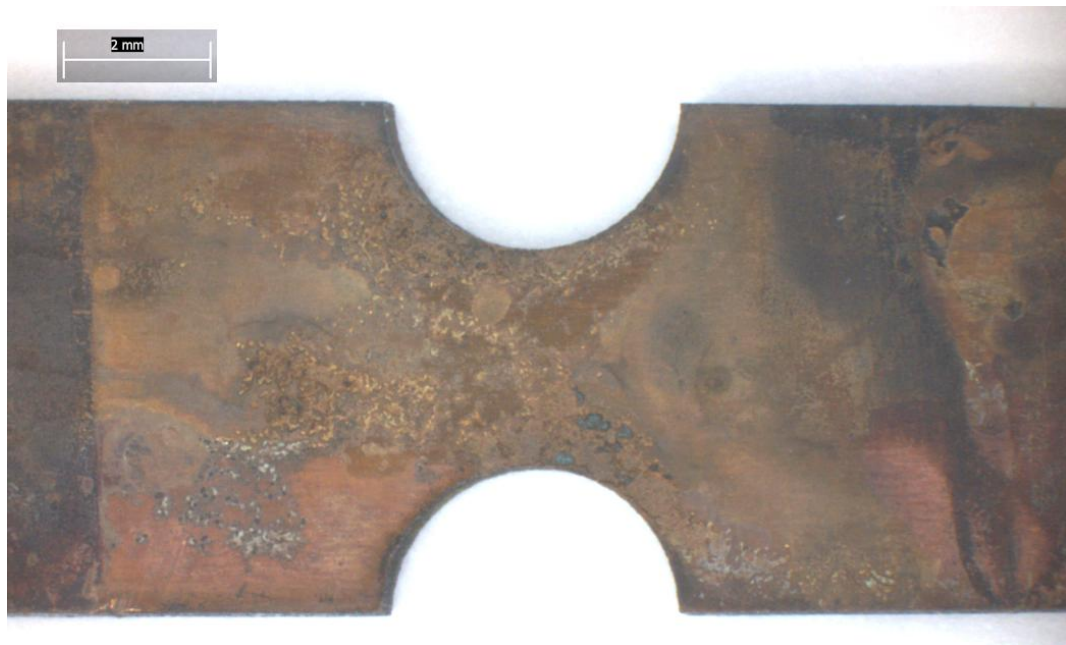
*Figure 6: Stereomicroscopy image of bar Cu6, which had been tested at a constant load of 250 MPa.*

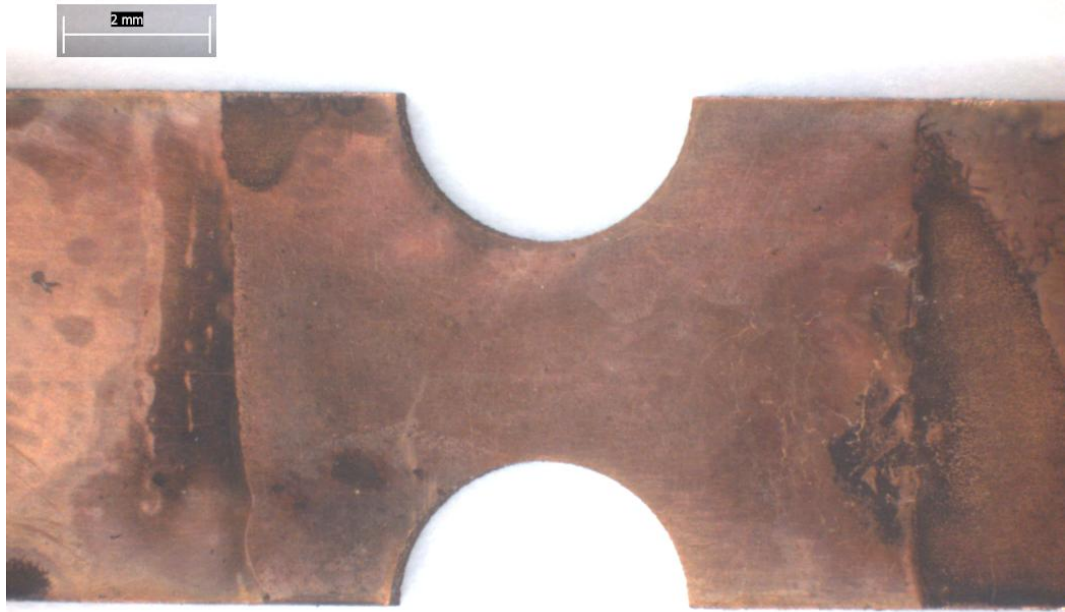
*Figure 7: Stereomicroscope image of bar Cu8, tested at a constant load of 320 MPa. On the right-hand side of the bar are some features said to be cracks initiated during the test.*

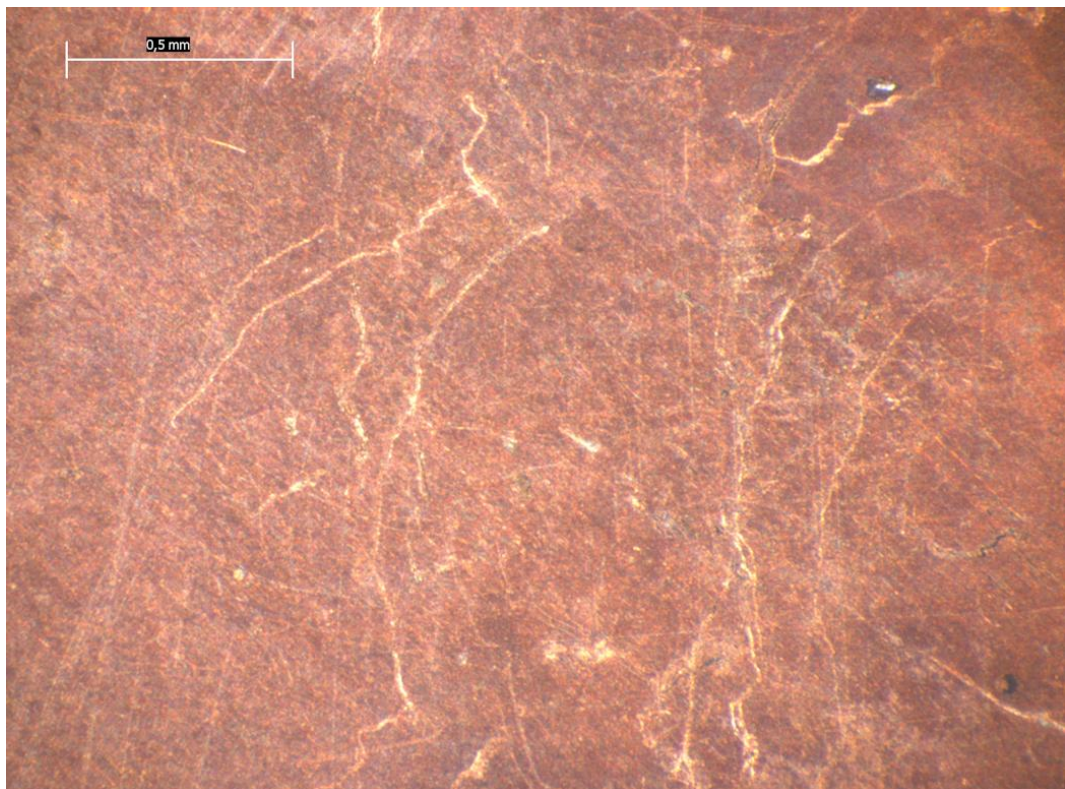
*Figure 8: Higher magnification stereomicroscope image of features in bar Cu8, said to be cracks initiated during the test.*

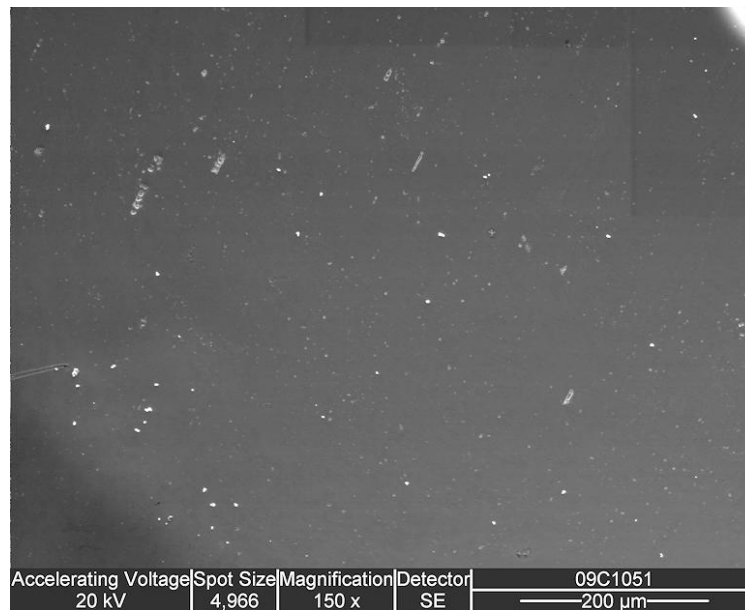
In order to estimate specimen quality, prepared TEM specimens were examined in SEM. In all cases, it was found that the specimens contained parallel stringers of second phase material, oriented along the axis of the test bars. An example from specimen Cu5\_4 is shown in Figure 9, and a higher magnification image of similar stringers in Cu8\_1 is shown in Figure 10. During electropolishing the interface between the matrix and stringers typically experienced preferential attack, leading to a significant amount of particle drop-out in the thin, electron-transparent material.

*Figure 9: Stringers of second phase are readily apparent in the electropolished materials, as in this example from specimen Cu5\_4.*

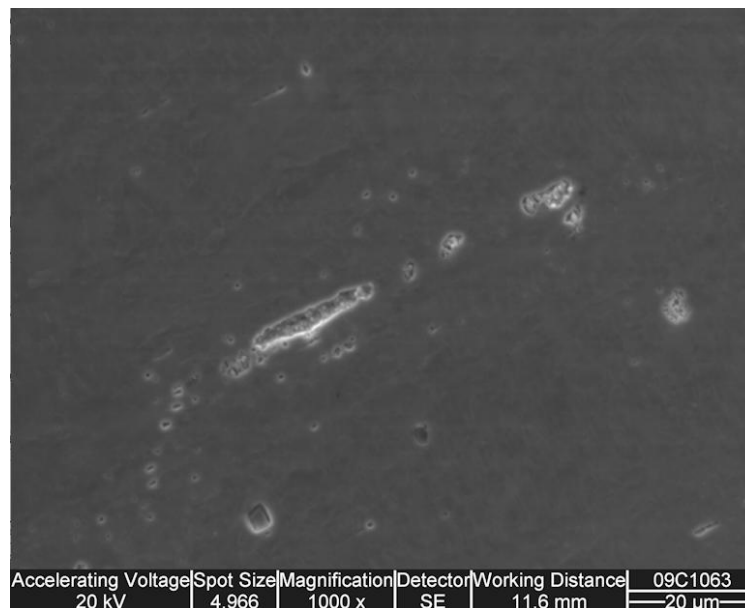
*Figure 10: Higher magnification SEM image of second phase particle stringers, this time from specimen Cu8\_1.*

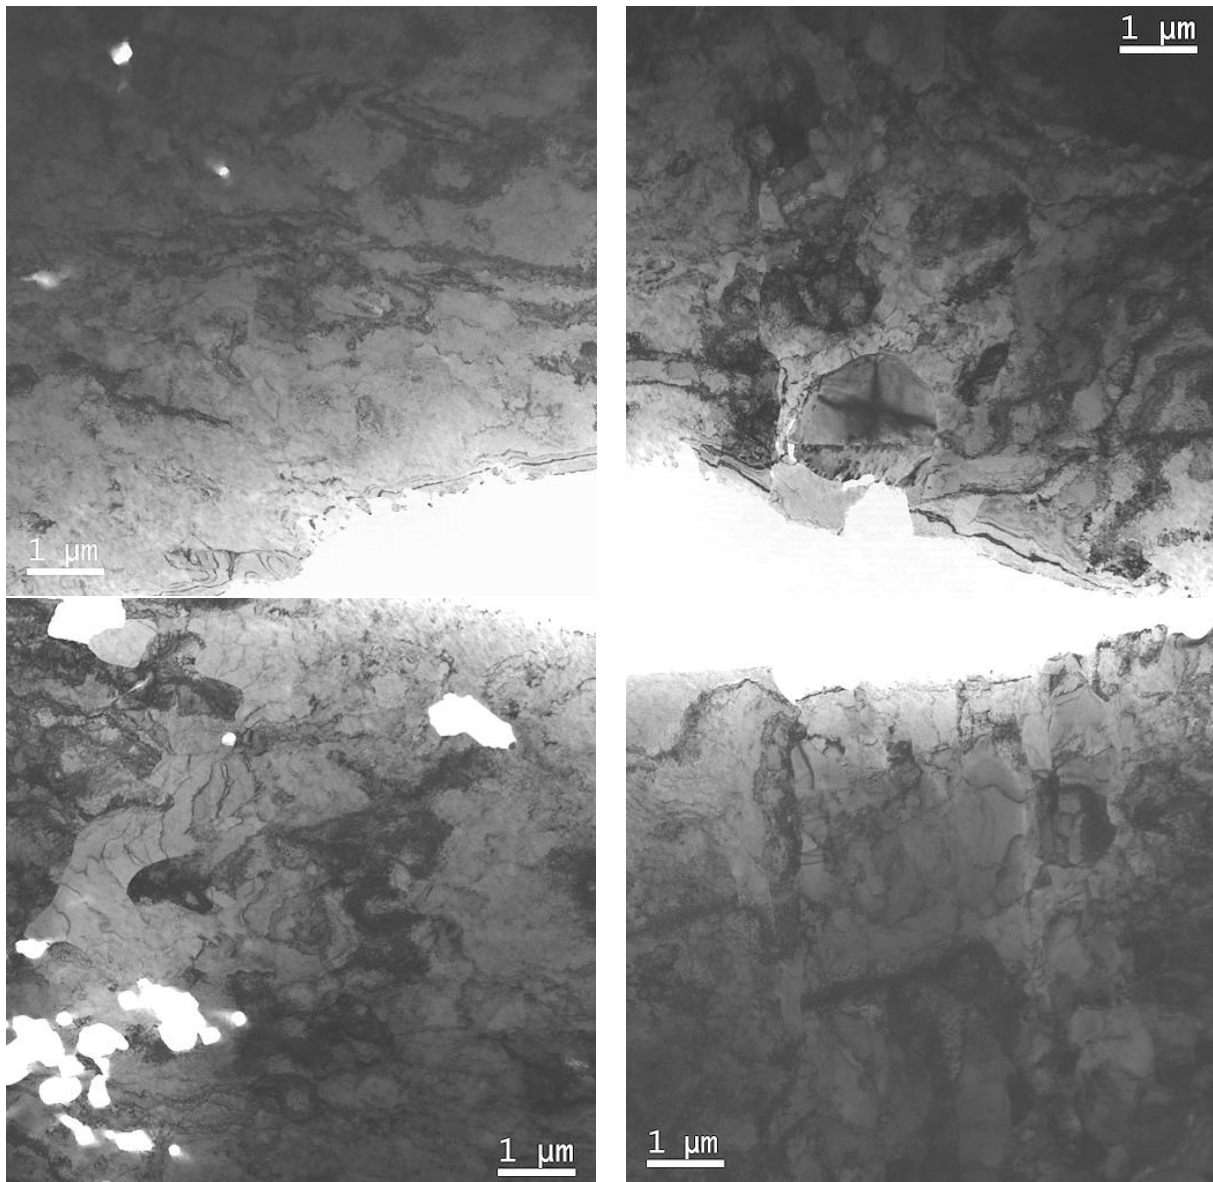
Figure 11 contains a sampling of microstructures from different regions of specimen Cu5\_6. The microstructure is heavily distorted, and contains a high density of dislocations. As particularly evident in the lower left image of that figure, particle fallout occurred during specimen preparation. As shown in Figure 12, one isolated grain was found which contained a remarkably low density of dislocations. Analysis of the composition of the grain showed it to be pure copper.

Figure 11: A sampling of microstructure from different regions of specimen Cu5\_6.

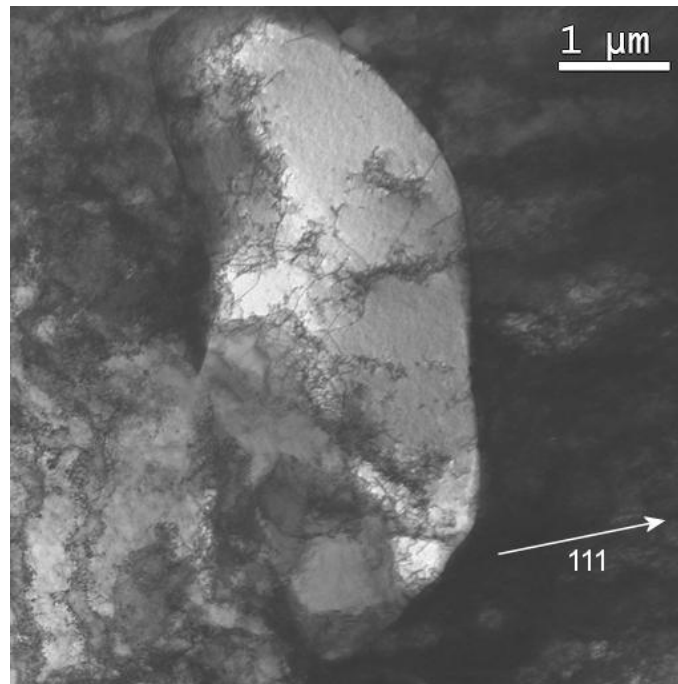
*Figure 12: An isolated grain within Cu5\_6 having a remarkably low density of dislocations.*

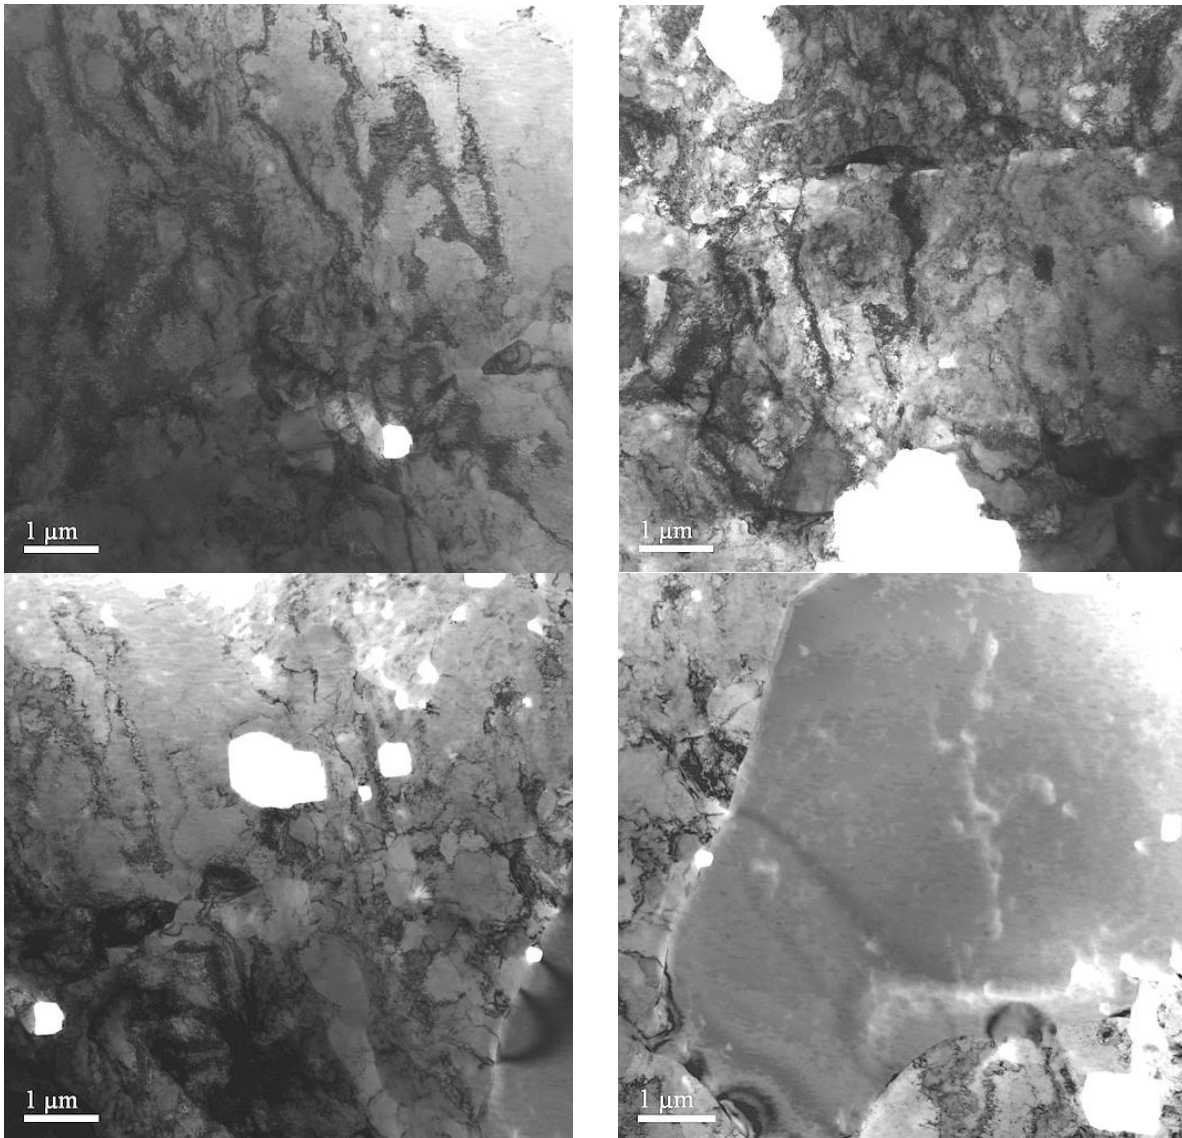
Figure 13 contains a sampling of microstructures from different regions of specimen Cu6\_3. In most regions the microstructure was similar to that of bar Cu5. However, remarkable in Cu6\_3 was the existence of particular grains which appeared to have no dislocations, an example of which is visible in the lower right image of Figure 13. Such regions were examined more carefully. Although in appearance they resembled a second phase inclusion, energy dispersive x-ray spectroscopy (EDS) revealed that they were comprised of pure Cu. Because they contained very little oxygen, they could not be considered to be oxide inclusions. Figure 14 is a higher magnification image of the same grain visible in the lower right image of Figure 13, but now tilted to a diffraction condition that should bring the dislocations in the material into contrast. It reveals a dislocation-free matrix having a diffraction pattern consistent with that expected for metallic copper, a well-defined boundary, and outside of the grain a dislocation density that is quite high. Whereas the 111-type reflection shown in selected area diffraction (SAD) pattern 22 of that figure should reveal half of the dislocations present, the 002-type reflection shown in SAD pattern 23 for the dislocation-free grain would be expected to reveal 2/3 of the dislocations present. Clearly such regions represent islands of dislocation free material within the surrounding highly deformed matrix. By contrast, Figure 15 shows how densely the dislocations are distributed in the rest of the material.

Figure 13: Sampling of microstructure in specimen Cu6\_3.

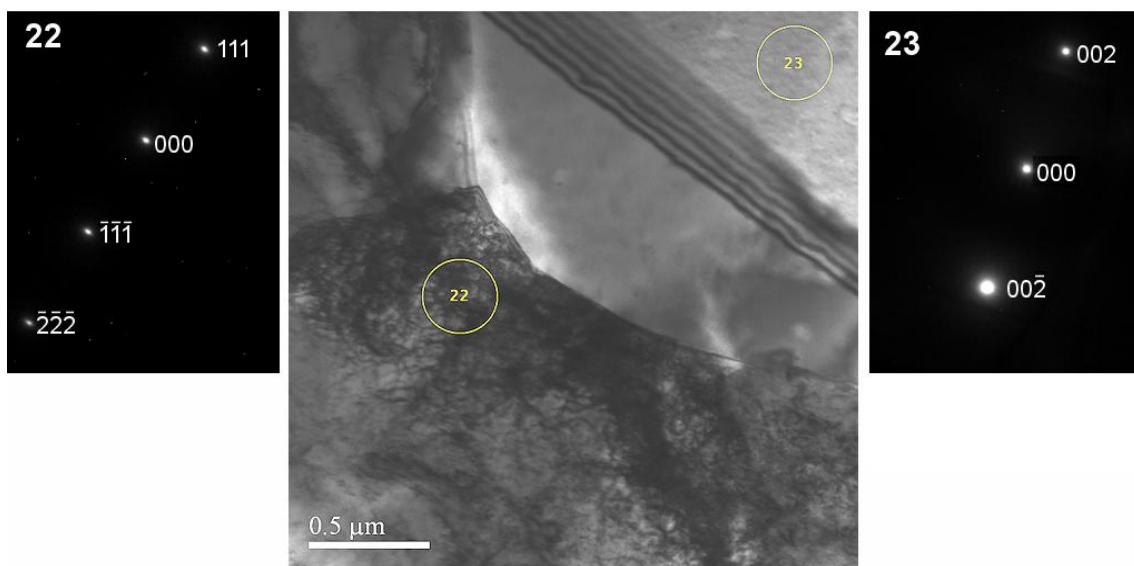
Figure 14: Tilted to conditions to reveal dislocations, it is evident that within the grain there are no dislocations, while outside it the density of dislocations is very high.

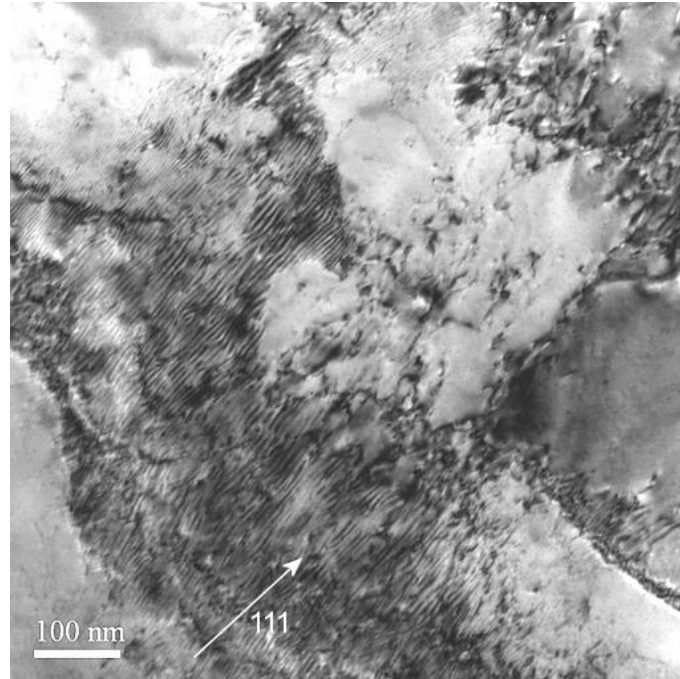
*Figure 15: High magnification image of dense mat of dislocations typical of the material outside of dislocation free grains.*

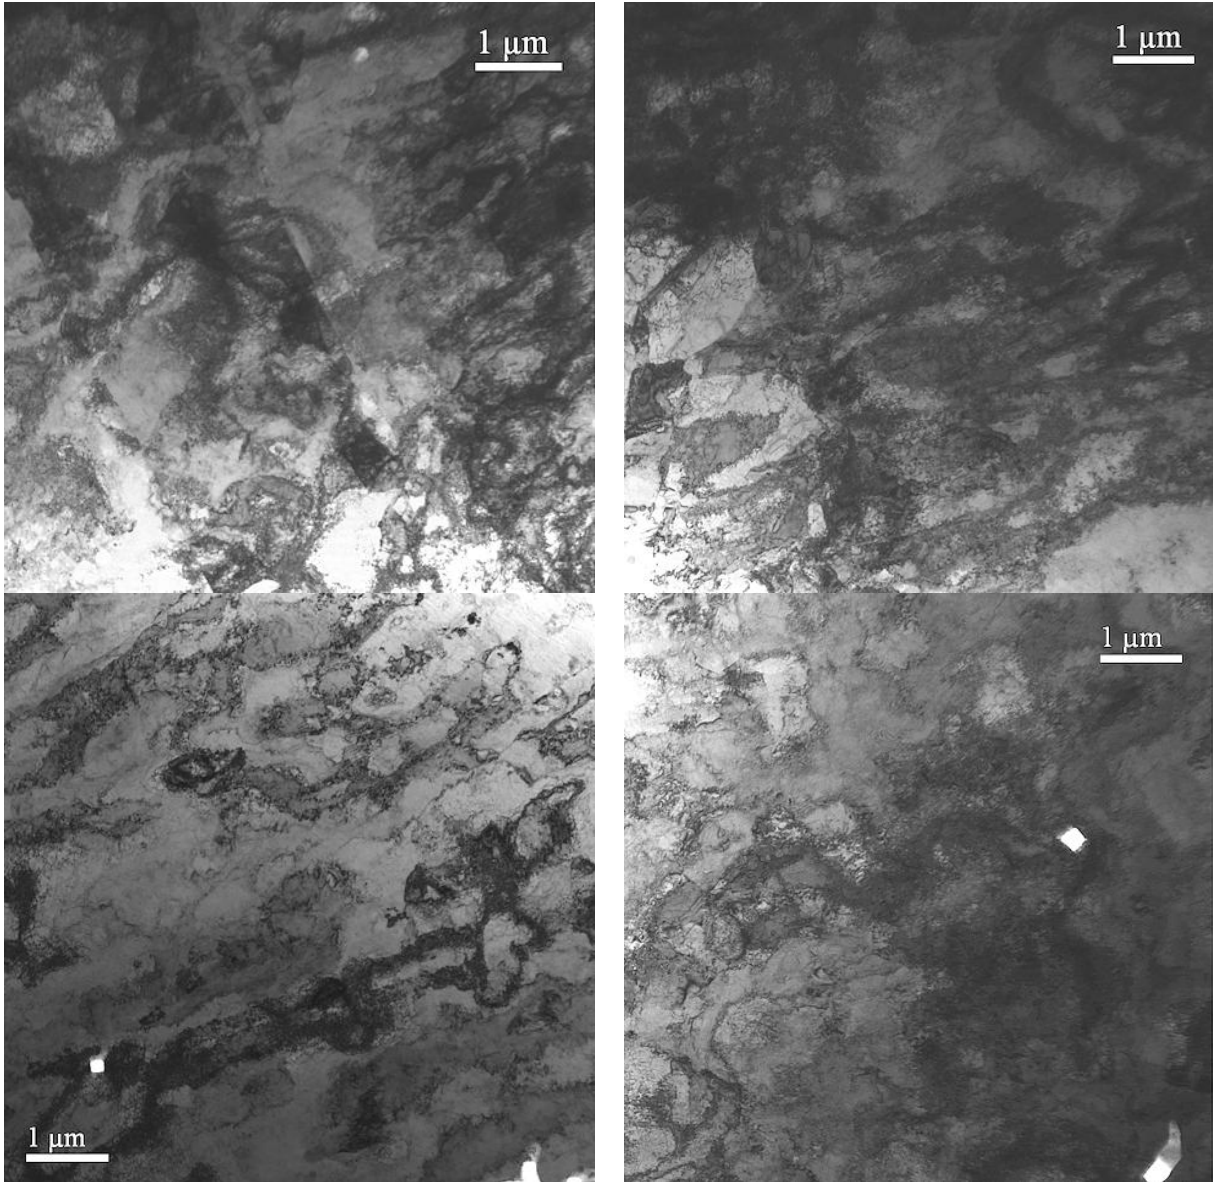
Because of the uniqueness of the dislocation-free grains found within specimen Cu6\_3, its pair from the same region of the test bar was also examined. Figure 16 contains a sampling of microstructures from different regions of specimen Cu6\_2. The principle finding from that specimen is that very few, if any, dislocation-free grains were apparent as manifested in Cu6\_3. However, one feature that may be noteworthy is the band about 3 microns wide that is visible in the upper left-hand image of Figure 16.

Figure 16: Sampling of the deformation microstructure in specimen Cu6\_2.

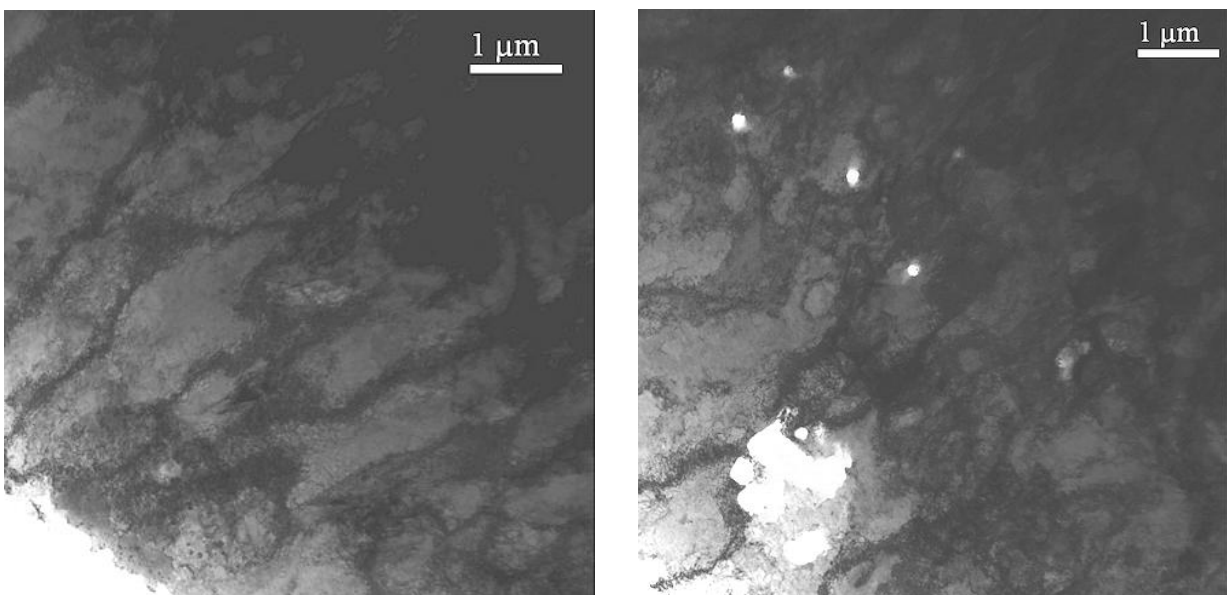
Because of the discrepancy between Cu6\_2 and Cu6\_3 regarding the presence of dislocation free grains, specimen Cu6\_4 was also examined. Its location at the gauge region of the test bar also made it interesting from the standpoint that the stress would be expected to be greatest in this region during the test. Figure 17 contains a sampling of microstructures from different regions of specimen Cu6\_4. At that magnification the microstructure is similar to that of Cu6\_2. At a higher magnification, as shown in Figure 18, the dislocation structure may be slightly less dense. However, since the density is overall still quite high, it is difficult to assess the extent of such a reduction in density on a broad basis. Most importantly, no dislocation free grains were found of the kind observed in Cu6\_3.

Figure 17: Sampling of the deformation microstructure within specimen Cu6\_4.

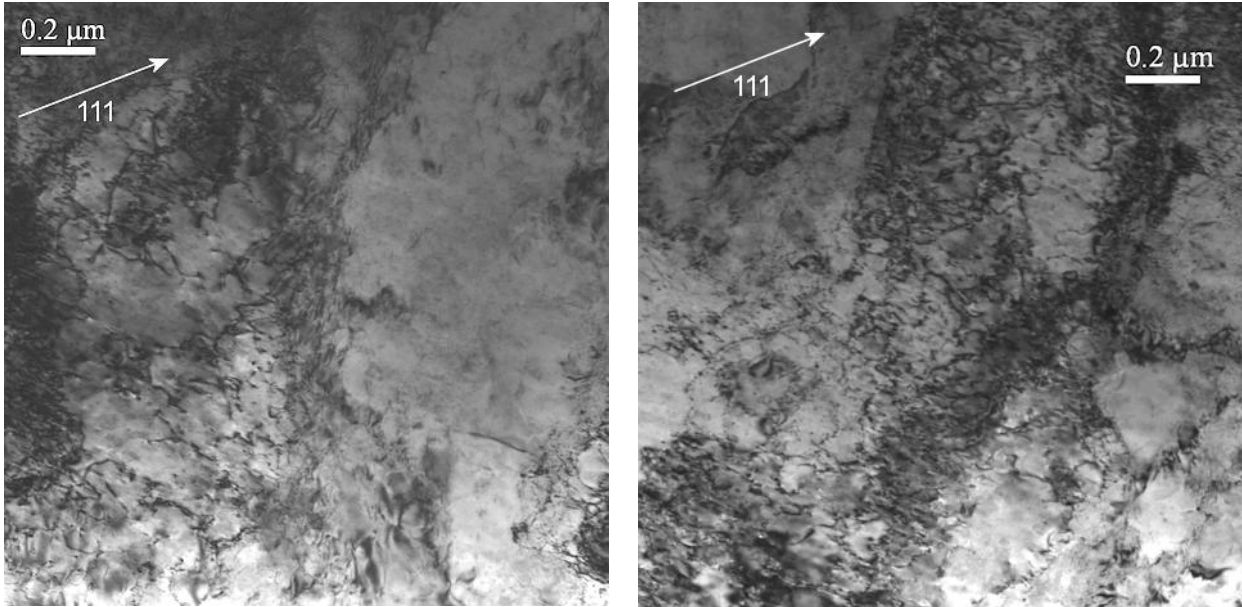
Figure 18: Higher magnification images of dislocation microstructure within specimen Cu6\_4. The overall dislocation distribution may be less dense than in Cu5.

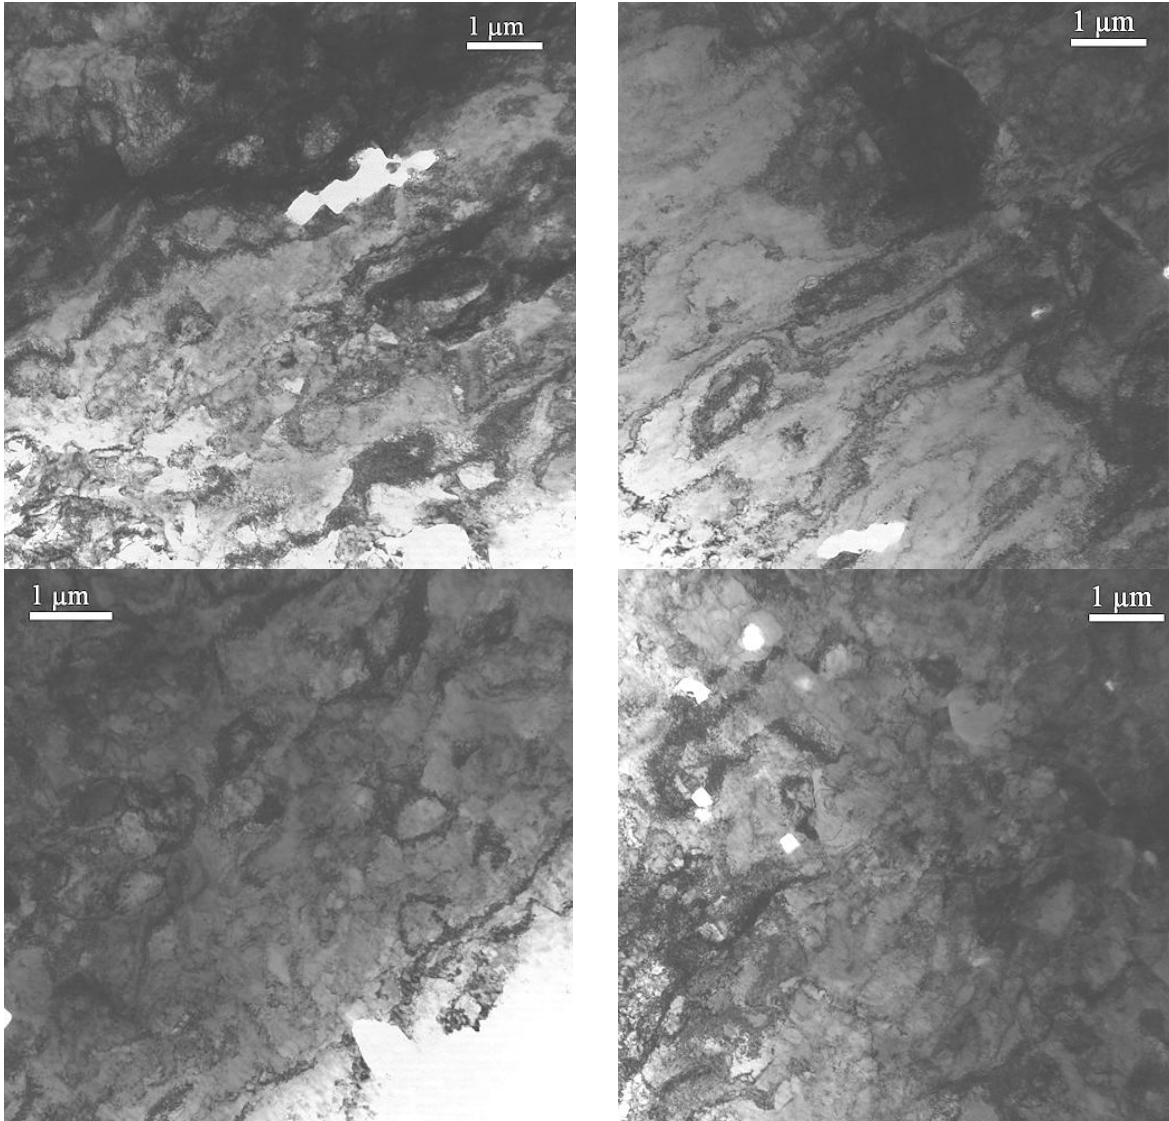
Figure 19 contains a sampling of microstructures from different regions of specimen Cu8\_1. At low magnification the microstructure is similar to that of the other specimens, showing a strongly distorted matrix and high dislocation density. However, when imaged at higher magnification, it was evident that the microstructure was still mostly comprised of dense mats of tightly packed dislocations, as shown in Figure 20. Because of lattice rotation, only portions of the fields are in contrast at a given tilt.

Figure 19: Sampling of microstructure within specimen Cu8\_1

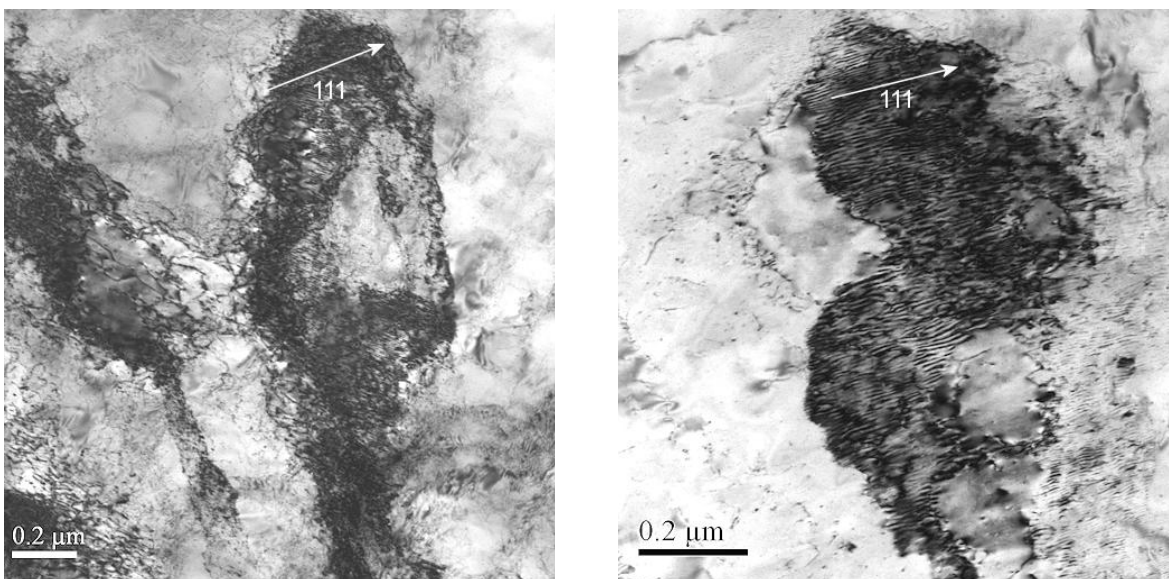
Figure 20: Higher magnification image of dense rafts of dislocations in Cu8\_1. Because of lattice rotation, only portions of the fields are in contrast at a given tilt.

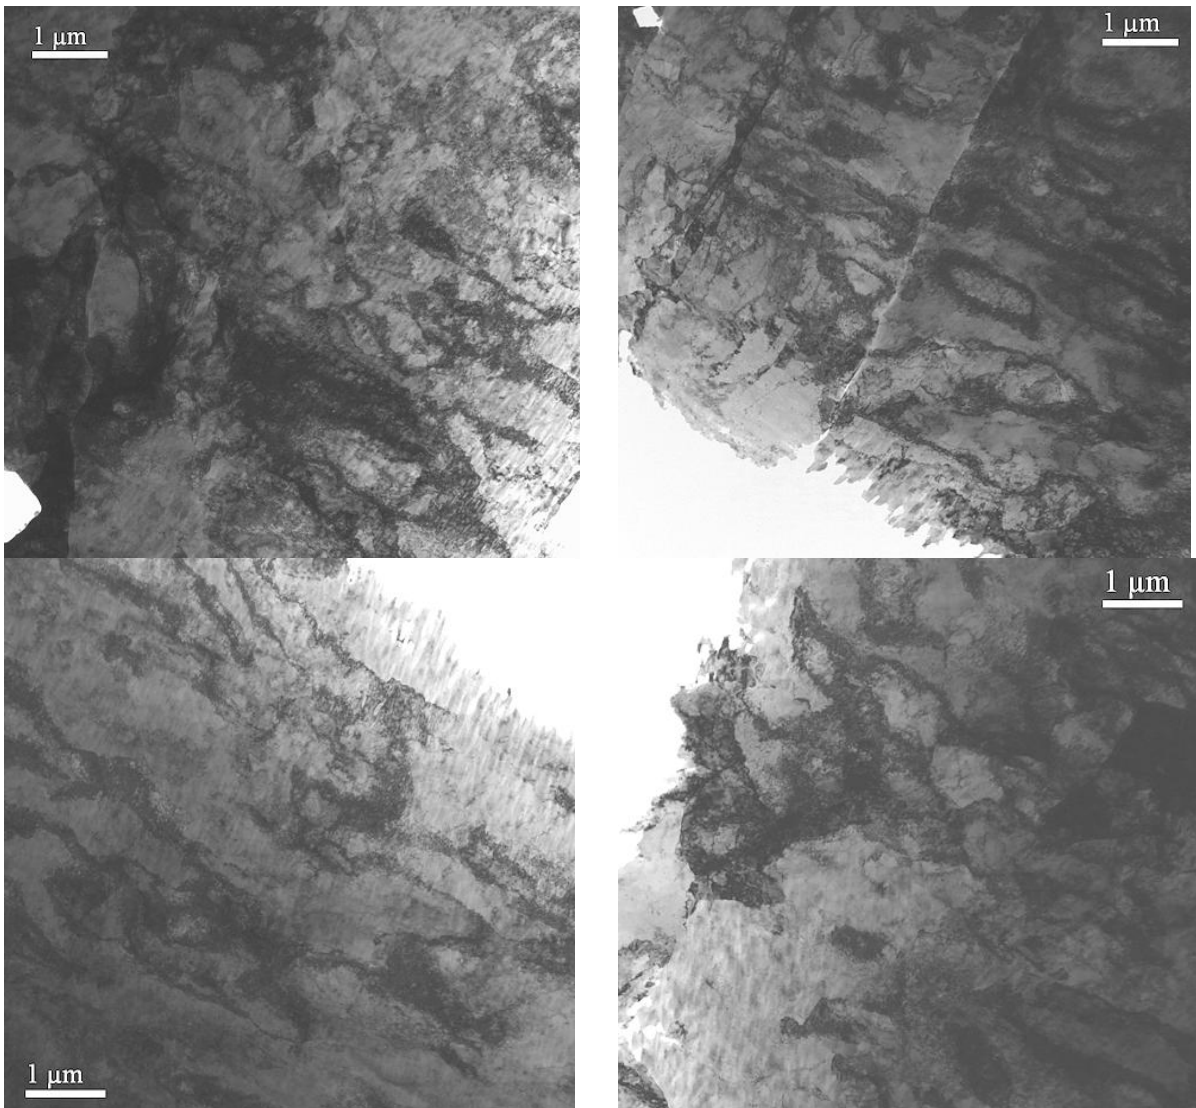
Specimen Cu8\_2 was extracted from a position comparable to that of Cu6\_2 and Cu6\_3, in the deformed region outside of the gauge region. Figure 21 contains a sampling of microstructures from different regions of the specimen. For the most part the microstructure appeared similar to that of the other materials at low magnification, showing a heavily distorted lattice. In the upper right-hand image of Figure 21 a 3 micron wide band is visible, similar to that observed in Cu6\_2. Several particles were also found in this specimen that were amenable to EDS analysis. It consistently showed them to be comprised of copper and oxygen, with the Cu:O ratio approximately 2:1. Meanwhile, when viewed at higher magnification, several areas were found in Cu8\_2 that seemed to have a remarkably reduced density of dislocations, as shown in Figure 22.

Figure 21: Sampling of deformation microstructure within Cu8\_2.

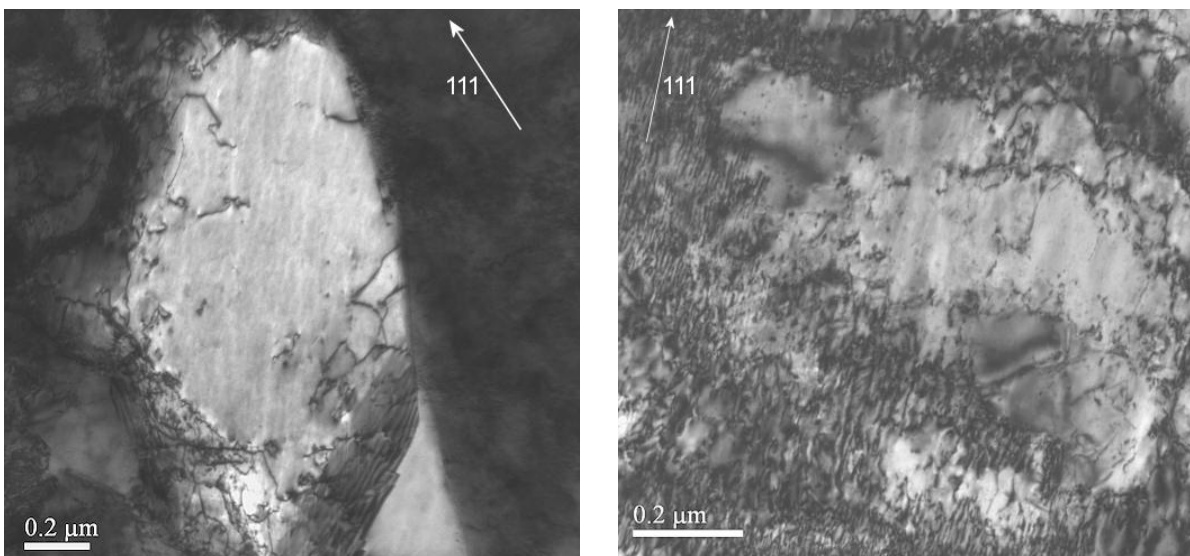
Figure 22: At higher magnification, one small grain in Cu8\_2 appeared to have a dramatically reduced density of dislocations (left), and other areas also appeared to exhibit reduced dislocation density (right).

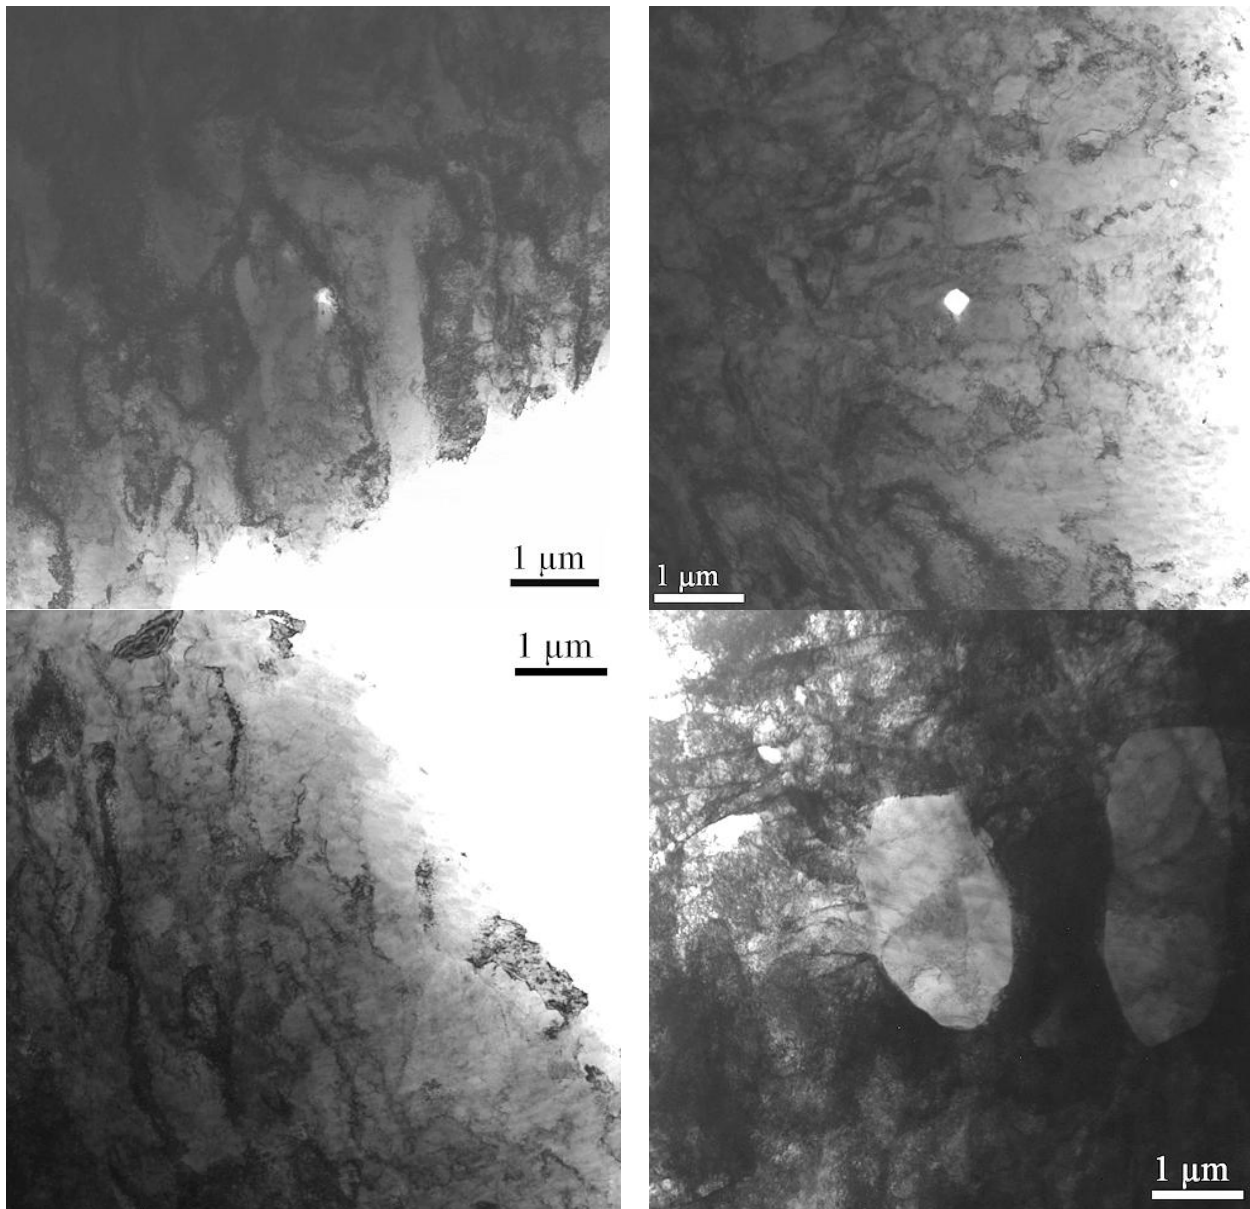
Specimen Cu8\_3 is the pair to Cu8\_2, from the deformed area outside the gauge region of the test bar. Figure 23 contains a sampling of microstructures from different regions of the specimen. For the most part the microstructure appeared similar as that of other specimens. However, as shown in the lower right image of Figure 23, some grains were also found which appeared to have a reduced dislocation density. This is shown more clearly at higher magnification in the left-hand image of Figure 24. However, such regions were still an exception, with most of the microstructure still being comprised of mats of densely packed dislocations, as shown in the right-hand image of Figure 24.

*Figure 23: Sampling of deformation microstructure within Cu8\_3.*

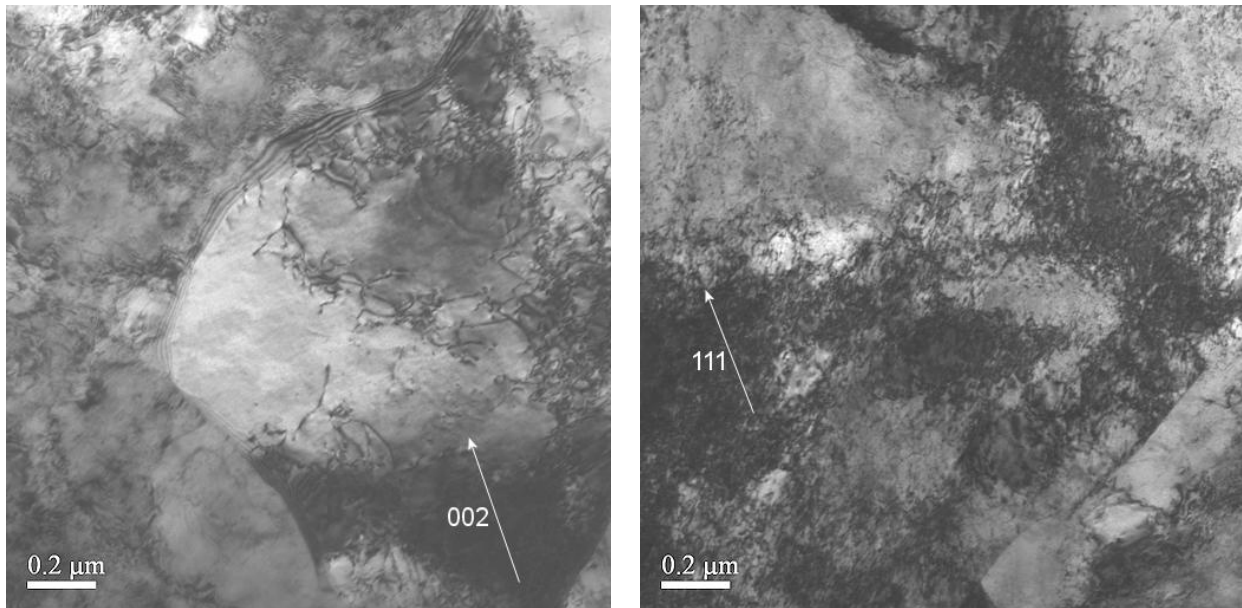
Figure 24: Higher magnification images of a grain showing reduced dislocation density (left) and a more typical region of a dense mat of dislocations (right).

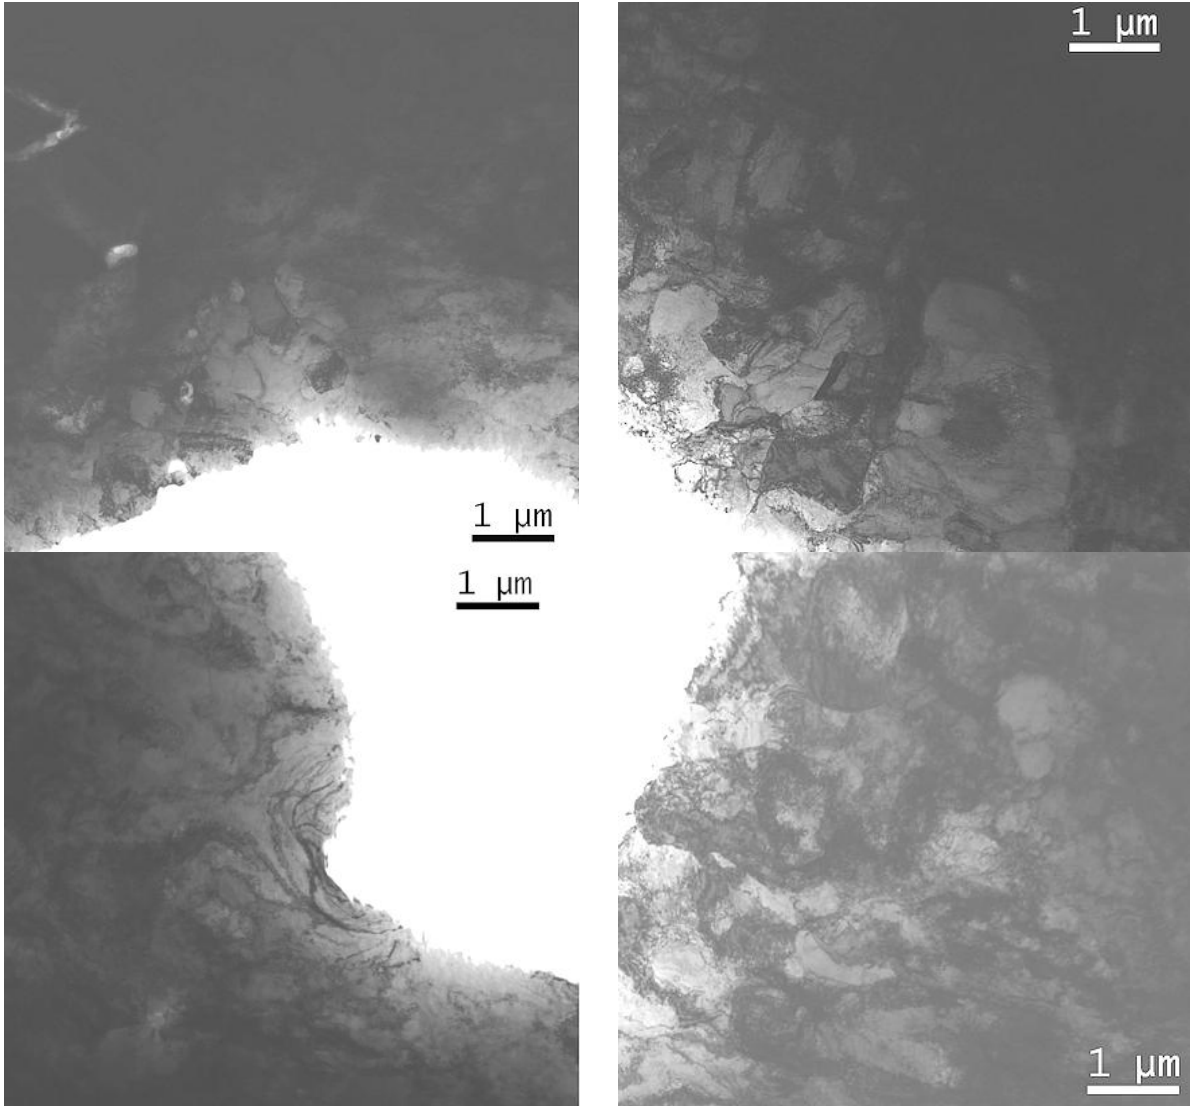
Like Cu6\_4 and Cu5\_6, specimen Cu8\_4 was from the gauge region of bar Cu8. Figure 25 contains a sampling of microstructures from different regions of specimen Cu8\_4. Although in many ways quite similar in appearance to that of the other specimens, it seemed that the microstructure of specimen Cu8\_4 may have exhibited more grains having reduced dislocation density than in the other specimens (with the exception of Cu6\_3.) Some examples of those regions are shown at higher magnification in Figure 26. Overall, therefore, it would seem that the deformed regions of bar Cu8 may have exhibited a marked reduction in dislocation population in many regions, albeit still exhibiting a substantial amount of heavily deformed material in most regions.

Figure 25: Sampling of microstructure within Cu8\_4. Several grains appear to have a reduced density of dislocations.

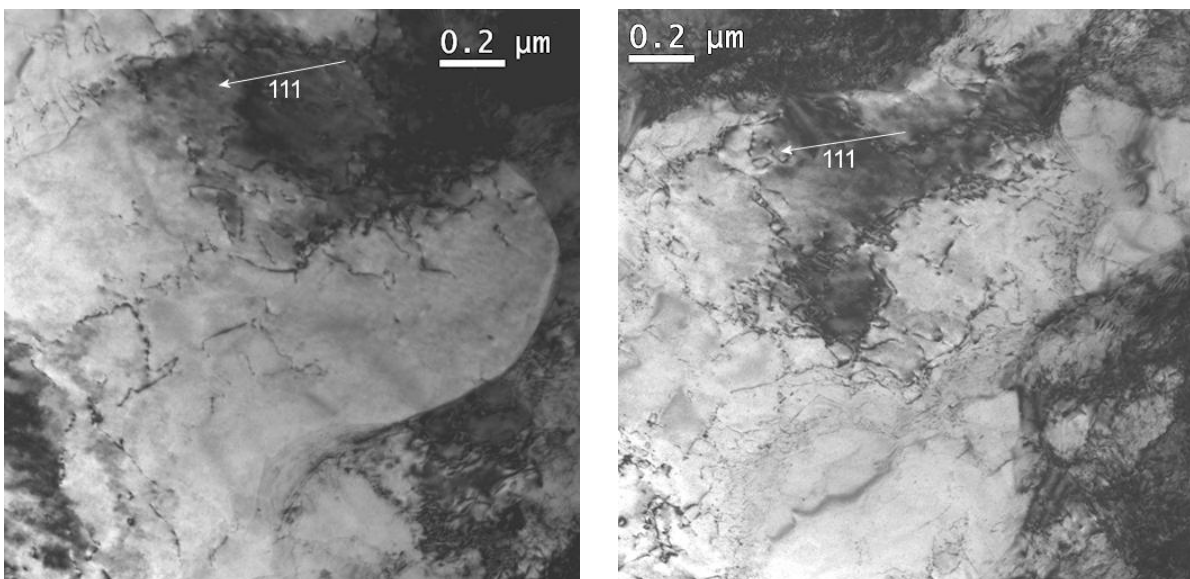
Figure 26: Higher magnification images of regions of reduced dislocation density. Such regions were more readily observable in Cu8\_4.
