Sulphide induced stress corrosion cracking of copper – Intermediate Report 3

Authors: Esko Arilahti, Taru Lehtikuusi, Timo Saario and Päivi Varis

This Intermediate Report covers the progress made in the KYT2010 –research program project “Sulphide induced stress corrosion cracking of copper” between January 22 and 30 December, 2010.

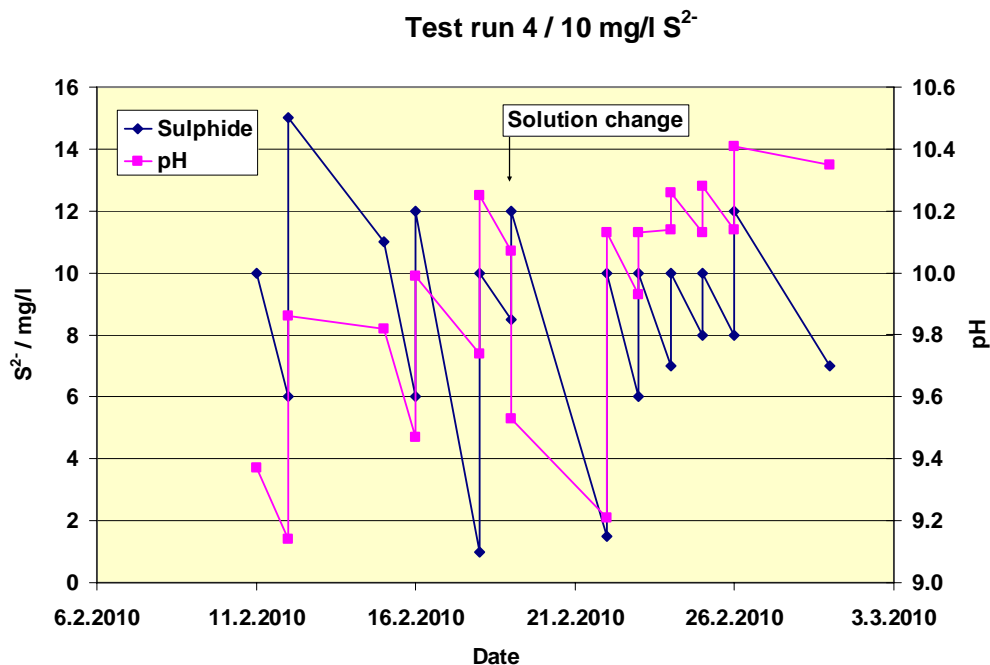
Figure 1. Sulphide concentration and pH as a function of test duration.

The test run was performed with a target level of 10 mg/l sulphide. During the test the sulphide level and pH were measured regularly, see Fig. 1. Sulphide measurement was performed with ampules (CHEMetris VACUettes Kit K-

9510D), which results in an accuracy of about ± 0.5 mg/l of sulphide. The pH was measured with Thermo scientific Orion 5 Star Benchtop meter. Despite of covering most of the surface of the CT-specimen with lacquer, the sulphide level was found to be decreasing as a function of time so that regular refilling was needed. The level was restored each day to about 10 mg/l by adding groundwater with 387 mg/l sulphide (storage electrolyte). The average level of sulphide during the test was 8.6 mg/l.

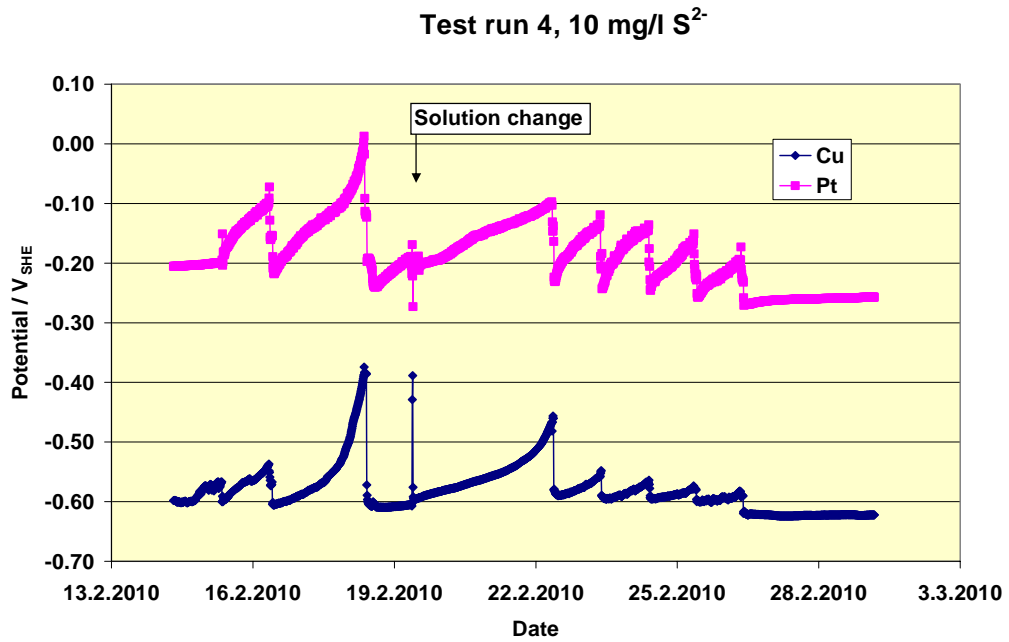
Figure 2. Potential of Cu-specimen and Pt-plate as a function of test duration.

The potential of the Cu-specimen and Pt-plate (redox-potential) are shown in Fig. 2. The Cu-specimen potential is about $E_{Cu} = -0.6 \text{ V}_{SHE}$ during most of the test period, increasing somewhat as sulphide concentration decreases, and returning to the original value as sulphide concentration is replenished. Potential of Pt-plate (the redox-potential) is between $-0.25 \text{ V}_{SHE} < E_{Pt} < -0.15 \text{ V}_{SHE}$ for most of the test period, also following the sulphide concentration.

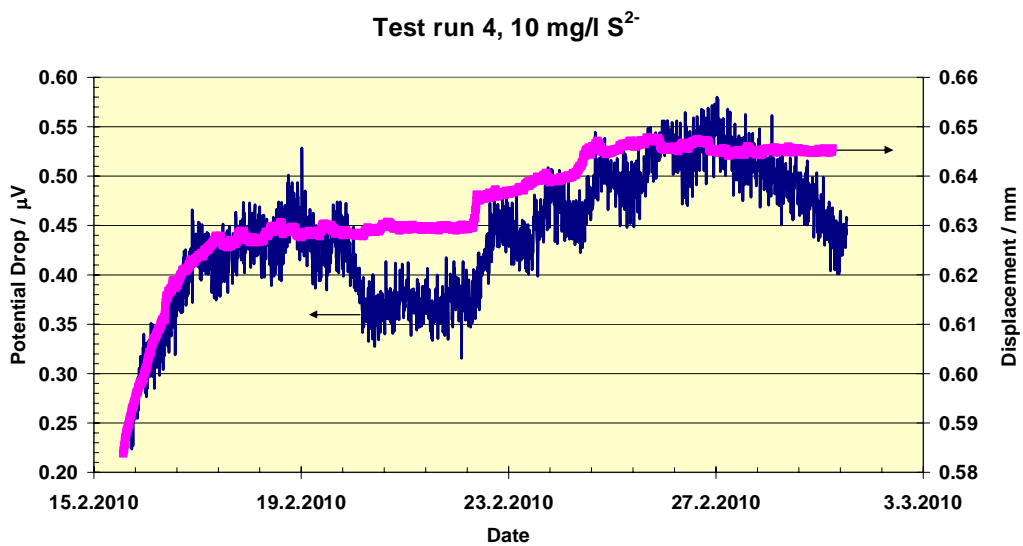
Figure 3. Potential Drop –signal and displacement of the test piece as a function of time.

The Potential Drop-signal (indicating electrical resistance of the test piece) and the displacement of the CT-specimen show a small increase during the test period, indicating some process changing the properties of the CuOFP-material ahead of the crack tip. Displacement measures the opening of the CT-specimen, and is affected by the initial loading and following time dependent processes such as creep and/or crack growth. An increase of the crack length during the test will result in a decrease of the cross sectional area of the test piece, which again is detected as an increase of the electrical resistance (in practise as an increase of the Potential Drop –voltage signal).

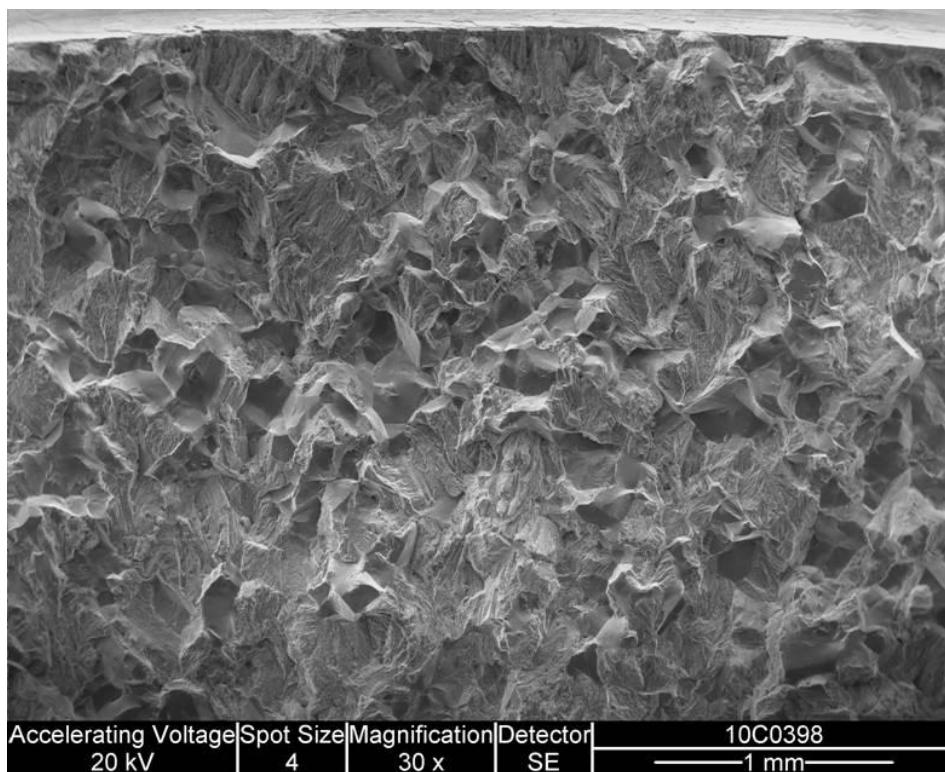
Figure 4. SEM-picture of the prefatigue area. The upper most detail is the machined notch tip.

After test termination the fracture surfaces were examined with both optical and scanning electron microscopy (SEM). The test piece showed an extensive share of grain boundaries in the fracture surface already within the air fatigue area as shown in Fig. 4. This is similar to all of the test pieces, and thus the fracture surface appearance can not be used to determine whether SCC has taken place during the test.

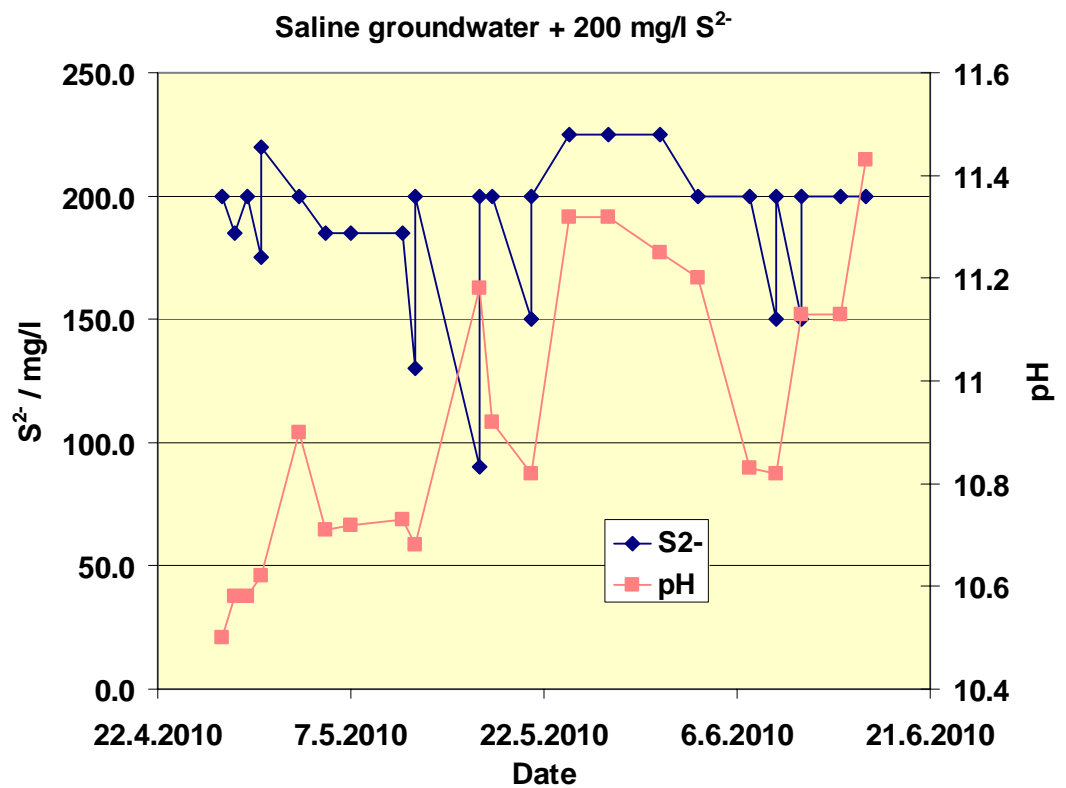
Figure 5. Sulphide concentration and pH as a function of test duration, Test run 5.

The fifth test run was performed with a higher sulphide level of S²⁻ = 200 mg/l. Fig. 5 shows the pH and sulphide concentration as a function of test duration. The pH on average increases slightly during the test run, as a result of sulphide hydrolysis. In Fig. 6, the potentials of Cu and Pt are shown to be rather stable and at a reasonable level. The displacement of the specimen shows a continuous slow increase throughout the test duration, as does the Potential Drop-signal, Fig. 7. As discussed above in case of the test run 4, an increase of these parameters is an indication of some process changing the properties of the CuOFP-material ahead of the crack tip.

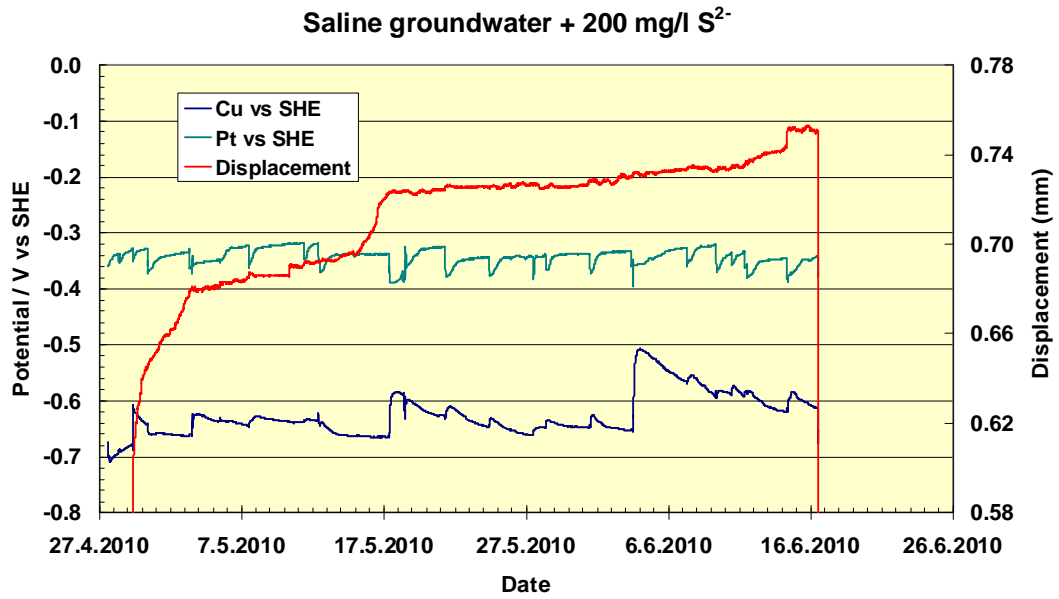
Figure 6. Potentials and displacement (crack opening) of the test piece as a function of time, Test run 5.

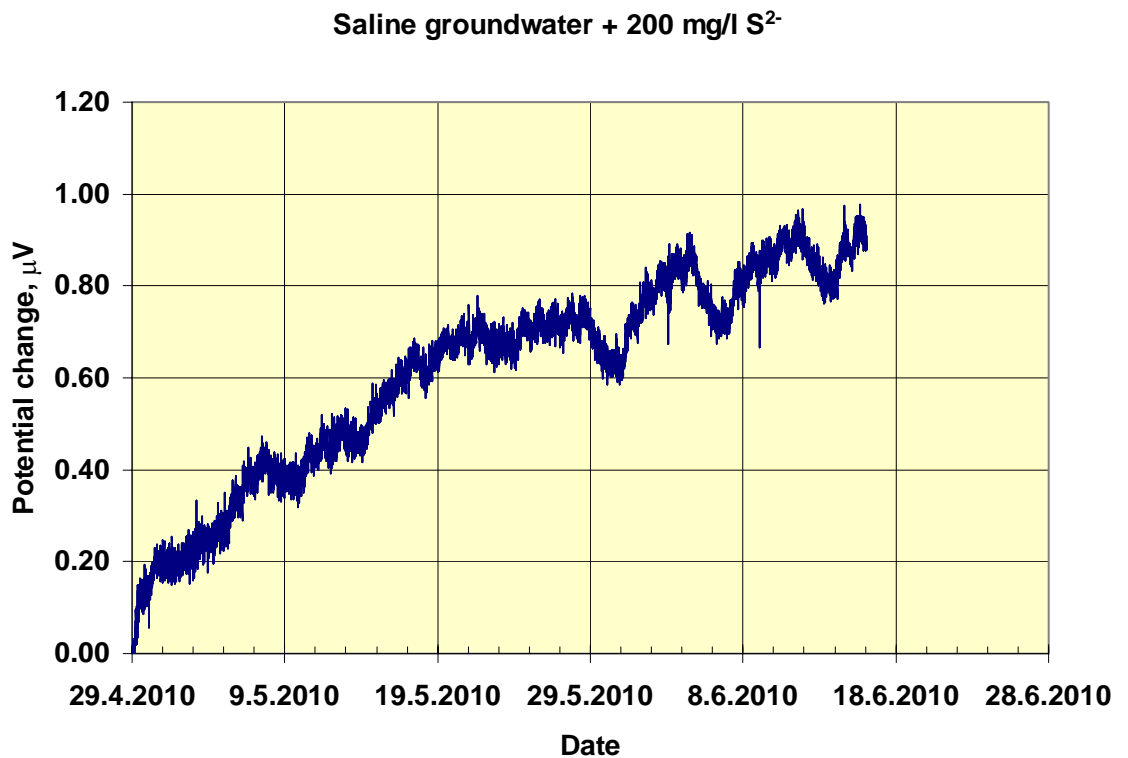
Figure 7. Potential Drop –signal of the test piece as a function of time, Test run 5.

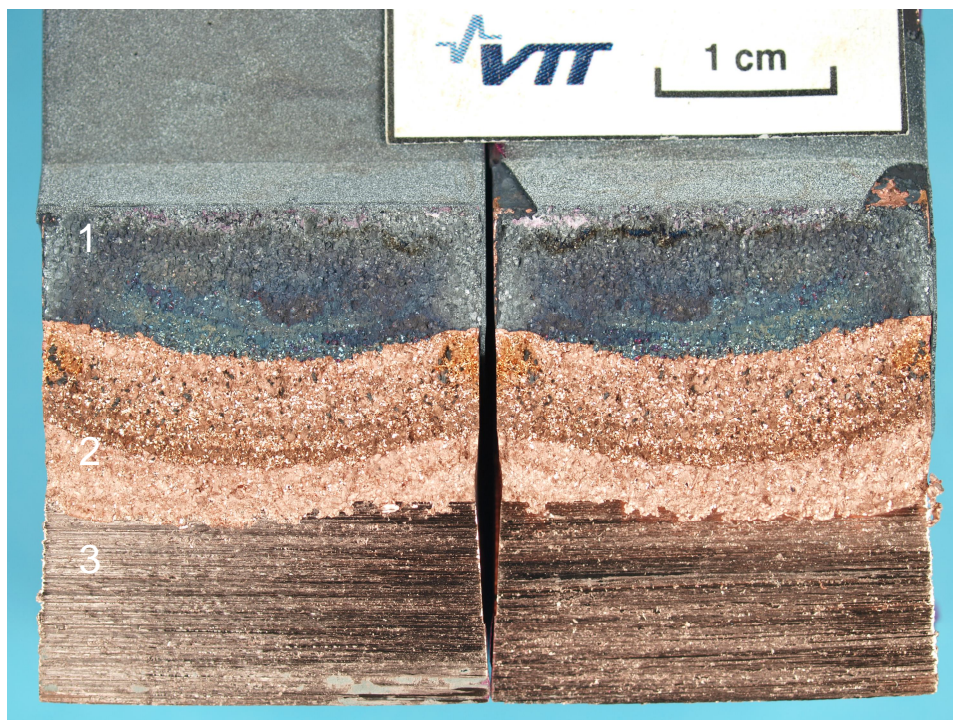
Figure 8. A digital image of the two sides of the fracture surface. s, red lines marking the crack extension during exposure. Number 1 refers to the prefatigue area next to the machined notch, number 2 to the afterfatigue area and 3 to the area mechanically cut from back side of the specimen to prevent extensive plastic deformation during afterfatigue.

plastic deformation during afterfatigue. Next, the specimen was fatigued in air until fracture occurred. The fracture surface of the specimen revealed by further fatigue (Figs 8 and 9) showed that the prefatigue area was covered with black surface layer (copper sulphide). The after-fatigue area (number 2) showed black spots and/or black areas several millimetres ahead of the crack tip, i.e. in material which was not directly exposed to the environment.

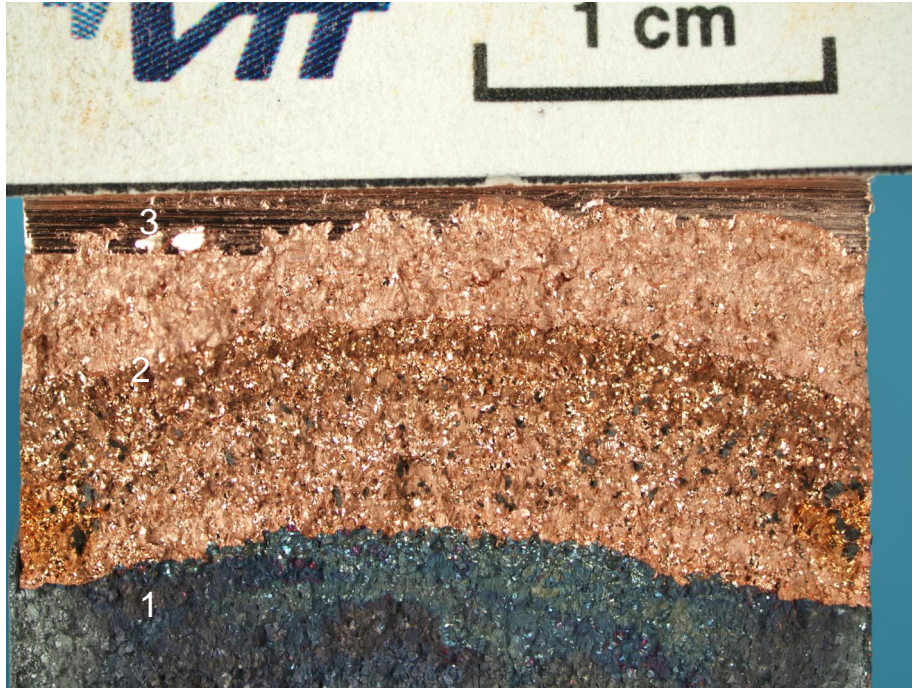
Figure 9. A close-up of the surface shown in Fig.8.

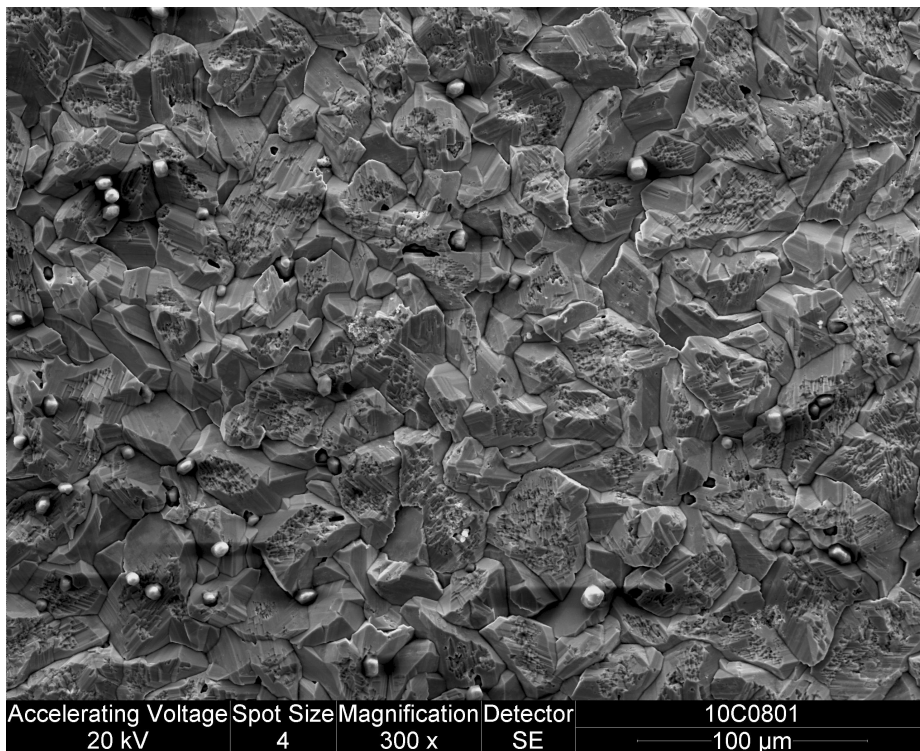
Figure 10a. SEM-picture of the after-fatigue area.

A compositional analysis of a representative part of the area (Fig. 10) with SEM/EDX showed 58.7 at% Cu and 22.5 at% S. This indicates that a considerable part of the exposed grain boundaries are covered with a sulphide film. Fig. 10 shows a comparison of normal and backscattered SEM images of a representative area ahead of the crack tip, revealing that there are some particles which seem like precipitates, and that also most grain boundaries that are perpendicular to the fracture surface contain of a lighter phase, presumably a Cu-S-precipitate. Spot analysis of a single grain boundary in this area showed basically only Cu and S. Some but not all of the particles were identified as Cu-S-precipitates. It is assumed that the increase of the PD-signal during the exposure (see Fig. 7) is caused by formation of sulphide films on grain boundaries and sulphide inclusions ahead of the crack tip. Copper sulphide is a poor electrical conductor compared to copper. Thus, the formation of copper sulphide ahead of the crack tip is seen as an average increase of electrical resistance of the load bearing cross sectional area of the specimen, i.e. as an increase of the PD-signal.

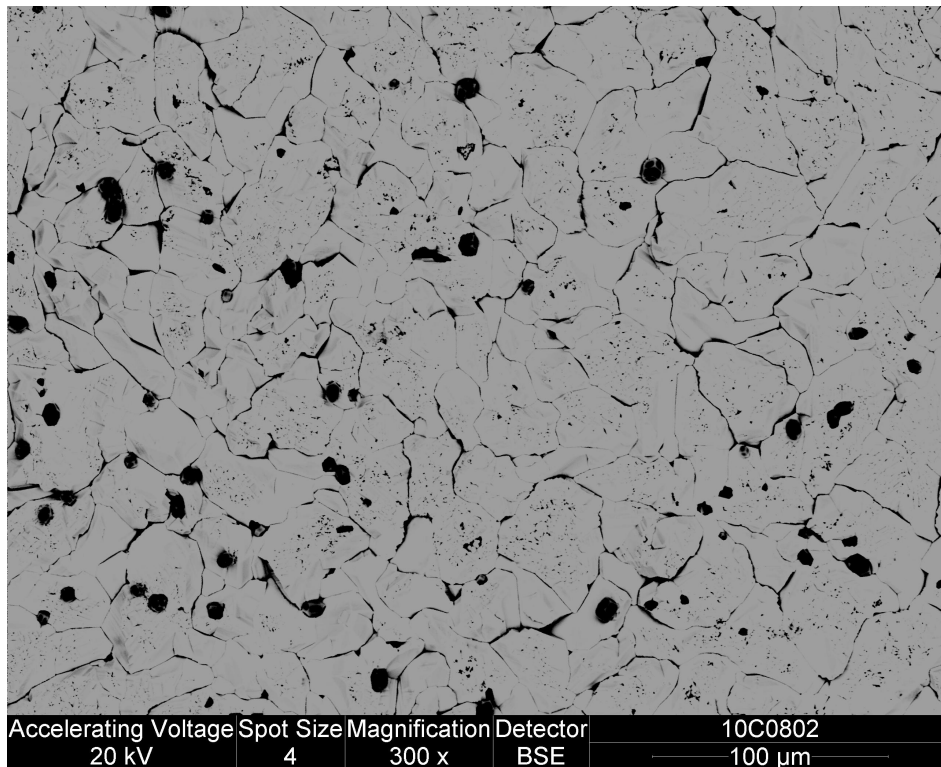
Figure 10b. The same area as in Fig. 10, in BSE -mode.

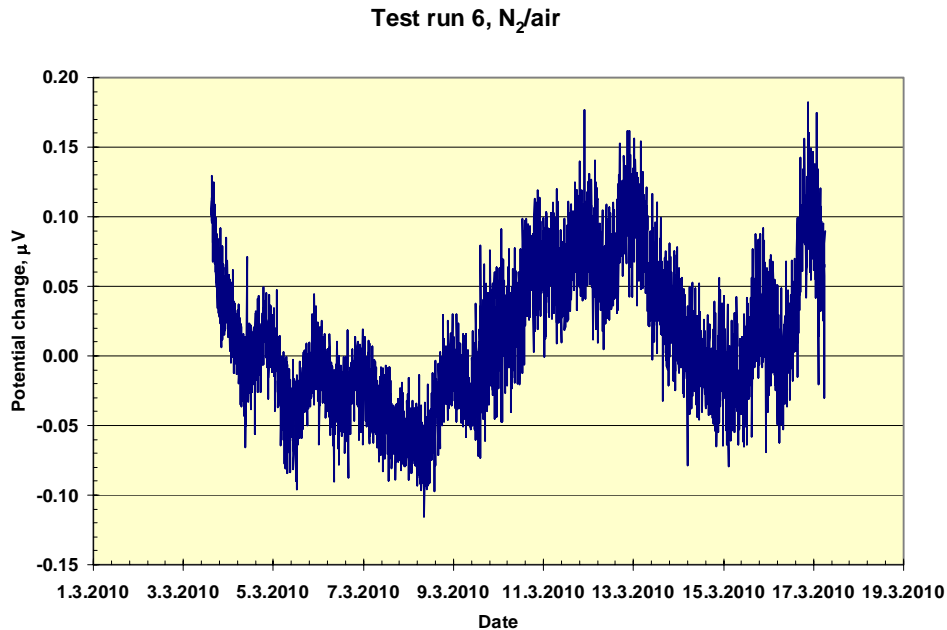
Figure 11. Potential Drop –signal of the test piece as a function of time, Test run 6 (N₂/air).

A test run was made using exactly the same testing sequence and equipment as before but instead of exposing the sample to groundwater with sulphide the pressure vessel was filled with nitrogen gas. Exposure time was two weeks. No continuous change in the Potential Drop signal was detected, as expected, Fig. 11.

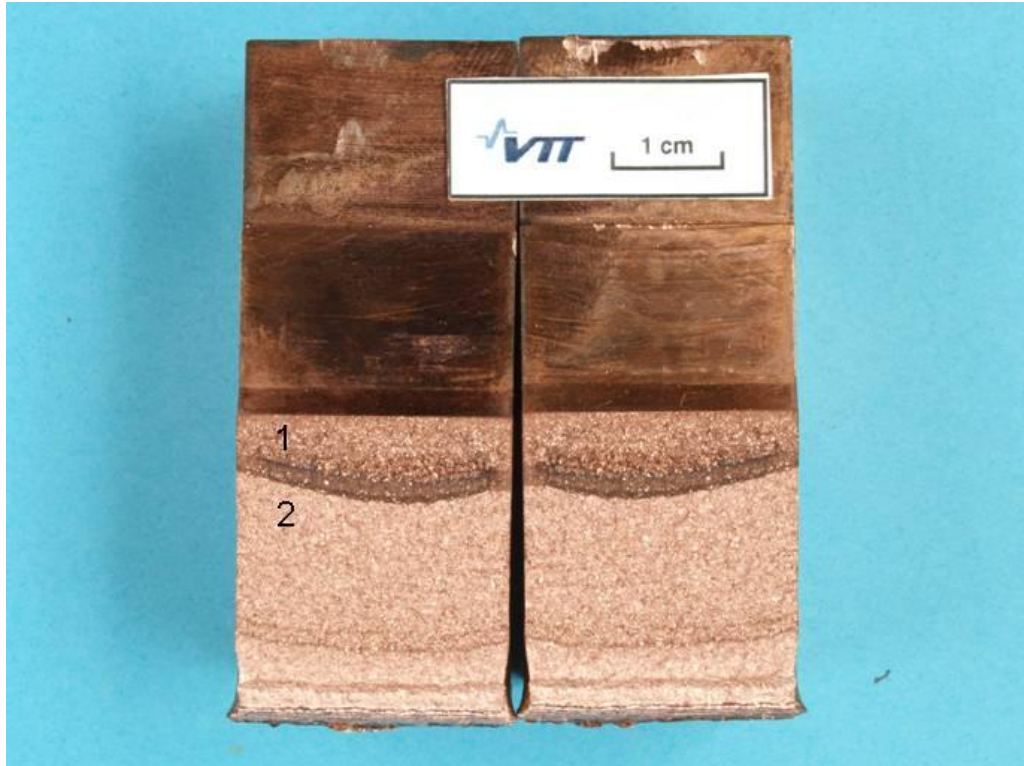
Figure 12a. A digital picture of the fracture surface, Test run 6 (N₂/air). The prefatigue area (1) and afterfatigue area (2).

Fig. 12a shows the fracture surface (produced by afterfatigue) and Figs 12b and 12c SEM pictures of the different parts of the surface. The percentage of grain boundaries on the fracture surface is very high both in the pre-fatigue and after-fatigue areas. The test was performed to verify that both the pre-fatigue and after-fatigue procedures produce a fracture surface with a considerable portion of grain boundaries without the presence of the groundwater environment. Thus, the presence of grain boundaries on the fracture surfaces could not be used as an indication of SCC in case of CuOFP. The reason why the fatigue procedure is able to drive the fatigue crack along the grain boundaries is unclear. The SEM/EDS analysis of the grain boundary areas for this sample showed only Cu and O. Thus, at least severe segregation of P into the grain boundaries as a possible cause of weakening the adhesion of the grain boundaries could be ruled out.

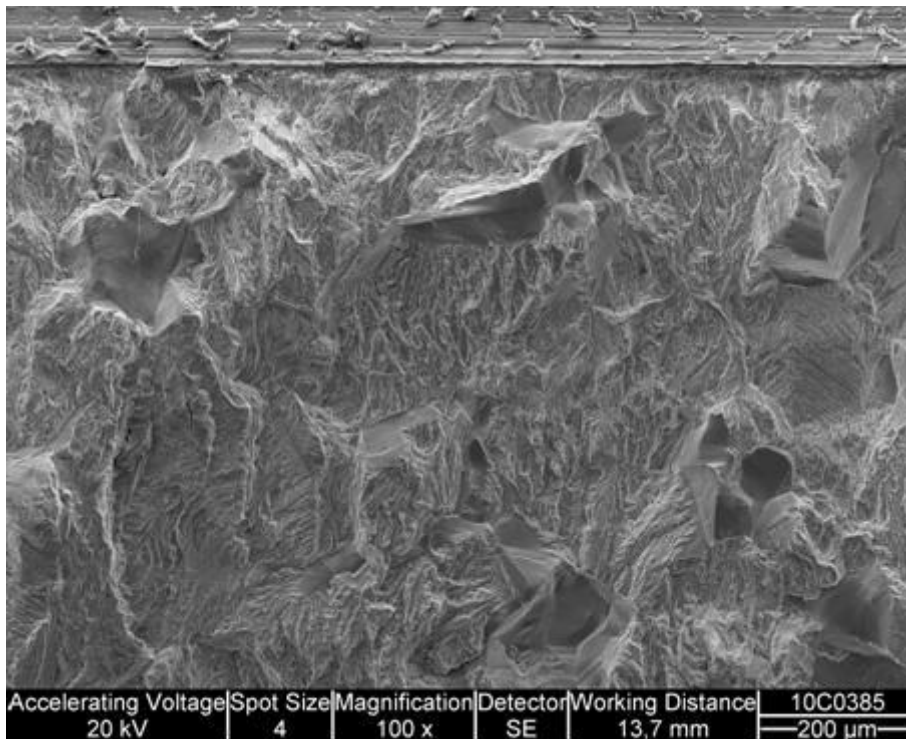
Figure 12b. SEM-picture of the prefatigue area, with the machined notch at the upper edge of the picture. Test run 6 (N₂/air).

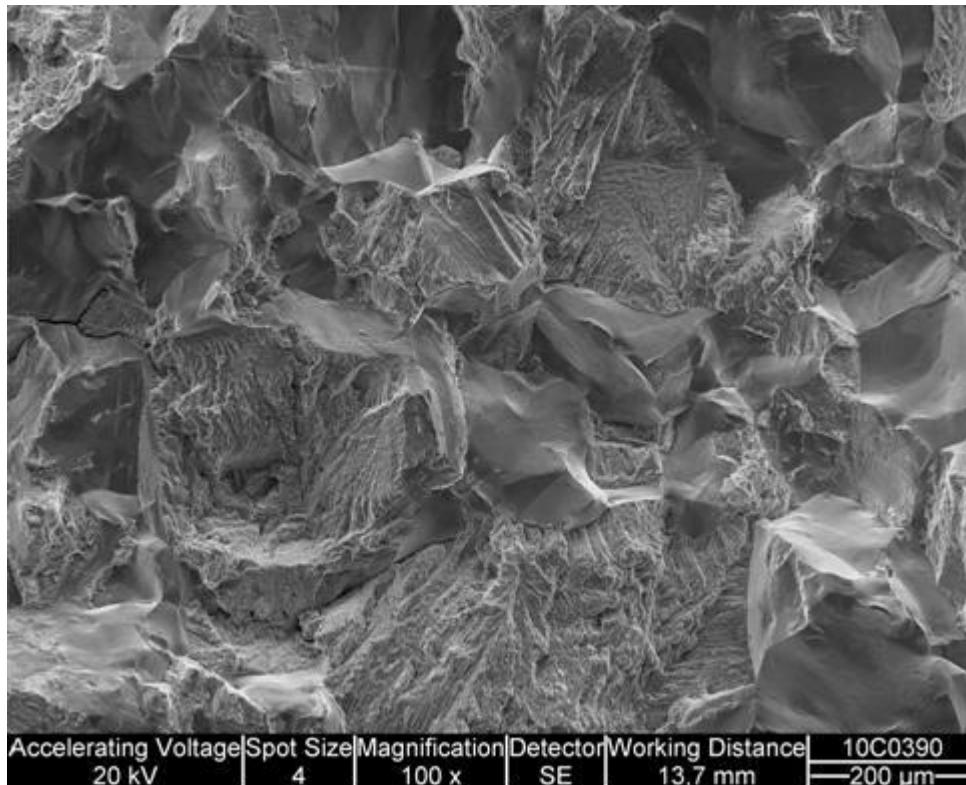
Figure 12c. SEM-picture of the start of the afterfatigue area. Test run 6 (N_2 /air).

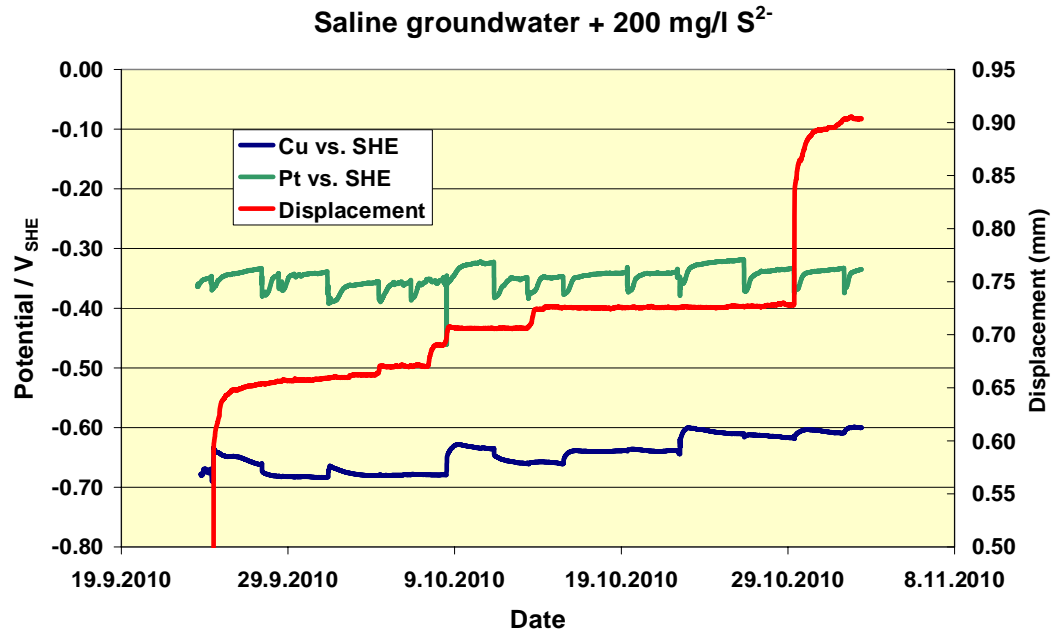
Figure 13. Potentials and displacement (crack opening) of the specimen 8 as a function of time, Test run 7/8 (specimen 7 was not loaded and not monitored).

The potentials of Cu and Pt, Fig. 13, were found to be very similar to the Test run 5 in a similar environment. The displacement of the specimen showed also a similar, continuously growing trend, with a large increase as a response to the increase in load at the end of the period, Fig. 14. The increase in displacement due to the load increase was about double to the one in Test run 1 (with 100 mg/l S^{2-}), which may indicate deterioration of the mechanical properties of CuOFP due to in-diffusion of sulphur.

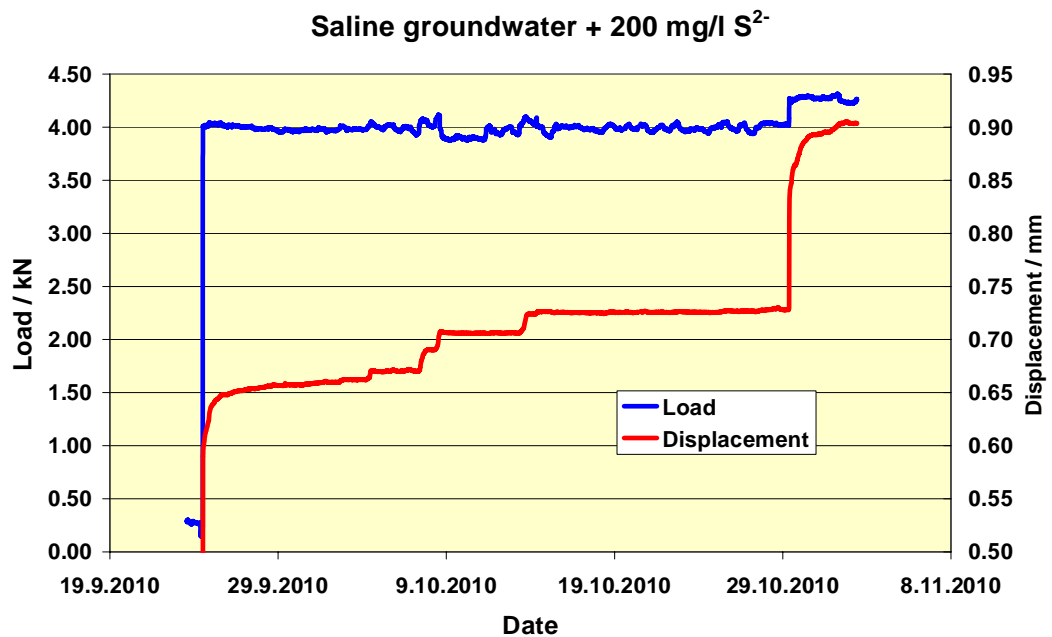
Figure 14. Load and displacement as a function of time, specimen 8, Test run 7/8.

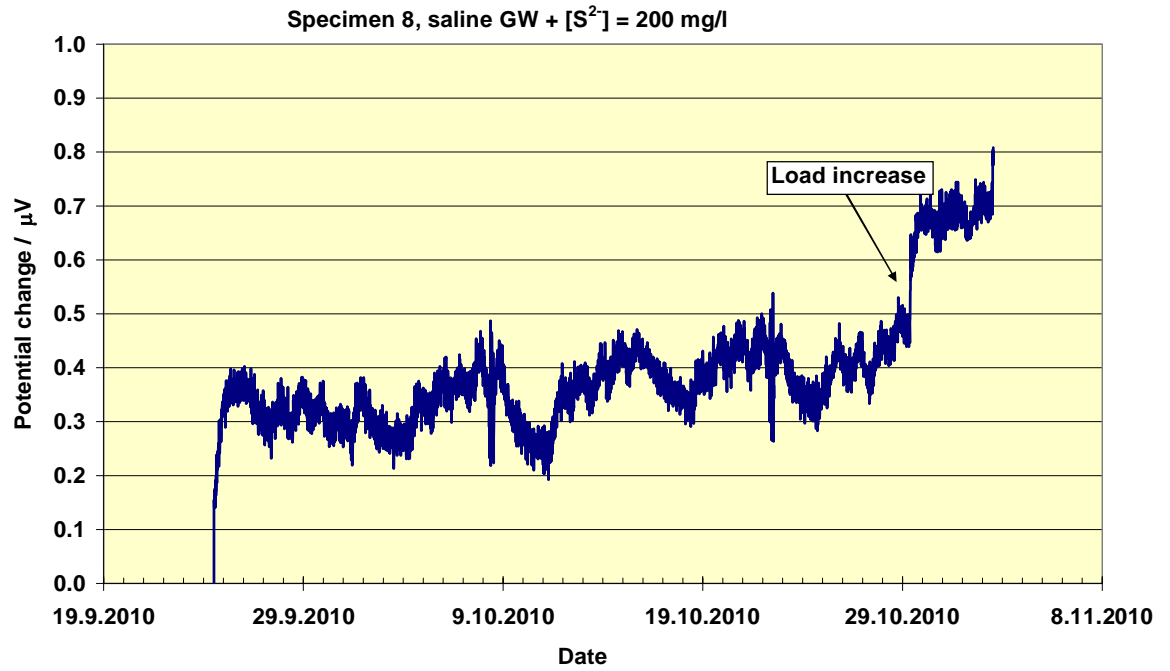
Figure 15. Potential Drop –signal of the test piece as a function of time, Test run 7/8.

The Potential Drop –signal showed only a small increase during the test period, with a relatively high increase as a response to the increase in load, Fig. 15. SEM/EDS analysis of the area ahead of the crack tip showed again considerable portion of grain boundaries, Fig. 17. The EDS area analysis on five areas at different locations ahead of the crack tip showed sulphur concentrations between

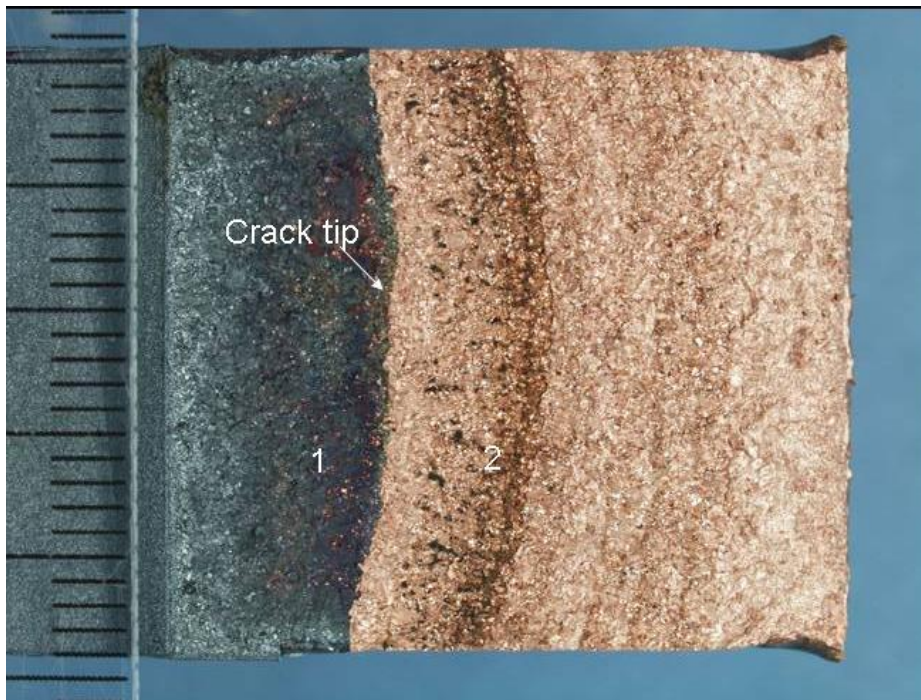
Figure 16. Fracture surface of specimen 8 after the exposure, showing black spots ahead of the crack tip. Prefatigue (1) and afterfatigue (2) areas. Test run 7/8, specimen 8 (loaded).

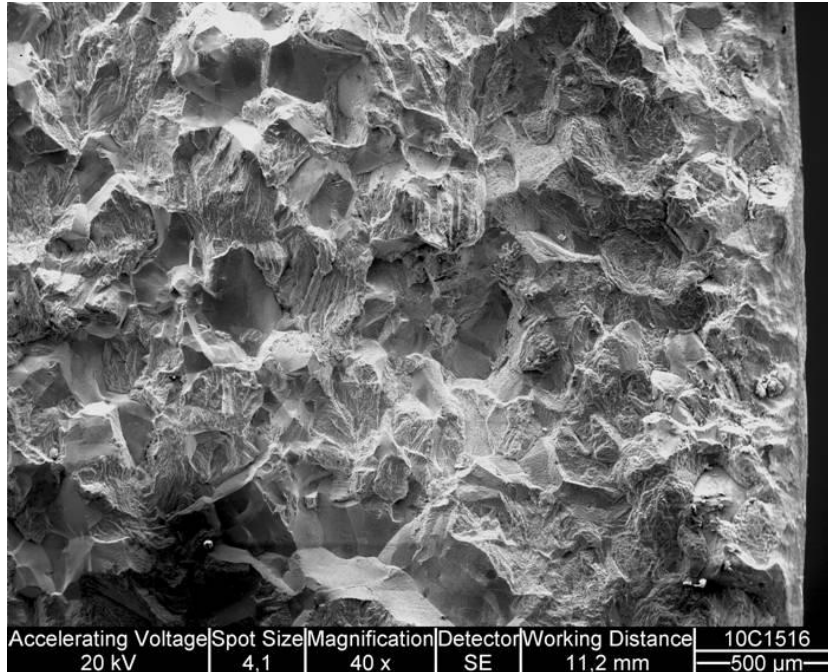
Figure 17. SEM-picture of the start of the afterfatigue area. Test run 7/8, specimen 8 (loaded).

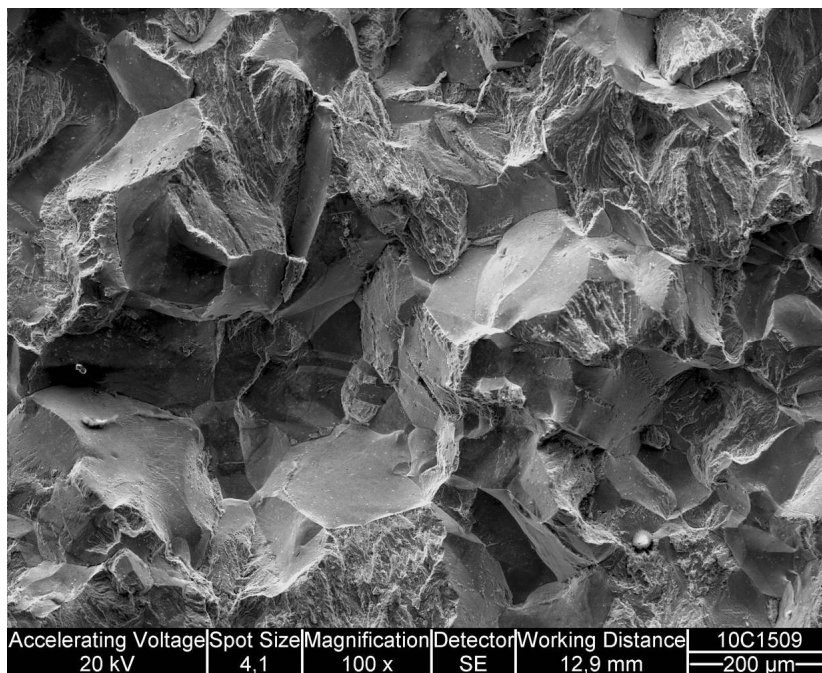
Figure 18. SEM-picture of the start of the afterfatigue area. Test run 7/8, specimen 7 (unloaded).

Fig. 18 shows the general appearance of the unloaded specimen (nr 7) in the after-fatigue area ahead of the crack tip with considerable portion of grain boundaries. The EDS area analysis on five areas at different locations ahead of the crack tip showed sulphur concentrations between 9 and 26 a%, slightly lower concentrations than in the case of the loaded specimen (Nr 8). This tends to indicate that stress (loading) increases the rate of in-diffusion of sulphur into CuOFP.

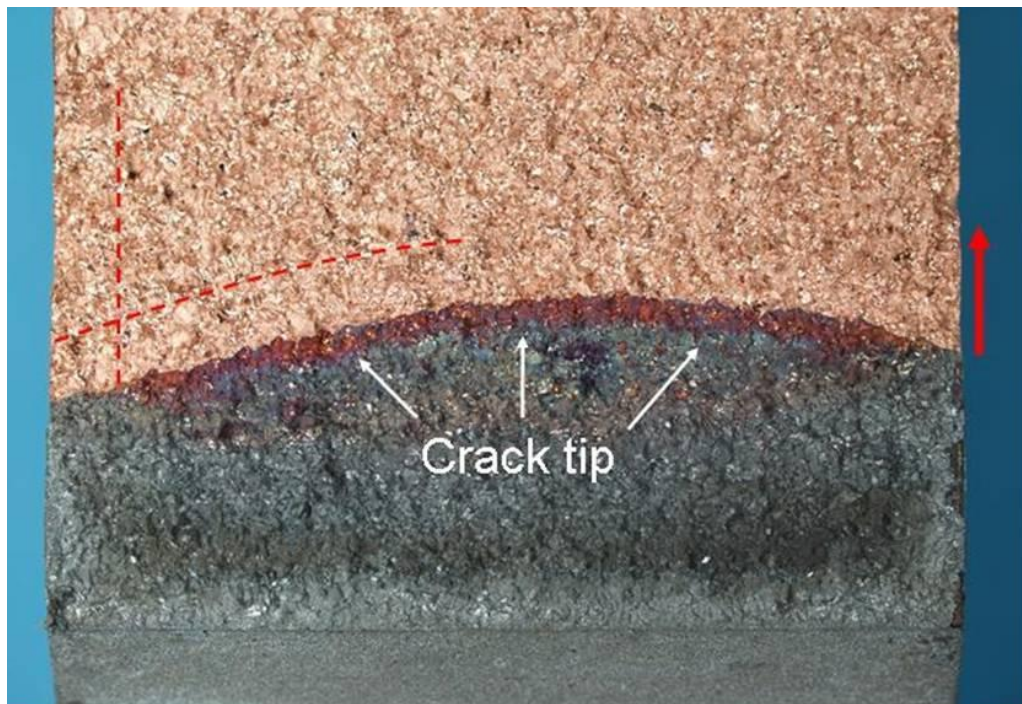
Figure 19. Fracture surface of specimen Nr 1 (tested in groundwater with 100 mg/l S^{2-}).

In the first phase, SEM/EDS analysis was performed in a more continuous way. Area analysis on the fracture surface ahead of the crack tip was performed along two red dashed lines (see Fig. 19), the distance between two adjacent areas chosen as 1 mm. The first line of analysis was located at about 2 mm from the left hand side of the specimen and extended 10 mm away from the crack tip. The second line of analysis was located at about 2 mm distance ahead of the crack tip and extended from about 2 mm distance from the side towards the centre of the specimen. The sulphur concentration (at%) decreased as a function of distance along both lines, see Fig. 20. The concentration profiles are not typical diffusion profiles, and a more detailed modelling effort would be needed to estimate e.g. the diffusion coefficient of sulphur/sulphide from these profiles.

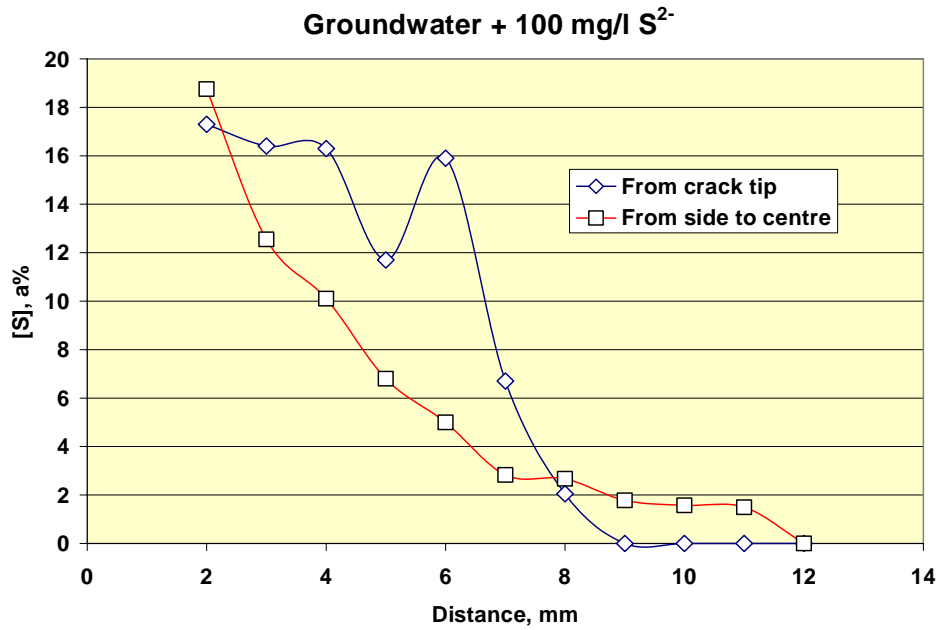
Figure 20. Sulphur concentration (at%) on the fracture surface of specimen Nr 1 (tested in groundwater with 100 mg/l S^{2-}) as found by SEM/EDS -analysis.

where the sulphur concentration measured on the crack surface starts to decrease and reaches a minimum (see Fig. 20). This may indicate that precipitation of the inclusions causes the decrease in sulphur concentration. According to fracture mechanical calculations (Irwin's model) the size of the plastic zone ahead of the crack tip can be estimated as

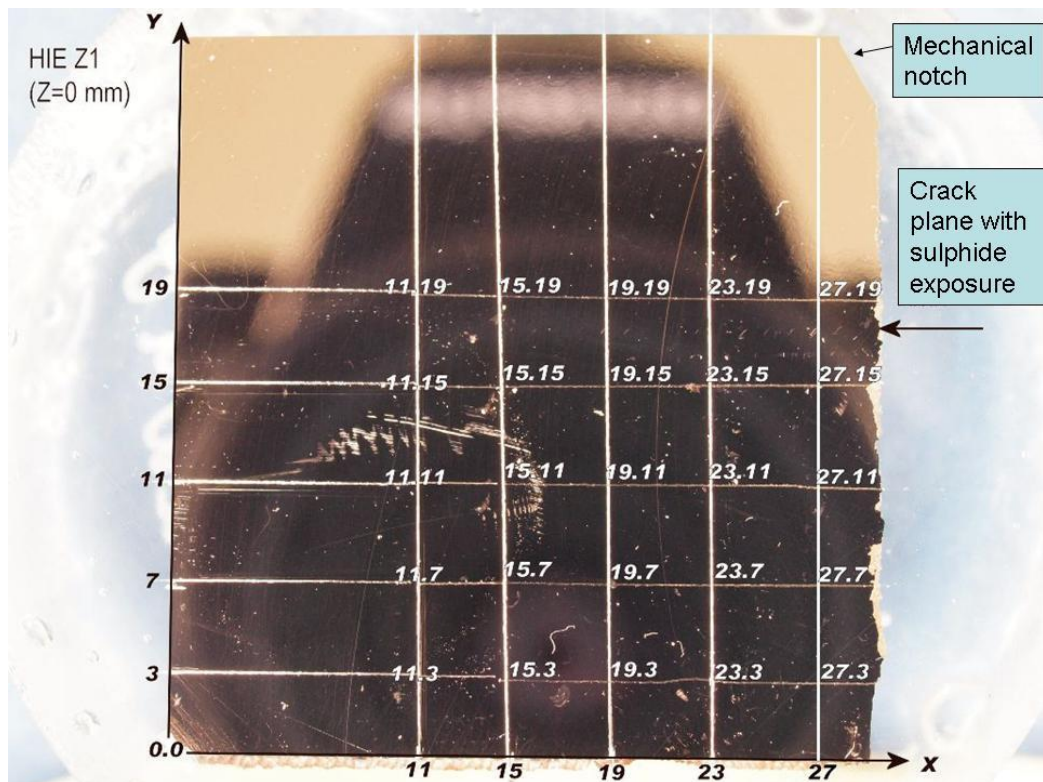
Figure 21. Slice Z1 of specimen Nr 1.

To further determine the extent of in-diffusion in specimen Nr 1, the specimen was sliced to reveal four separate planes ahead of crack tip and perpendicular to the crack plane (see Fig. 21). Here Z is the distance from the side towards the centre of the specimen. Thus, $Z = 0$ mm indicates that this surface is the outer surface of the specimen. The X and Y are the coordinates according to which digital images were taken with light microscope and further analysed with Image J –software to provide a particle area fraction and size distribution analysis of the sulphide inclusions. An analysis was performed for the X and Y coordinates of every cross section, i.e. 25 analyses for one slice. The other three slices had Z coordinates $Z_2 = 4$ mm, $Z_3 = 8$ mm and $Z_4 = 12$ mm. Thus, slice Z4 would represent the material right at the centre of the specimen.

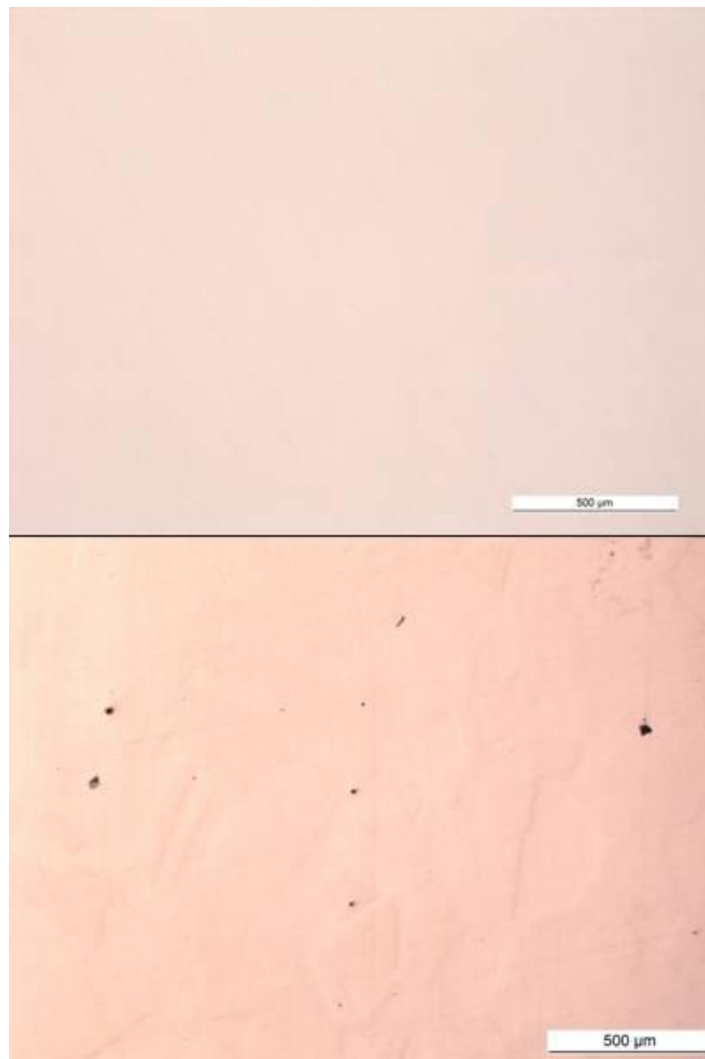
Figure 22. Comparison of polished surface of unexposed CuOFP and that of cross section 27.11 of slice Z1 in Fig. 21. Area fraction of inclusions is $6.5 \cdot 10^{-4}$.

As an example of the images, Fig. 22 shows a comparison of unexposed CuOFP and the cross section 27.11 in Fig. 21. Based on such a comparison, it is safe to assume that all inclusions found (at this magnification) are in fact sulphides. In the Image J –analyses, the lower limit was set to $1 \mu\text{m}^2$, i.e. about one pixel. Using the same criteria for the unexposed sample shown in Fig. 22 below resulted in no indications.
