Sulphide induced stress corrosion cracking of copper – Intermediate Report 3

Authors: Esko Arilahti, Taru Lehtikuusi, Timo Saario and Päivi Varis

This Intermediate Report covers the progress made in the KYT2010 –research program project “Sulphide induced stress corrosion cracking of copper” between January 22 and 30 December, 2010.

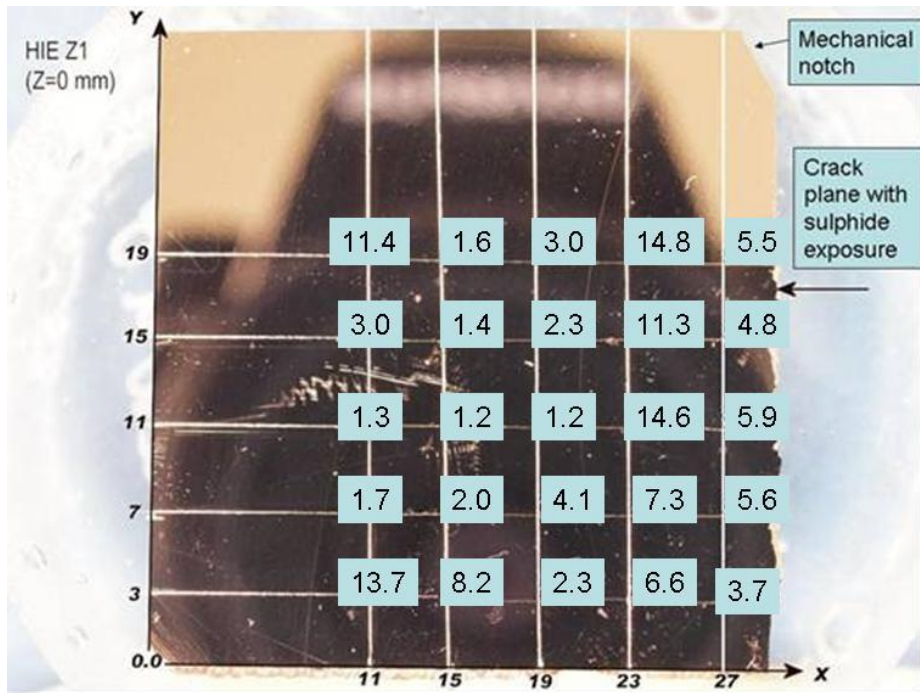
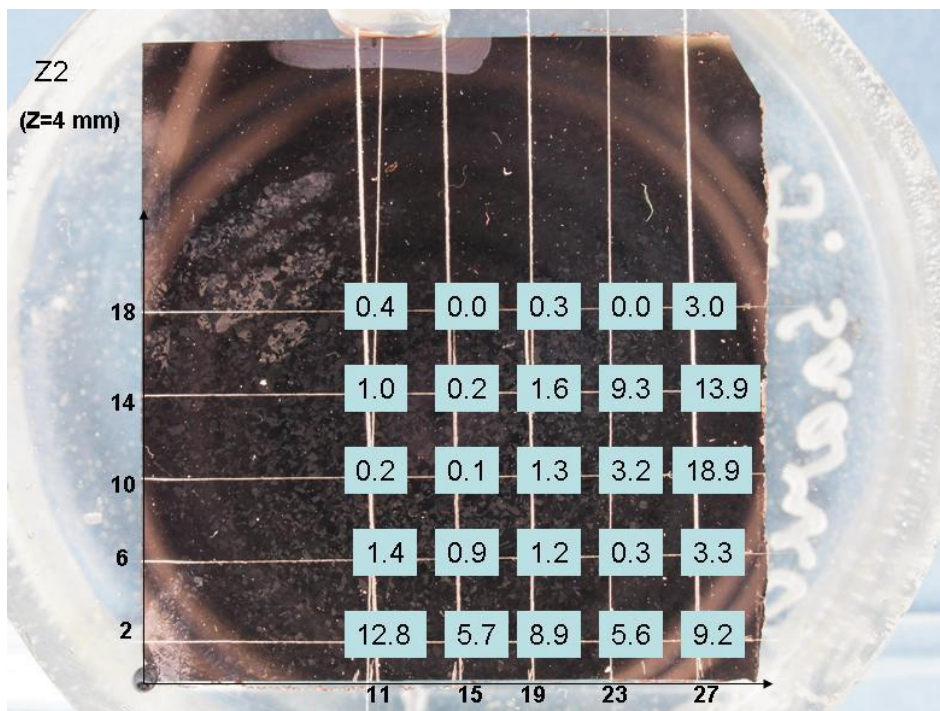
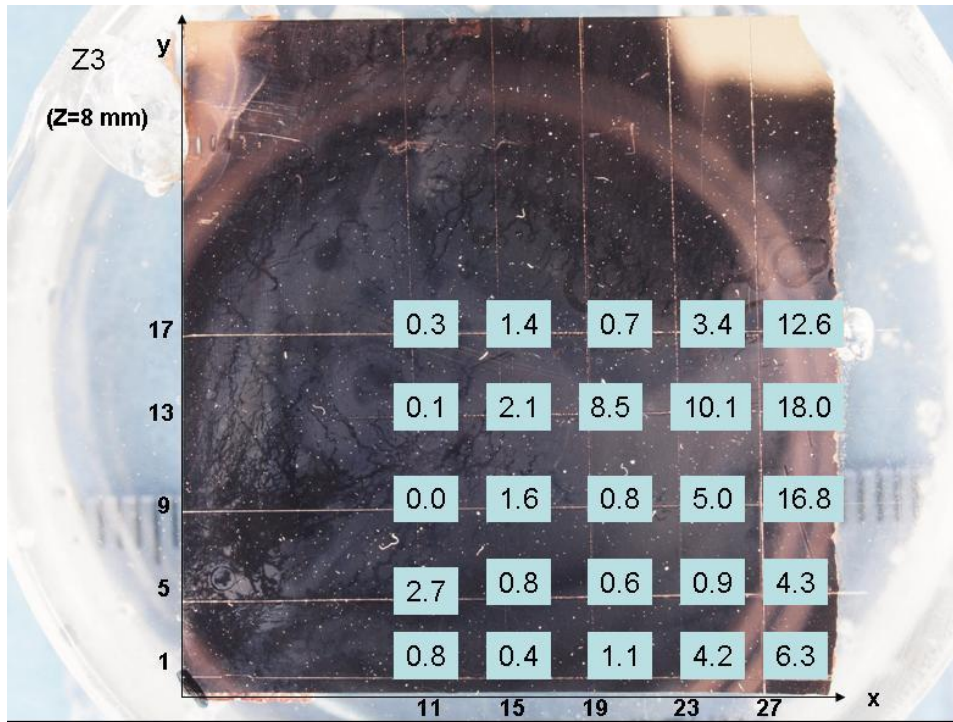
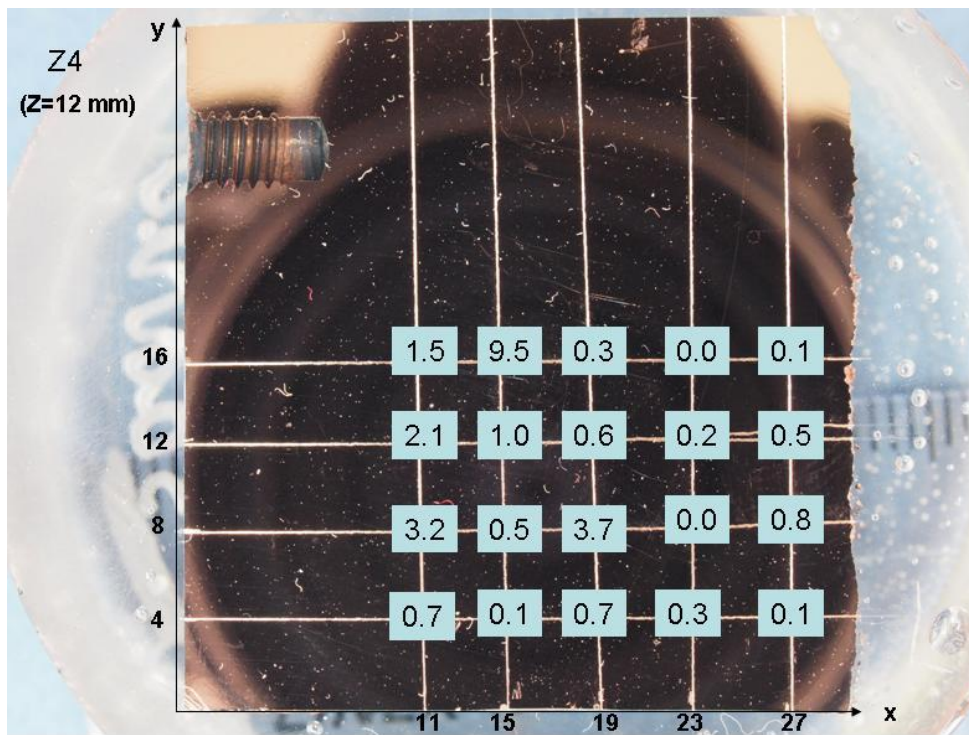
Figure 23. Area fractions of inclusions ($\times 10^4$) in slice Z1 (0 mm from outer surface) as a function of location.

Figure 24. Area fractions of inclusions ($\times 10^4$) in slice Z2 (4 mm from outer surface) as a function of location.

Figure 25. Area fractions of inclusions ($\times 10^4$) in slice Z3 (8 mm from outer surface) as a function of location.

Figure 26. Area fractions of inclusions ($\times 10^4$) in slice Z4 (12 mm from outer surface) as a function of location.

Figures 23 to 26 show the area fraction of inclusions found on the different slices as a function of location on each slice. The analysed area at each location was 3.6 mm^2 . The inclusion size (average for each location analysed) varied between 1.7 and $66 \text{ }\mu\text{m}$.

When looking through the data in Figs 23 to 26 one may wish to keep in mind the distance of different locations to the source of sulphur, the groundwater. For example, in case of slice Z1, i.e. the outer surface of the specimen, sulphur has had access to all of the surface locations directly. Thus, one would expect to find high values at practically all the locations. In practise, inclusions were found at all analysed locations, although there seems to be a very high variability on the area fraction. Going deeper into the material one would expect to find less inclusions at the locations farthest from the source, e.g. at location $x=11$ $y=18$ in Fig. 24 and $x=11$ $y=17$ in Fig. 25. This is also roughly in line with the actual results. As expected high area fractions are found closer to the fracture plane (i.e. along the line $x = 27$ mm), i.e. closer to the source (groundwater in the crack enclave). The slice Z4, representing material in the centre of the specimen, shows rather low area fractions close to the fracture plane. This could be explained by the restricted access of sulphide containing groundwater to this area (most of the sulphide would have been consumed in reactions with the outer parts of the crack flanges before the water reached the centre part).

It is also clear from the results that there must be some preferential paths within the microstructure for sulphur/sulphide entrance. For example, at location $x=15$ $y=16$ in slice Z4 a rather high area fraction of $9.5 \cdot 10^{-4}$ is found, despite of the facts that the location is very far from the source of sulphur/sulphide and that the nearest neighbouring locations show very low area fractions.

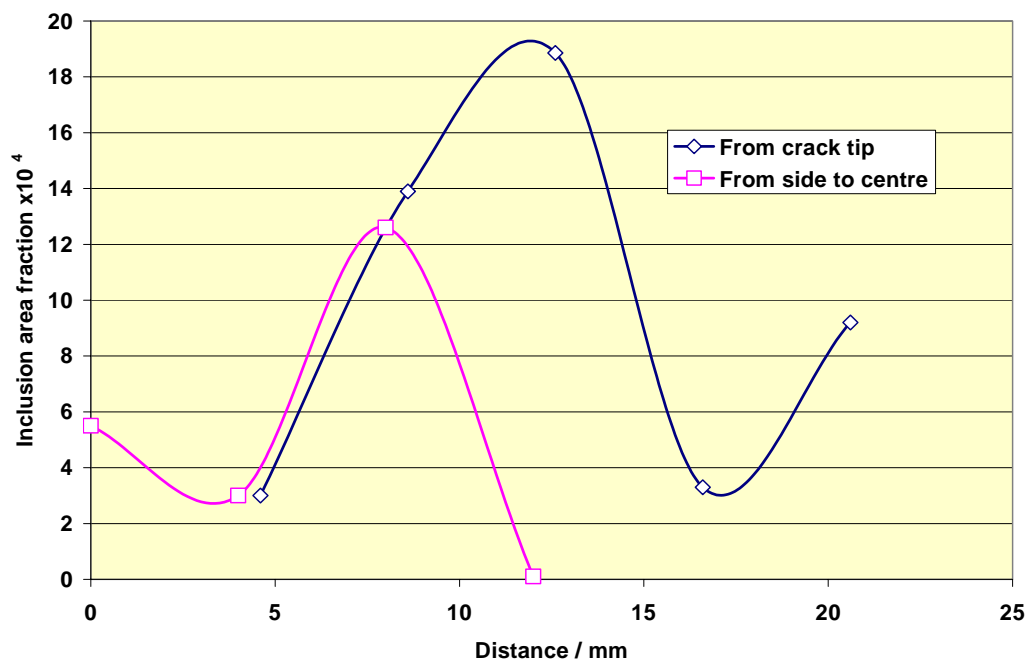
Figure 27. Area fractions of inclusions ($\times 10^4$) as a function of distance from the crack tip and from the side of the specimen.

Figure 27 shows the area fraction of inclusions as a function of distance from the crack tip (data from line $x=27$ mm in slice Z2), and from the side of the specimen towards the centre (one data point from each slice corresponding to the highest x - and y -values). This data can be basically compared with data gained by SEM/EDS on the fracture surface (shown in Fig. 20). Based on the comparison it would seem that the area fraction of inclusions increases and reaches a maximum at distances

where the sulphur concentration measured on the crack surface starts to decrease and reaches a minimum (see Fig. 20). This may indicate that precipitation of the inclusions causes the decrease in sulphur concentration. According to fracture mechanical calculations (Irwin's model) the size of the plastic zone ahead of the crack tip can be estimated as

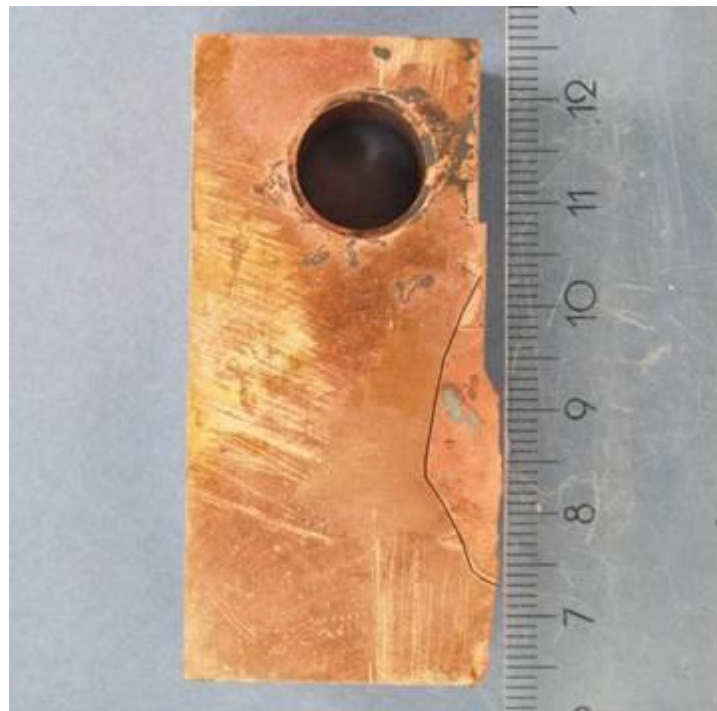
Figure 28. Side view of specimen 4 after the test. The black line contours the area that was not covered by lacquer during the exposure.

Test run 4 was performed in groundwater with $10 \text{ mg/l [S}^{2-}]$. The specimen was covered with lacquer except for the crack tip area (see Fig. 28). Inclusion analysis was performed only on the area not covered with lacquer.

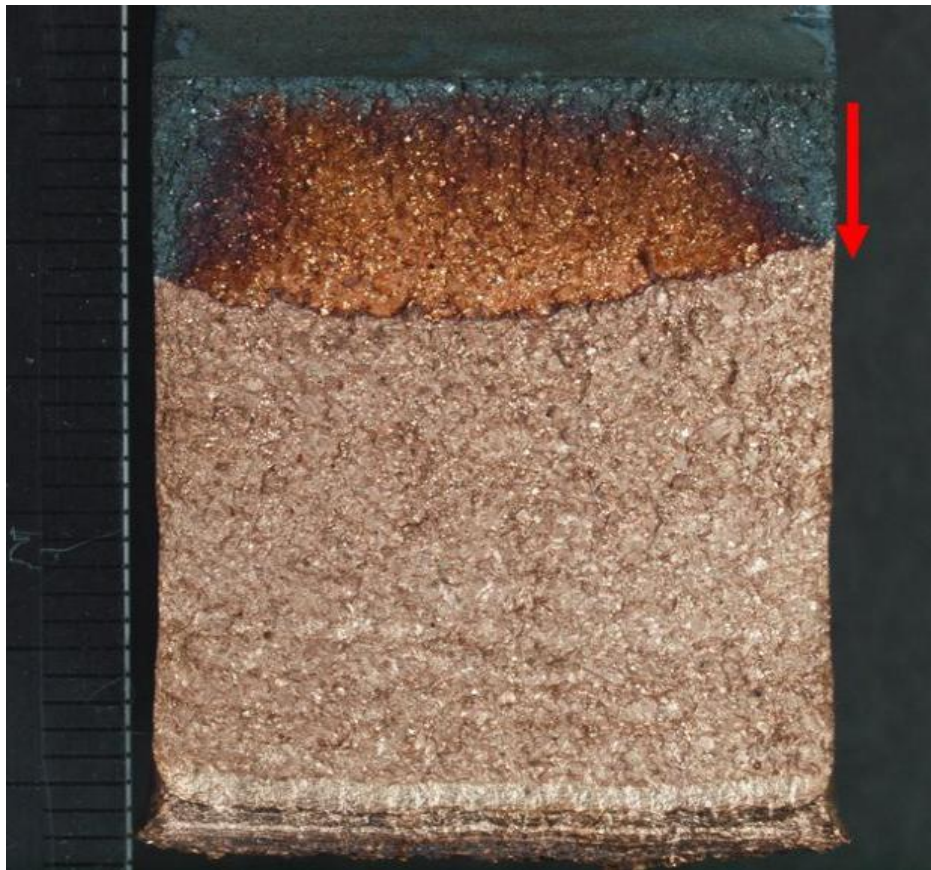
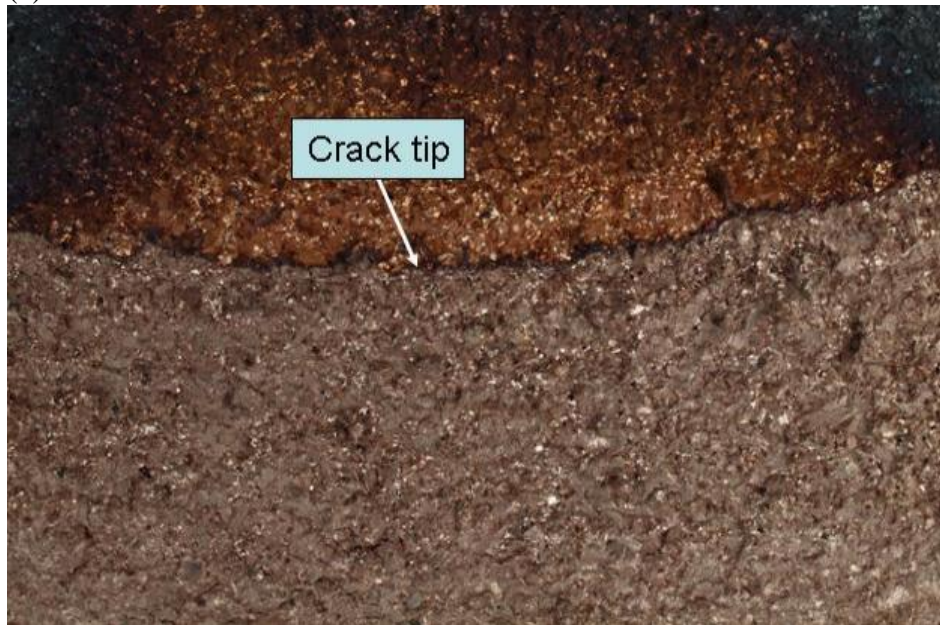
Figure 29. Fracture surface of specimen 4 after the exposure; general appearance (a) and detail (b).

From Fig. 29a it is clear based on the colour difference (which reflects a difference in film thickness) that the central part of the prefatigue area (red-brown colour) has not seen as much sulphide as the areas with shorter distance to the groundwater. This indicates that at this relatively low sulphide concentration most of the sulphide is consumed in reactions with those parts of the prefatigue area

more closer to the water, and the central area (due to restricted flow conditions) has been exposed to lower sulphide concentration. In the detail picture (29b), some small black spots could be detected ahead of the crack tip (more clearly visible directly under the microscope). The specimen was sliced in three parts so that the first surface was the outer surface of the specimen, the second one 6.25 mm and the third one 12.5 mm from the outer surface. Thus, the third slice represents the central part of the specimen. The image analysis for inclusions was performed using

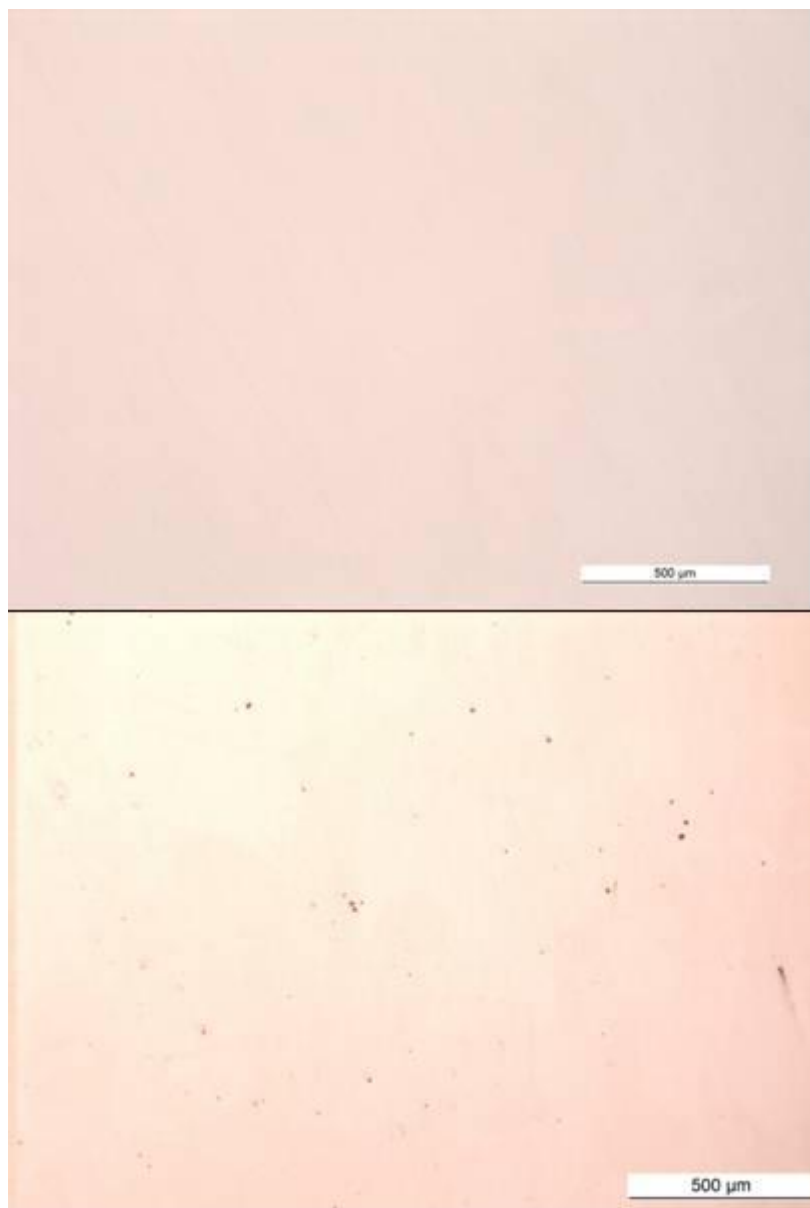
Figure 30. Comparison of polished surface of unexposed CuOFP and that of slice Z1 of specimen 4 (see below Fig. 31).

Fig. 30 shows a comparison of un-exposed CuOFP and CuOFP exposed to groundwater with 10 mg/l [S^{2-}] for two weeks. In comparison to exposure to groundwater with 100 mg/l [S^{2-}] (see Fig. 22), the average size of inclusions is smaller and the number is larger.

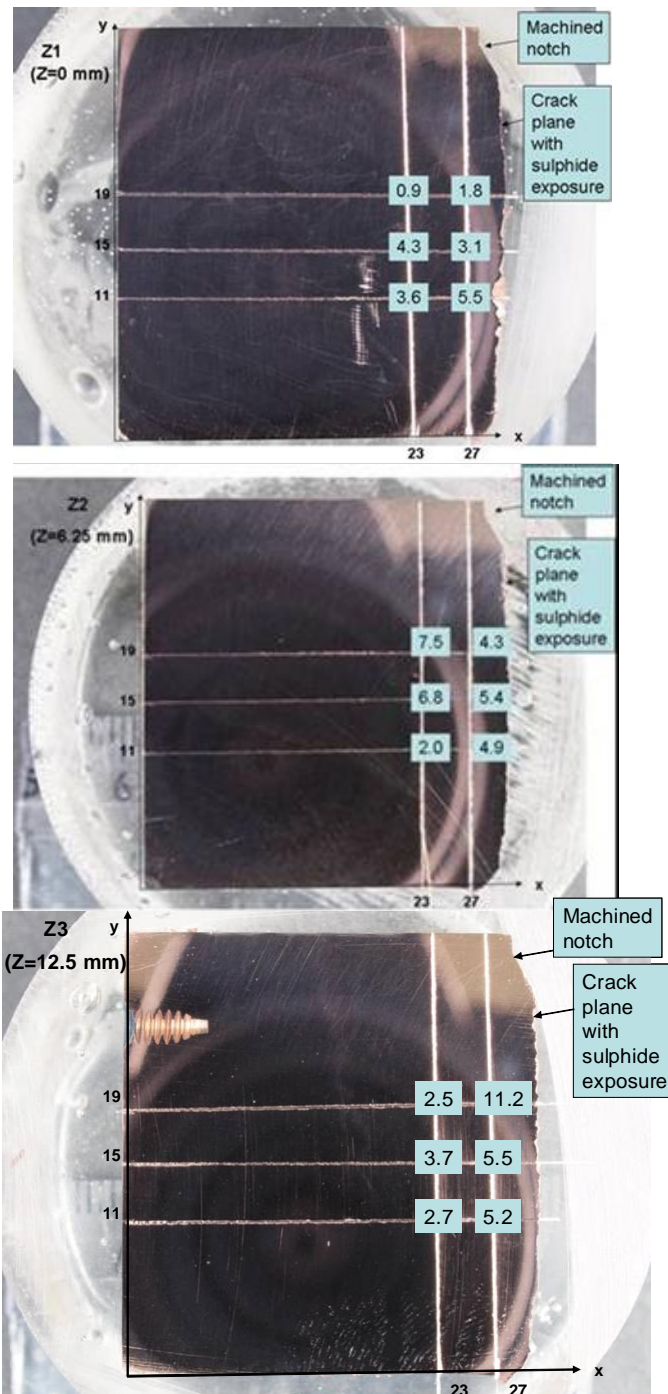
Figure 31. Area fractions of inclusions ($\times 10^4$) in specimen 4, slice Z1 (0 mm from outer surface, upper picture), slice Z2 (6.25 mm from outer surface, centremost picture), and slice Z3 (12.5 mm from outer surface, lowest picture), as a function of location.

The area fractions shown in Fig. 31 are surprisingly high, comparable to those found for the higher sulphide concentration (see Figs. 23 to 26). Based on these limited number of data it seems that the in-diffusion of sulphur/sulphide is possibly not directly related to the concentration of sulphide in the groundwater.

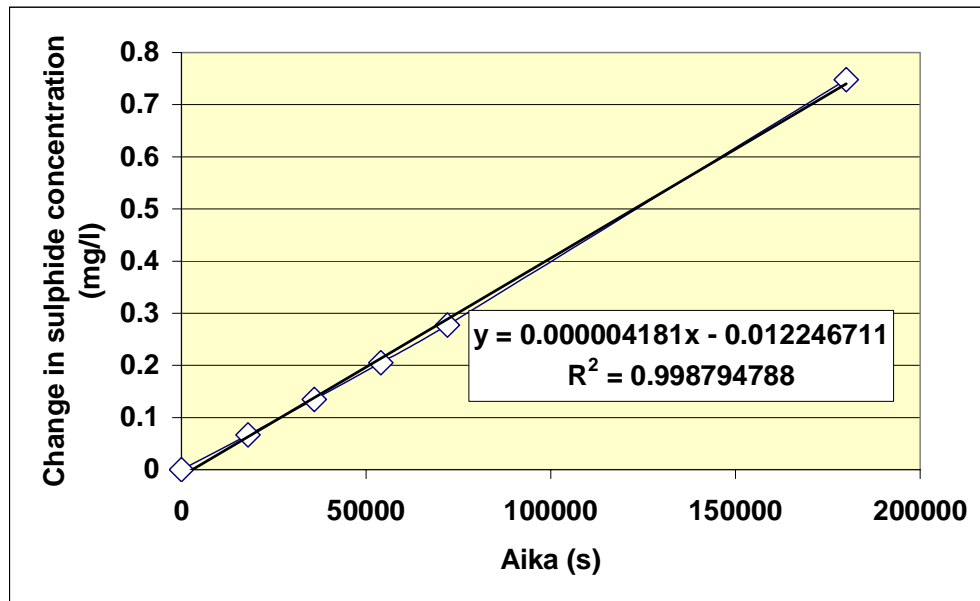
Figure 32. Difference in sulphide consumption as a function of time between a blank test and one with 5.5 cm² copper as thin sheets. Groundwater (10 l) with 2 mg/l sulphide.

Fig. 32 shows the difference in sulphide consumption between the blank test and the one with copper sheets. Calculating for the volume (10 l) and surface area (5.5 cm^2) results in a reaction rate constant of

It is noteworthy that according to the data in Fig. 32 the reaction is zero-order with regard to sulphide concentration, i.e. the reaction rate does not depend on the sulphide concentration (at least within the concentration range in this test, i.e. 2 mg/l to 0.5 mg/l). This may indicate that the rate of the reaction is determined by the surface reaction itself and not by e.g. diffusion of sulphide towards the surface. Also, the reaction product layer forming on the copper sheets, i.e. Cu_2S , seems not to be protecting as it does not have the ability to slow down the reaction rate. The reaction rate constant is roughly two orders of magnitude higher than the maximum flux estimated to arrive at the copper canister surface /3/. Thus, the diffusion rate of sulphide to the canister surface would always be expected to be rate limiting with respect to this reaction. The scenario used for the maximum flux estimation was as follows. Advective conduction through the bentonite was assumed (e.g. as a result of bentonite erosion) and the source sulphide concentration at the bentonite/rock interface was taken to be $450 \text{ mg/l [S}^2\text{]}$ (e.g. SRB population with unlimited flux of nutrients).
