KYT 2014 / MICO

Material integrity of welded copper overpack – Final report 2011

Authors: Juhani Rantala, Jorma Salonen, Pertti Auerkari, Stefan Holmström / VTT
 Tapio Saukkonen / Aalto University

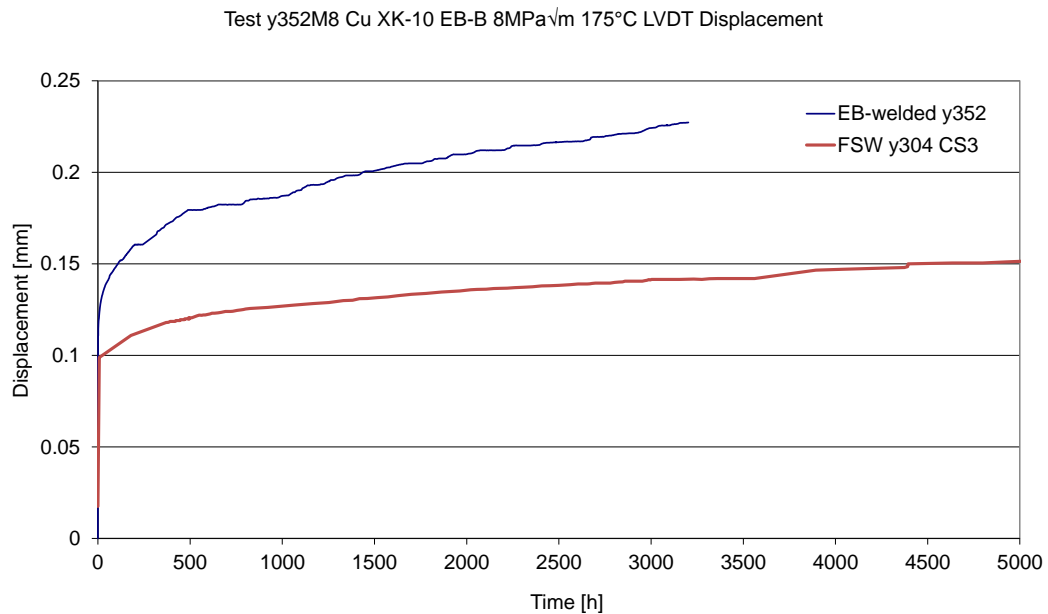
Fig. 11. Comparison of load line displacement curves of FSW and EB welded CT specimens at $175^\circ\text{C} / 8 \text{ MPa}\sqrt{\text{m}}$

Another test series was started for EB-welded CT specimen at $K_I = 8 \text{ MPa}\sqrt{\text{m}}$ at 175°C to compare with the long-running FSW CT specimen CS3 (35 MPa reference stress, $K_I = 8 \text{ MPa}\sqrt{\text{m}}$). The LLD curves are shown in Fig. 11, again demonstrating the higher initial LLD and higher creep rate in the EB welded specimen.

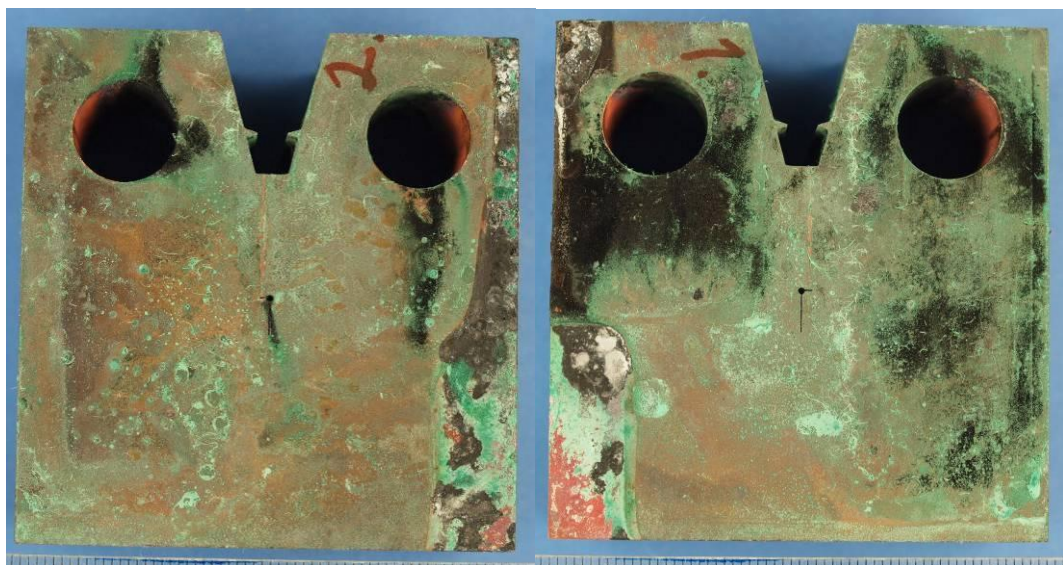
Fig. 14. The outer surface of the specimen FSW L75-2 after the corrosion experiment in saline water at a plane stress reference stress of 55 MPa at 90°C

After the 5000 h test the specimen had clearly corroded (Fig. 14), although much less than the previous specimen [13]. Pitting corrosion was observed on the outer surface with some recrystallized copper crystals (Figs. 15-16). Crystallization of copper in the corrosion pits is a result of water being oversaturated with copper. Changing the pin material to oxidised zirconium has much reduced the general corrosion on the outer surface, but there is still a possibility of galvanic corrosion in the test loop due to metallic materials further away from the test specimen. Therefore, the next test is suggested to be conducted without mechanical loading under aerated conditions but with excluded possibility of galvanic corrosion.

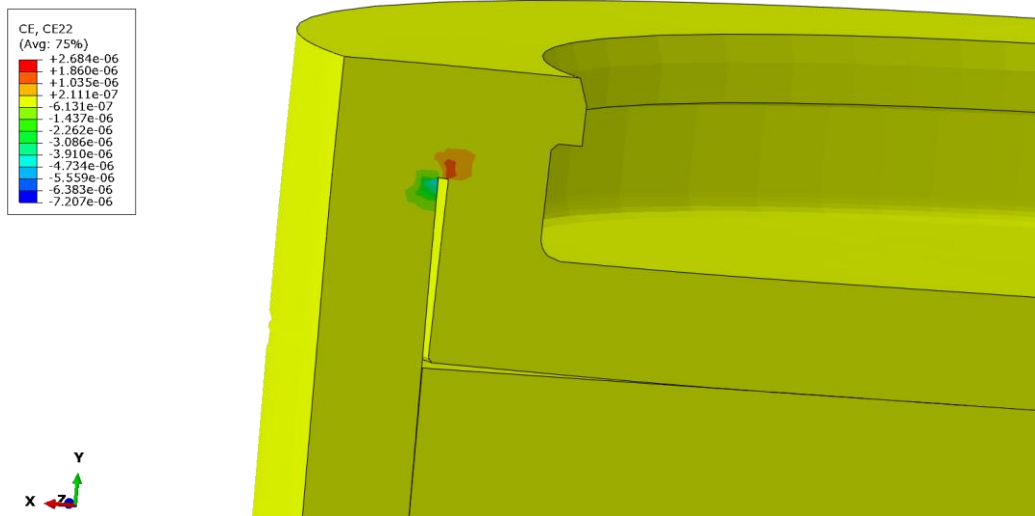
Fig. 29. Predicted equivalent strain distribution in y-direction (vertical) with pressure 14 MPa, 50 kh.

The LCSP creep model [14] developed at VTT has been implemented and applied in FE analysis. Primary, secondary and tertiary creep terms are included in the model and analysis. The analysis of the copper overpack was started with two meshes, Fig. 27. In the general mesh (Fig. 27 left) there is a bigger gap between the cylinder and the lid than in the design specification [15]. This is done deliberately in order to study the stresses and strains in the case where the lower corner of the lid does not come into contact with the cylinder (Fig. 28). In the other mesh (Fig. 27 right) the gap is according to the specification. In that case the lid will creep into contact with the cylinder and the stress state will change especially around the inner corner of the lid. The von Mises stress distribution after 50 kh of creep under pressure of 14 MPa with the oversized gap is shown in Fig. 28 and the vertical equivalent strain distribution in Fig. 29. The analysis will continue in 2012 with special emphasis on the weld areas of the FSW and EB welded canisters and their lifetime.
