# Ultrasonic tests to compare mechanical and thermal fatigue cracks in 316L plates

Authors: Esa Leskelä, Ari Koskinen

This report has been prepared in the research project Monitoring of the structural integrity of materials and components in reactor circuit. This project is a part of the SAFIR2014, the Finnish Research Program on Nuclear Power Plant Safety for years 2011 – 2014. The work was carried out at VTT Technical Research Centre of Finland. The work has been funded by the State Nuclear Waste Management Fund (VYR) and VTT.

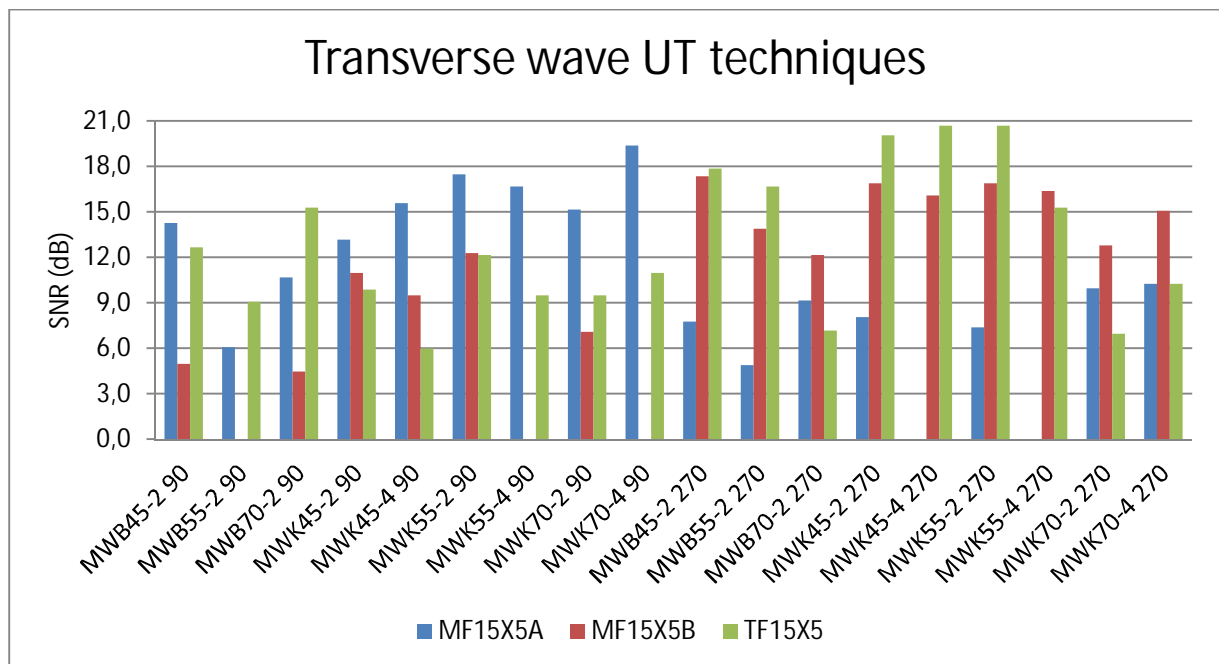
Figure 10. Signal-to-noise ratio of all defects with transverse wave UT techniques.

Signal-to-noise ratios of all three defects inspected by conventional transverse probes are presented in Figure 10 and by longitudinal TRL probes in Figure 11.

In inspection of mechanical fatigue cracks with conventional single crystal probes the scanning direction near/far side of the defect usually has a clear influence on SNR. In case of thermal fatigue crack the SNR with several probes seems to be better when scanned from far side of the defect.

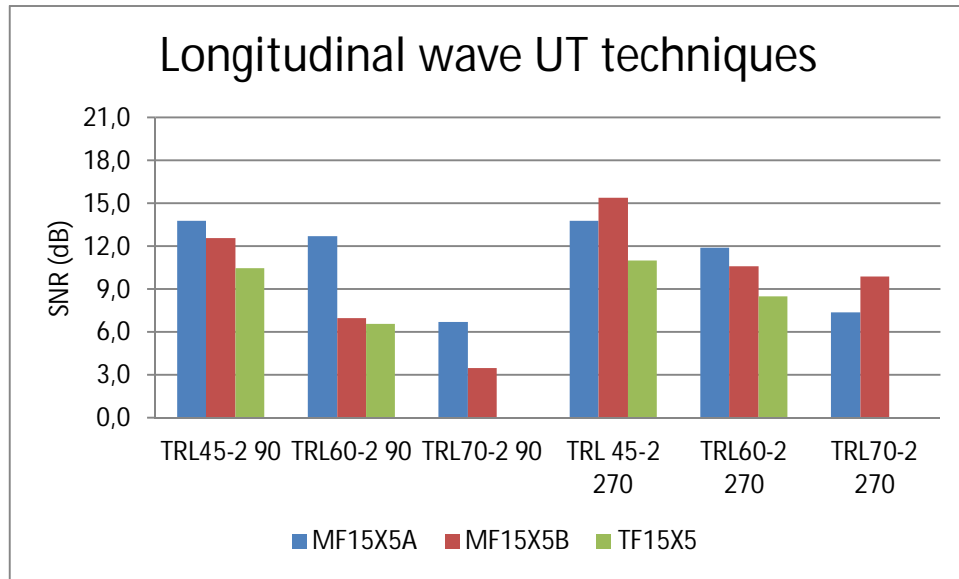
Figure 11. Signal-to-noise ratio of all defects with longitudinal wave UT techniques.

With conventional longitudinal TR technique the 45 degree probe SNR was rather high regardless of scanning direction. When probe angle increases the SNR decreases significantly and with 70 degree probe defect TF was missed from both scanning directions.

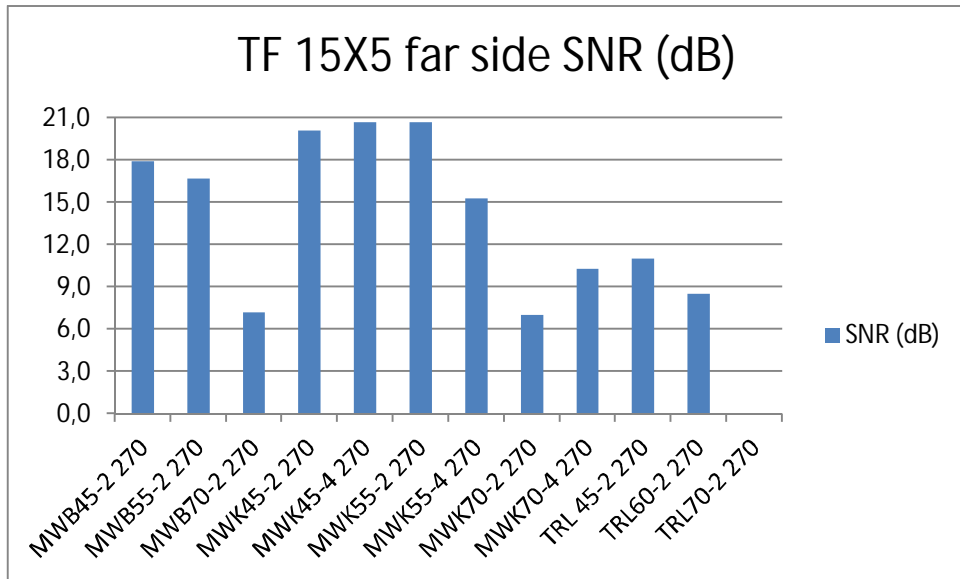
Figure 17. Signal-to-noise ratio of defect TF15X5 scanned from far side of the defect.

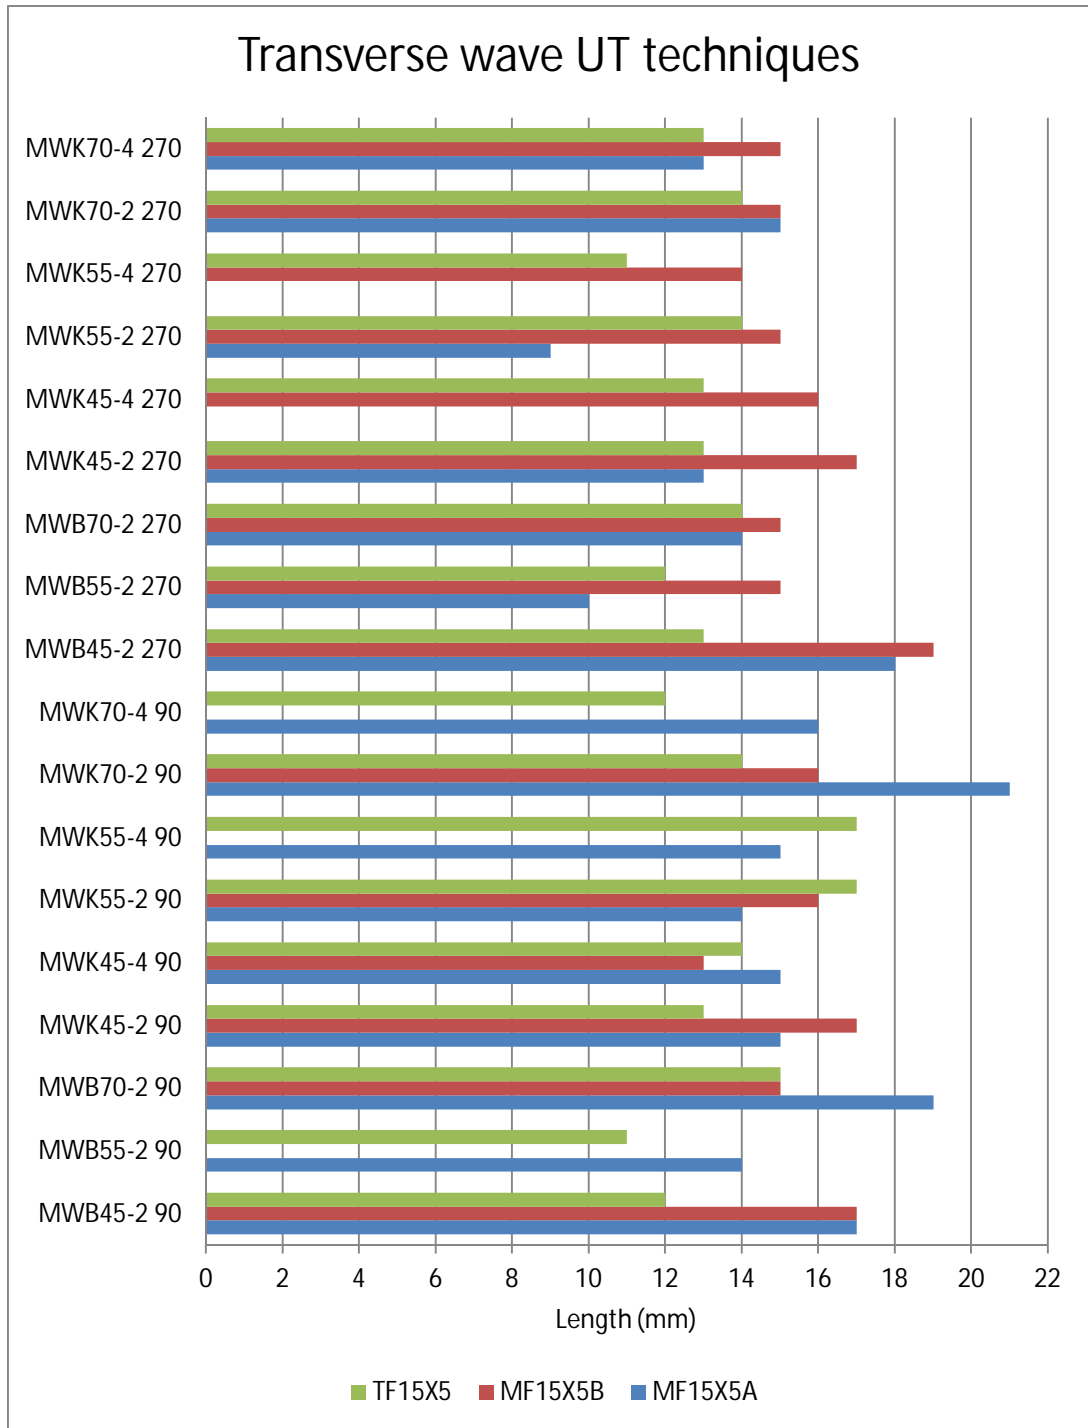
Figure 18. Length sizing results of all defects scanned with transverse wave ultrasonic techniques.

Defect length sizing results with transverse ultrasonic techniques are shown in Figure 18 and with longitudinal wave techniques in Figure 19.

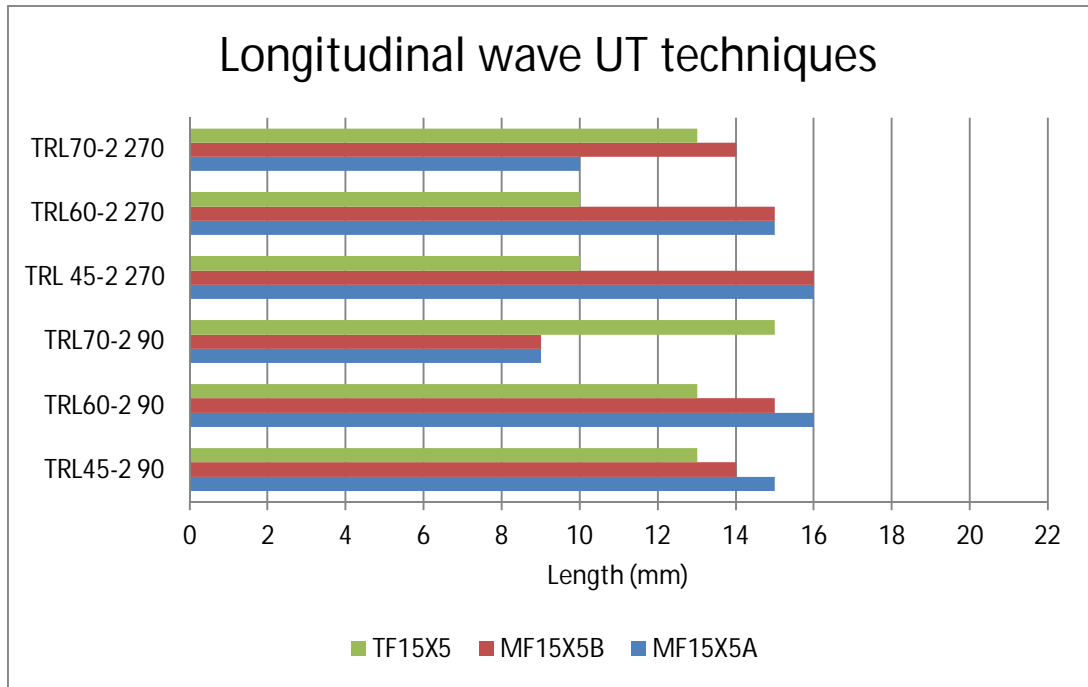
Figure 19. Length sizing results of all defects scanned with longitudinal wave ultrasonic techniques.

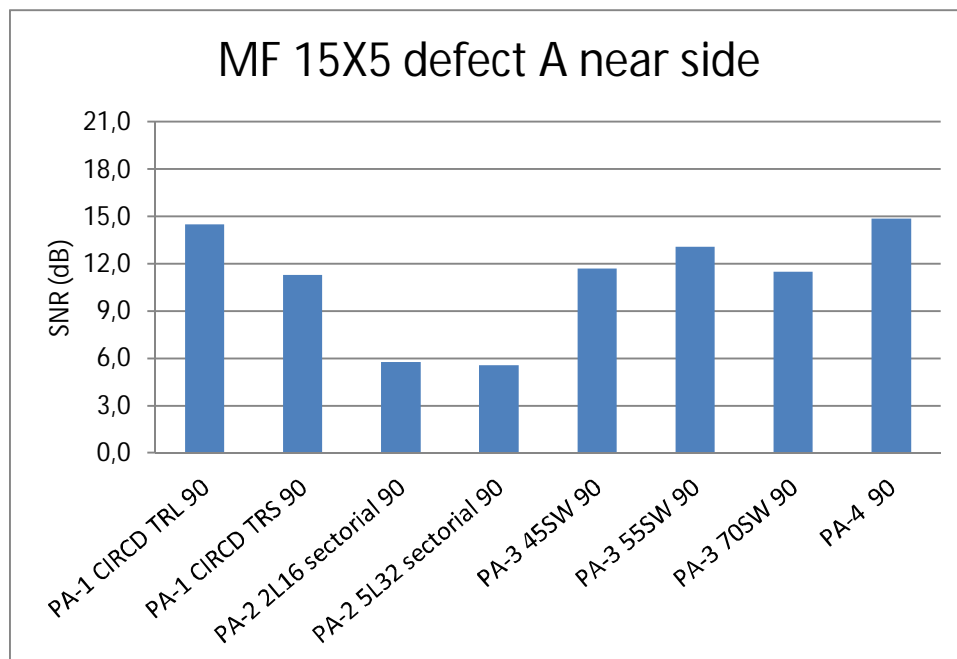
Figure 30. Signal-to-noise ratio of defect MF15X5 A scanned from near side of the defect.

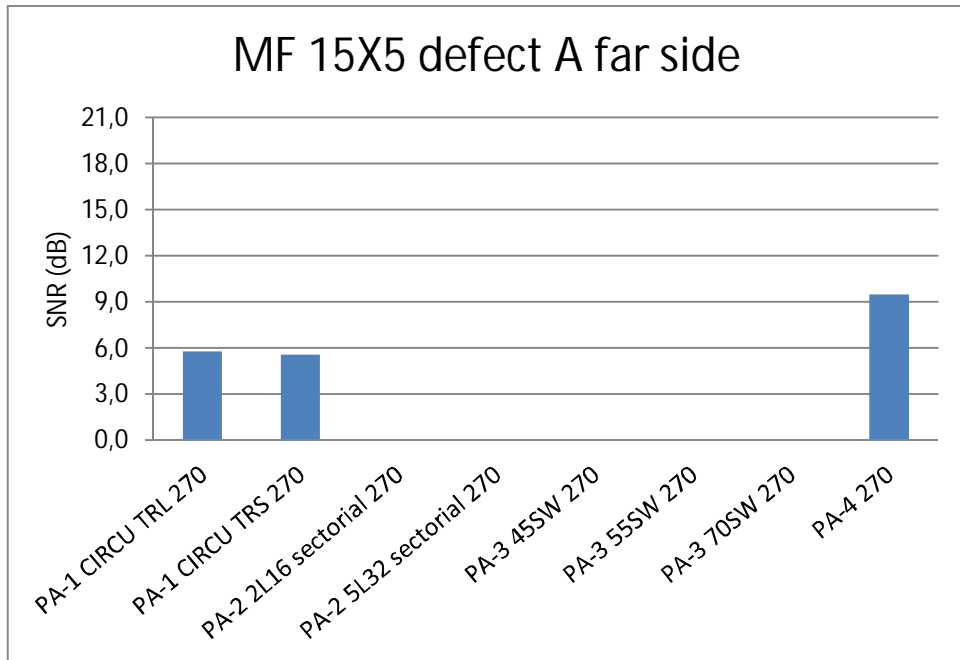
Figure 31. Signal-to-noise ratio of defect MF15X5 A scanned from far side of the defect.

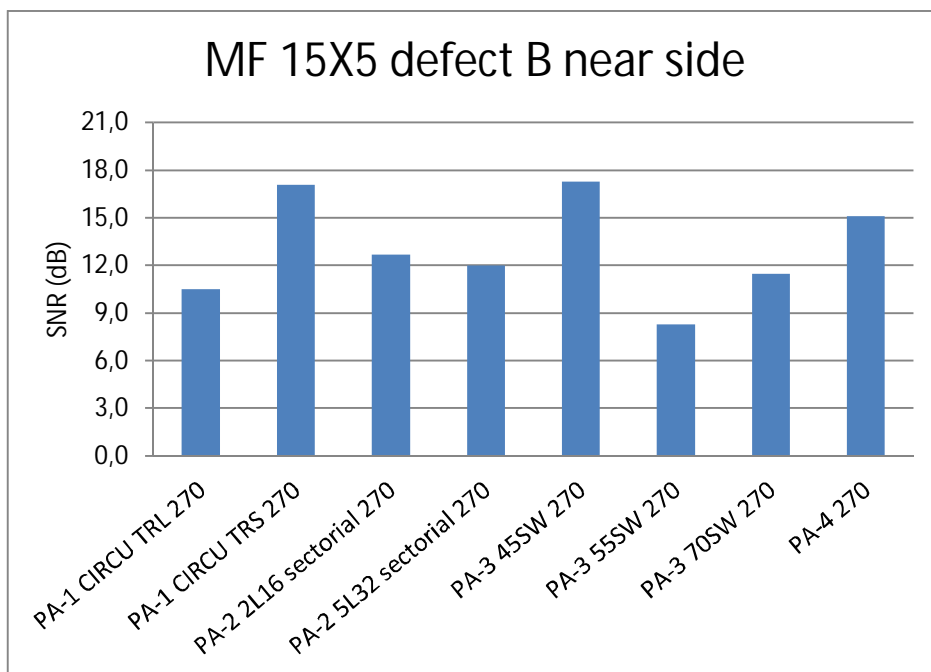
Figure 32. Signal-to-noise ratio of defect MF15X5 B scanned from near side of the defect.

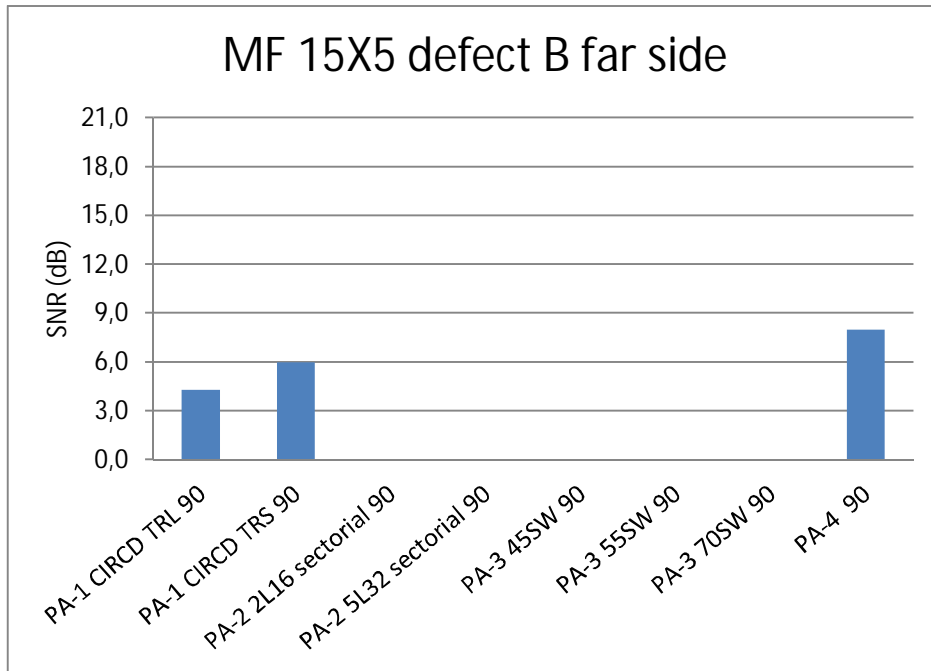
Figure 33. Signal-to-noise ratio of defect MF15X5 B scanned from far side of the defect.

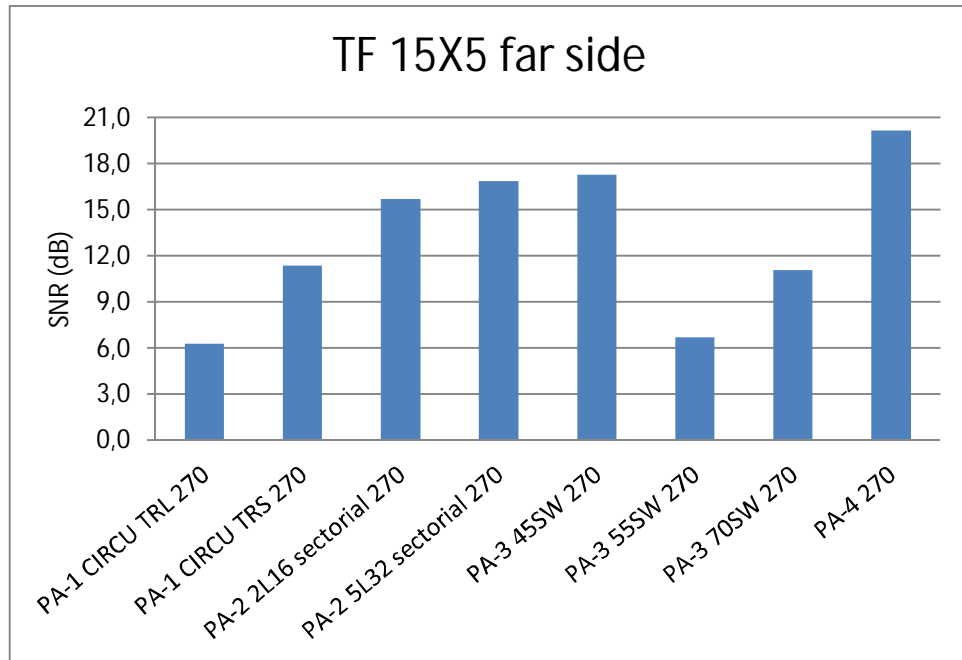
Figure 35. Signal-to-noise ratio of defect TF15X5 scanned from far side of the defect.

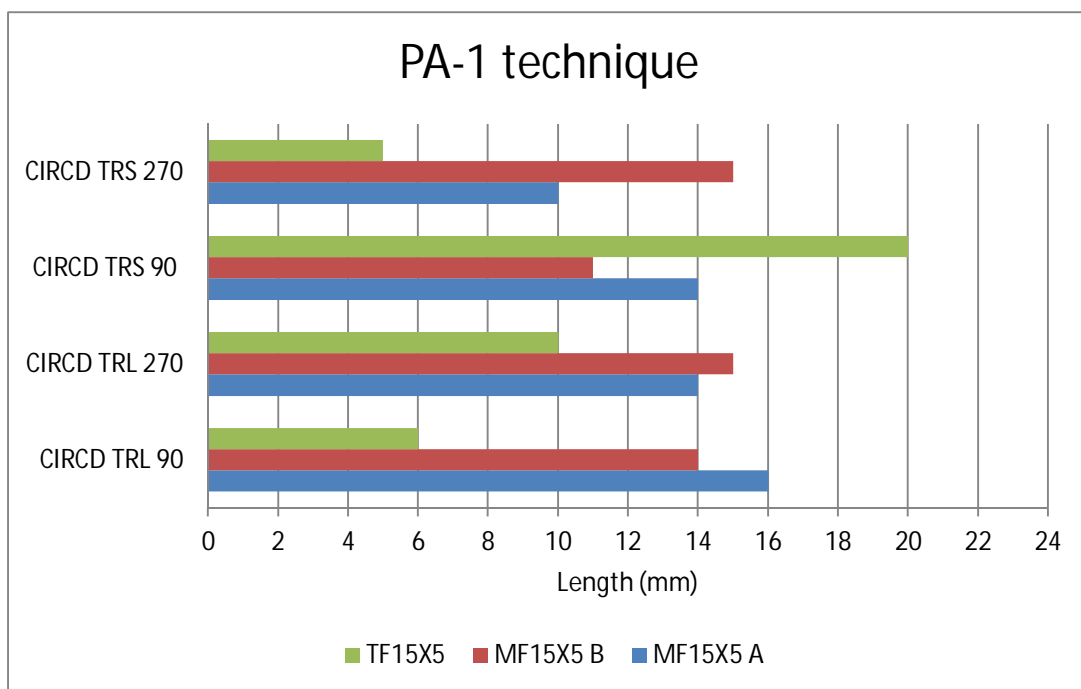
Figure 36. Length sizing results of all defects inspected with PA-1 technique.

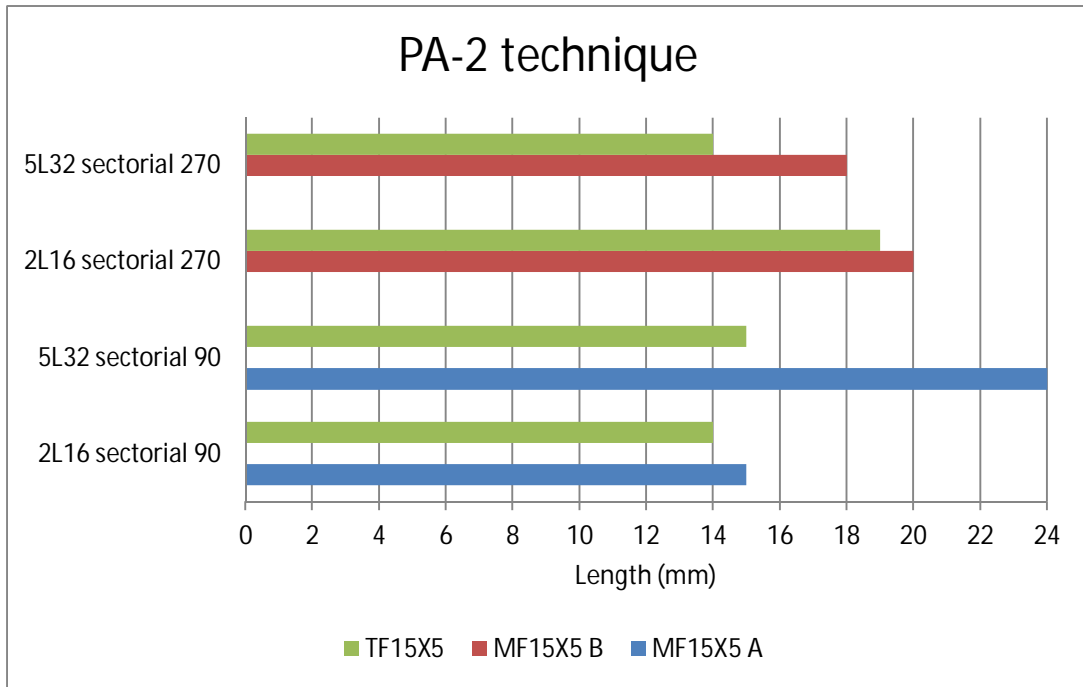
Figure 37. Length sizing results of all defects scanned with PA-2 technique.

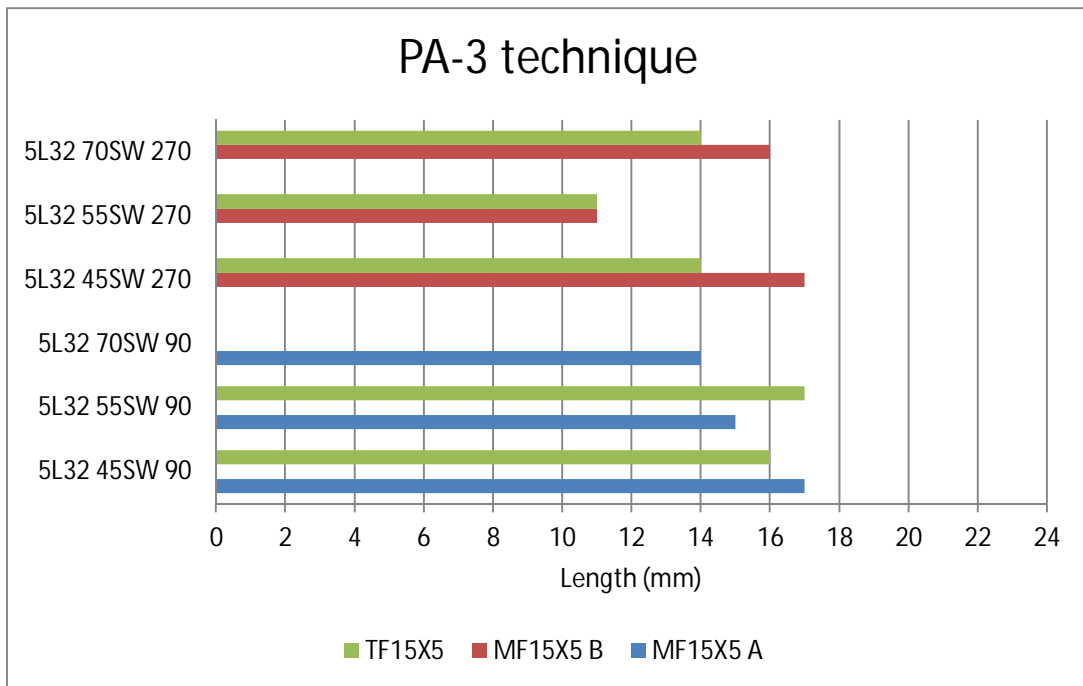
Figure 38. Length sizing results of all defects scanned with PA-3 technique.

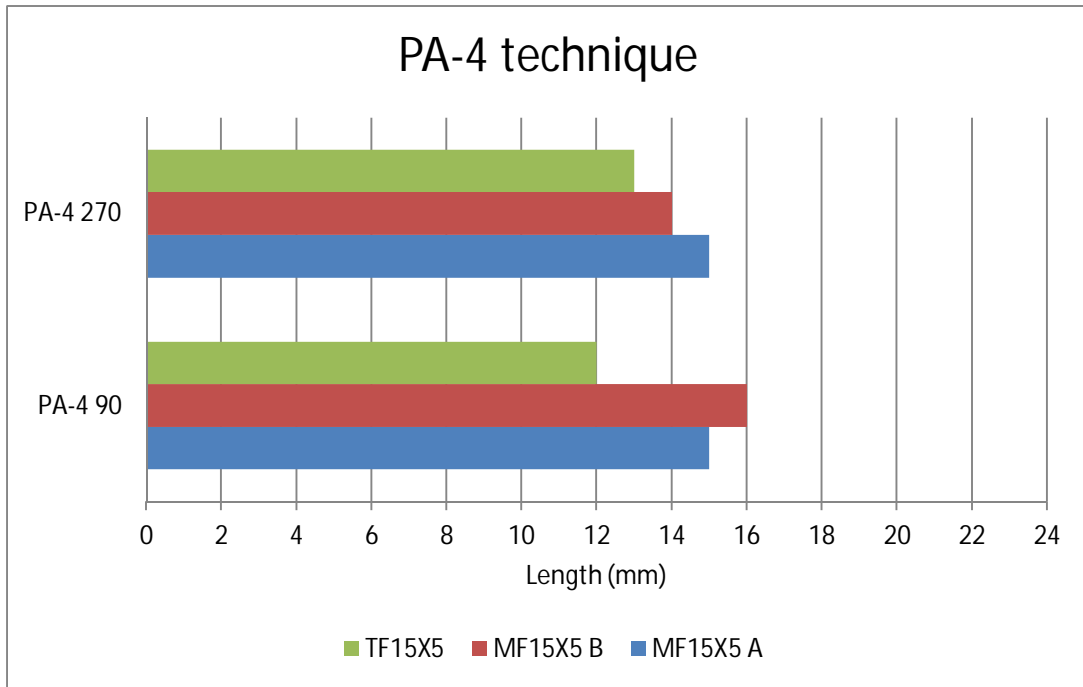
Figure 39. Length sizing results of all defects scanned with PA-4 technique.

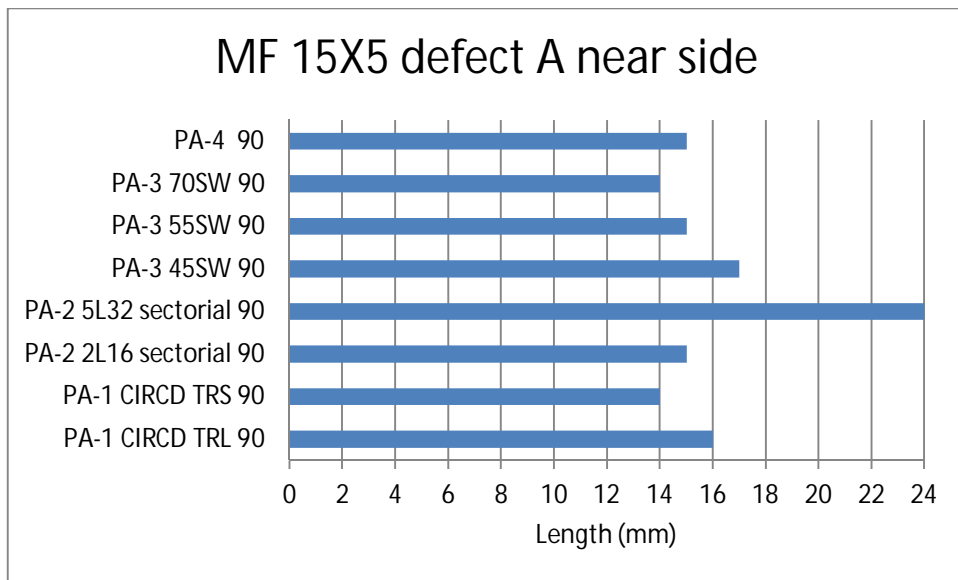
Figure 40. Length sizing results of defect MF15X5 A scanned from near side of the defect.

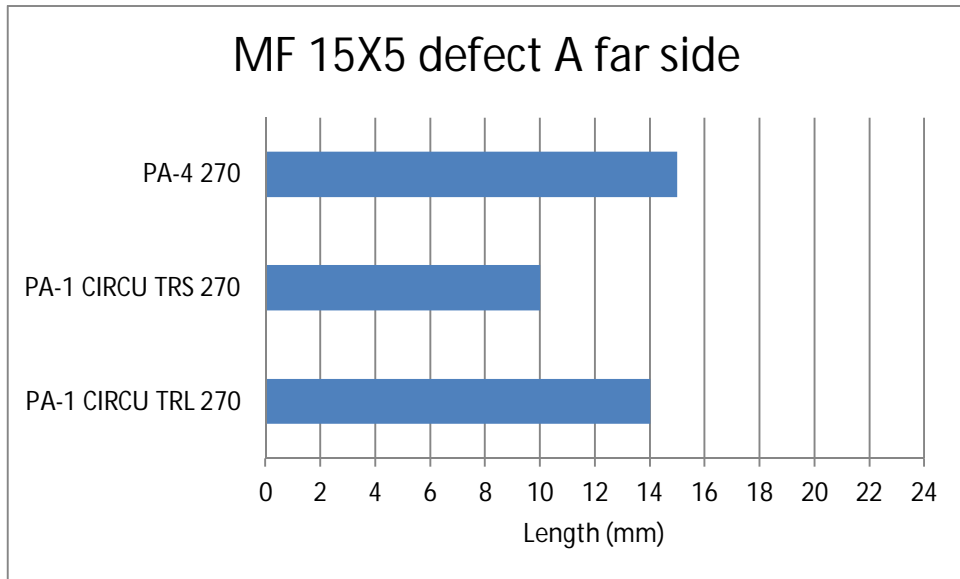
Figure 41. Length sizing results of defect MF15X5 A scanned from far side of the defect.

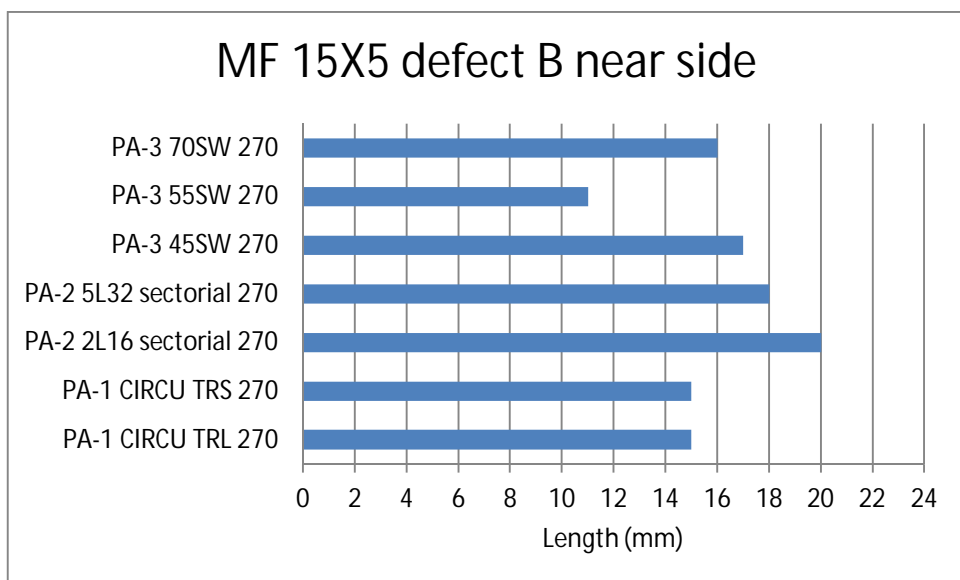
Figure 42. Length sizing results of defect MF15X5 B scanned from near side of the defect.

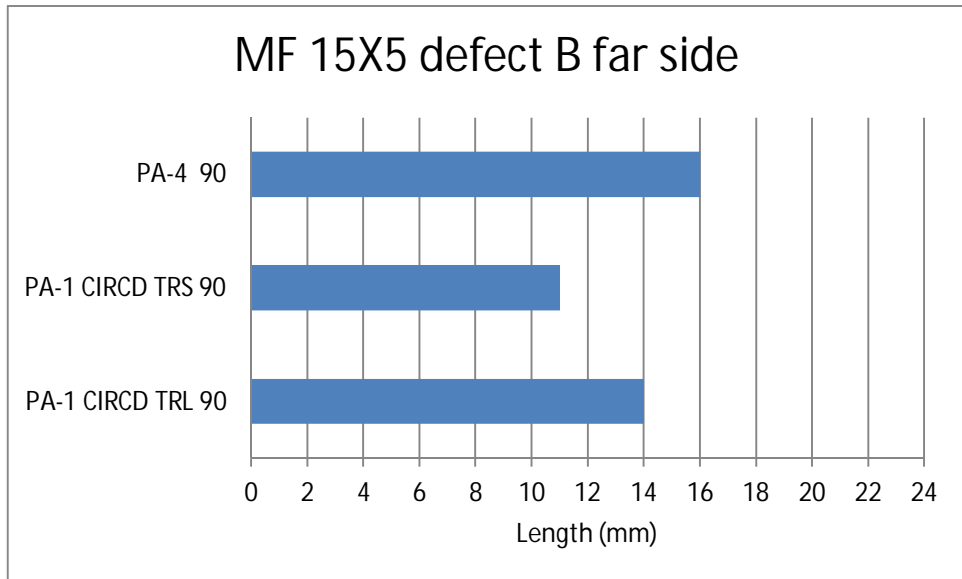
Figure 43. Length sizing results of defect MF15X5 B scanned from far side of the defect.

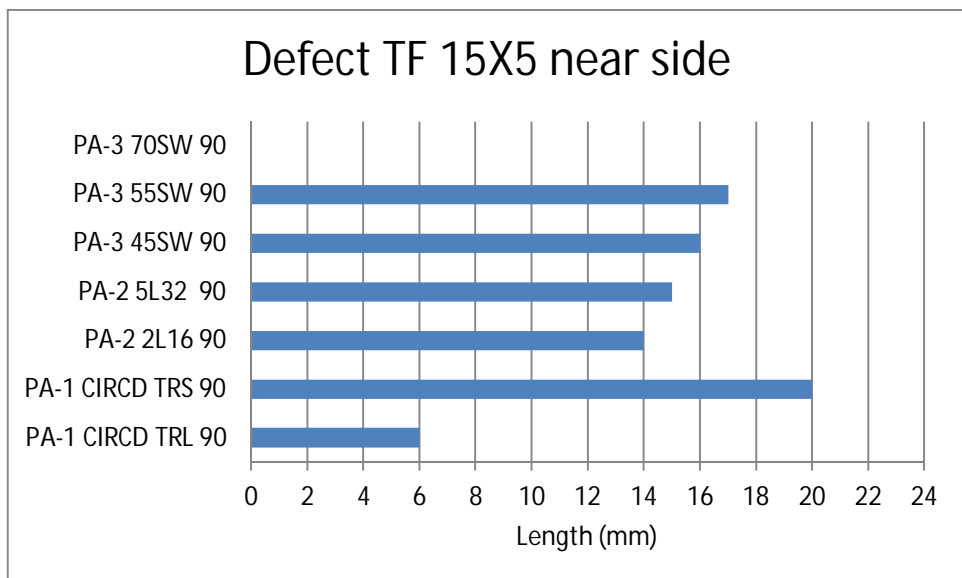
Figure 44. Length sizing results of defect TF15X5 scanned from near side of the defect.

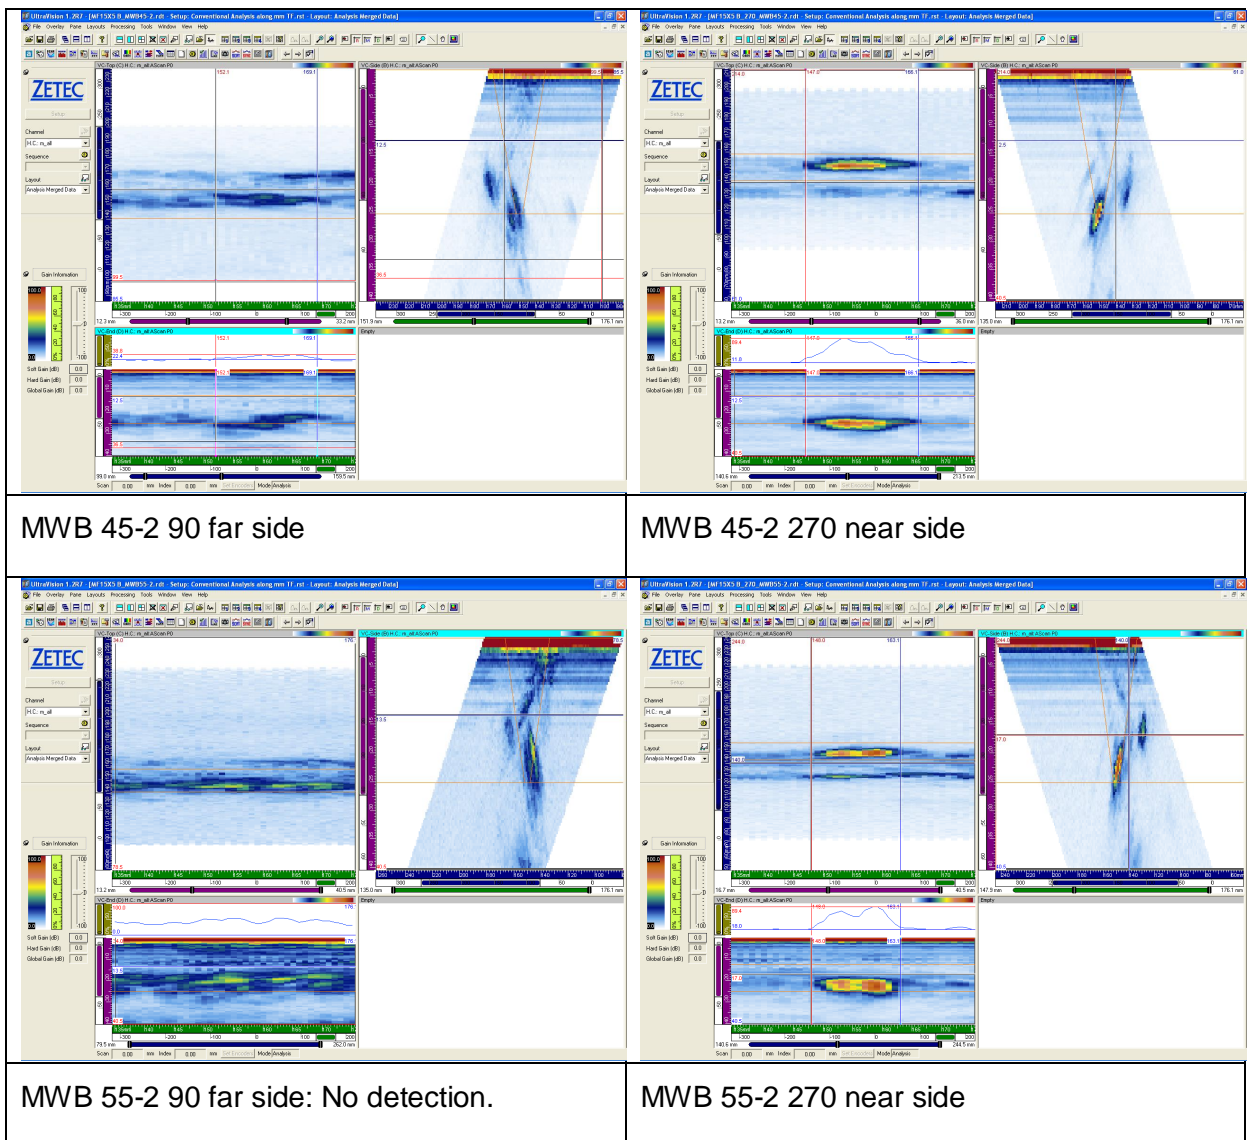
Figure 5. Screen captures of defect MF15X5 B inspection with MWB probes.

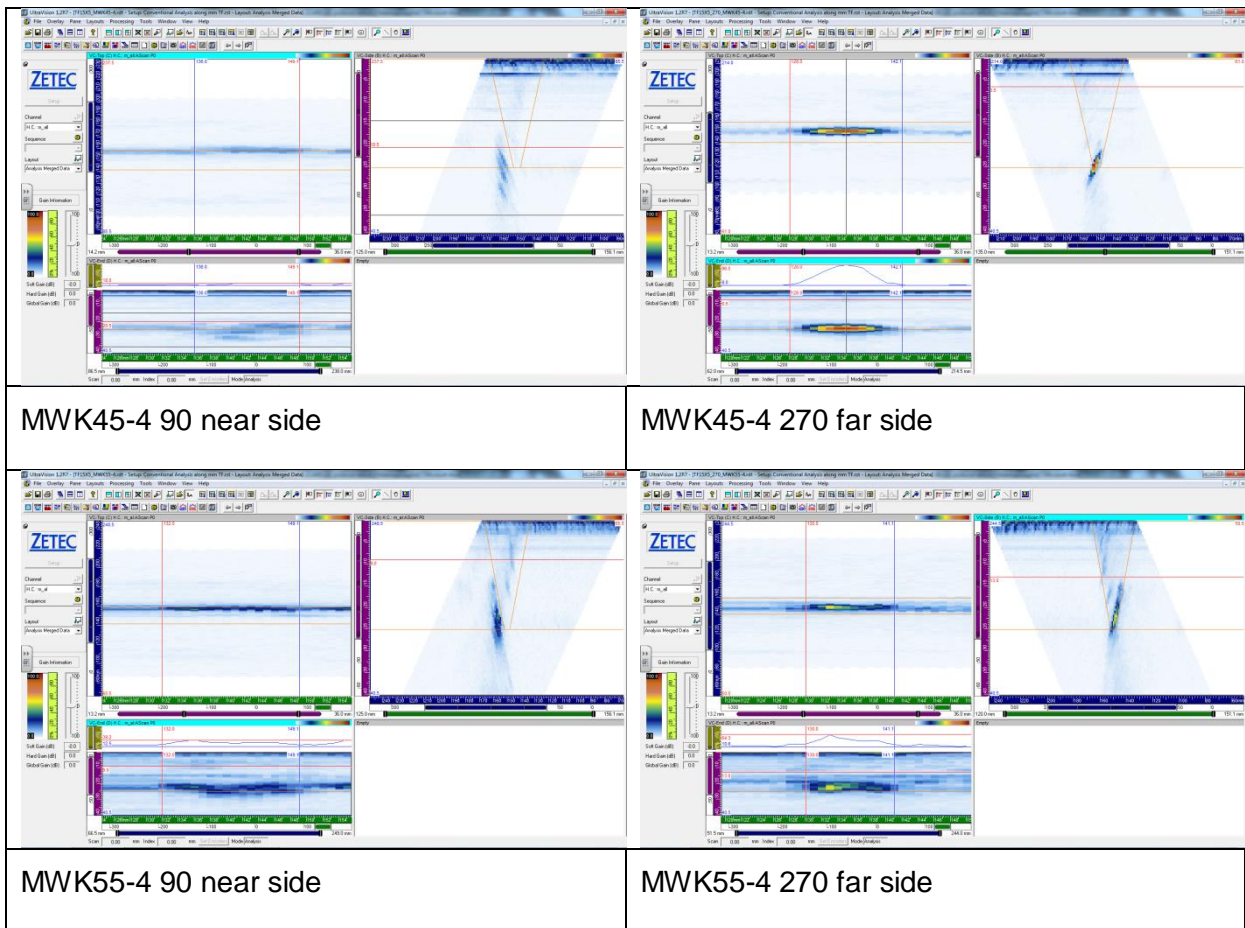
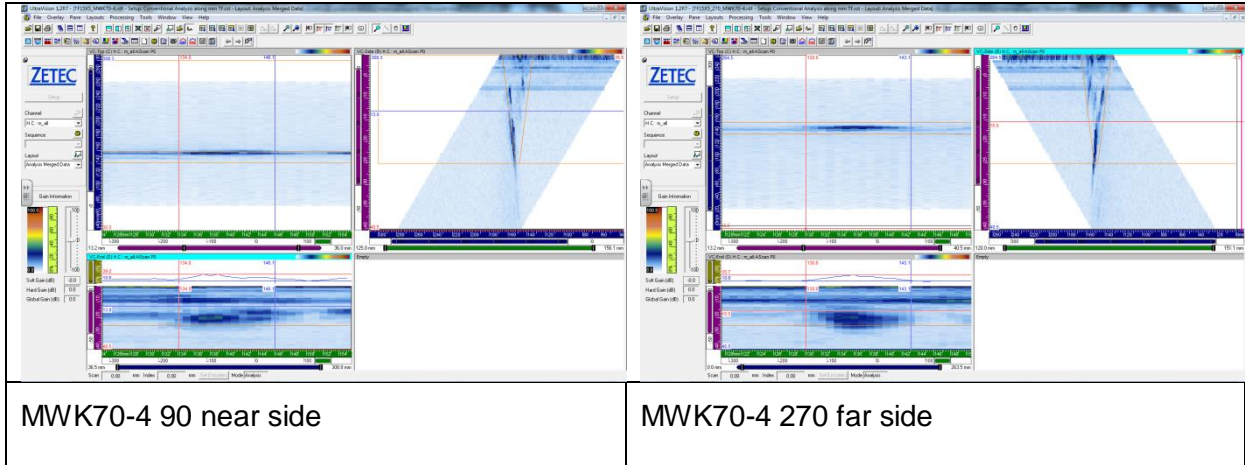
Figure 11. Screen captures of defect TF15X5 inspection with 4 MHz MWK probes.

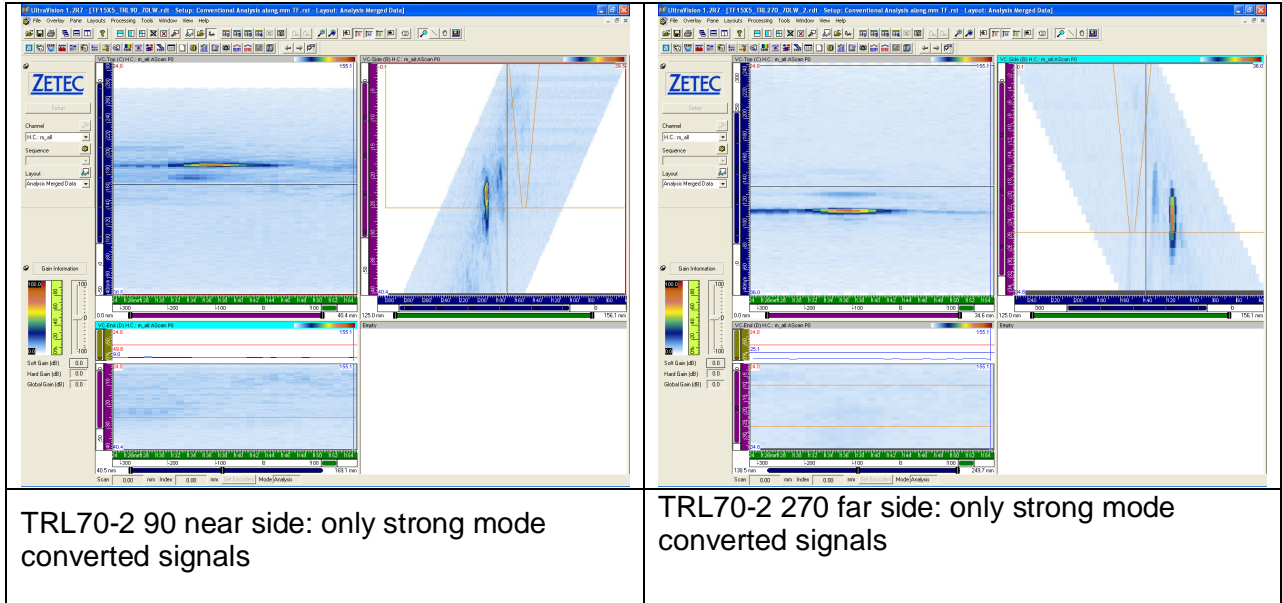
Figure 12. Screen captures of defect TF15X5 inspection with TRL probes.

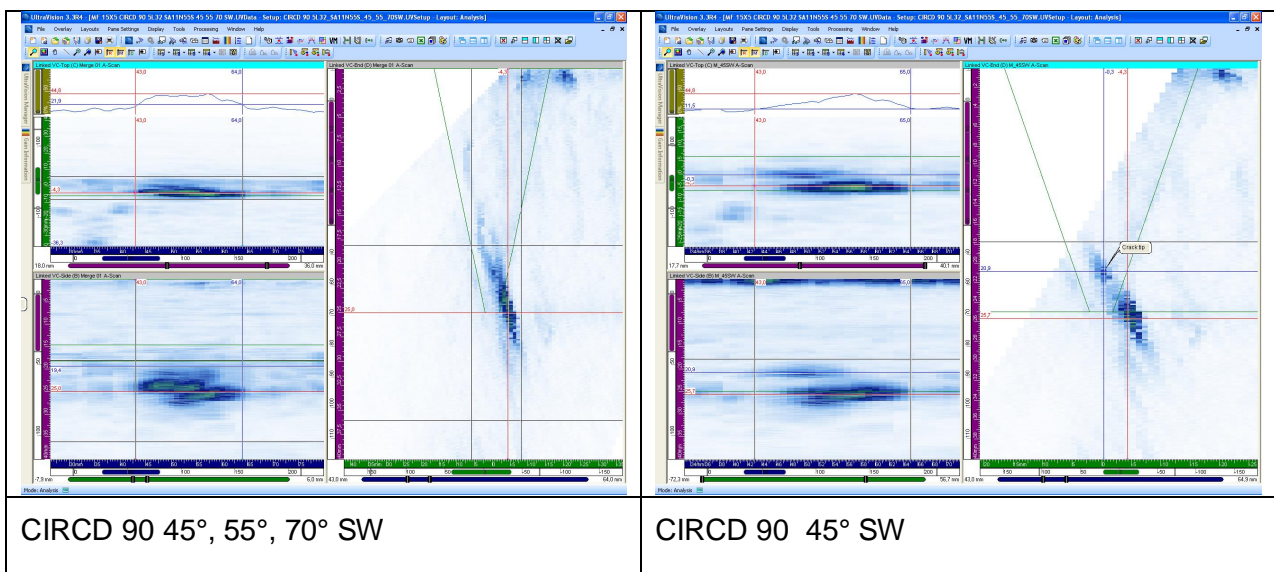
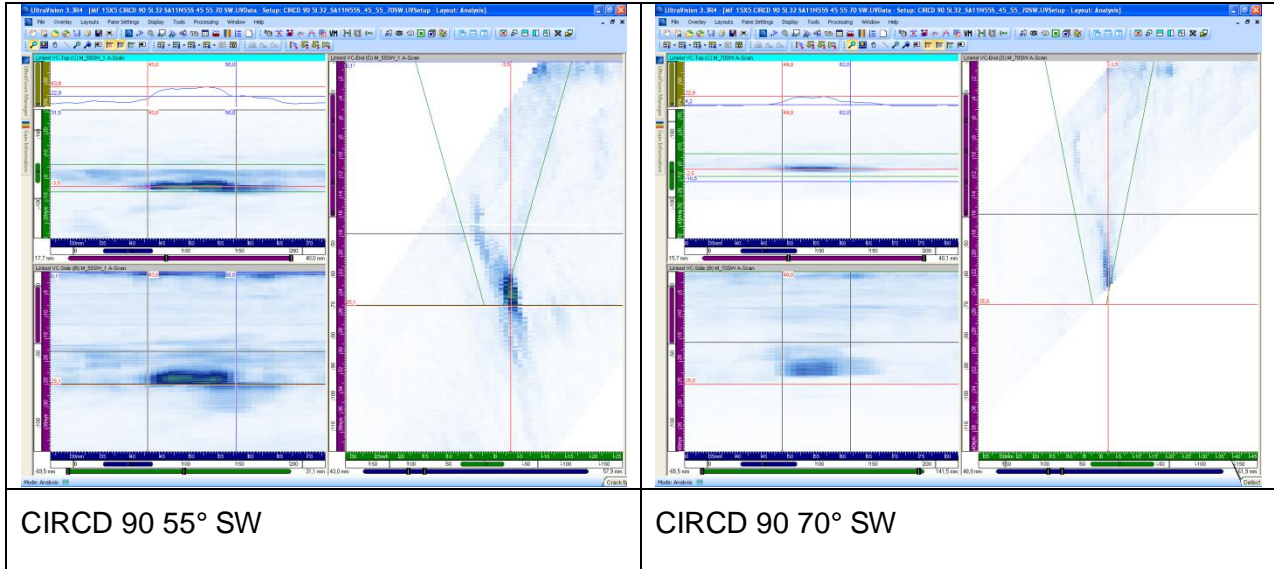
Figure 12. Screen captures of defect MF15X5A scanned with technique PA-3.

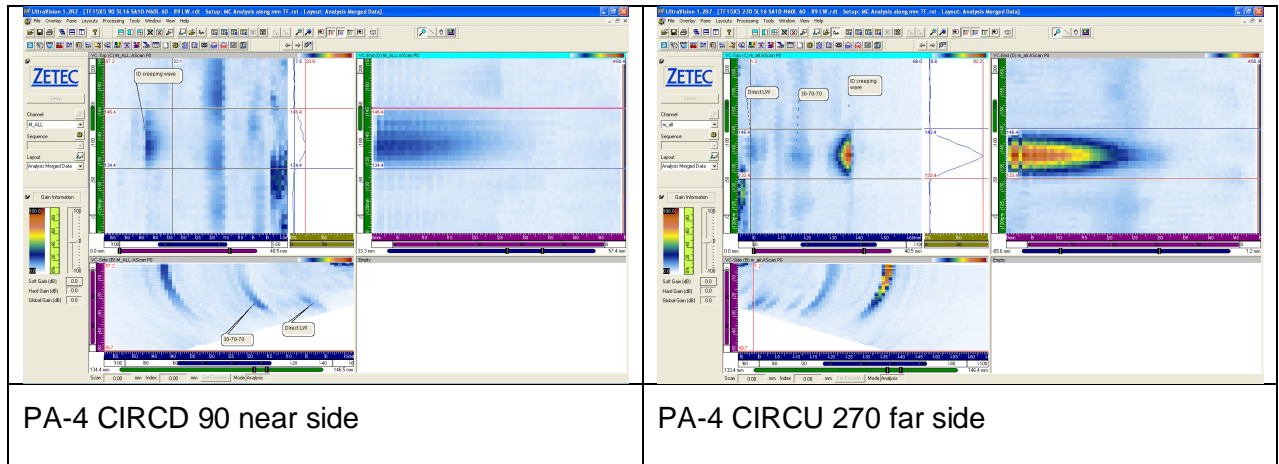
Figure 20. Screen captures of defect TF15X5 scanned with technique PA-4.
