VTT-R-04178-13

# Thermally Sprayed Sulphur Trap Coating proof-of-concept study

Authors: Henriikka Brandt, Tomi Suhonen and Peter Andersson

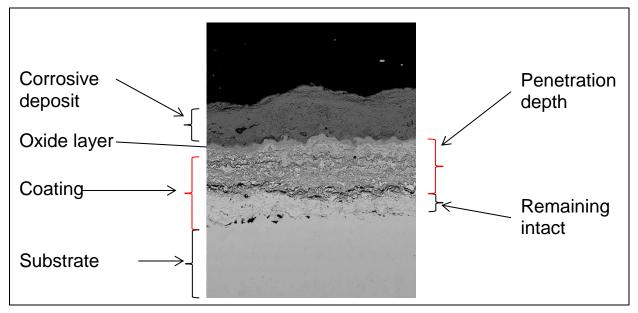
Figure 1. Highly corrosive compound penetration to coating structure through formed oxide layer at high temperature. The corrosion has nearly reached to substrate-coating interface.

Protective coatings produced with such techniques as thermal spray have found industrial applications in wide field of industries to protect components against e.g. wear and/or corrosion. Today, it is estimated that the thermal spray industry is worth approximately \$6.5 billion with the majority of revenue generated in coating services [1]. Thermal spray coatings have their unique structure compared to bulk material, typically described as a lamellar structure. Especially in demanding corrosive conditions this lamellar structure needs to be taken into account. In such conditions the lamella boundaries (like grain boundaries in bulk materials) will act as a main route for corrosive compounds. If corrosive compounds are able to penetrate even slightly all the way to the coating-substrate interface, a catastrophic delamination of the coating can occur as presented in Figure 1.

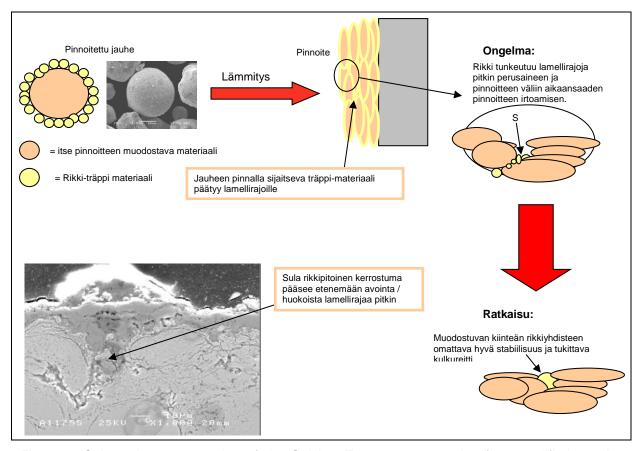
Figure 2. Schematic representation of the Sulphur Trap concept starting from modified powder, desired coating structure and the formation of stable solid lubricant in sulphuric conditions.

The idea of Sulphur Trap technology is to manufacture coatings where the basic structure can provide other functionalities, such as wear resistance and low the friction, by introducing an elemental or compound solid phase to the lamella boundaries. This additional "trap" phase is selected to withstand vaporisation and to form a stable solid compound with the corrosive element or compound. For example, trap material molybdenum will react with sulphur in wide variety of conditions (see section 5.1.1 for thermodynamical evaluation) and form molybdenum disulfide (Mo + S -> MoS<sub>2</sub>). MoS<sub>2</sub> is a highly stable compound which possesses closed packed structure (densest possible way to pack atoms) with easy glide lattices between sulphur and molybdenum layers. The volume grove (Mo to MoS<sub>2</sub>) also benefits the lamella boundary blockage. Schematic representation of the concept is shown in Figure 2.

MoS<sub>2</sub> is also a well-known solid lubricant which provides a dual function for Sulphur Trap coatings. In sulphuric conditions the coating prevents corrosion and provides lubrication lowering the friction and protecting the coating as well as the counterpart. The solid lubricant will continuously form throughout the coatings lifetime.

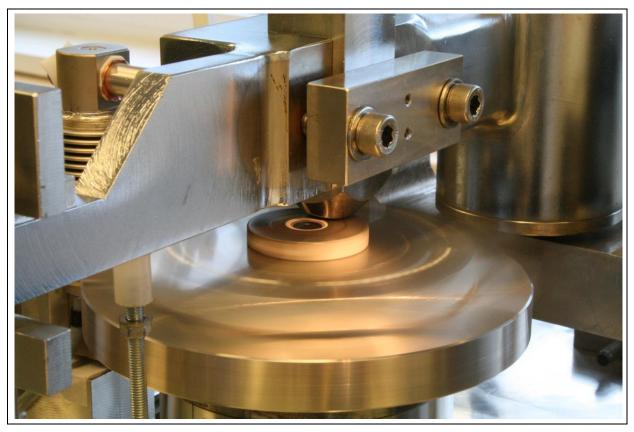
Figure 5. Image of Pin-On-Disk test equipment. The coated sample is the "Disk" and alumina ball is the "Pin" pressed against the sample surface.

Adhesive wear tests were performed according to standard ASTM G99. The Pin-On-Disc machine is a tribometer designed to evaluate the wear and friction characteristics of selected material in sliding contacts in dry or lubricated environments. The sliding friction test occurs between a stationary pin stylus and a rotating disk. Normal load, rotational speed, and wear track diameter can be varied. Electronic sensors monitor wear and the tangential force of friction as a function of load, speed, lubrication, or environmental condition. All of these parameters are recorded during the test. Pin-On-Disk tribometer is shown in Figure 5.

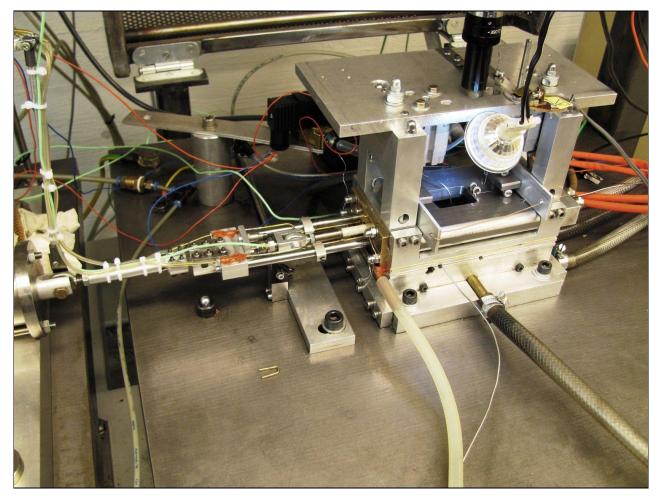
Figure 6. The friction measurement chamber of the VTT piston ring tribometer, as equipped for the present investigation.

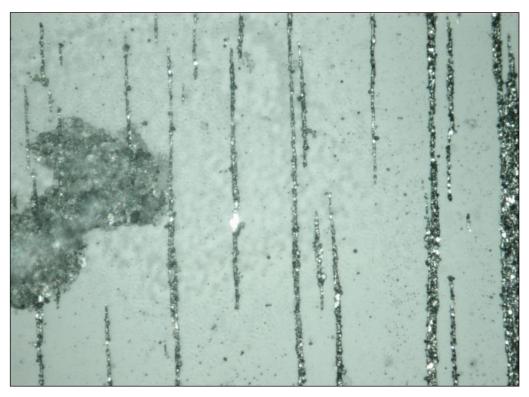
Figure 7. A ferrography image of a sample of the contaminated oil after filtering. The shiny particle close to the centre of the image has a width of about 10  $\mu$ m.

- New, clean Shell Argina XL 40 oil with a kinematic viscosity of 135 cSt @ 40 °C and 14 cSt @ 100 °C [1]. The same type of oil was used for the lubrication of the moving tribometer parts in the vicinity of the test samples.
- Used, contaminated Shell Argina XL 40 oil from engine tests at VTT, filtered by a filter with 12
   µm nominal retention rate. A ferrography image of a sample of the contaminated oil after the
   filtering is shown in Figure 7.

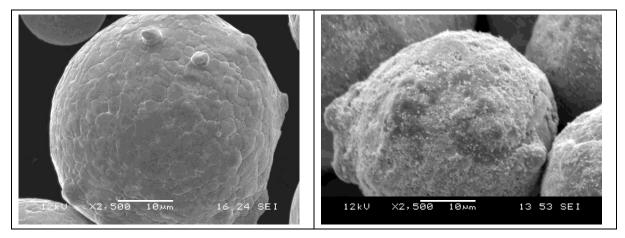
Figure 10. a) SEM image of uncoated atomized Ni49Cr1Fe powder (used to produce reference coatings) and b) coated Ni49Cr1Fe-10wt%n-Mo powder (used to produce Sulphur Trap coating)

Experimental Ni49Cr1Fe-10 wt-% nano-Mo and  $Cr_3C_2$ -25(Ni20Cr)-10 wt-% nano-Mo powders were manufactured from commercials raw materials with planetary ball milling. Optimized milling process pot contained 300g NiCr or  $Cr_3C_2$ -NiCr powder (base material), 30 g nanosized molybdenum (Trap material), 3,3 g heksane and 300 g milling balls. Optimal milling time was 90 min and milling speed 150 rmp. Powders were sieved with 125  $\mu$ m sieve to remove large agglomerates and with 25  $\mu$ m sieve to remove separate nano particles. With these milling parameters both base materials (Ni49Cr1Fe or  $Cr_3C_2$ -25(Ni20Cr)) were coated with nanosized Mo without any harmful deformation. Example of uncoated Ni49Cr1Fe and coated Ni49Cr1Fe-10wt%n-Mo powders are presented in Figure 10.

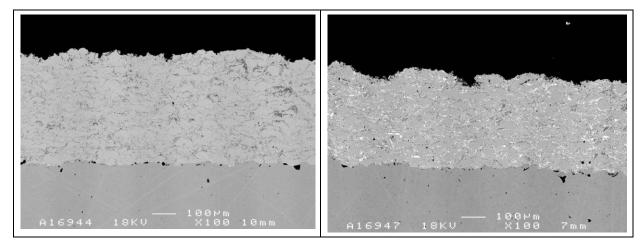
Figure 11. a) Cross section of reference Ni49Cr1Fe coating and b) Sulphur Trap Ni49Cr1Fe-10wt%n-Mo.

Reference coatings (Ni49Cr1Fe and  $Cr_3C_2$ -25(Ni20Cr)) and Sulphur Trap coatings (Ni49Cr1Fe-10wt%n-Mo and  $Cr_3C_2$ -25(Ni20Cr)-10wt%n-Mo) were manufactured using commercial Sulzer Metco DJ Hybrid HVOF-system using hydrogen as a fuel gas. Deposition parameters were optimized in order to reach dense coating structure, good adhesion to the base material and good mechanical properties. Examples of coating cross sections are shown in Figure 11. The trap material shows in bright contrast located in lamella boundaries throughout the coating structure as desired.

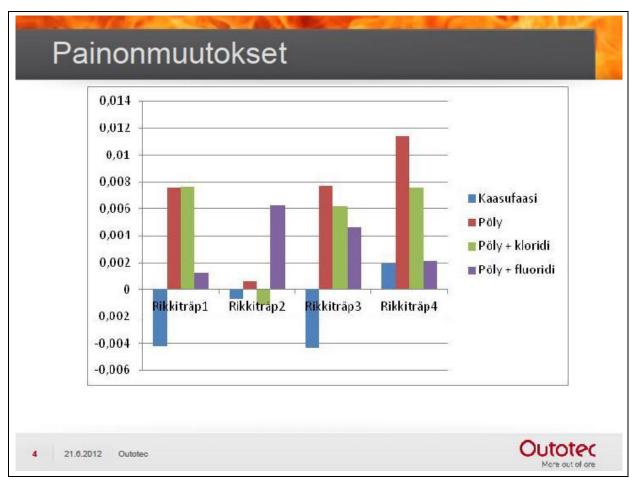
Figure 12. Mass loss/increase in all four test conditions (Test 1 = kaasufaasi, blue, Test 2 = pöly, red, Test 3 = pöly+kloridi, green, Test 4 = pöly+fluoride, purple). Sample Rikkiträp1 = Reference Ni49Cr1Fe, Rikkiträp2 = Sulphur Trap Ni49Cr1Fe-10wt%n-Mo, Rikkiträp3 = Reference  $Cr_3C_2$ -25(Ni20Cr) and Rikkiträp4 = Sulphur Trap  $Cr_3C_2$ -25(Ni20Cr)-10wt%n-Mo

Test duration was 5 days for all Outotec tests. The test conditions were selected to match real life process conditions and to provide a comparison against several previously tested bulk materials. Weight loss/increase was measured and cross sectional SEM-EDS analysis was performed for all coatings. Example of mass losses/increase is shown in Figure 12.

The weight loss/increase was observed to be so small that no clear conclusions could be made from these results. This was verified in cross sectional SEM-EDS studies (example of coating surface in Figure 13). Basically no corrosion layer could be observed for any of the tested coatings.

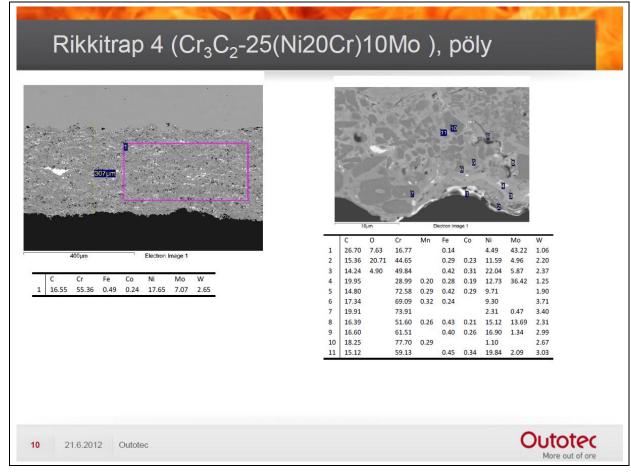
Figure 13. SEM-EDS analysis of tested Sulphur Trap Cr<sub>3</sub>C<sub>2</sub>-25(Ni20Cr)-10wt%n-Mo coating.

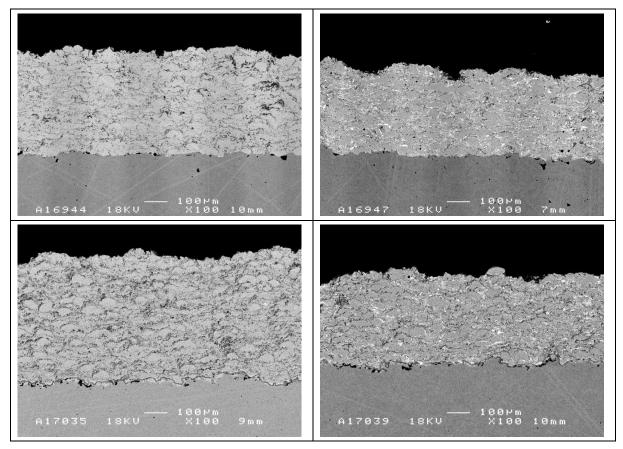
Figure 14. a) SEM (BSE) image of N49iCr1Fe-coating cross-section before the test, b) Ni49Cr1Fe-10wt%n-Mo-coating before the test, c) Ni49Cr1Fe-coating after the test and d) Ni49Cr1Fe-10wt%n-Mo-coating after the test. Figures from a to d clockwise starting from up-left.

SEM-EDS study was conducted for the coatings before and after the test. All of the coating survived the test well. No corrosion products could be clearly detected from the surfaces of the coatings. Slight interdiffusion between coating and substrate was observed. This typically increases the adhesion of the coating to the substrate. These high temperature sulphur exposed coatings were also subjected to adhesive wear tests. The results are shown in following section 5.4. Cross sectional images of the coating are shown in figure 14.

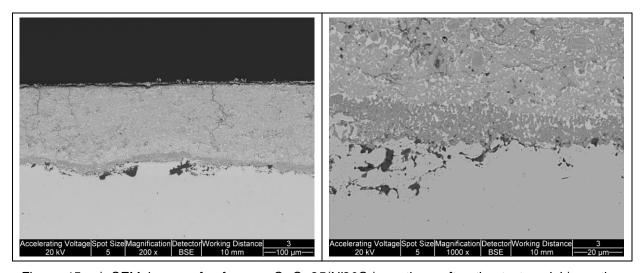
Figure 15. a) SEM image of reference  $Cr_3C_2$ -25(Ni20Cr) coatings after the test and b) coating-substrate interface.

SEM-EDS study was conducted for the tested reference  $Cr_3C_2$ -25(Ni20Cr) and Sulphur Trap  $Cr_3C_2$ -25(Ni20Cr)-10wt%n-Mo coatings. Cross section of reference coating after the test is shown in Figure 15. It can be observed that the coating did not suffer from catastrophic corrosion from the top surface, but major cracking can be observed. Such cracks will result in catastrophic delamination failure when they reach the substrate. In this test the major cracks propagated almost to the substrate (vertical crack length 4/5 of the coating thickness). Such coatings cannot be used in tested process conditions.

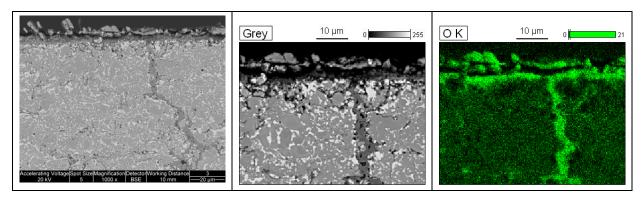
Figure 16. a) Higher magnification SEM-image of reference coating after the test, b) studied EDS area and c) oxide map revealing heavy crack oxidation.

EDS study of the reference coatings confirmed cracking and crack oxidation as shown in Figure 16.

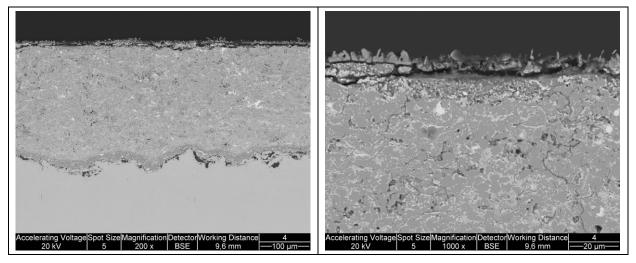
Figure 17. a) SEM image of Sulphur Trap coating after the test and b) higher magnification from the cross section surface

No crack formation or significant corrosion was observed for Sulphur Trap  $Cr_3C_2$ -25(Ni20Cr)-10wt%n-Mo coating. The coating survived the test conditions extremely well compared to the reference coating. Cross sectional image of the Sulphur Trap coating after the test is shown in Figure 17.

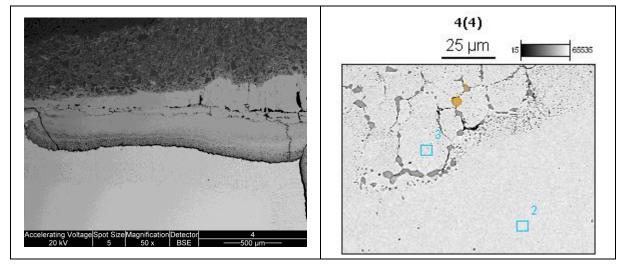
Figure 19. a) Cross sectional SEM image of the substrate material after the test and b) more detailed image of the area beneath the fully oxidized layer

Evidence of extremely corrosive condition of test 6 was observed when the substrate material (low carbon steel S355) was studied. The substrate steel suffered extreme corrosion even though it was protected with ceramic paste specially designed to protect from the surface. Figure y shown an example of the formed corrosion layer.

In Figure 19 a) a thick fully oxidized layer (approximately 500  $\mu$ m thick) can be observed but also evidence of grain boundary corrosion beneath it. More detailed image is shown in Figure 19 b). The EDS analysis revealed the presence of high concentrations of sulphur from the grain boundaries (e.g. 35at% of sulphur in location 1).

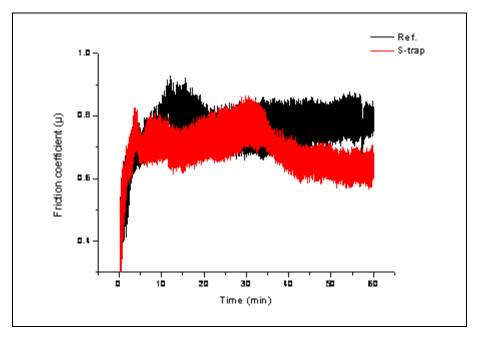
Figure 20. Recorder friction coefficients for reference (black) and Sulphur Trap (red) coatings.

Sulphur Trap coating had approximately 25% lower friction coefficient at the end of the test compared to the reference coating. Other interesting observation was the decreasing trend in friction coefficient for Sulphur Trap coating, starting from 30 minutes test time. These phenomena are assumed to be caused by the transfer of MoS<sub>2</sub> also to the pin material. The increasing trend as a function of time (like for reference coating) is highly typical for thermal spray coatings.

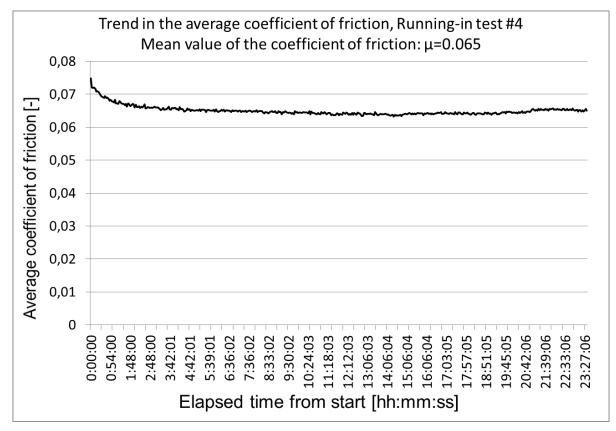
Figure 21. Example of the trend in the average coefficient of friction in a running-in test.

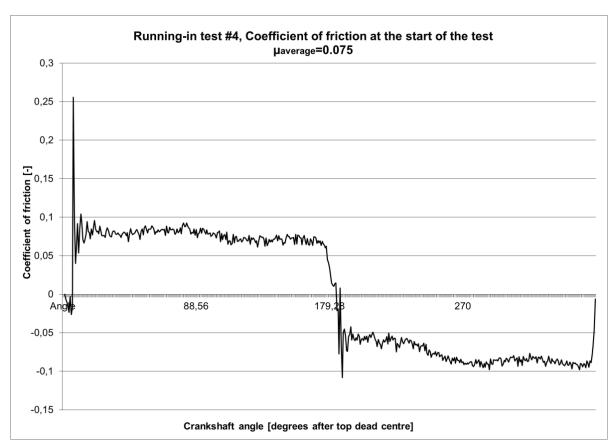
Figure 22. Example of a detailed friction graph, for a full crankshaft revolution, at the start of a running-in test.

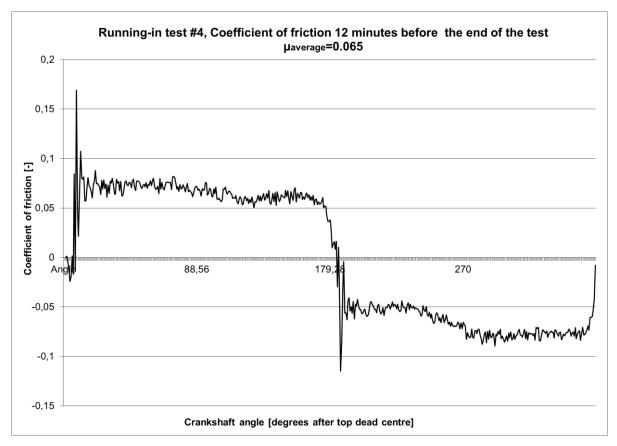
Figure 23. Example of a detailed friction graph, for a full crankshaft revolution, 12 minutes before the end of a running-in test.

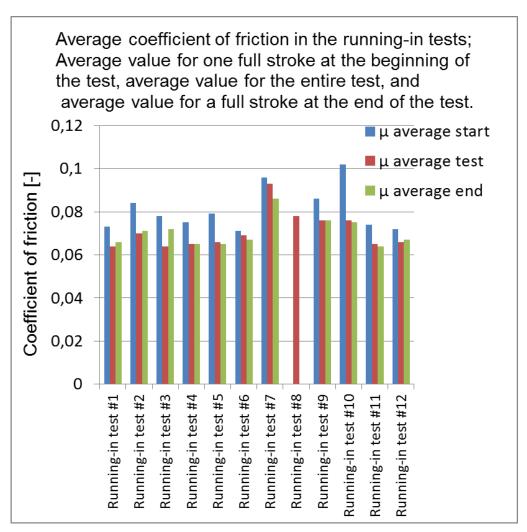
Figure 24. Summary of the calculated coefficients of friction in the running-in tests.

A summary of the results of the friction measurements, or the calculated coefficients of friction, during the running-in tests, is given in Table 4 and Figure 24. A comparison of the calculated coefficients of friction in the running-in tests, for the three groups of coatings studied, is shown in Figure 25. The mean values for the average coefficient of friction were  $\mu$ =0.072 for the 661-3 reference coating,  $\mu$ =0.065 for the 661-4 Sulphur Trap coating and  $\mu$ =0.076 for the SALT coatings.

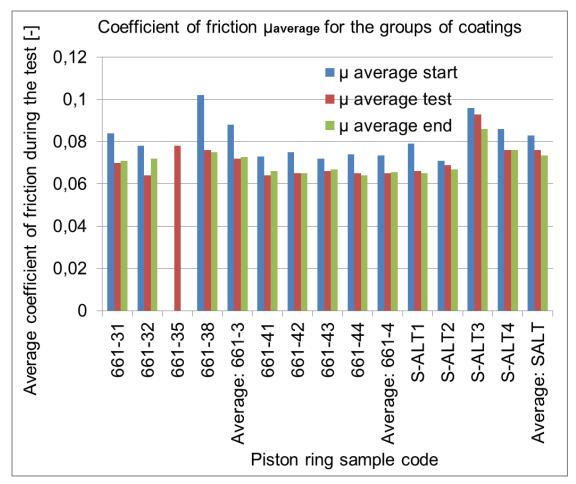
Figure 25. Comparison of the calculated coefficients of friction in the running-in tests, for the three groups of coatings studied.

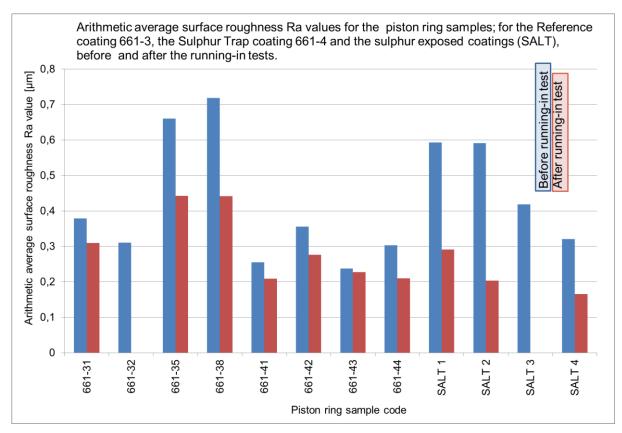
Figure 26. Overview of the surface roughness Ra-values for the piston ring samples before and after the running-in tests.

Before the running-in tests, the mean arithmetic average surface roughness of the 12 piston ring samples had a mean value of Ra=0.43  $\mu$ m  $\pm$  0.17  $\mu$ m ( $\pm$ 38.9%). After the running-in tests, the mean value on the worn proportions of those of the piston-ring surfaces that had not been subjected to scuffing was Ra=0.28  $\mu$ m  $\pm$  0.10  $\mu$ m ( $\pm$ 35.0%), which indicates a smoothening of the sliding surfaces of those of the piston ring samples that had not been subjected to scuffing, see the overview of the Ravalues before and after the running-in tests in Figure 26. The initial Ra-values were particularly high for the piston ring samples 661-35, 661-38, SALT-1 and SALT-2.

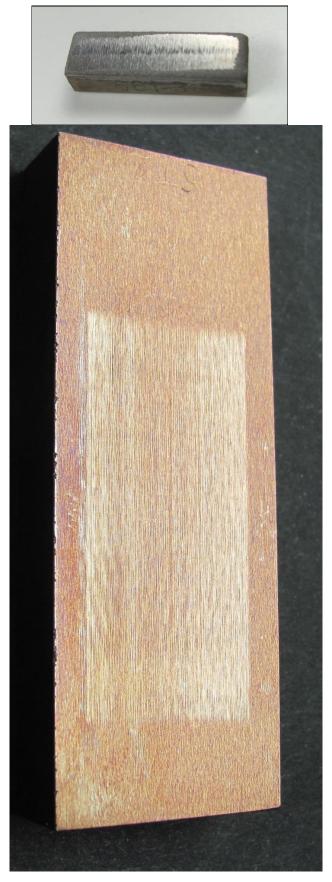
Figure 27. Example of a piston ring sample and cylinder liner plate sample combination after a running-in test (Test #2).

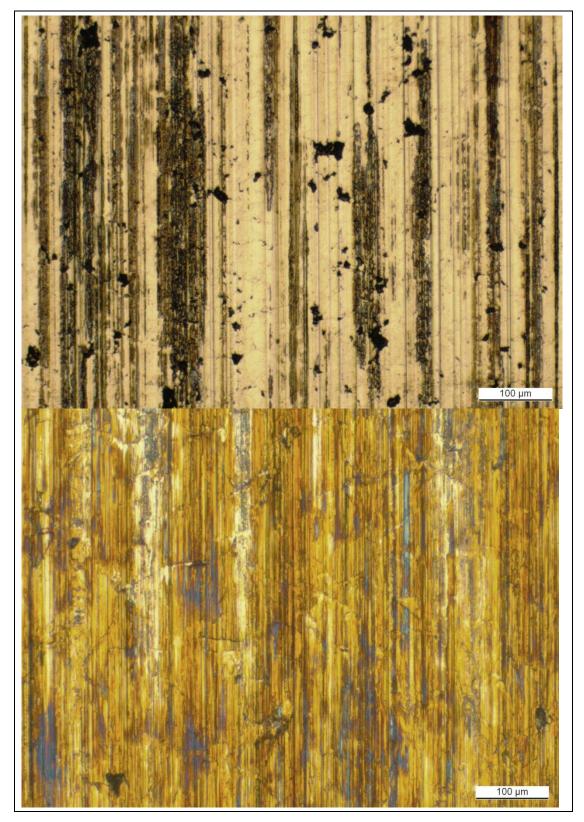
Figure 28. Example of detailed views showing the run-in surfaces of a (upper image) piston ring sample and the bottom dead centre zone of a (lower image) cylinder liner plate sample (from Test #4)

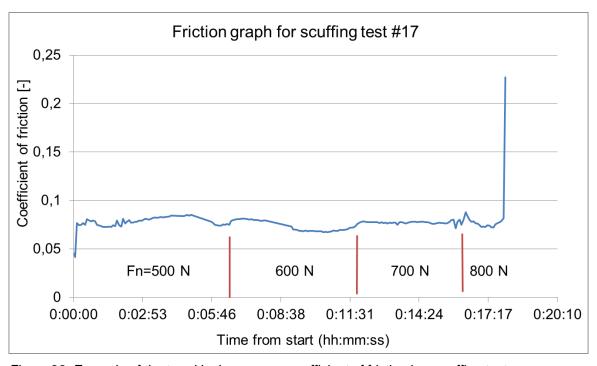
Figure 29. Example of the trend in the average coefficient of friction in a scuffing test.

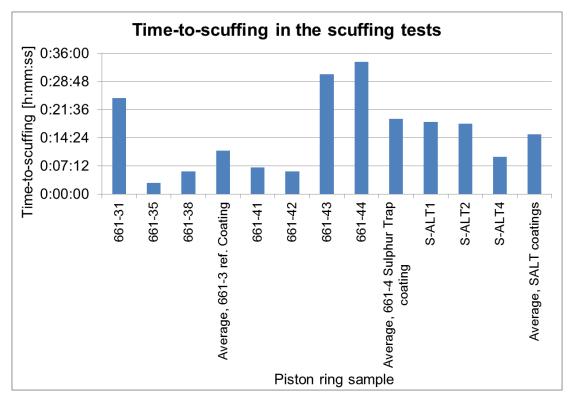
Figure 30. Summary of the Time-to-scuffing results of the scuffing tests.

A conclusion of the present scuffing tests is that the 661-4 Sulphur Trap coating gave the best resistance against scuffing among the materials of the present study, with a mean values of 19 minutes and 18 seconds, to be compared with only 11 minutes and 6 seconds for the 661-3 Reference coating, and 15 minutes and 20 seconds for the SALT sulphur exposed coatings. The mean values for the maximum normal force were correspondingly higher for the Sulphur Trap coating than for the other coatings of the present study.

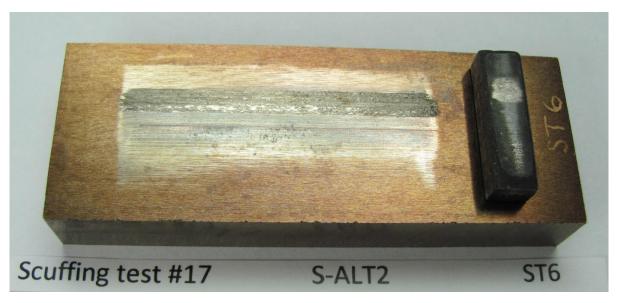
Figure 31. Example of a sample combination after a scuffing test (Test #17).

The visual inspection of the piston ring samples and the cylinder liner plate samples after the scuffing tests showed that the sliding surfaces had been roughened by strong adhesion and the subsequent tearing-off of adhesively formed joints. An example of a sample combination after a scuffing test (Test #17) is shown in Figure 31.
