Non-destructive examination of BWR and Alloy 52 NGW mock-ups

Author: Esa Leskelä

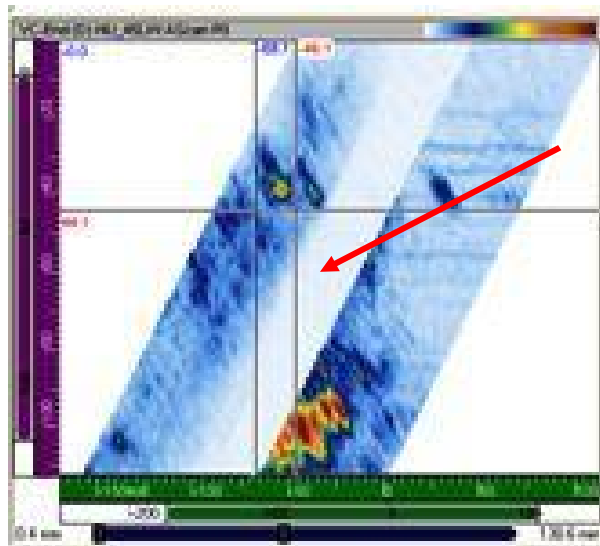
Figure 9. D-scan where an example of the adverse effect of the access limitation to the phased array data can be seen. Data from one scan line pointed with an arrow is completely missing due to a loss of contact.

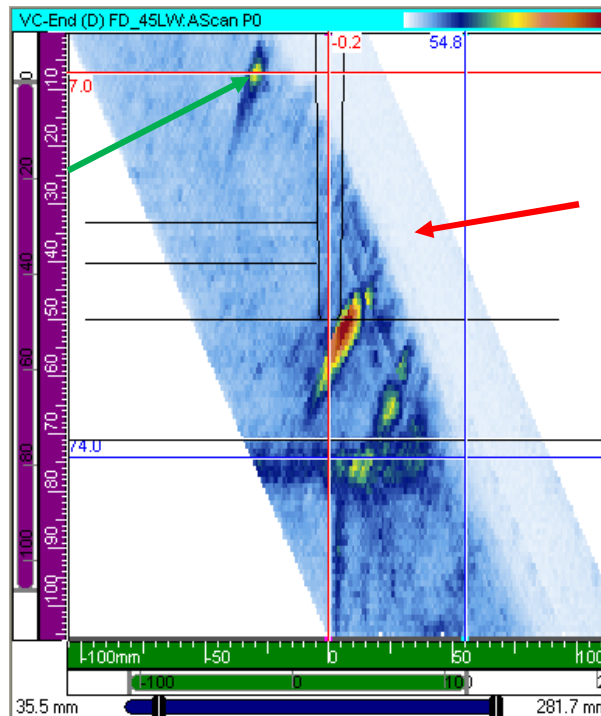
Figure 12. D-scan where an example of the adverse effect of the access limitation to the ultrasonic data can be seen. Data from one scan line pointed with red arrow is missing due to insufficient coupling. The geometrical indication from the corner of the counter bore is pointed with green arrow.
