RESEARCH REPORT

Sizing of fatigue cracks using different eddy current techniques and simulation

Author: Kari Lahdenperä

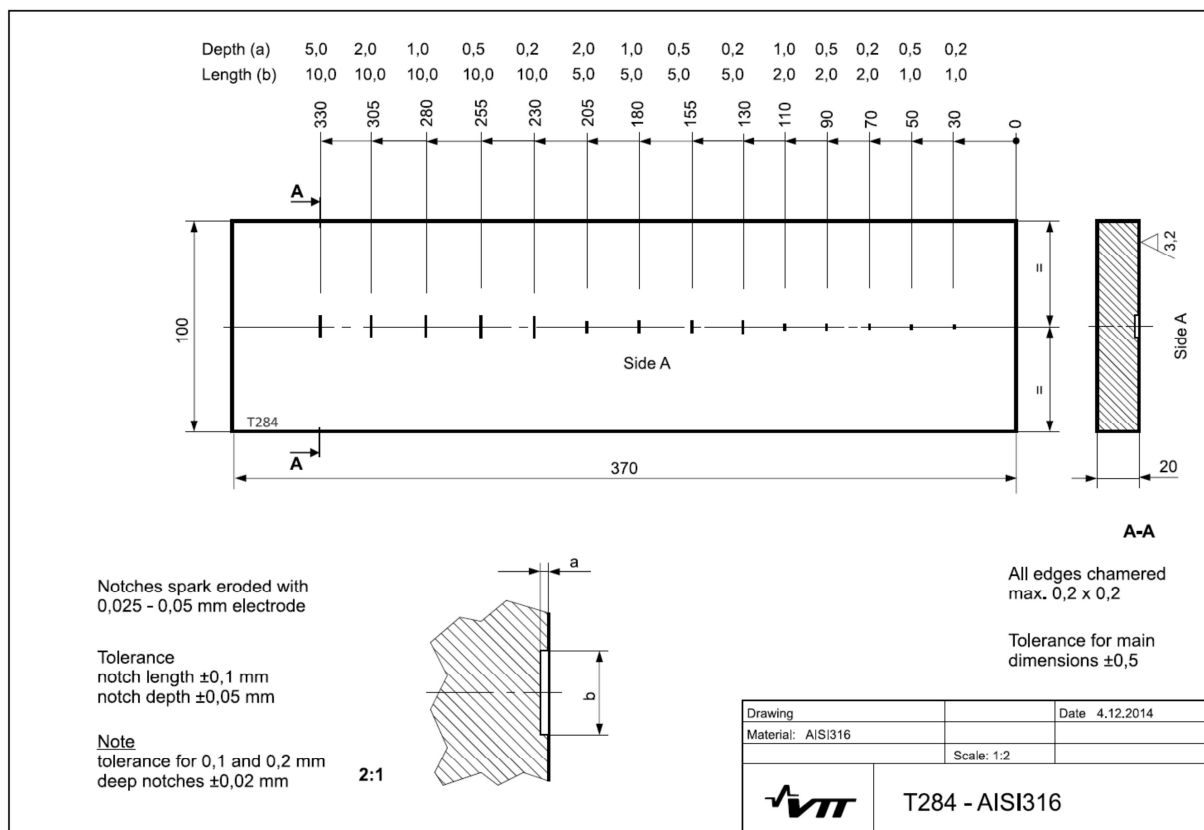
Figure 1. Test piece T284 includes 14 smaller EDM notches.

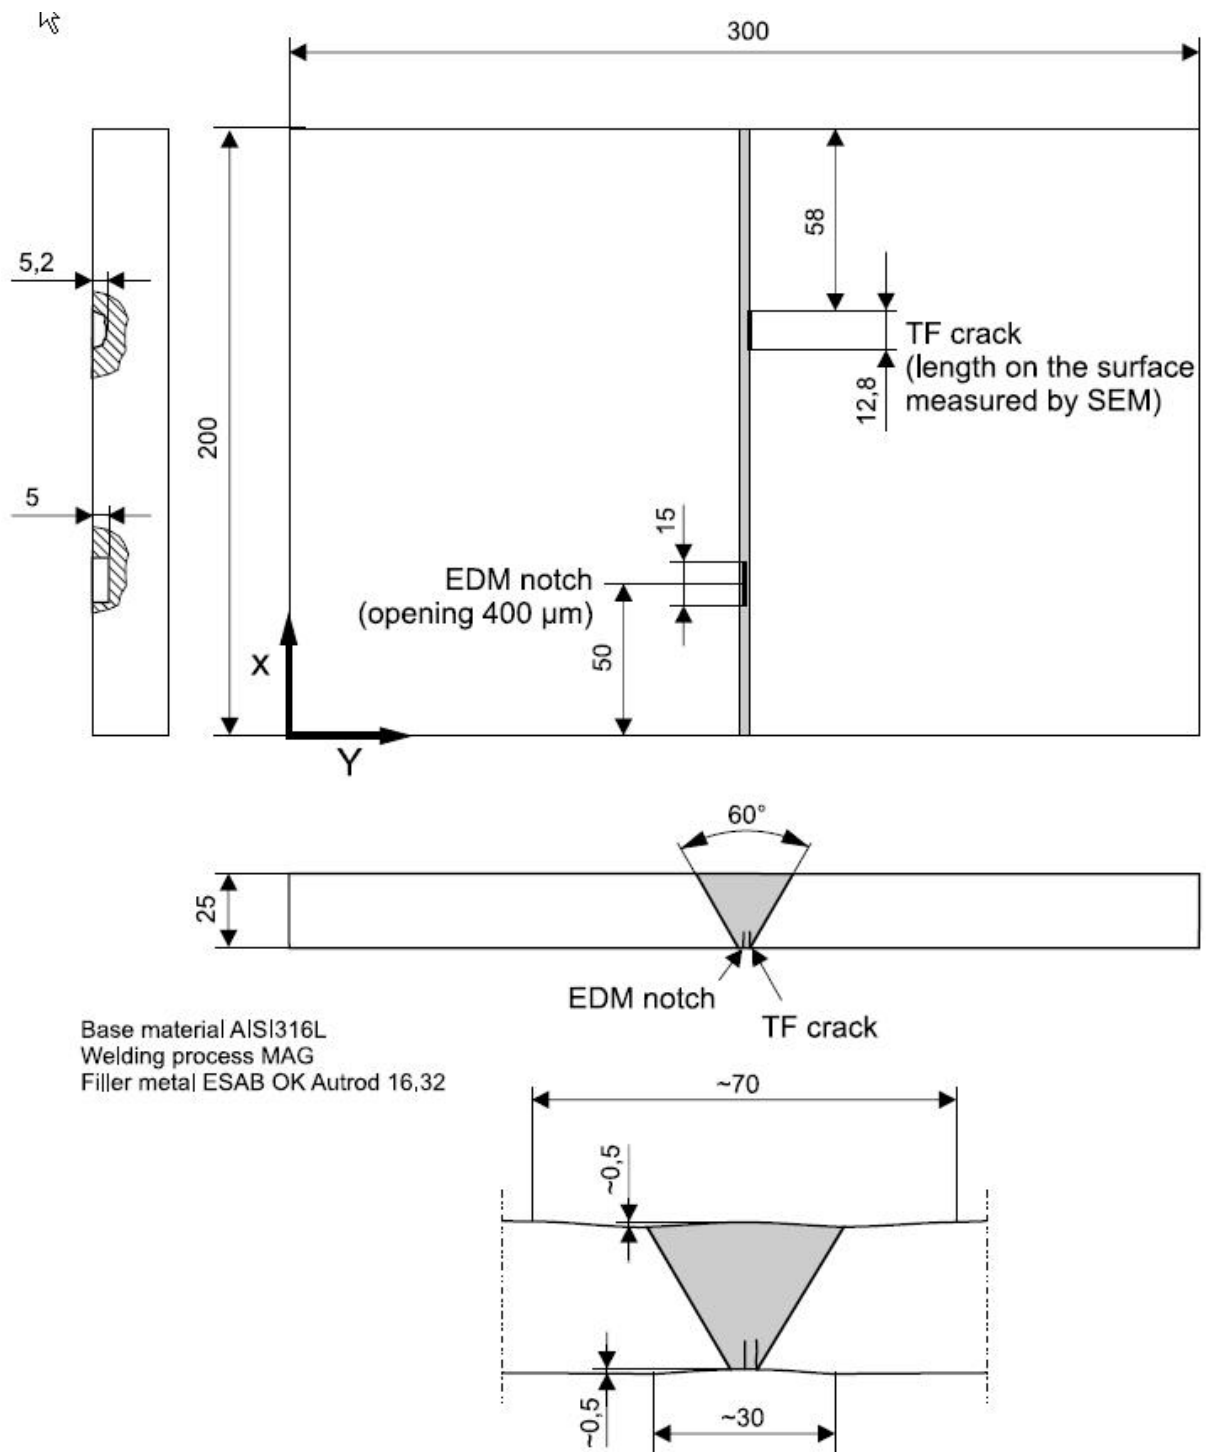
Figure 3. Drawing of TF test piece and location of fabricated TF crack and EDM notch.

The cracks and one EDM notch were fabricated on root side of the welds. The cracks and EDM notch were parallel to the weld and located in the solidification line of the weld to simulate surface breaking service induced cracks. In the TF piece there was a thermal fatigue crack and an EDM notch, see **Figure 3**. In the MF piece there were two MF cracks (MFA and MFB), see **Figure 4**. After fabrication the face and root side of the welds were ground to be able to scan across the weld and to decrease indications due to rough weld root and crown. The weld crown and root were completely removed in the grinding. After grinding the crown and root side of the weld were below the surfaces of the base material, see the lower part of **Figure 3 and 4**.

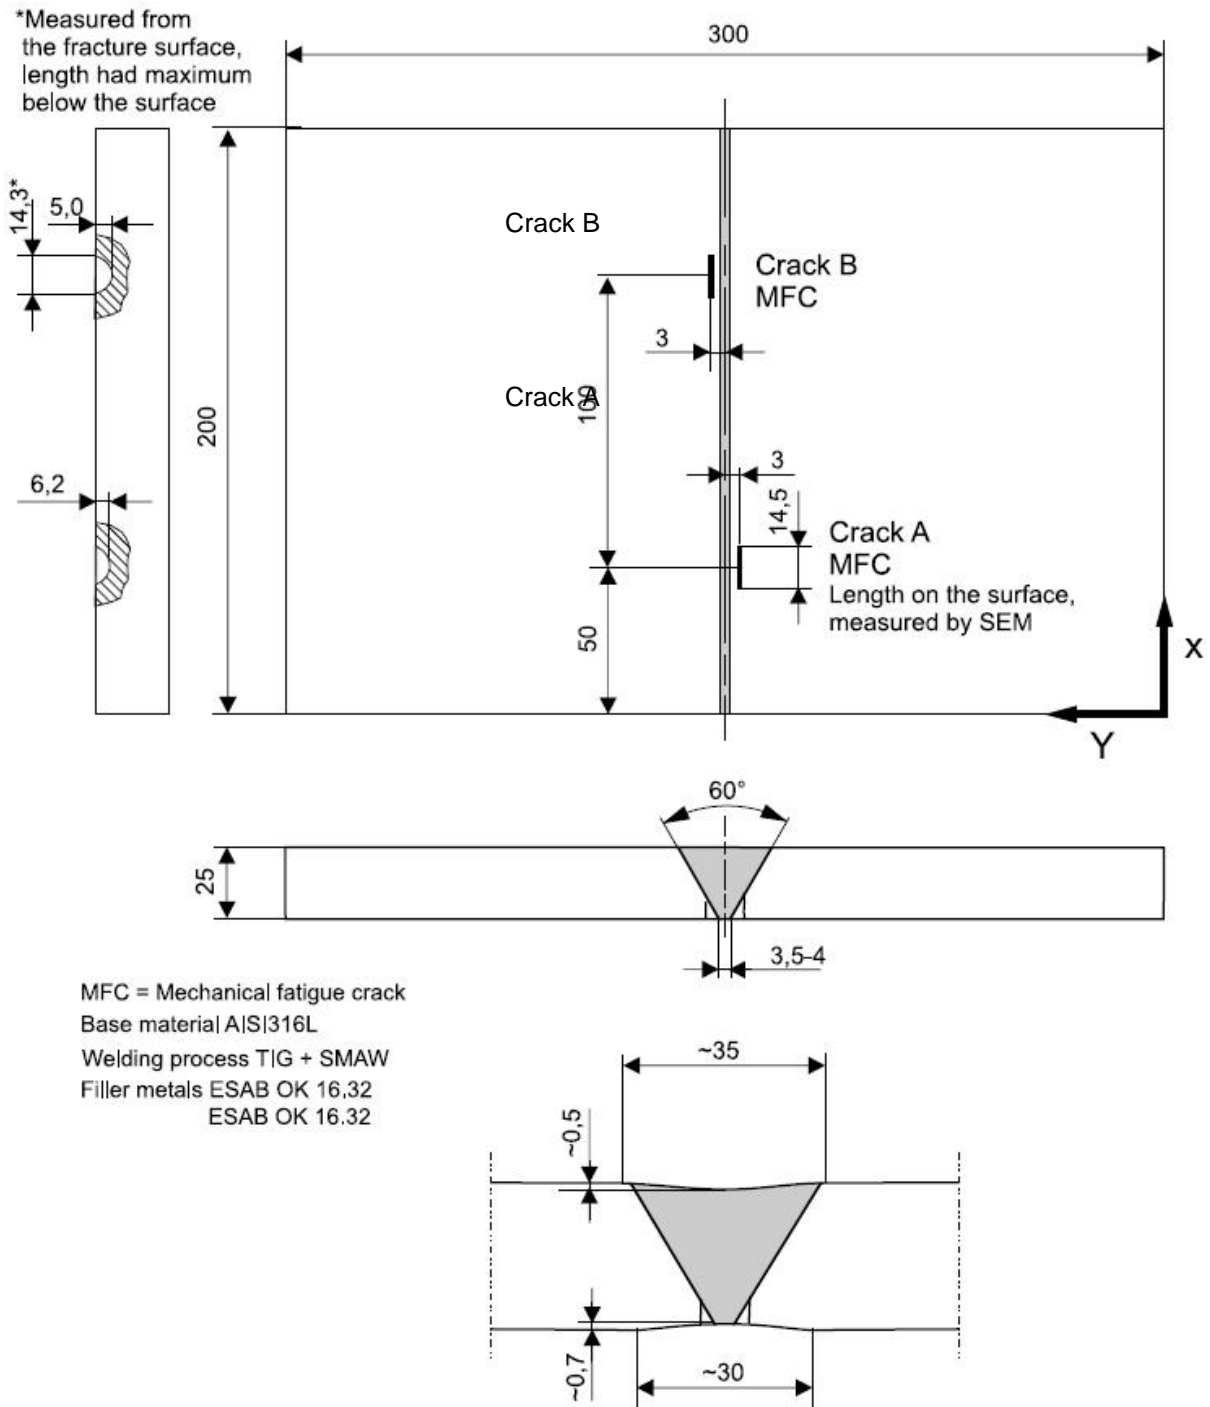
Figure 4. Drawing of MF test piece and location of fabricated MF cracks.

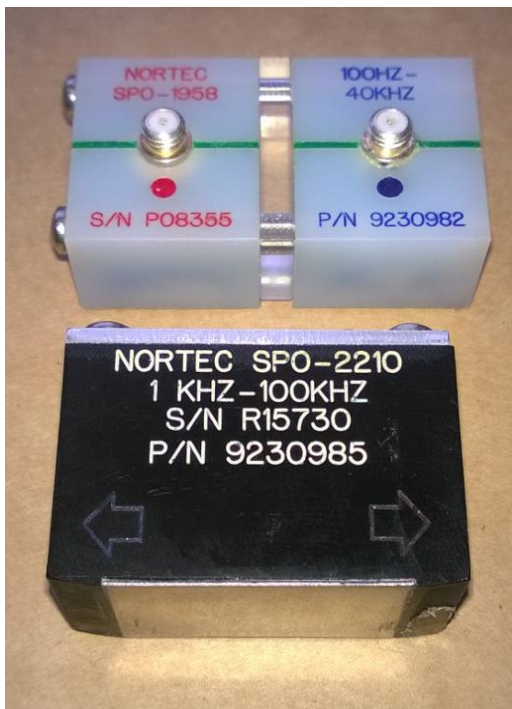
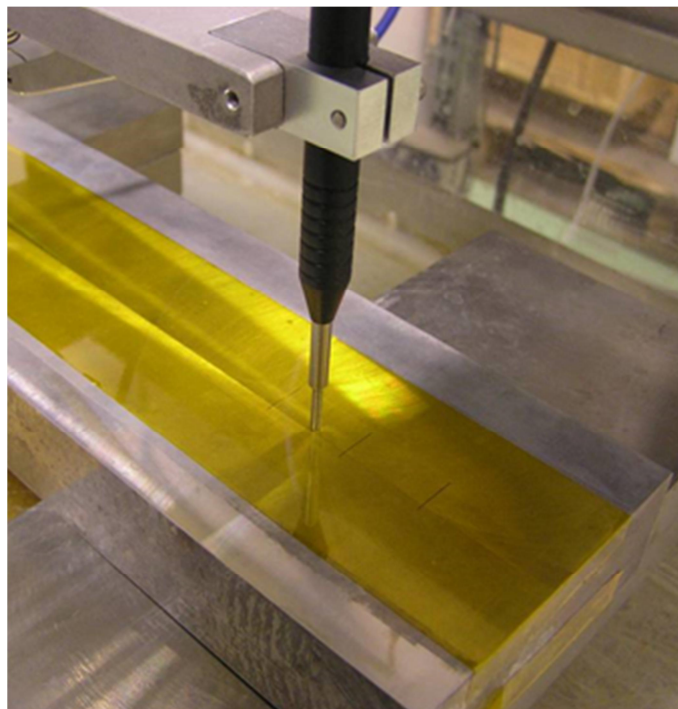
Figure 6. Left: the large size eddy current probes (sliding coils) with separate transmitting and receiving coils. Right: small diameter pencil probe applied in scanning (photograph not from this study).

All four test pieces were tested with eddy current method. Mechanized scanning was used, see **Figure 6**. The cracked sides of the test pieces (root side) were scanned. Scanned area extended across the weld. The applied eddy current techniques (probes and frequencies) are shown in **Table 1** and **Figure 6**. The probes SPO-2210 and SPO1958 include two parallel axial coils side by side perpendicular to the surface to be tested. One coil is transmitter and the other is receiver. Both coils have ferrite shield. The distance between the coils of the probe SPO-1958 can be adjusted.

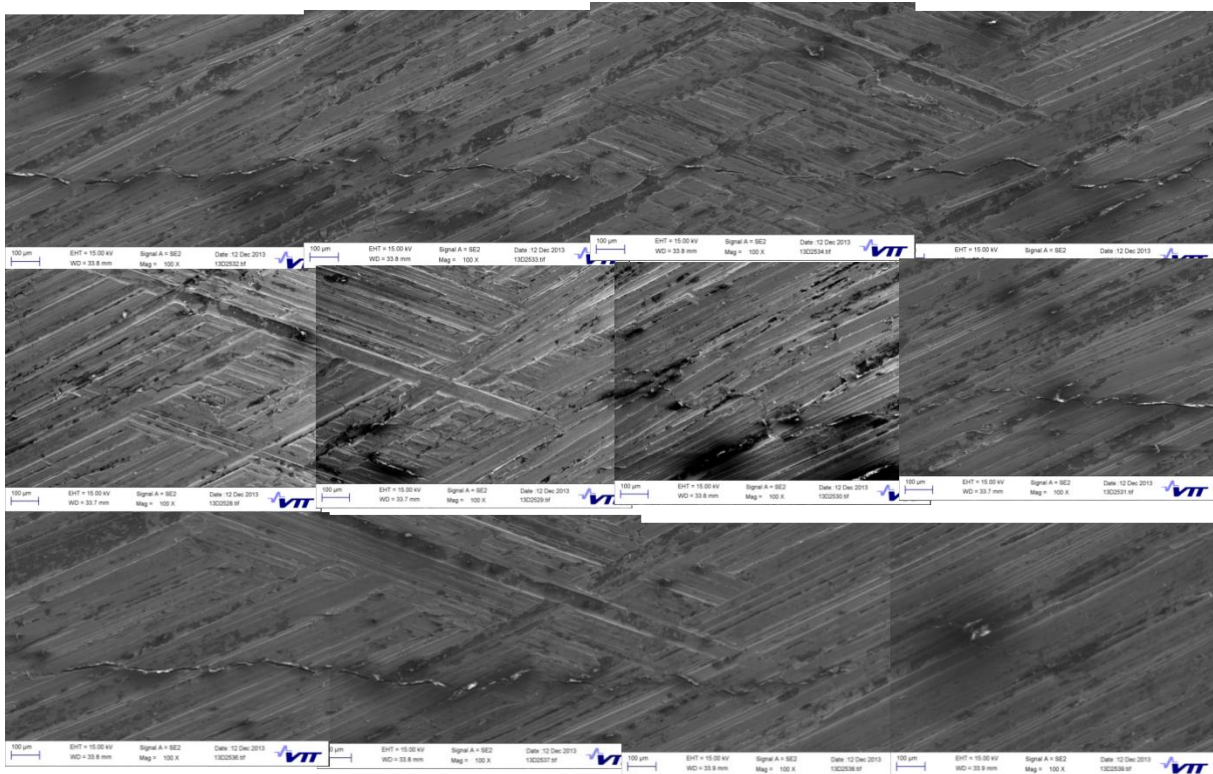
Figure 7. The surface in sample MF A. The surface has been ground. The crack is rather straight, and the length along the surface was measured to be ~14.5 mm. [1]

The surface of sample MF was rather roughly ground. The crack A was straight without any branching. The opening of crack A was 3 – 4 μm . The surface length of the crack A was about 14.5 mm.

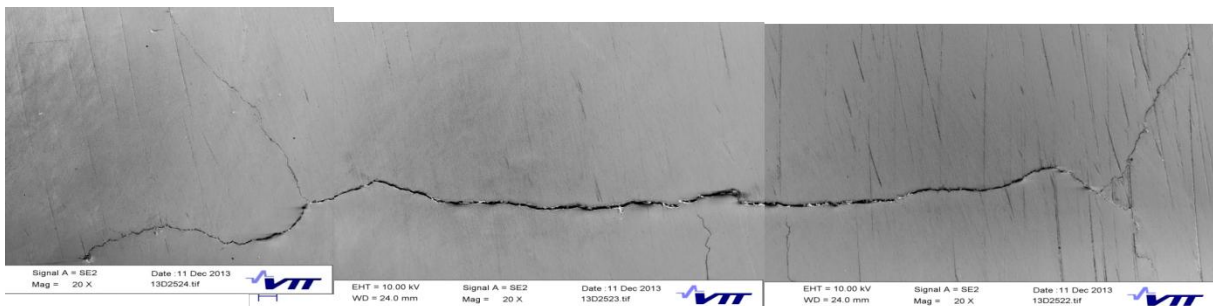
Figure 8. SEM-picture of the surface of sample TF showing the crack with V-shaped branches in both ends. The total length of the crack was measured to be 12.8 mm. [1]

The surface of the sample TF was not so rough even if it was also ground. The mid-part of the crack was almost straight. There were V-shaped branches at both ends of the crack. There were altogether five side branches. The typical crack opening displacement of the centre part of the crack on the surface of the test piece was about of 60 μm . The measured maximum surface length of the TF crack was 12.8 mm.

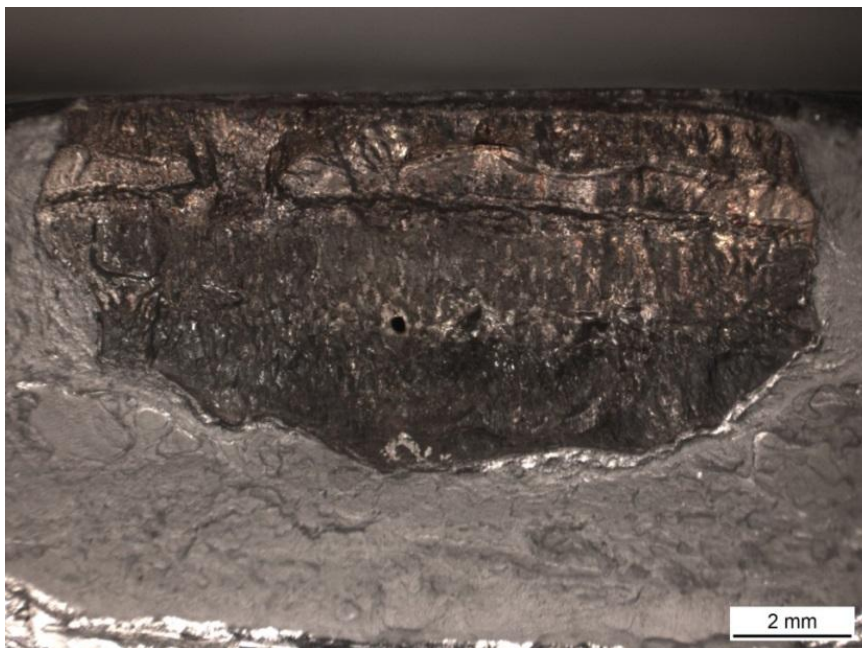
Figure 9. Photograph of the surface of the crack in test piece MF A. [1]

In the destructive examination the cracks were opened and length and depth of the cracks were measured by stereo-microscope [1]. The results are presented in **Table 2**. The photographs of the surfaces of the opened MF cracks A and B are shown in **Figure 9 and 10**. From the figures it can be deduced that the MF cracks have been “closed” by welding. SEM examination revealed that the fracture surfaces of the MF cracks were smeared. This is obviously due to hammering of the defect area after welding to make the opening displacement of the crack smaller. Hammering is necessary because the opening displacement of implanted crack is quite large after welding. The width of the weld root in the middle of the MFB crack was about 6 mm.

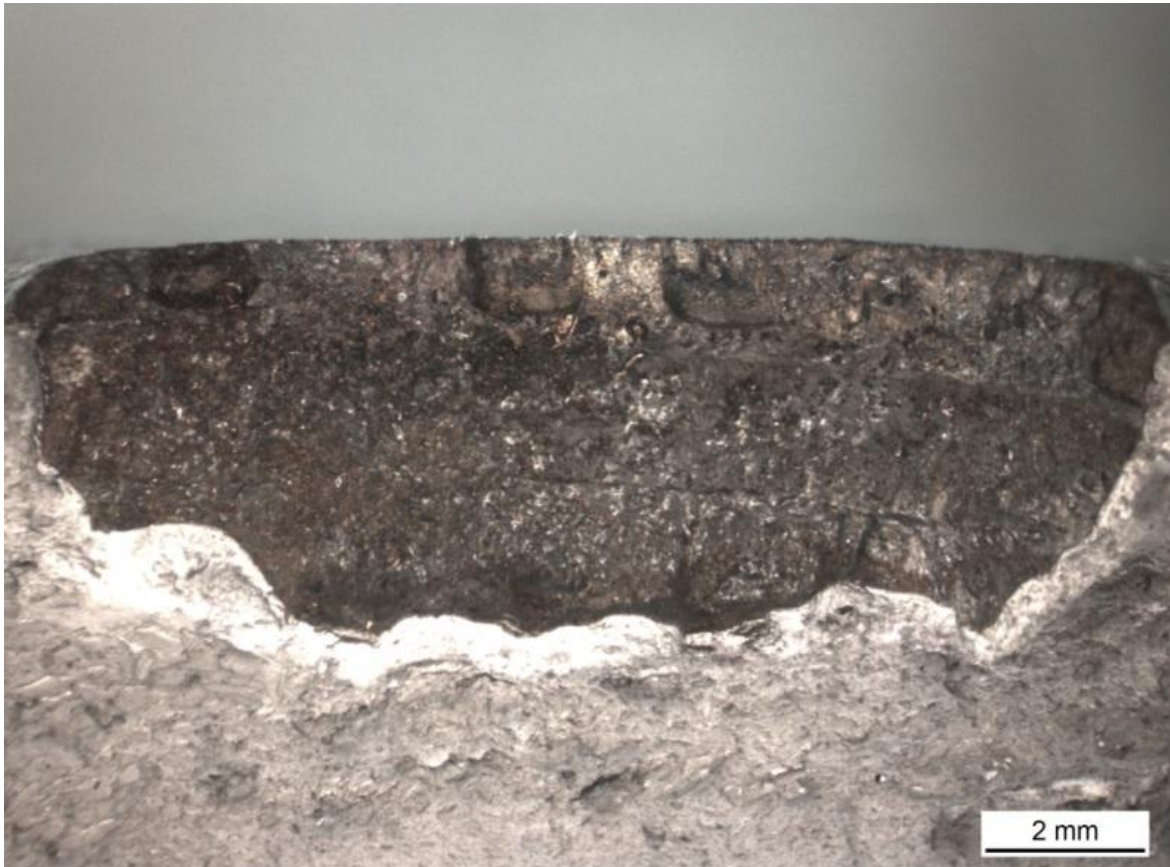
Figure 10. Photograph of the surface of the crack in test piece MF B. [1]

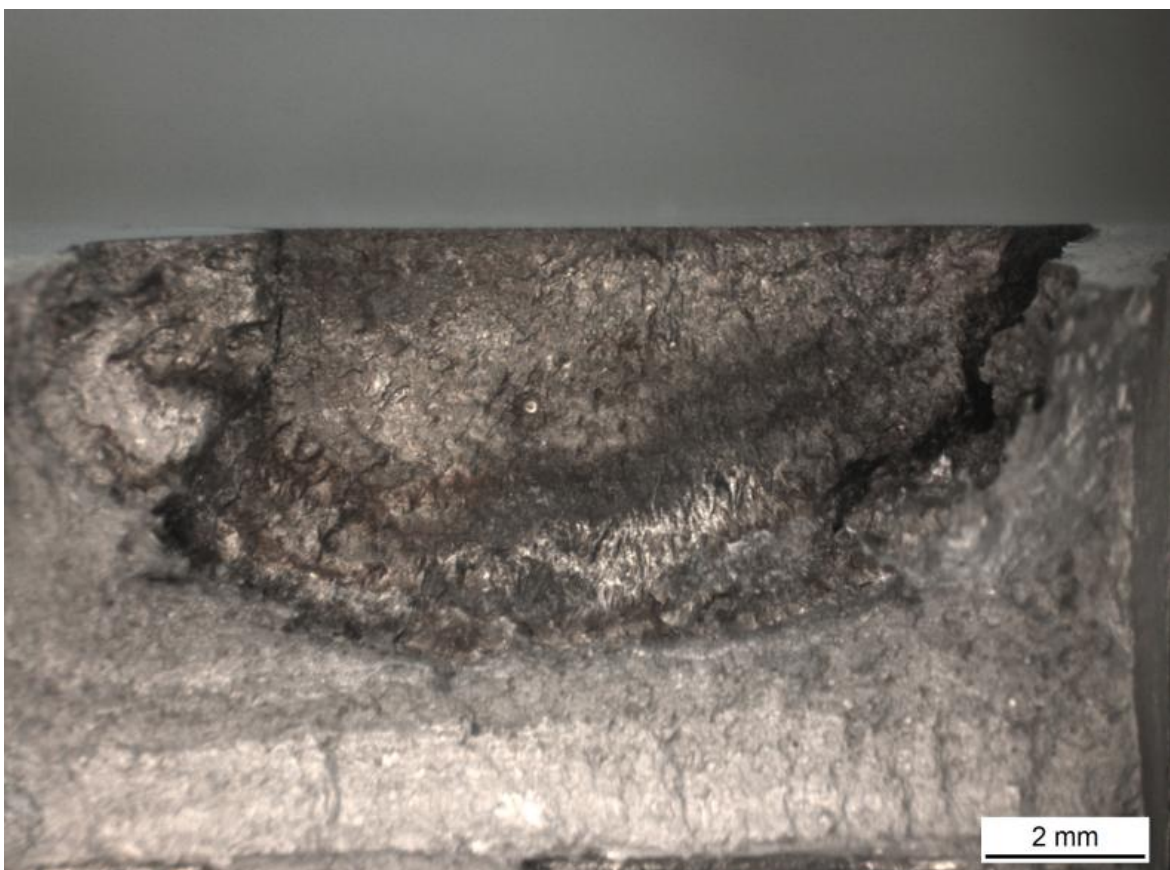
Figure 11. Photograph of the surface of the crack in test piece TF. [1]

The photograph of the surfaces of the opened TF crack is shown in **Figure 11**. TF crack was not at all hammered or processed after thermal fatigue. Thus the fatigue striations on the

fracture surface of the unmodified TF crack were clearly seen in SEM examination. The width of the weld root in the middle of the TF crack was less than 3 mm.

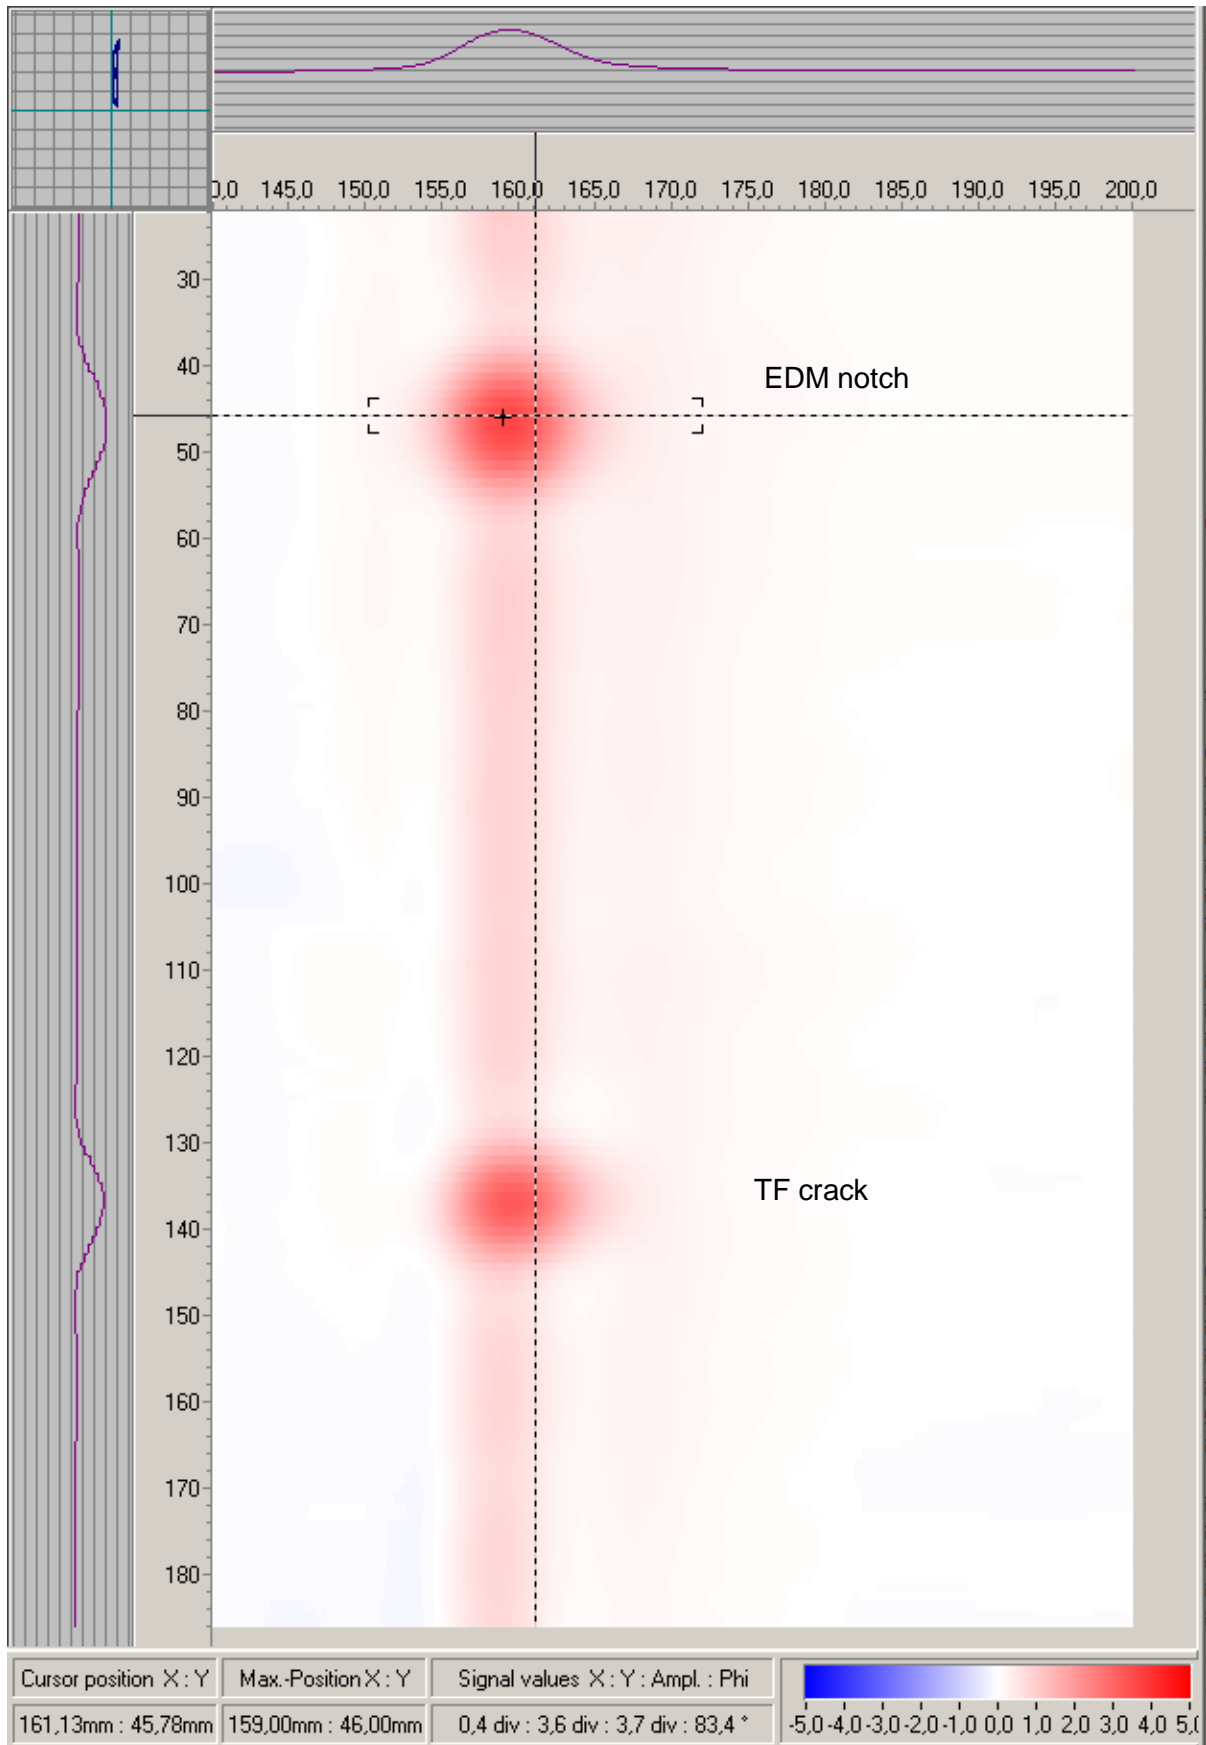
Figure 12. C scan of test piece TF, indications of a notch and a TF crack, probe SPO-2210, applied frequency 10 kHz.

The C scans of TF and MF test pieces using 10 kHz and 30 kHz frequencies are shown in **Figures 12 and 13**. The indication of the large notch and all fatigue cracks were detected easily. The defect and weld indications have been shown in **Figure 14**. The amplitude of the smallest defect indication exceeded the typical respective weld indication at least by 7 dB. The angles of the indications of weld and defect were the same, when the frequency was 30 kHz. When 10 kHz frequency was used the angle between weld indication and defect indication was about 45°. This feature can be used to distinguish crack and weld indication in multi frequency testing.

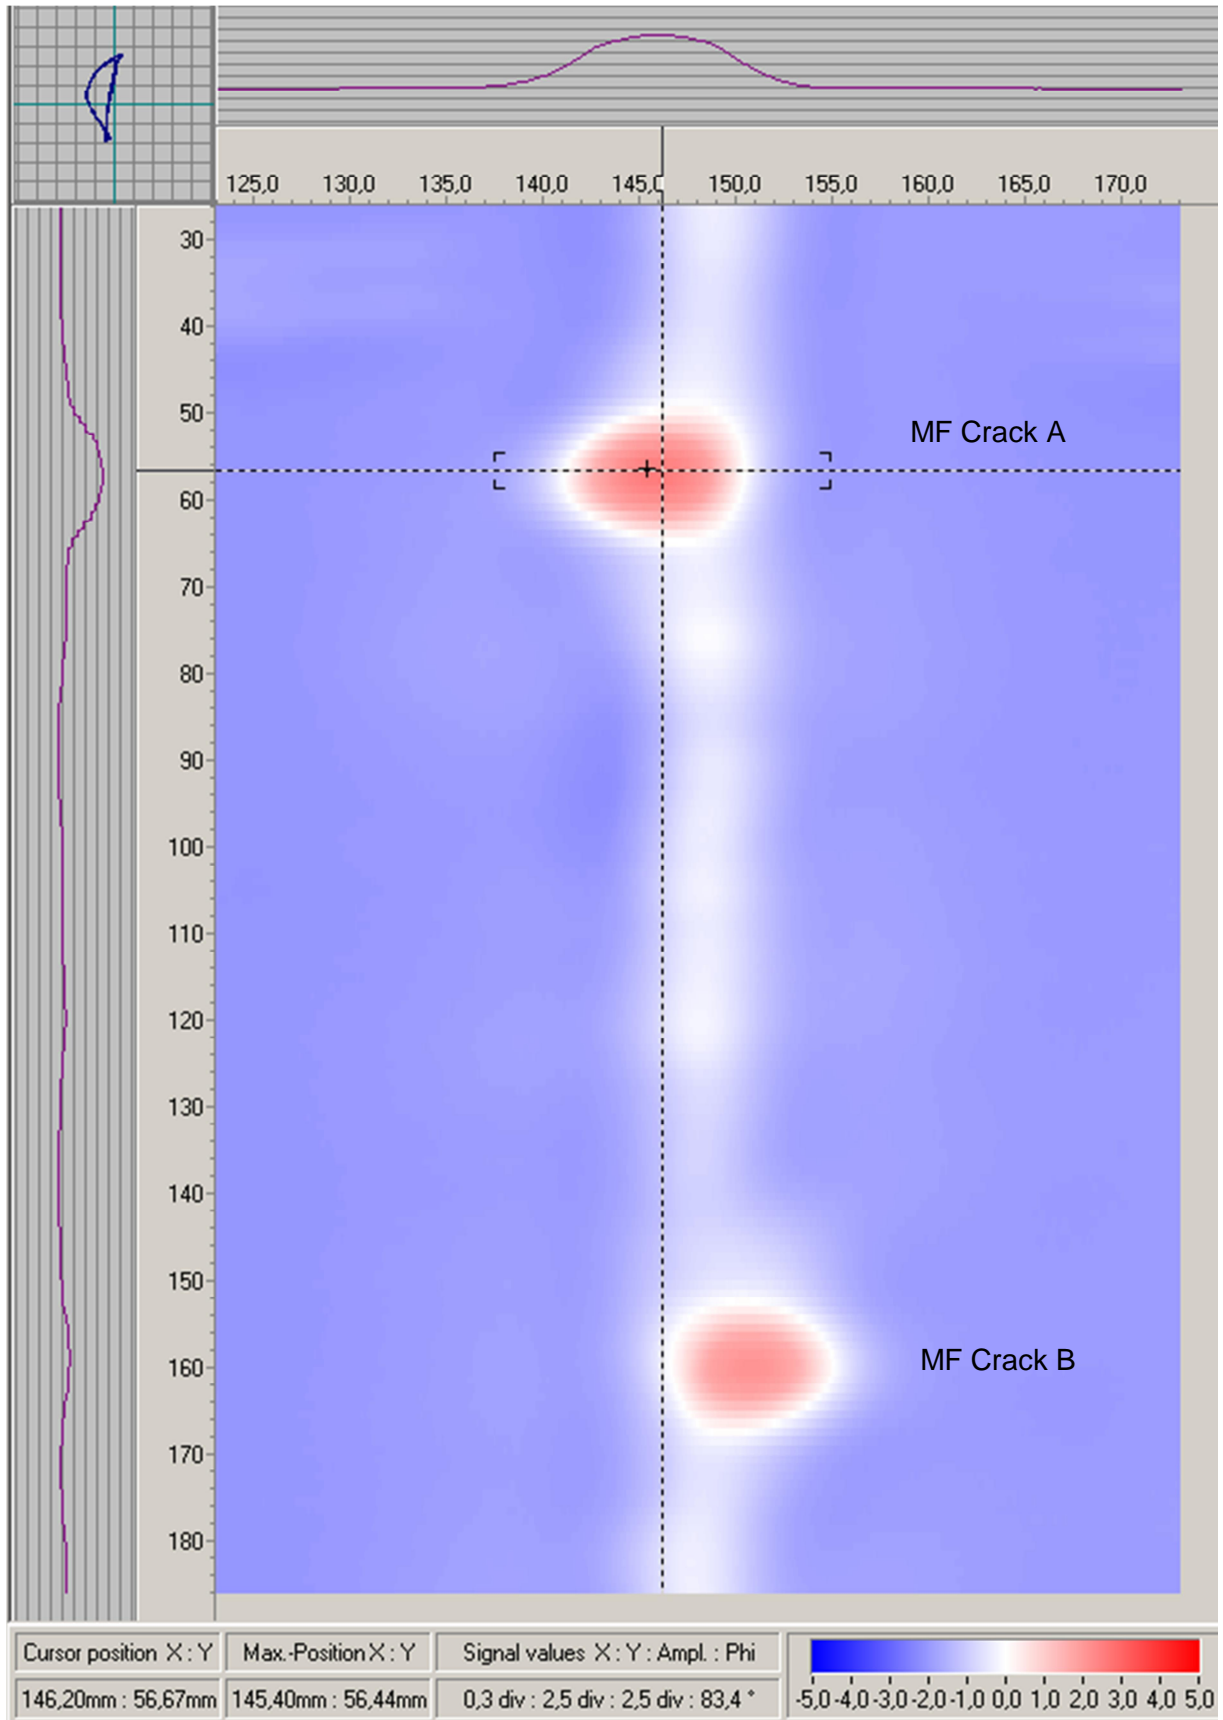
Figure 13. C scan of test piece MF, indications two MF cracks, probe SPO-2210, applied frequency 30 kHz.

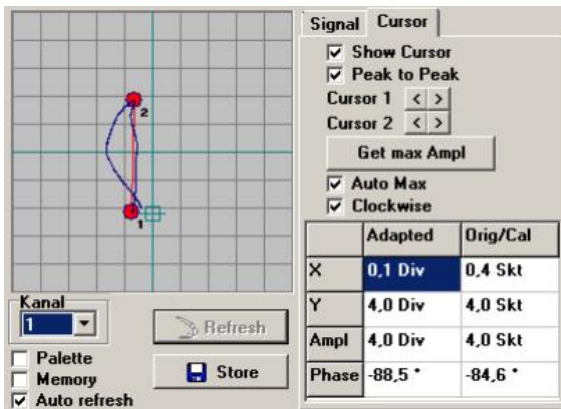
a) EDM notch, TF test piece (10 kHz)

b) TF crack, TF test piece (10 kHz)

c) Typical weld indication TF (10 kHz)

d) Typical weld indication MF (30 kHz)

e) Indication of MFA crack (30 kHz)

f) Indication of MFB crack (30 kHz)

Figure 14. Impedance plane presentations of indications of a notch, fatigue cracks and welds in test pieces TF and MF, probe SPO 2210.

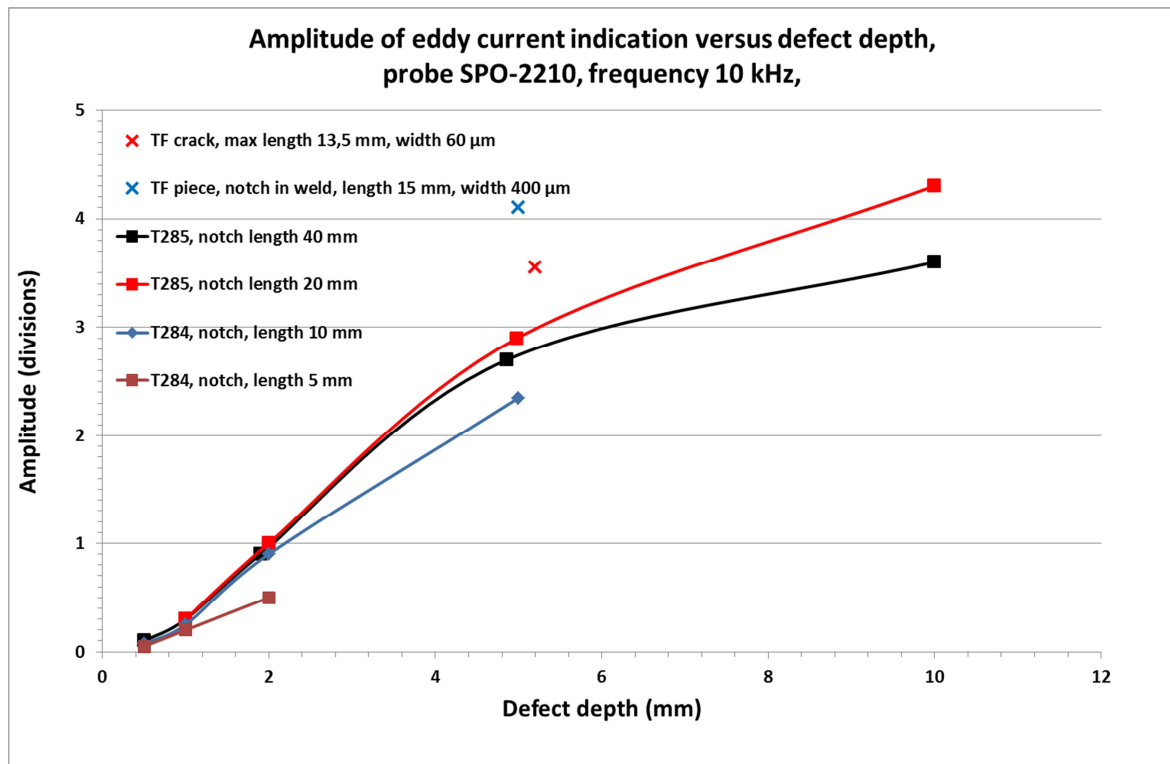
Figure 15. Amplitude of eddy current indications of TF crack and notches versus defect depth, when probe SPO-2210 was used. The studied test pieces were TF, T284 and T285. The eddy current frequency was 10 kHz.

The amplitudes of all indications of fatigue cracks and notches of the test pieces MF, TF, T284 and T285 recorded with the smaller size probe SPO-2210 are given in **Figure 15, 16 and 17**. The applied frequencies were 10, 30 and 100 kHz. The test piece MF was tested only with 30 kHz technique. In all three cases the amplitudes of the indications of 20 mm long notches were higher than that of 40 mm long notches of equal depth. In the case of 20 mm long notch the amplitude of the indication on C scan had maximum value in the middle of the indication. In the case of 40 mm long notch the amplitude of the indication on C scan had maximum values at the ends of the indication, when the notch depth was 5 or 10 mm. The amplitude of the indication of the EDM notch (5 x 12 mm) in the weld of the TF piece was higher than that of the larger EDM notch (5 x 20 mm) in the test piece T285. When the eddy current frequency was lowest the difference between the amplitudes of these two notches was the highest. In all cases the amplitude of the indication due to this 5 mm deep and 12

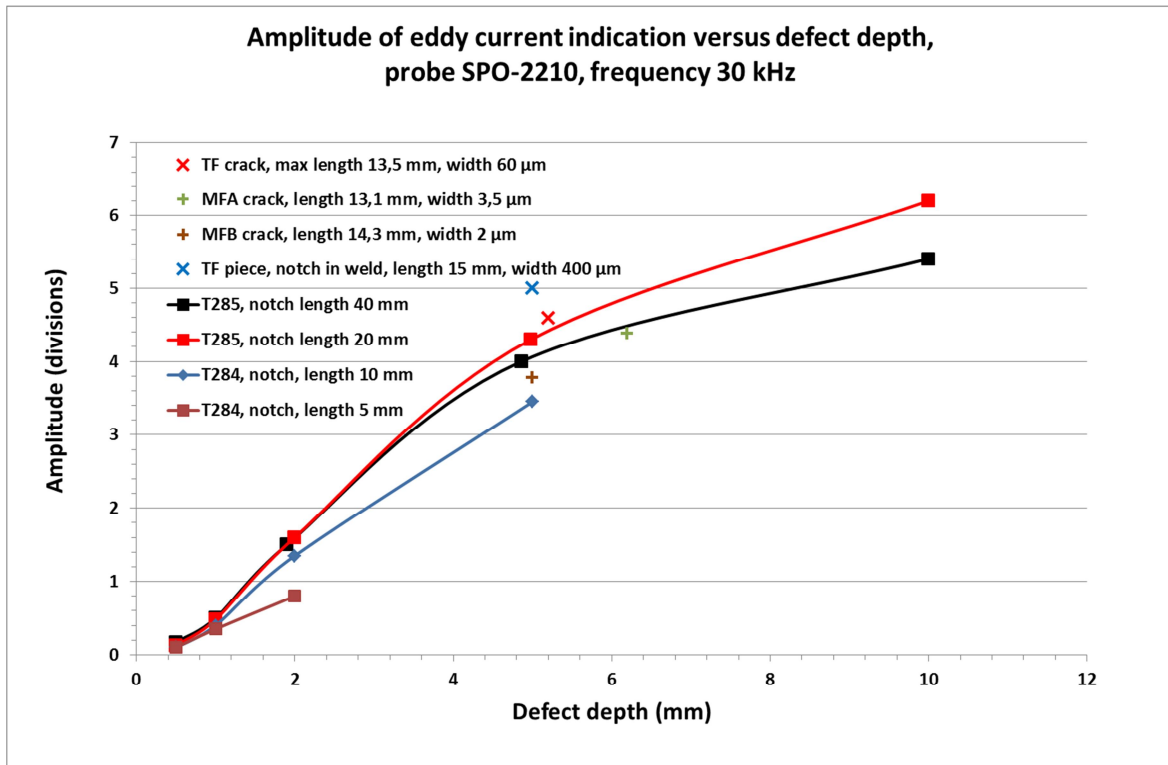
Figure 16. Amplitude of eddy current indications of TF, crack, two MF cracks and notches versus defect depth, when probe SPO-2210 was used. The test pieces were TF, MF and T284 and T285. The eddy current frequency was 30 kHz.

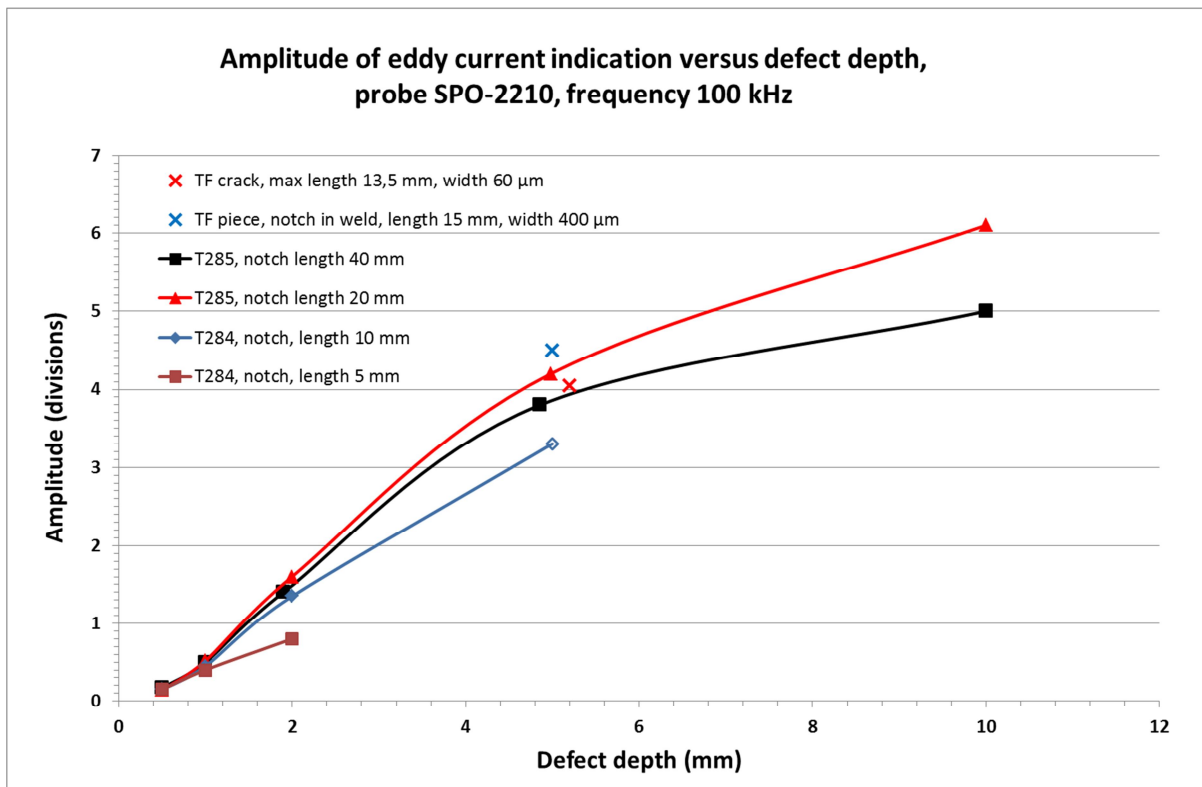
Figure 17. Amplitude of eddy current indications of TF crack and notches versus defect depth, when probe SPO-2210 was used. The eddy current frequency was 100 kHz.

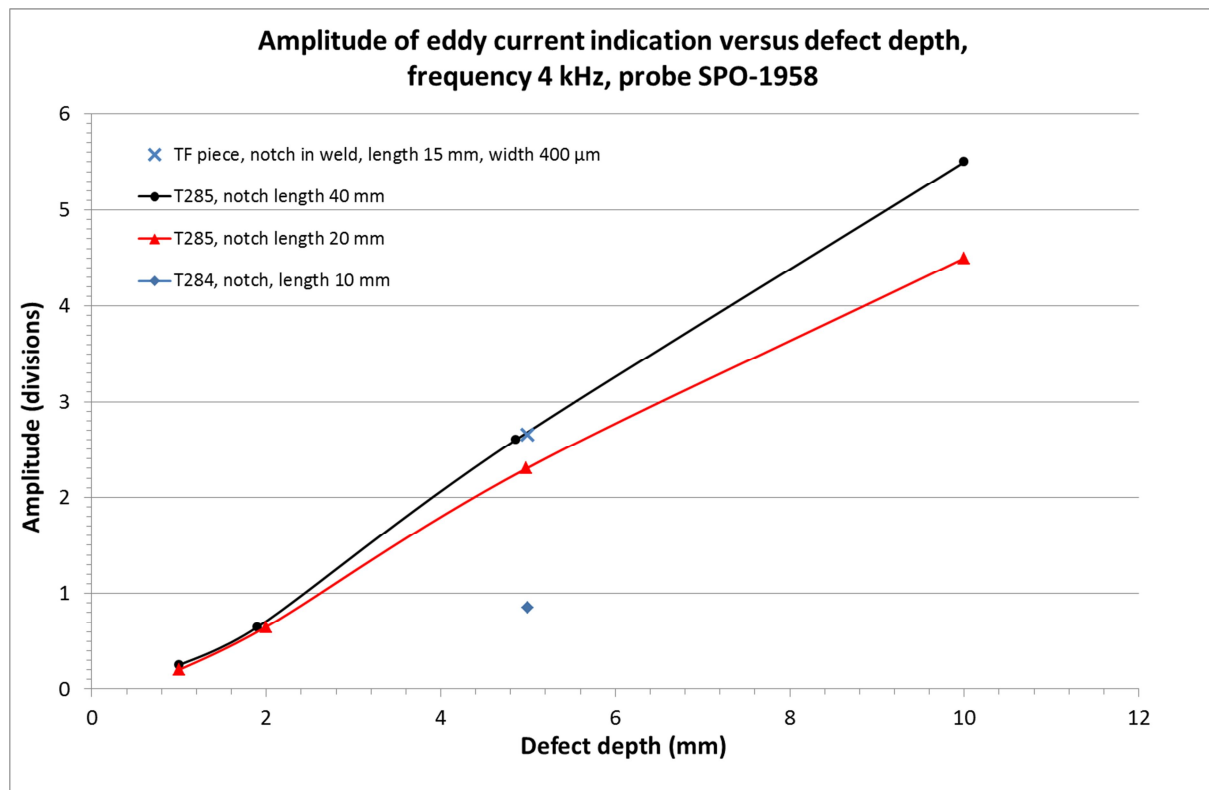
Figure 18. Amplitude of eddy current indications of EDM notches versus defect depth, when probe SPO-2210 was used. The studied test pieces were TF, T284 and T285. The eddy current frequency was 4 kHz.

The amplitudes of all indications of fatigue cracks and notches of the test pieces MF, TF, T284 and T285 recorded with the probe SPO-1958 are given in **Figure 18 and 19**. The applied frequencies were 4 and 10 kHz. The test piece MF was tested only with 10 kHz technique. In both cases the amplitudes of the indications of 40 mm long notches were higher than that of 20 mm long notches of equal depth. The amplitude of the indication of the EDM notch (5 x 12 mm) in the weld of the TF piece was higher than that of the longer EDM notch (5 x 20 mm) in the test piece T285. In all cases the amplitude of the indication of this 5 mm deep and 12 mm long notch was higher than that of the three slightly deeper and longer fatigue cracks.

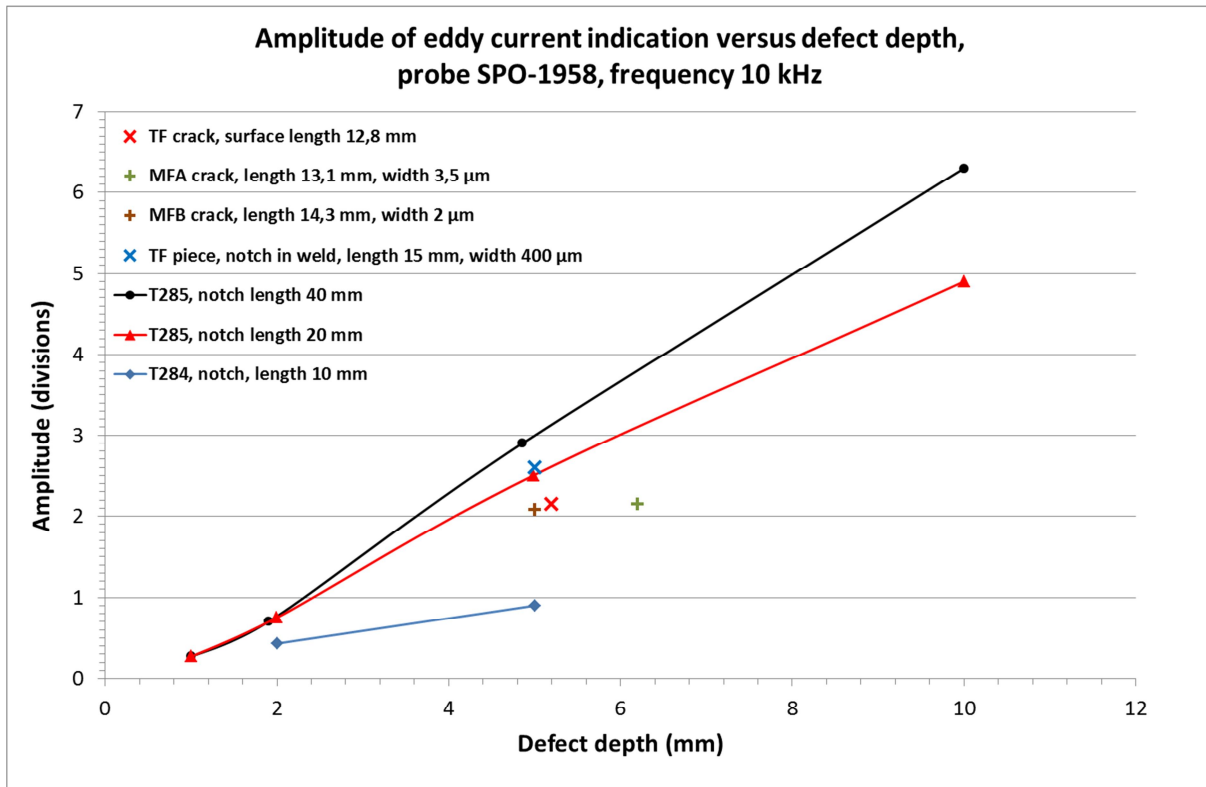
Figure 19. Amplitude of eddy current indications of TF crack and notches versus defect depth, when probe SPO-2210 was used. The studied test pieces were TF, T284 and T285. The eddy current frequency was 10 kHz.

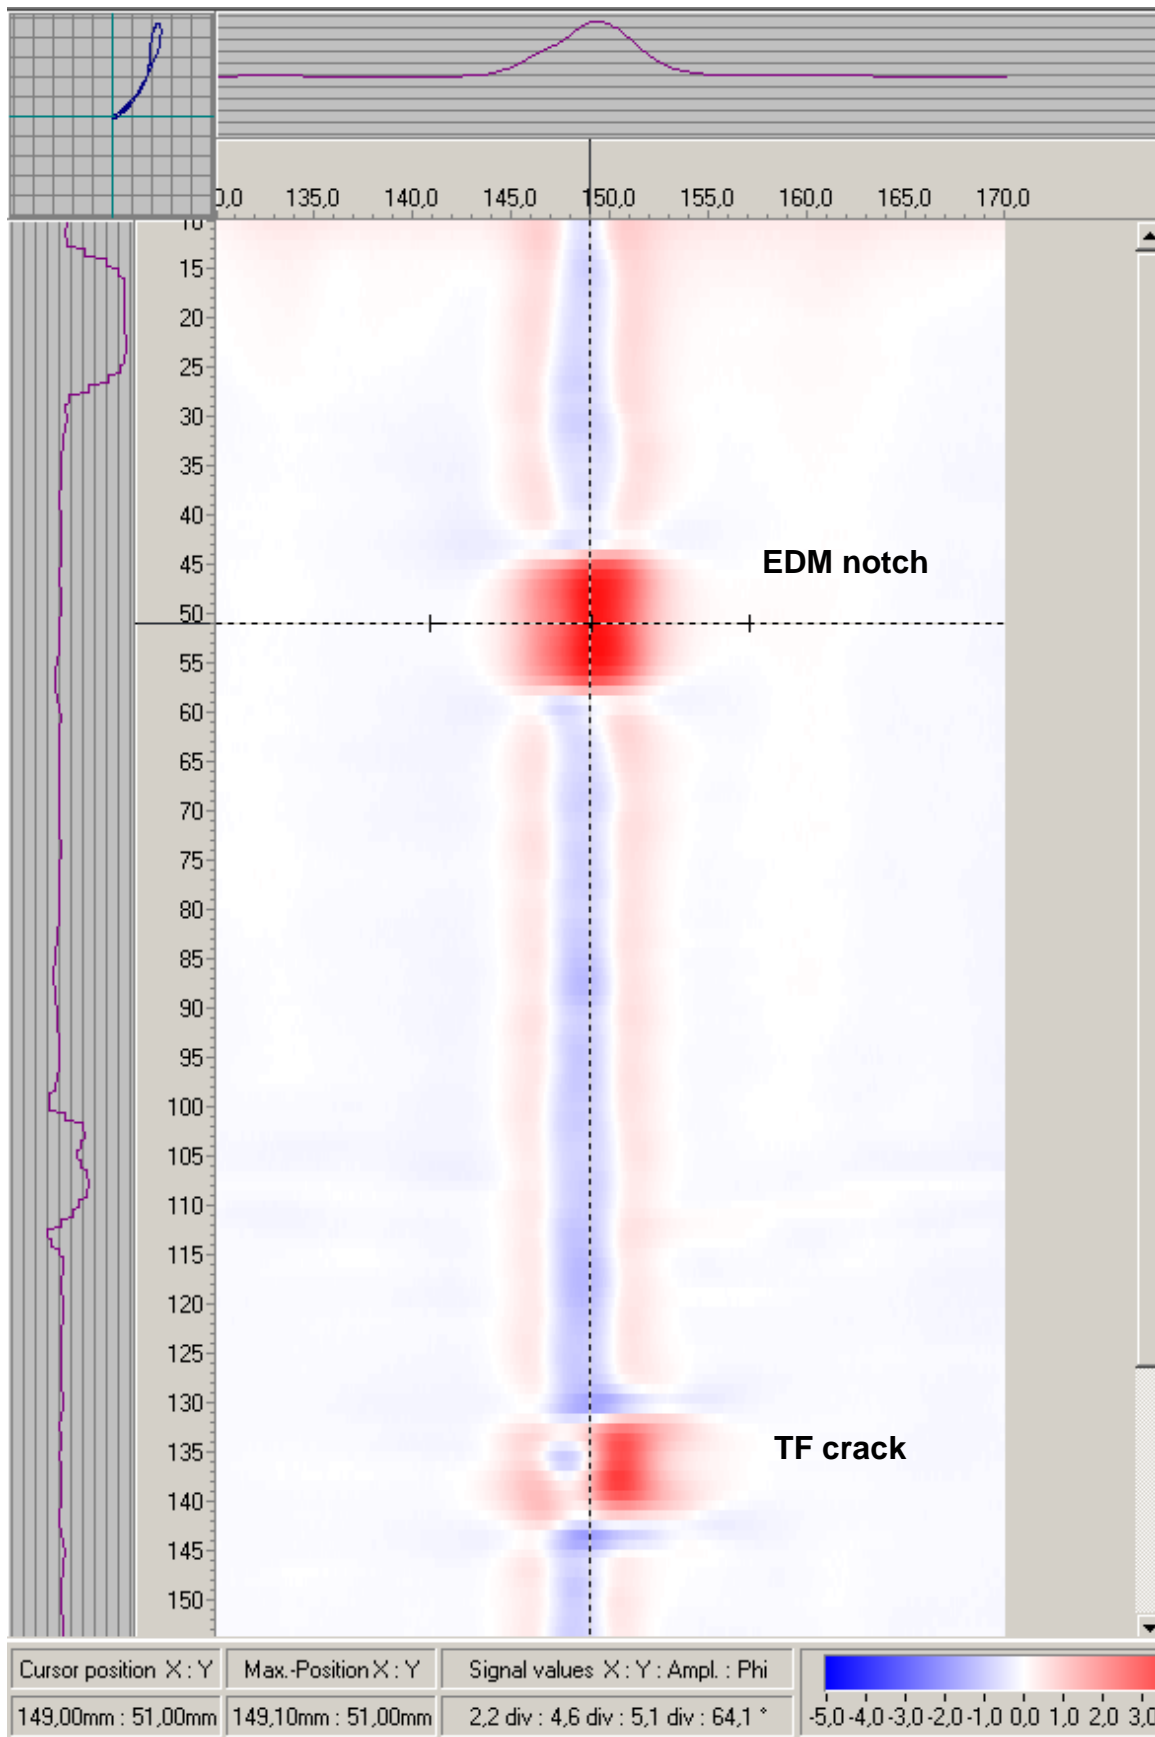
Figure 20. C scan of test piece TF, when X probe was used and the applied frequency was 200 kHz.

The C scans of TF and MF test pieces using X probe and 200 kHz frequency are shown in Figures 20 and 21. The indication of the large notch and fatigue cracks can be detected easily. The defect and weld indications have been shown in Figure 14. The amplitude of the smallest defect indications exceeds the typical respective weld indication least by 8 dB. The angles of the indications of the welds, notch and cracks were practically the same.
