RESEARCH REPORT

Sizing of fatigue cracks using different eddy current techniques and simulation

Author: Kari Lahdenperä

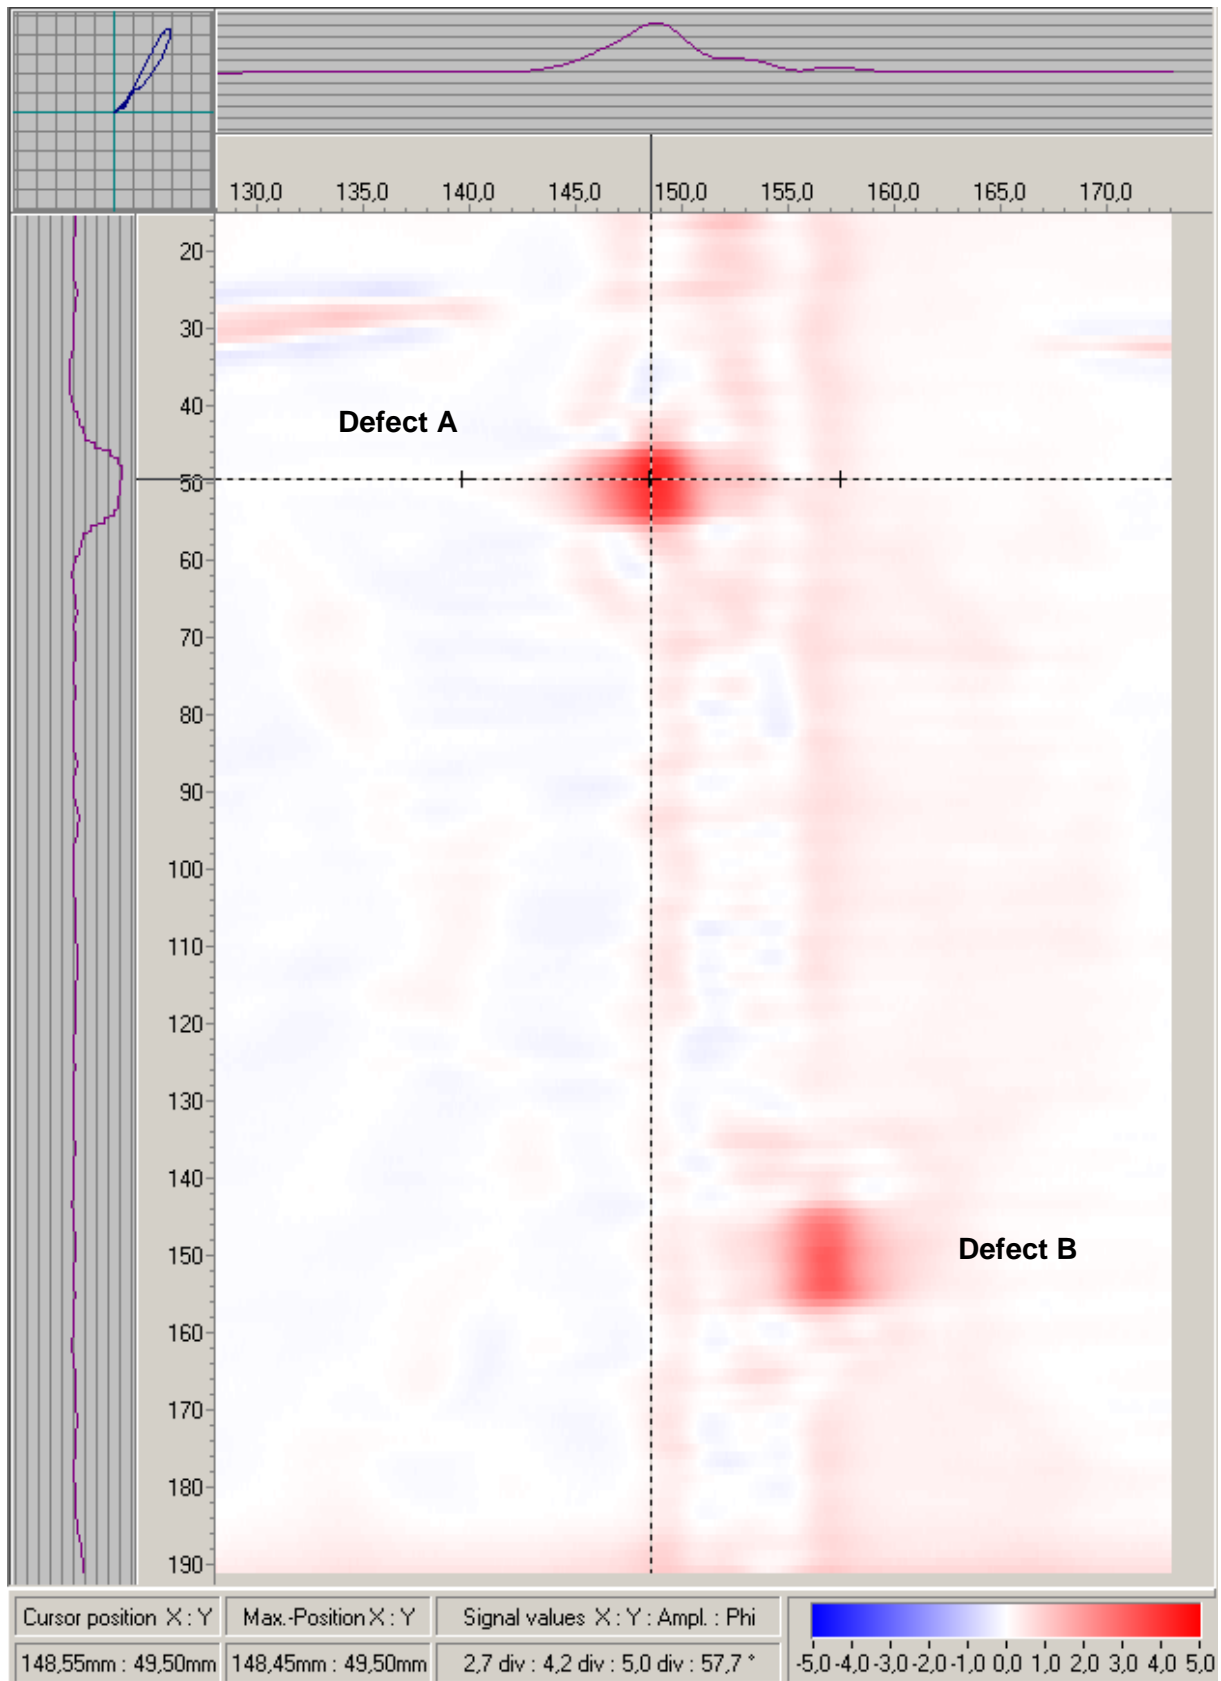
Figure 21. C scan of test piece MF, when X probe was used and the applied frequency was 200 kHz.

The C scans of TF and MF test pieces using X probe and 200 kHz frequency are shown in Figures 20 and 21. The indication of the large notch and fatigue cracks can be detected easily. The defect and weld indications have been shown in Figure 14. The amplitude of the smallest defect indications exceeds the typical respective weld indication least by 8 dB. The angles of the indications of the welds, notch and cracks were practically the same.

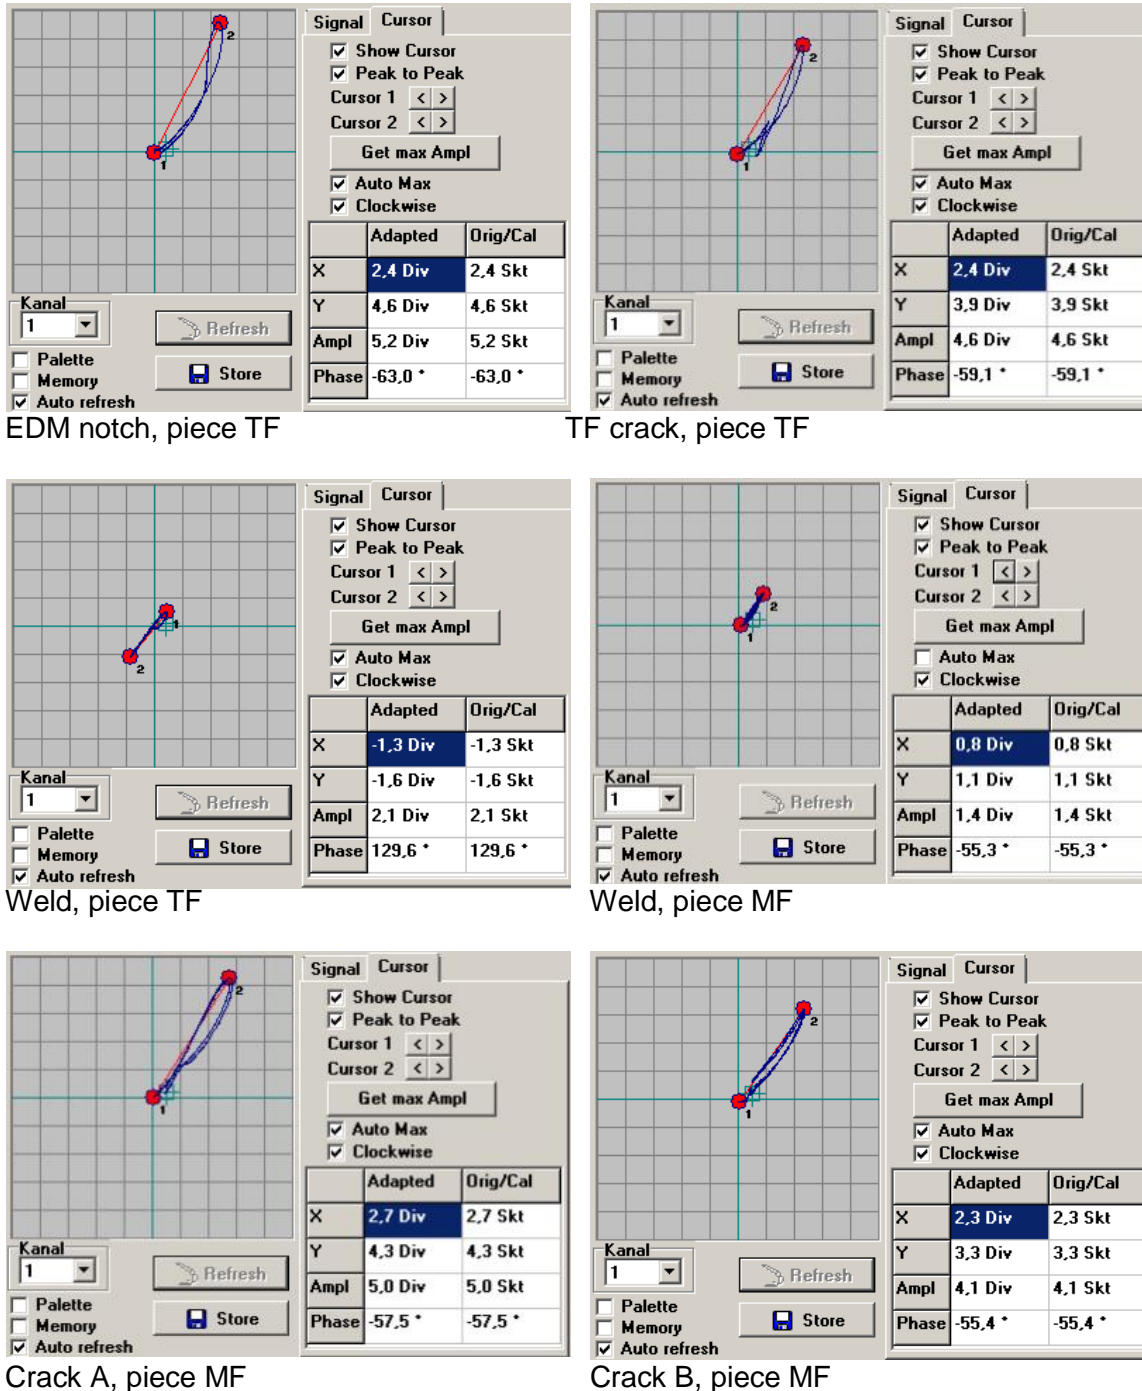
Figure 22. Impedance plane presentations of indications of a notch, fatigue cracks and welds in test pieces TF and MF, when X probe was used.

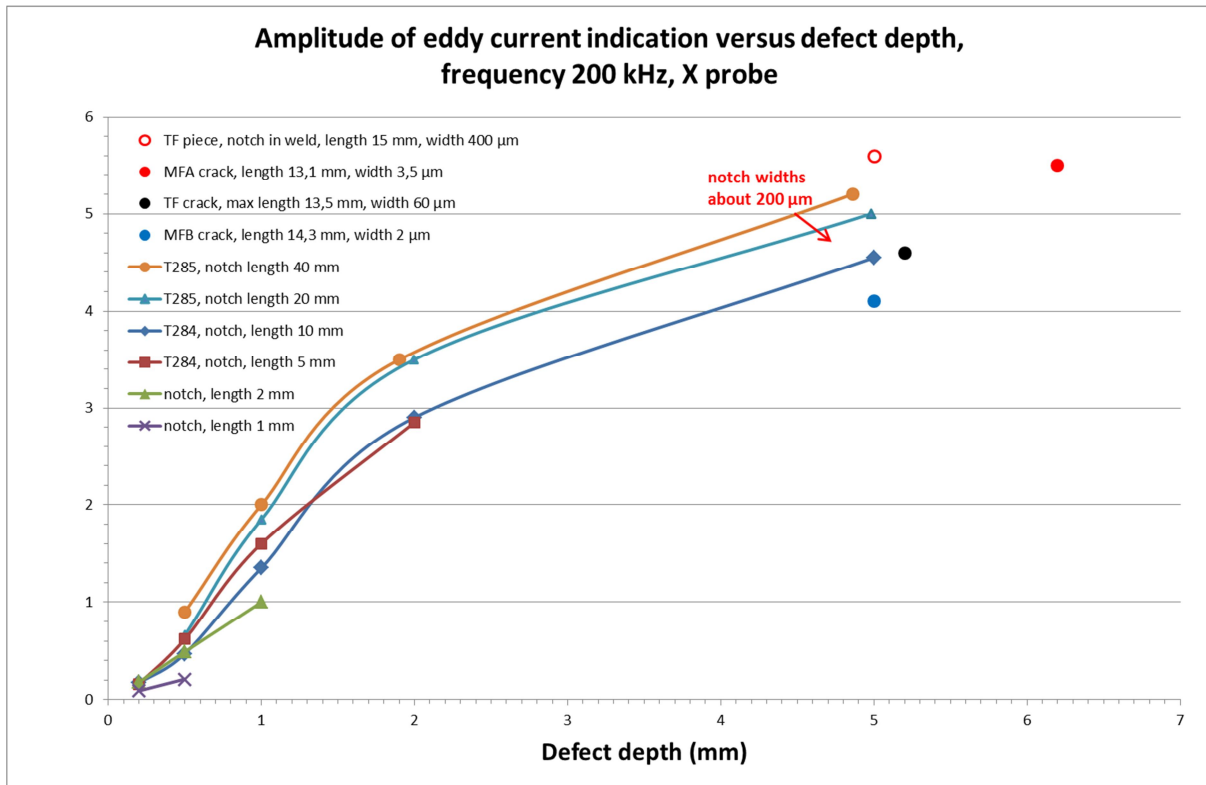
Figure 22. Amplitude of eddy current indications of TF and MF crack and notches versus defect depth, when X probe was used. The studied test pieces were TF, MF, T284 and T285. The eddy current frequency was 200 kHz.

The amplitudes of all indications of fatigue cracks and notches of the test pieces MF, TF, T284 and T285 recorded with the X probe are given in **Figure 23**. The applied frequency was 200 kHz. The amplitudes of the indications of 40 mm and 20 mm long notches were practically the same. The amplitude of the indication of the EDM notch (5 x 12 mm) in the weld of the TF piece was higher than that of the longer EDM notch (5 x 20 mm) in the test piece T285. In all cases the amplitude of the indication due to this 5 mm deep and 12 mm long notch was higher than that of the three slightly deeper and longer fatigue cracks. The amplitude of the MF crack A was the highest of all crack indications. The applied technique can be used to size defect lengths, but not to size the depths deeper than 2 mm due to the increasing saturation of the amplitude of the indications when the defect depth exceeds 2 mm.

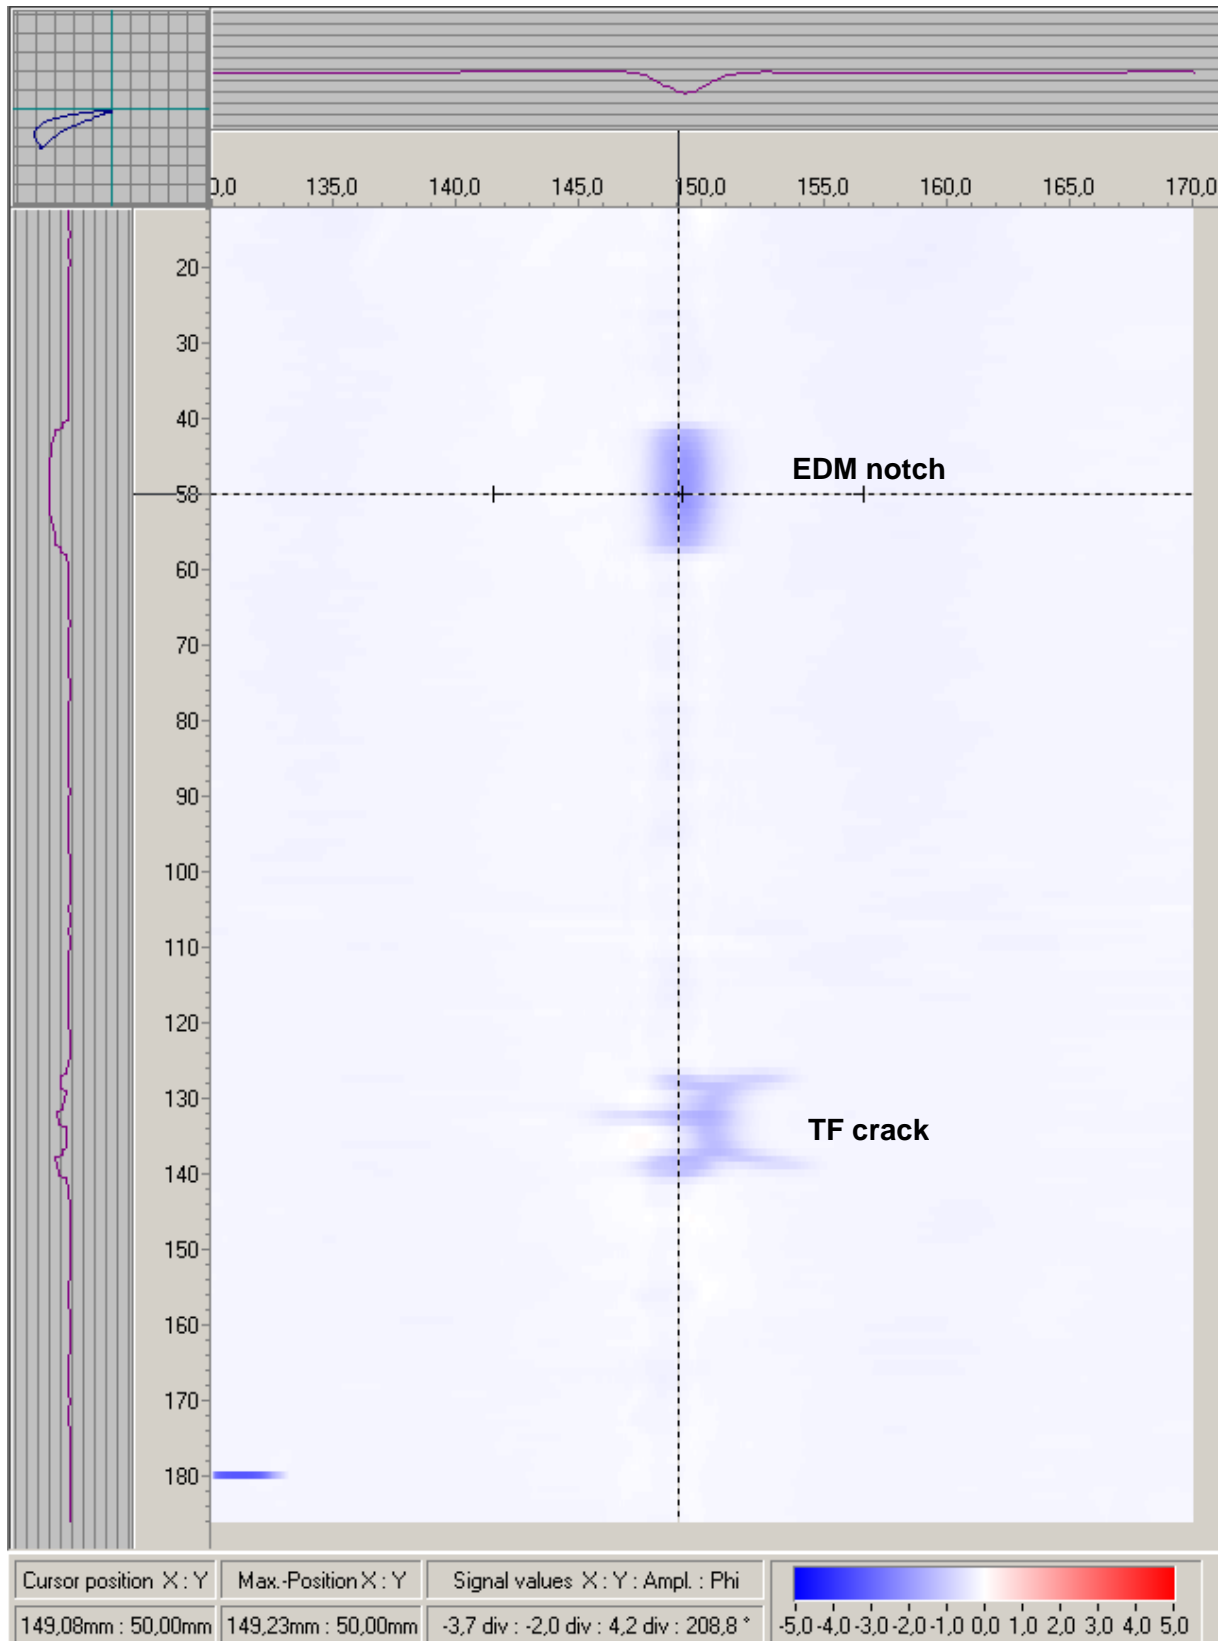
Figure 23a. C scan of the test piece TF (Y-component), small diameter absolute probe A-T-TS10-F4, frequency 100 kHz.

The C scans of TF and MF test pieces using absolute probe A-T-TS10-F4 and 100 kHz frequency are shown in **Figures 23 and 24**. In the C scans of the TF piece the Y component of the recorded eddy current signal is presented. The crack and notch can be clearly seen in **Figure 23a**. Even the five side branches of TF crack can be clearly seen. The weld line can be seen well in **Figure 23b**, where 20 dB additional gain was applied.

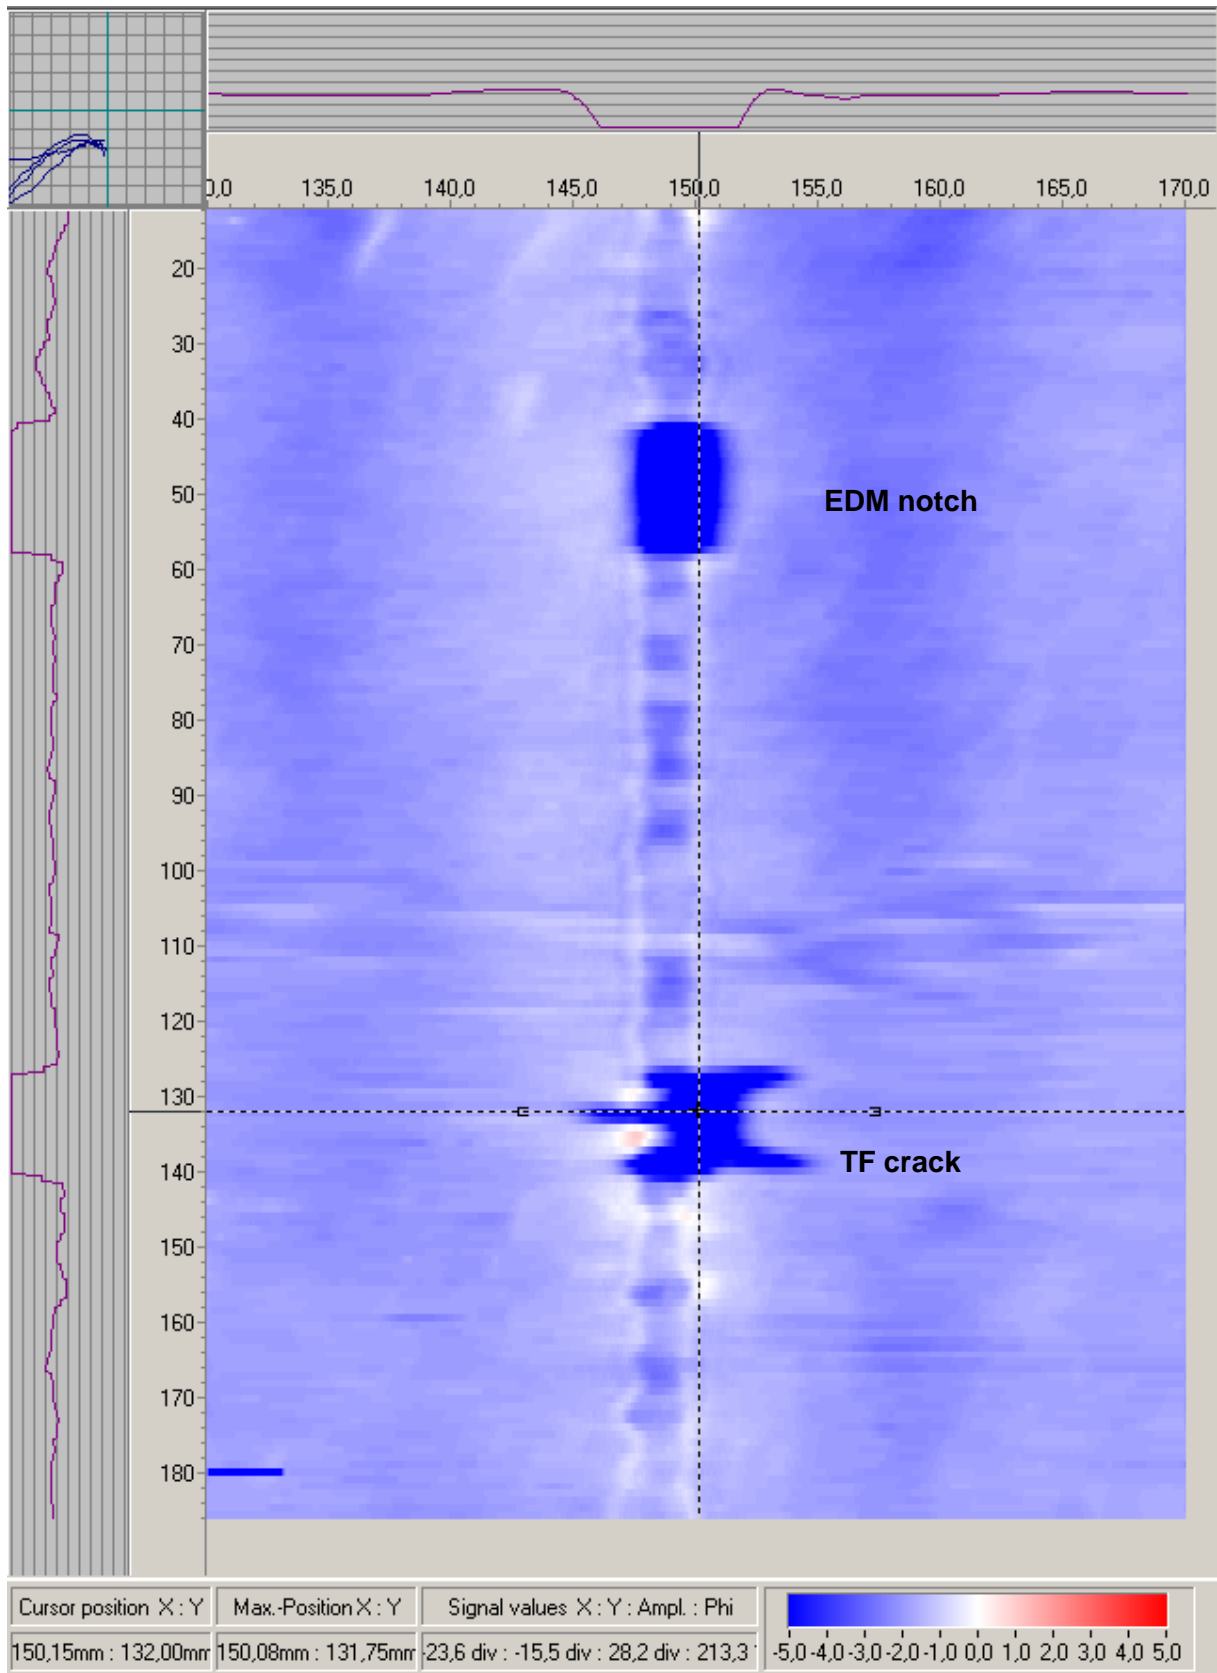
Figure 23 b. C scan of the test piece TF (Y-component), small diameter absolute probe A-T-TS10-F4, frequency 100 kHz, 20 dB additional gain was applied.

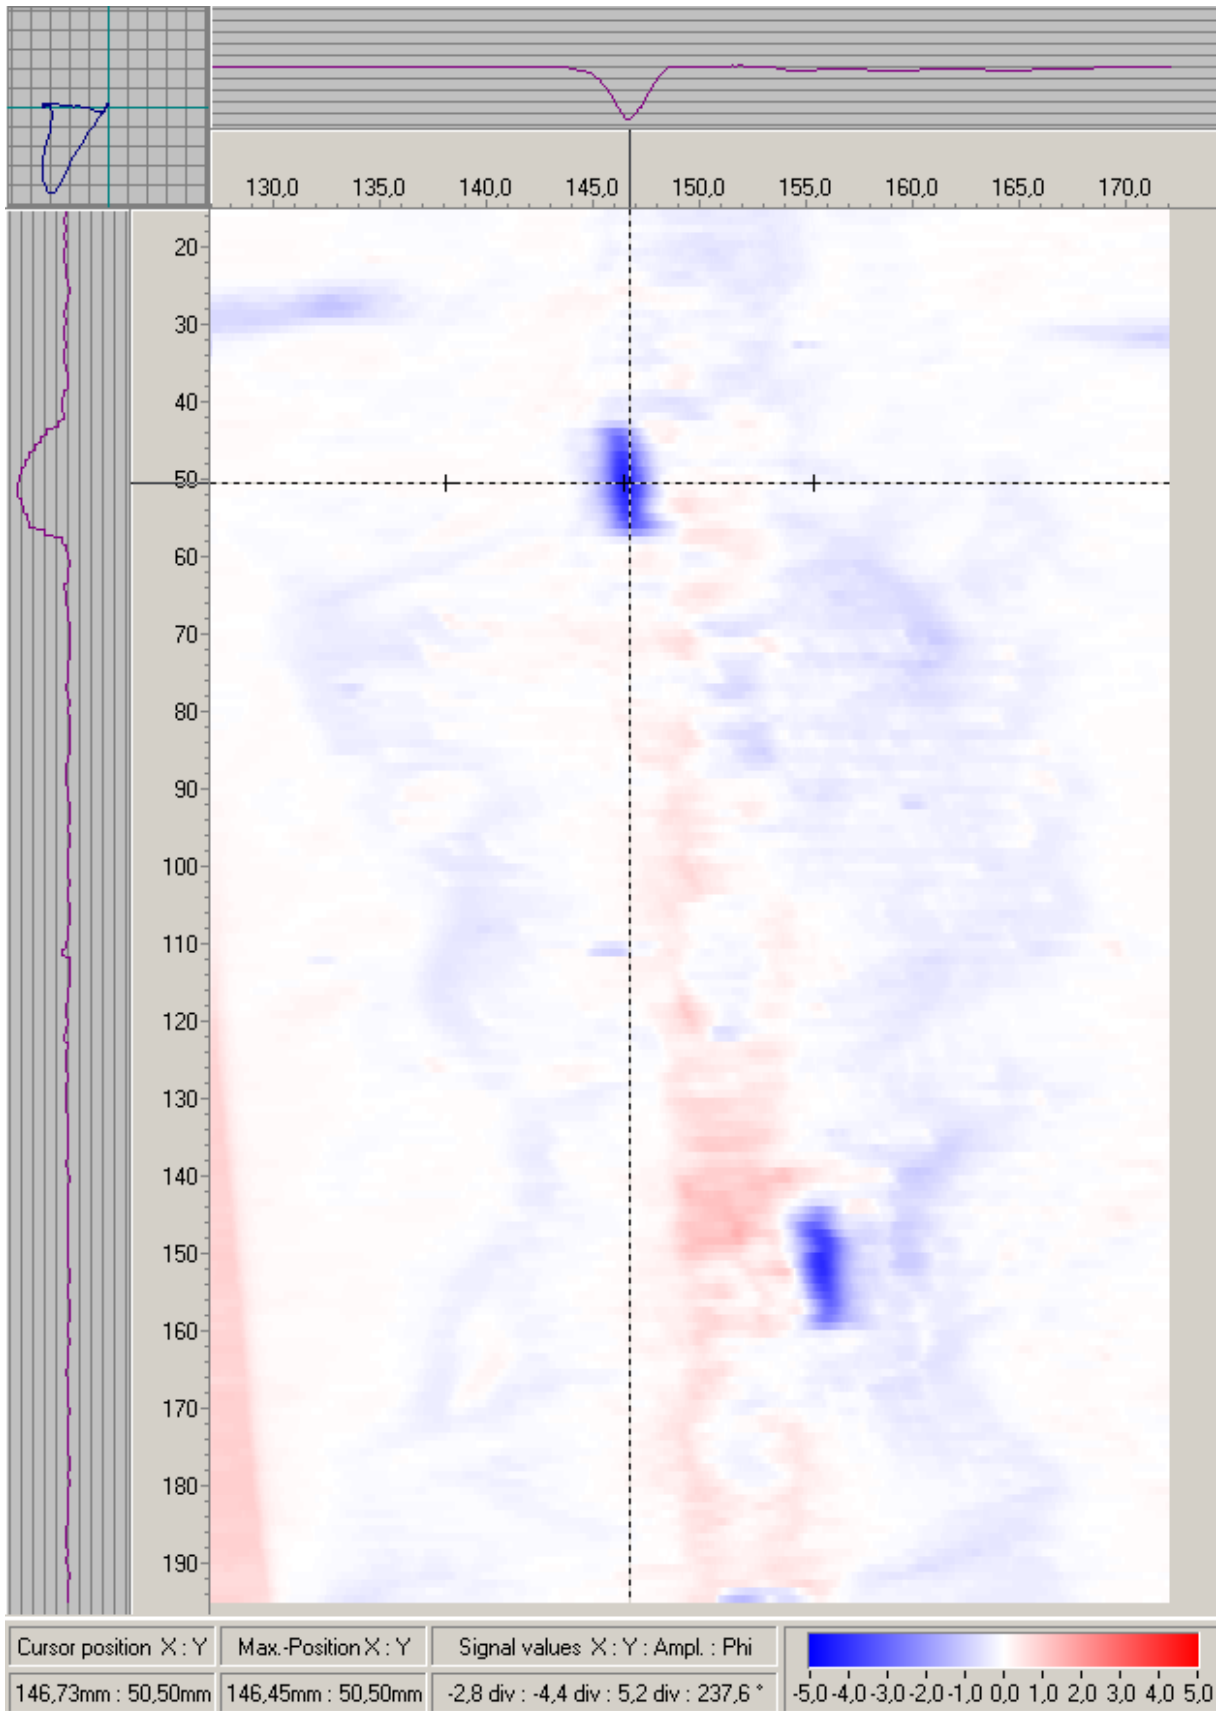
Figure 24a. C scan of the test piece MF (Y-component), small diameter absolute probe A-T-TS10-F4, frequency 100 kHz, 10 dB additional gain was applied for Y.

The indications of the fatigue cracks A and B can in the MF test piece be seen easily in **Figure 24 a**. The weld line can be seen and the additional welds needed in defect fabrication and implanting can also be easily seen in **Figure 24 b**. Here the scanning direction during data acquisition was not exactly perpendicular to the weld line. For this reason the indications of the weld and defects in the C scan of test piece MF (**Figure 24 a and b**) are slightly tilted in respect to index axis (vertical axis).

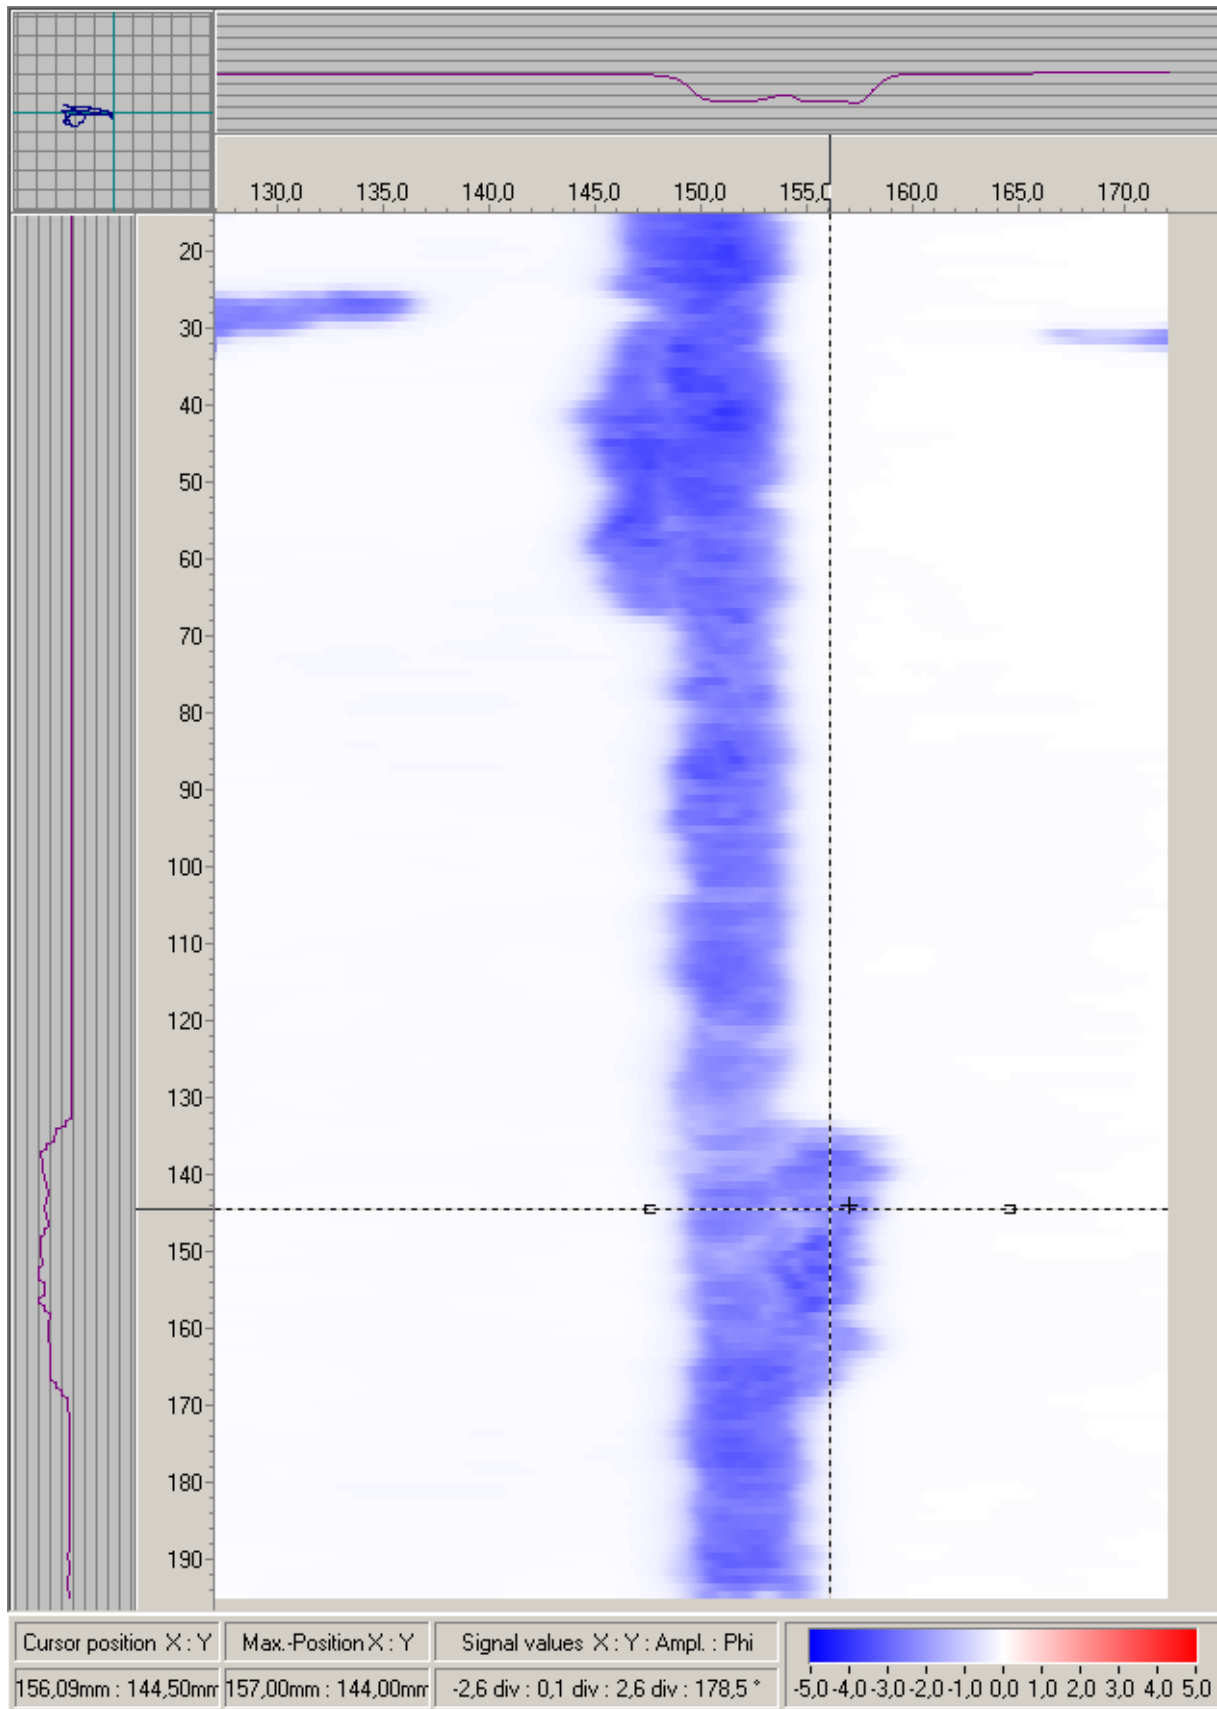
Figure 24 a. C scan of the test piece MF (X-component), small diameter absolute probe A-T-TS10-F4, frequency 100 kHz.

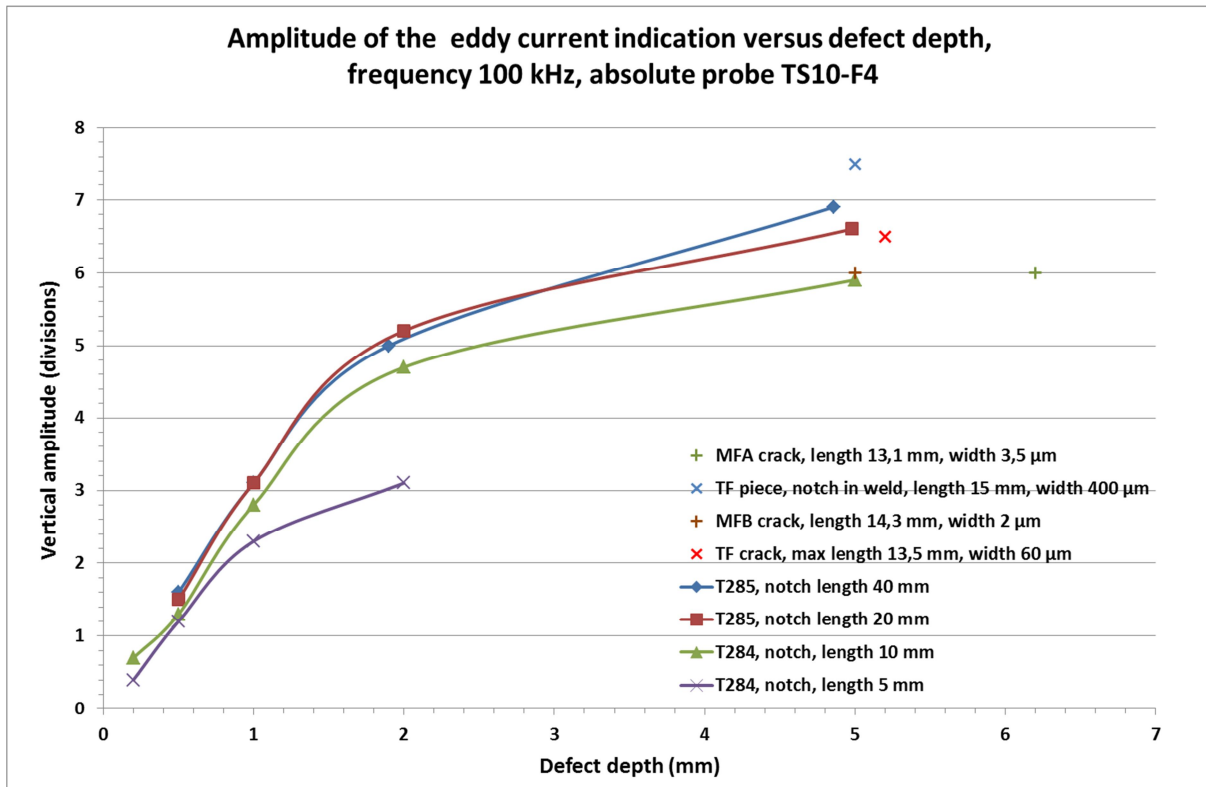
Figure 26. Amplitude of eddy current indications of TF and MF cracks and notches versus defect depth, when absolute probe A-T-TS10-F4 was used. The studied test pieces were TF, MF, T284 and T285. The eddy current frequency was 100 kHz.

The amplitudes of all indications of fatigue cracks and notches of the test pieces MF, TF, T284 and T285 recorded with the A-T-TS10-F4 are given in **Figure 26**. The applied frequency was 100 kHz. The amplitudes of the indications of 40 mm and 20 mm long notches were practically the same. The amplitude of the indication of the EDM notch (5 x 12 mm) in the weld of the TF piece was higher than that of the longer EDM notch (5 x 20 mm) in the test piece T285. The amplitude of the indication due to this 5 mm deep and 12 mm long notch was equal to the one of MF crack. The amplitude of the MF crack A was the highest of all crack indications.

The applied technique can be used to size defect lengths, but not to size the depths deeper than 2 mm due to the increasing saturation of the amplitude of the indications when the defect depth exceeds 2 mm.

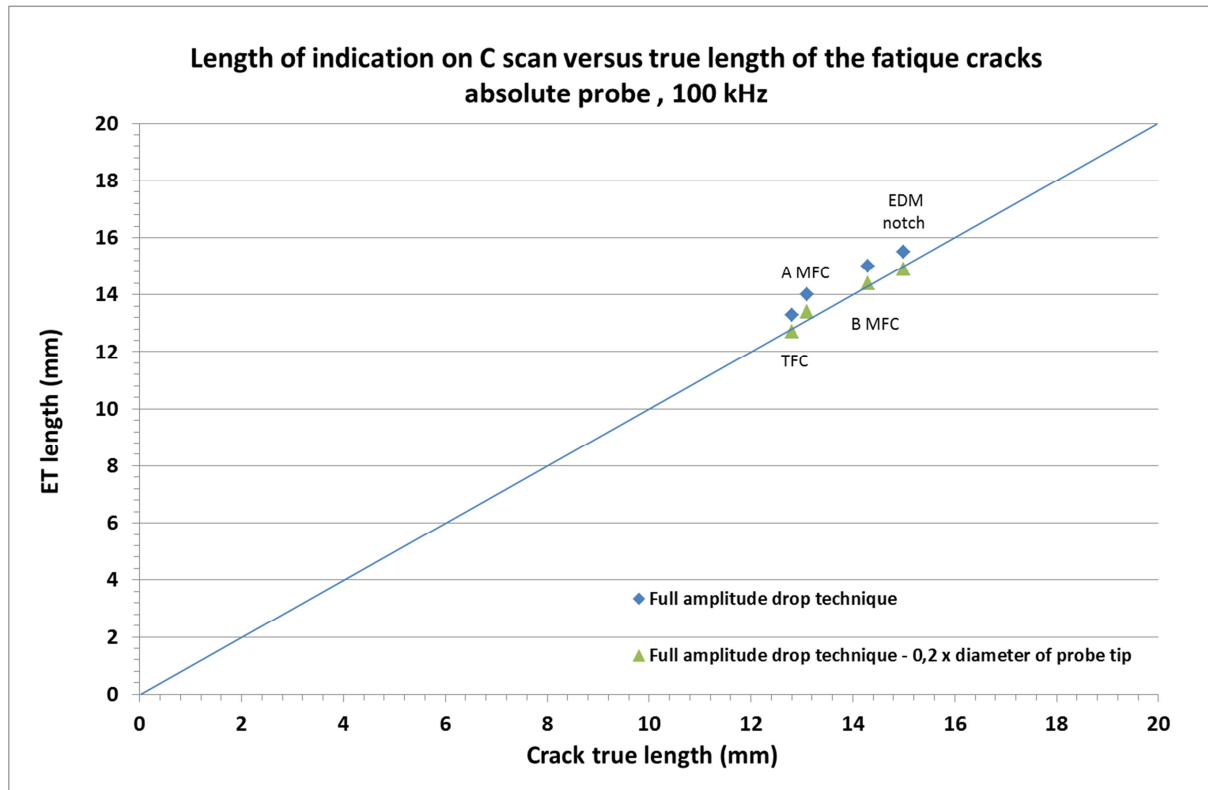
Figure 27. ET defect length versus true defect length of TF and MF cracks and an EDM notch, when absolute probe A-T-TS10-F4 was used. The eddy current frequency was 100 kHz.

Pencil probes can be used to size the length of the cracks. **Figure 27** shows the “ET lengths” of the three studied cracks and the EDM notch in the TF piece. Several different criteria can be applied when sizing the length of the crack. Here the full amplitude drop technique was used to size the crack lengths (blue dots in **Figure 27**). This sizing technique slightly oversized the length of the cracks. More accurate results will be achieved if $0.2 \times$ diameter of the probe dip is subtracted from the length measured with the full amplitude drop technique (green dots in **Figure 27**).

This kind of family of curves can be used to size the defect depth, if the length of the defect has been measured by small diameter pencil probe, see **Figure 27**. This is demonstrated in **Figure 32**, which includes a family of amplitude versus depth curves and the amplitudes and lengths of the TF crack and the two MF cracks.

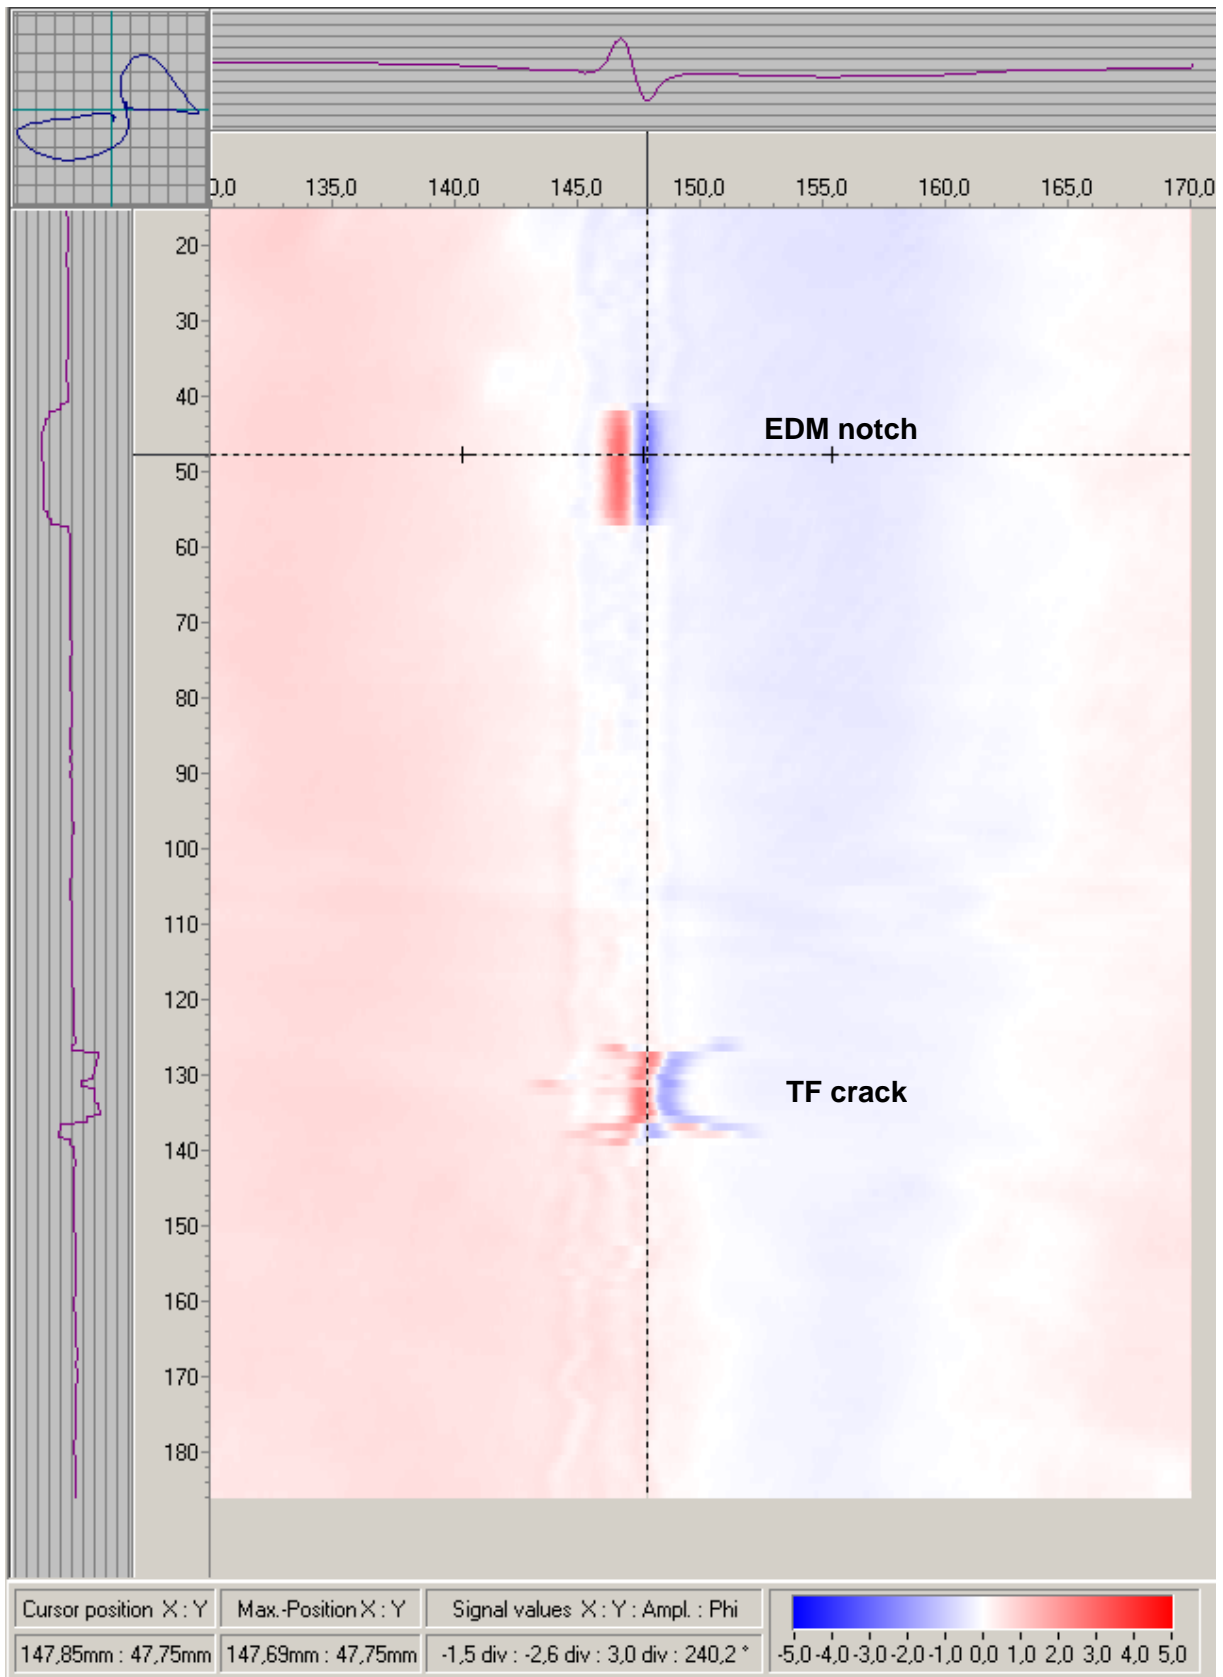
Figure 28. C scan of test piece TF (Y-component), small diameter differential probe A-T-TS10-F4, frequency 500 kHz.

The TF test piece was scanned using differential probe TMT DP21 and 500 kHz frequency. The C scan is shown in **Figure 28**. In the C scan the Y component of the recorded eddy current signal is presented. The indications of the large notch and fatigue crack can be easily detected. Even all five side branches of TF crack can be seen. The crack, notch and weld indications are shown in **Figure 29**. The Y-coordinate of the amplitude of the TF crack indications exceeded the maximum weld indication by 16 dB. This technique was not used to scan the MF test piece due to higher noise around the MF cracks.

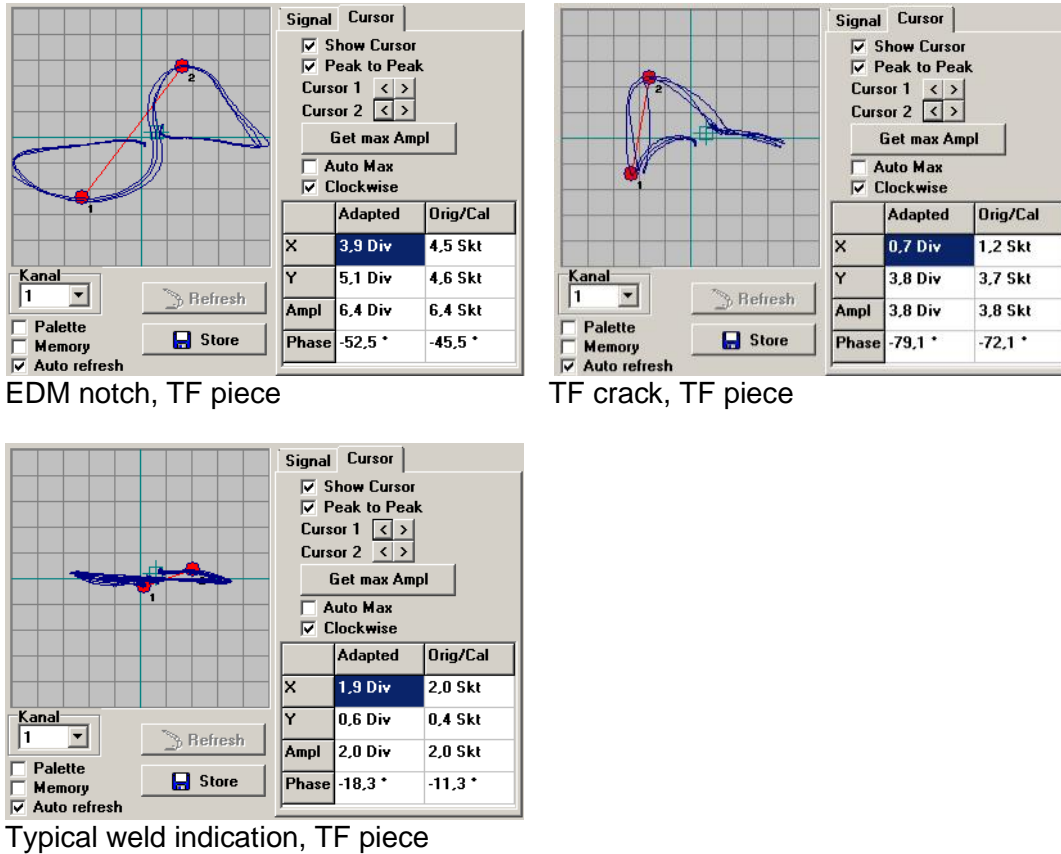
Figure 29. Impedance plane presentations of indications of a notch, fatigue cracks and welds in TF test piece, when differential pencil probe TMT DP21 was applied, frequency 200 kHz.

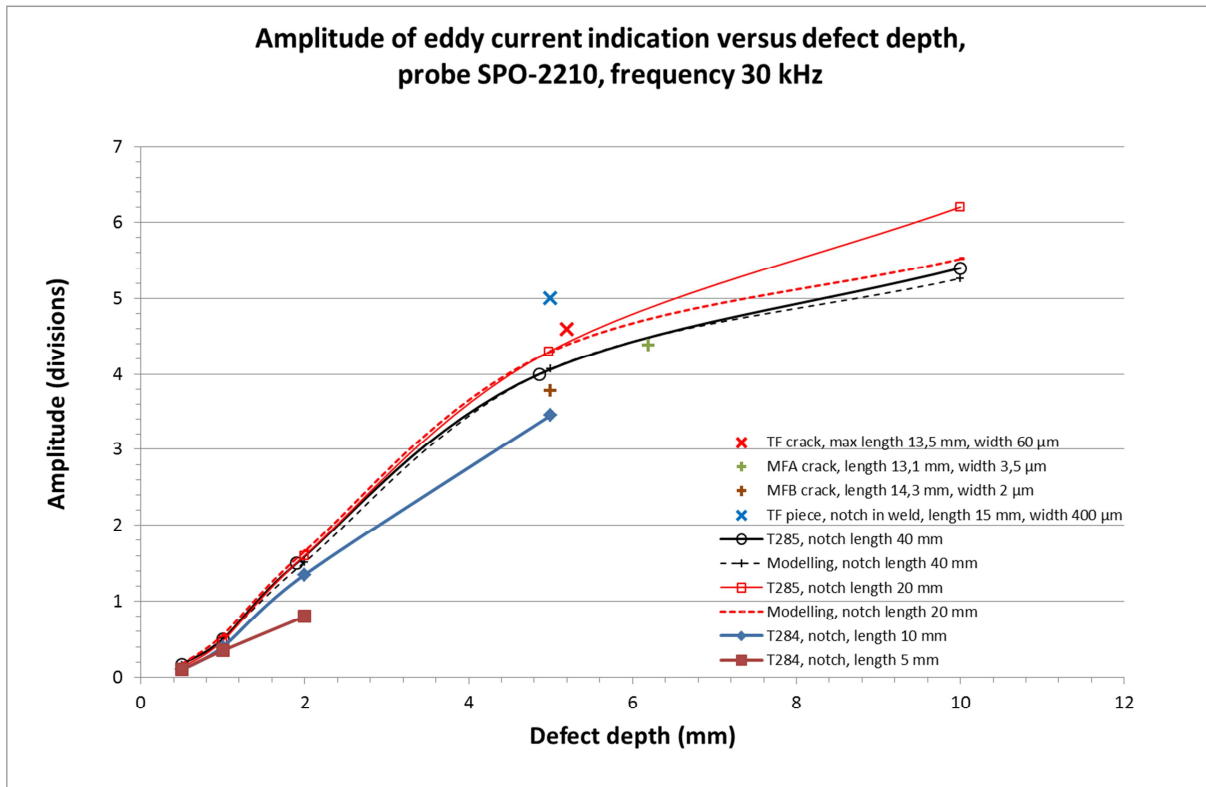
Figure 30. Amplitudes of measured and simulated eddy current indications of EDM notches versus defect depth, the measured amplitudes of TF and MF cracks are also included. Here the maximum length of MFA crack is given.

In simulation of the widths of the 1 mm, 2 mm, 5 mm and 10 mm deep notches were 60 μm , 100 μm , 200 μm and 400 μm respectively. In **Figure 30** there is an example where a family of solid curves present the measured amplitudes as a function of defect depth and a family of dotted curves present amplitudes generated in the ET simulation. The same results of measurements were presented also in **Figure 16**. The amplitudes of simulated indications were “calibrated” by using the measured amplitudes of 40 mm long notches. After “calibration” the amplitudes of simulated indications fit quite well with the measured amplitudes except in the case of 10 mm deep and 20 mm long notch. The reason for this deviation is not fully understood.

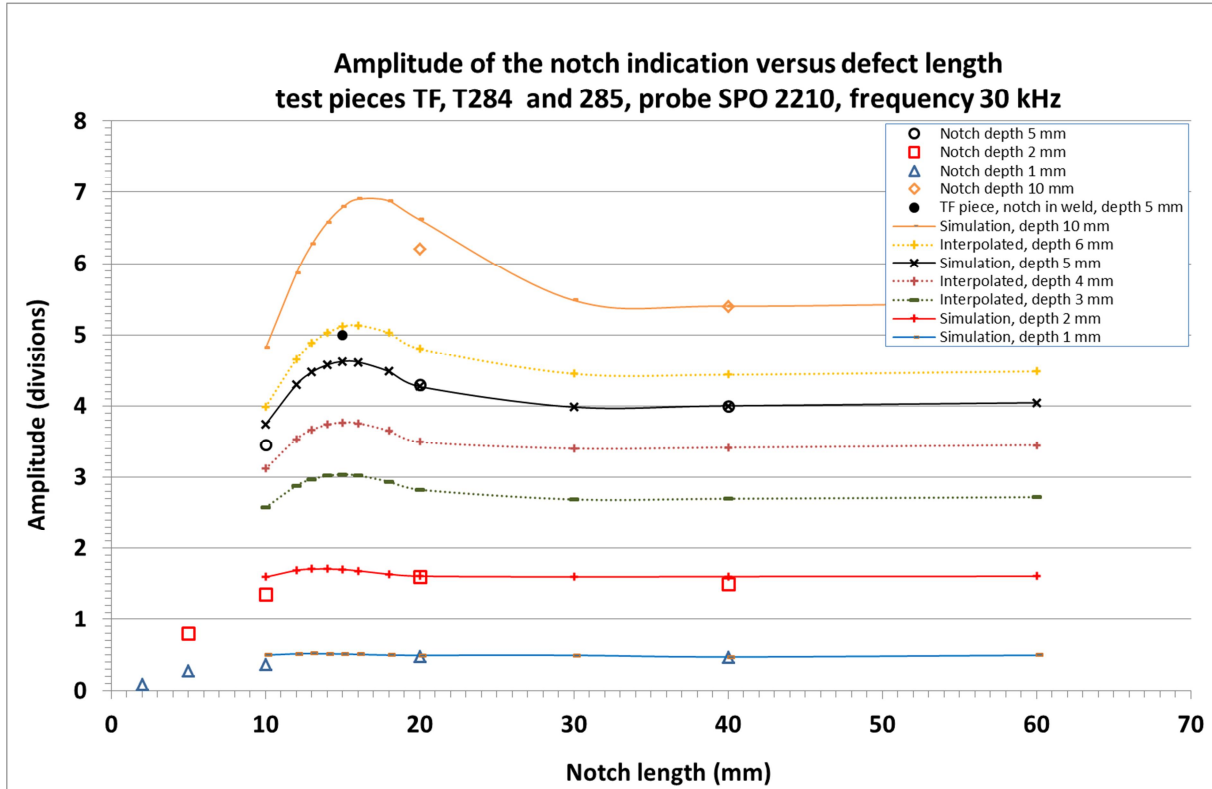
Figure 31. Open marks: the measured amplitudes of the indications due to notches of different length and depth. Solid lines: amplitude versus defect length calculated by Siva simulation program. Dotted lines: amplitude versus defect length interpolated values.

Figure 31 shows the amplitudes of measured and simulated indications of EDM notches as a function of defect length. There open marks present the true amplitudes of the indications of notches in the test pieces T284 and T285 and in test piece TF. The solid lines present the results of simulation (brown, black, red and blue lines). The results of simulation have been scaled using the amplitude of 40 mm long notches. The dotted lines present the interpolated values. In interpolation the values achieved by simulation were applied. Surprisingly the amplitudes of the indications have clear maximum, when the defect length is about 15 mm.

software were used to generate the family of calibration graphs shown in **Figure 31 and 32**. The depths of the fatigue cracks were estimated using these graphs. As shown in **Figure 33** the accuracy in sizing the depth of TF crack was good in spite of the five side branches. The depths of the two MF crack were underestimated about 20% - 23%. One reason for the underestimation might be the small opening of the MF cracks (3.5 μm and 2 μm) compared to the EDM notches used as reference defects even if the opening of notches was taken into account in simulation. The width of EDM notches used to generate the calibration graphs varied from 60 μm up to 440 μm depending on the depth of the EDM notch. The deeper the notch the higher was the notch width. The success in sizing of TF crack, which was also narrow compared to EDM reference notches, might be due to the additional branches which may boost the eddy current indications of the TF crack.
