RESEARCH REPORT

Sizing of fatigue cracks using different eddy current techniques and simulation

Author: Kari Lahdenperä

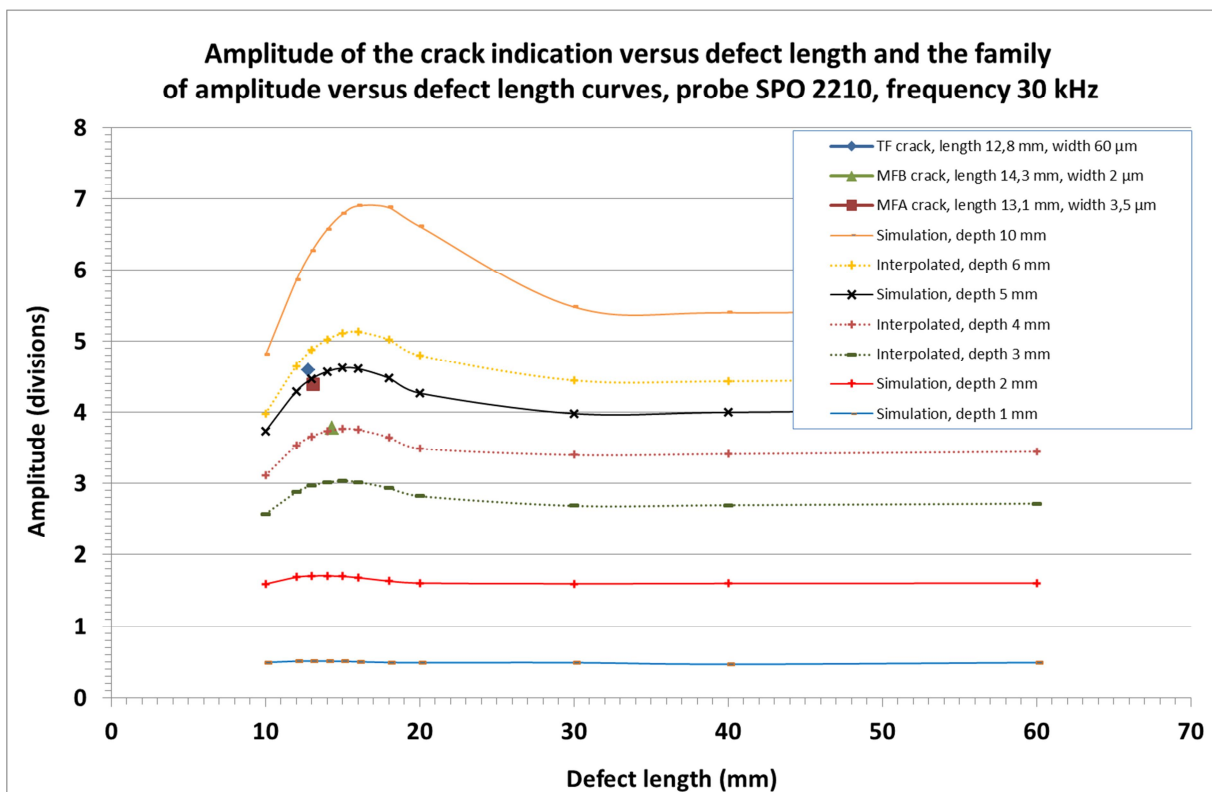
Figure 32. A family of amplitude versus defect length curves and the amplitude and the length of the studied TF and MF cracks.

This kind of family of curves can be used to size the defect depth, if the length of the defect has been measured by small diameter pencil probe, see **Figure 27**. This is demonstrated in **Figure 32**, which includes a family of amplitude versus depth curves and the amplitudes and lengths of the TF crack and the two MF cracks.

software were used to generate the family of calibration graphs shown in **Figure 31 and 32**. The depths of the fatigue cracks were estimated using these graphs. As shown in **Figure 33** the accuracy in sizing the depth of TF crack was good in spite of the five side branches. The depths of the two MF crack were underestimated about 20% - 23%. One reason for the underestimation might be the small opening of the MF cracks (3.5 μm and 2 μm) compared to the EDM notches used as reference defects even if the opening of notches was taken into account in simulation. The width of EDM notches used to generate the calibration graphs varied from 60 μm up to 440 μm depending on the depth of the EDM notch. The deeper the notch the higher was the notch width. The success in sizing of TF crack, which was also narrow compared to EDM reference notches, might be due to the additional branches which may boost the eddy current indications of the TF crack.

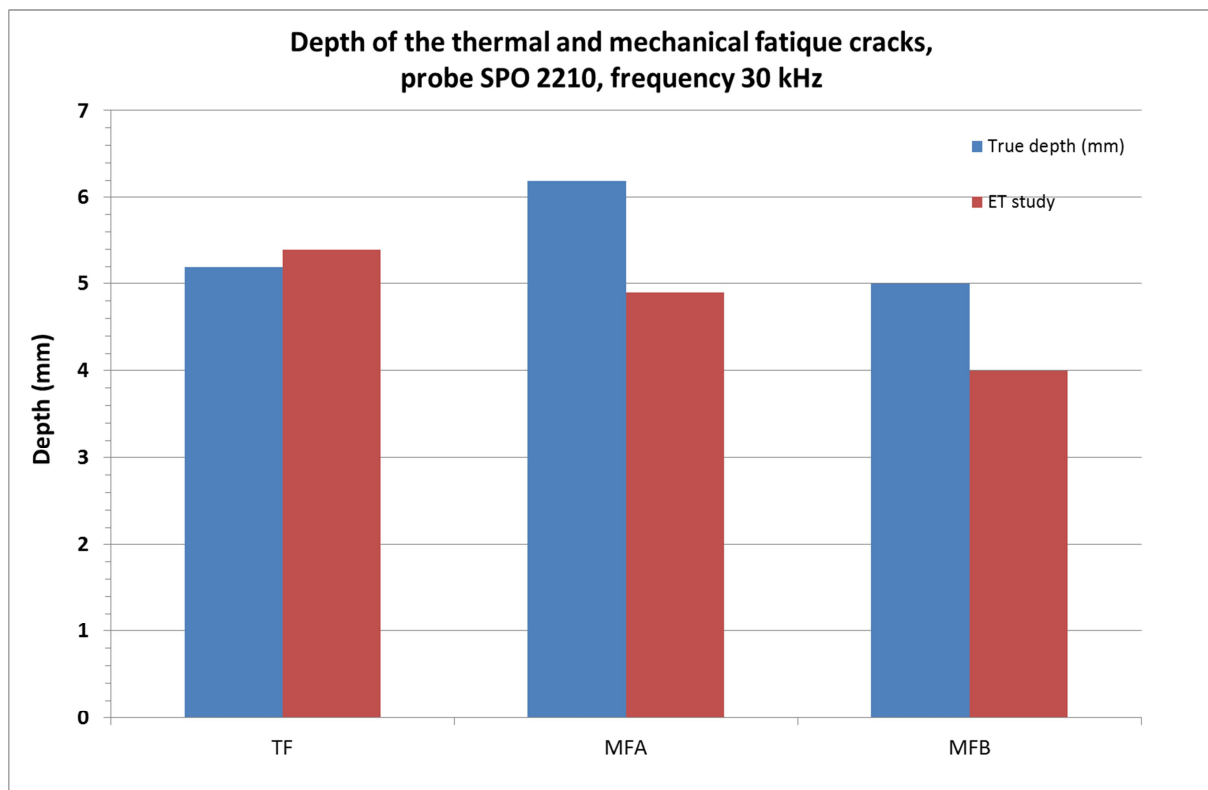
Figure 33. Estimated depth of TF and MF cracks, estimation is based on the length sized the absolute probe A-T-TS10-F4 and the amplitudes measured by the probe SPO 2210 (frequency 30 kHz) and amplitudes calculated by Civa simulation software.

The results of measurements with the probe SPO 2210 and simulation of the measurement with the probe SPO 2210 in sizing the depths of the fatigue cracks are given in **Figure 33**. The depth of TF crack was estimated well in spite of the five side branches. The depths of the MF crack were underestimated about 20%. One reason for the underestimation might be the small opening of the MF cracks (3.5 μm and 2 μm) compared to the EDM notches used as reference defects. The width of EDM notches varied from 60 μm up to 440 μm depending on the depth of the EDM notch. The success in sizing of TF crack which was also narrow compared to EDM reference notches may be due the additional branches which may boost the eddy current indications of the TF crack.

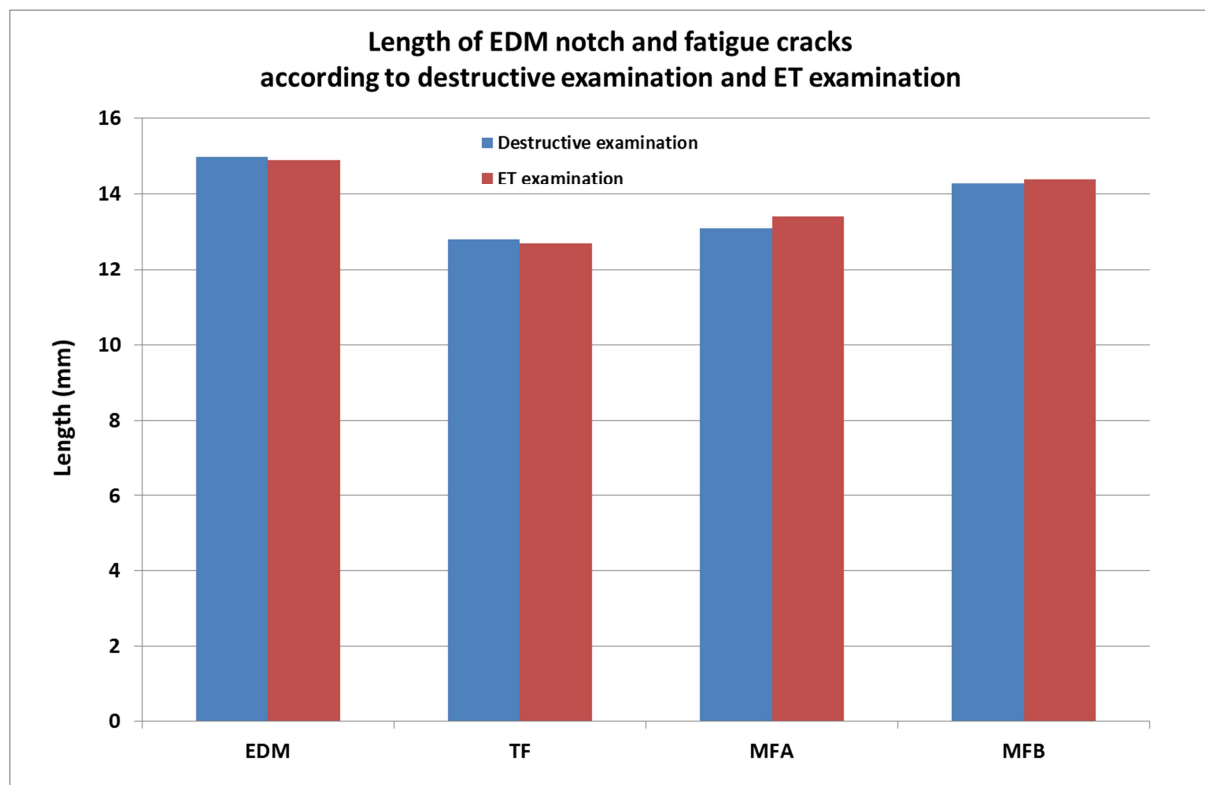
Figure 33. The DT and ET lengths of an EDM notch and three fatigue cracks, the full amplitude drop technique with correction was applied. The absolute pencil probe A-T-TS10-F4 was used. The eddy current frequency was 100 kHz.

The error in length sizing was smallest when small diameter pencil probes were used. In length sizing the full amplitude drop technique was used. The applied eddy current transducer was the small diameter absolute pencil probe A-T-TS10-F4. The accuracy in length sizing was surprisingly good, see Figure 27. The best results were achieved after minor correction based on the diameter of the probe tip was conducted. The length error was only from -0.1 mm to 0.3 mm, when this correction was applied. The general shape of all cracks (and EDM notch) was similar (cracks were nearly semi-circular). The depth length ratio of the cracks varied from 2.1 to 2.86. The depth of the crack increased abruptly at the ends of the cracks. For this reason it was quite easy to locate the ends of the crack with high repeatability. This is main reason for the exceptional good length sizing result.
