# Technical Assessment of NordicWay Coop Demonstration

Authors: Kimmo Kauvo, Sami Koskinen

<b>Report's title</b> Technical Assessment of NordicWay Coop Demonstration		
<b>Customer, contact person, address</b> Finnish Transport Agency, Ilkka Kotilainen		<b>Order reference</b>
<b>Project name</b> NordicWay, Coop, vaikuttavuustutkimus		<b>Project number/Short name</b> 106417 / NordicWay Evaluointi
<b>Author(s)</b> Kimmo Kauvo, Sami Koskinen		<b>Pages</b> 39
<b>Keywords</b> Technical evaluation, C-ITS, cellular communication, positioning		<b>Report identification code</b> N/A
<b>Summary</b> <p>This report presents the findings from a technical assessment made for a proof of concept implementation of a traffic information system within NordicWay project. The NordicWay project pilots cellular Cooperative ITS (C-ITS) services in a road network which extends from Denmark and Norway to Sweden and Finland. The proof of concept demonstration targeted the Finnish implementation of the services. HERE and Infotripla supplied the technology and VTT carried out an assessment.</p> <p>Ten scenario tests were run during a single demonstration day, collecting log data from network servers and mobile

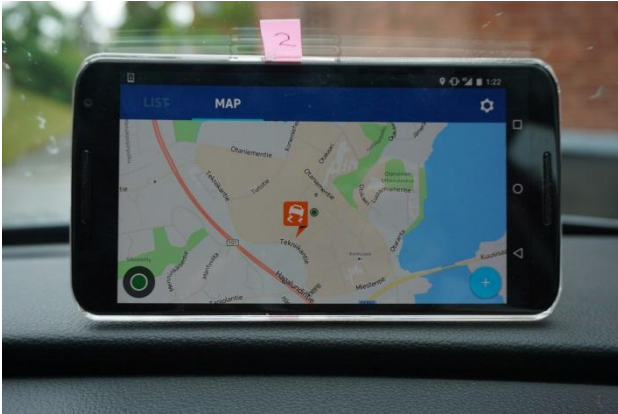
Figure 4 Informative icon was shown on a map

Regarding the common setup, the mobile phones were located during the scenarios either in subscription area A or B (Figure 6). Two subscription areas had been set up to test information broadcasting to correct mobile phones depending on the area they were in. If information was regarded to affect only users in subscription area A, users in subscription area B should receive no messages. Based on the received information, either an informative icon was shown on a map (Figure 4), or, if the user was at impact area or entering the impact area, a warning was given (Figure 5).

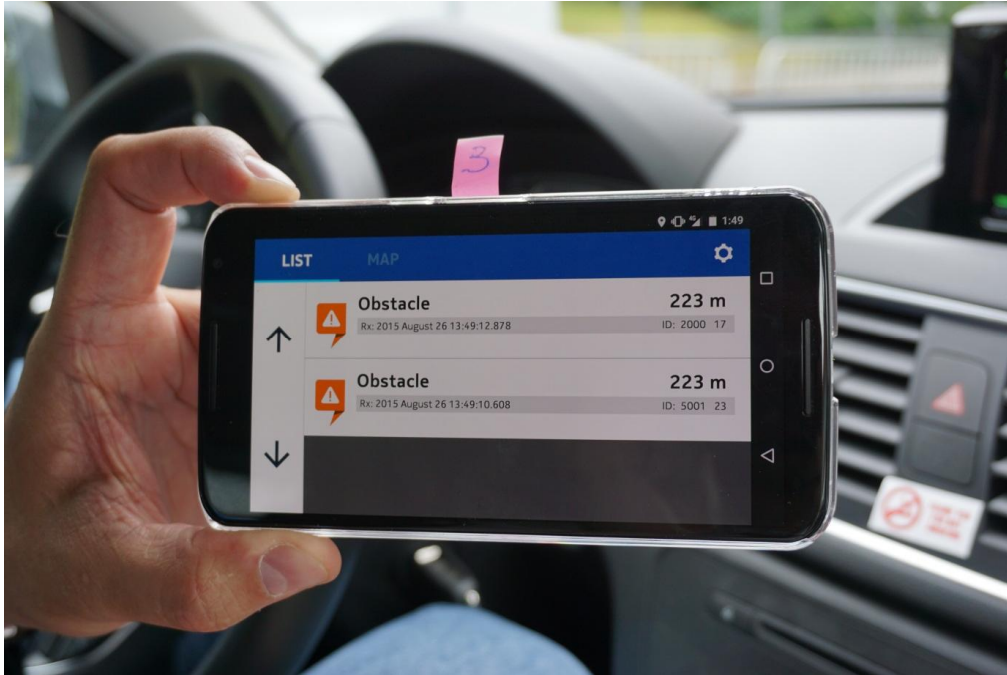
Figure 7. Acknowledge from short (HERE) and long loop (Infotripla) to a mobile phone initiated warning, therefore user sees two messages.

In the current implementation, the users received two separate messages (Figure 7): first the message sent by a user (short loop), then a separate message from Infotripla, confirming the observation (long loop). Showing both messages on screen does not represent the final plan but is a matter for further development. The plan is to modify the information quality bit of the initial message, confirming the observation and possibly raising its priority. Unconfirmed observations might be handled differently in the final HMI than those observations that are considered to be more reliable.

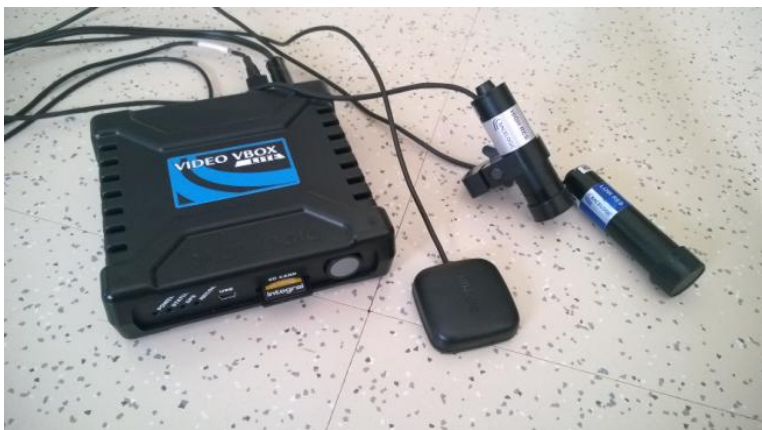
Figure 9. Video VBOX Lite

The system for video recording was the Video VBOX Lite by Racelogic, an in-car video system with the following features: accurate GPS logging at 10 Hz, 2 video camera inputs, SD card logging, rugged enclosure and customisable UI graphics.

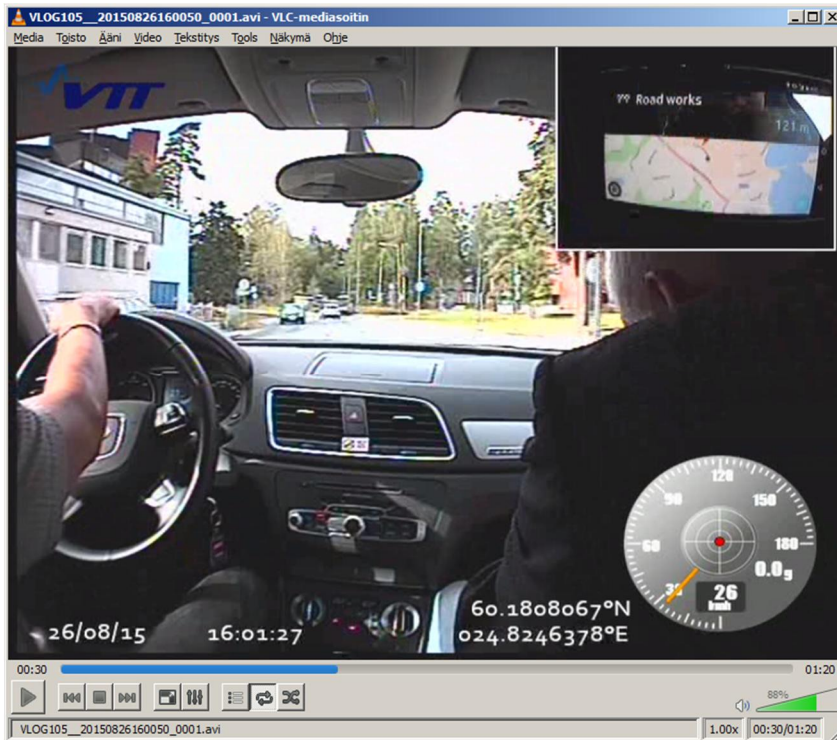
Figure 10. VBOX video with inlayed timestamp, coordinates, speed, acceleration and M5 user interface

Five video shots were recorded using the same procedure. One camera of the VBOX was recording the front view from the car and the second camera was recording the mobile user interface. GPS time, coordinates, speed and acceleration were inlayed on the video.

The VBOX had an old firmware and therefore the GPS time was not the same as the NTP time (~15 s off). Snapshots of these videos were compared to the QGIS application at the moments of show/dismiss icon.

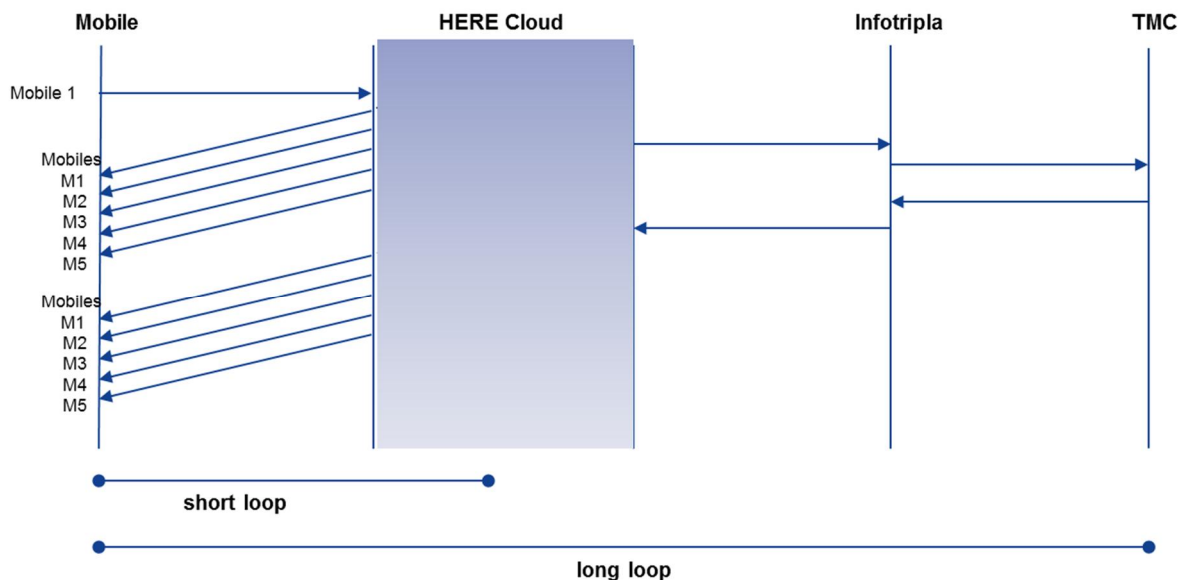
Figure 13 Short loop and long loop sequences

Figure 13. depicts the idea of the short and long loops and Figure 14 figure shows a worked out full timeline from scenario 3B to illustrate the magnitude of different delays in the process.
