A REVIEW OF AERONAUTICAL FATIGUE INVESTIGATIONS IN FINLAND MARCH 2015 - MARCH 2017

Presented at the 35th Conference of the
International Committee on Aeronautical Fatigue and
Structural Integrity (ICAF),
Nagoya, Japan, 5-6 June 2017

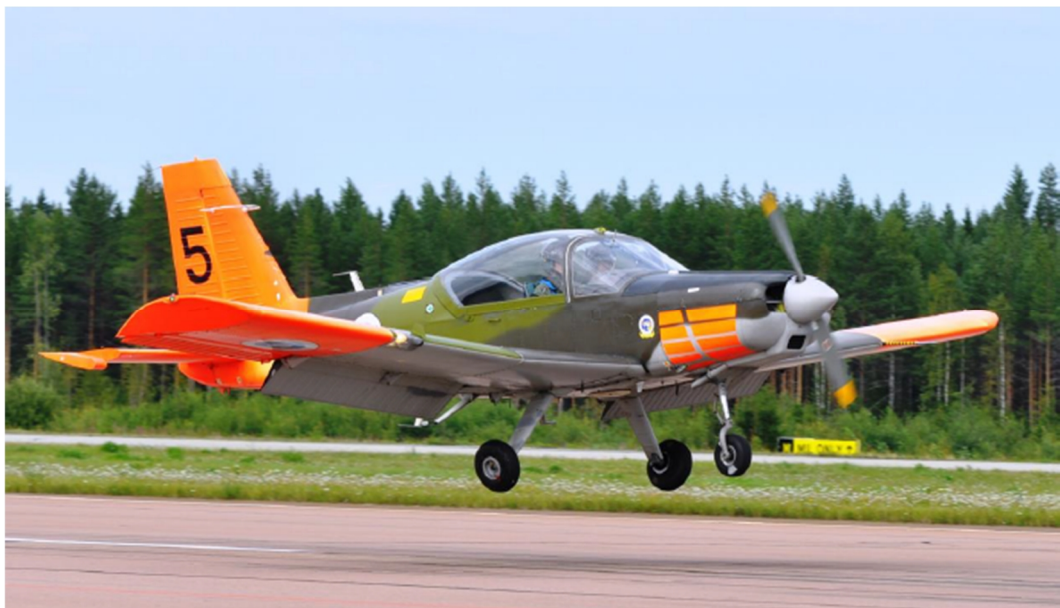
The Valmet L-70 Vinka is a three-seat piston-engine aircraft of Finnish design and manufacture (Figure 3). The Vinka is used by the FINAF in a primary training role since 1980 to teach basic flying skills to military pilots. Due to its long service life the Vinka has undergone several minor structural reinforcements and other modifications. 27 of the original 30 Vinkas remain in service with the FINAF. The German Grob G 115E will replace the Vinka aircraft in the primary and basic training role (Ref. Chapter 1.2). According to the FINAF’s current plans the Vinkas planned withdrawal date is 2018. [1]

Figure 3: Valmet L-70 Vinka primary trainer aircraft. Figure by courtesy of the FINAF.

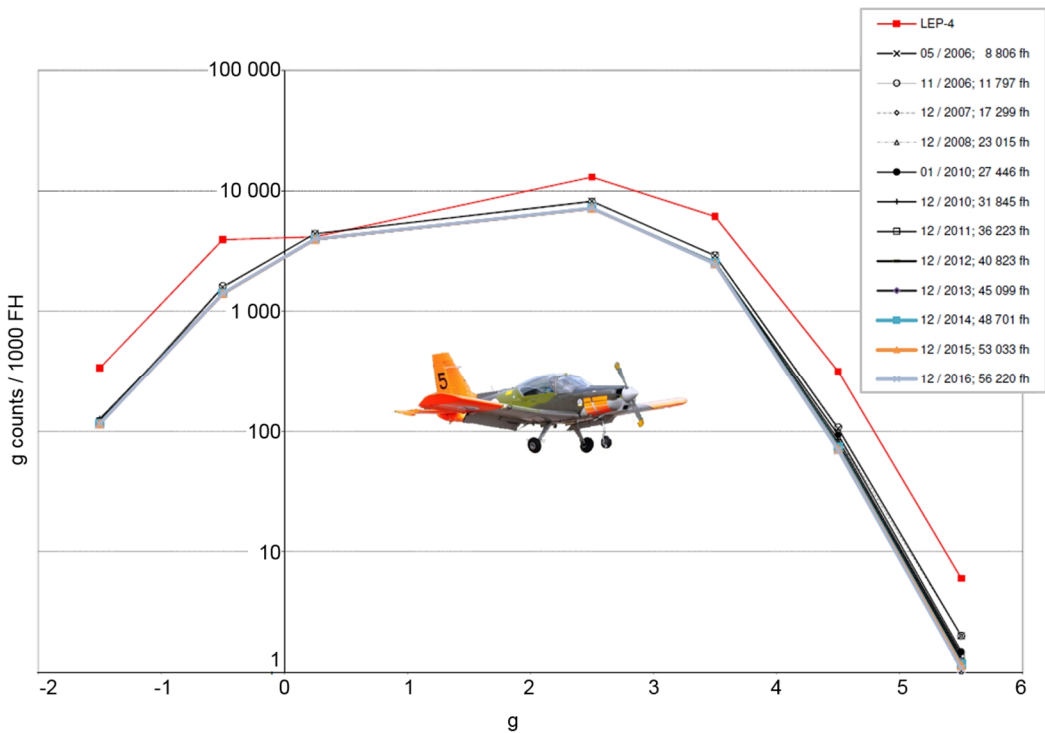
Figure 4: The g counts per 1000 FH of the Valmet Vinka. From top to bottom: The spectrum representing the LEP design assumptions (LEP-4); the post LEP g counter spectrum as of May 2006; as of November 2006; as of December 2007; as of December 2008; as of January 2010; as of December 2010; as of December 2011; as of December 2012; as of December 2013; as of December 2014; and the updates from the previous review: as of December 2015; as of December 2016 including a total of 56 220 FH. All curves (excluding the red LEP-4) represent the fleet average from all Vinkas, as ranked according to the aircraft center of gravity normal acceleration. Figure by courtesy of Patria Aviation.

Based on the g counter information, the aircraft are in good structural condition with regard to the flight hours. The severity of usage in view of the g counter status is more benign than that used as the basis of LEP analyses and tests, see Figure 4.

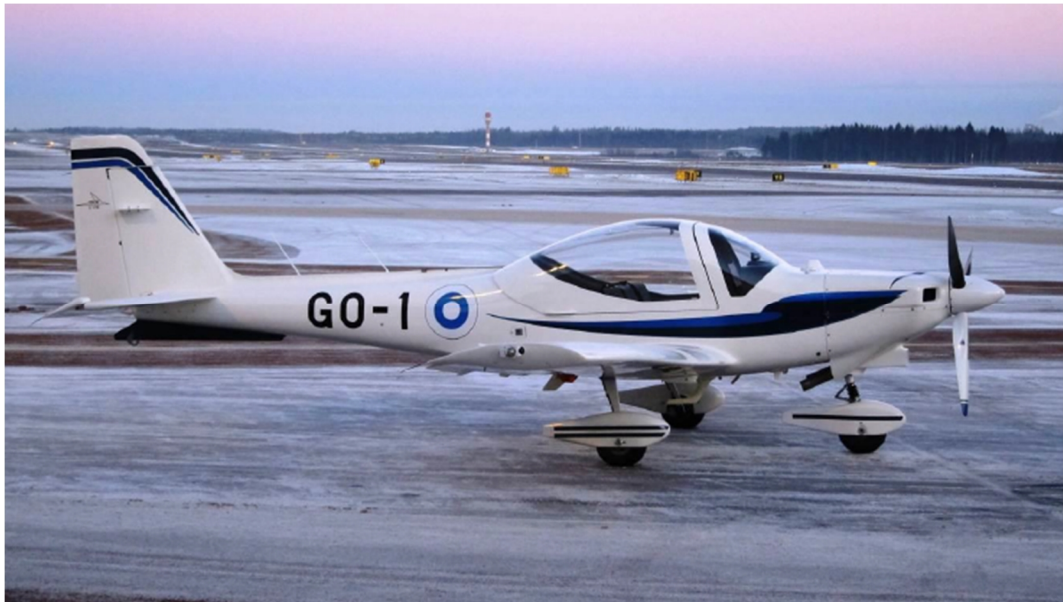
On the contrary to its successors (Vinkas), the structure of Grob G 115E is manufactured of composite materials. It is constructed predominantly from carbon fiber reinforced composites, has a tapered low wing, a 180 hp engine with a 3-bladed variable-pitch propeller, a fixed tricycle undercarriage, fixed horizontal and vertical stabilizers and conventional flight control surfaces (Figure 5)

Figure 5: Grob G 115E primary trainer aircraft. Figure by courtesy of the FINAF.

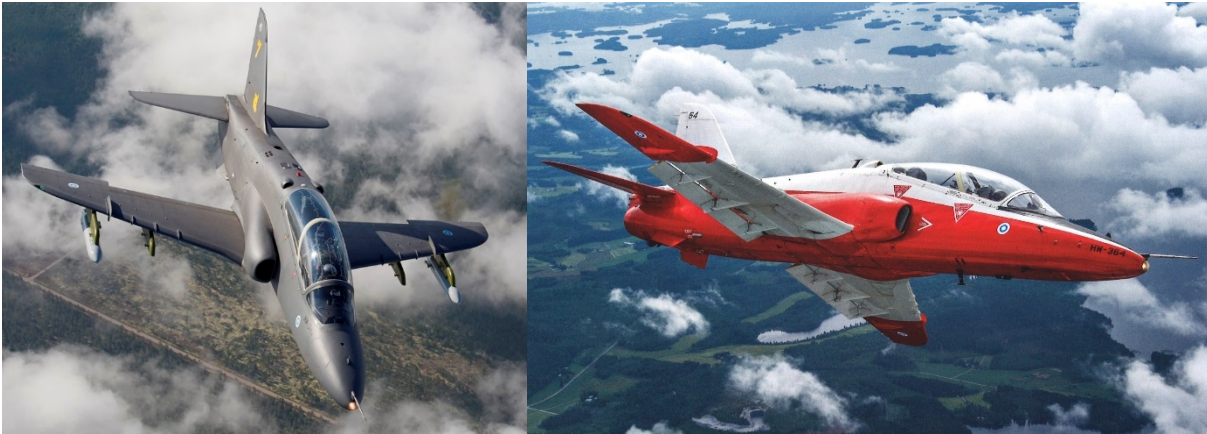
The BAE Systems Hawk is a British single-engine two-seat jet trainer which is operated in Finland by the Air Force Academy in advanced and tactical training roles. The first Hawks, Mk.51s, entered Finnish service in 1980-1985. In 1993, the FINAF ordered an additional batch of seven Hawk Mk.51As that contain minor improvements in structure and avionics compared with the Hawk Mk.51. Finland augmented its Hawk fleet in 2007 by sourcing 18 low-hour Hawk Mk.66s from Switzerland. Externally, the former Swiss Hawks stand out from the grey legacy Hawks owing to their red-and-white paint scheme (see Figure 6). [1]

Figure 6: BAE Systems Hawk Mk.51A (left), and Mk.66 (right) advanced jet trainer. Figures by courtesy of the FINAF.

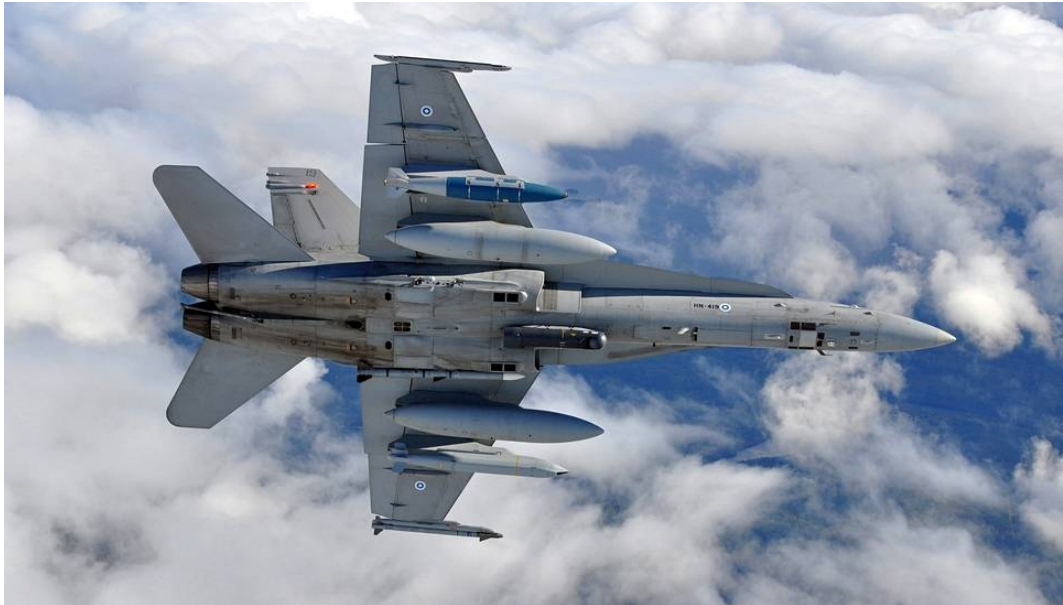
The Boeing F/A-18C (single seat) and F/A-18D (two seat) Hornet are twin-engine, mid-wing, carrier-capable, multirole jet fighters (see Figure 8), that form the nucleus of the Finnish air defence. The late-production Lot 17 aircraft entered Finnish service between 1995-2000. The Finnish two-seaters were built in the United States by McDonnell Douglas which later merged with Boeing, while the single-seat aircraft were assembled at the Patria Aviation facility in Finland. [1]

Figure 8: The Boeing F/A-18C Hornet multirole jet fighter. Figure by courtesy of the FINAF.

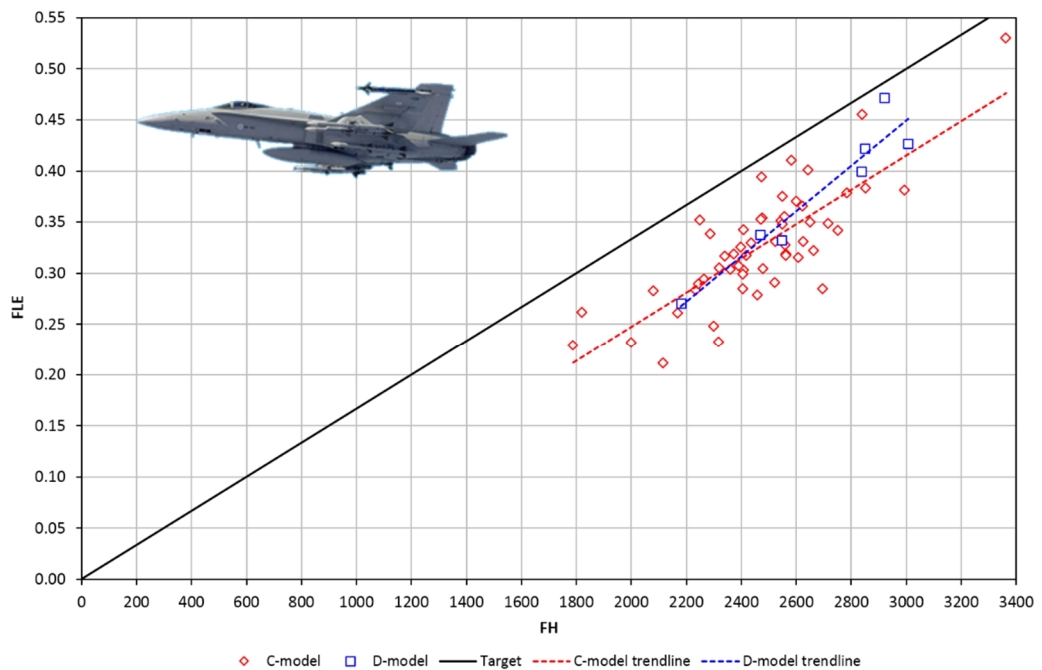
Figure 9: Summary of the left wing root fatigue life expended (LWR FLE) of the FINAF F/A-18C/D fleet at the end of 2016. The data is from all 62 aircraft included. The target is 4500 FH and 0.75 FLE simultaneously. Figure by courtesy of the Joint Systems Centre.

The severity of the Finnish usage in view of structural fatigue with the aircraft of noteworthy maneuvering capability can be seen in Figure 9 (Hornet). Figure 9 clearly demonstrates the need to maintain, further develop and apply concrete and systematic efforts to cope with the structural deterioration effects of these two aircraft types.

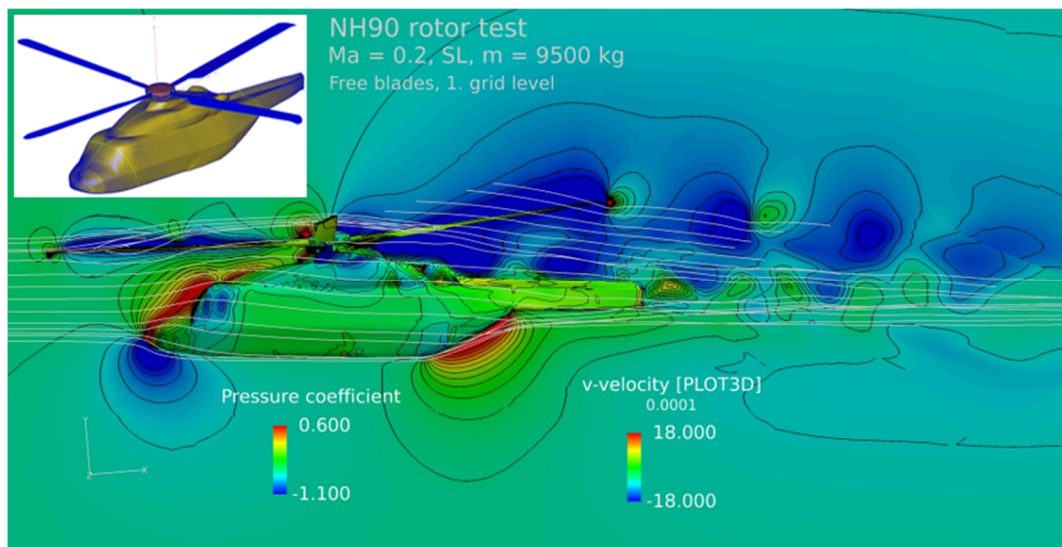
Figure 12: Instantaneous vertical flow speed components in the fuselage model symmetry plane as computed by FINFLO applying the new NH90 rotor modelling. Figure by courtesy of Patria Aviation.

The new model for main rotor simulations, shown in the top left corner of Figure 12, was initially tested with FINFLO in a fast cruise condition. The physical time steps of 0.001 s applied in the second-order accurate dual-time stepping simulation correspond to rotor rotational steps of 1.54 degrees, and the rotor thrust averaged over a blade cycle is around 100 kN. The model was proven applicable and the results agree with expectations. An example of an instantaneous flowfield is given in Figure 12 that shows the blade tip vortices in the rotor wake on the symmetry plane of the truncated fuselage. However, the simulations with the 27-million grid system covering several rotor revolutions to reach a steady operational state are quite slow even applying parallelization to 22 processes. For the future work, several items were identified for potential improvements to shorten the time required for such computations.

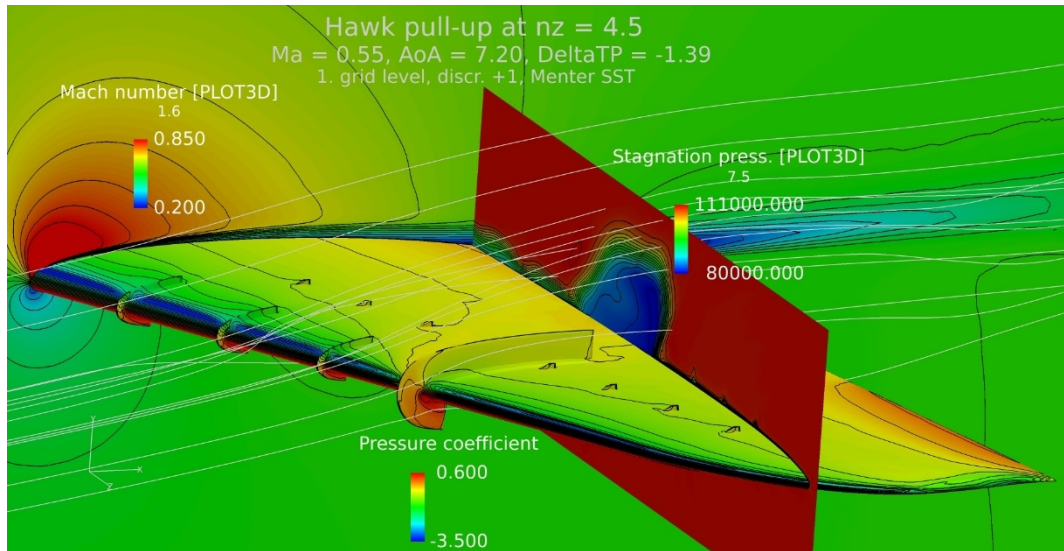
Figure 14: Flow over the Hawk wing in a 4.5 g pull-up involving tail buffet as computed by FINFLO. Figure by courtesy of Patria Aviation.

An example of the results is shown in Figure 14, where the flow over the wing is illustrated by the pressure coefficient on the wing, a Mach number distribution at a chordwise plane and a total pressure distribution in a plane perpendicular to the aircraft longitudinal axis. The mildly transonic pull-up represents a situation, where the separating wake from the mid-wing behind the stall strip hits the tip of the tailplane, as expected. In addition to the blue flow loss area, the small wakes of the outer vortex generators can be seen in the total pressure distribution. In all the cases studied, the wing wake trajectories predicted by FINFLO seemed to correspond to the knowledge about the occurrence of tailplane buffet which gives some credibility to the numerical studies.

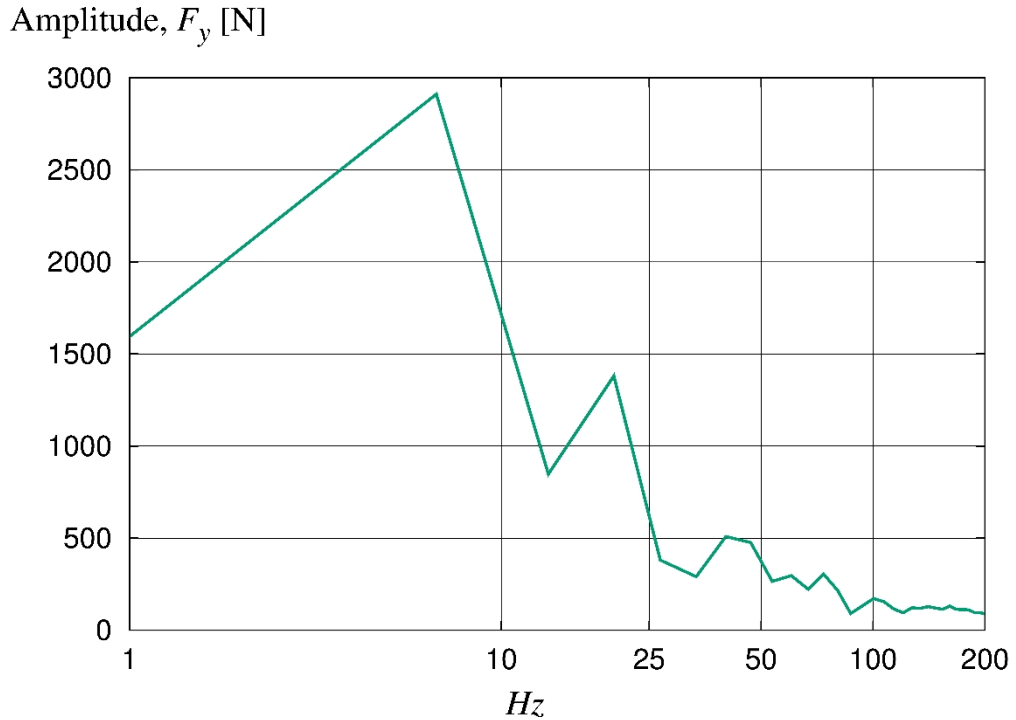
Figure 15: Fourier transformation for the aerodynamic force of the vertical tail in a pull-up case. Flight parameters are $Ma=0.64$, $\alpha=15.7^\circ$ and $n_z=5.9$. Figure by courtesy of Finflo Ltd.

The goal of the CFD simulations is to provide loads for subsequent fatigue analysis. The FINFLO flow solver allows very flexible definition of the force groups on different parts of the aircraft. The time history from these entities can be presented as a function of time or Fourier transforms can be done. As an example of the frequency domain analysis, the Fourier transformation for the aerodynamic force of the vertical tail in the particle body coordinate system (y-direction) is presented in Figure 15.

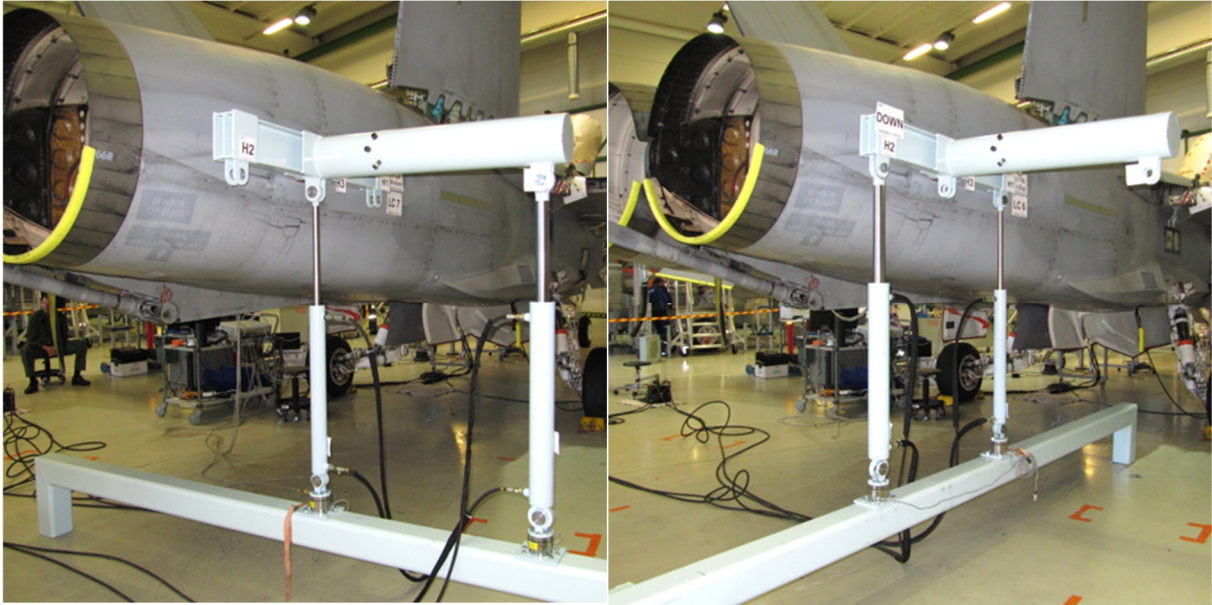
Figure 19: Mechanical calibrations of the HN-416 Bootstrap area. The tool providing bending (left) and torque (right) is manufactured by Patria Aviation. Figure by courtesy of Patria Aviation and VTT Ltd.

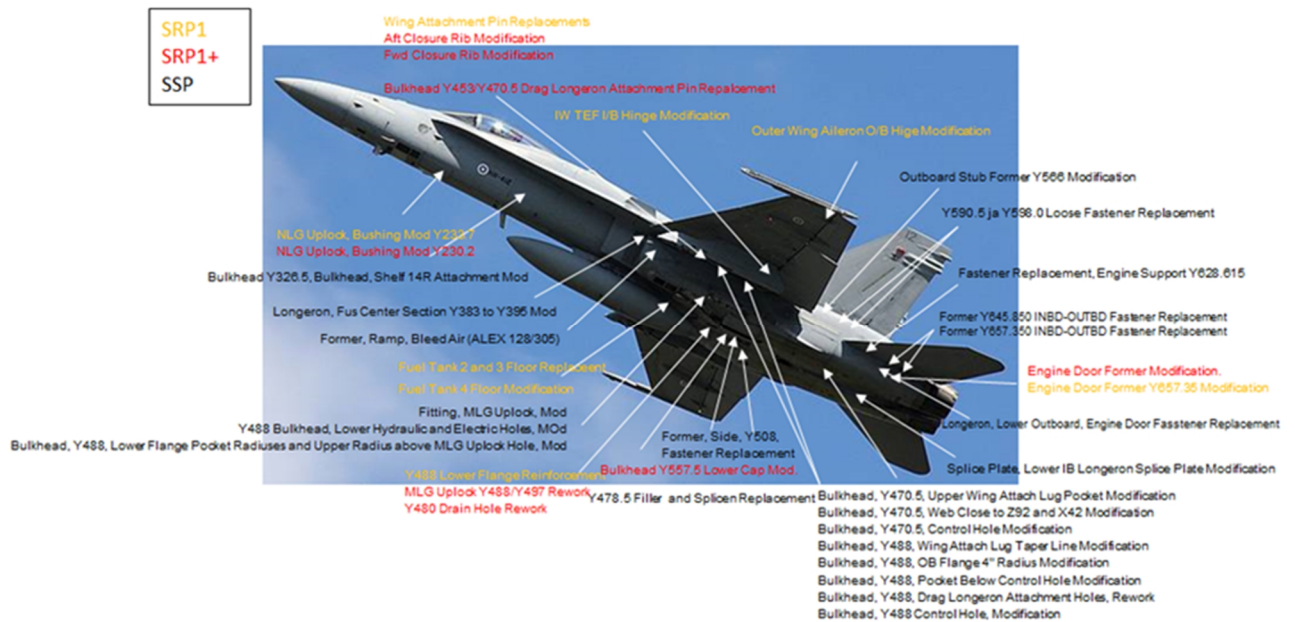
Figure 24: The overview of the SRP1, SRP1+ and SSP modification locations. Figure by courtesy of Patria Aviation.

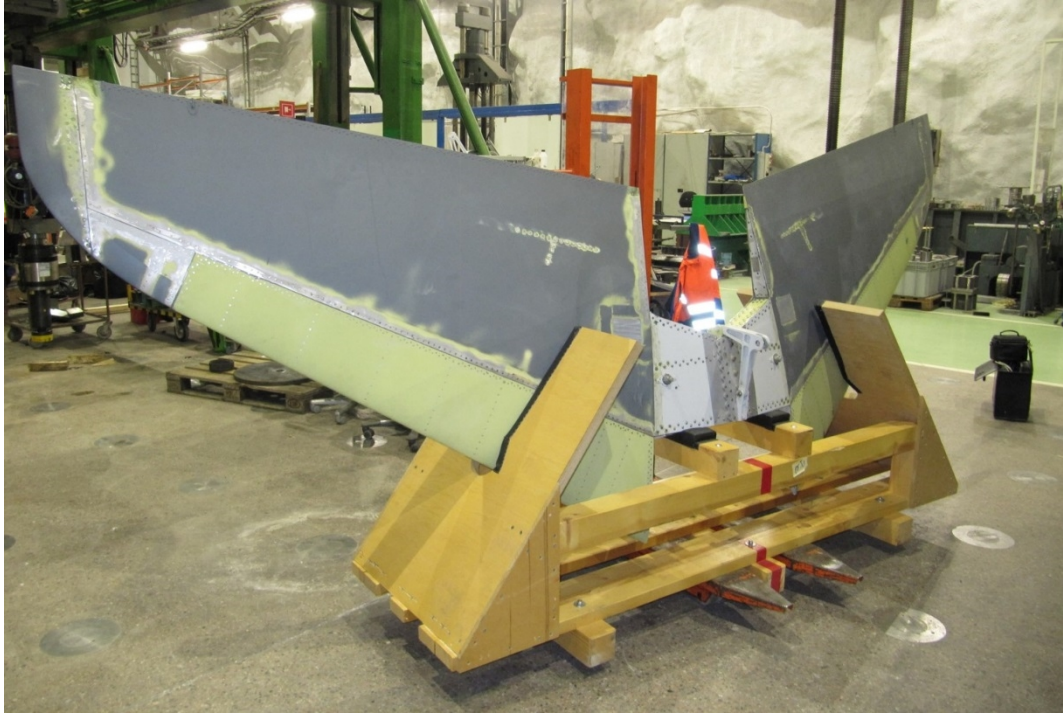
Figure 25: The FINAF Hawk Mk.51/51A/66 Tailplane (LYK45). Figure by courtesy of the FINAF and VTT Ltd.

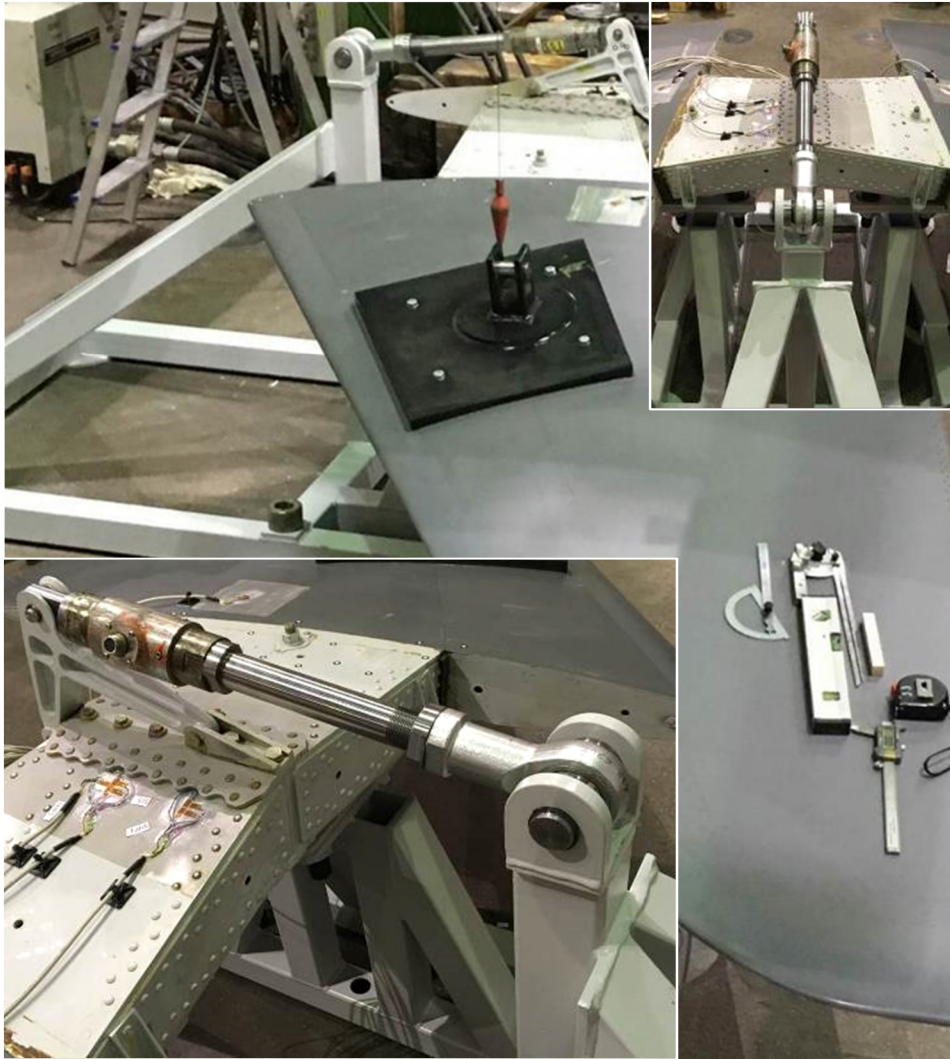
Figure 29: Aligning the upper attachments of the test bench. Figure by courtesy of VTT Ltd.

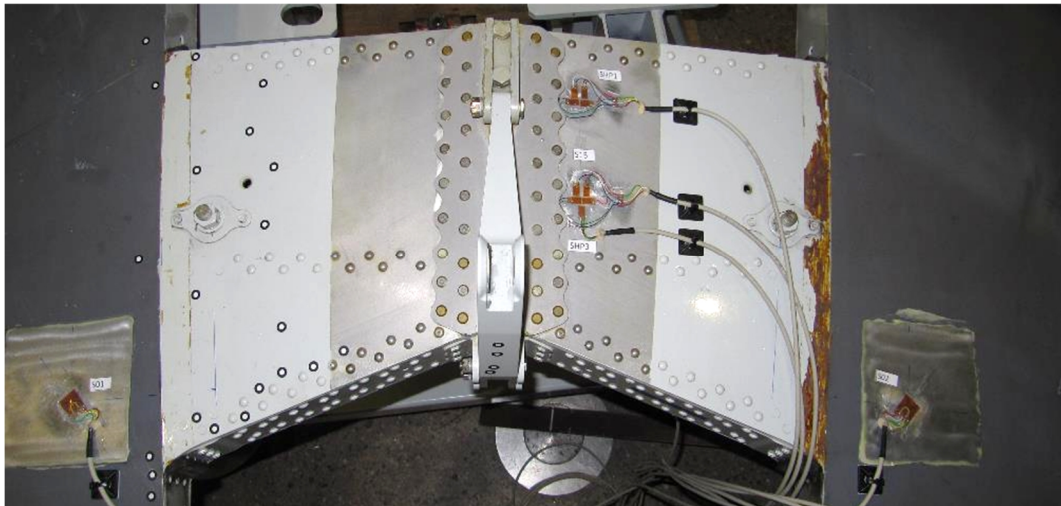
Figure 31: Strain gauges on top of the tailplane. Figure by courtesy of VTT Ltd.

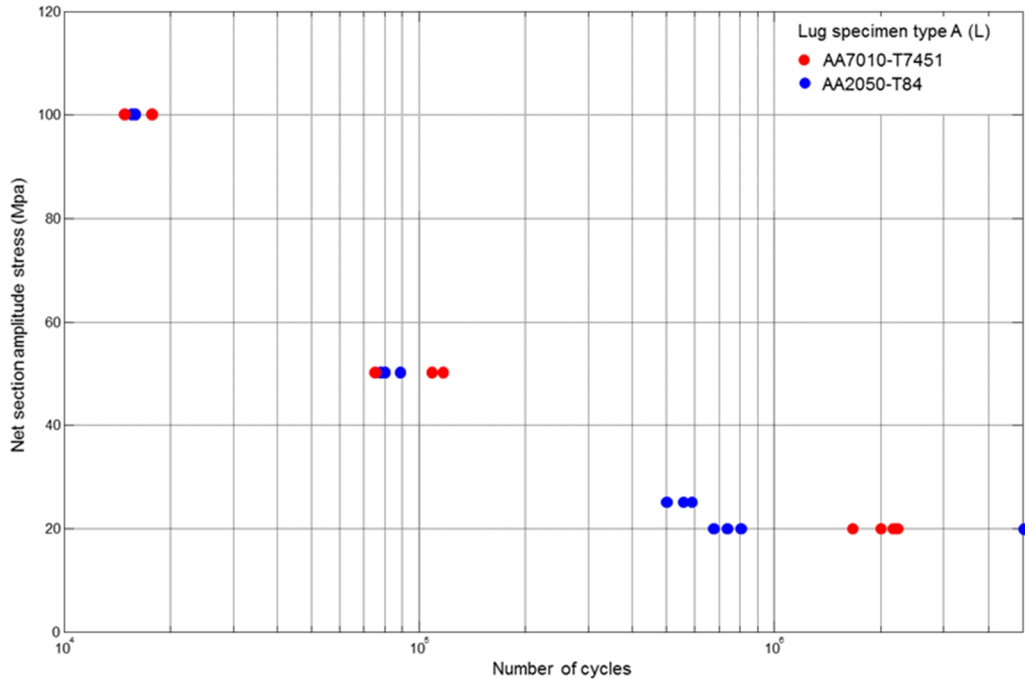
Figure 35: SN test data for type A lug specimens made of AA7010-T7451 and AA2050-T84. Figure by courtesy of Saab Aeronautics.

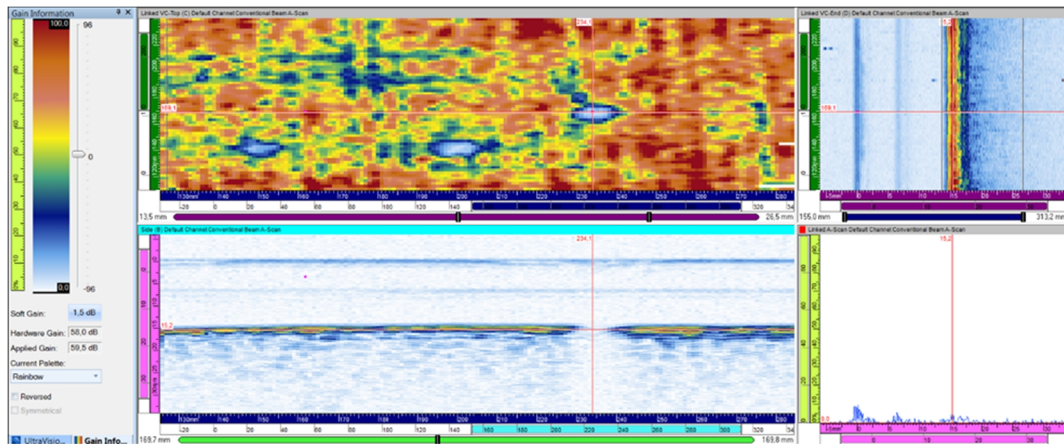
Figure 47: Through-transmission ultrasound (with 2.25 MHz probe) images of the repaired sandwich panel including 3x10x10 mm artificial defects. All flaws were detected and measured accurately enough. The flaws were sized from left to right: 8x8 mm, 10x10 mm, and 8x9 mm respectively. Figure by courtesy of VTT Ltd.

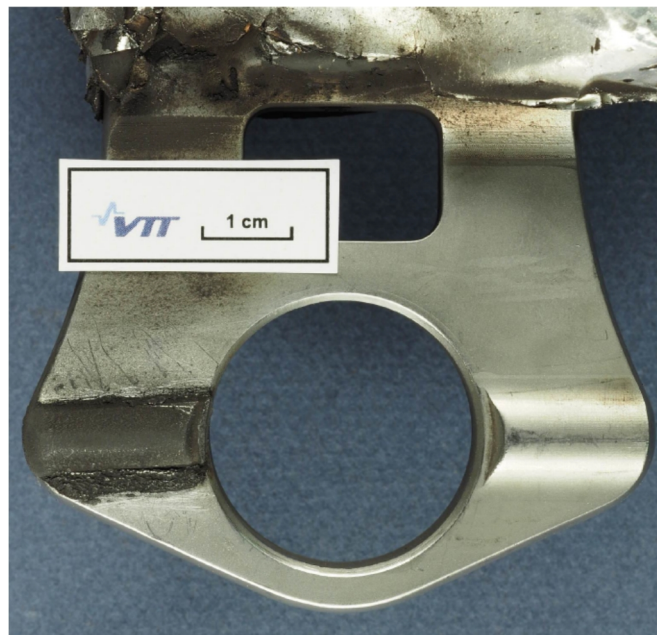
Figure 49: An overview of the thermal sprayed flange prior to machining. Picture courtesy by VTT Ltd.

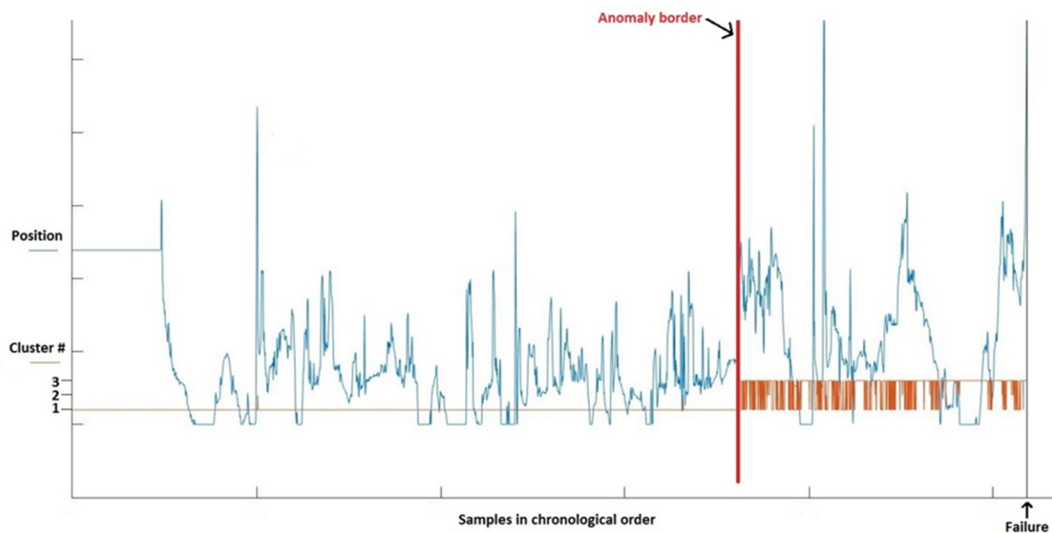
Figure 52: This figure presents the one position parameter of process data from the healthy and properly running system, but before the actual failures the clustering method reveals the exceptional behavior in the data. Figure by courtesy of Tampere University of Technology.
