VTT PUBLICATIONS 280

# Microstructural degradation of boiler tube steels under long term exposure to high temperature

Jorma Salonen & Pertti Auerkari

VTT Manufacturing Technology

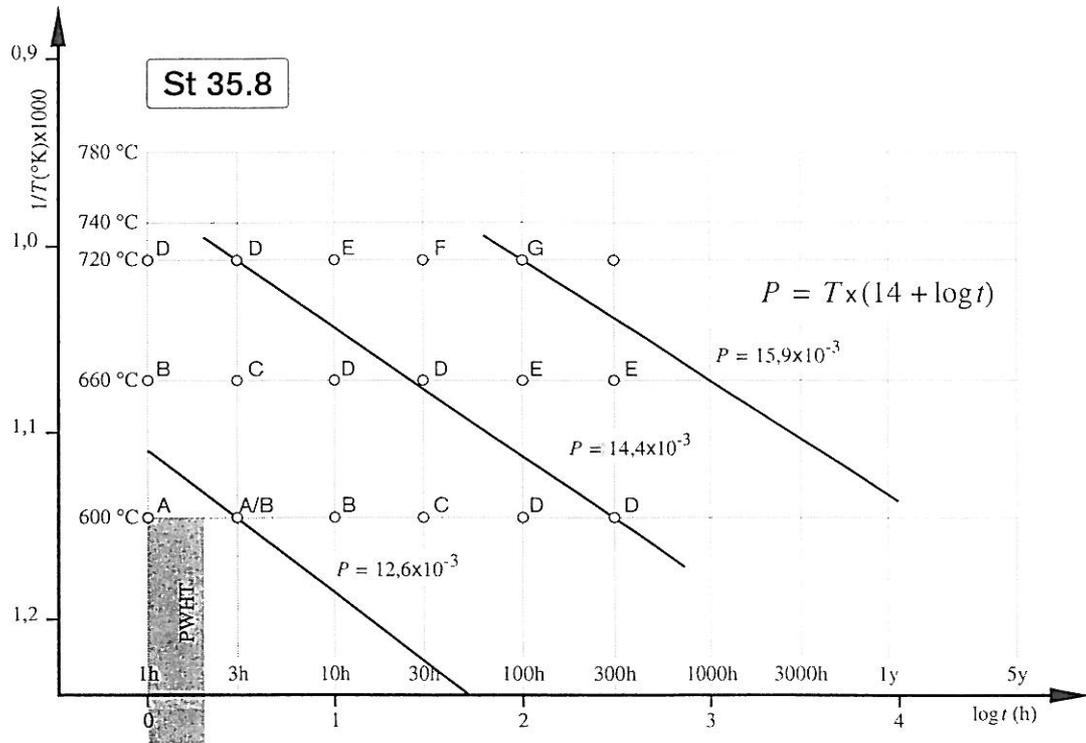
Fig. 1. Time-temperature dependence of microstructural degradation in unalloyed steel St 35.8.

The results of microstructural investigations are shown in Figures 1 to 5 according to the above classification as time-temperature dependence. It is seen that to produce an equal microstructural degradation, the required time-temperature combinations appear on parallel lines. In addition to carbide changes, graphitisation was observed in 15 Mo3 at 600°C after more than 300 h of annealing.

In all cases the value of C has been estimated from lines outside the tempering regions given by DIN 17175 (shown in Figs 1 - 5). This has the effect that the original tempering treatment exerts a negligible influence on the estimated values of C. Figure 6 shows the dependence of the microstructural changes on the value of the isothermal LM parameter for all steel types of the present work.

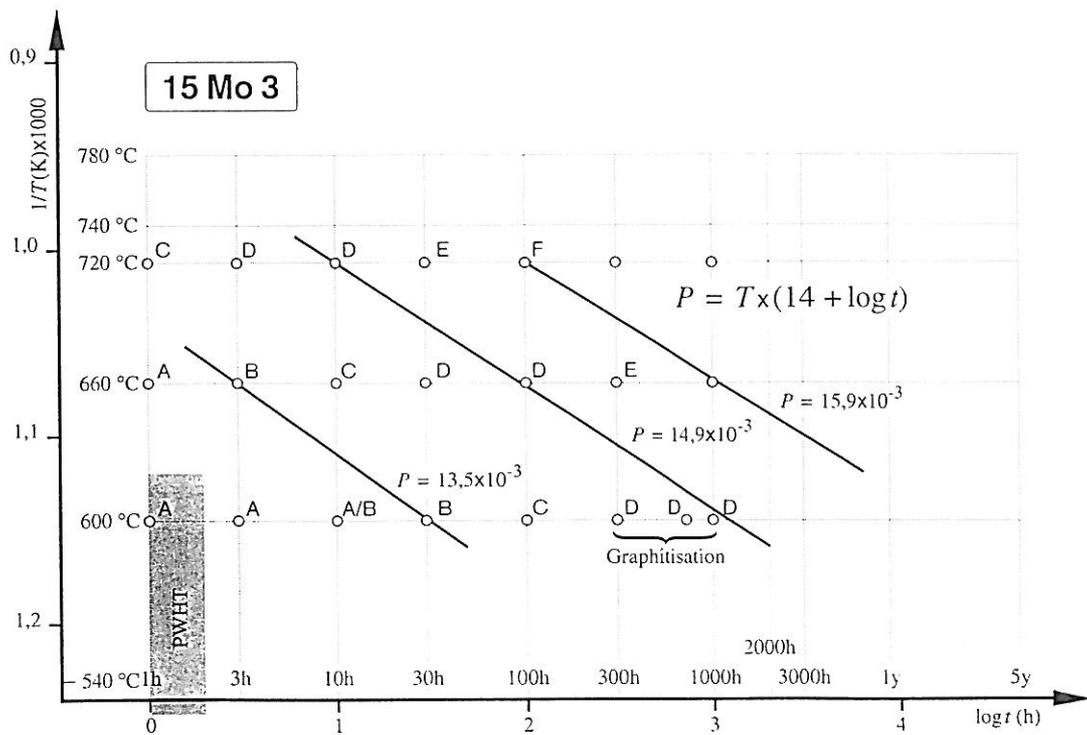
Fig. 2. Time-temperature dependence of microstructural degradation in steel 15 Mo 3.

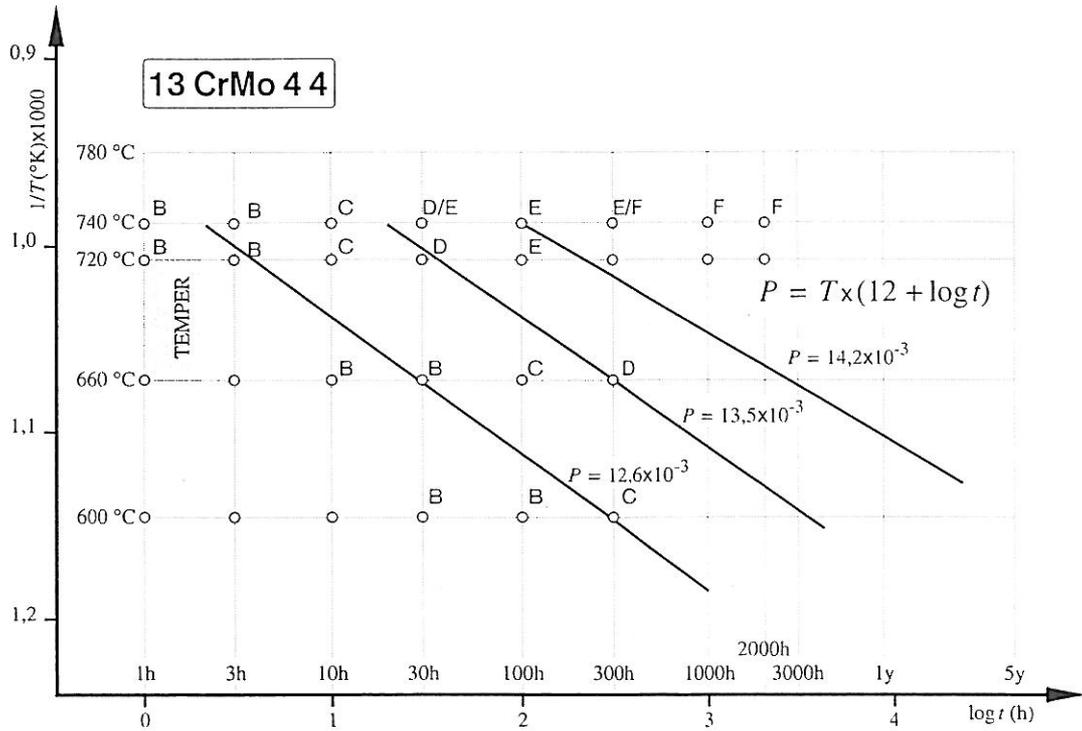
Fig. 3. Time-temperature dependence of isothermal microstructural changes in steel 13 CrMo 4 4.

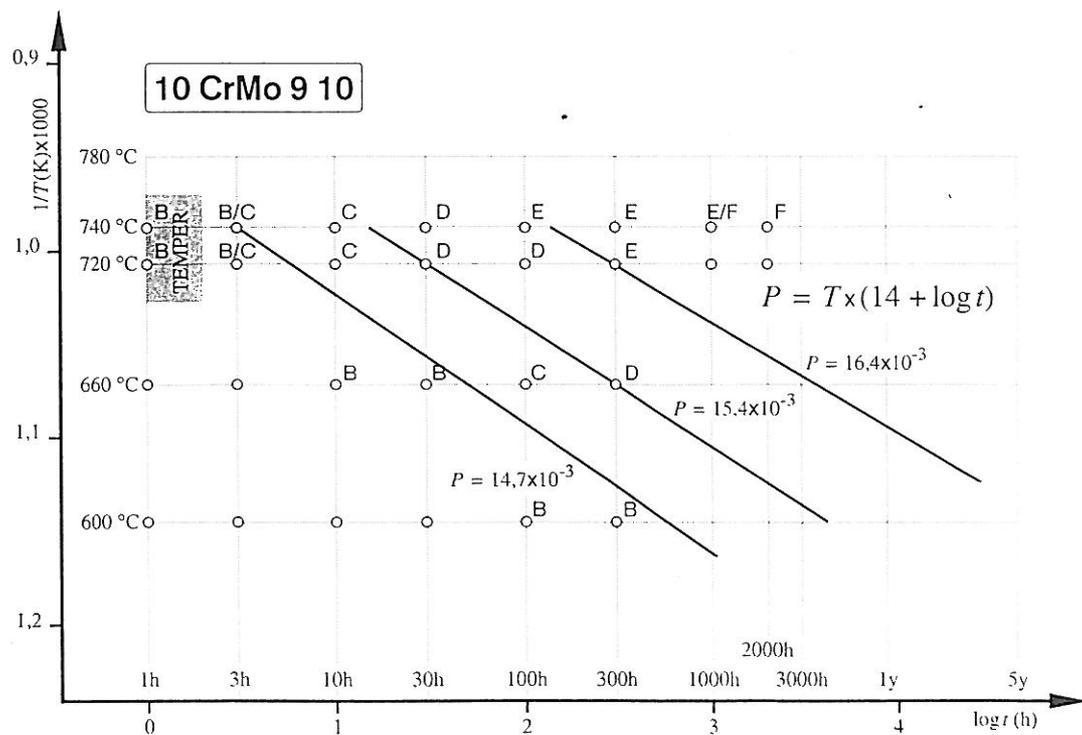
Fig. 4. Time-temperature dependence of isothermal microstructural changes in steel 10 CrMo 9 10.

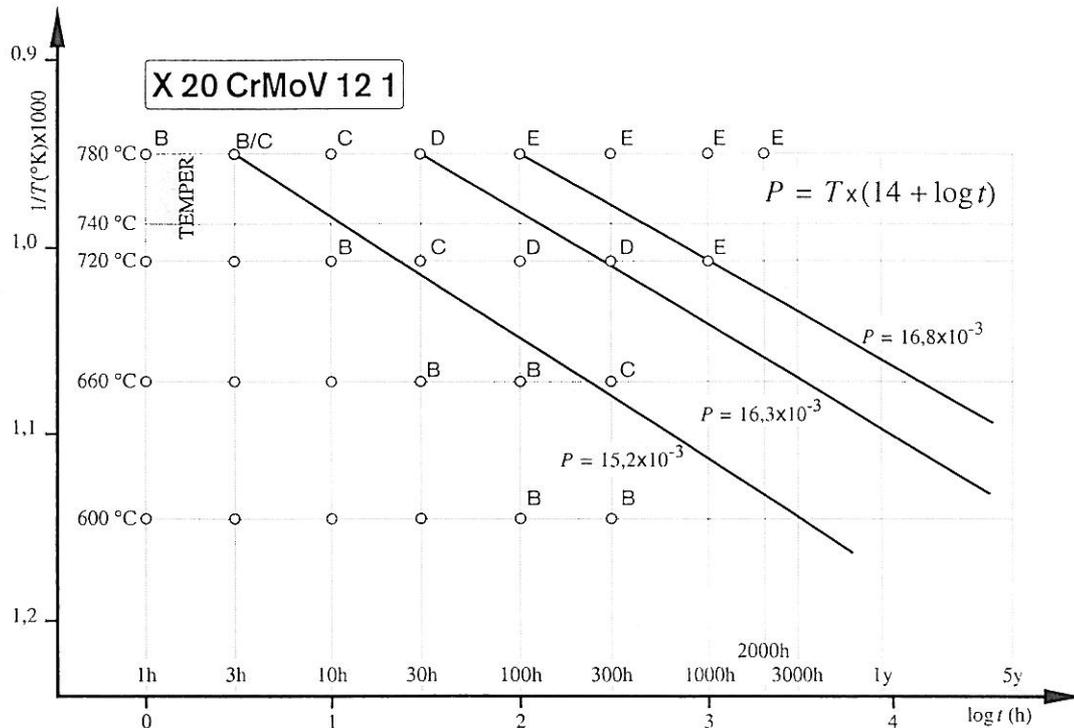
Fig. 5. Time-temperature dependence of isothermal microstructural changes in steel X 20 CrMoV 12 1.

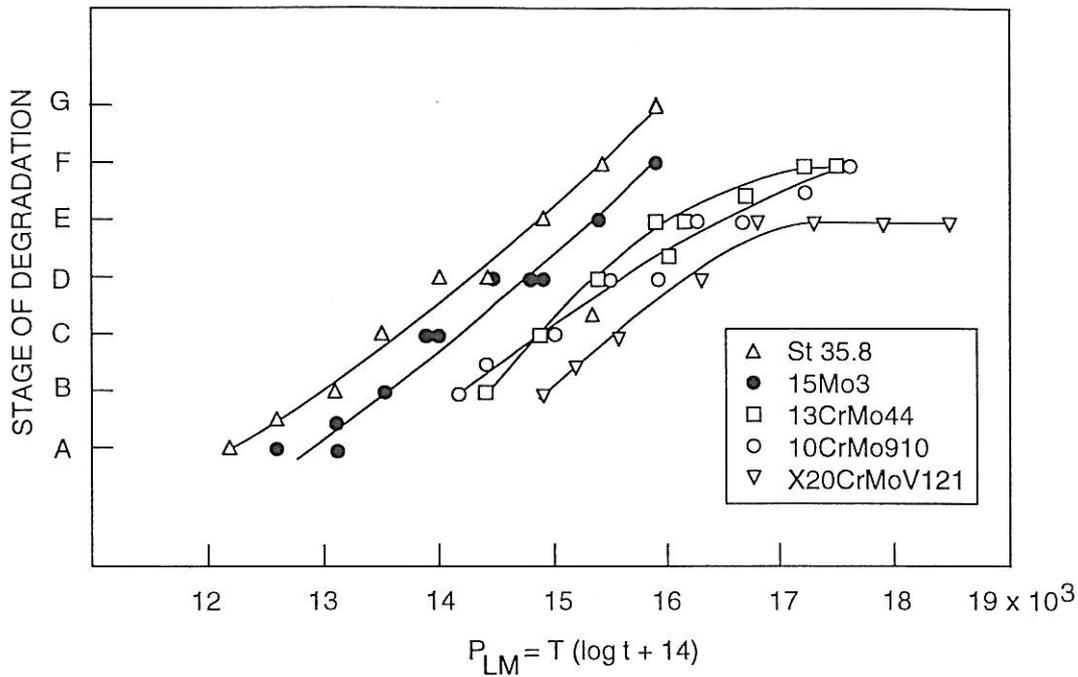
Fig. 6. Thermal degradation as a function of the LM parameter corresponding to isothermal annealing. Note that the degradation scale involves different definitions for ferritic-pearlitic (St 35.8 and 15 Mo 3) and other steels.

The value  $C = 14$  means approximately that an order of magnitude difference in annealing time corresponds to a  $60^\circ\text{C}$  difference in temperature. Since for microstructural changes the value of  $C$  is clearly less than the common value ( $C = 20$ ) often assigned to the time-temperature correspondence of creep failure, the kinetics of creep failure and microstructural degradation can be clearly different. However, the common observation that shorter term creep tests correspond to higher values of  $C$  than long-term tests approaching service behaviour would suggest that this discrepancy need not to be universal.

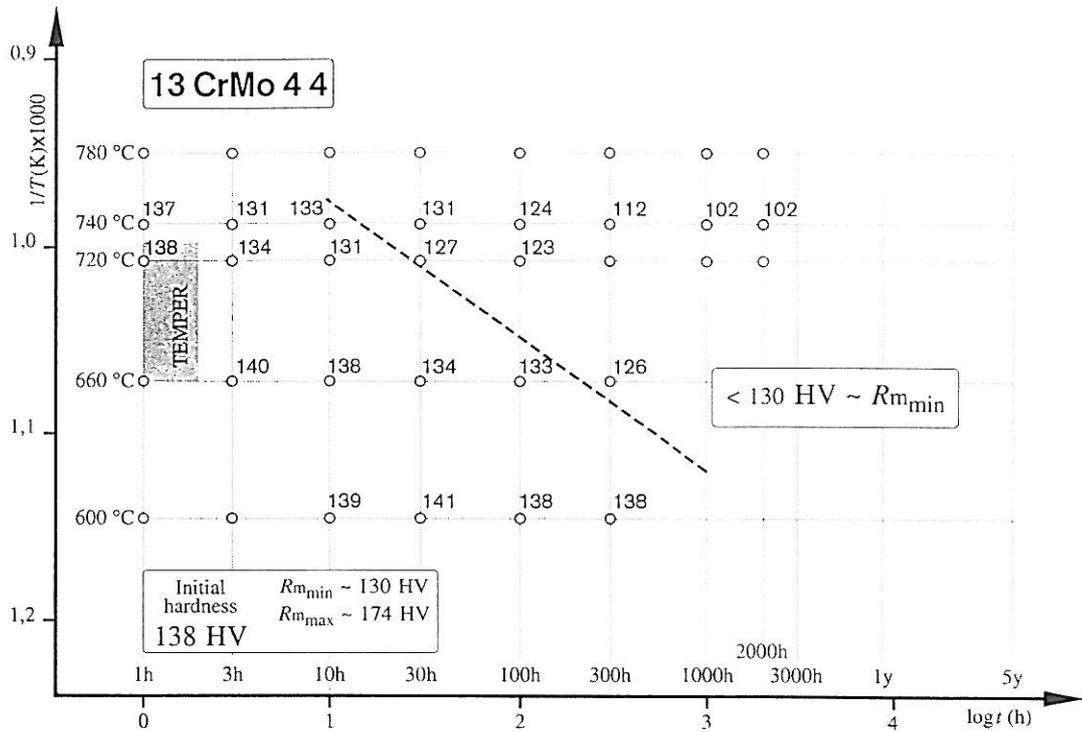
Fig. 9. Time-temperature dependence of isothermal hardness changes in steel 13 CrMo 4 4.

The hardness testing results are shown in Figures 7 to 11. Generally the time-temperature combinations to yield equal hardness appear as lines with similar slopes as for microstructural changes in Figures 1 to 5.

Figures 7 to 11 also show the time-temperature limits for lowering the hardness to a level corresponding to the minimum tensile strength according to DIN 17175. These hardness limits have been estimated by assuming linear proportionality between hardness and tensile strength, and multiplying the measured initial hardness by the ratio of minimum strength to initial strength (Table 2).

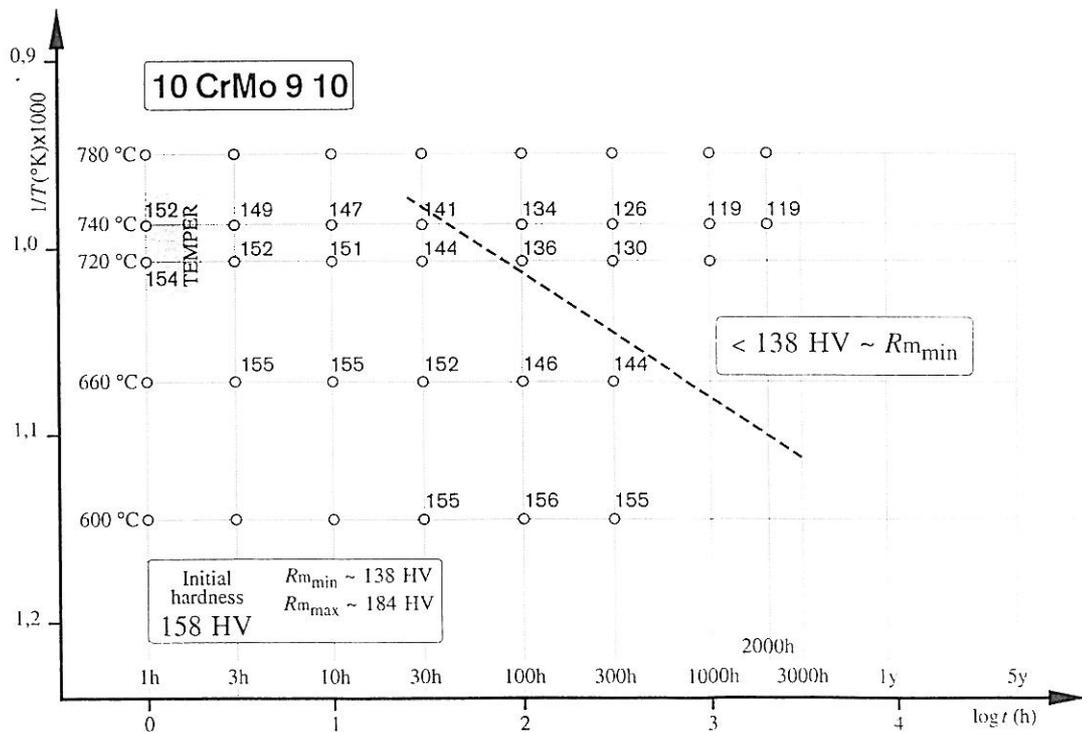
Fig. 10. Time-temperature dependence of hardness changes in steel 10 CrMo 9 10.

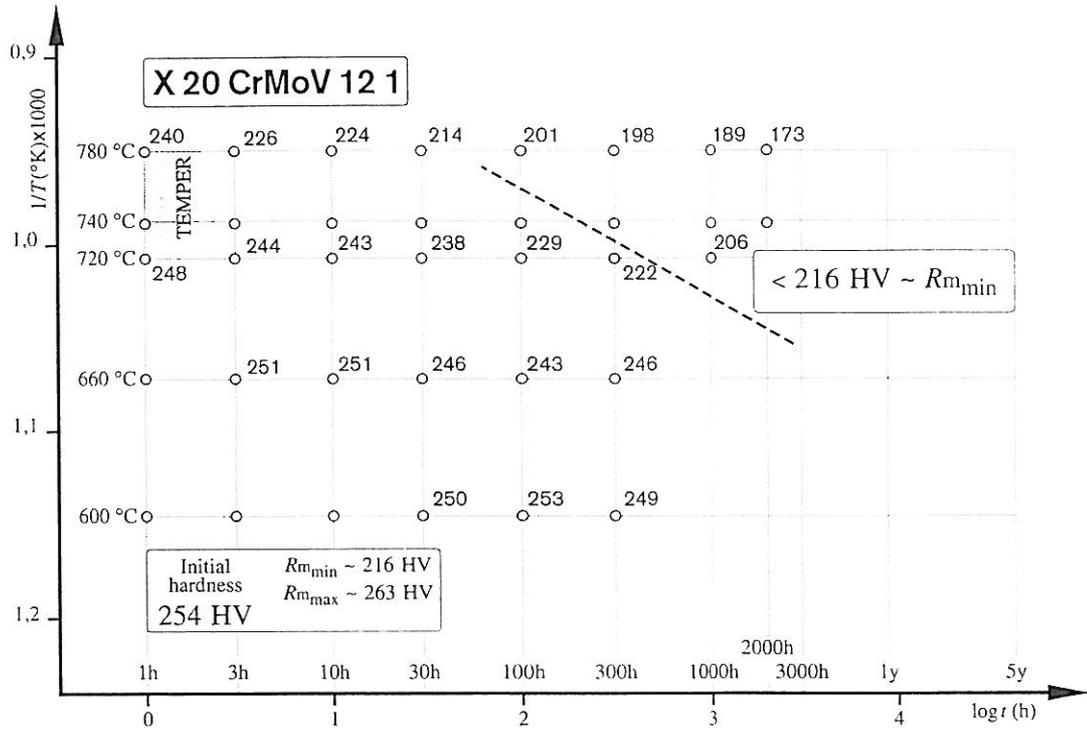
Fig. 11. Time-temperature dependence of hardness changes in steel X 20 CrMoV 12 1.

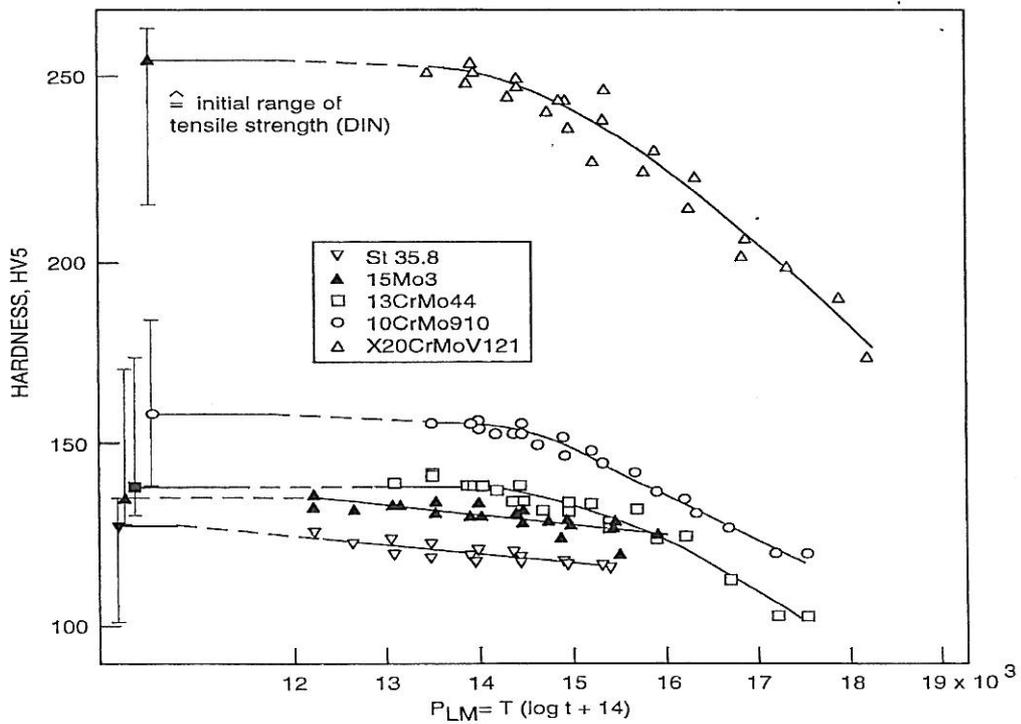
Fig. 12. Hardness as a function of the LM parameter of isothermal annealing.

The general trend of softening with increasing thermal exposure can be seen from Figure 12. Considerable scatter in the initial values of hardness are possible, although this is likely to be much less for small section boiler tubes than for thick section components. Therefore relative changes in hardness better reflect the thermal exposure than results from individual post-service hardness measurements.

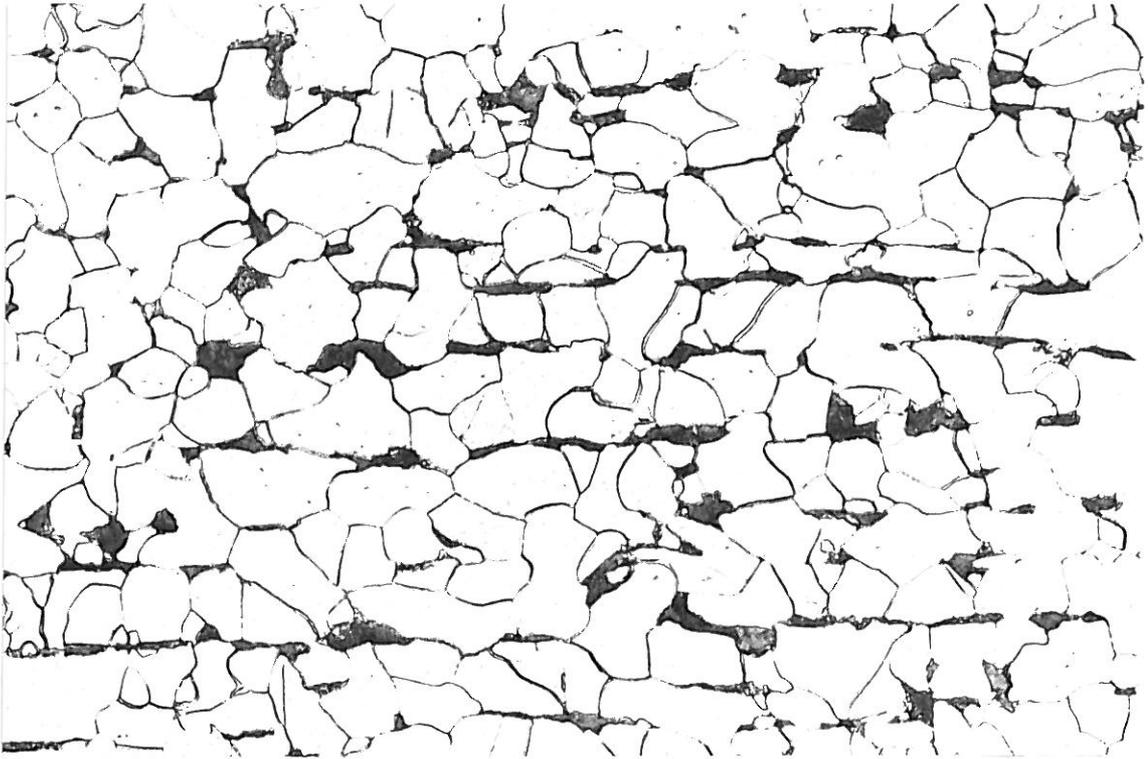
*Fig. 1. Steel St 35.8: as new, stage A. Magnification 500x.*

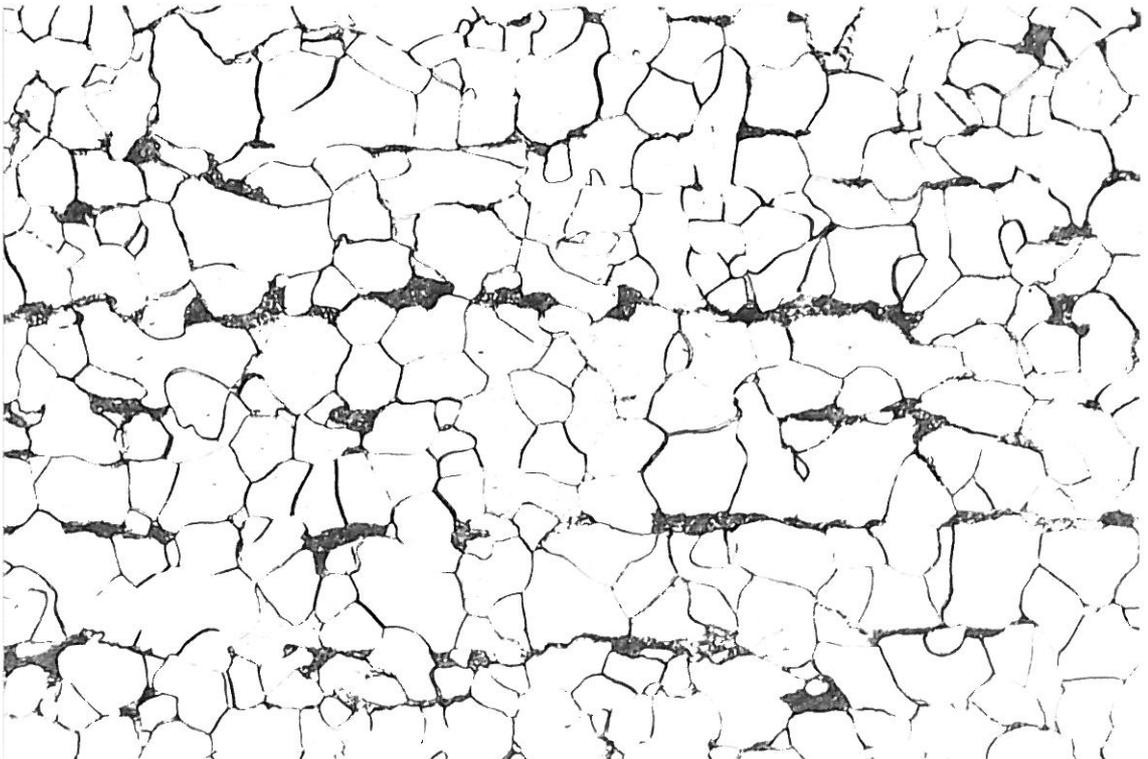
*Fig. 2. Steel St 35.8: 600°C / 3 h,  $P_{LM} (C = 14) = 12\ 600$ , stage A/B. Magnification 500x.*

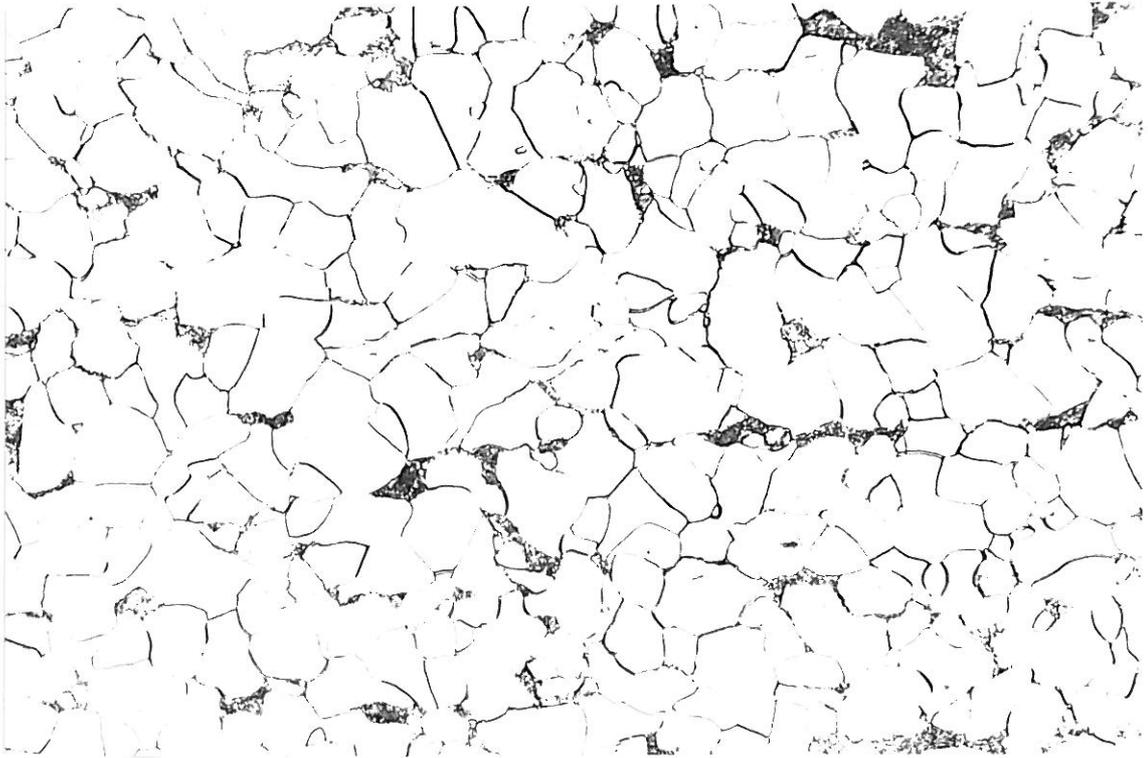
*Fig. 3. Steel St 35.8: 600°C / 10 h,  $P_{LM} (C = 14) = 13\ 100$ , stage B. Magnification 500x.*

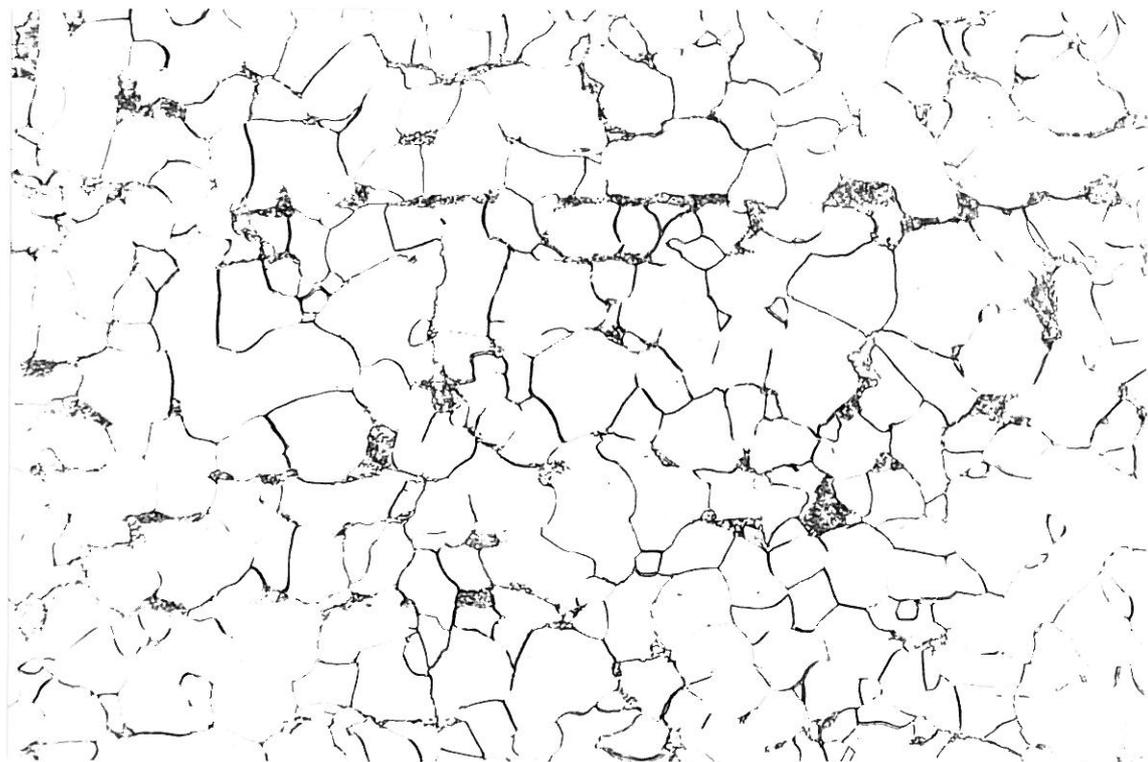
*Fig. 4. Steel St 35.8: 600°C / 30 h,  $P_{LM} (C = 14) = 13\ 500$ , stage C. Magnification 500x.*

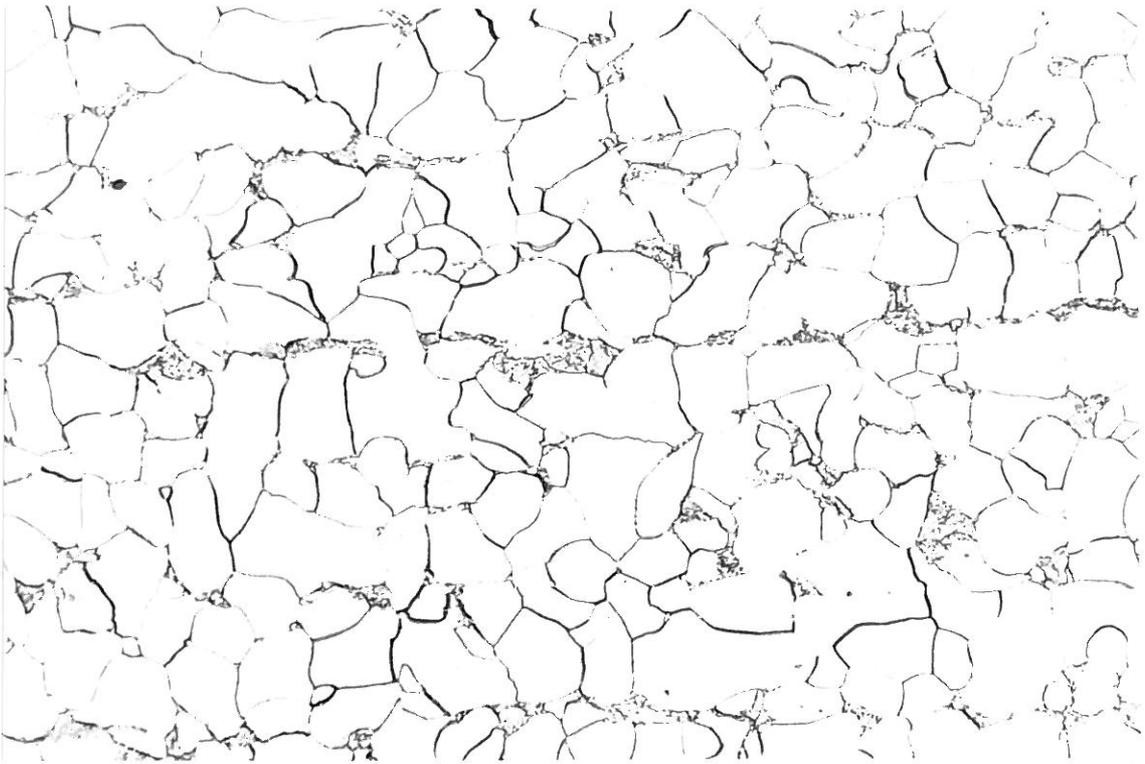
*Fig. 5. Steel St 35.8: 600°C / 100 h,  $P_{LM} (C = 14) = 14\ 000$ , stage D. Magnification 500x.*

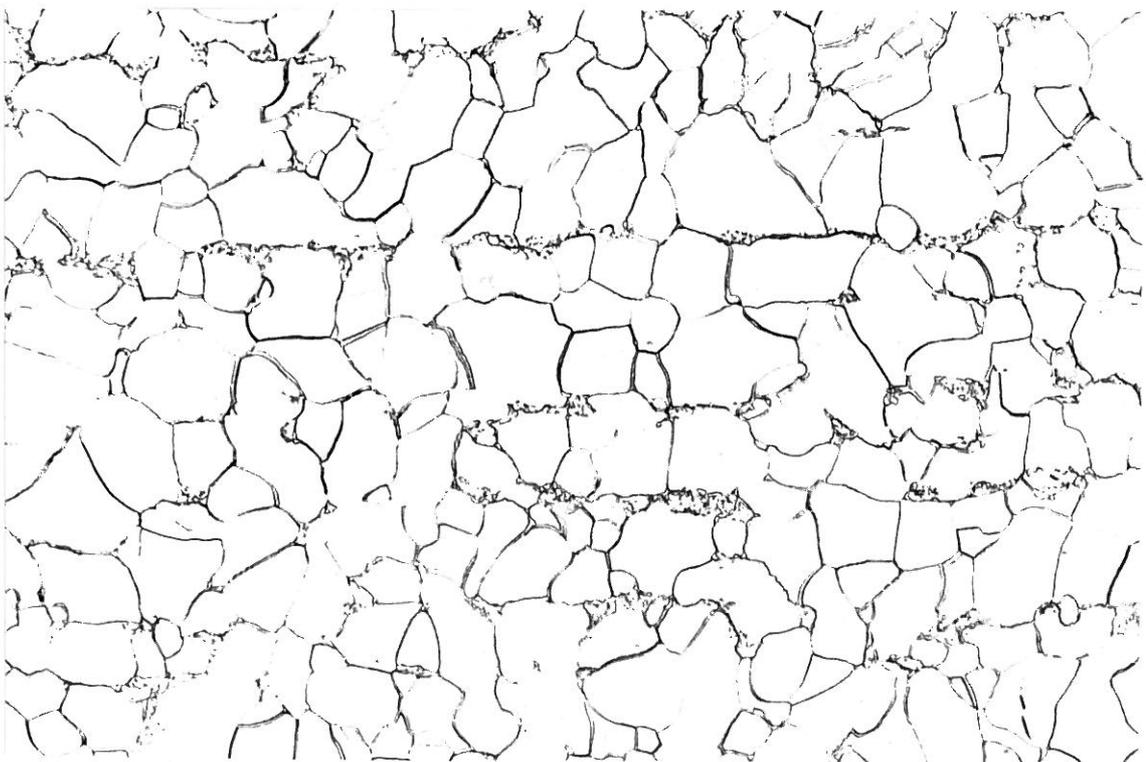
*Fig. 6. Steel St 35.8: 600°C / 300 h,  $P_{LM} (C = 14) = 14\ 400$ , stage D. Magnification 500x.*

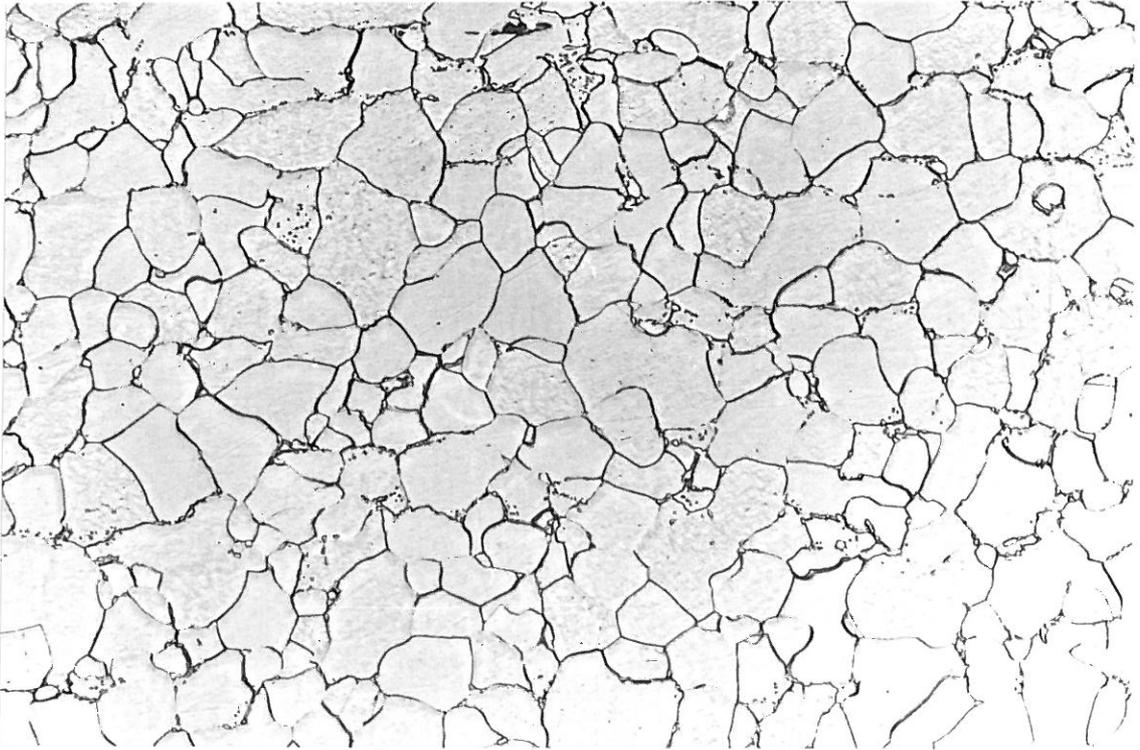
*Fig. 7. Steel St 35.8: 720°C / 10 h,  $P_{LM} (C = 14) = 14\ 900$ , stage E. Magnification 500x.*

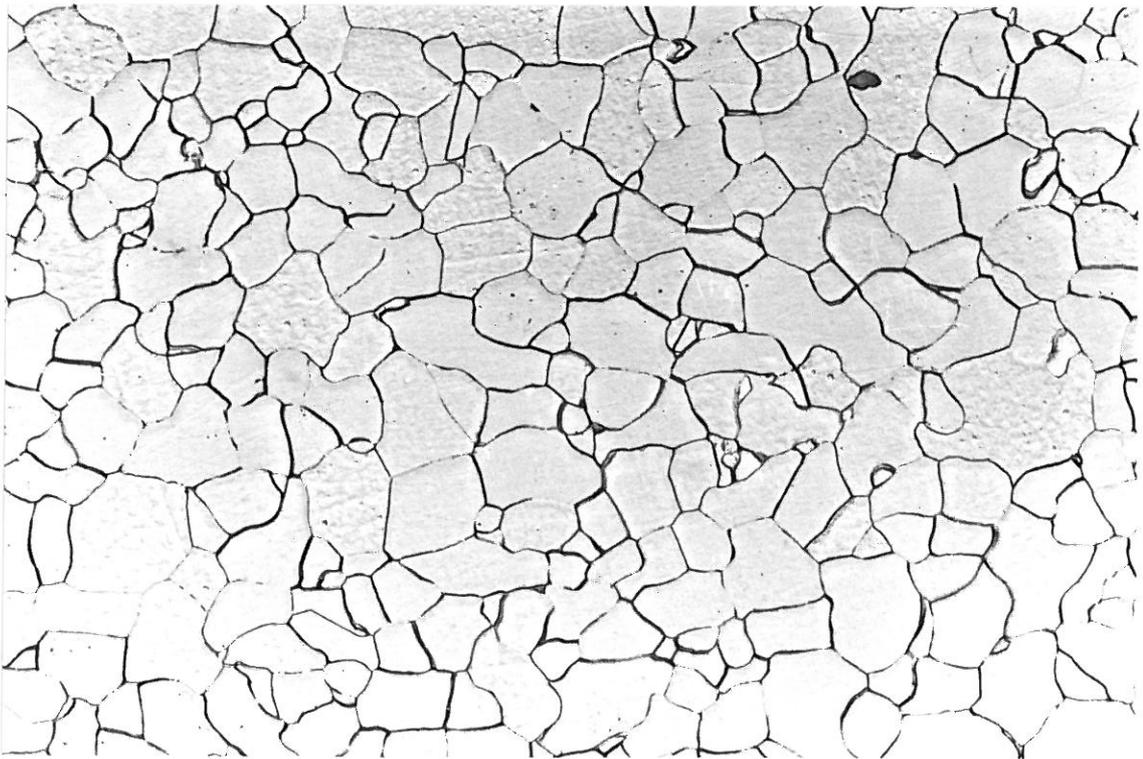
*Fig. 8. Steel St 35.8: 720°C / 30 h,  $P_{LM} (C = 14) = 15\ 400$ , stage F. Magnification 500x.*

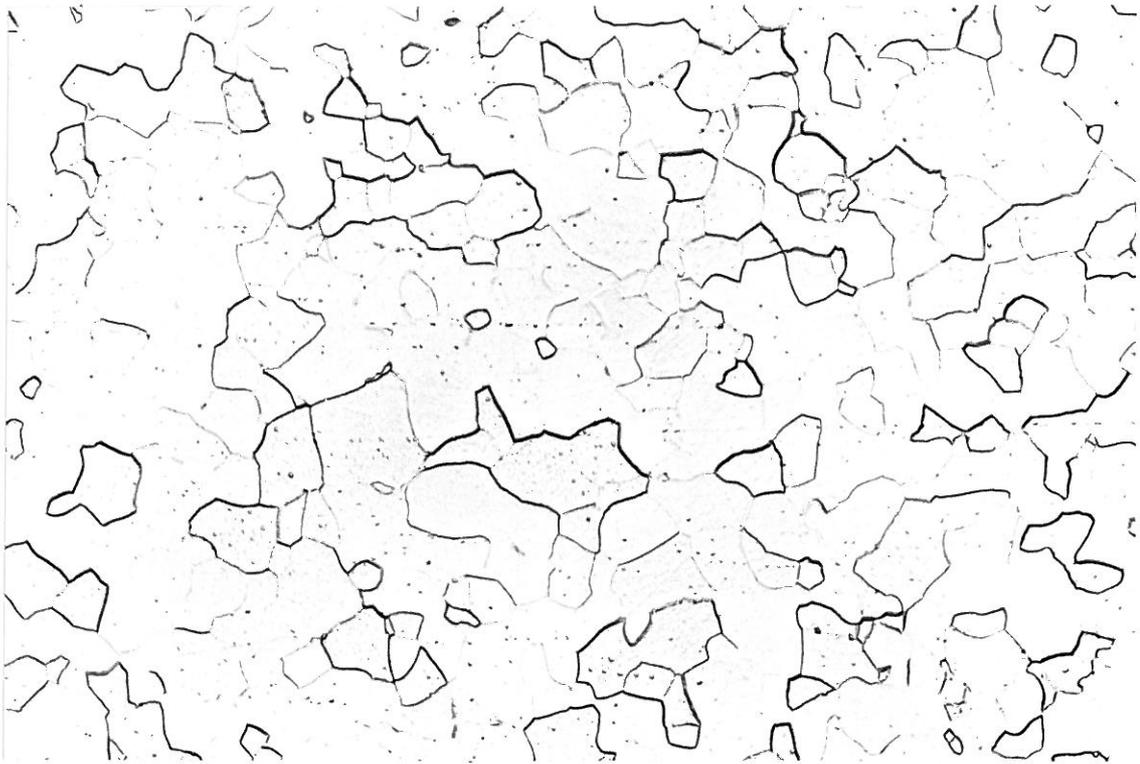
*Fig. 9. Steel St 35.8: 720°C / 100 h,  $P_{LM} (C = 14) = 15\ 900$ , stage G. Magnification 500x.*

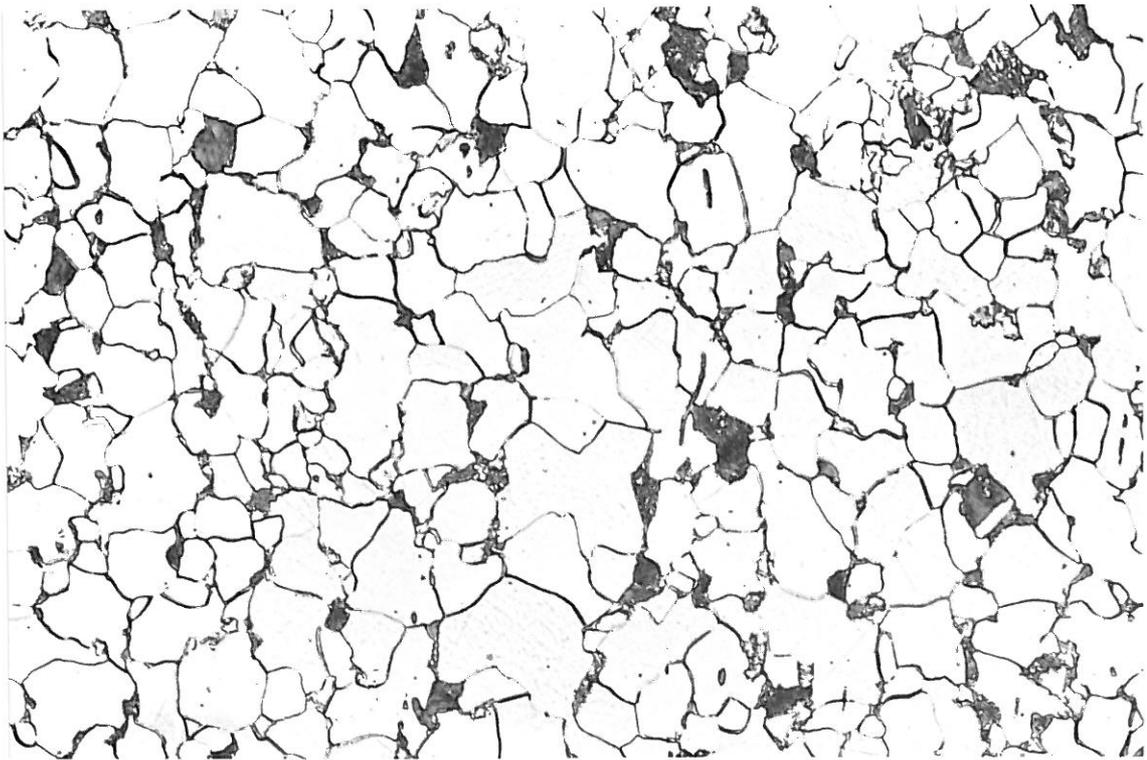
*Fig. 10. Steel 15 Mo 3: as new, stage A. Magnification 500x.*

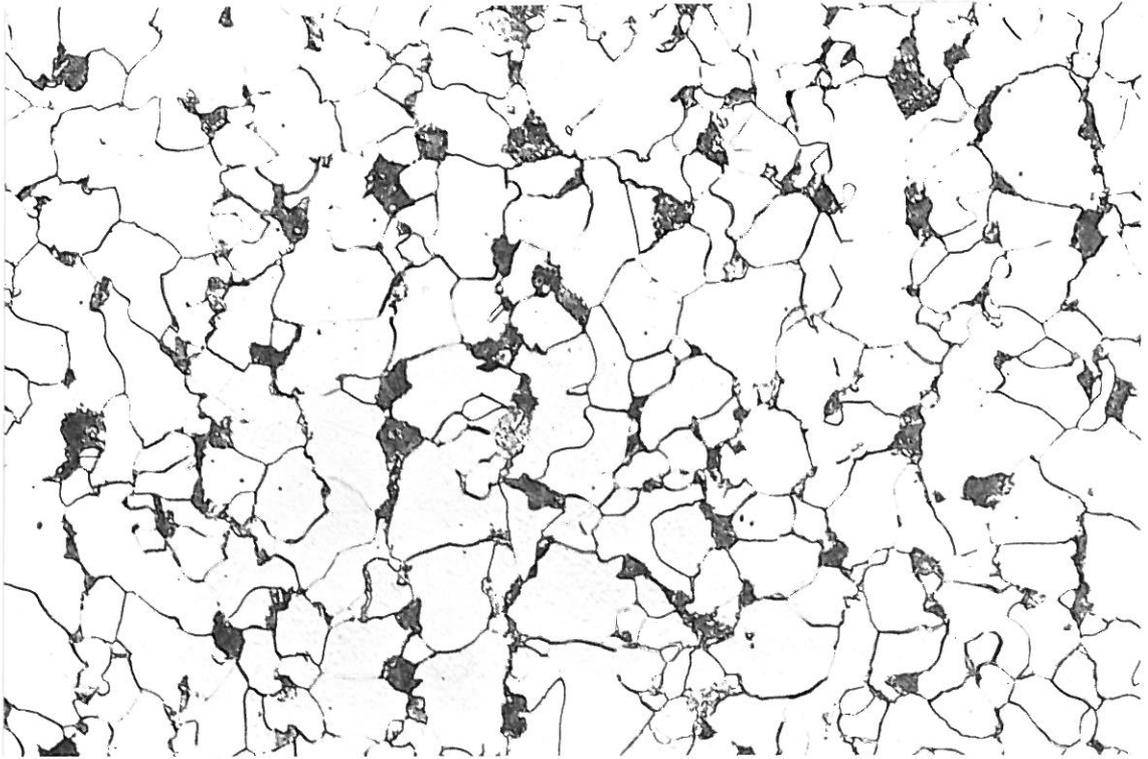
*Fig. 11. Steel 15 Mo 3: 600°C / 30 h,  $P_{LM} (C = 14) = 13\ 500$ , stage B. Magnification 500x.*

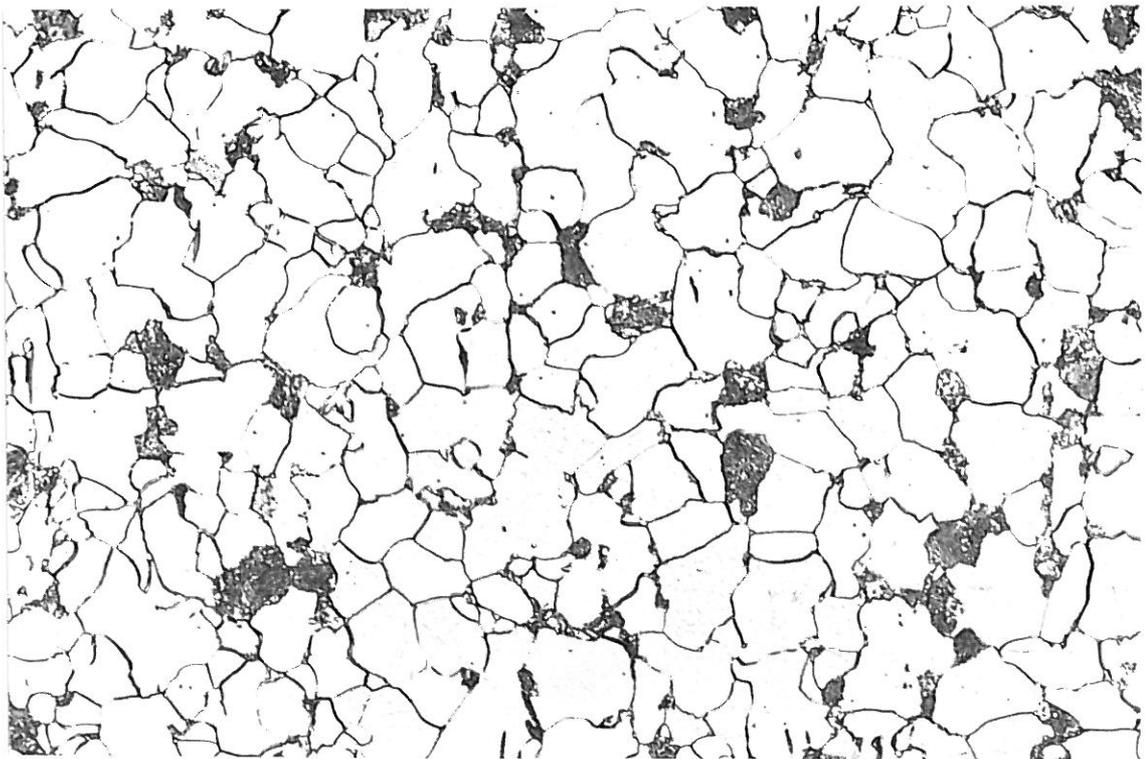
*Fig. 12. Steel 15 Mo 3: 600°C / 100 h,  $P_{LM} (C = 14) = 14\ 000$ , stage C. Magnification 500x.*

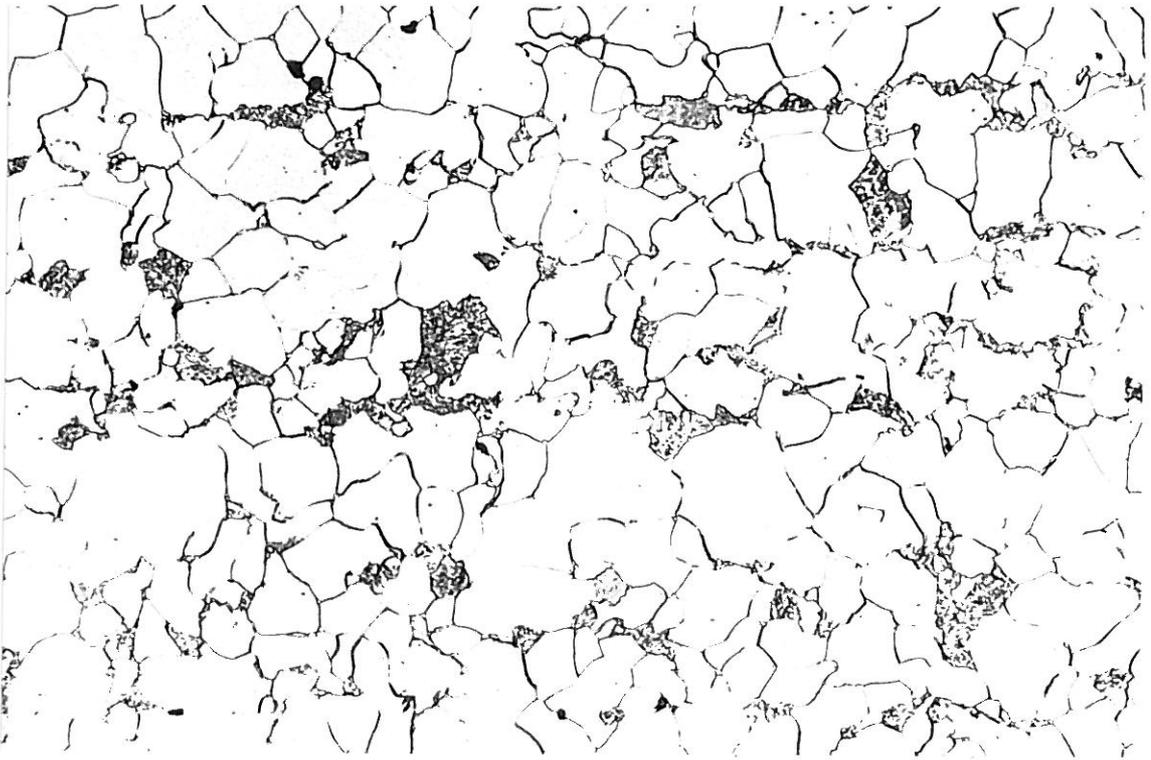
*Fig. 13. Steel 15 Mo 3: 600°C / 300 h,  $P_{LM} (C = 14) = 14\ 400$ , stage D. Magnification 500x.*

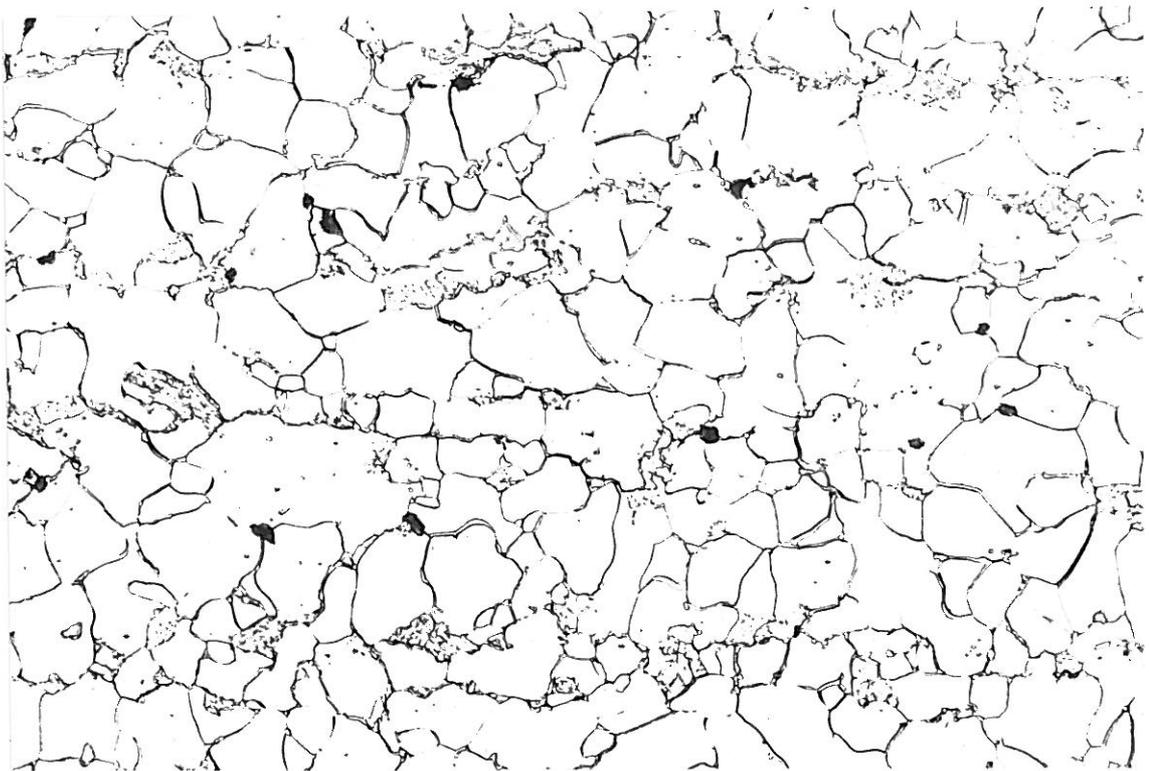
*Fig. 14. Steel 15 Mo 3: 600°C / 1000 h,  $P_{LM} (C = 14) = 14\ 800$ , stage D. Magnification 500x.*

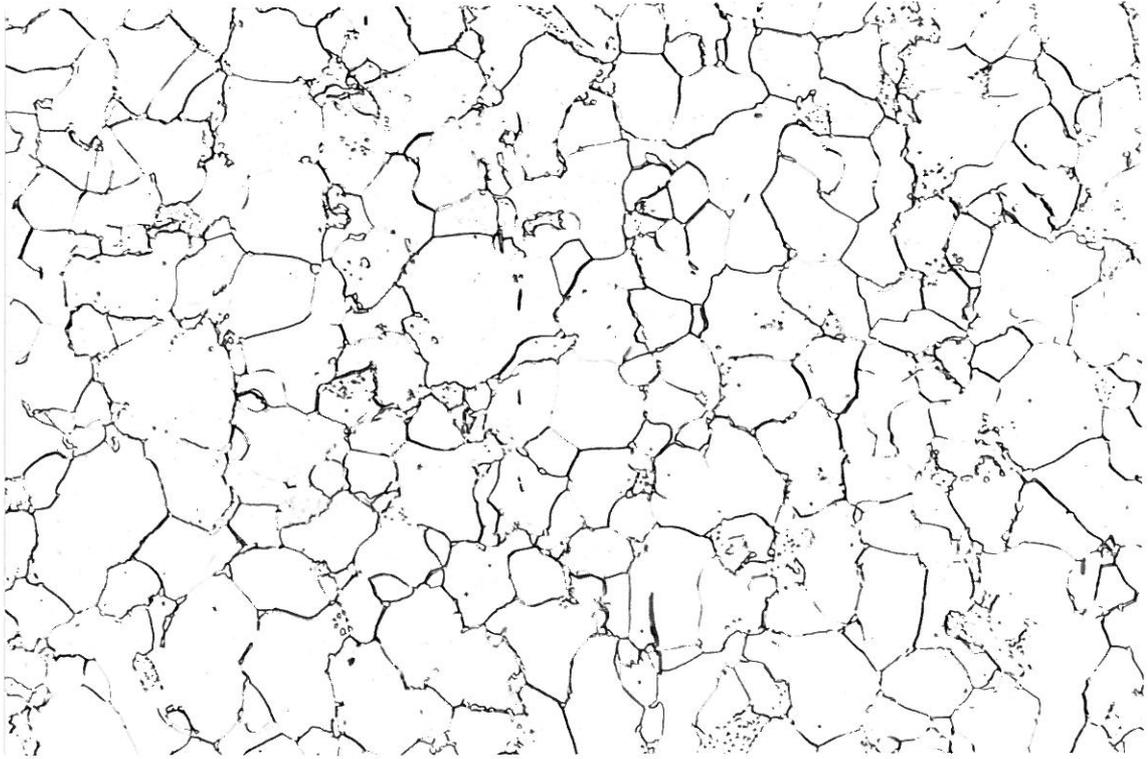
*Fig. 15. Steel 15 Mo 3: 720°C / 30 h,  $P_{LM} (C = 14) = 15\ 400$ , stage E. Magnification 500x.*

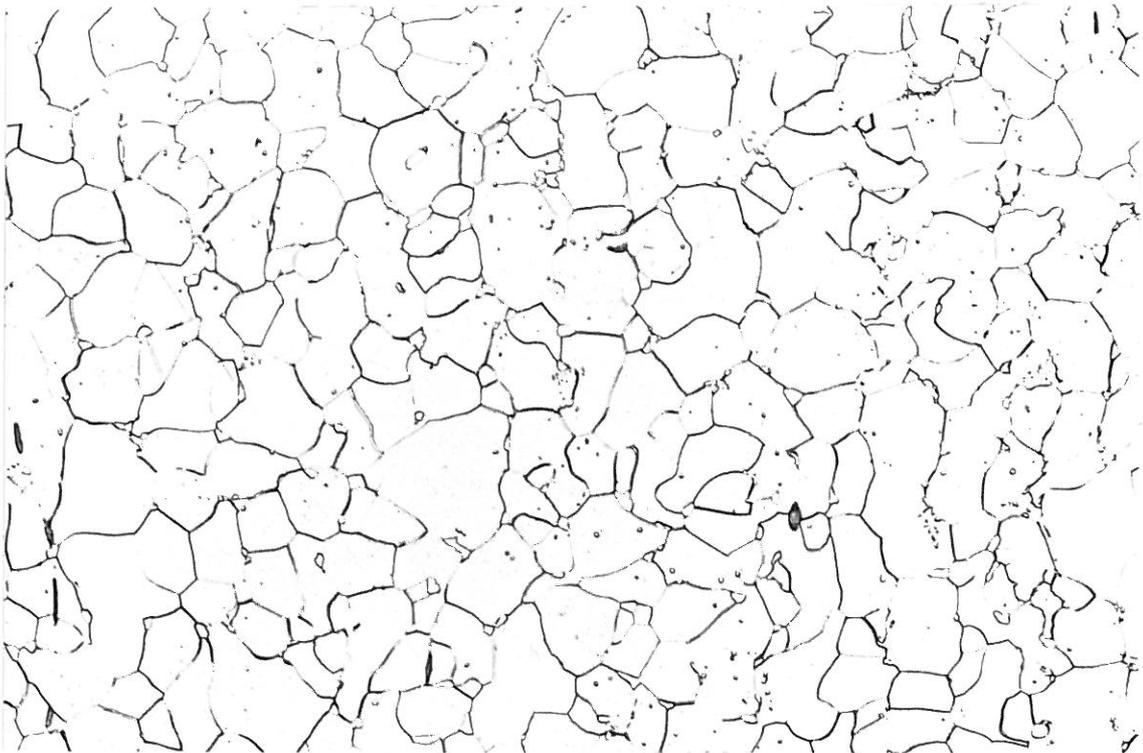
*Fig. 16. Steel 15 Mo 3: 720°C / 100 h,  $P_{LM} (C = 14) = 15\ 900$ , stage F. Magnification 500x.*
