VTT PUBLICATIONS 280

# Microstructural degradation of boiler tube steels under long term exposure to high temperature

Jorma Salonen & Pertti Auerkari

VTT Manufacturing Technology

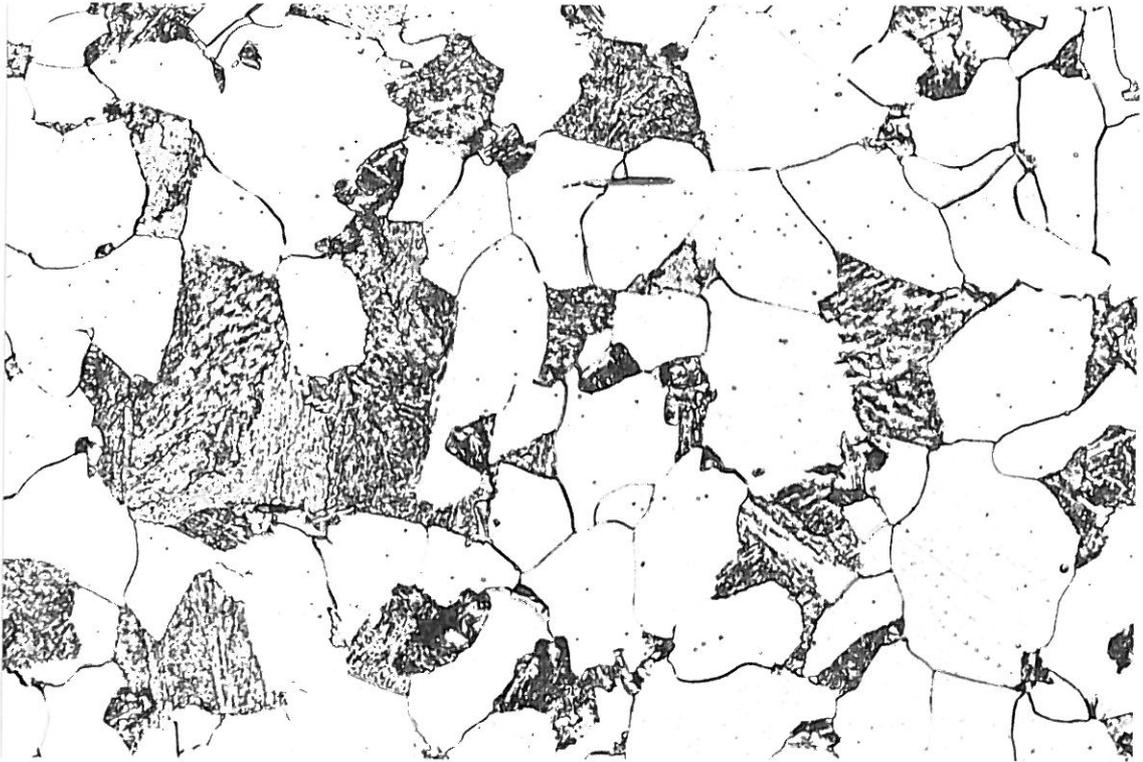
*Fig. 17. Steel 13 CrMo 4 4: as new, stage B. Magnification 500x.*

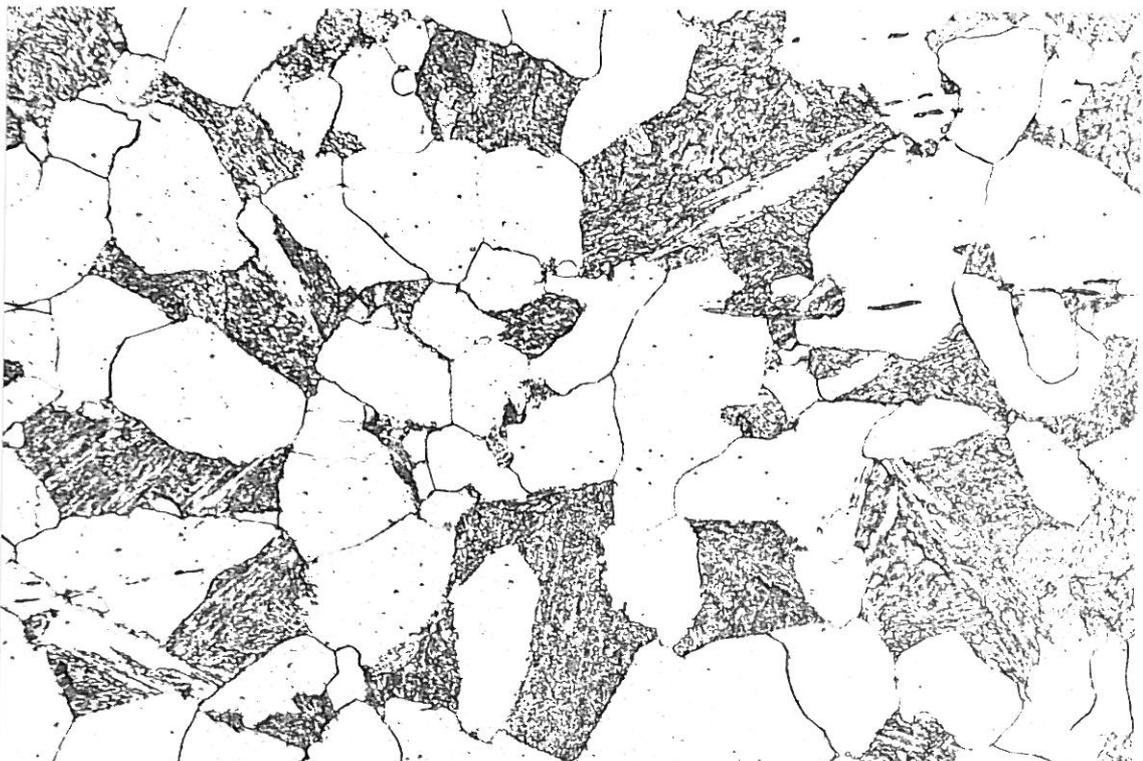
*Fig. 18. Steel 13 CrMo 4 4: 720°C / 3 h,  $P_{LM}(C = 12) = 12\ 400$ ,  $P_{LM}(C = 14) = 14\ 400$ , stage B. Magnification 500x.*

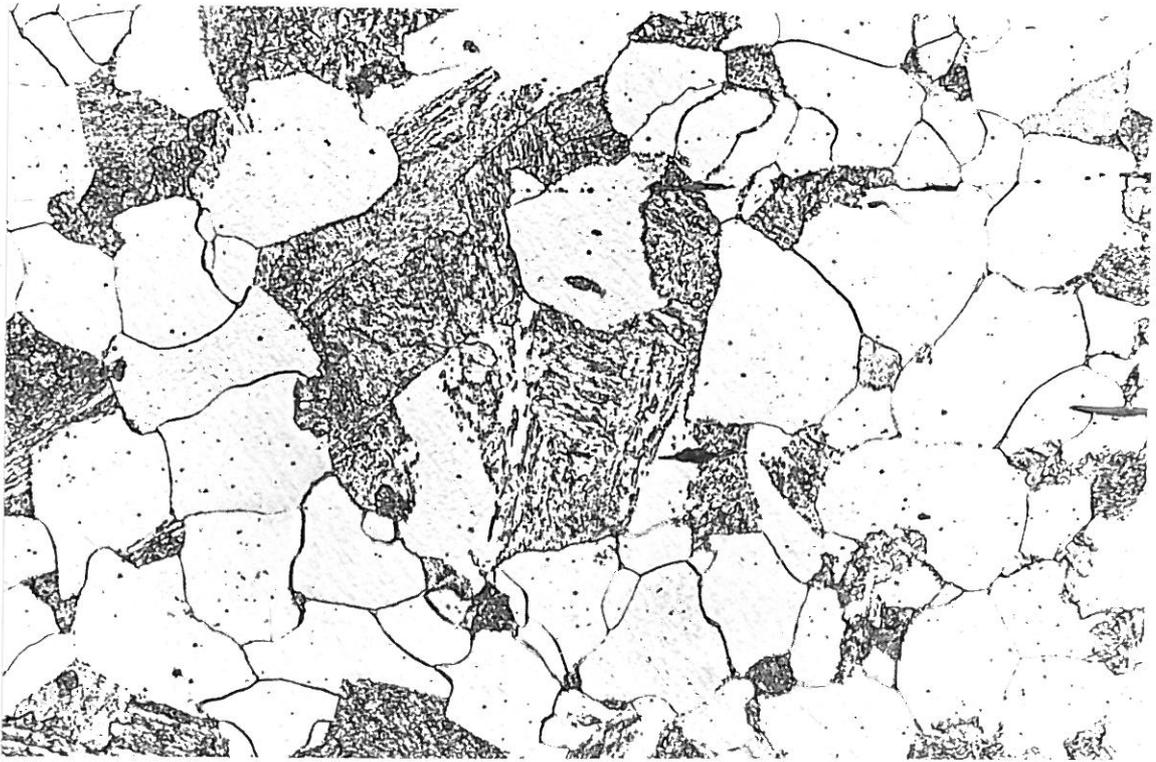
*Fig. 19. Steel 13CrMo 4 4: 720°C / 10 h,  $P_{LM}(C = 12) = 12\ 900$ ,  $P_{LM}(C = 14) = 14\ 900$ , stage C. Magnification 500x.*

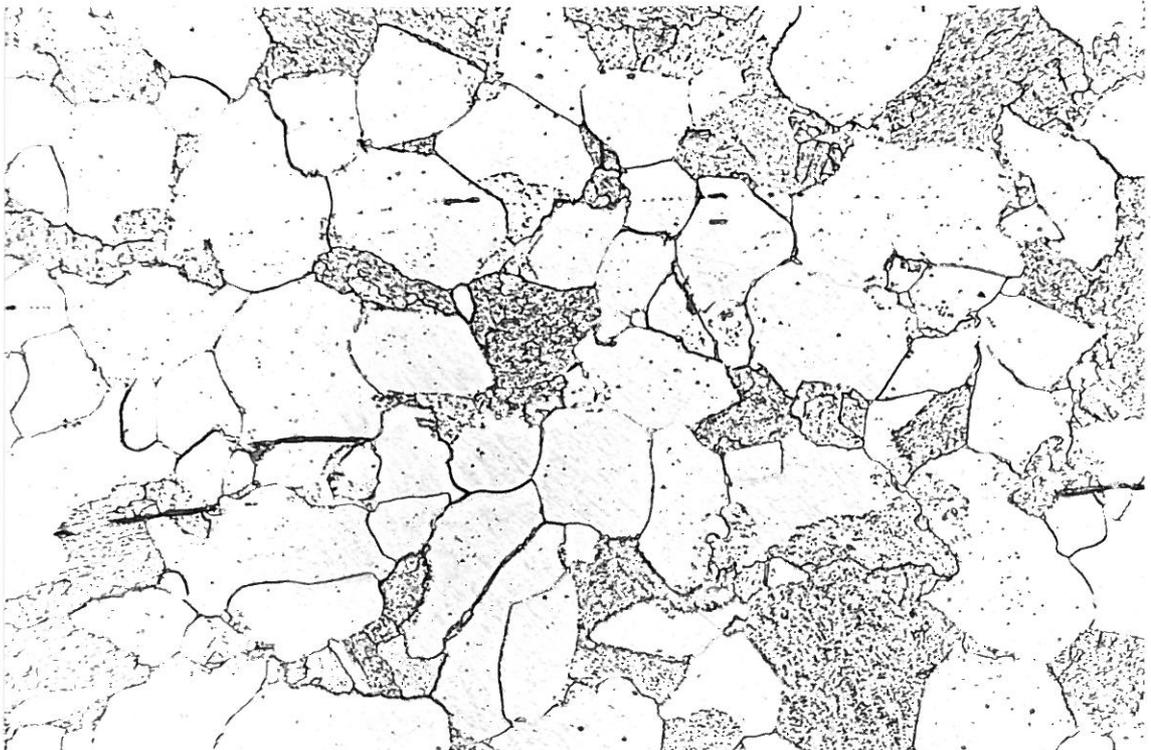
*Fig. 20. Steel 13CrMo 4 4: 720°C / 30 h,  $P_{LM}(C = 12) = 13\ 400$ ,  $P_{LM}(C = 14) = 15\ 400$ , stage D. Magnification 500x.*

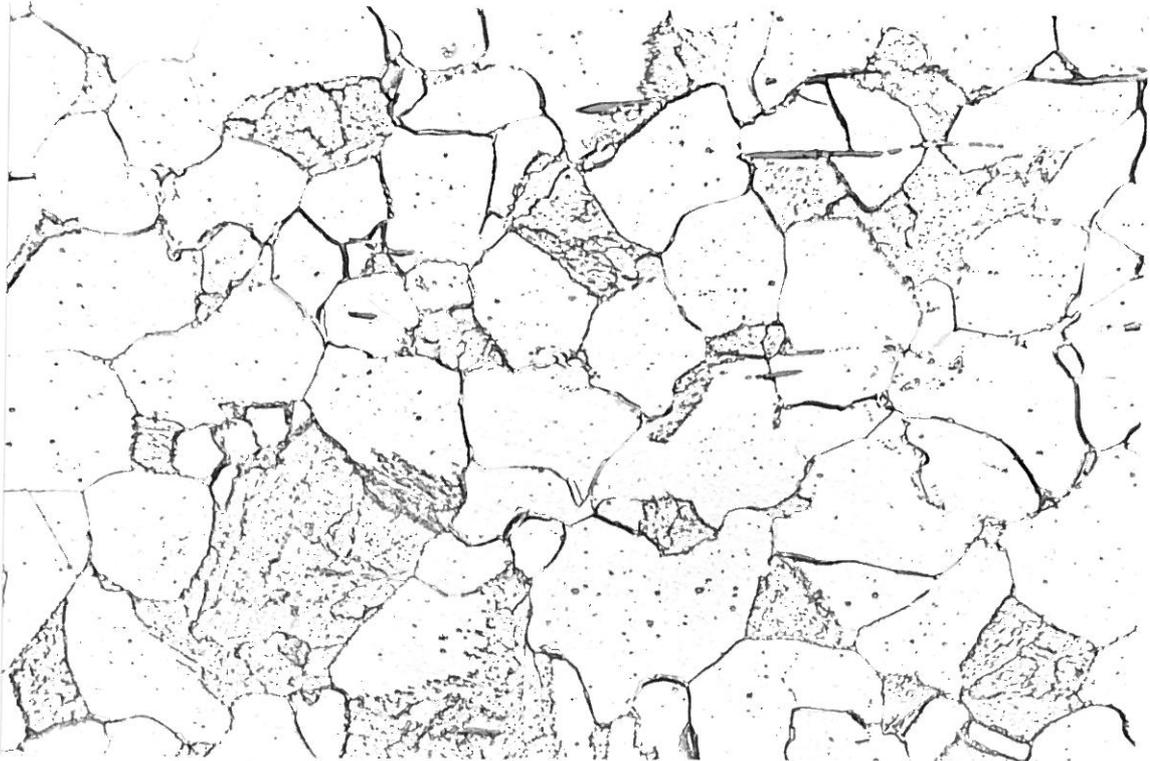
*Fig. 21. Steel 13 CrMo 4 4: 720°C / 100 h,  $P_{LM}(C = 12) = 13\ 900$ ,  $P_{LM}(C = 14) = 15\ 900$ , stage E. Magnification 500x.*

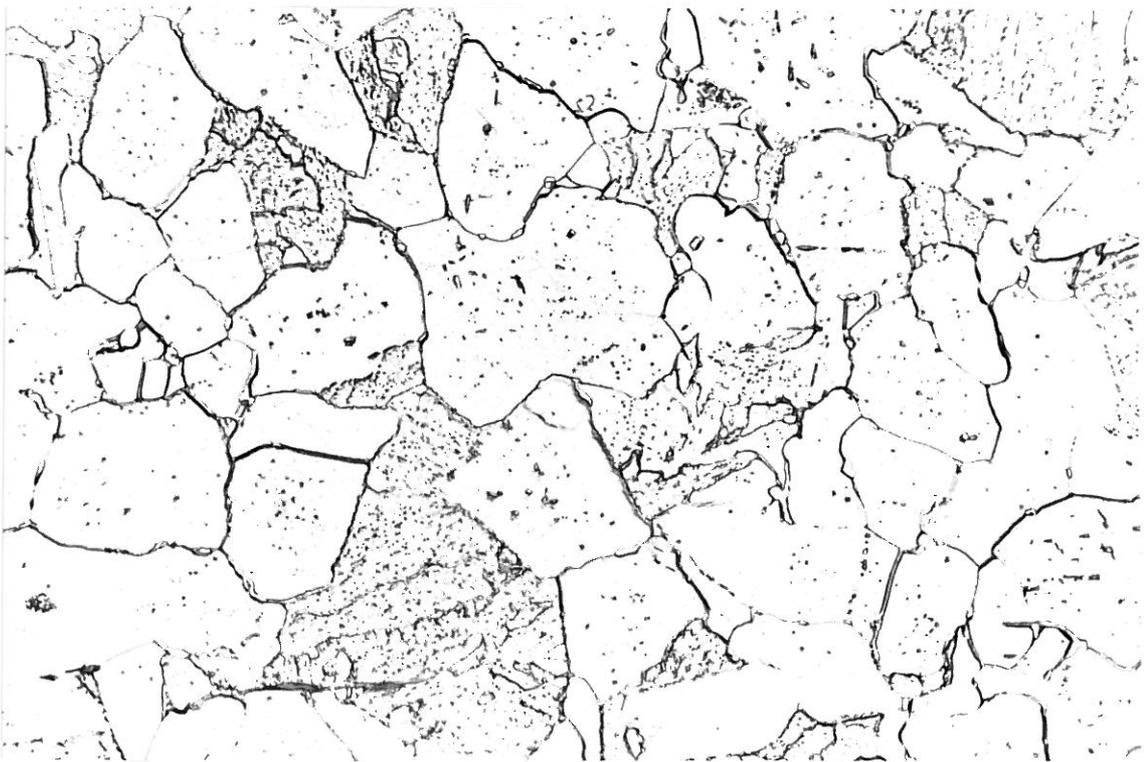
*Fig. 22. Steel 13 CrMo 4 4: 740°C / 100 h,  $P_{LM}(C = 12) = 14\ 200$ ,  $P_{LM}(C = 14) = 16\ 200$ , stage E. Magnification 500x.*

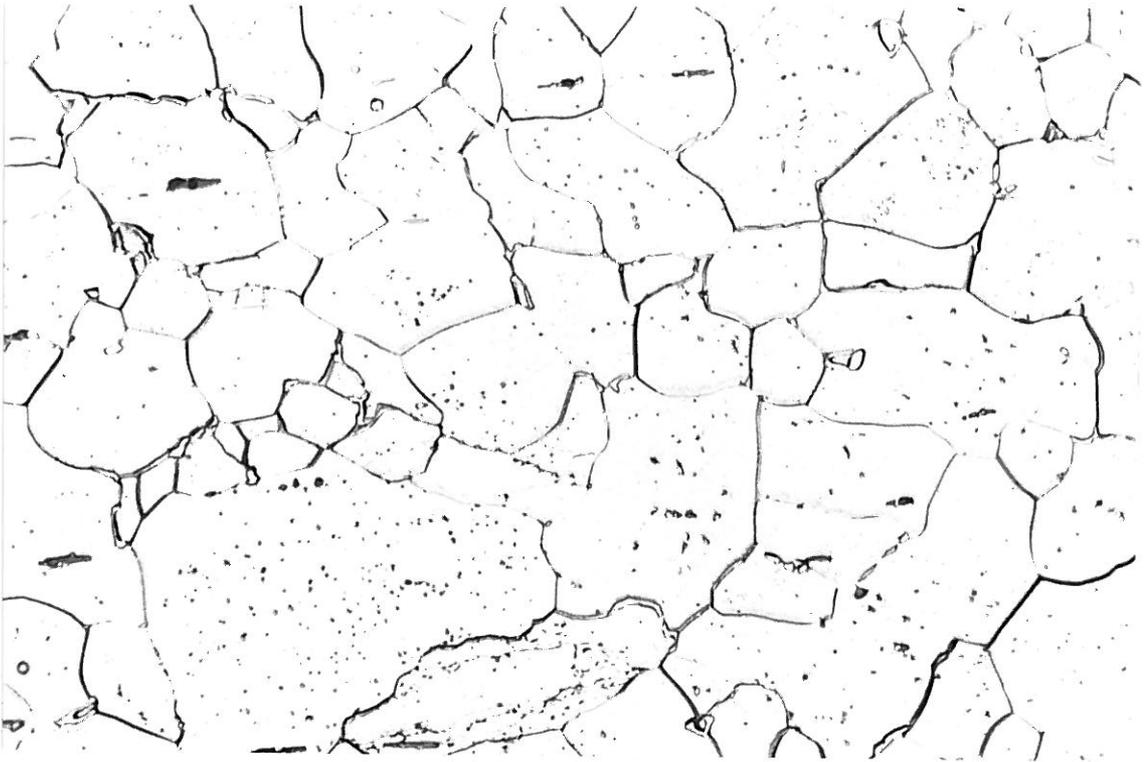
Fig. 23. Steel 13 CrMo 4 4: 740°C / 300 h,  $P_{LM}(C = 12) = 14\ 700$ ,  $P_{LM}(C = 14) = 16\ 700$ , stages E/F. Magnification 500x.

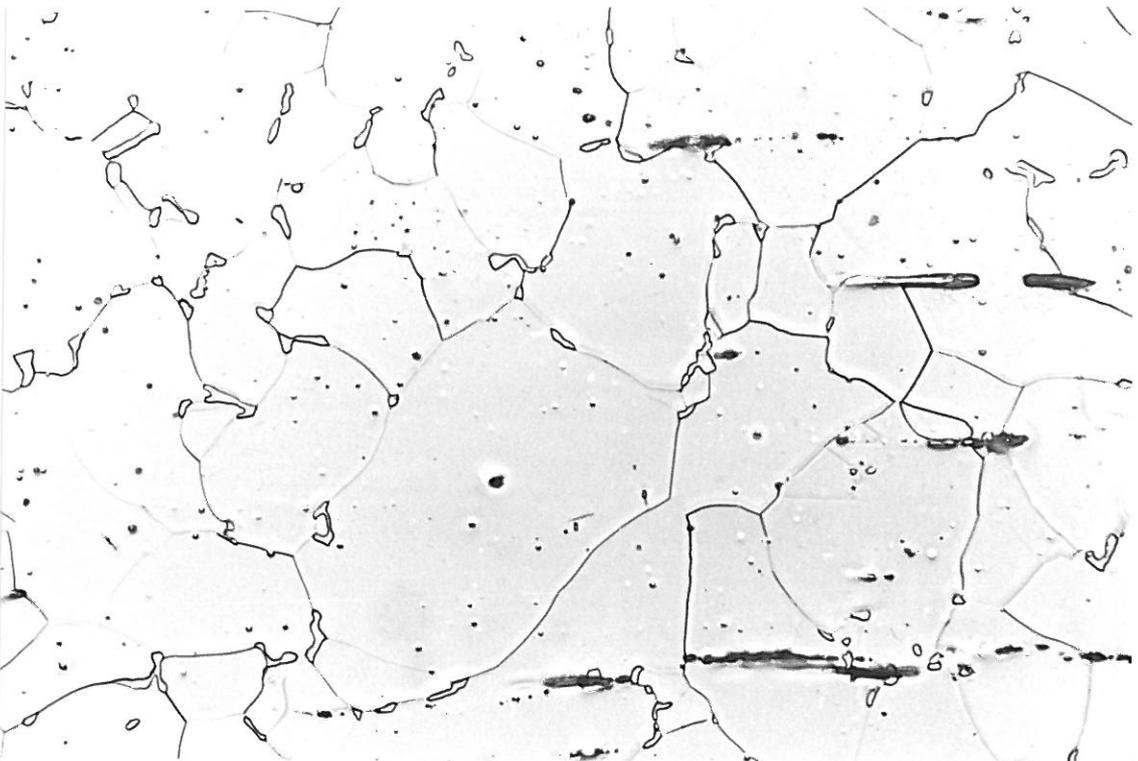
Fig. 24. Steel 13 CrMo 4 4: 740°C / 1000 h,  $P_{LM}(C = 12) = 15\ 200$ ,  $P_{LM}(C = 14) = 17\ 200$ , stage F. Magnification 500x.

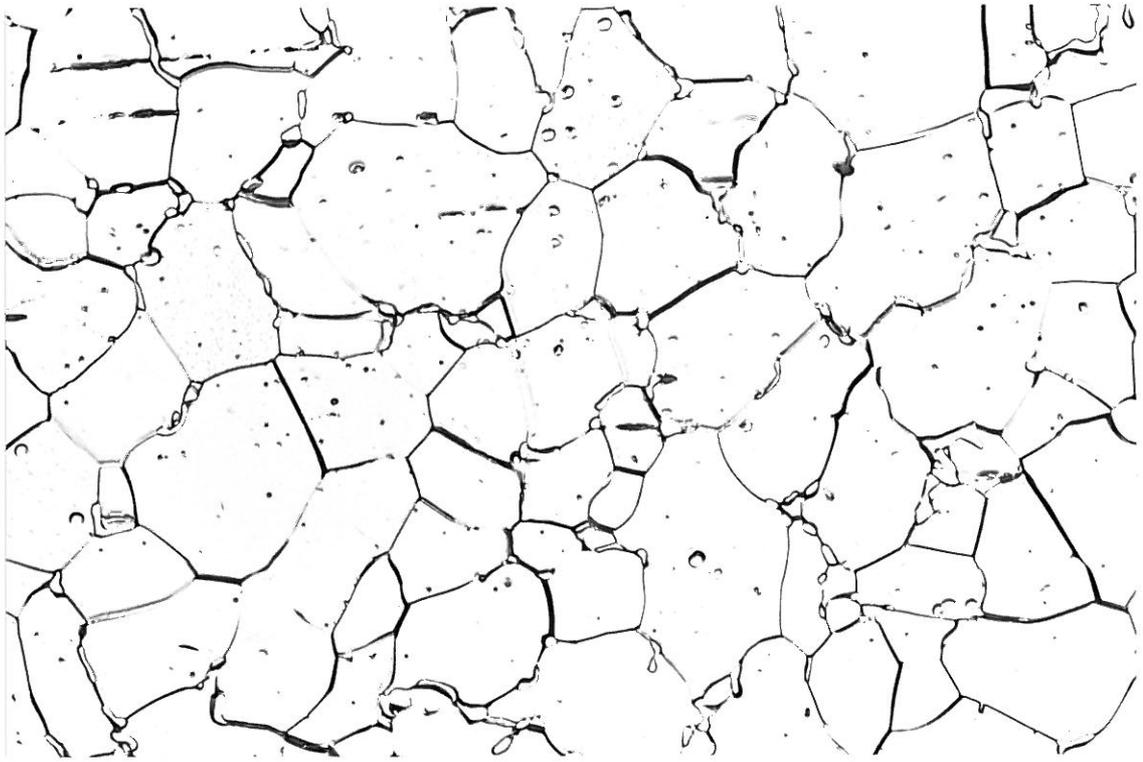
*Fig. 25. Steel 13 CrMo 4 4: 740°C / 2000 h,  $P_{LM}(C = 12) = 15\ 500$ ,  $P_{LM}(C = 14) = 17\ 500$ , stage F. Magnification 500x.*

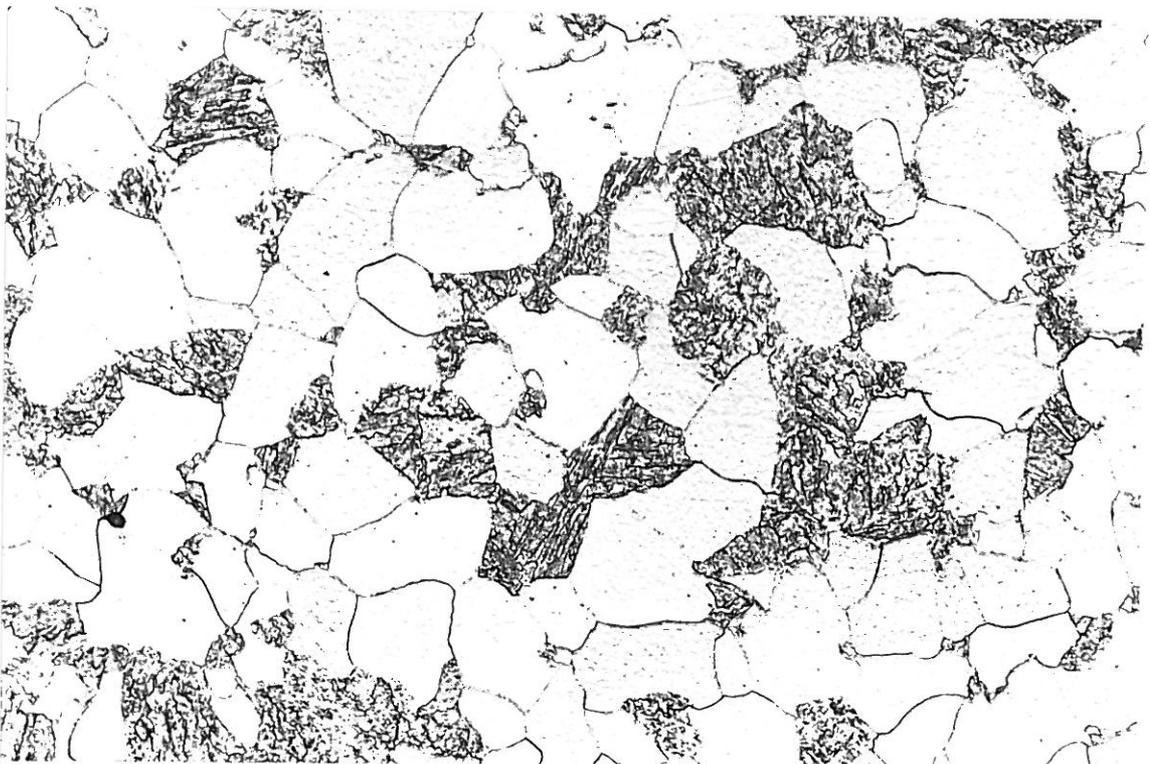
*Fig. 26. Steel 10 CrMo 9 10: as new, stage B. Magnification 500x.*

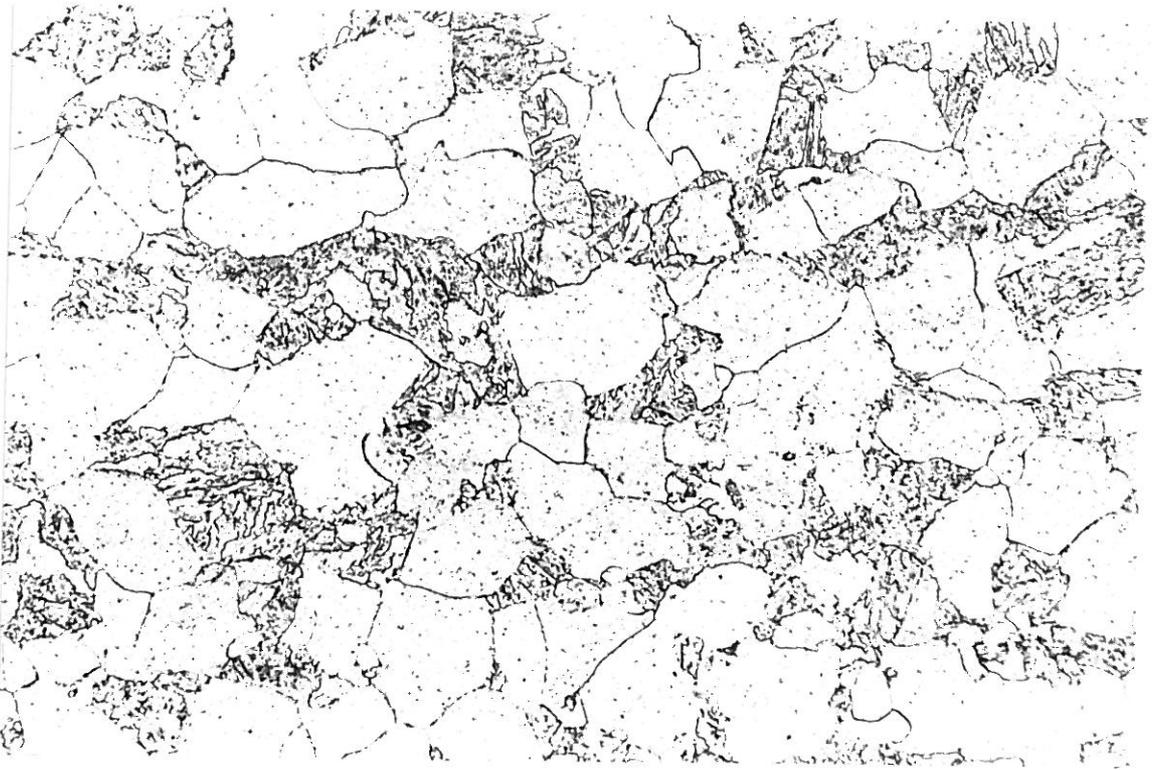
*Fig. 27. Steel 10 CrMo 9 10: 720°C / 3 h,  $P_{LM}(C = 14) = 14\ 400$ , stage B/C. Magnification 500x.*

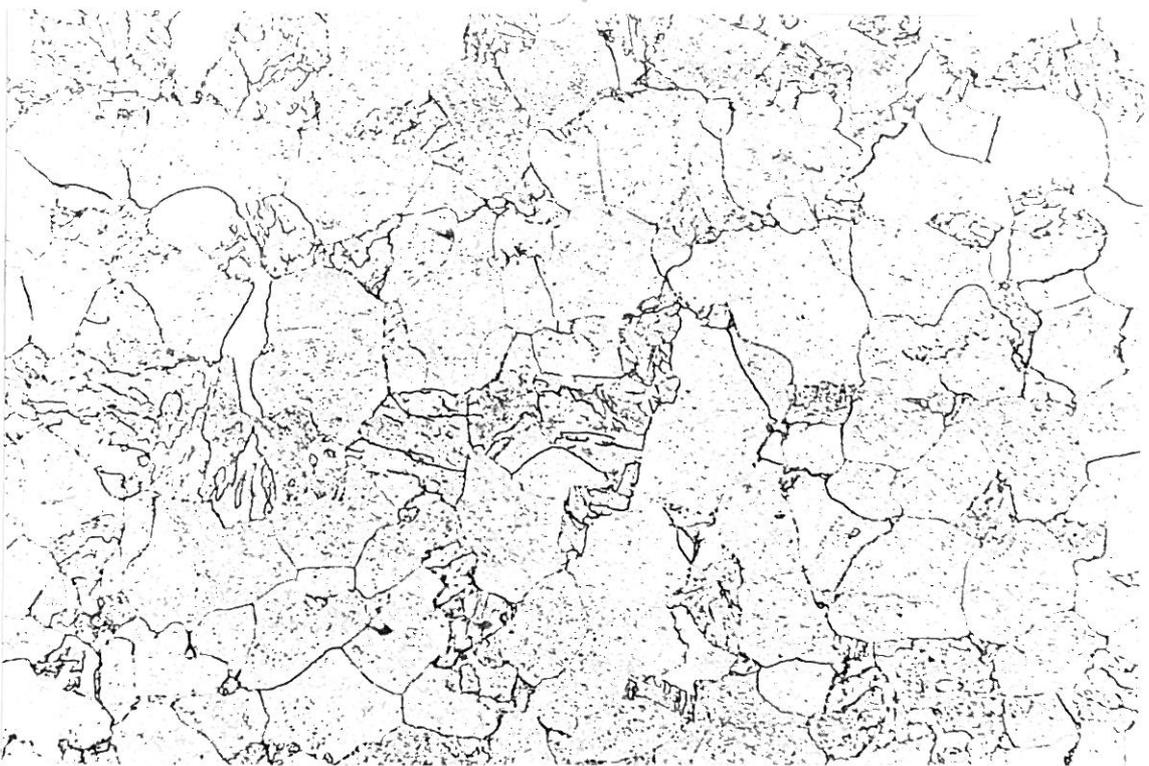
*Fig. 28. Steel 10 CrMo 9 10: 720°C / 10 h,  $P_{LM}(C = 14) = 14\ 900$ , stage C. Magnification 500x.*

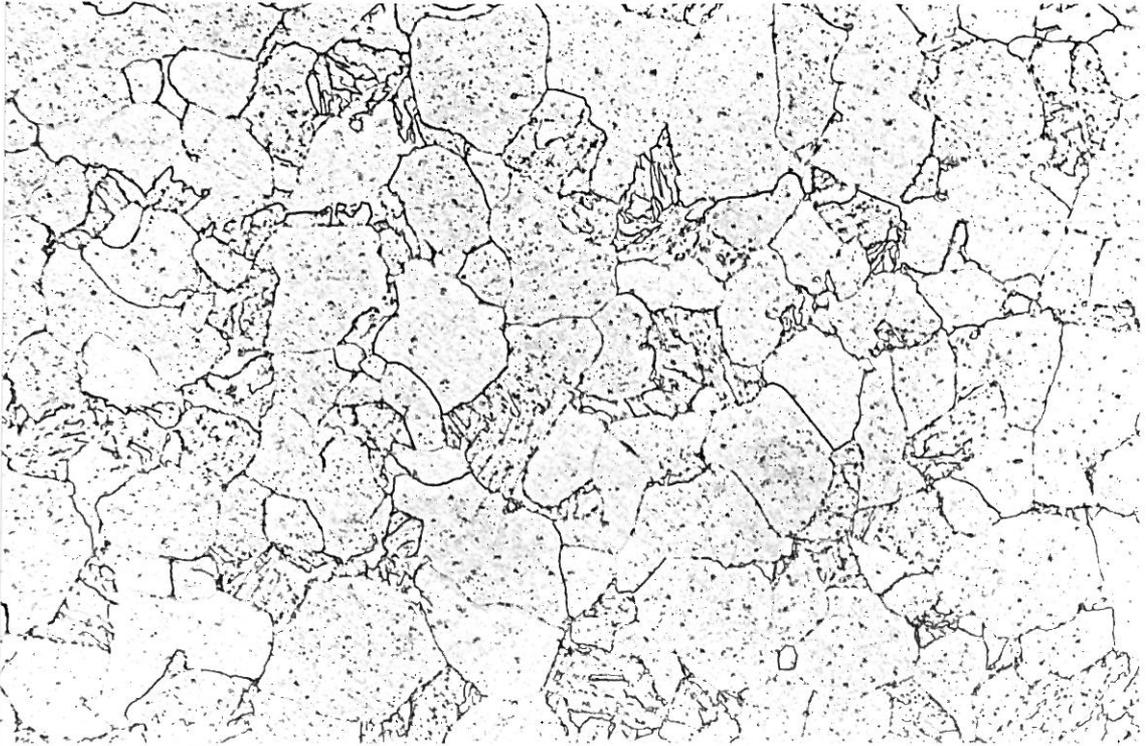
*Fig. 29. Steel 10 CrMo 9 10: 720°C / 30 h,  $P_{LM}(C = 14) = 15\ 400$ , stage D. Magnification 500x.*

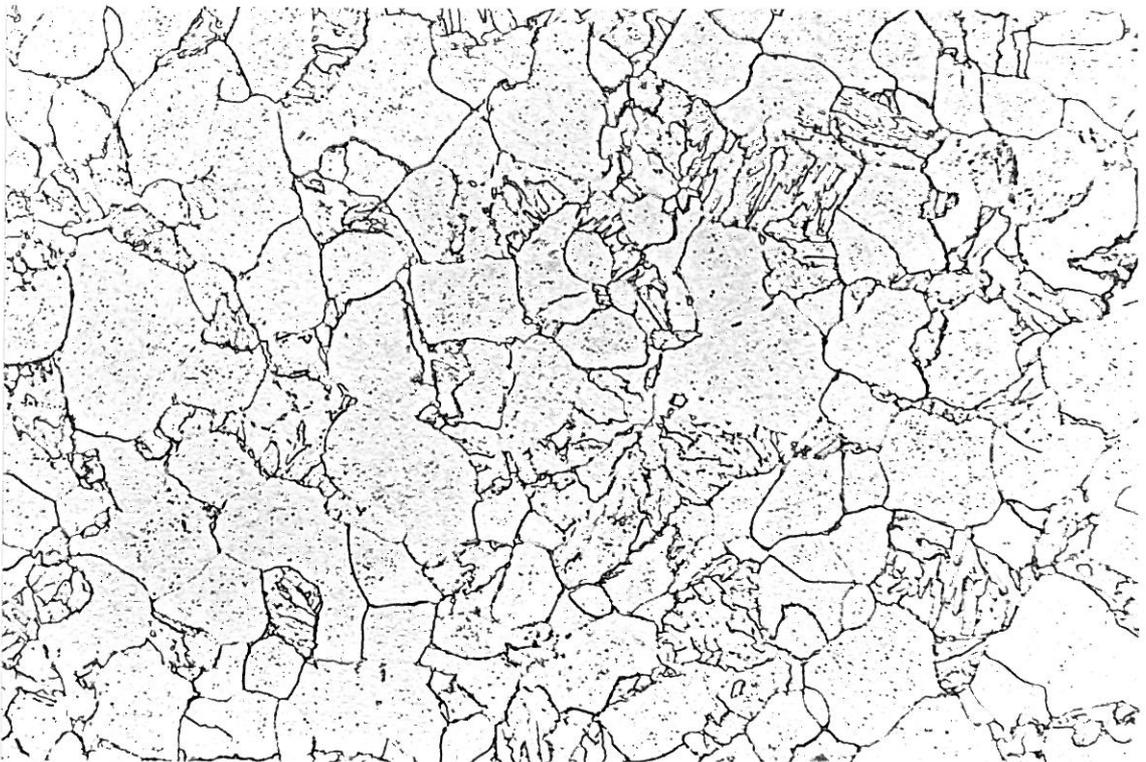
*Fig. 30. Steel 10 CrMo 9 10: 720°C / 100 h,  $P_{LM}(C = 14) = 15\ 900$ , stage D. Magnification 500x.*

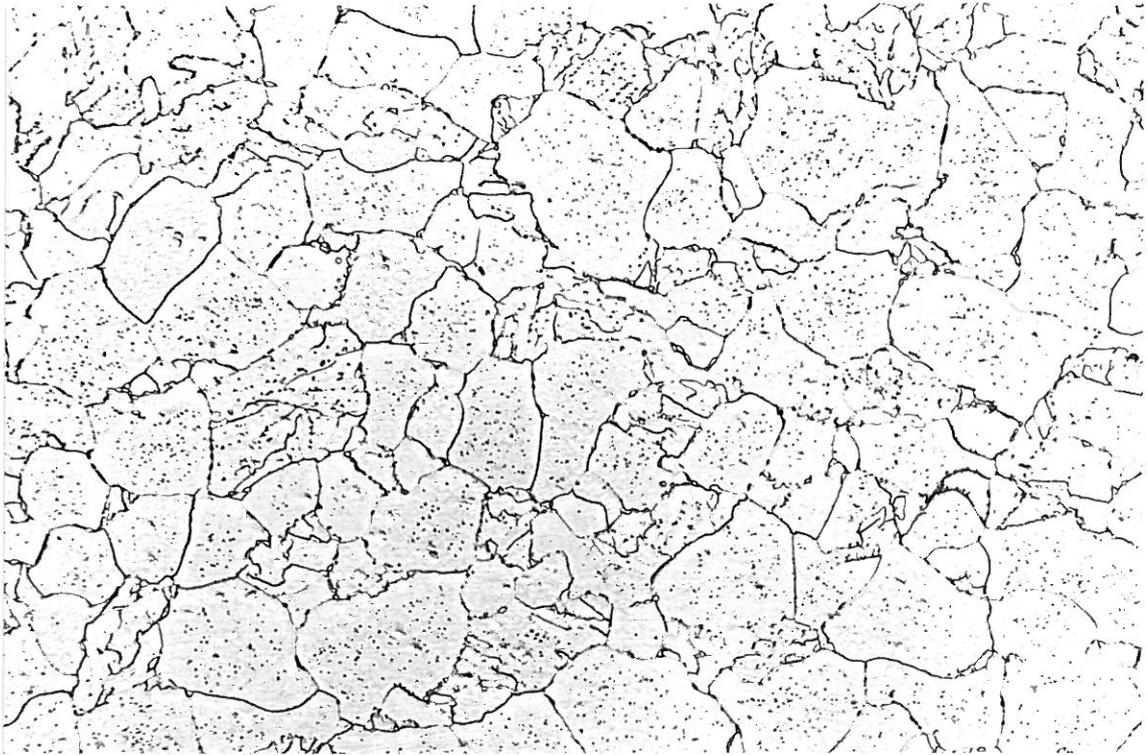
*Fig. 31. Steel 10 CrMo 9 10: 720°C / 300 h,  $P_{LM} (C = 14) = 16\ 400$ , stage E. Magnification 500x.*

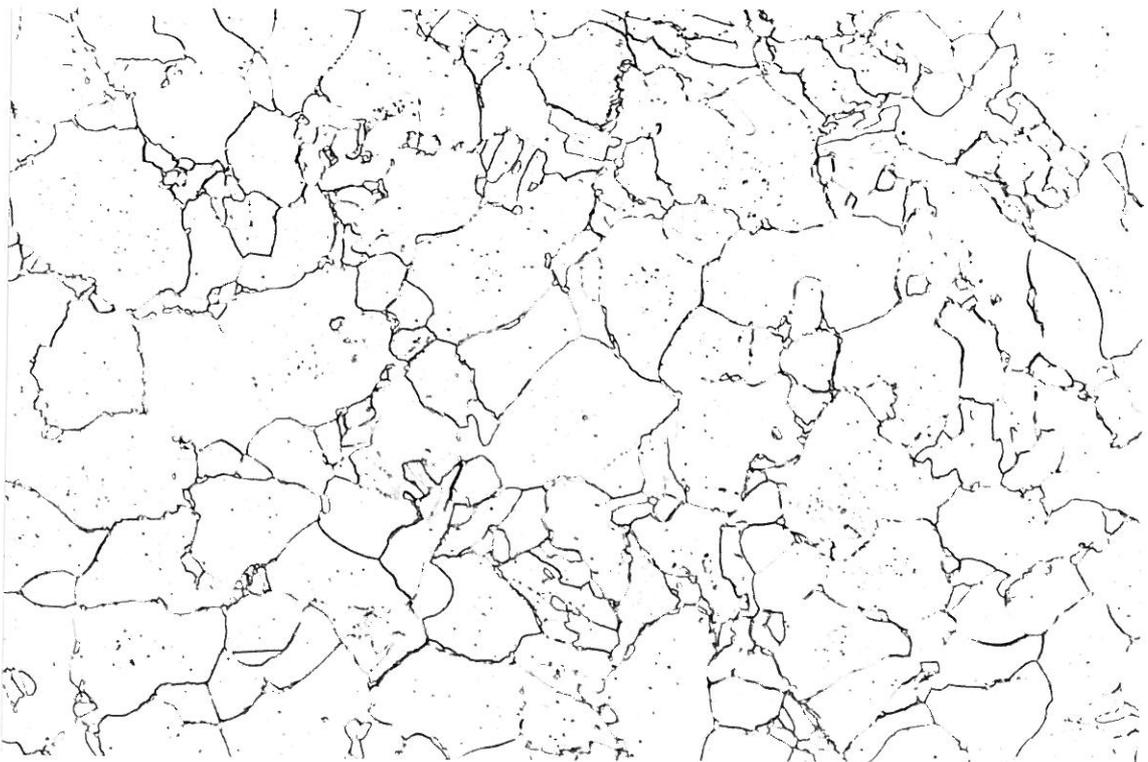
*Fig. 32. Steel 10 CrMo 9 10: 740°C / 300 h,  $P_{LM} (C = 14) = 16\ 700$ , stage E. Magnification 500 x.*

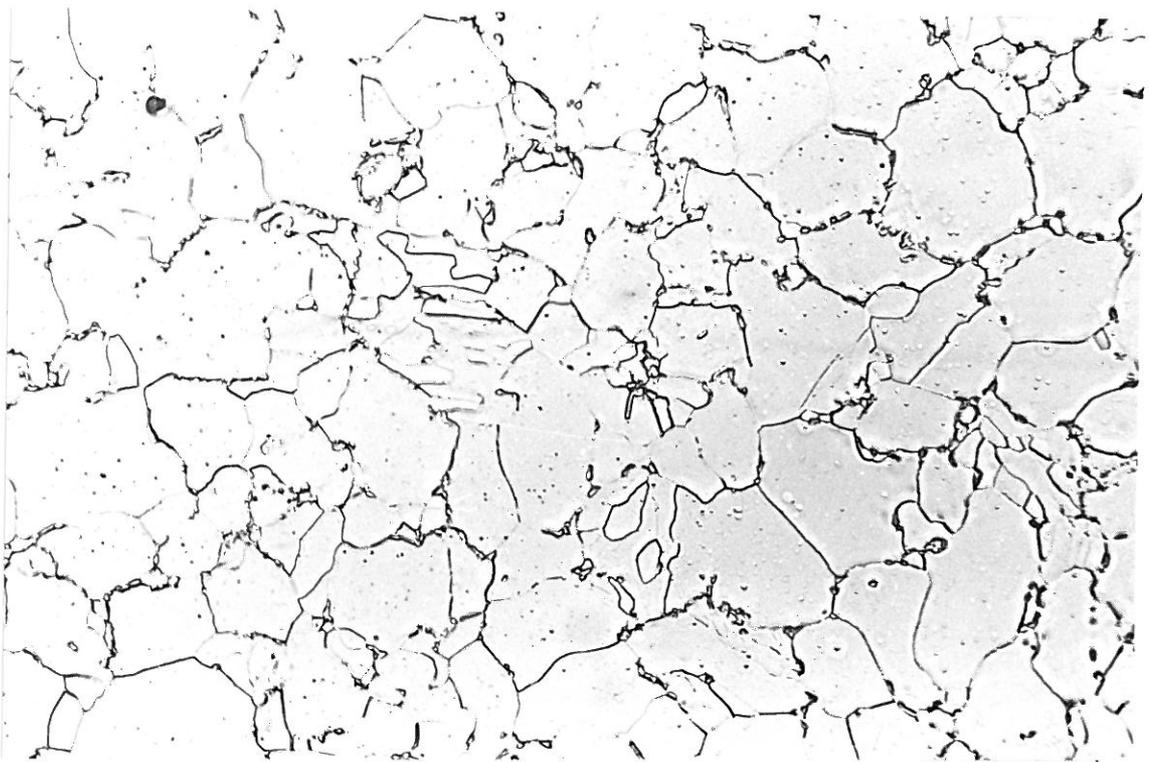
*Fig. 33. Steel 10CrMo910: 740°C / 1000 h,  $P_{LM}(C = 14) = 17\ 200$ , stage E/F. Magnification 500x.*

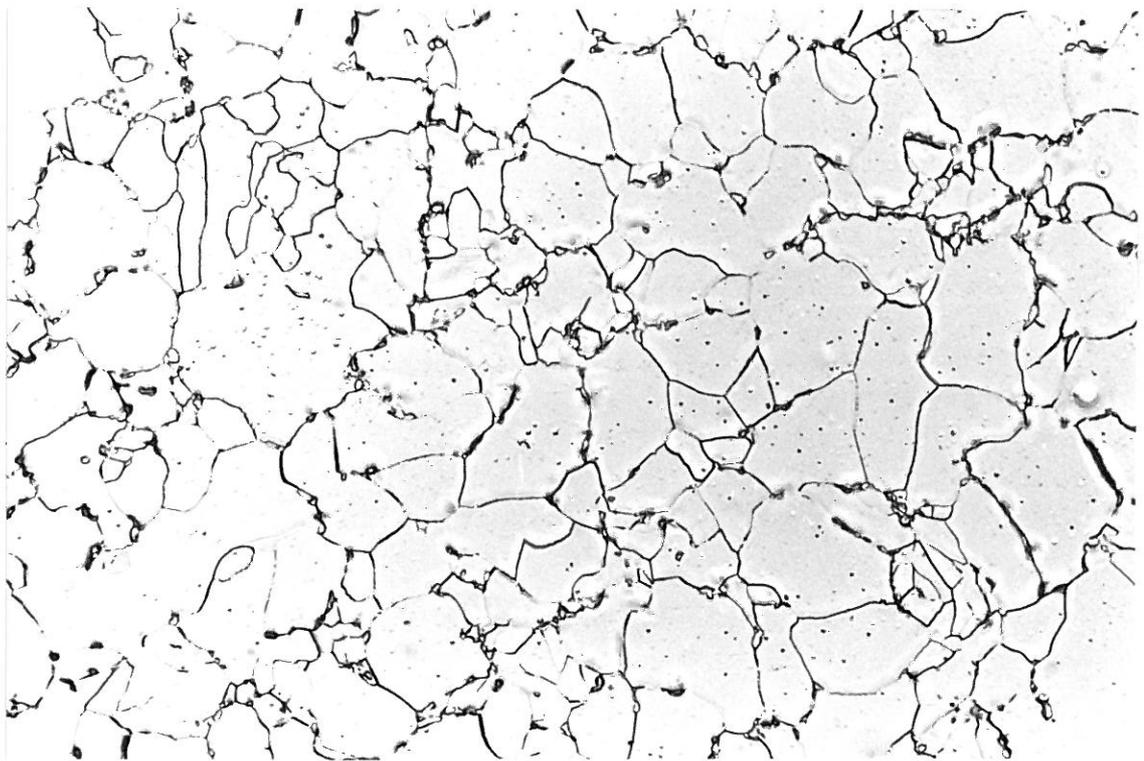
*Fig. 34. Steel 10CrMo910: 740°C / 2000 h,  $P_{LM}(C = 14) = 17\ 500$ , stage F. Magnification 500x.*

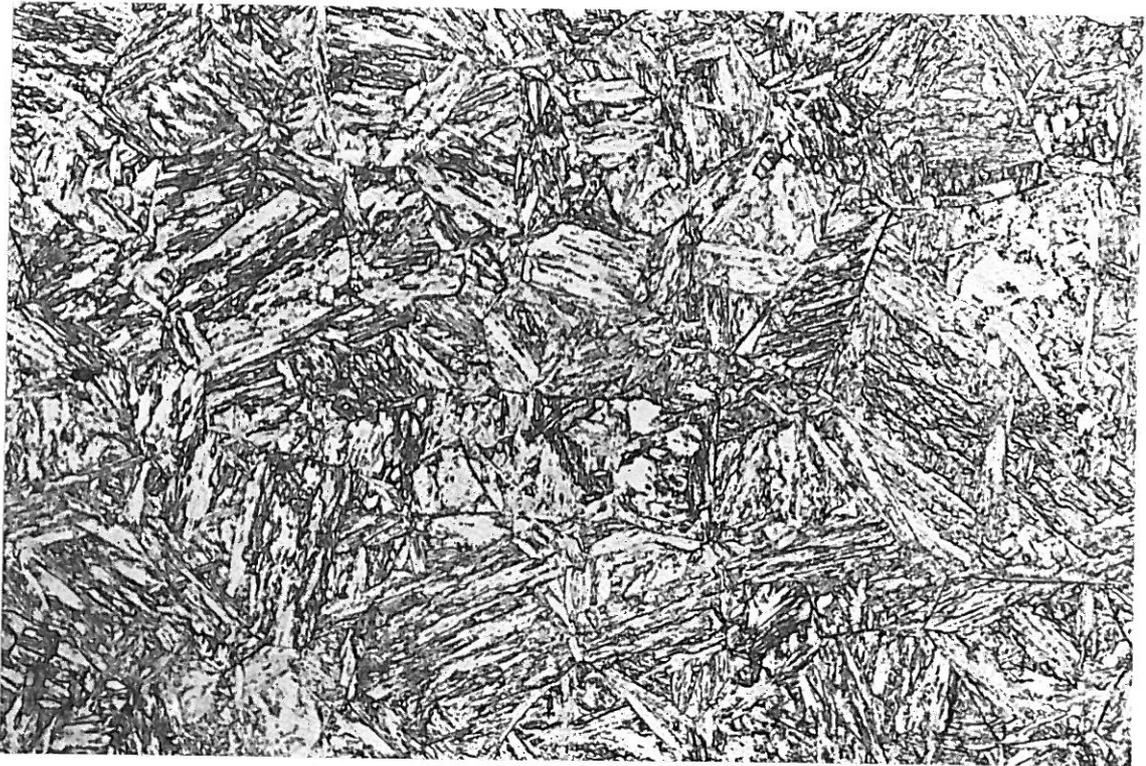
*Fig. 35. Steel X 20 CrMoV 12 1: as new, stage B. Magnification 500x.*

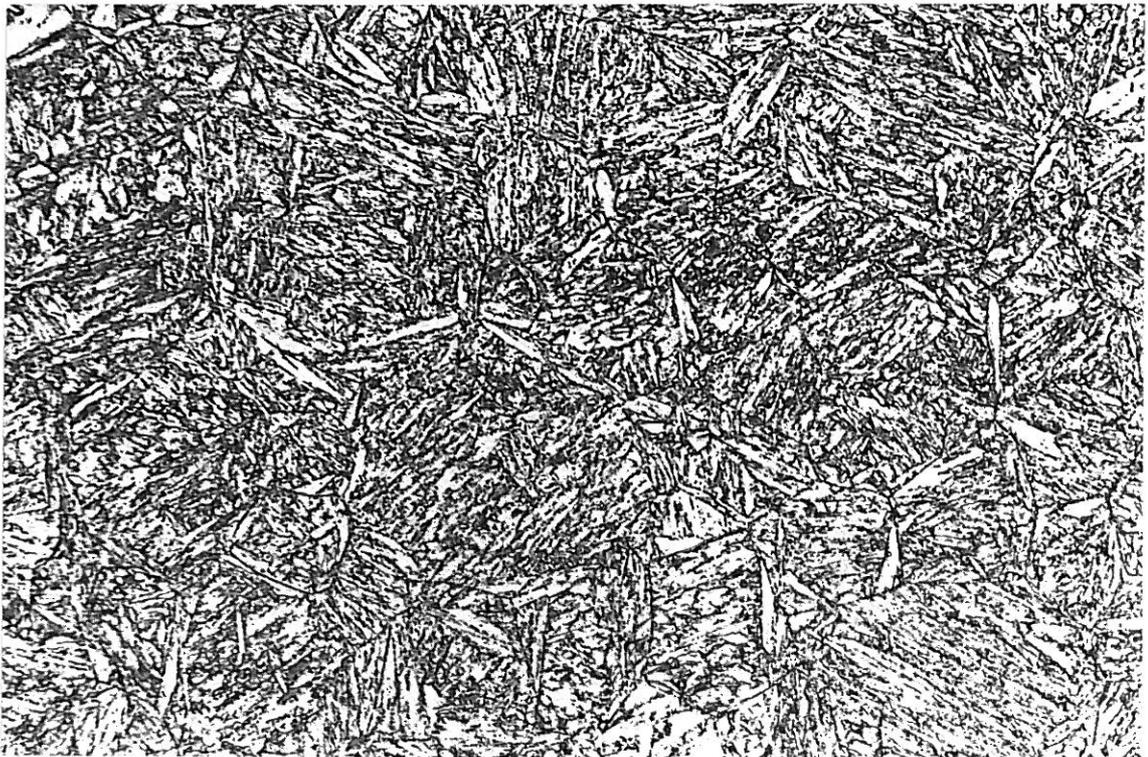
*Fig. 36. Steel X 20 CrMoV 12 1: 720°C / 10 h,  $P_{LM} (C = 14) = 14\ 900$ , stage B. Magnification 500x.*

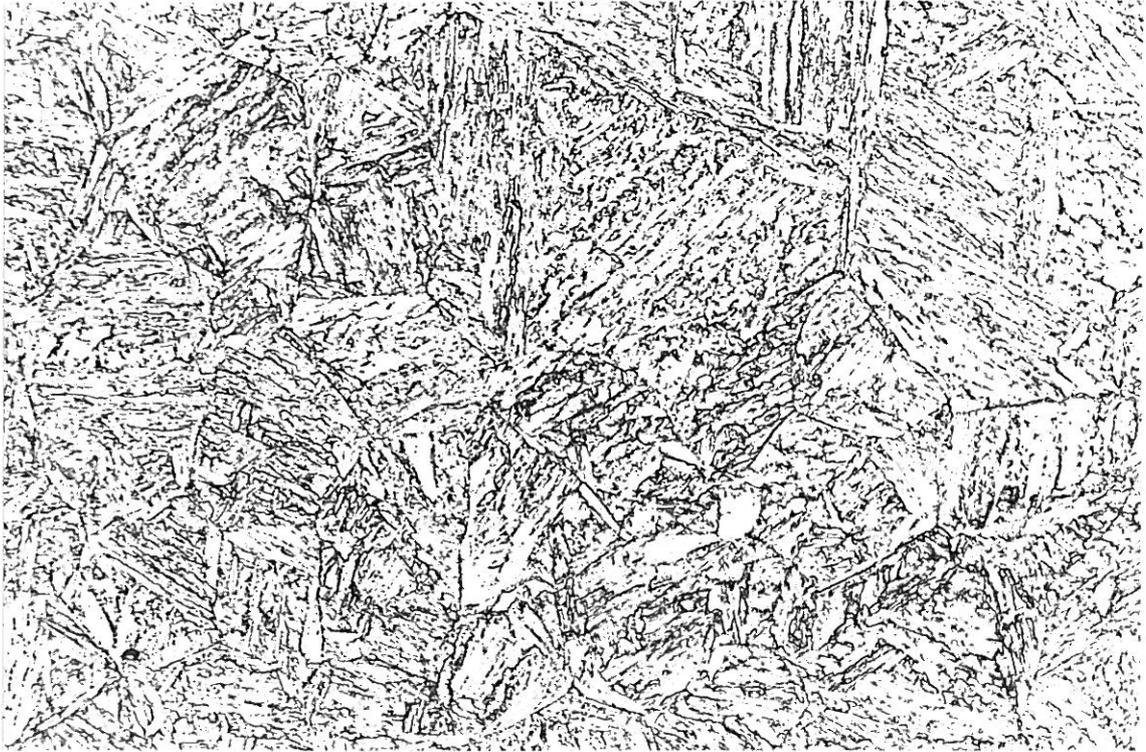
*Fig. 37. Steel X 20 CrMoV 12 1: 780°C / 3 h,  $P_{LM} (C = 14) = 15\ 200$ , stage B/C. Magnification 500x.*

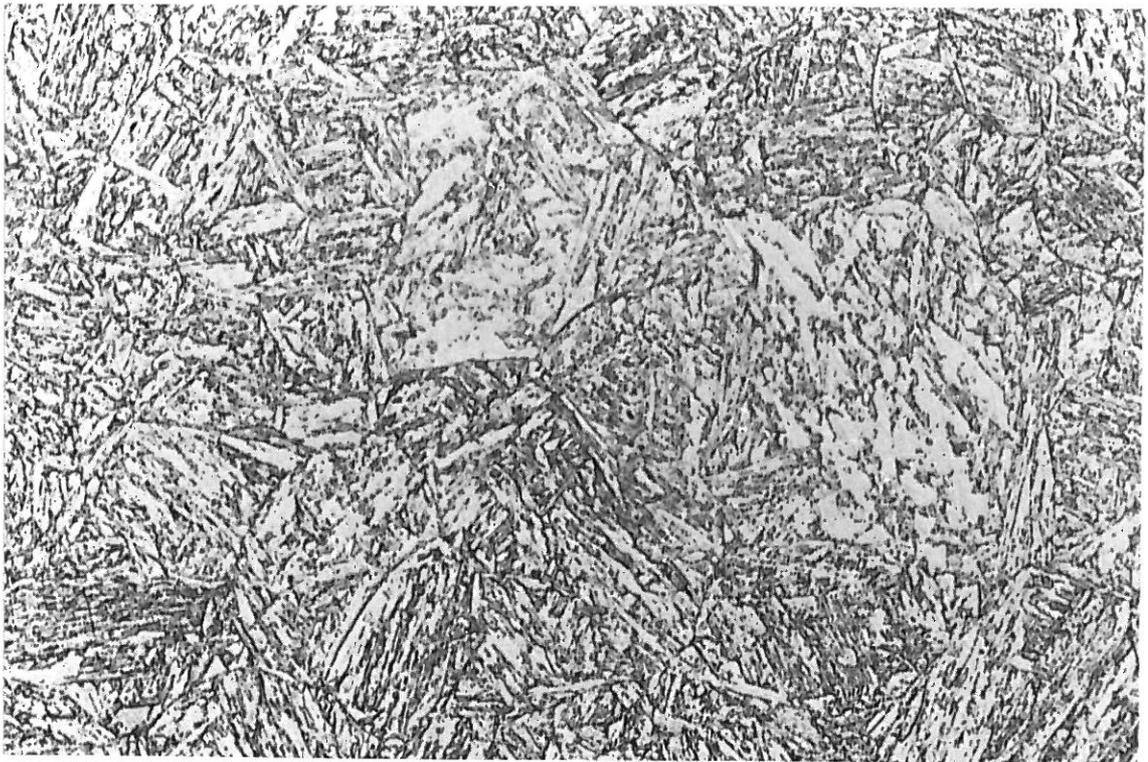
*Fig. 38. Steel X 20 CrMoV 12 1: 780°C / 10 h,  $P_{LM} (C = 14) = 15\ 800$ , stage C. Magnification 500x.*

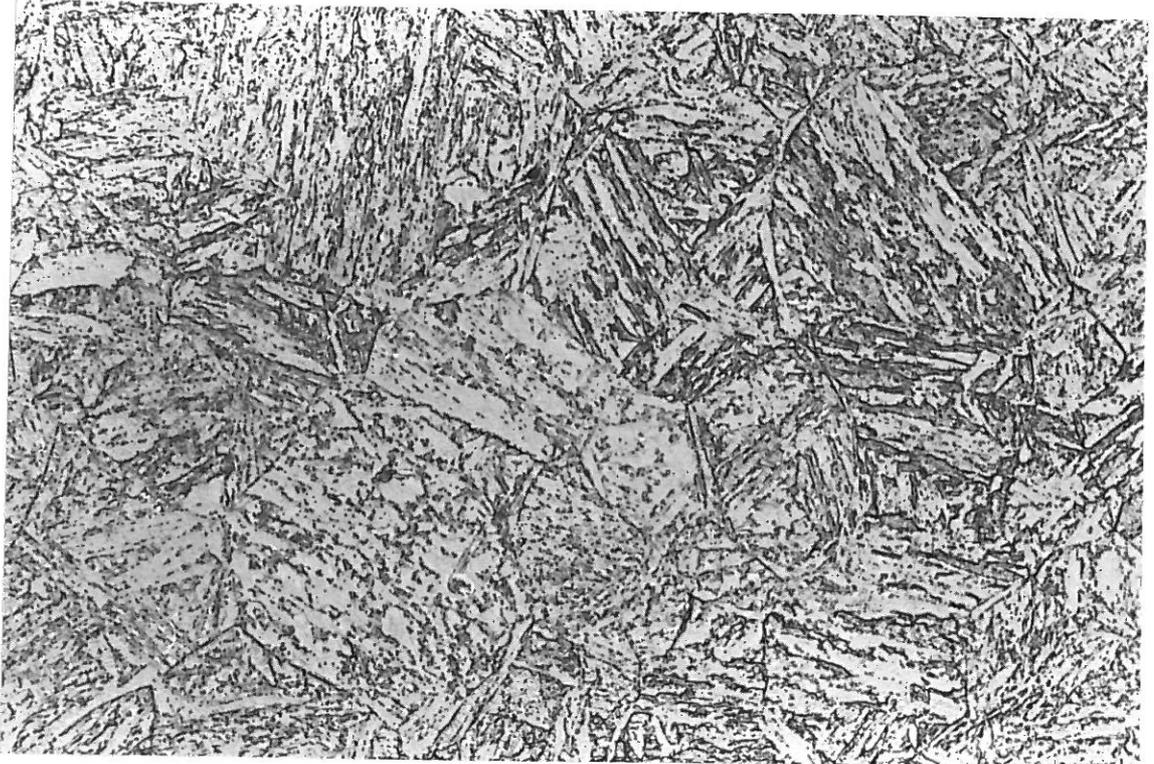
*Fig. 39. Steel X 20 CrMoV 12 1: 780°C / 30 h,  $P_{LM}(C = 14) = 16\ 300$ , stage D. Magnification 500x.*

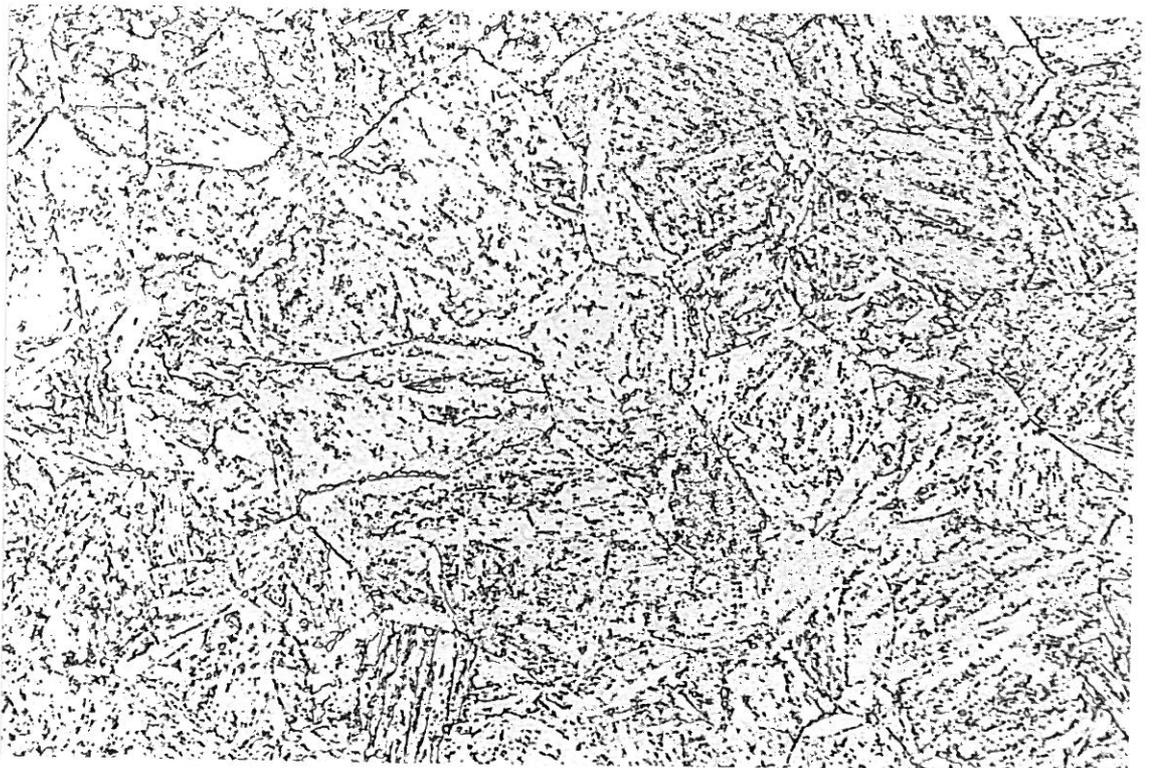
*Fig. 40. Steel X 20 CrMoV 12 1: 780°C / 100 h,  $P_{LM}(C = 14) = 16\ 800$ , stage E. Magnification 500x.*

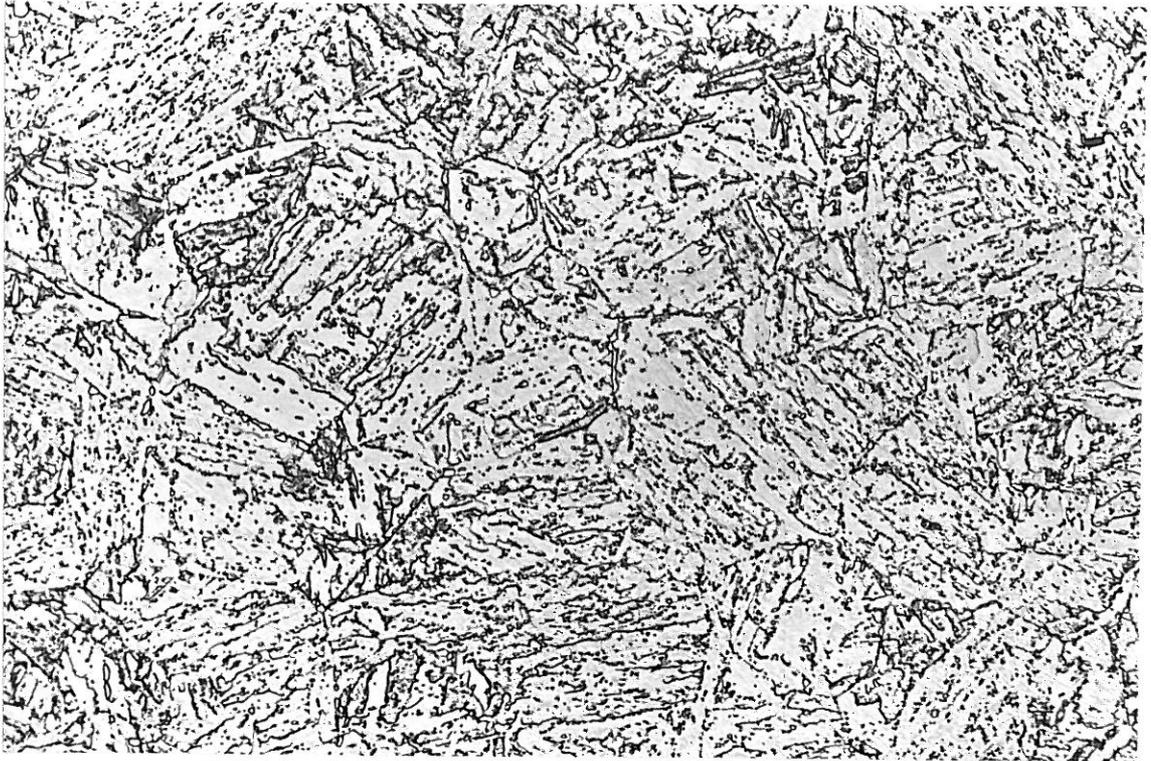
*Fig. 41. Steel X 20 CrMoV 12 1: 780°C / 300 h,  $P_{LM} (C = 14) = 17\ 400$ , stage E. Magnification 500x.*
