VTT PUBLICATIONS 280

# Microstructural degradation of boiler tube steels under long term exposure to high temperature

Jorma Salonen & Pertti Auerkari

VTT Manufacturing Technology

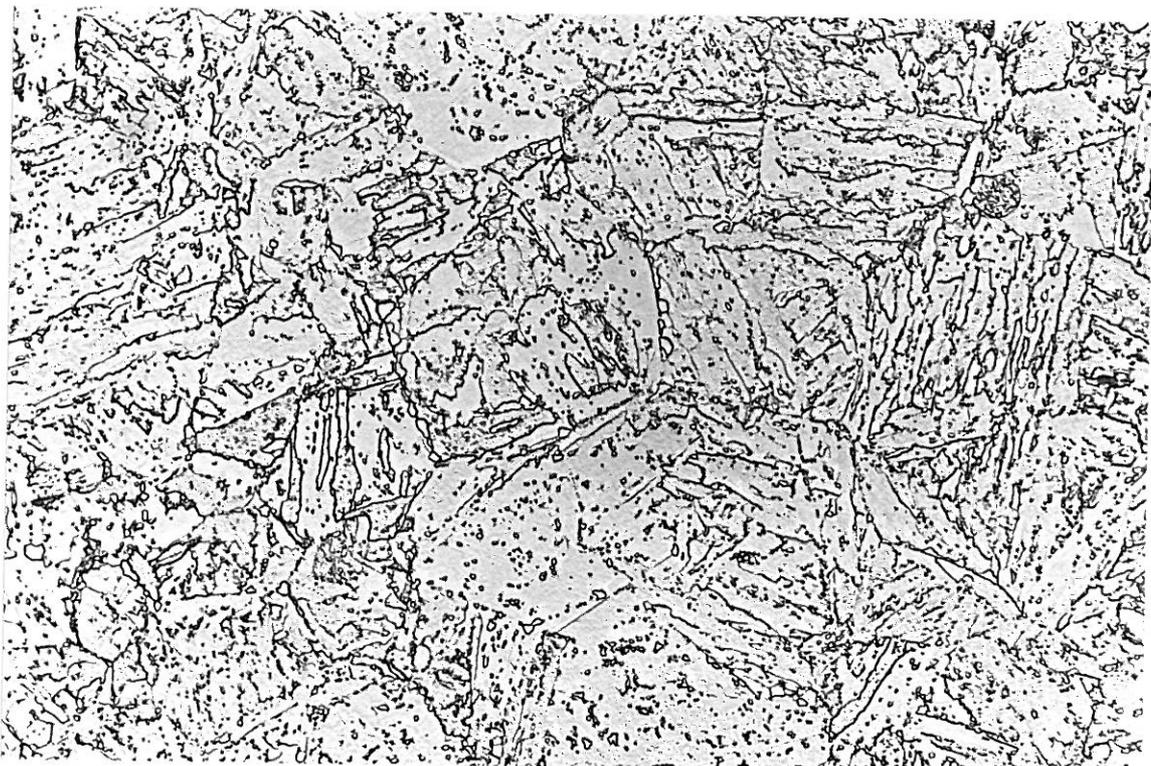
*Fig. 42. Steel X 20 CrMoV 12 1, 780°C, 1000 h,  $P_{LM} (C = 14) = 17\ 900$ , stage E. Magnification 500x.*

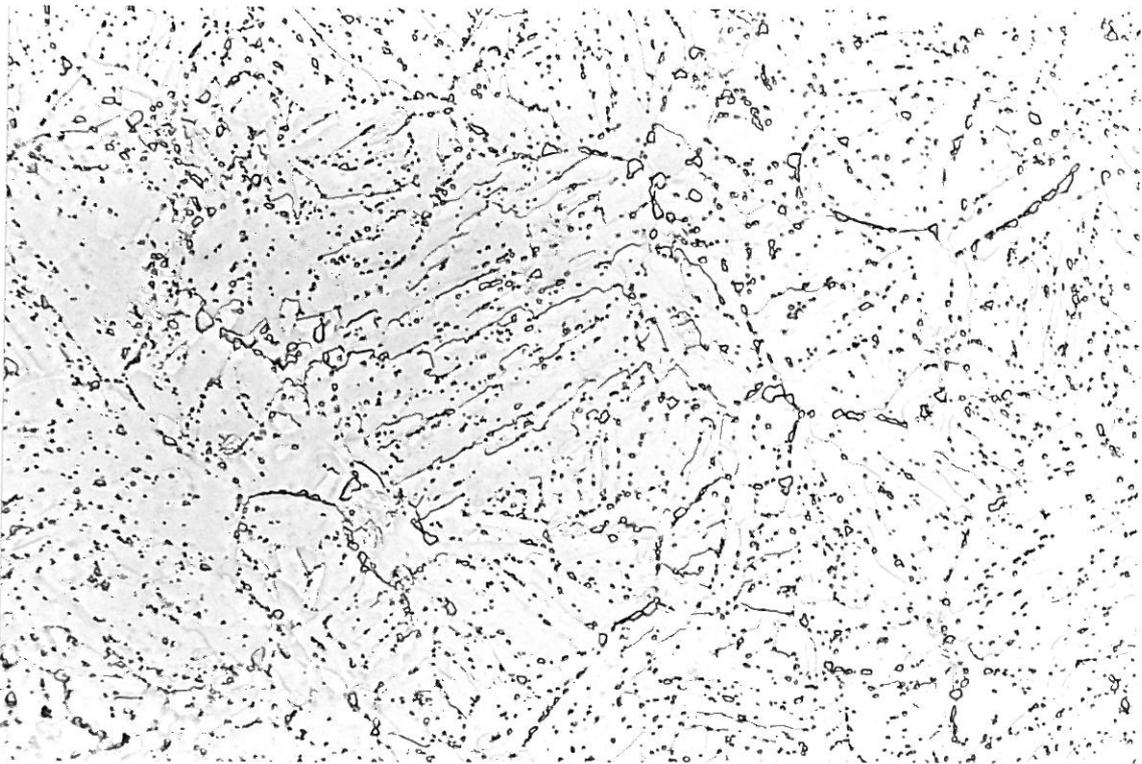
*Fig. 43. Steel X 20 CrMoV 12 1: 780°C / 2000 h,  $P_{LM}(C = 14) = 18\ 200$ , stage E. Magnification 500x.*

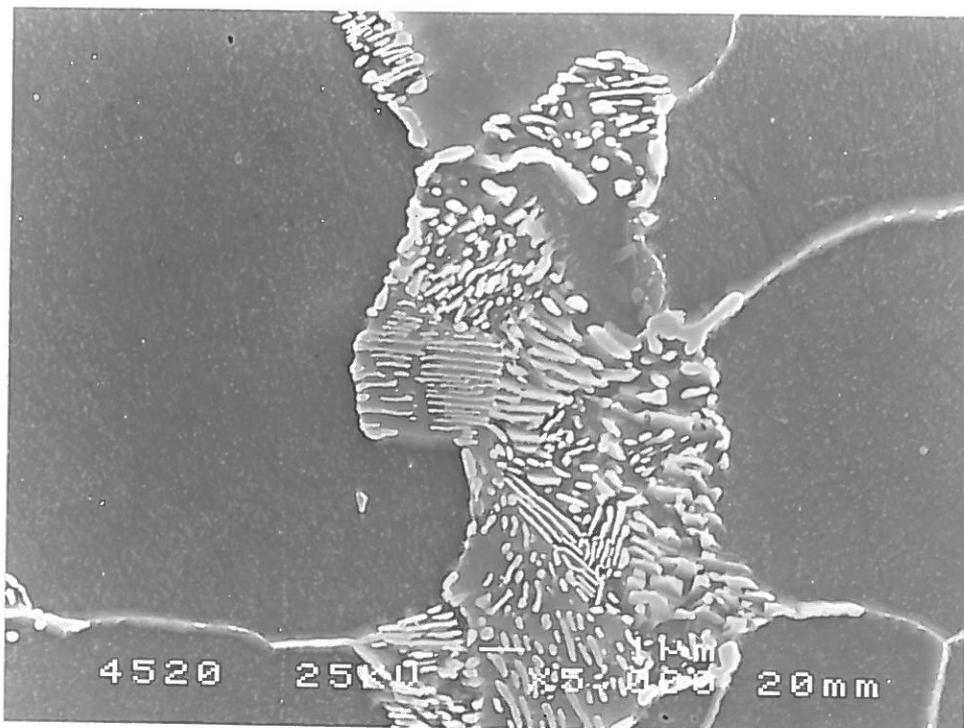
*Figs. 3 and 4. Steel St 35.8: 600°C / 3 h,  $P_{LM}(C = 14) = 12\ 600$ , stage A/B. Magnification 1500x (Fig. 3) and 5000x (Fig. 4).*

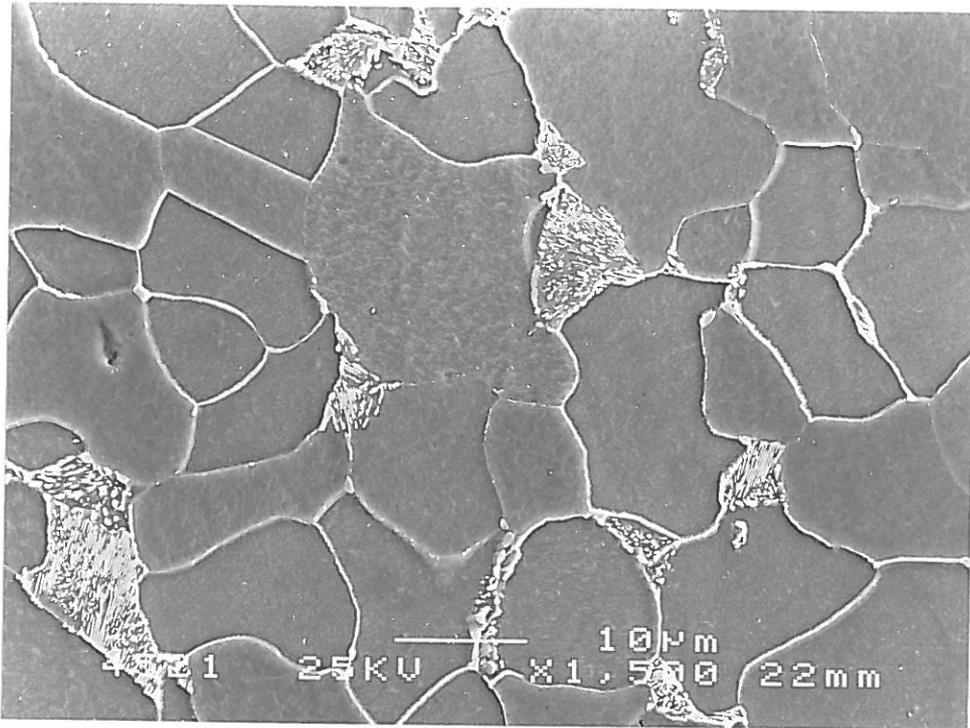
*Figs. 5 and 6. Steel St 35.8: 600°C / 10 h,  $P_{LM}(C = 14) = 13\ 100$ , stage B. Magnification 1500x (Fig. 5) and 5000x (Fig. 6).*

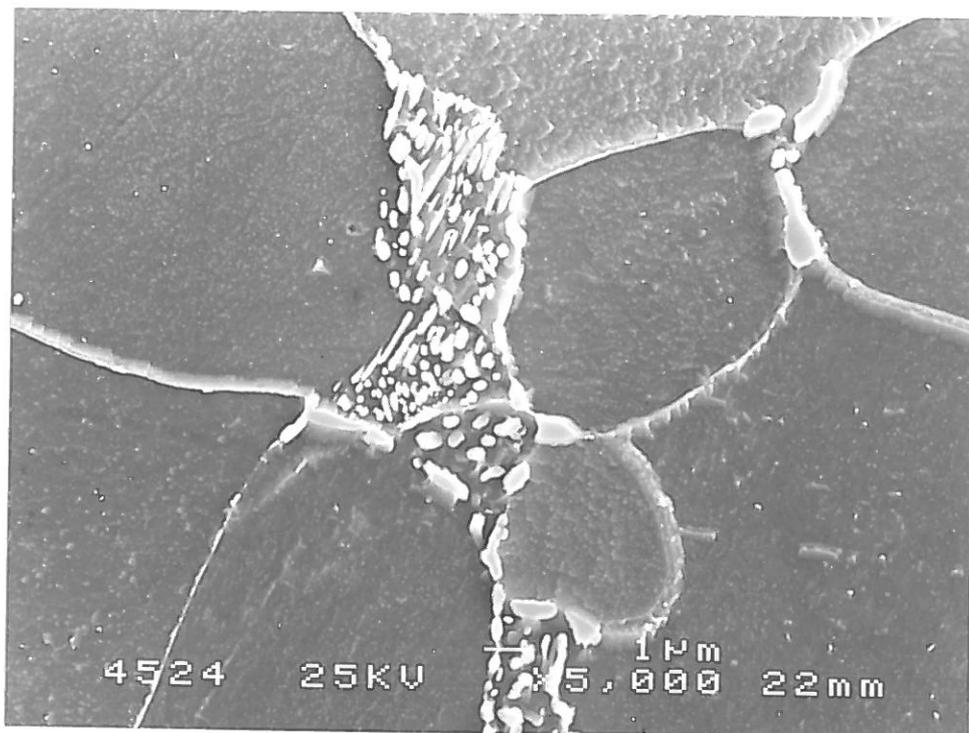
*Figs. 7 and 8. Steel St 35.8: 600°C / 30 h,  $P_{LM}(C = 14) = 13\,500$ , stage C. Magnification 1500x (Fig. 7) and 5000x (Fig. 8).*

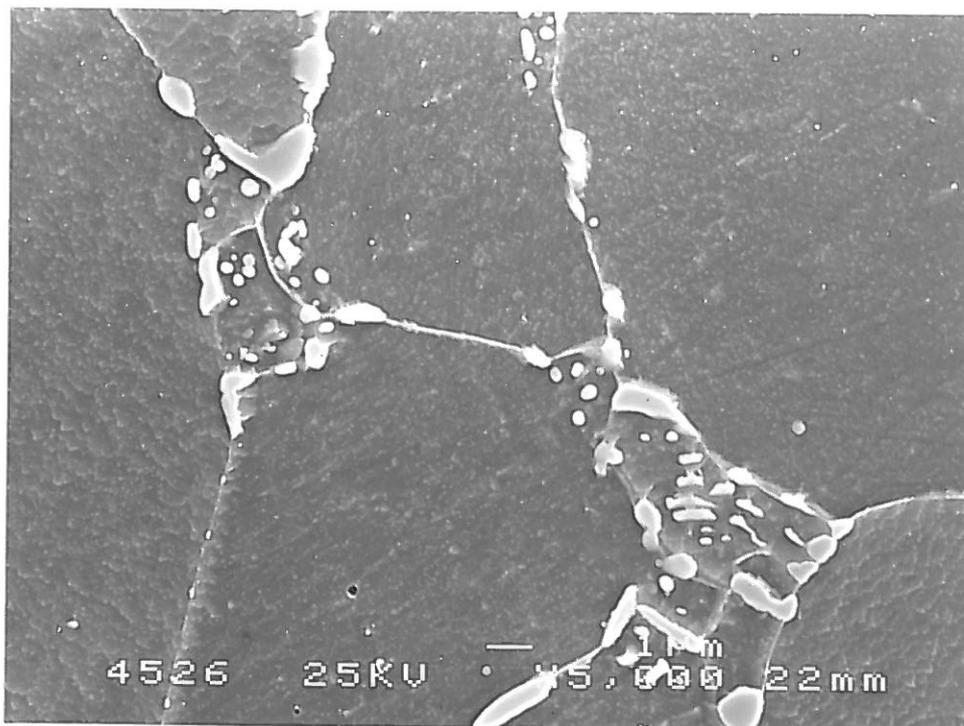
*Figs. 9 and 10. Steel St 35.8: 600°C / 100 h,  $P_{LM}(C = 14) = 14\ 000$ , stage D. Magnification 1500x (Fig. 9) and 5000x (Fig. 10).*

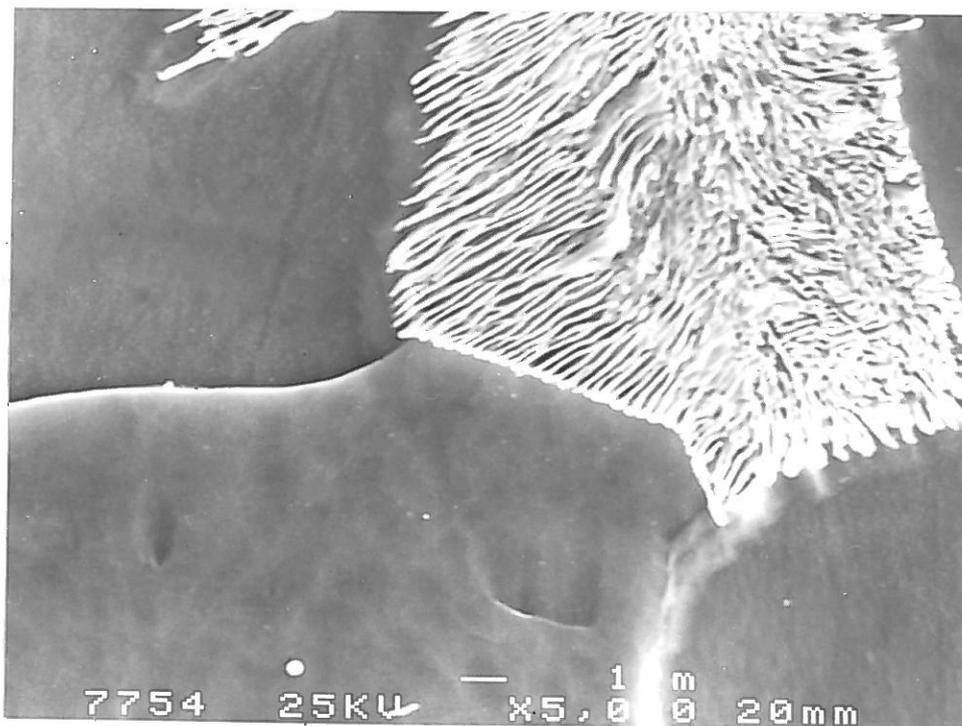
*Figs. 11 and 12. Steel 15 Mo 3: as new, stage A. Magnification 1500x (Fig. 11) and 5000x (Fig. 12).*

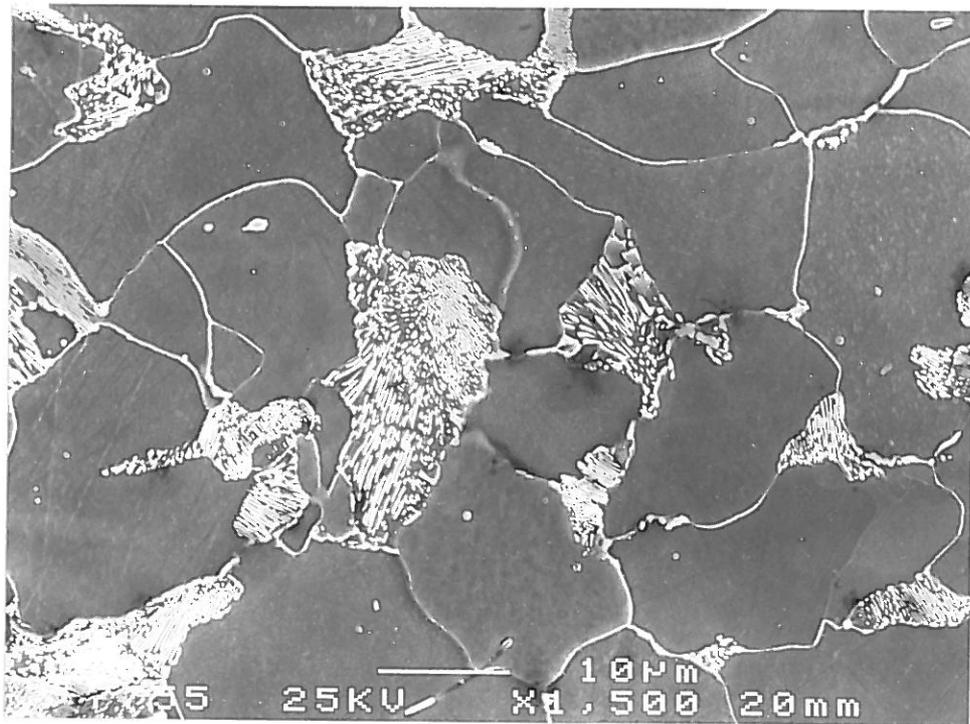
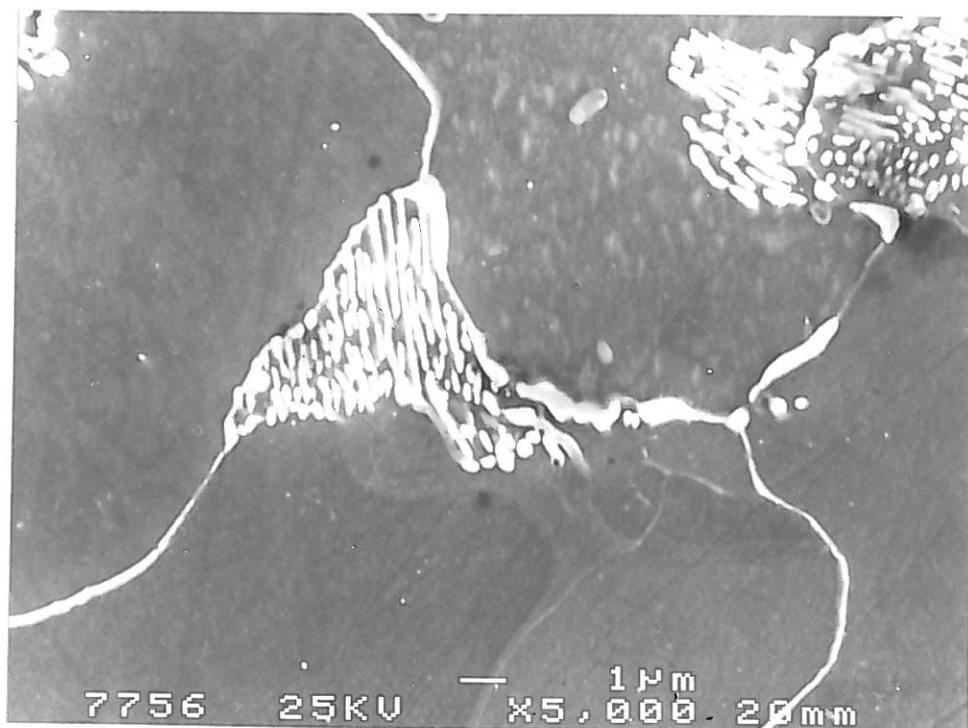
*Figs. 13 and 14. Steel 15 Mo 3: 600°C / 10 h,  $P_{LM}(C = 14) = 13\ 100$ , stage A/B. Magnification 1500x (Fig. 13) and 5000x (Fig. 14).*

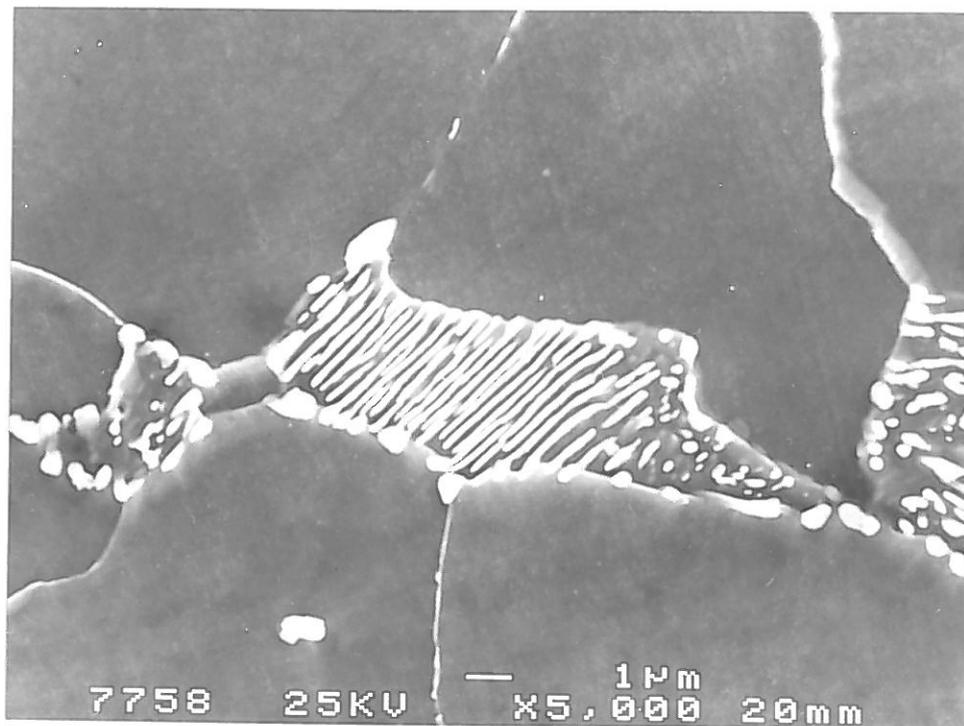
*Figs. 15 and 16. Steel 15 Mo 3: 600°C / 30 h,  $P_{LM}(C = 14) = 13\ 500$ , stage B. Magnification 1500x (Fig. 15) and 5000x (Fig. 16).*

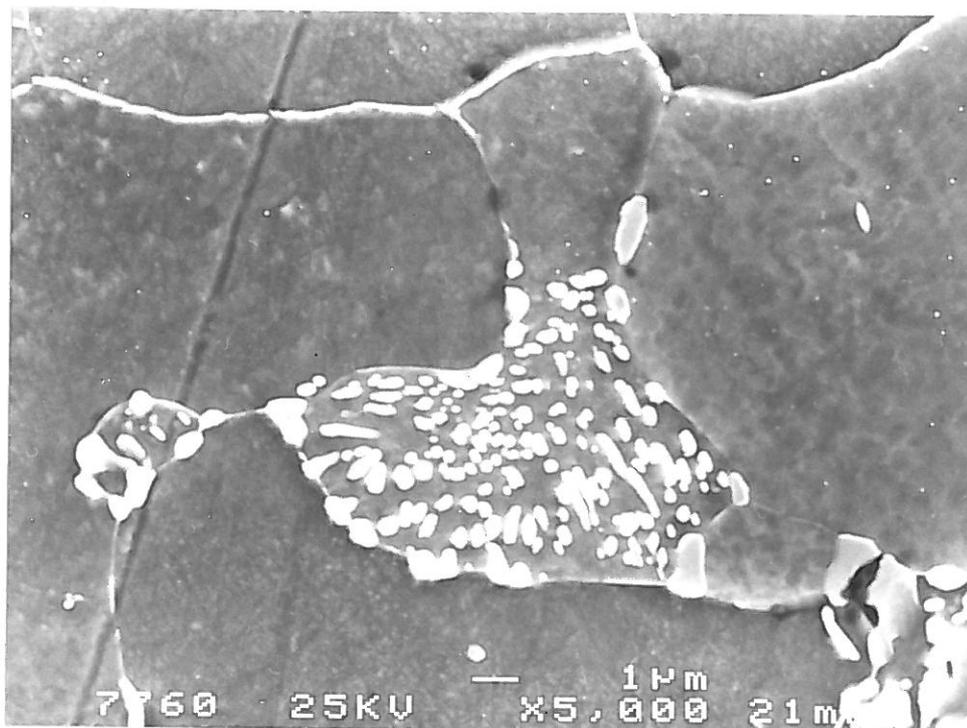
*Figs. 17 and 18. Steel 15 Mo 3: 600°C / 100 h,  $P_{LM}(C = 14) = 14\ 000$ , stage C. Magnification 1500x (Fig. 17) and 5000x (Fig. 18).*

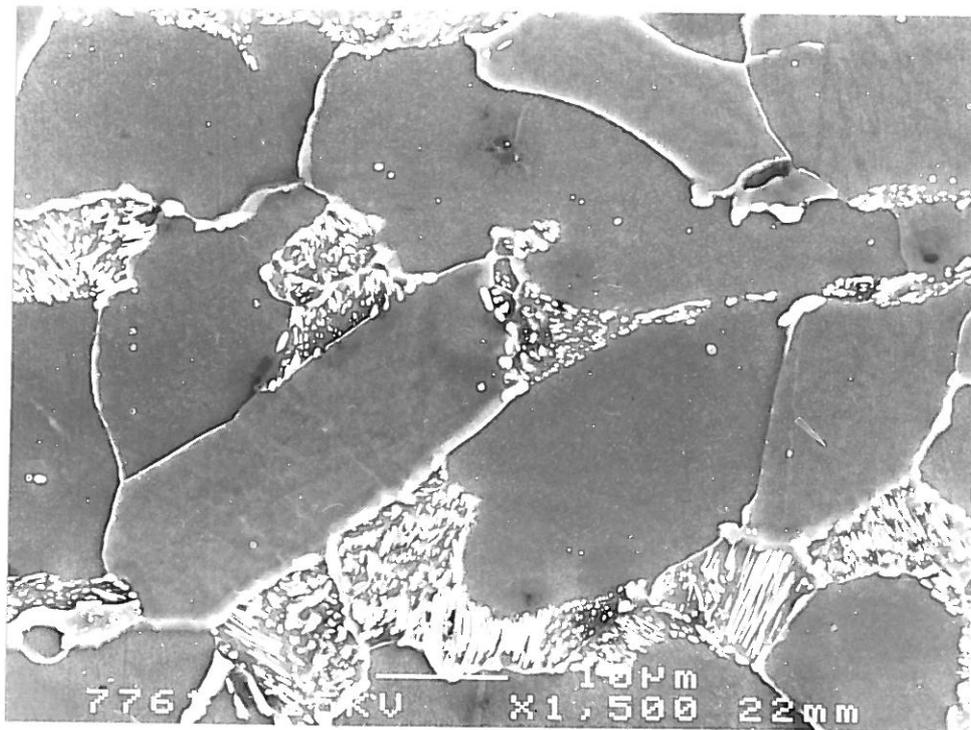
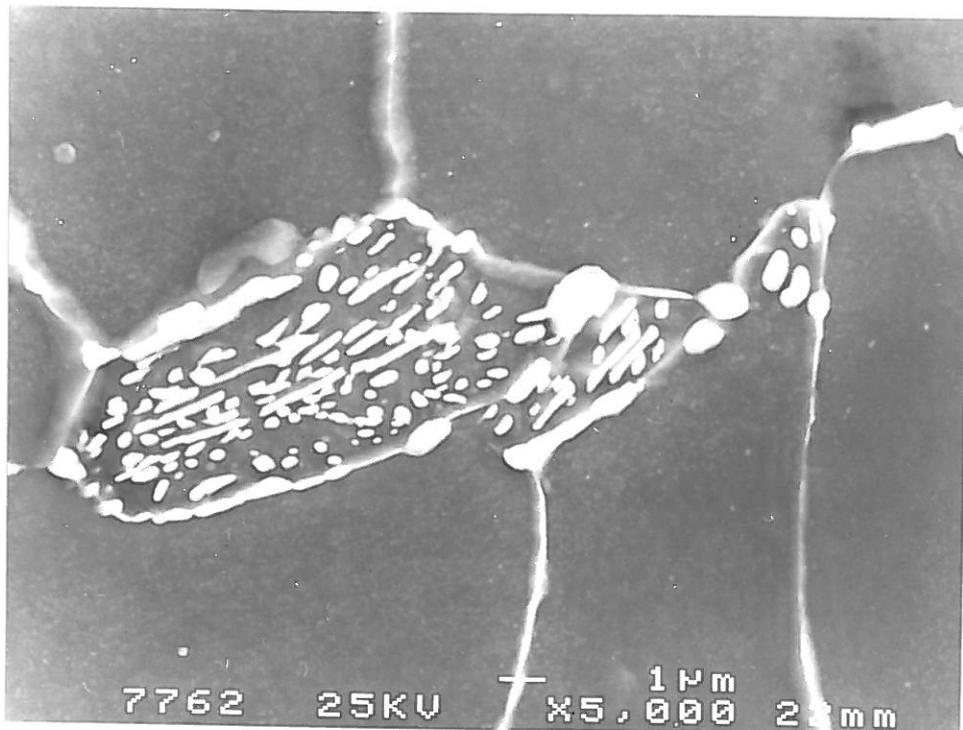
*Figs. 19 and 20. Steel 15 Mo 3: 600°C / 300 h,  $P_{LM}(C = 14) = 14\ 400$ , stage D. Magnification 1500x (Fig. 19) and 5000x (Fig. 20).*

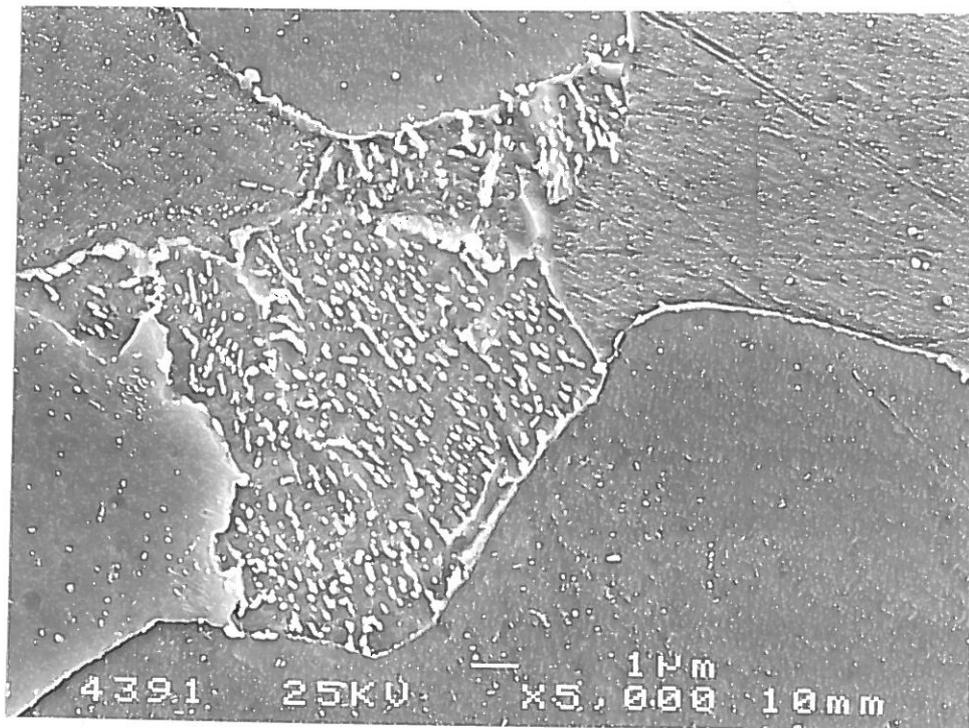
*Figs. 31 and 32. Steel 10CrMo910: as new, stage B. Magnification 1500x (Fig. 31) and 5000x (Fig. 32).*

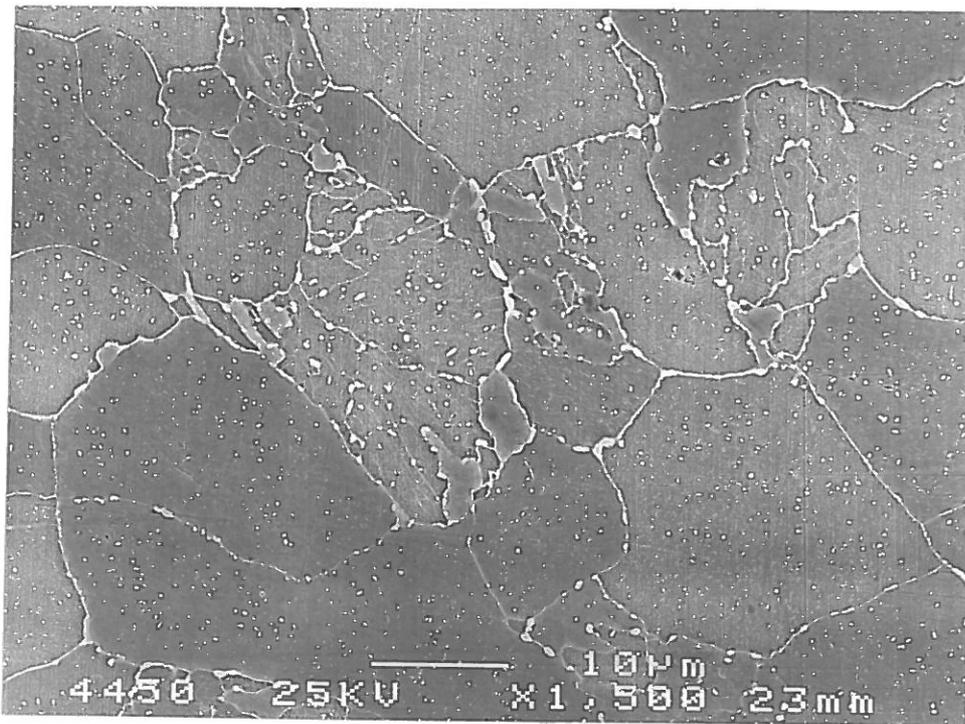
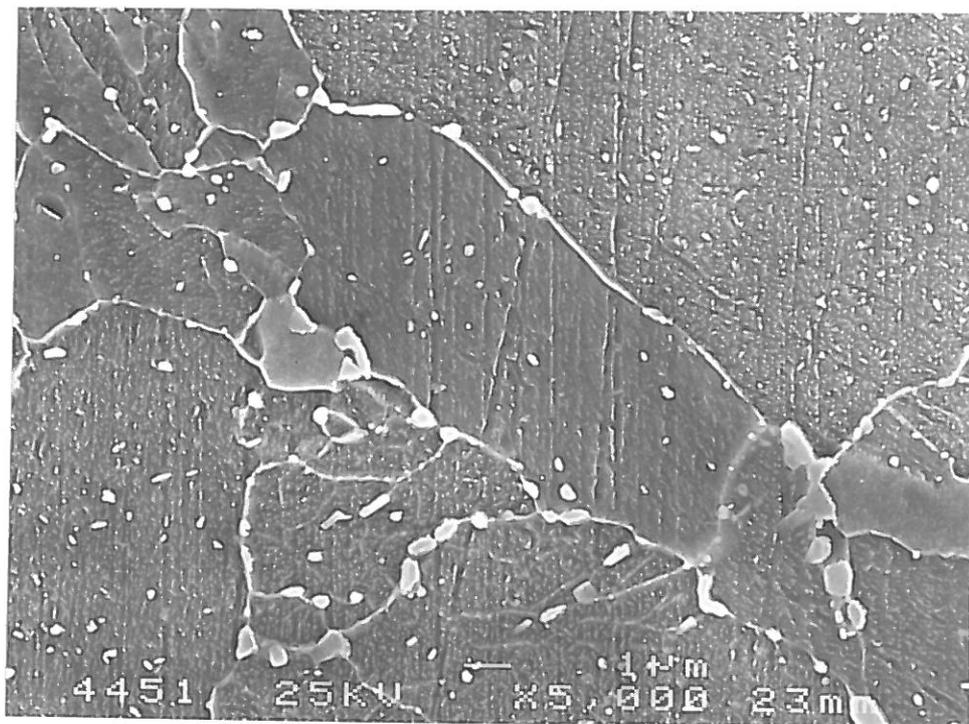
*Figs. 37 and 38. Steel 10CrMo9 10: 720°C / 30 h,  $P_{LM}(C = 14) = 15\,400$ , stage D. Magnification 1500x (Fig. 37) and 5000x (Fig. 38).*

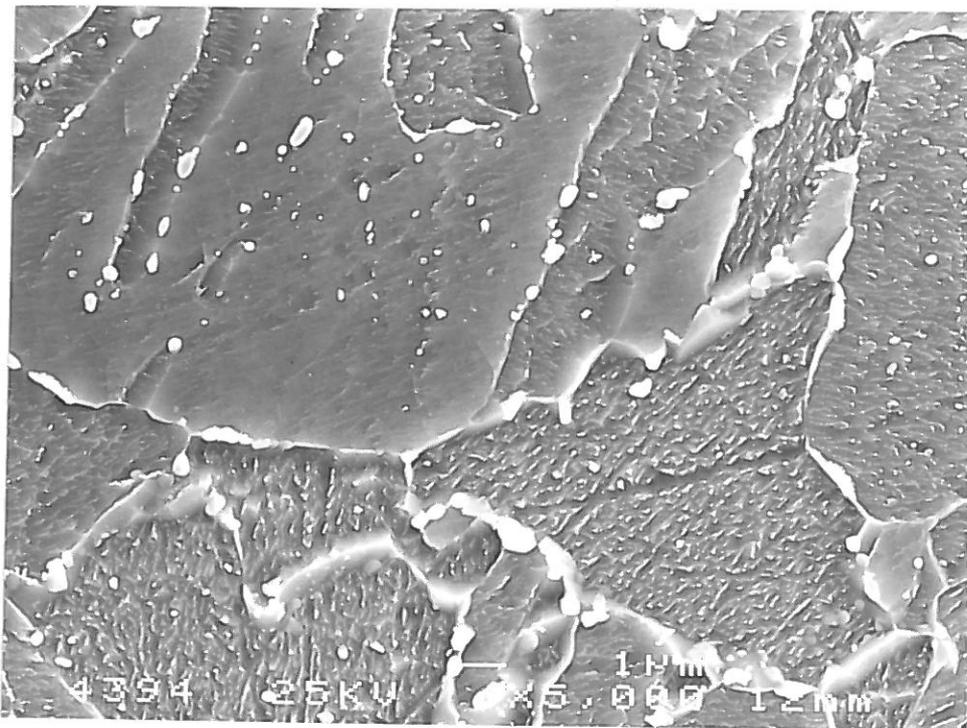
*Figs. 39 and 40. Steel 10CrMo910: 720°C / 100 h,  $P_{LM}(C = 14) = 15900$ , stage D. Magnification 1500x (Fig. 39) and 5000x (Fig. 40).*

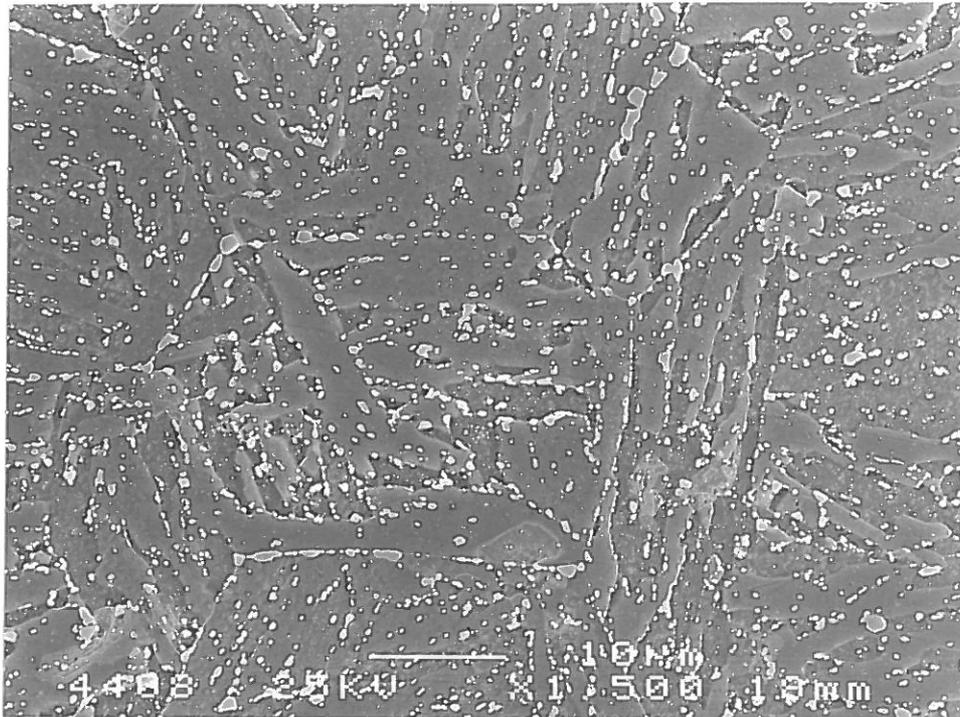
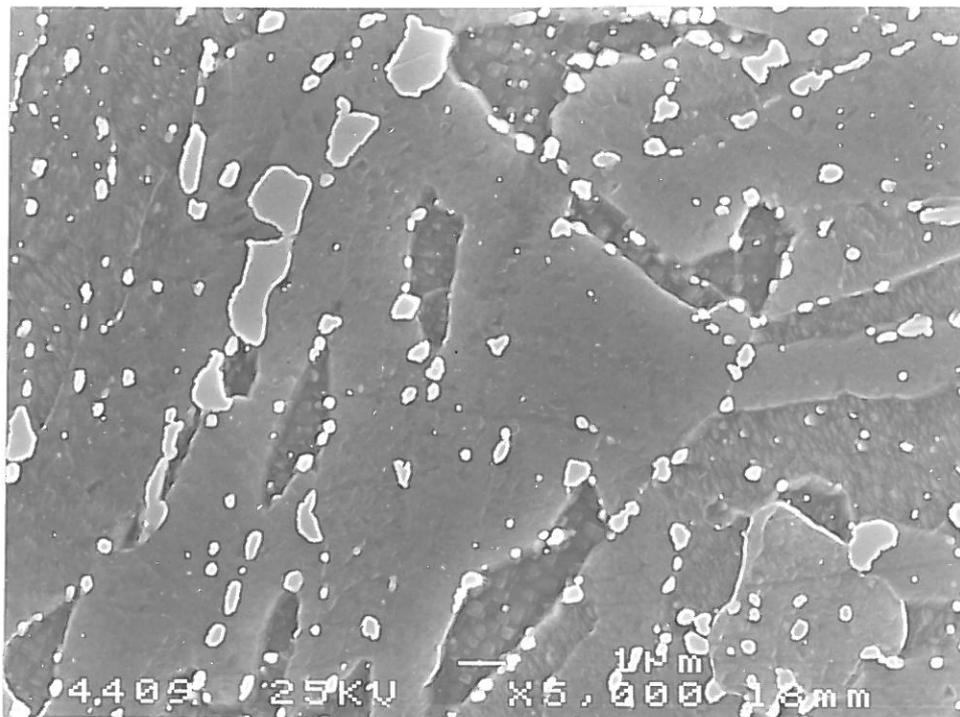
*Figs. 49 and 50. Steel X 20 CrMoV 12 1: 780°C / 100 h,  $P_{LM}(C = 14) = 16800$ , stage E. Magnification 1500x (Fig. 49) and 5000x (Fig. 50).*
