Full scale fire experiments on electronic cabinets II

Johan Mangs & Olavi Keski-Rahkonen

VTT Building Technology, Fire technology
Espoo 1996

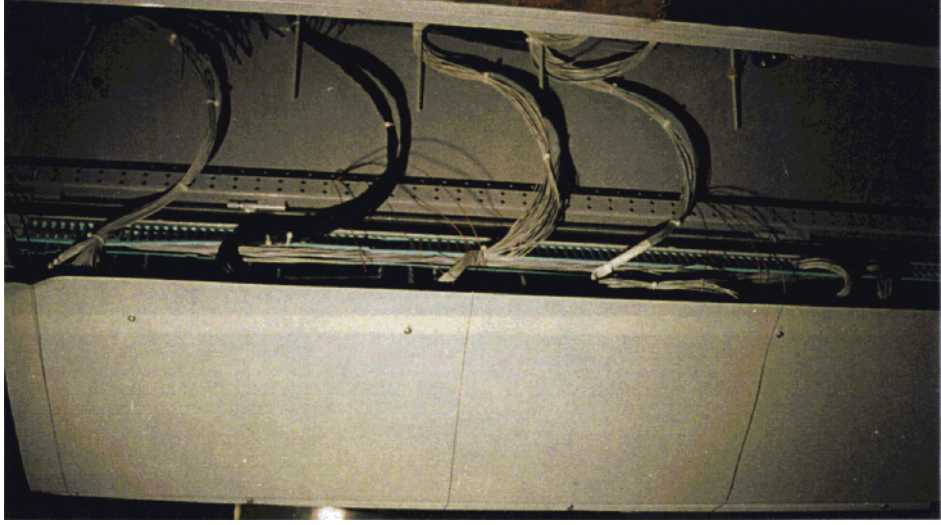
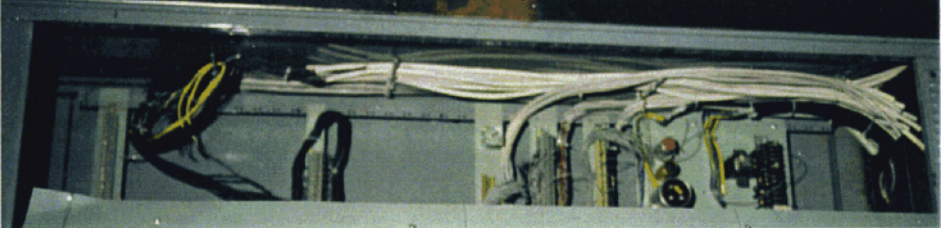
Figure 1. The fire cabinet before experiment 1. A) relays and circuit boards in the hinged rack, b) wiring on the left side wall leading into the hinged rack with vertical steel plate separating the rack from the rest of the cabinet, c) wiring at the rear, d) vertical cablebundle on the right side wall. The hinged rack is swilled out from the cabinet in b), c) and d).

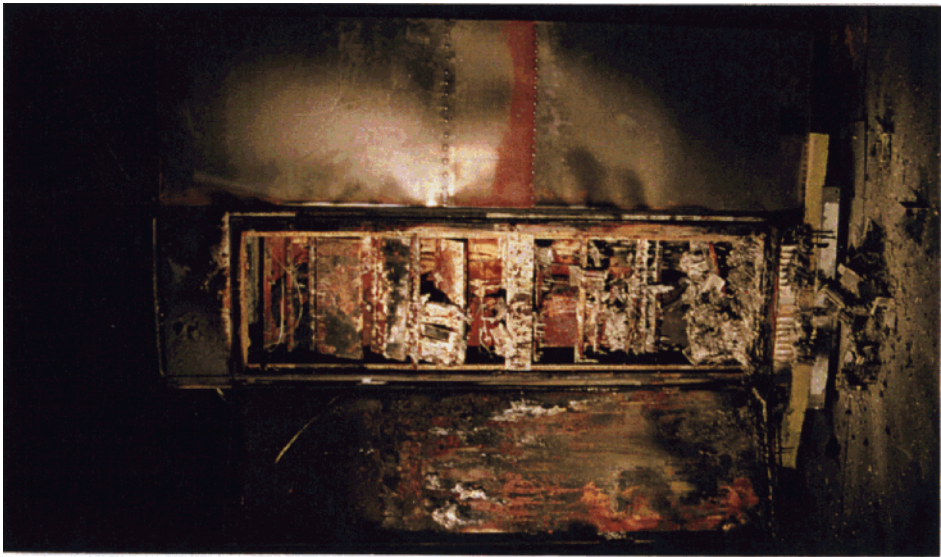
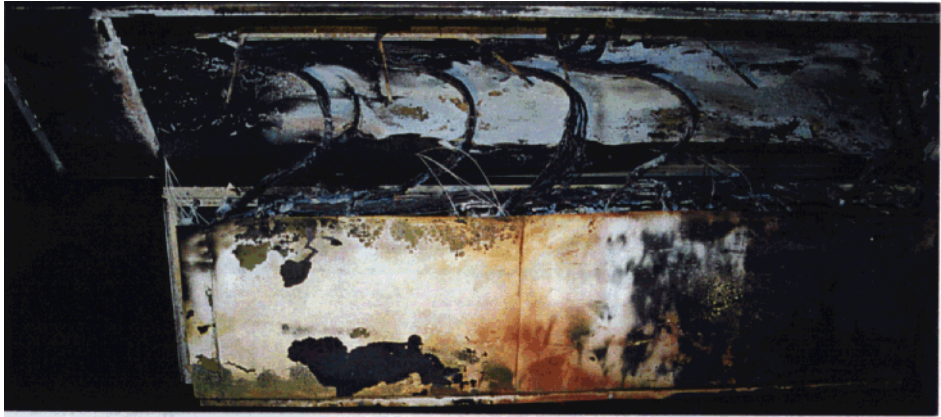
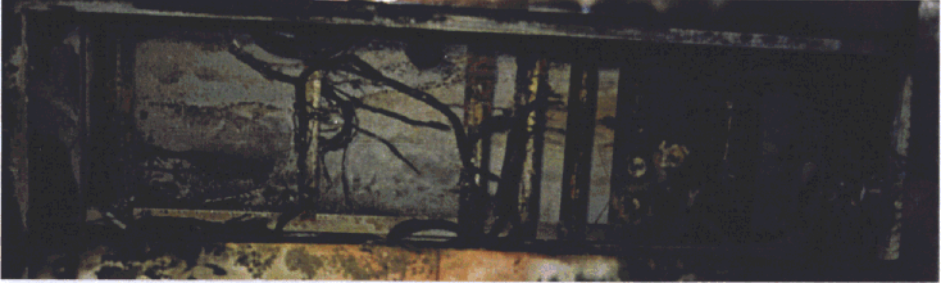
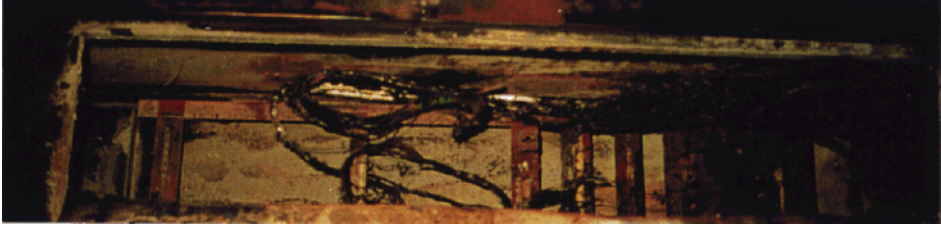
Figure 2. The fire cabinet after experiment 1. A) relays and circuit boards in the hinged rack, adjoining cabinet on the right, b) wiring on the left side wall, c) wiring on the rear, d) vertical cable bundle on the left side wall.

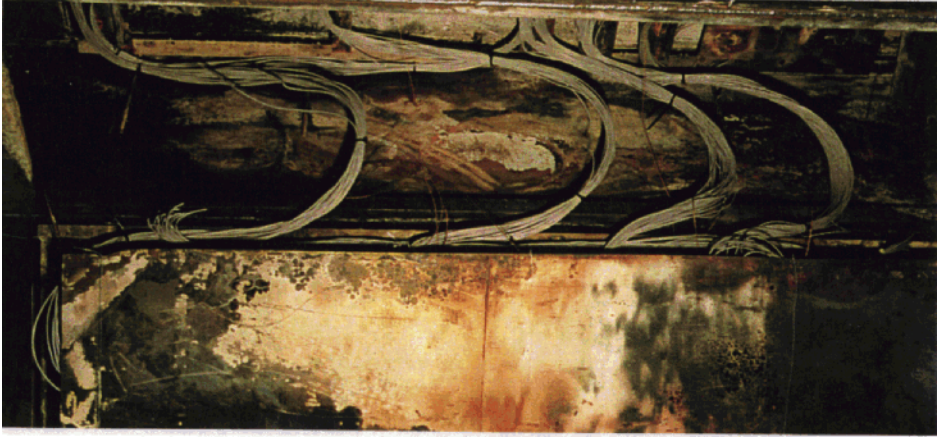
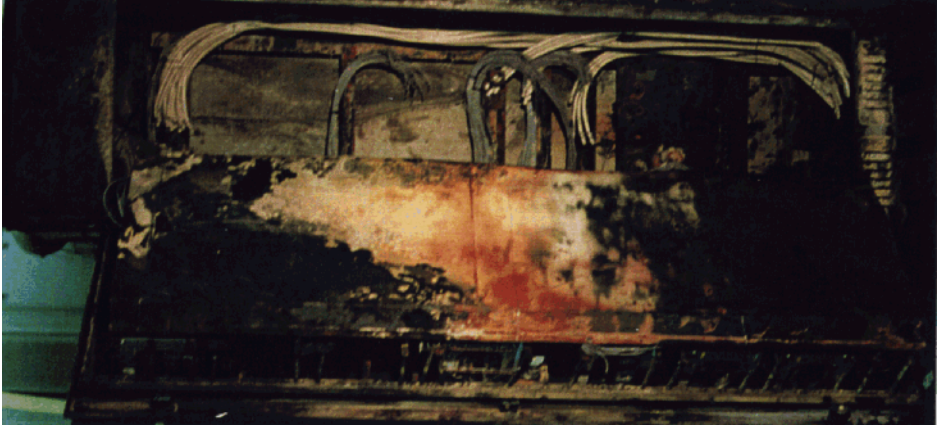
Figure 3. The fire cabinet before experiment 2. A) relays and circuit boards in the hinged rack, b) wiring on the left side wall leading to the relays in the hinged rack, c) wiring on the rear and vertical cable bundle on the left side wall.

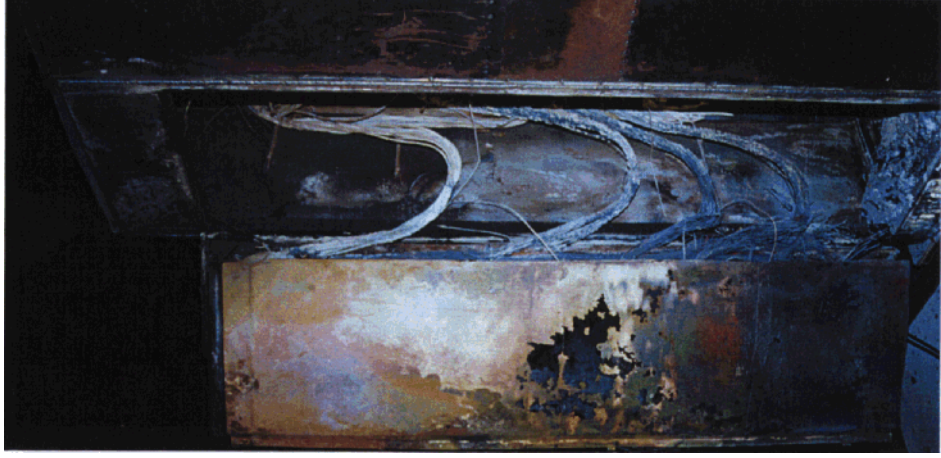
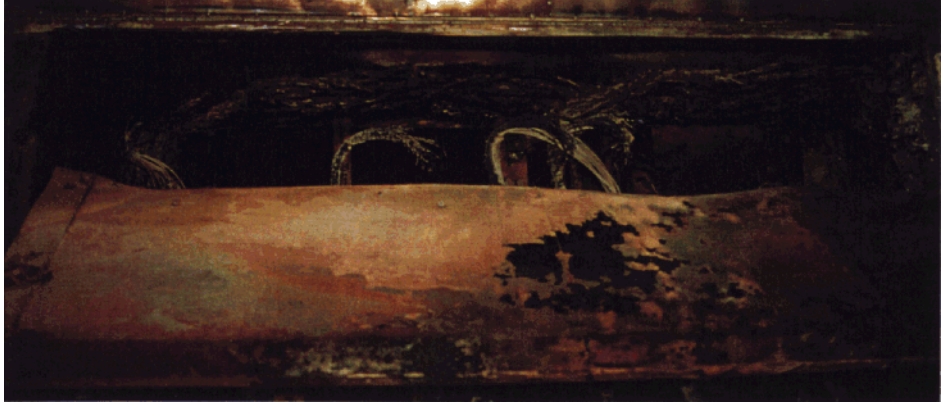
Figure 4. The fire cabinet after experiment 2. A) relays and circuit boards in the hinged rack, b) wiring on the left side wall leading to the relays in the hinged rack, c) wiring on the rear and vertical cable bundle on the left side wall.

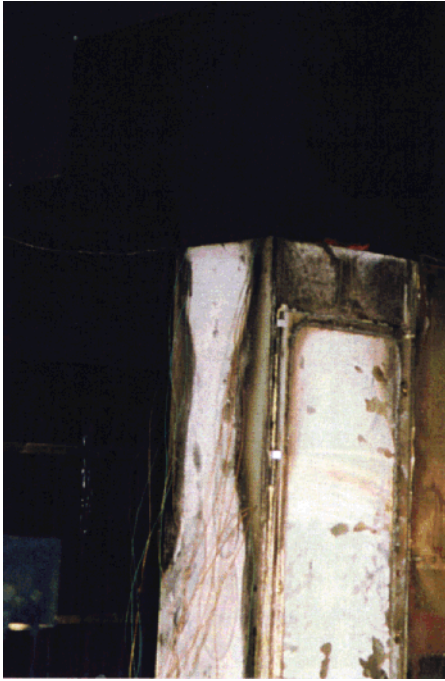
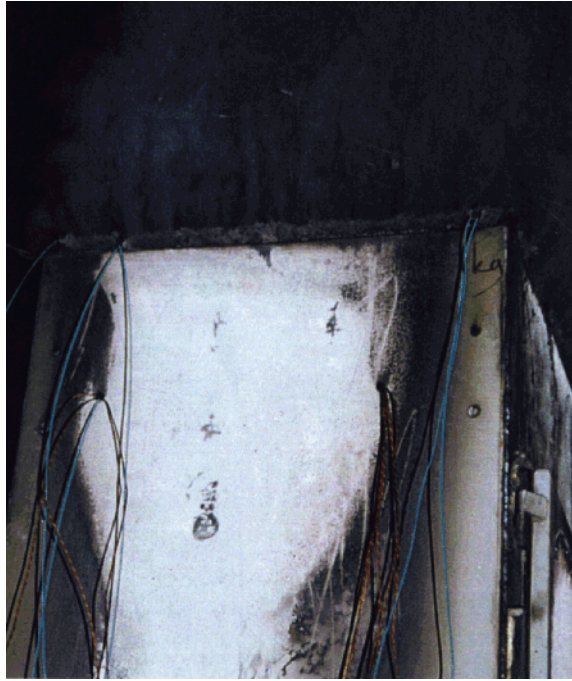
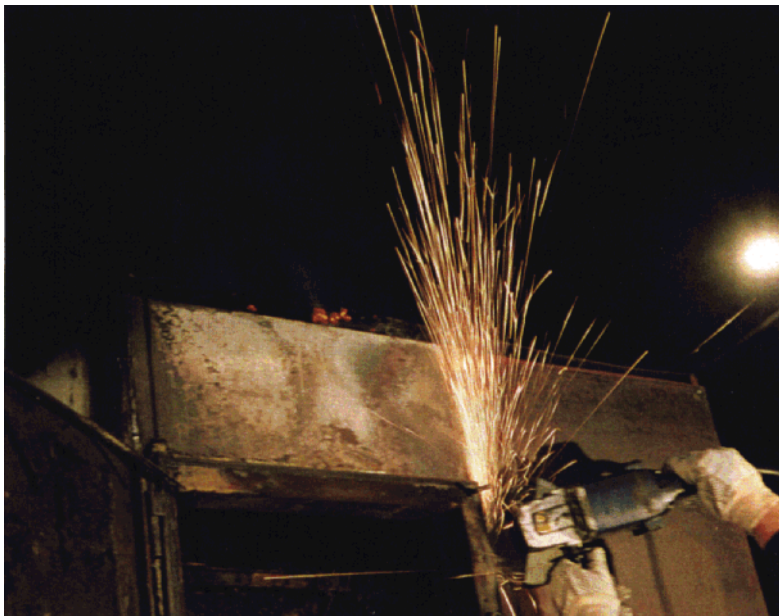
Figure 5. Experiment 3. A) fire cabinet, time after ignition 29.5 min, b) fire cabinet with ceiling ventilation openings blocked with soot, time after ignition 46.5 min, c) 3 days after the experiment, soot in the upper part of the cabinet was ignited by sparks when cutting open the welding seams between the rack and the cabinet frame.

No additional gaps were present in experiment 3. This is reflected in the RHR curve which overall shows lower values than in the preceding experiments. The restricted air intake could also be noted visually as notable soot formation during the experiment indicating a high degree of incomplete combustion.

The soot stuffed up the ceiling ventilation openings which further decreased the air exchange possibilities in the cabinet. The peak in the RHR curve rising at 93 min corresponds to improved ventilation conditions when relatively large amounts of soot fell from the blocked ceiling openings which were thus partially cleared. The effect of insufficient air intake in experiment 3 is also seen in the large amount of melted and partly burned material that accumulated on the bottom of the cabinet where the temperatures had been too low to sustain burning (tables 7 and 8, Appendix 1 figure 6).

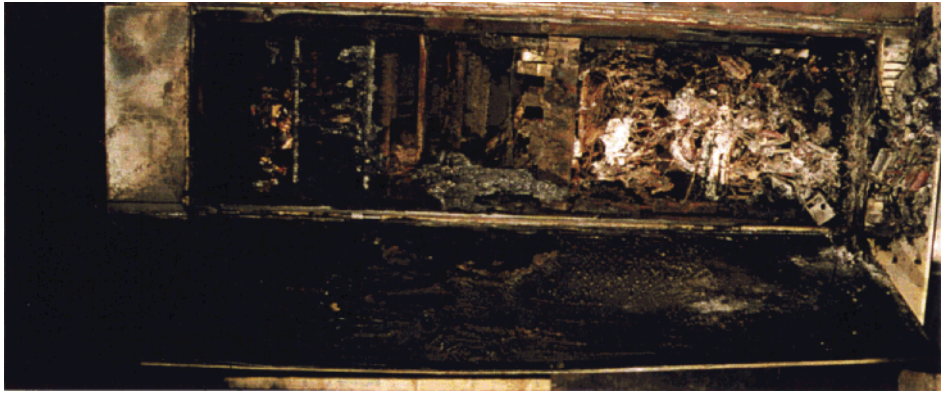
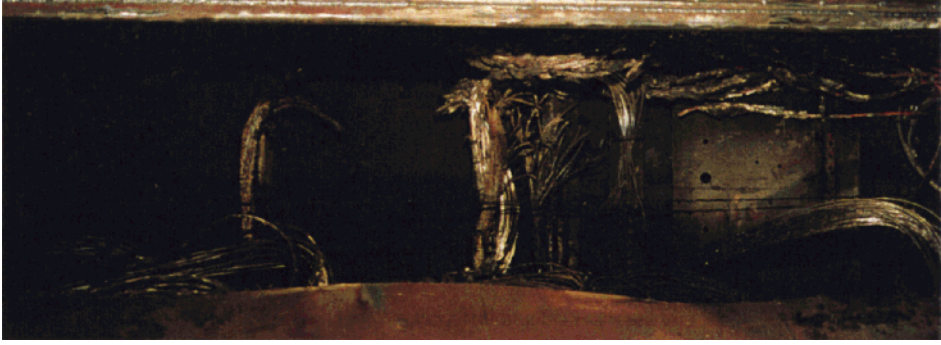
Figure 6. The fire cabinet after experiment 3. a) relays and circuit boards in the hinged rack, b) wiring at the rear and vertical cable bundle on the left side of the wall, c) the slab composed of melted plastics on the bottom of the fire cabinet has been broken while emptying the cabinet. Note the soot depositions in the upper part of the cabinet in a) and b).
