Machinability effects of stainless steels with a HIPed NiTi coating in high-efficiency machining operations

VTT PUBLICATIONS 610

Thesis for the degree of Doctor of Technology to be presented with due permission for public examination and criticism at Helsinki University of Technology in auditorium K216 on October 20 2006, at 12 o'clock.

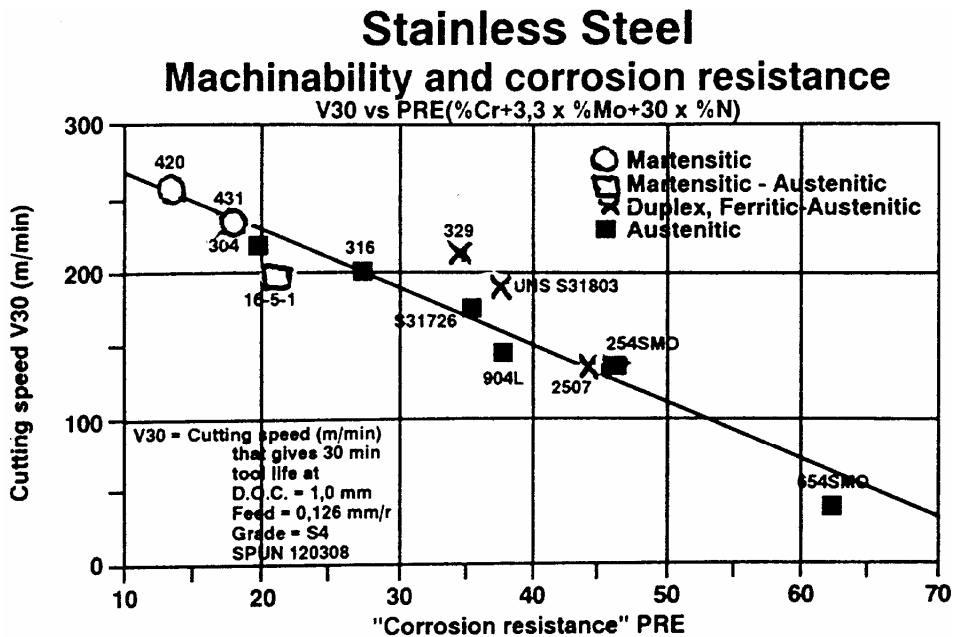
Figure 1. Machinability and corrosion resistance of stainless steels. V30 vs. PRE (Östlund 1994).

The machinability of stainless steels is often compared to the pitting resistance equivalent value representing the alloying content of the steel. The Pitting Resistance Equivalent (PRE) index, $PRE = wt\%Cr + 3.3x \text{ wt}\%Mo + 30x \text{ wt}\% N$ is presented in Figure 1.

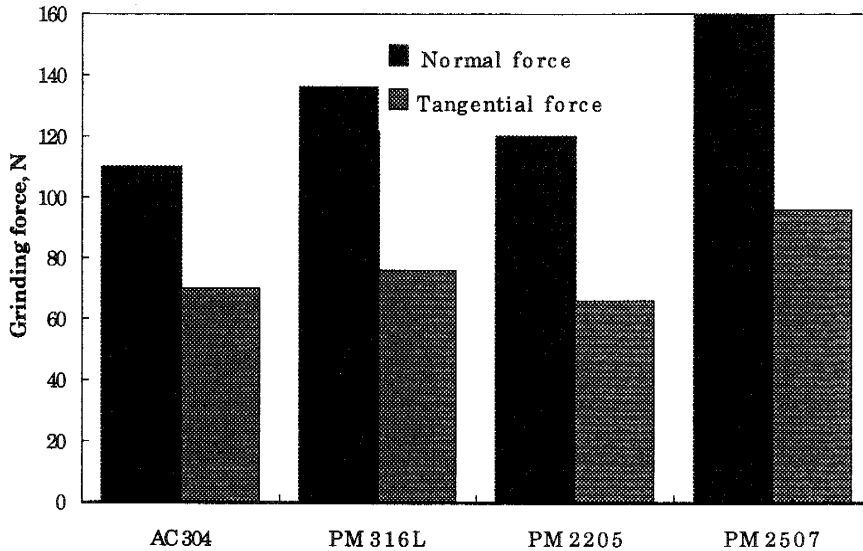
Fig. 3. Normal and tangential forces when grinding stainless steels using alumina wheels.

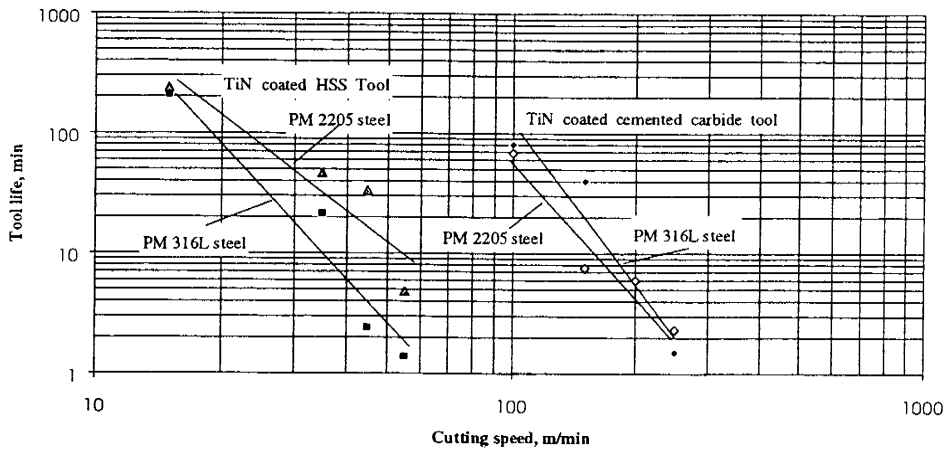
Fig. 1—Tool lives for TiN-coated HSS and TiN-coated cemented carbide tools in the low and high cutting speed ranges, respectively, when machining PM 316L and PM 2205 stainless steels.

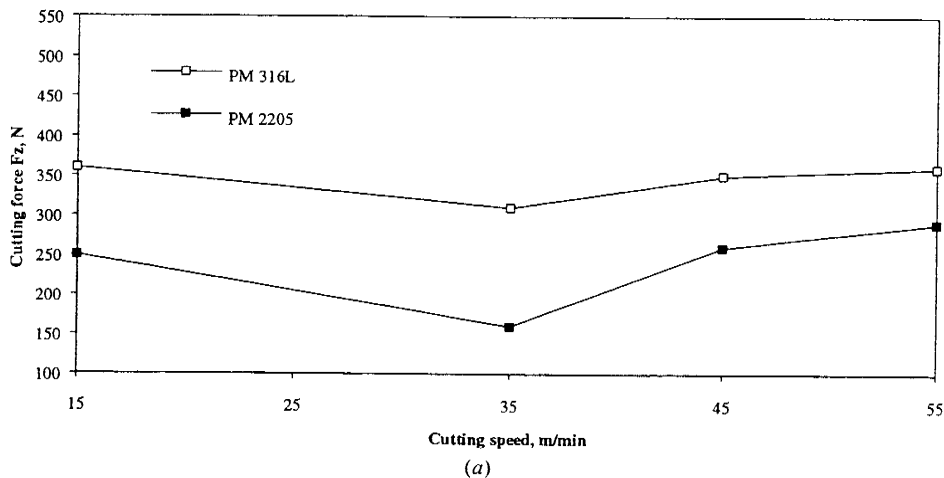
Fig. 2—Cutting forces when machining PM 316L and PM 2205 steels in low and high cutting speed ranges: (a) in the low cutting speed range using TiN-coated HSS tool; and (b) in the high cutting speed range using TiN-coated cemented carbide tool.

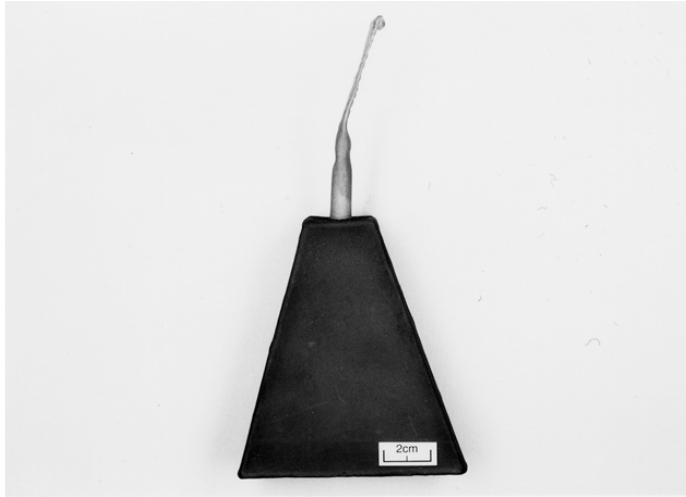
Figure 1: The HIPing capsule
