Plant Life Management

| Progress for structural integrity

VTT SYMPOSIUM 227

Plant Life Management Progress for structural integrity

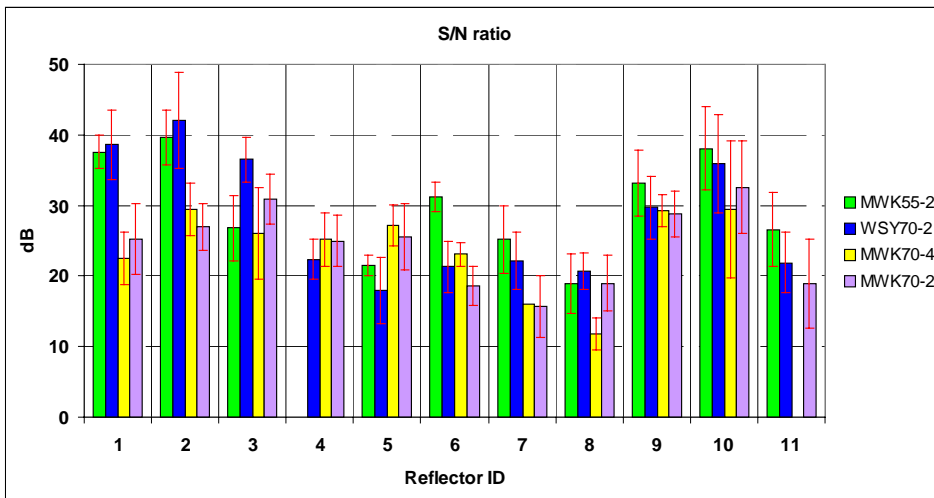
Figure 2. Signal-to-noise ratio of all reflectors measured with different probes. The columns show the average values of the measurements of all examiners. The lines at the top of the columns indicate the standard deviation.

The examiners were asked to record several numerical values about the reflectors. As an example the measured signal-to-noise ratios are given in Figure 2 to describe the detectability of reflectors using different probes.

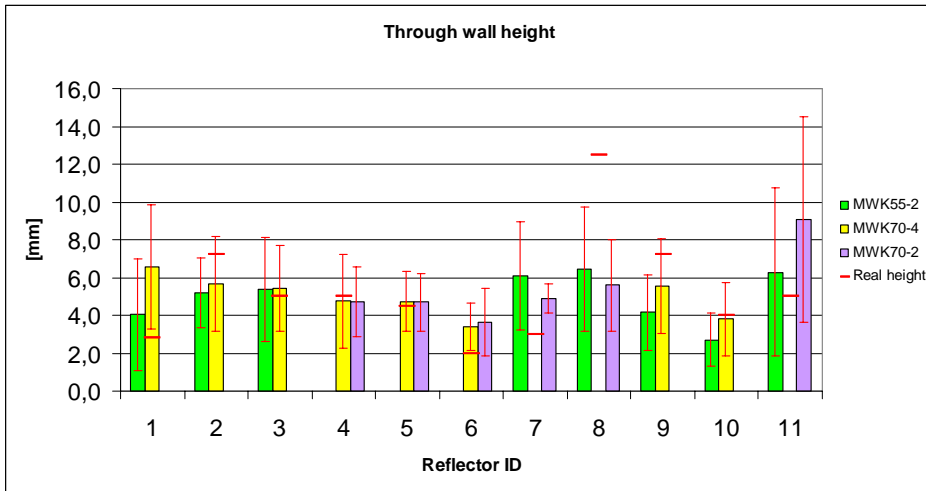
Figure 4. The results of reflector through wall height measurements. The columns show the average values of the measurements of all examiners. The lines at the top of the columns indicate the standard deviation.

Figure 4 that in some cases the difference between measured and real reflector height is rather large and also the standard deviation is quite significant.

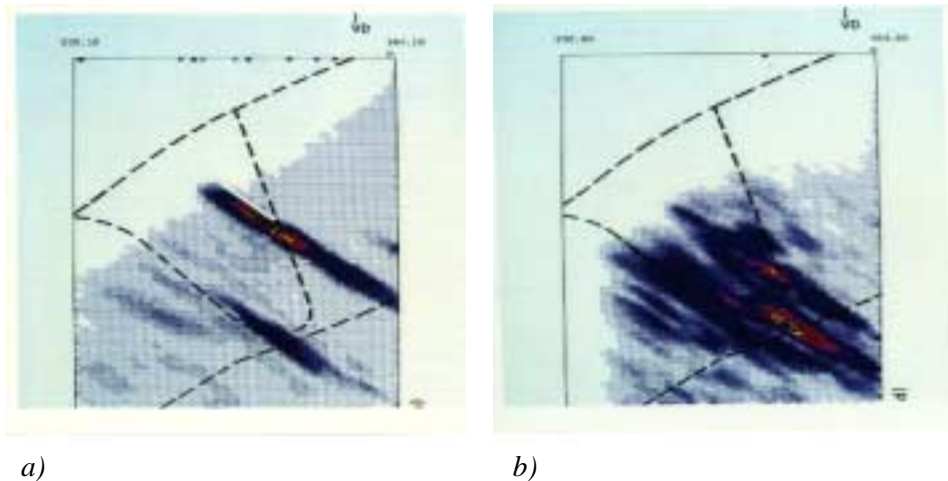
Figure 6. Saft reconstruction of a calibration defect from a real size mock up (a) and real defect (b) in the weld of main gate valve.

In Fig. 6 there is a saft reconstruction of a calibration defect (a) in size of 20 mm in through wall direction. It is difficult to detect a defect behind the weld in normal A-scan due to the low SNR. In Fig. 6 the real size and location of the calibration defect is marked with a white rectangular. In Fig. 6b there is a real indication, which could be divided in two different indications with the help of saft reconstruction.

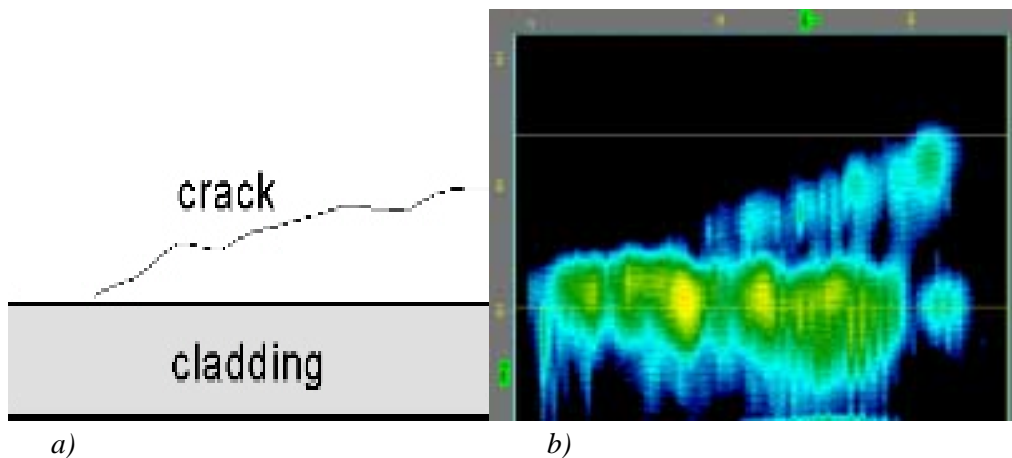
Figure 9. Crack tip front of a sub cladding defect in the test block PS 13 and corresponding measurement with 0°L probe (b).

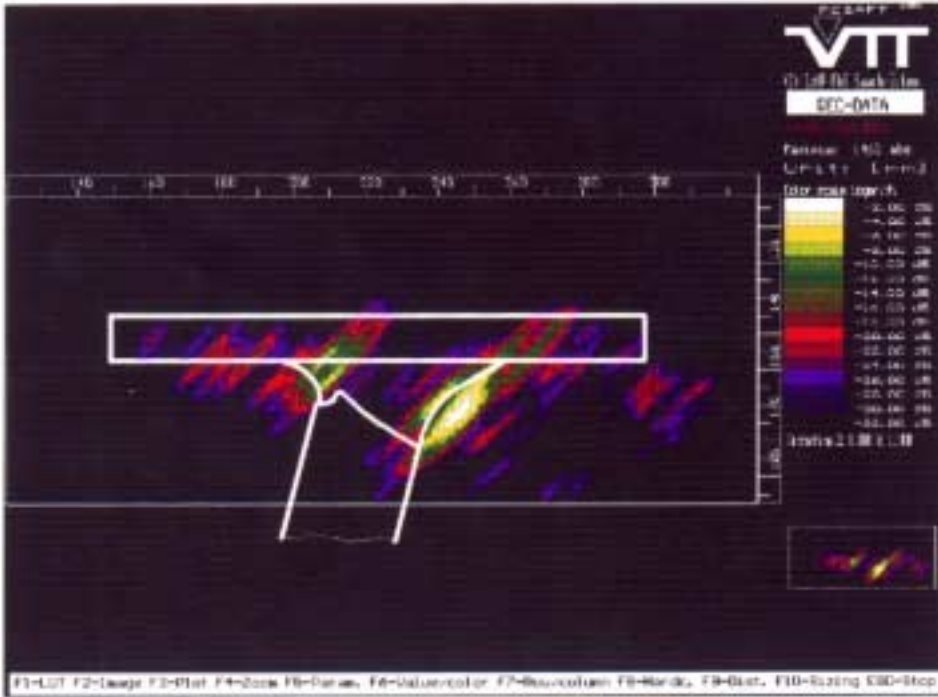
Figure 13. Saft measurement from a radial support using saft.

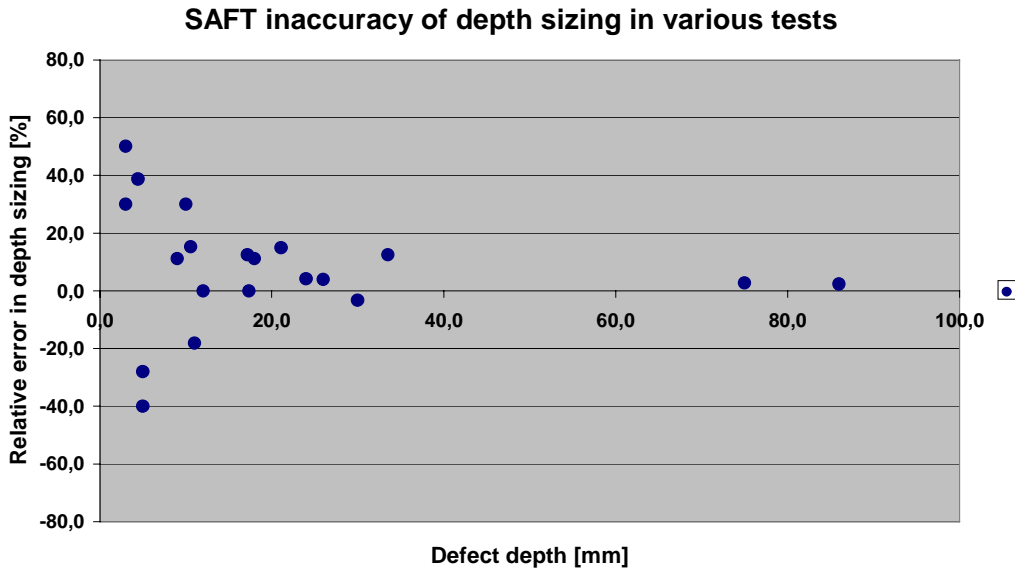
Figure 15. Relative error using saft measurement with different defect sizes.

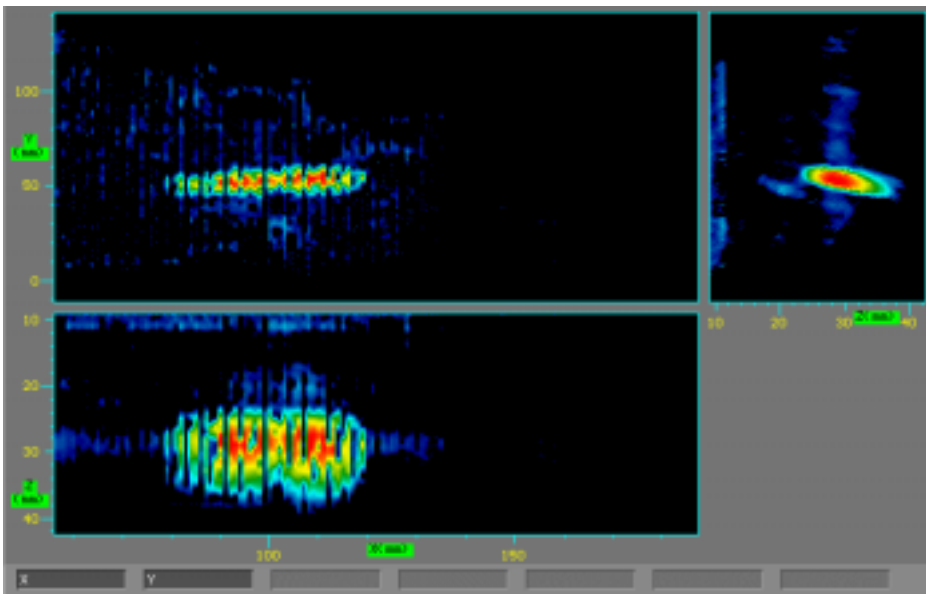
Figure 6. Artificial produced circumferential thermal fatigue crack in an austenitic block detected with $45^{\circ}T$ 2 MHz composite probe.

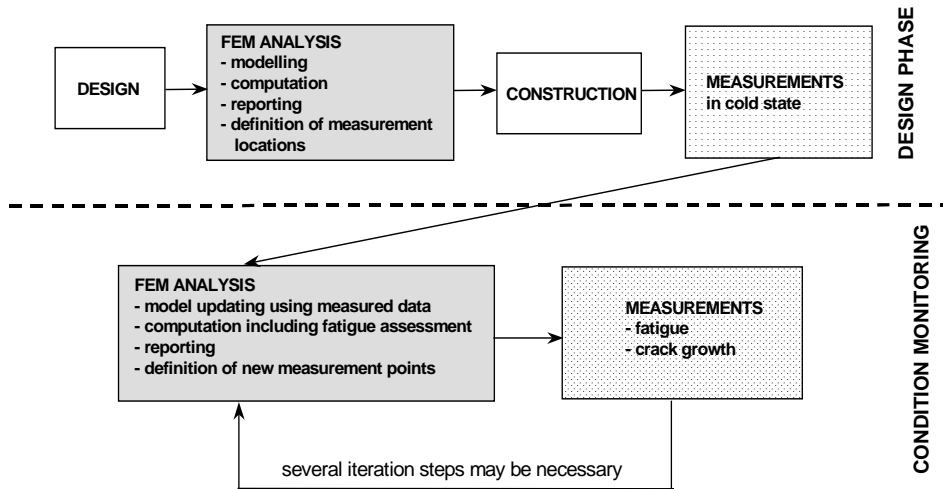
Figure 1. The approach to come to an adequate model to monitor the vibration behaviour of a piping system, starting from the piping design phase [6].

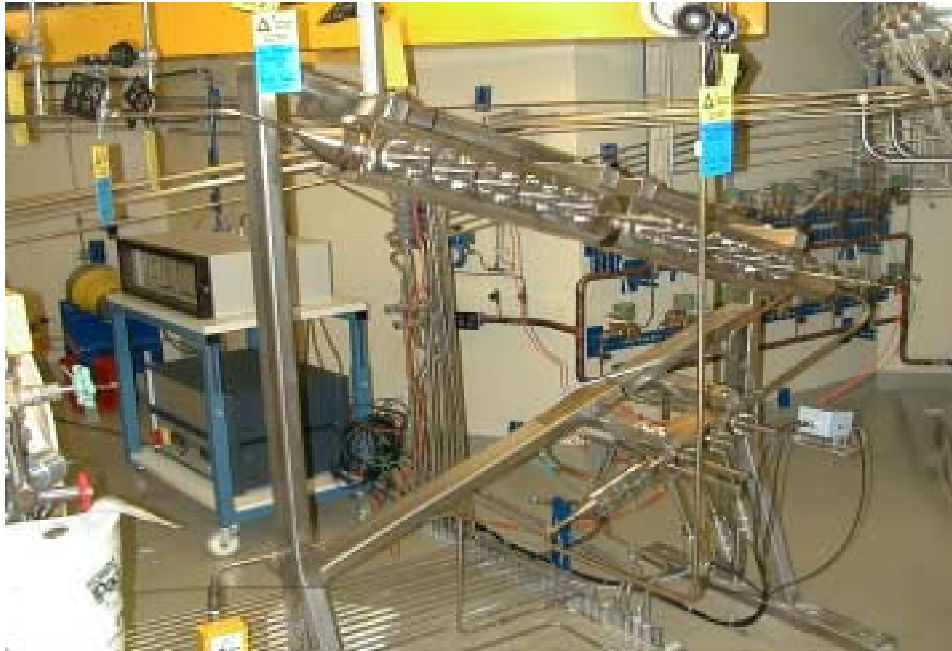
Figure 1. The flow-through cells with high temperature water chemistry sensors and 80 material samples at Loviisa 1 plant.

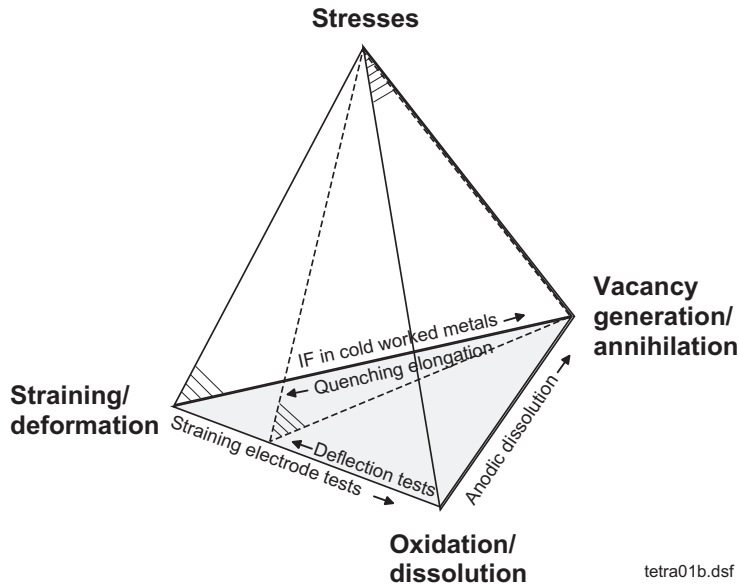
Figure 1. EAC tetrahedron describing associated reactions included in material/environment/loading interactions.

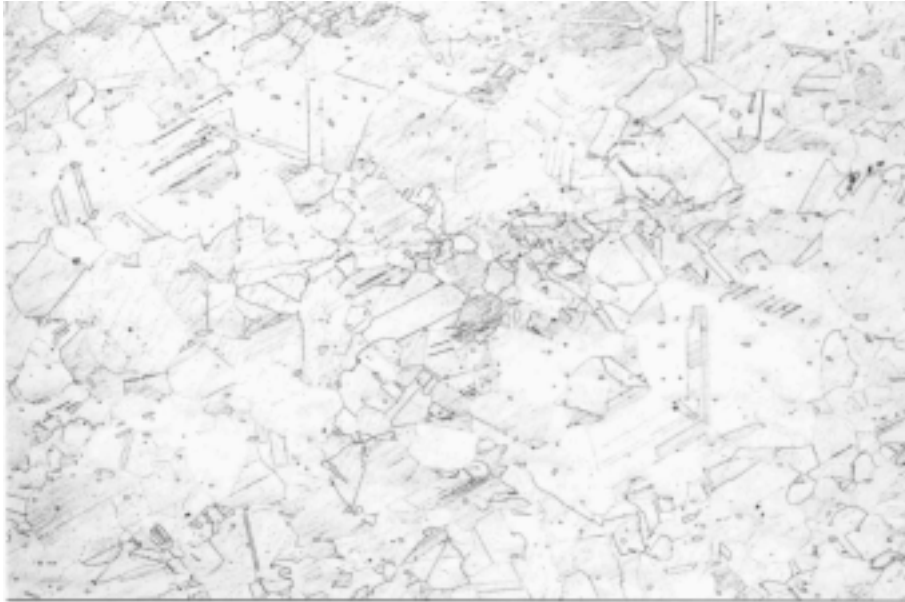
Figure 15. Optical micrograph of the lower fluence material, initially calculated 1.5 dpa. Grain size ASTM 4–4.5. (100X).

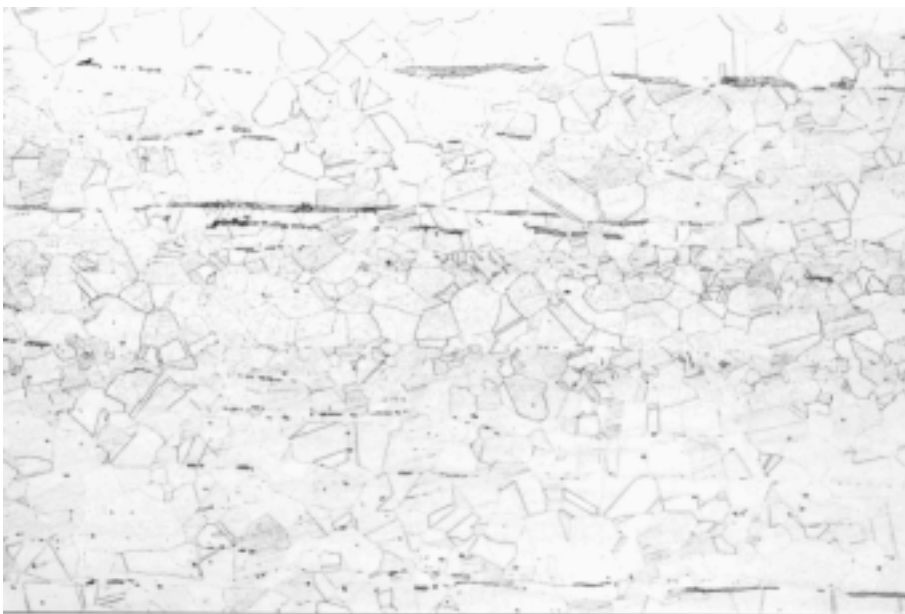
Figure 16. Optical micrograph of the higher fluence material, initially calculated 4 dpa. Grain size ASTM 5. (100X).

Microstructure of the absorber element lower end material is shown in Figs 15 and 16. Fig. 15 represents the lower fluence part and Fig. 16 the higher fluence part. The ASTM grain sizes are 4–4.5 and 5, respectively. The structures are typical austenitic structures with twins and small amount of probably δ -ferrite, seen as long horizontal bands in Fig. 16. The samples were etched by HF+HNO₃+glycerol after mechanical polishing.

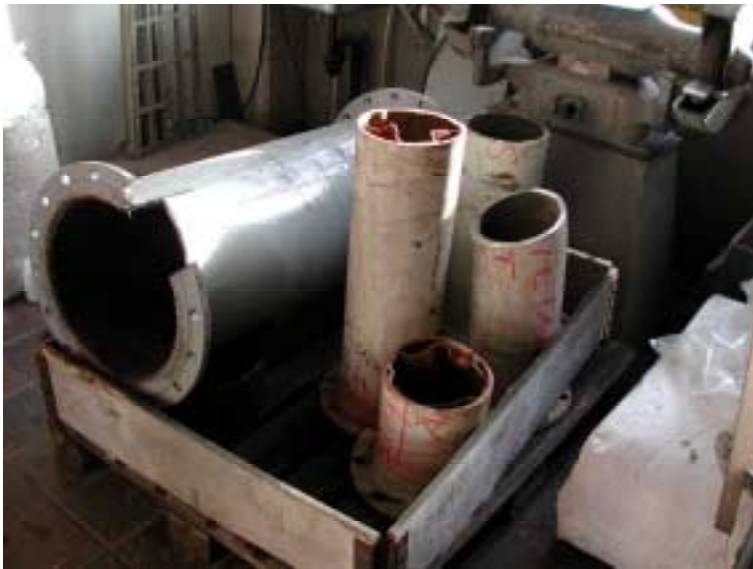
Figure 1. Flanged seawater pipes having outside diameter of 220 mm and 420 mm were examined.

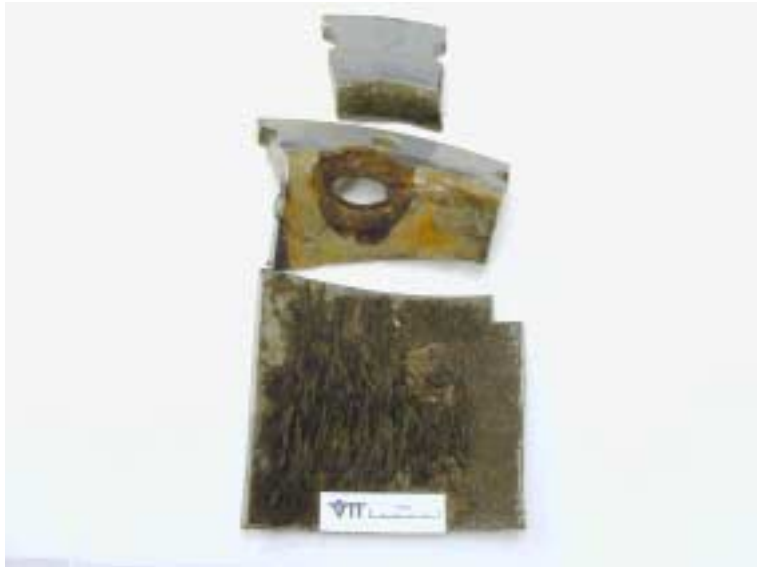
Figure 2. Painted seawater pipe having a breakthrough hole adjacent to the flange.

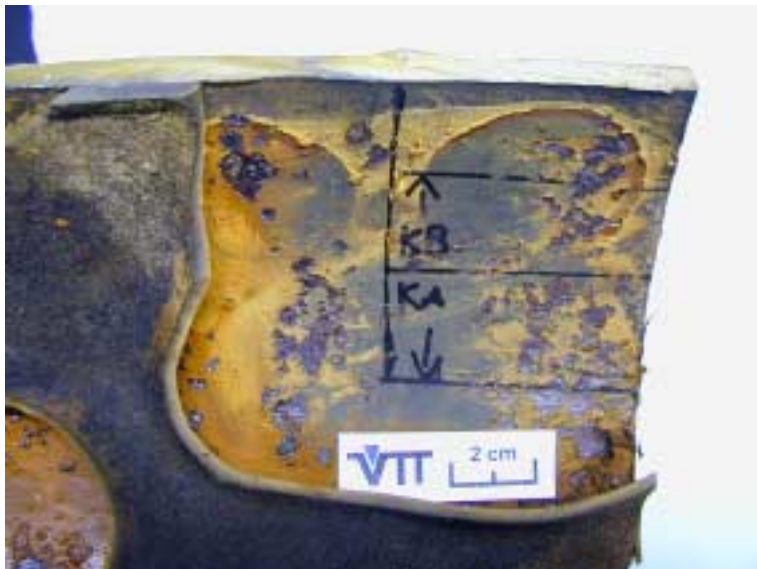
Figure 3. Surface of the steel under the large rubber blisters is not heavily corroded.

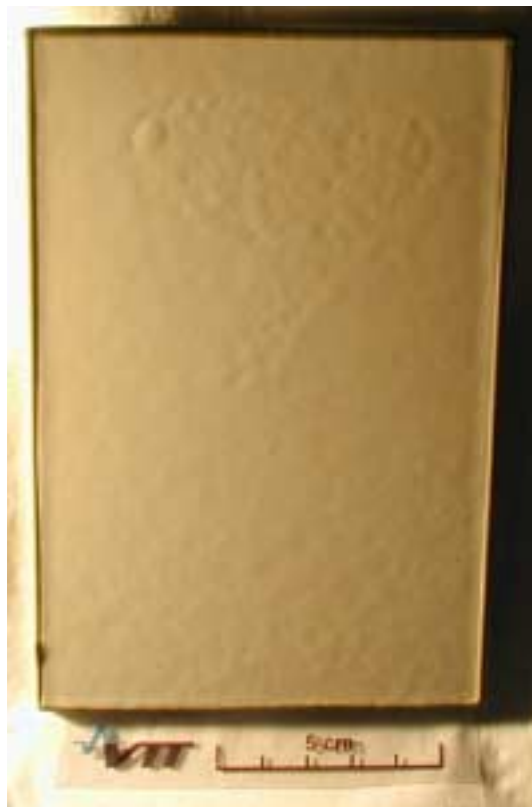
Figure 4. Oil smear on the steel surface destroys the coating in the immersion test. Oil smear area can be seen in the upper part of the specimen where also one large blister is seen.
