VTT SYMPOSIUM 265

# **Baltica VIII**

## **Life Management and Maintenance for Power Plants**

### **Vol. 2**

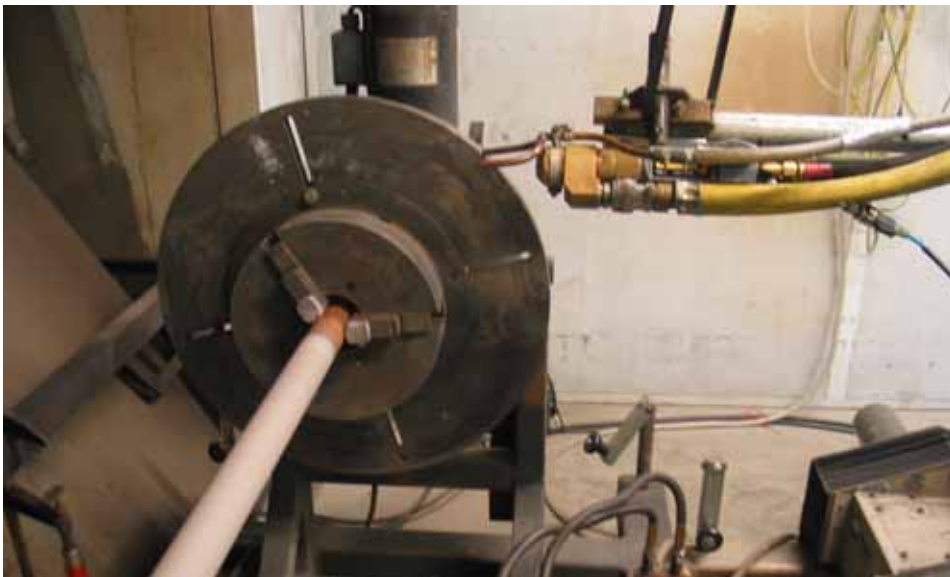
Figure 1. An as-coated tube attached to a rotating fixture.

position where ash blockages and tube failures have been recorded. The base material of the  $\text{Ø}48.5 \times 5.05$  mm (measured dimensions) test tube was 16Mo3. The HVOF thermal spray process using a DJ hybrid with hydrogen and Amperit 584.1 powder was applied to produce an about 200  $\mu\text{m}$  thick 75%  $\text{Cr}_3\text{C}_2$ -25% NiCr coating on the tube, Figure 1. The selected type of coating is mainly intended for applications against erosion, but with the high chromium and nickel contents (Ni-20%Cr) of the matrix also shows considerable resistance to corrosion. A maximum service temperature of 870°C is indicated by the powder manufacturer for  $\text{Cr}_3\text{C}_2$ -NiCr coating. A short section at each end of the tubes was left uncoated to facilitate appropriate tube attachment by welding. The coated length of the tube was about 1 m. The coated tube was installed in the economiser, Figure 2. The targeted time of exposure was set at about one calendar year.

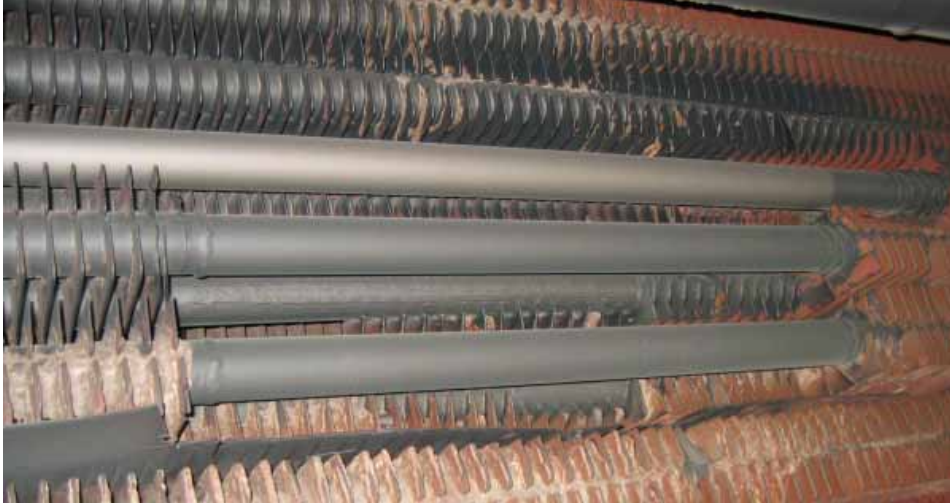
Figure 2. A coated tube installed into an economiser in boiler 2.

Boiler II was also a fluidized bed boiler with solid biomass, mainly wood-based fuels mixed with small amounts of peat. Test tubes were located at two positions, at cold and hot economiser, where tube failures have been recorded. The base materials of the test tubes were P235 in the cold end and P265 in the hot end of the economiser. The measured dimensions of the test tubes and applied coatings are presented in Table 1. Both the HVOF process using a DJ Hybrid and arc spray using a Smart Arc were applied to produce about 300  $\mu\text{m}$  and 400  $\mu\text{m}$  thick coatings, respectively, on the tubes. As in previous case, the targeted time of exposure was set to about one calendar year. After about one year of exposure, the coated test tubes were removed for post-exposure analysis.

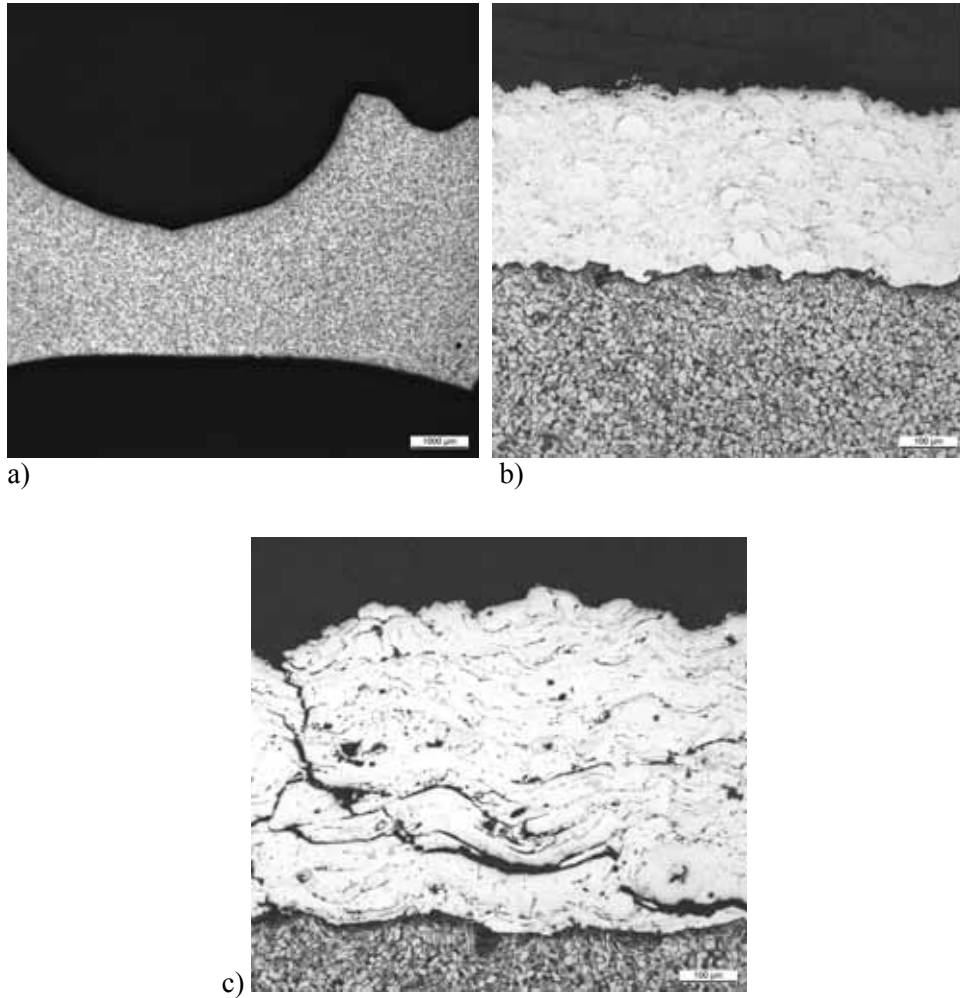
Figure 5. Tube cross-sections after one year service from Boiler II. a) Uncoated tube, b) HVOF sprayed nickel-chromium coating and c) arc sprayed iron-chromium coating.

The visual inspection of hot economiser tubes of the second boiler application revealed undamaged coating surfaces whereas corrosion pitting could be seen on un-coated tube surfaces. Coatings resisted conditions quite well in the conditions where uncoated tubes lost even 2 mm of their thickness. Deepest pits were found on the windward side at the positions of ten and two o'clock. Some differences between the coatings were observed in cross-sectional study, Figure 5. HVOF sprayed nickel-chromium coatings seemed undamaged after a one year service. Some cracking and spallation of amorphous iron-chromium coatings could be observed, especially in the case of arc sprayed coating. However, all coatings were still attached to the tube surfaces.

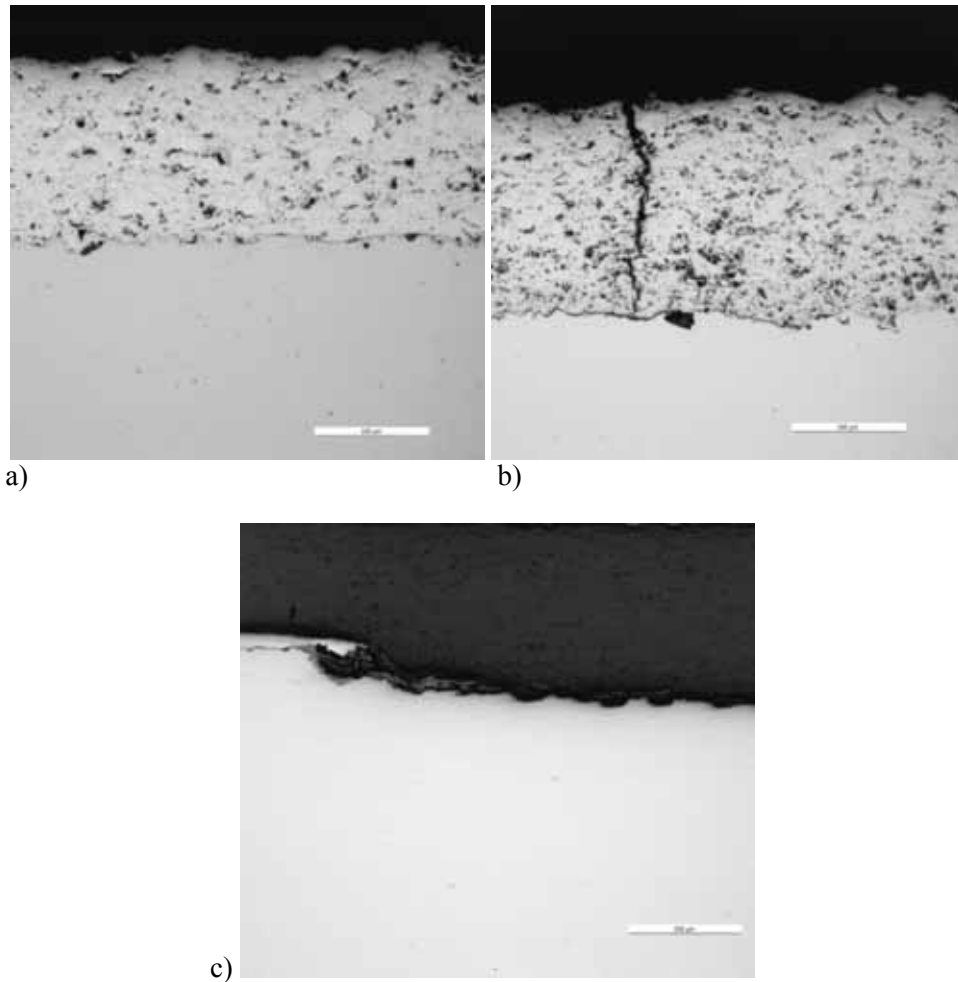
Figure 6. Cross-sections of the coated tubes from Boiler III. a) HVOF sprayed Ni-24Cr-16Mo, b) cracked HVOF sprayed Fe-25Cr and c) corroded tube surface near the coating edge.

The visual inspection of the external surfaces of the sample tubes in the third boiler applications did not reveal any signs of coating damages. The cross-sectional studies showed that all the coatings were principally in a good condition, Figure 6. At the inspection points, no peeling of coatings, no corrosion of the coating structure or tube below the coating was found. However, in some points a thin continuous oxide layer was formed at the coating-tube interface. This phenomenon was usually connected to the vertical cracking of the coating (Figure 6b) but not in all cases. Although cracks were found, no corrosion products were observed inside the cracks. Some minor cracks near the coating surface were also observed in the spray and fused coating. In all cases uncoated tube material was corroded and corrosion penetrated near the coating edge to around 100  $\mu\text{m}$ , Figure 6c. The typical thinning depth of tubes was around 100  $\mu\text{m}$ .

The coatings in Boiler III performed well and no corrosion was observed in the coated areas. Some coatings, particularly amorphous coating and spray and fused coating, had some cracks, but no corrosion products were observed inside the coatings. Fusion treatment might form some stresses in the coating structure, which facilitate crack formation. The spray and fused coating composed of different phases and no clear lamellar structure which is typical for sprayed coatings was present. The cracks are suggested to facilitate the formation of

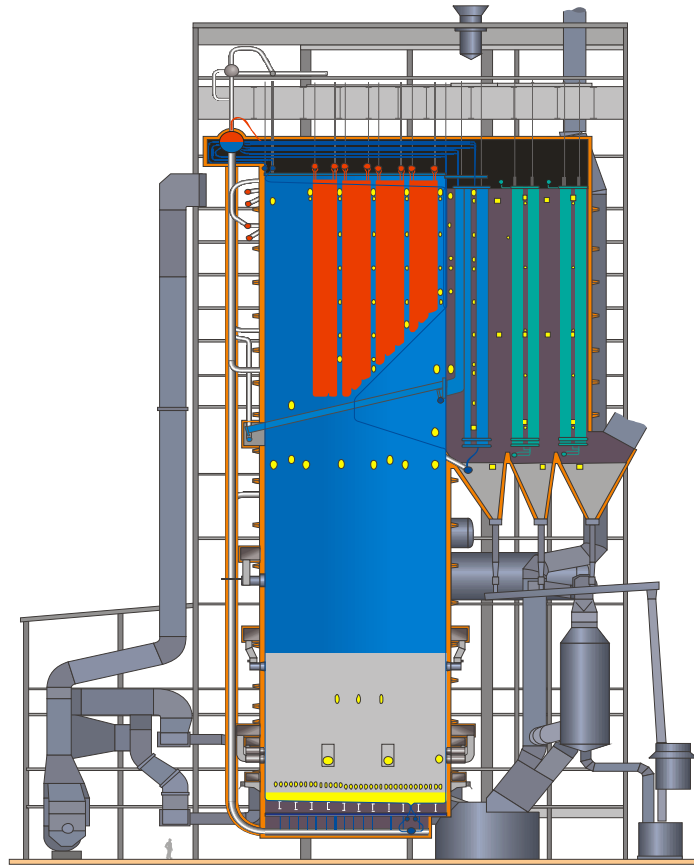
Figure 1. Typical modern recovery boiler. The superheater tubes are colored red. [3].

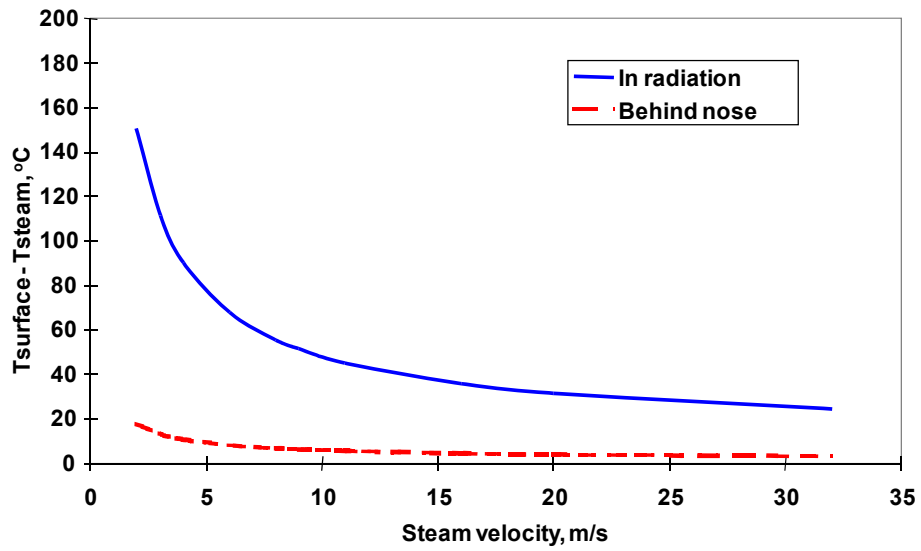
Figure 3. Effect of steam velocity on superheater surface temperature [1].

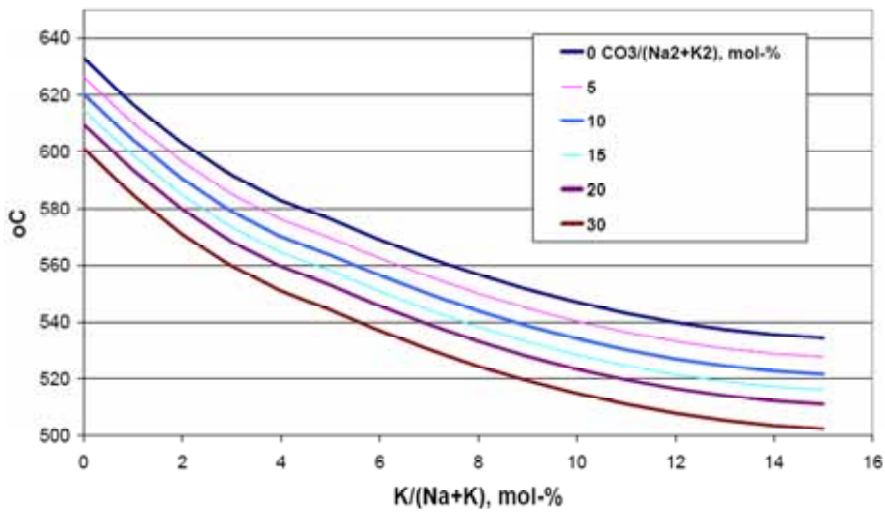
Figure 5. First melting temperature ( $T_0$ ) of recovery boiler superheater deposit.

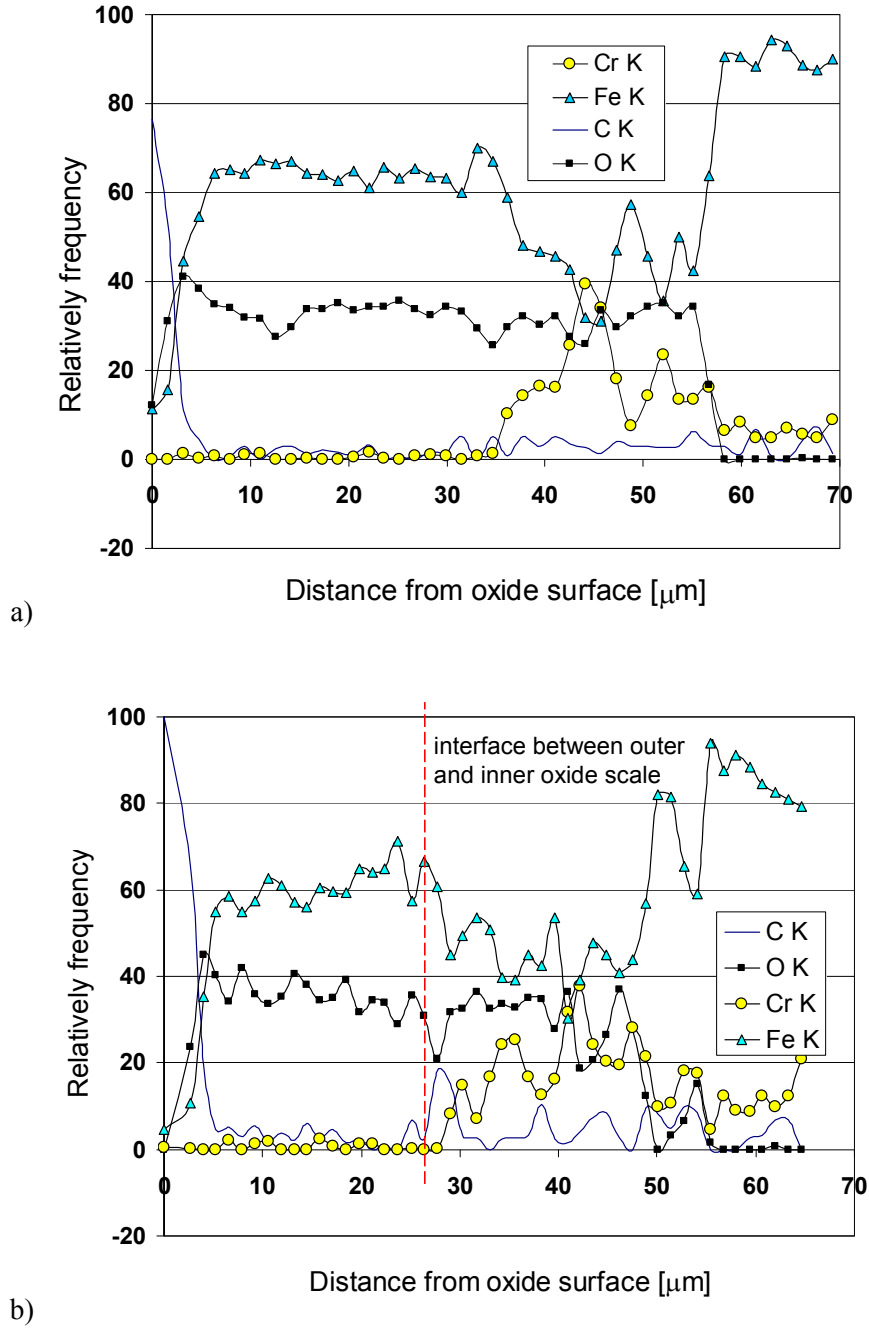
Figure 4. EDS line scan analyses representing main components of oxide scales formed on X20 after 1 000 h at 650°C in a) air combustion and b) oxyfuel combustion environment.

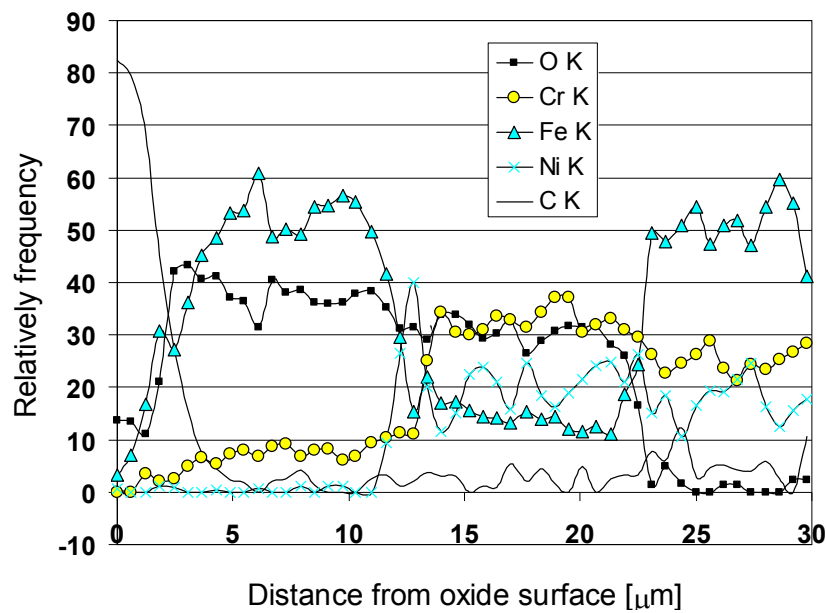
Figure 8. EDS analysis of oxides formed on HR3C after 1 000 h at 650°C in oxyfuel conditions.

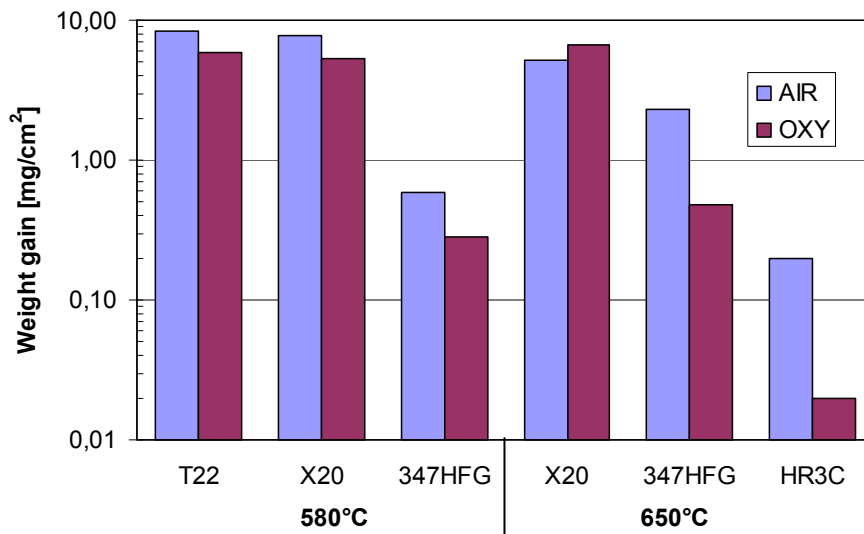
Figure 9. Weight gain of different samples exposed 1 000 h at 580 and 650°C in air-fired and oxyfuel conditions.

substantially similar than at 580°C, although it appears to be marginally better in air than in oxyfuel conditions. Steel 347HFG has approximately one order of magnitude less weight gain at 580°C, and it seems to be somewhat better in simulated oxyfuel conditions. At 650°C in air 347HFG is clearly more oxidised. However, in oxyfuel conditions the difference between 580°C and 650°C in oxidation is less. Alloy HR3C has clearly less weight gain than other test materials. The results show one order of magnitude less weight gain under oxyfuel condition in comparison with testing under air.

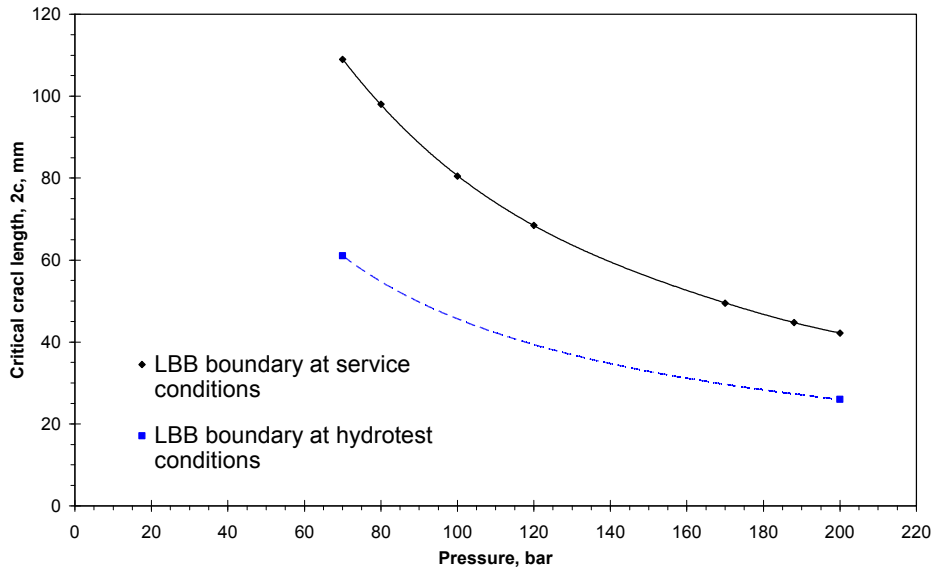
Figure 3. Leak-before-break boundary.

At the service temperature and the operating and test pressures of interest, the lower constraint on growth in this scenario leads to a more mixed failure mode than was predicted in the through-wall direction. For the hydrostatic test pressures the increased flow stress and considerably reduced fracture toughness at ambient temperature lead to a predominantly brittle failure mode and a reduced critical crack length. Figure 3 defines the calculated leak-before-break boundary in terms of critical crack length as a function of service pressure.

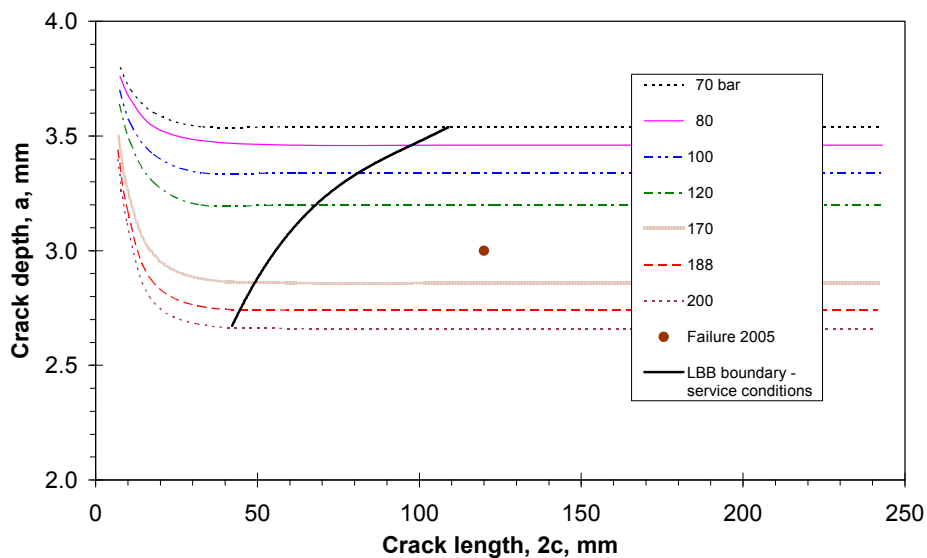
Figure 4. Total crack stability predictions at service conditions

Putting these parts of the analysis together allows the total stability behaviour of the cracks to be described, see Figure 4. The broadly horizontal lines are failure loci derived from the through-wall crack stability analysis; each represents a different operating or test pressure. A crack of dimensions below the appropriate failure locus is predicted to be stable: i.e. static or growing by a progressive mechanism such as corrosion fatigue. A crack of dimensions above the failure locus is predicted to be unstable and will penetrate the tube wall instantaneously. The leak-before-break boundary is derived from Figure 3. Any crack whose growth behaviour causes it to cross the appropriate failure locus at a point to the left of this boundary will generate a leak; any crack whose growth behaviour crosses the failure locus to the right of this boundary will generate a burst.

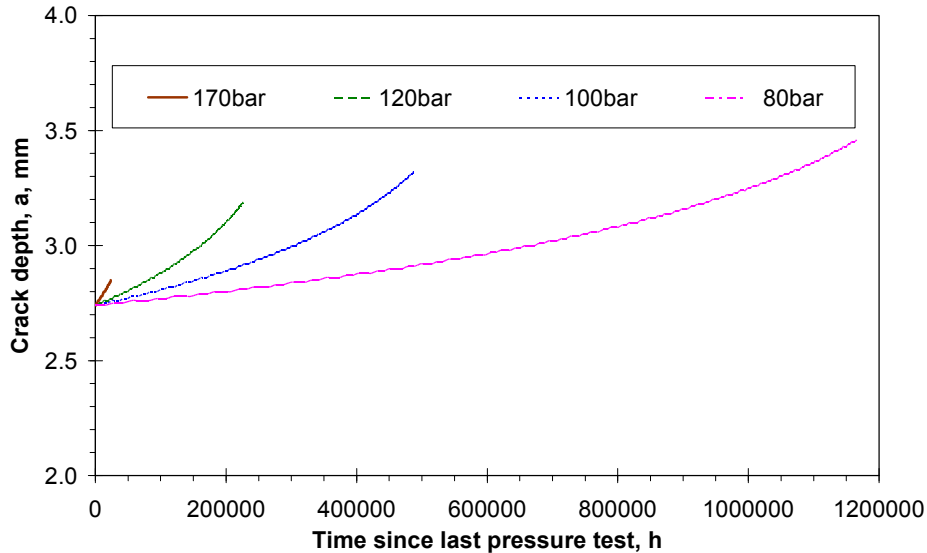
Figure 5. Predicted crack growth behaviour for the sister unit.

It must be stressed that these estimates of crack growth behaviour are illustrative, rather than indicative, let alone definitive. Many assumptions have been made from a relatively small amount of hard data. In particular, the irregular crack growth rates evidenced by the metallography have not been addressed. Nonetheless, reasonable assumptions on loading and materials properties have produced predictions of defect stability and development that are compatible with observation and experience.

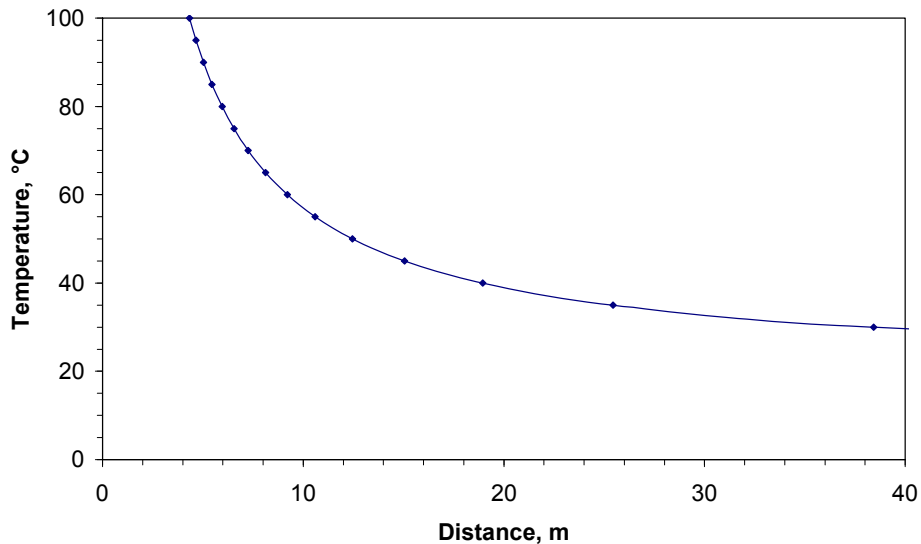
Figure 6. Decrease in temperature of the release with distance from the rupture

In simple terms, therefore, the mass released (and therefore the heat released) is more-or-less proportional to the operating pressure, but the distance over which the temperature falls to a tolerable level is broadly constant.

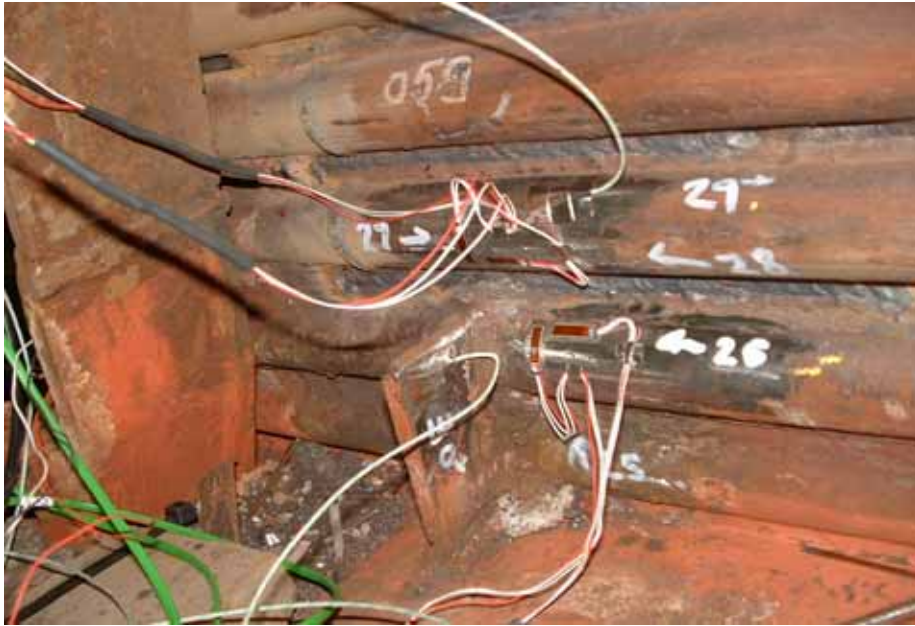
Figure 7. Typical strain gauge installation.

thermocouples in place (Figure 7) along with potentiometers to monitor boiler movements. This enabled various operational modes to be studied and control procedures implemented that would allow the desired operational flexibility whilst minimising cyclic stresses within the waterwall.

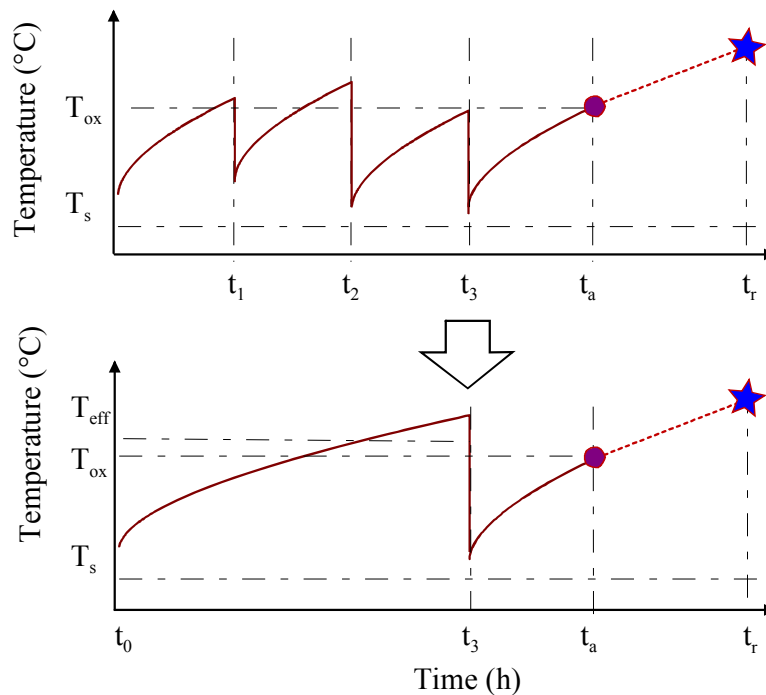
Figure 3. Reduction of service history to simplified cycles;  $T_{eff}$  = effective tube temperature in past service,  $T_{ox}$  = tube temperature from internal oxide;  $T_s$  = steam temperature;  $t_1$  to  $t_3$  = time to oxide removal,  $t_a$  = time of assessment,  $t_r$  = predicted end of life.

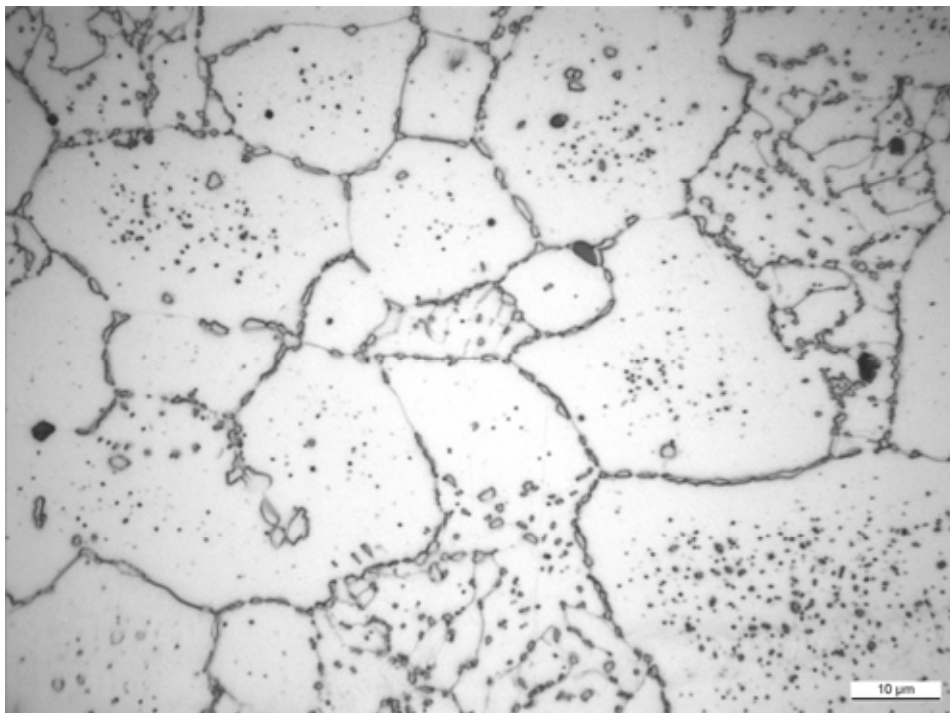
Figure 5. Microstructure of a reheater tube, scale bar 10  $\mu\text{m}$ .

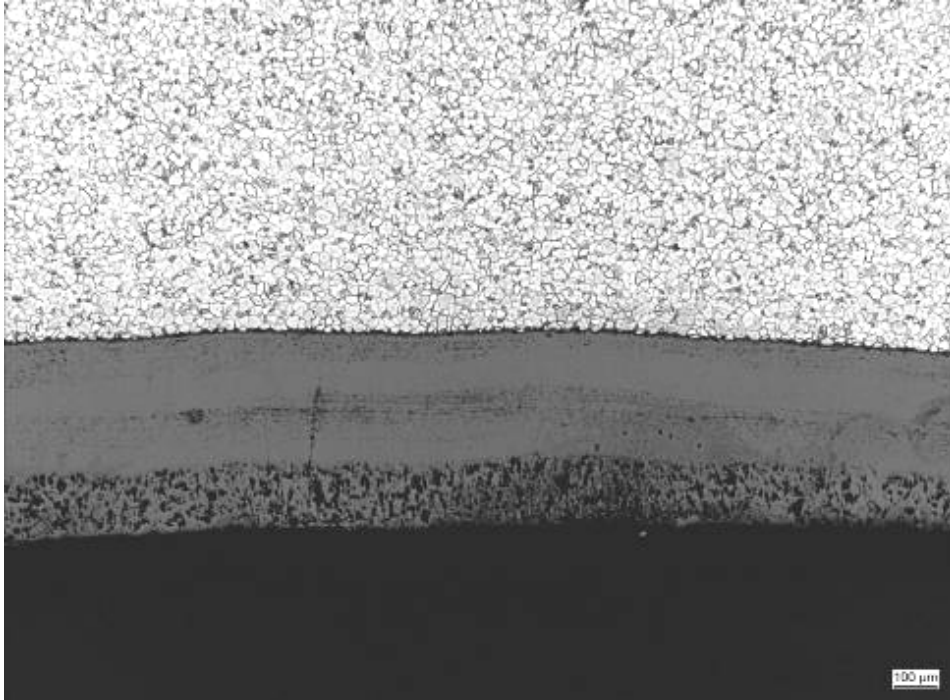
Figure 6. Sectioned internal oxide; scale bar 100  $\mu\text{m}$ .

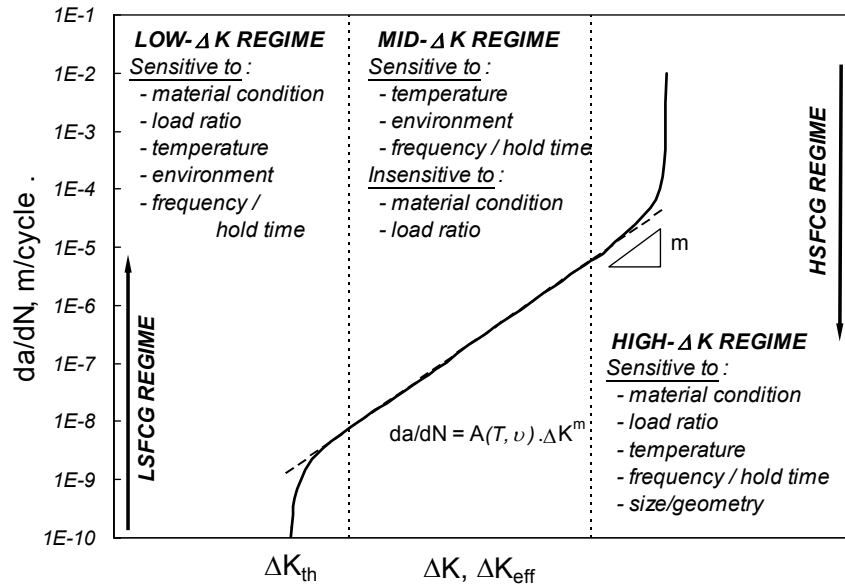
Figure 1. Cyclic crack growth rate regimes [1].

In equation (1),  $A(T, \nu)$  and  $m$  are material constants dependent on temperature, environment and frequency (below a limiting value).

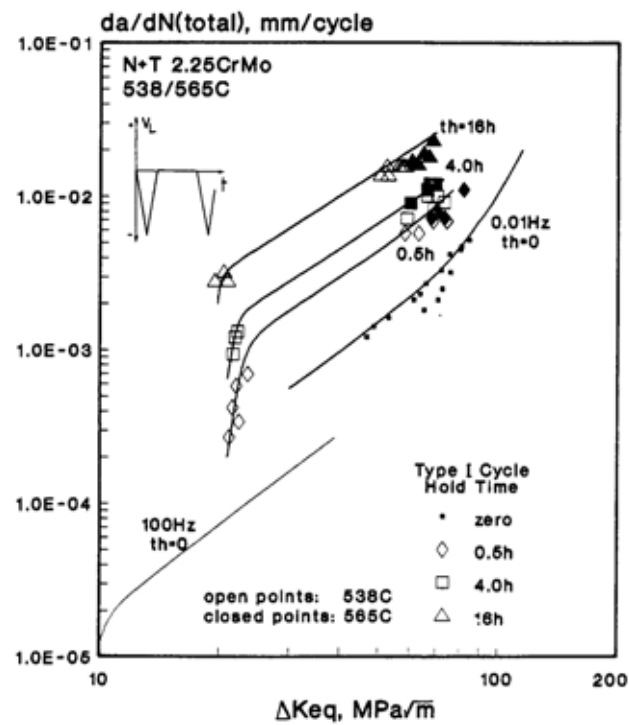
Figure 5. Long crack cyclic/hold creep-fatigue crack growth test data for 2¼CrMo cast turbine steel at 538/565°C [3].

Any enhancement of the total growth rate per cycle due to creep-fatigue-oxidation interaction is covered by  $A(T, \nu, t_h)$  which is determined experimentally (e.g. Figure 5).

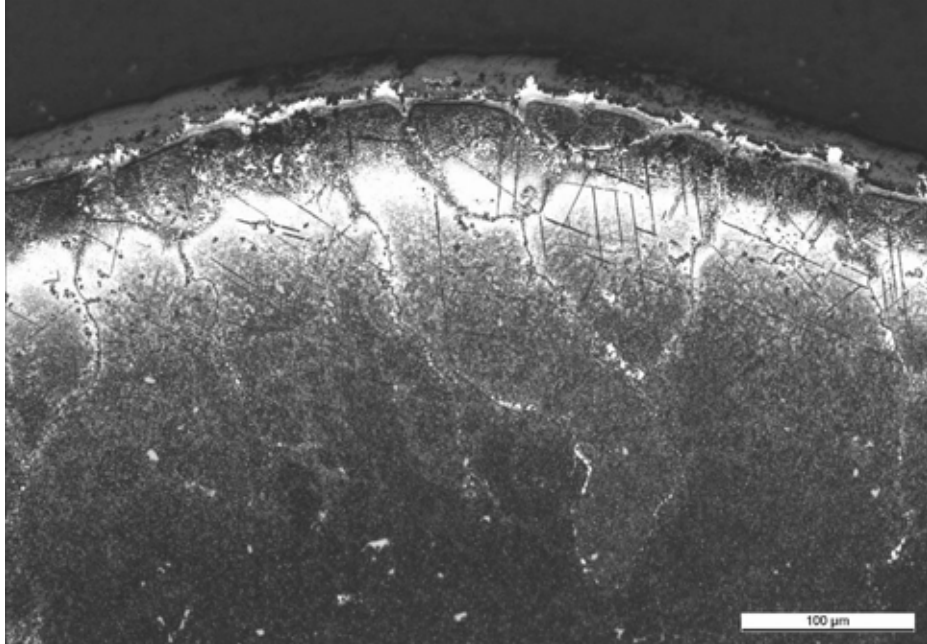
Figure 1. Cross-section of the airfoil leading edge (case 3).

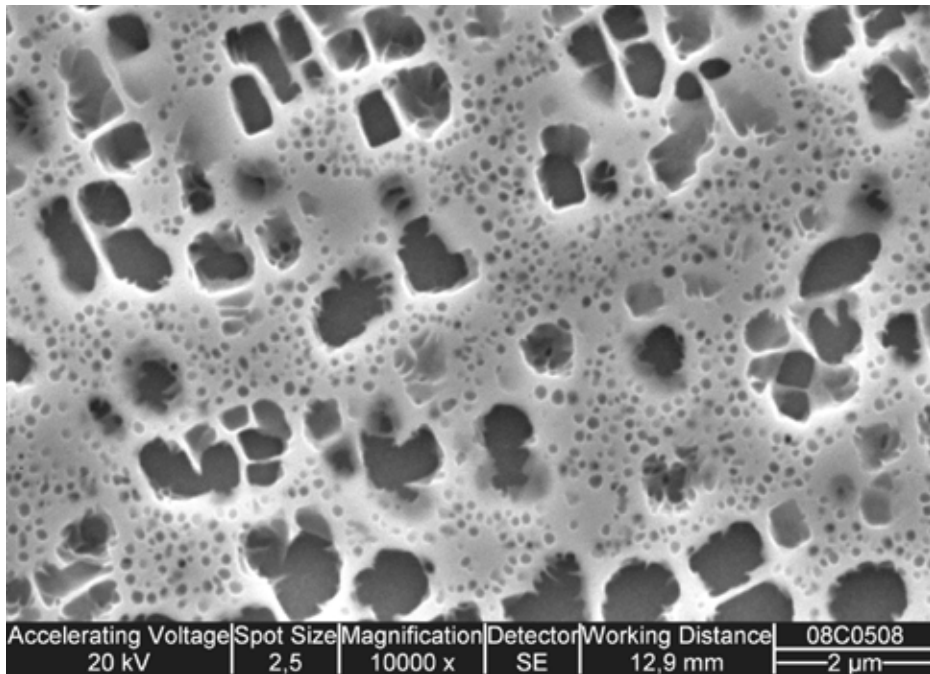
Figure 2. Blade microstructure, hot cross-section of the airfoil (case 3).

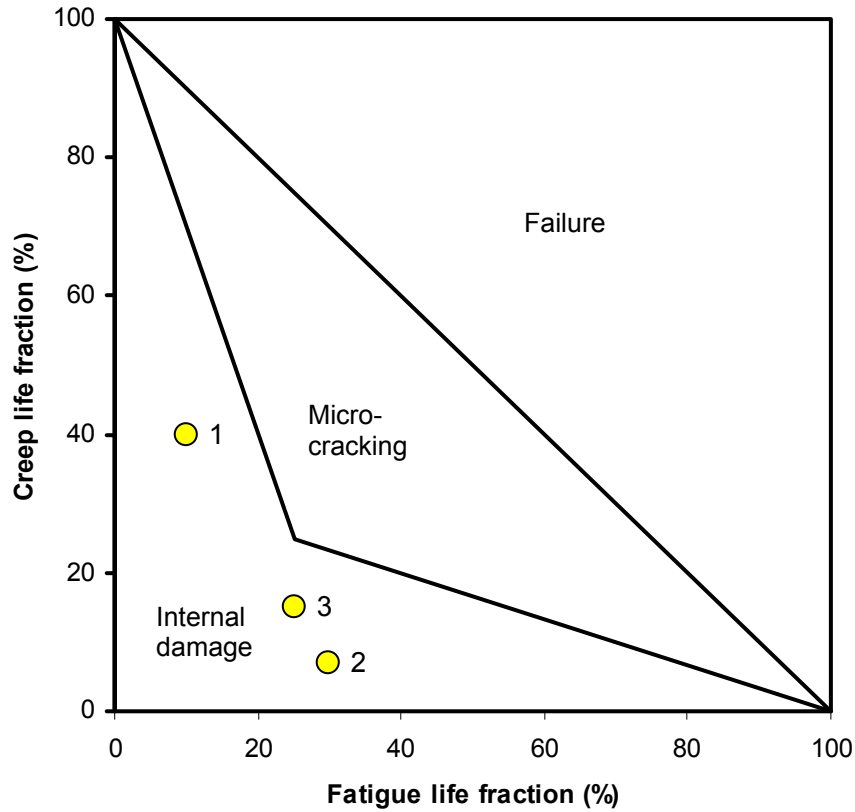
Figure 3. Approximate position of the blade cases 1–3 on a creep-fatigue life fraction map.

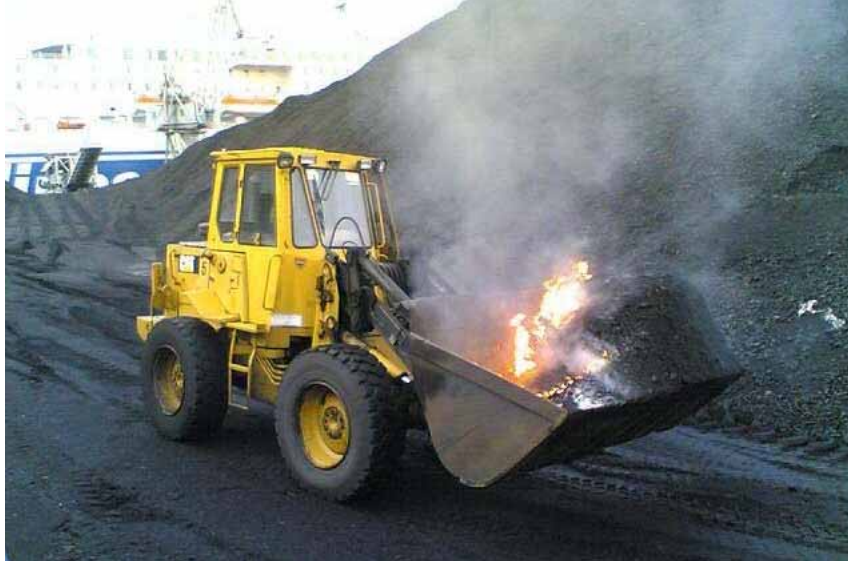
Figure 1. Digging out an open storage coal fire to spreading it for self-extinction.

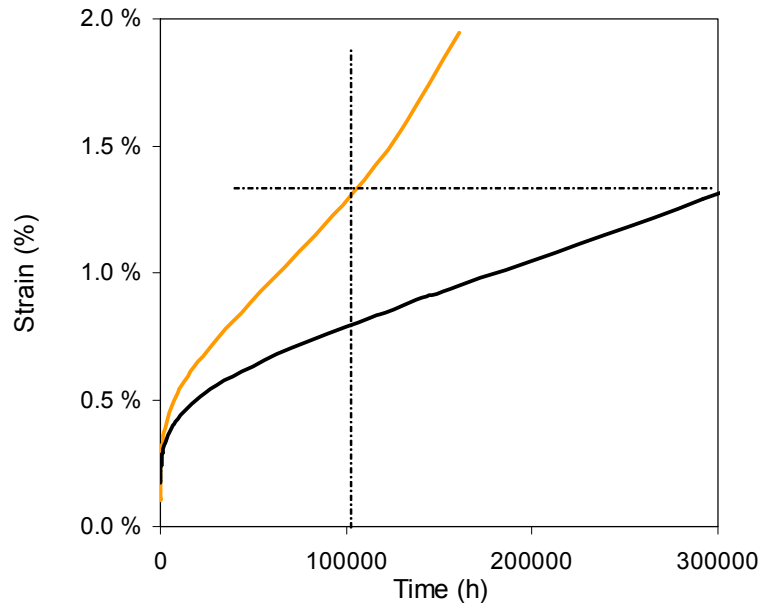
Figure 2. Predicted creep strain history for X20 parent material (lower curve) and outer heat affected zone (Type IV position, upper curve) at the design limit of the branch to the boiler; the vertical line shows time of first inspection.

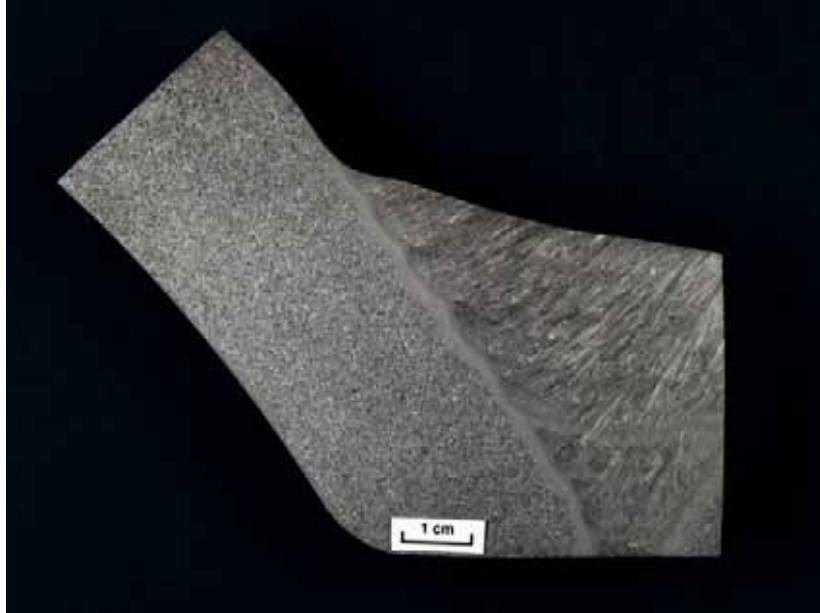
Figure 3. Cross-section of the saddle point crack location.

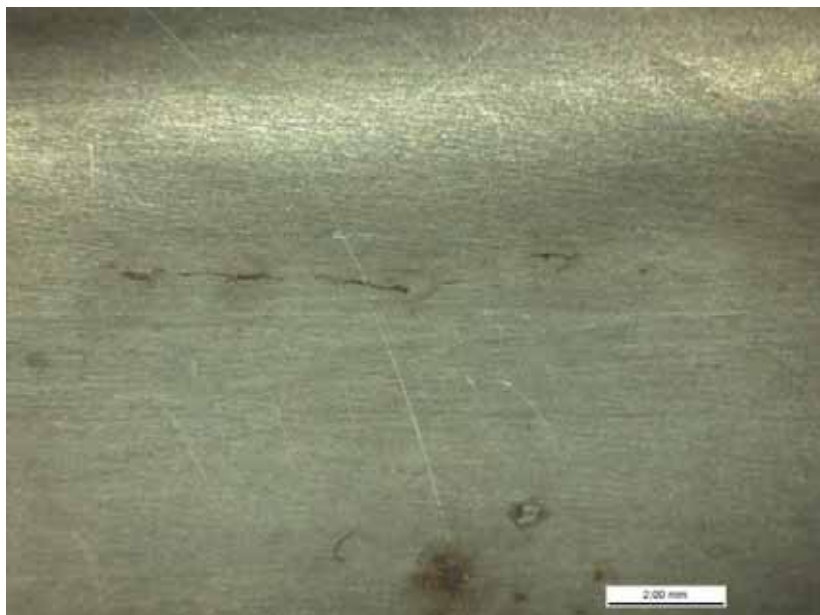
Figure 4. Appearance of the "toilet paper" crack on the header surface (axial direction of the header body horizontal).

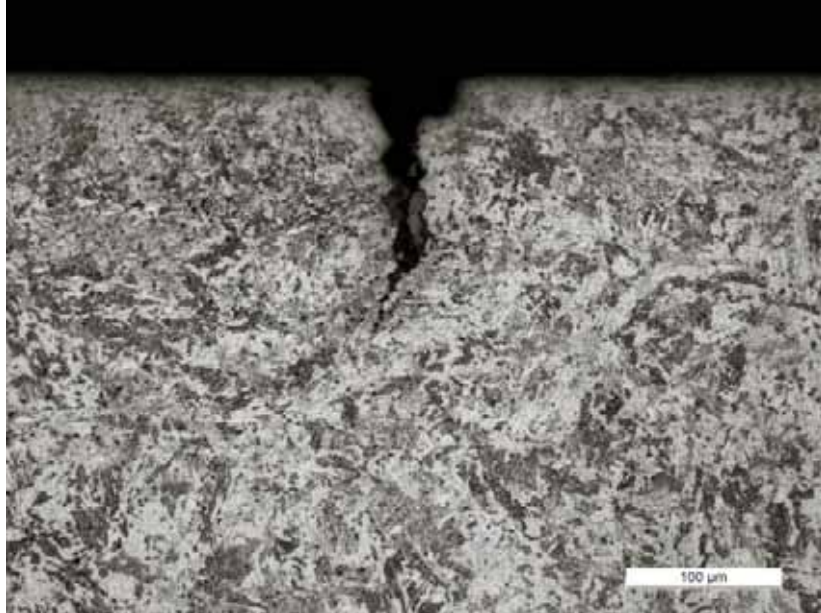
Figure 5. Cross-section of the surface crack.

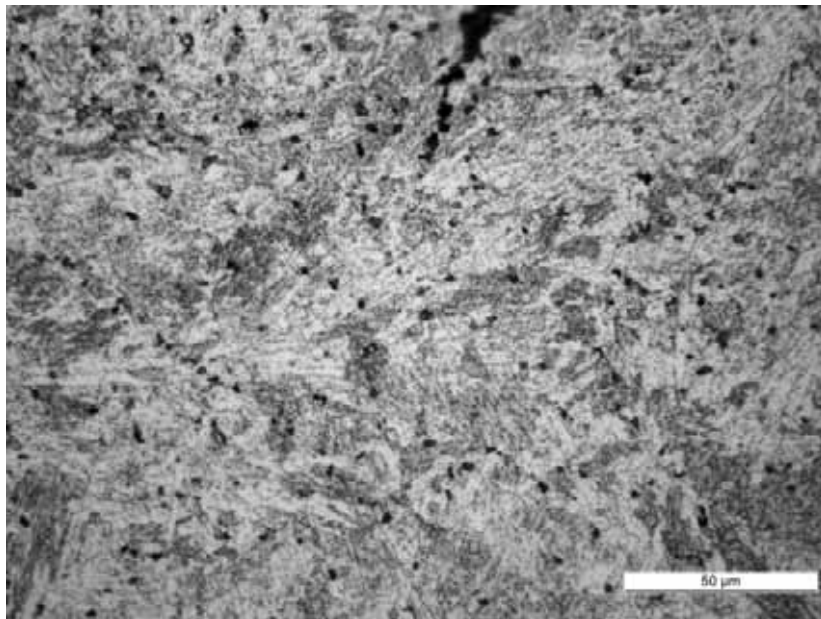
Figure 6. Creep cavitation in front of the crack tip.

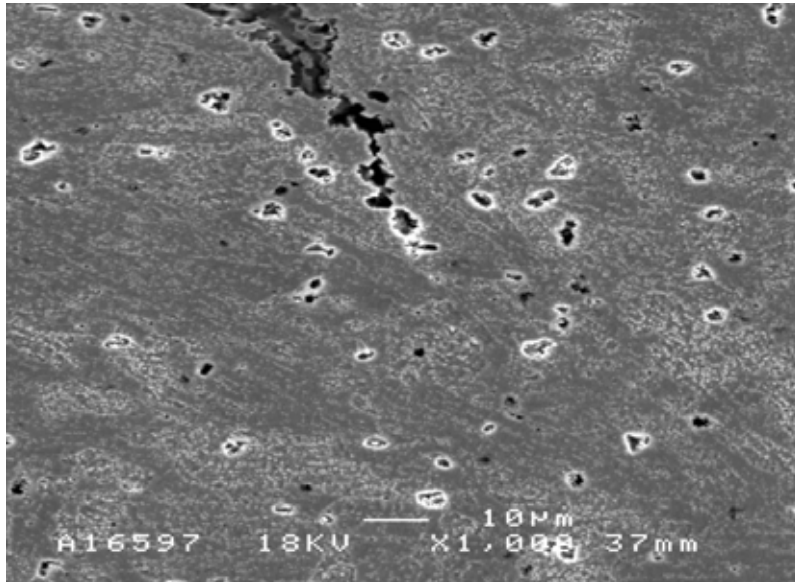
Figure 7. Creep cavitation ahead of the crack tip.

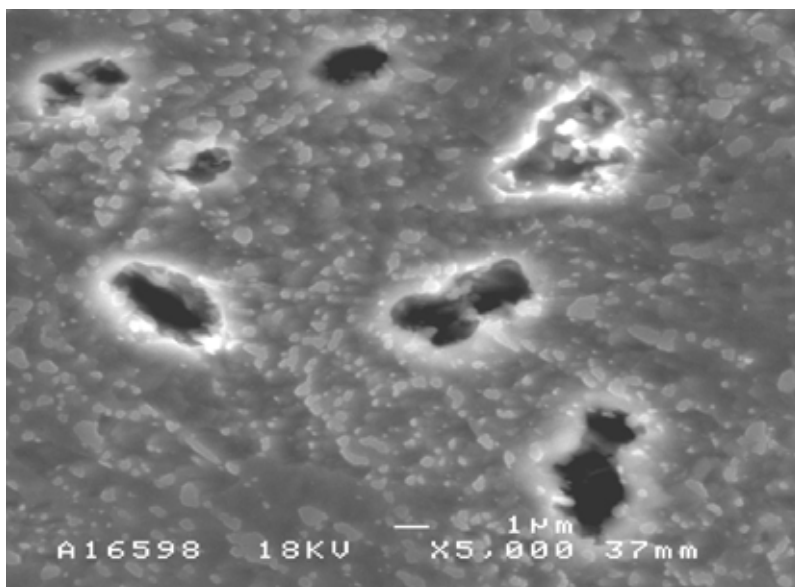
Figure 8. Creep cavities near the crack tip.

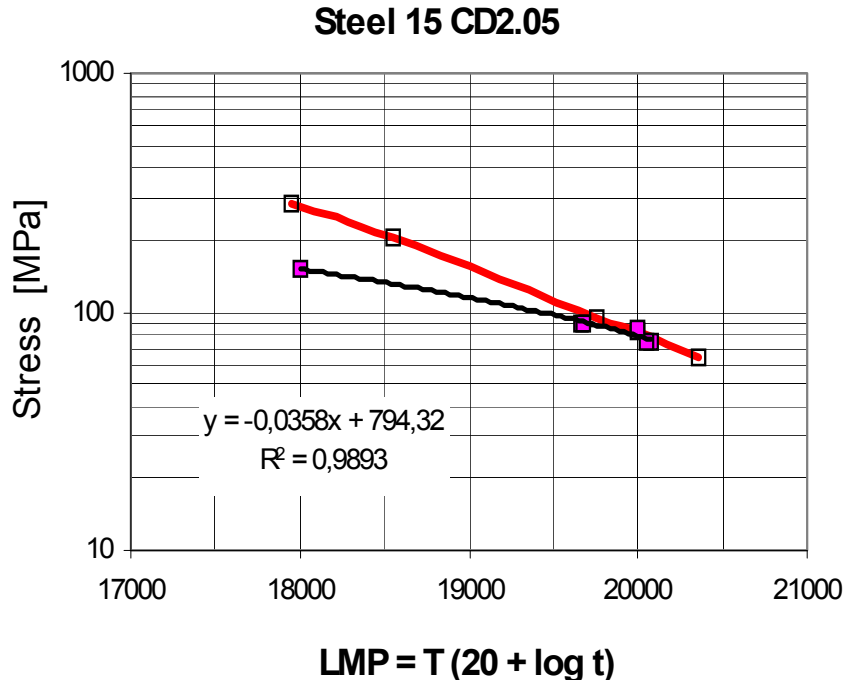
Figure 4. Creep to Rupture Curve and accelerated Creep Test Results, steel 15 CD2.05 (A213 T2).

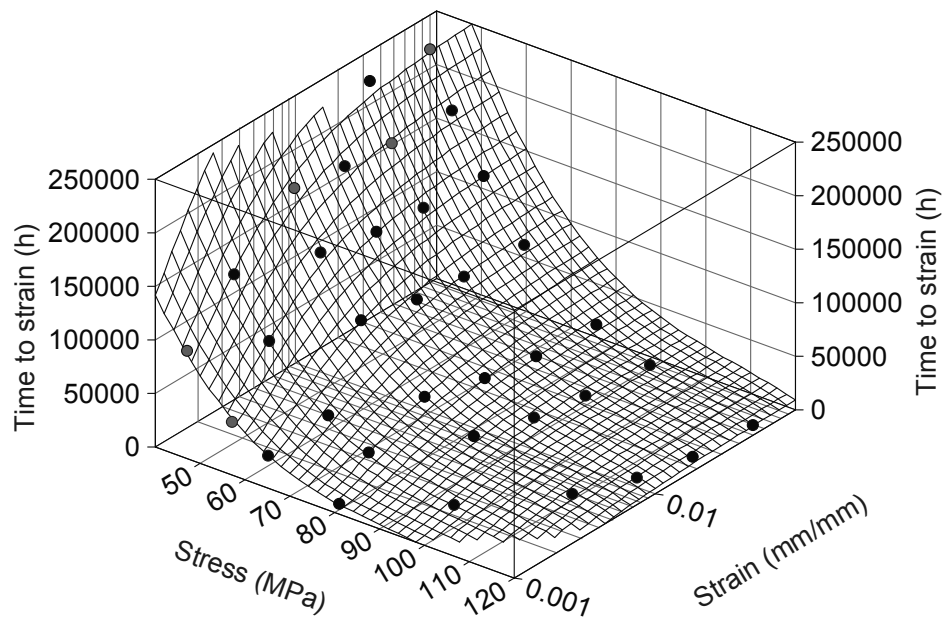
Figure 1. The 550°C isotherm for time to specified strain (SPRINT/ISO data).
