VTT SYMPOSIUM 265

# **Baltica VIII**

## **Life Management and Maintenance for Power Plants**

### **Vol. 2**

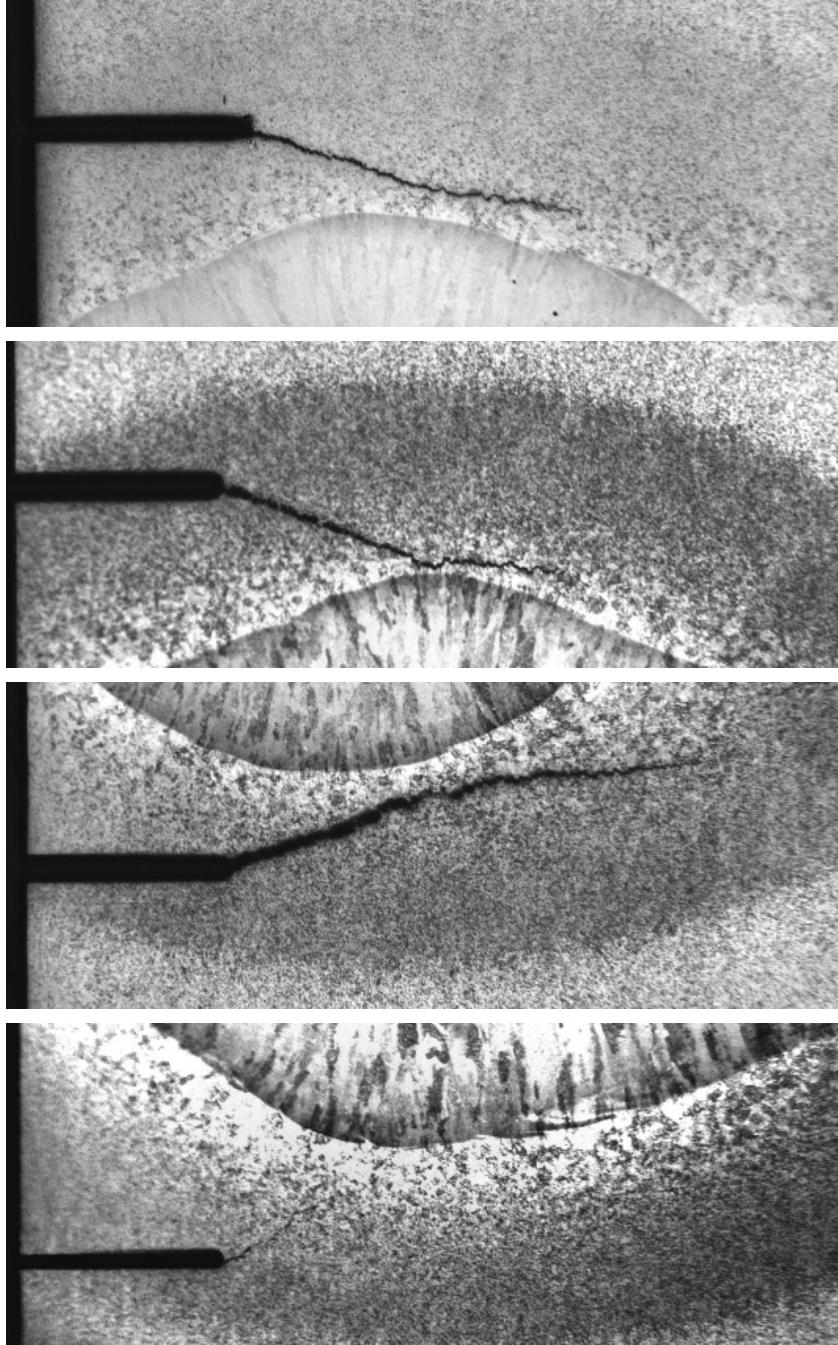
Figure 3. The crack of specimens CT1-CT4: crack has grown to CGHAZ close to the fusion line. Scale as in Figure 4.

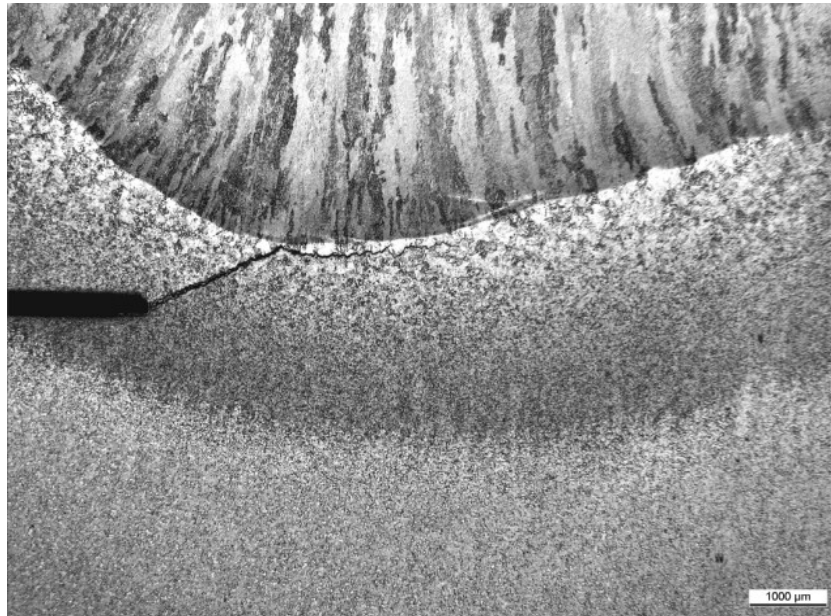
Figure 4. The crack of specimen CT5: crack has grown through CGHAZ to region close to the fusion line (type III crack).

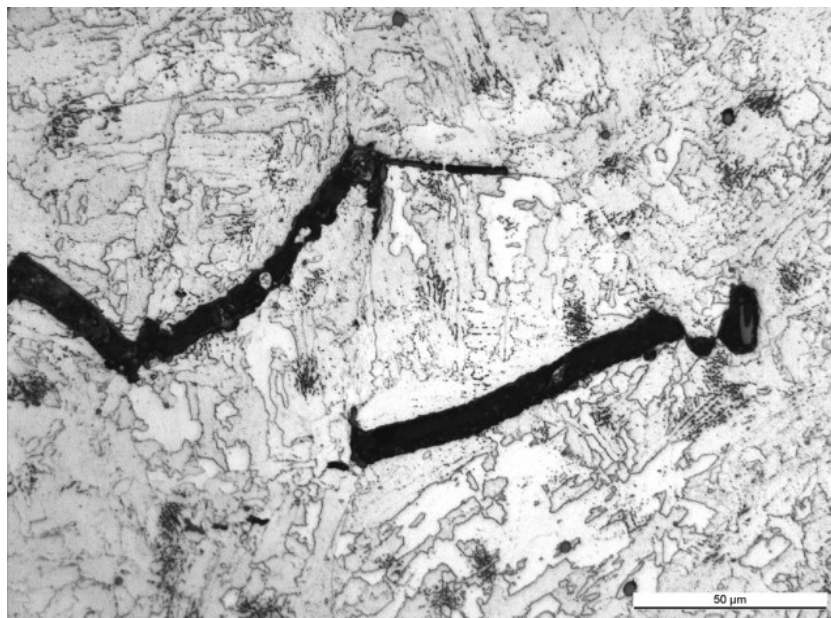
Figure 5. The crack tip of specimen CT2: note opening of intergranular cracks in the vertical (loading) direction.

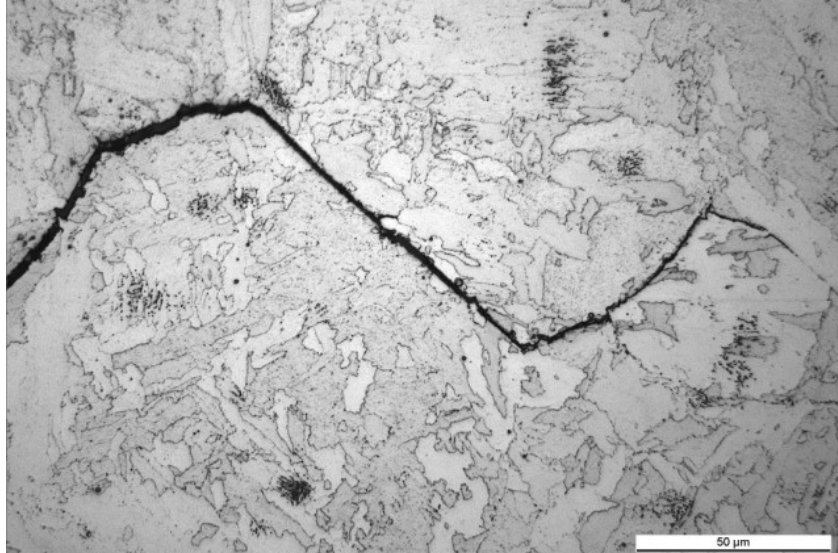
Figure 9. A detail of Figure 6; crack tip of specimen CT5.

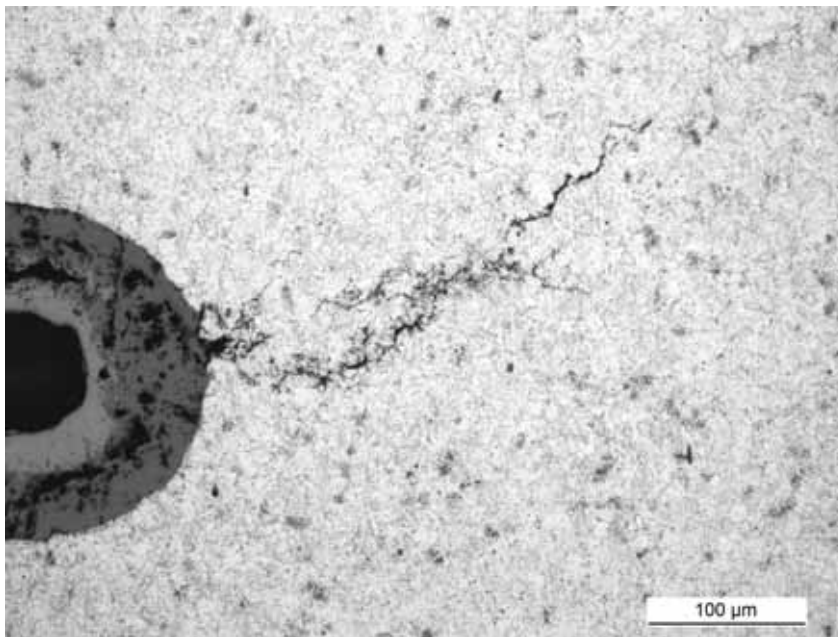
Figure 10. Specimen/test CT6: the crack is growing towards the CG-HAZ.

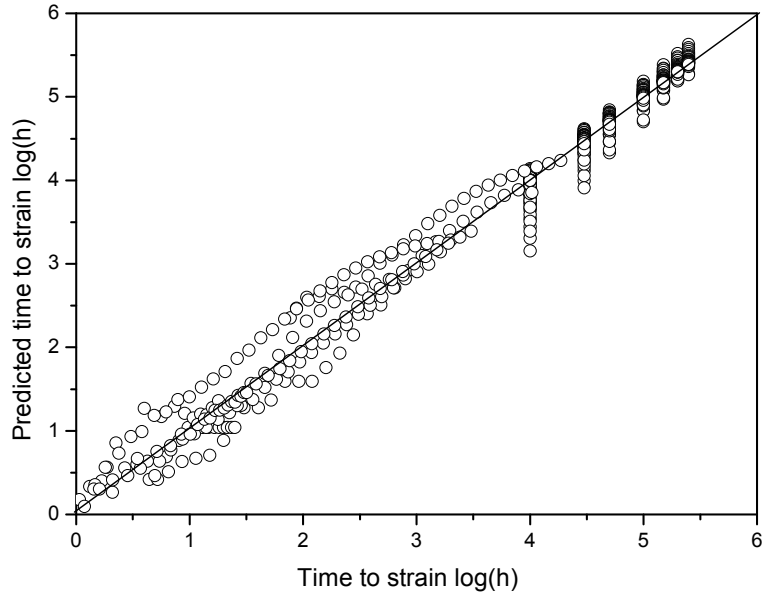
Figure 11. Predicted vs. measured/table values of time to specified strain (continuous curves from tests, vertically aligned data from [6];  $Z = 2.1$ )

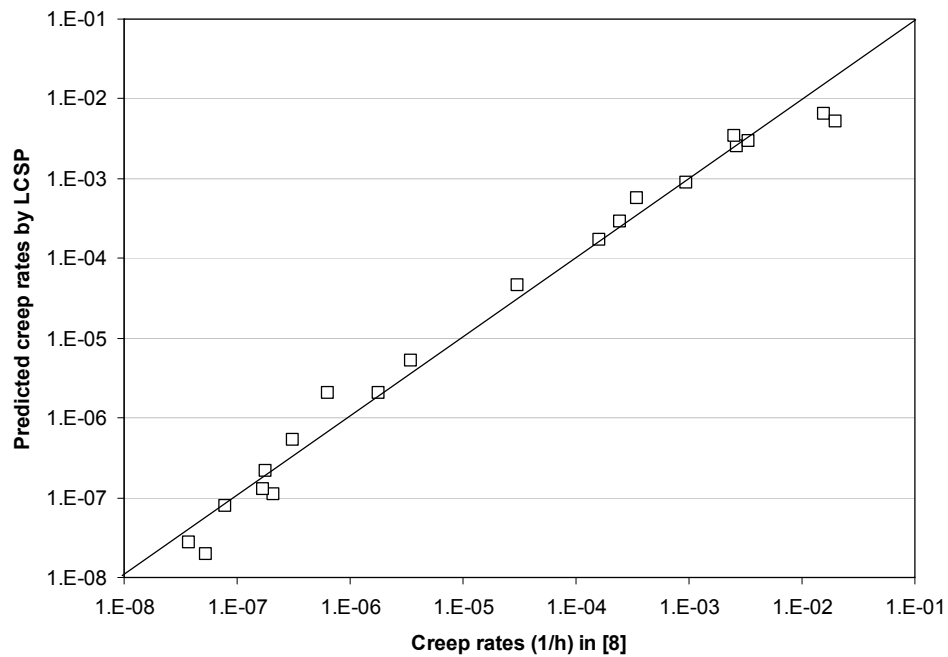
Figure 13. LCSP predicted minimum creep rates for 0.5CMV steel in comparison to rates given in [8], with time to rupture calculated using SRF = 0.7 in relation to EN-10216 model; for strain rate  $Z = 4.5$ .

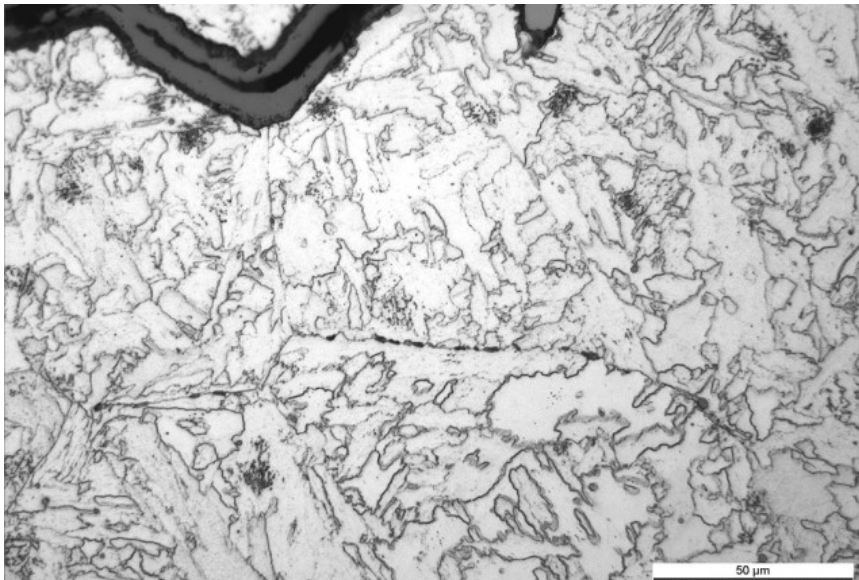
Figure 14. Grain boundary cavitation parallel to crack growth in CGHAZ of specimen CT5.

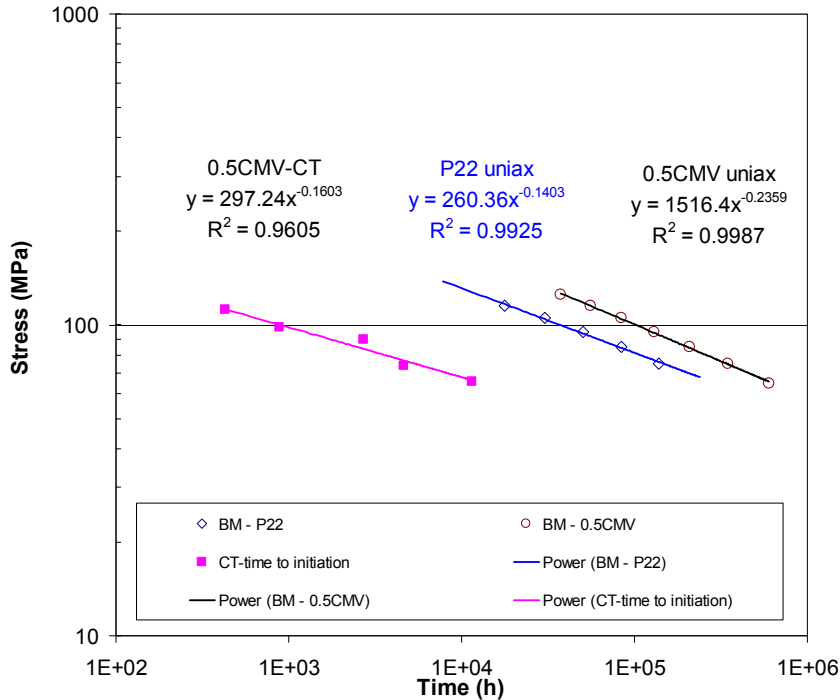
Figure 15. Comparison of CT (multi-axial) testing results and uniaxial data for 0.5CMV and 2.25Cr-1Mo steel (weld metal) using the LICON approach.

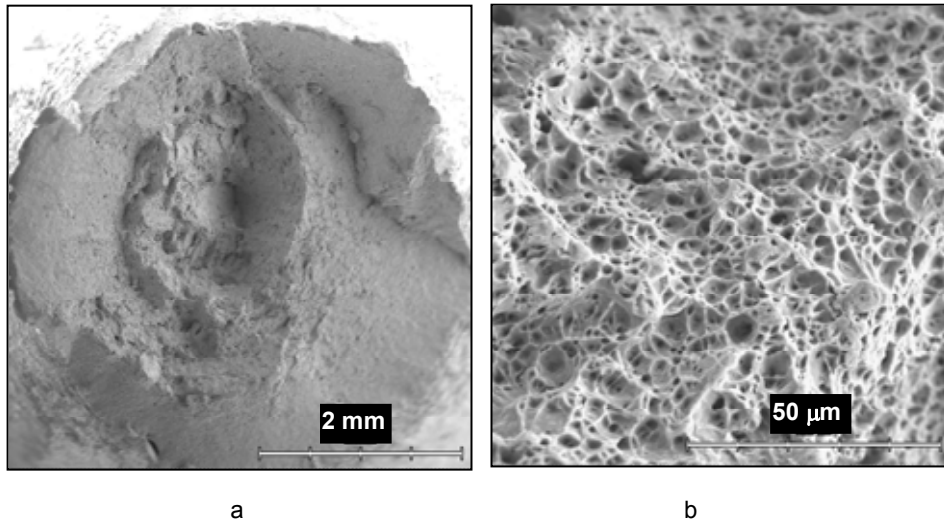
Figure 3. Fracture surface of the tube weld joint crept at 525°C/240 MPa/3 772 hrs: a) general view, b) detail of the central part. Specimen 2C1, SEM micrographs.

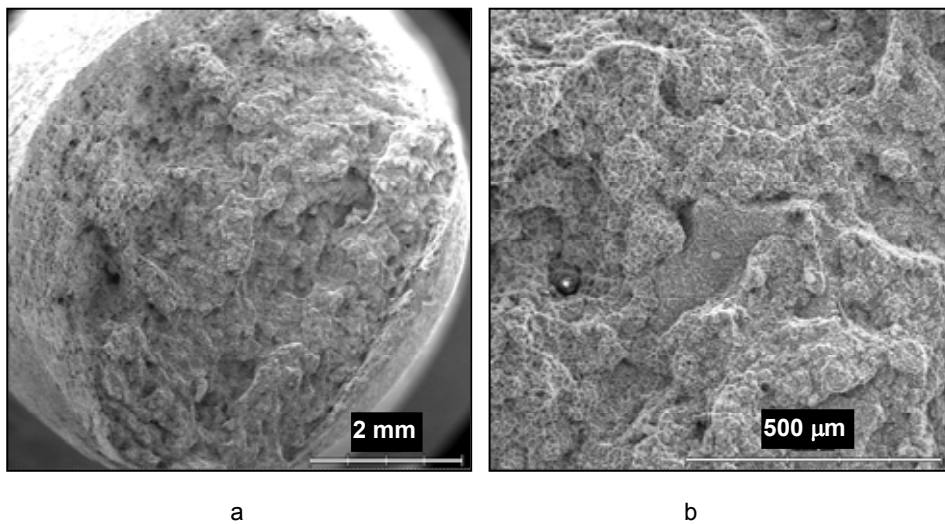
Figure 5. Fracture surface of the plate weld joint crept at 575°C/160 MPa/3 793 hrs: a) general view, b) detail of the central part. Specimen C15, SEM micrographs.

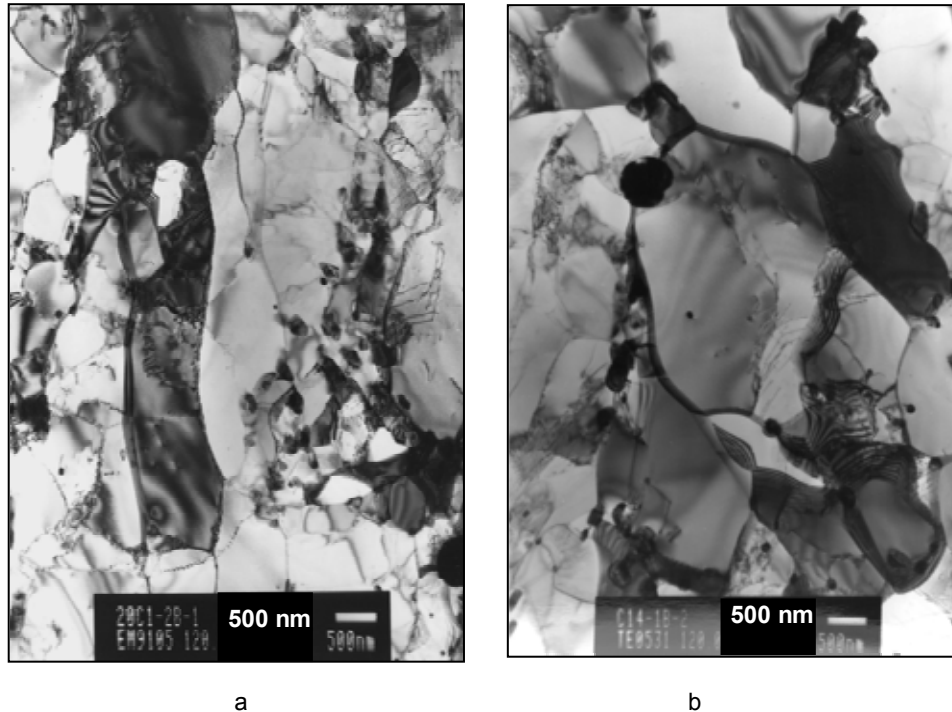
Figure 9. Substructure of WM after creep tests at 625°C and 50 MPa: a) the tube weld joint, 20C1 specimen, b) the plate one, C14 specimen. TEM micrographs.

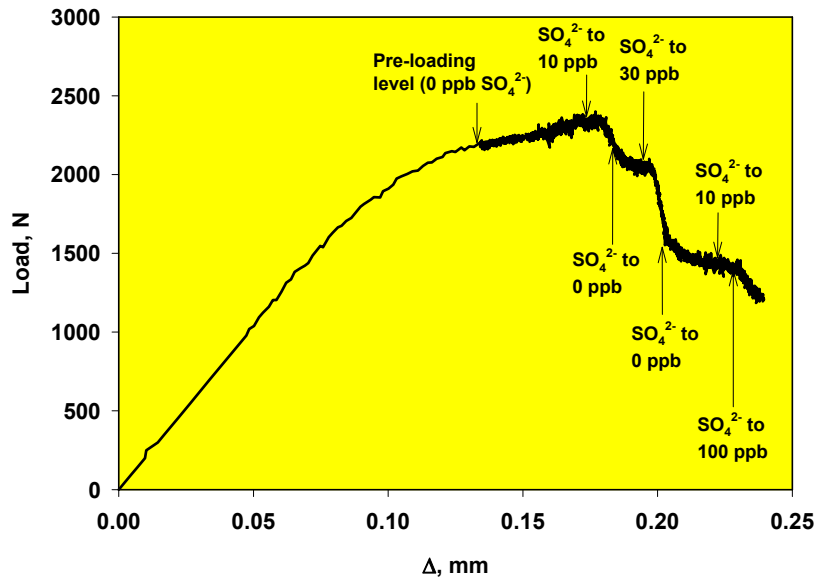
Figure 4. Example of a typical load-displacement curve of Inconel 182 with the effects of sulphate intrusions [1].

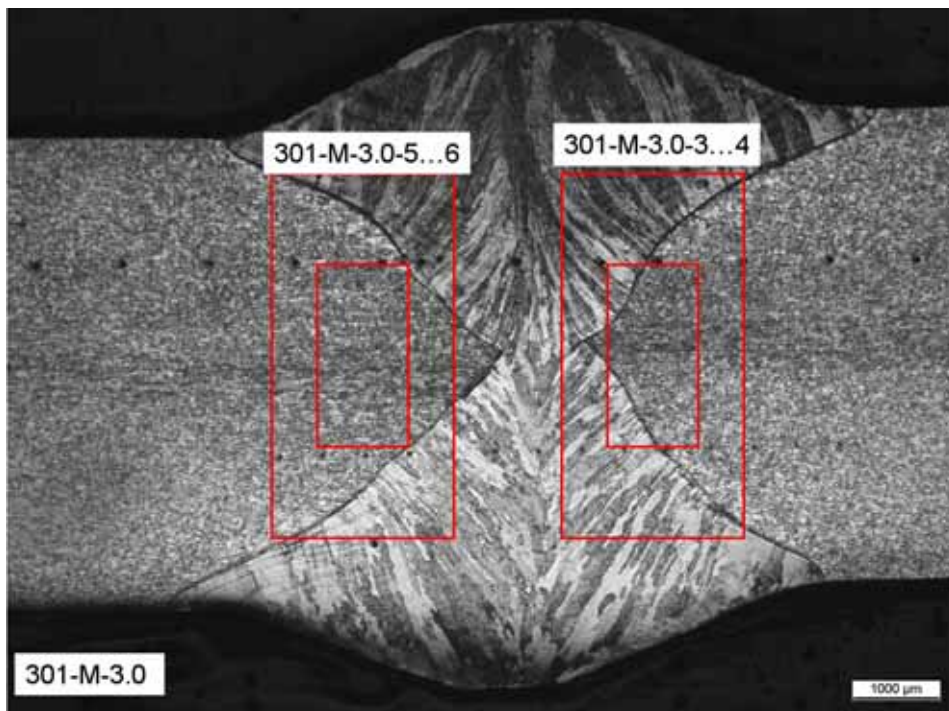
Figure 1. Example of the macrosection of the GMAW multipass welded austenitic EN 1.4318 (AISI 301 LN) steel, 5 mm plate thickness. Extraction of the  $1 \times 2$  mm<sup>2</sup> size flat-bar specimens (in realistic scale): inner rectangular lines: specimen's measuring gauge dimensions; outer rectangular lines: specimen-end dimensions. Right-hand side: specimen sampling the grain-coarsened HAZ immediately adjacent to the fusion boundary (with some weld metal included); left-hand side: specimen sampling the outer HAZ (without any weld metal involved) [2].

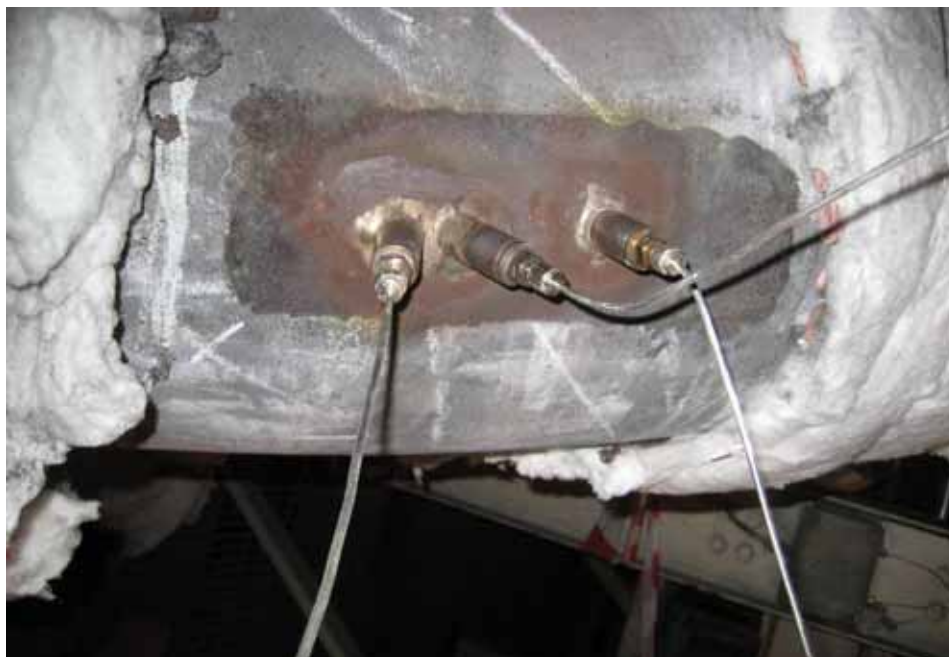
Figure 1. High temperature probe installation at Ratcliffe in 2007.

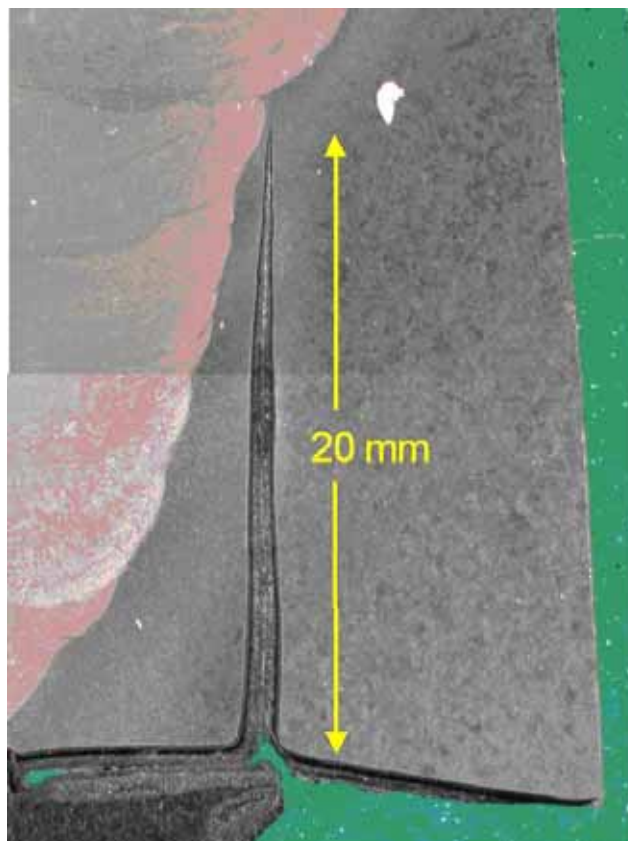
Figure 2. Section through a steam-line circumferential bore crack.

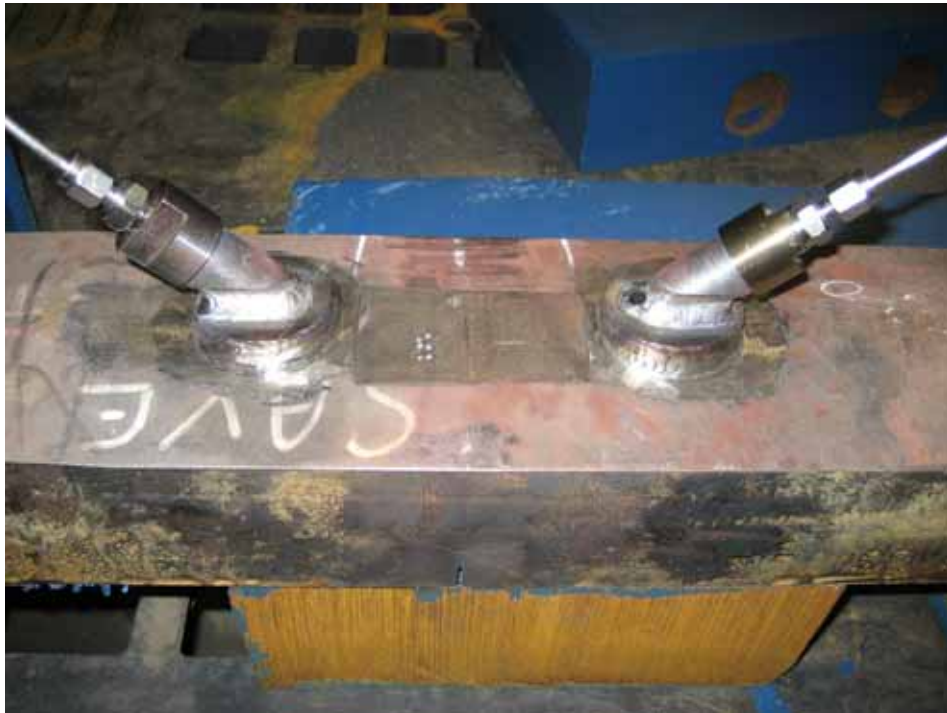
Figure 3. High temperature probes welded onto specimen in TOFD arrangement.

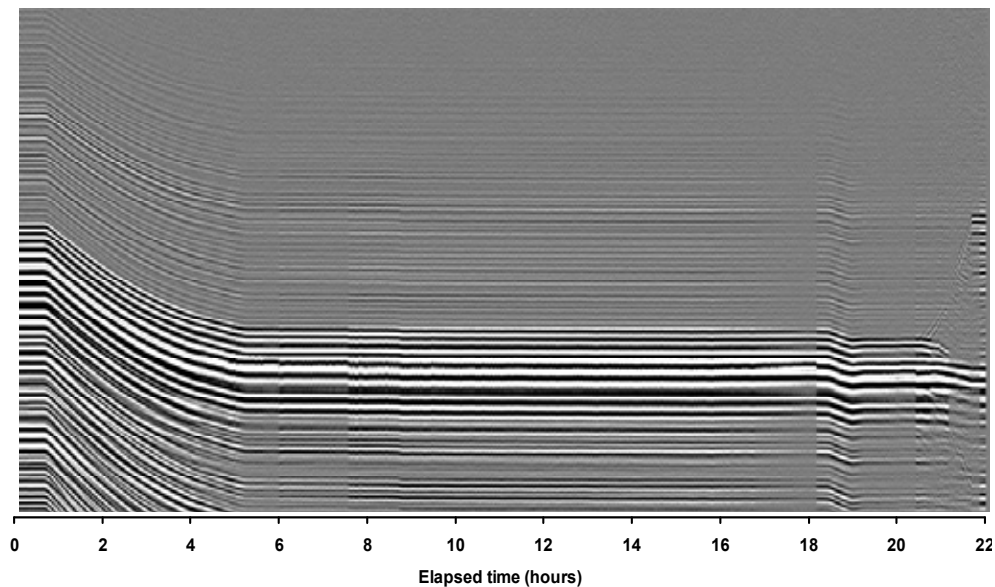
Figure 5. UT data from monitoring trial.

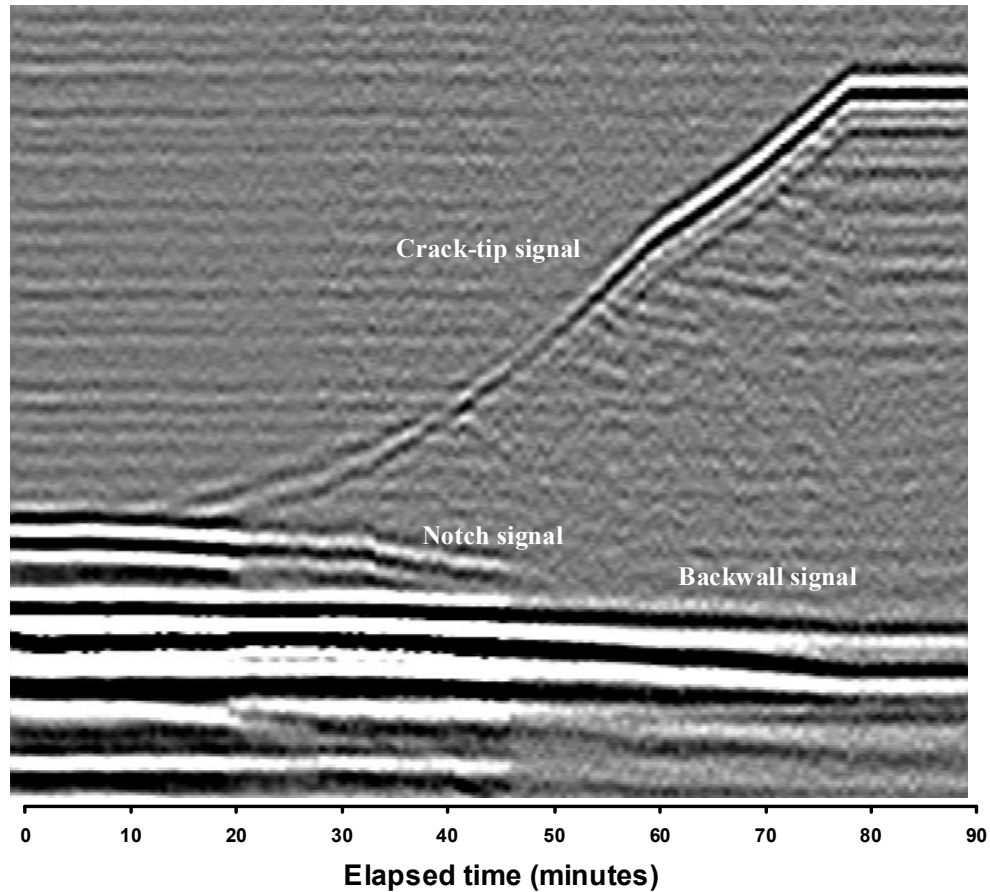
Figure 6. Crack growth detail.

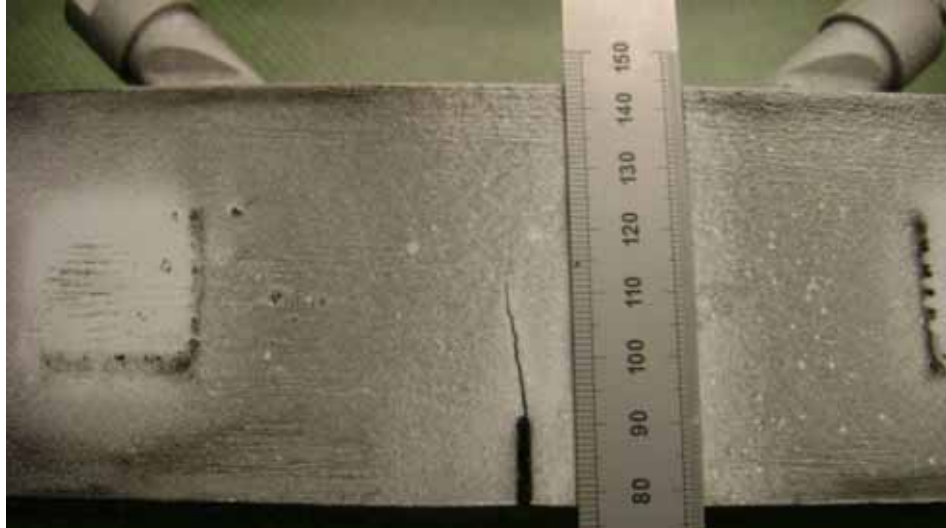
Figure 7. Fatigue crack detail after completion of test.

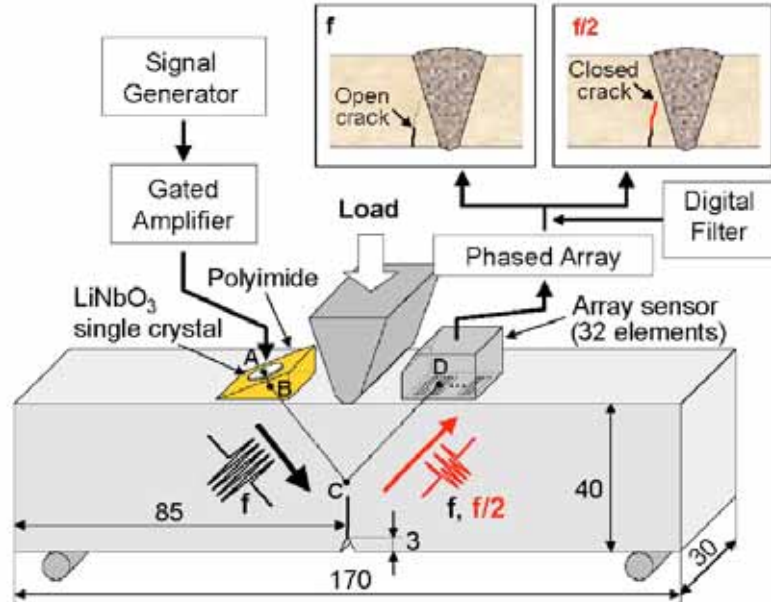
Figure 8. Three point bending was used to control the opening and closure of fatigue cracks. The dimensions are in mm (Yamanaka, 2007).

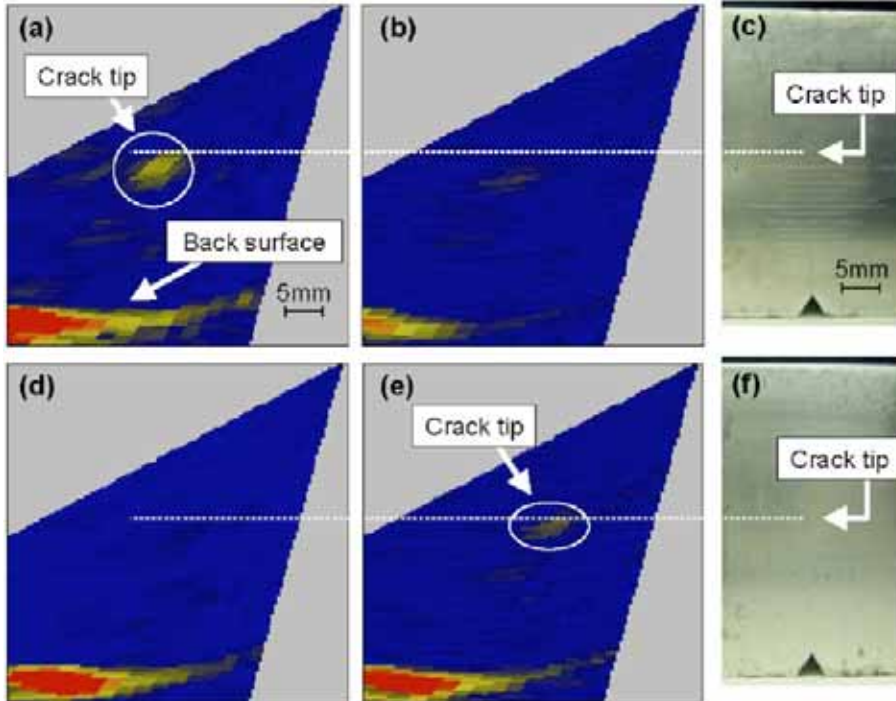
Figure 9. Phased array images of a crack tip in an aluminium specimen (A7075). The crack tip is open in a) and b) while it is closed in d) and e). Images a) and d) are taken at fundamental frequency while b) and e) are taken at subharmonic frequency. The closed crack tip cannot be observed at fundamental frequency d) but it is clearly observed at subharmonic frequency e) (Ohara et al. 2007).

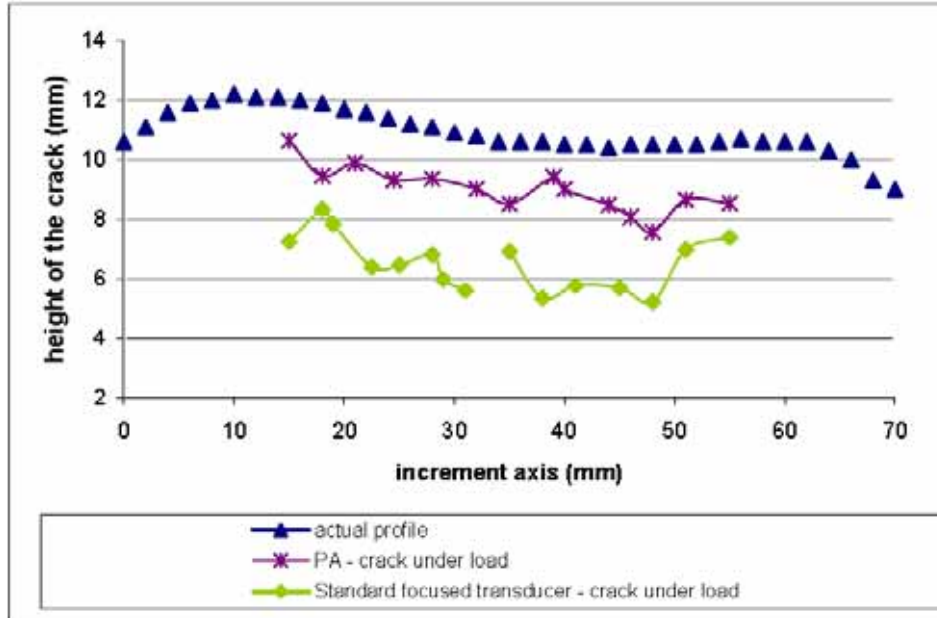
Figure 15. Destructively (actual profile) and ultrasonically obtained crack height for a partially closed crack. The large aperture phased array (PA) gives a better result than the standard focused transducer (Dupond et al. 2004).

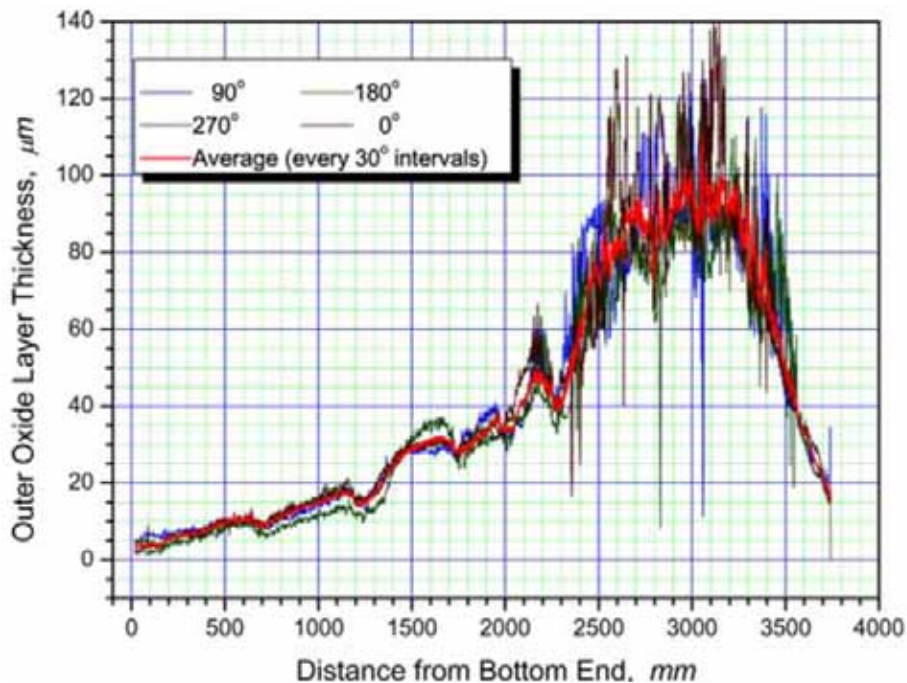
Figure 2. Oxide thickness on a Zircaloy-4 fuel cladding tube after a fuel burn-up of about 65 GWd/tU using eddy current measurement [5]

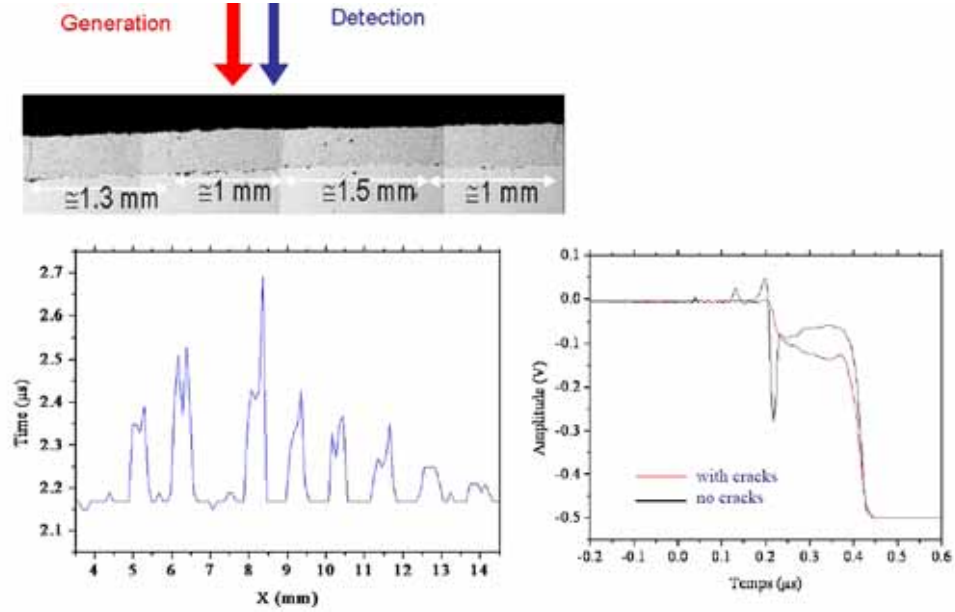
Figure 6. Laser ultrasonic detection of cracks in a WC-Co coating layer. Left, upper picture, cross-sectional view of the sample with the generation/detection scheme and (lower left) the variation of a waveform parameter along the sample. Right, the variation of the vibrational amplitude in a region with partial delamination between the coating and the substrate [8].

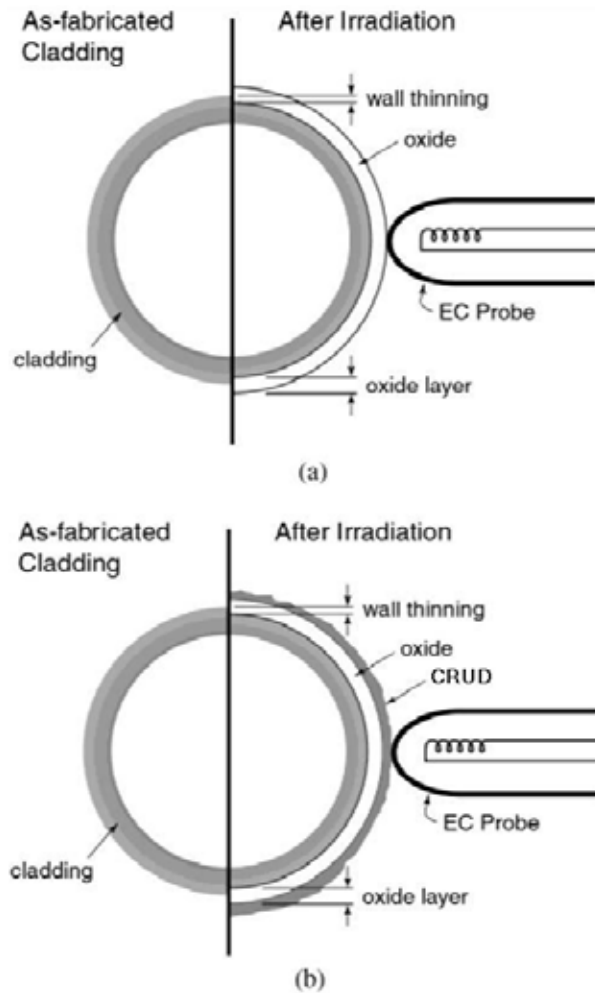
Figure 9. The principle of the eddy current oxide thickness measurements (a) Cladding tube with white oxide layer only (b) Cladding tube with white oxide layer and grey CRUD layer [10]
