Sustainable refurbishment of exterior walls and building facades

Final report, Part C – Specific
refurbishment concepts

Ruut Peuhkuri, Sirje Vares, Sakari Pulakka et al. Espoo 2012. VTT Technology 35. 198 p.
+ app. 1 p.

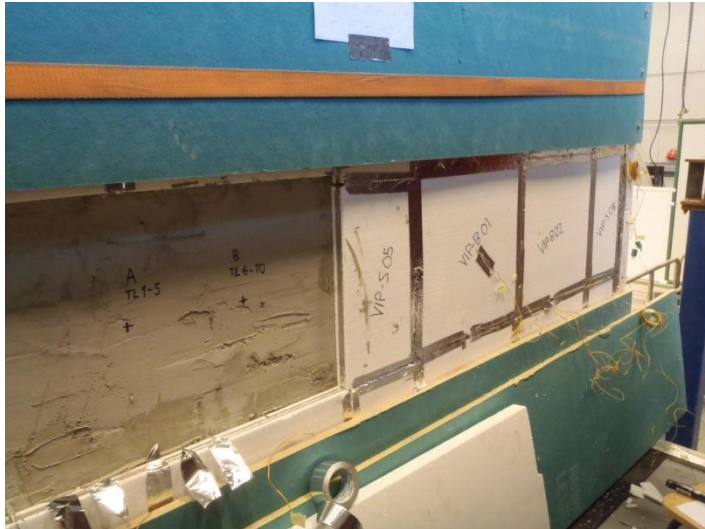
Figure 2. Concept B1 by VAHANEN, vacuum insulated test wall.

The test was conducted to study the building physical behavior of a vacuum insulated brick wall. The test wall, shown in figure 2 was the same as concept B1 with the exception that vacuum panel used in the test had 10 mm EPS boards on both sides (Concept B1 uses 5 mm). In addition the ventilation space was 30 mm (Concept B1 uses 40 mm) and there was a porous wind barrier board on the left side of the vacuum insulation panel. A temperature difference of 40 °C was set across the wall. Studies also included a version of the wall that had no ventilation space but all the same construction layers. Thermocouples were set up between construction layers and in the ventilation space.

When choosing vacuum insulation panel sizes one should consider the limiting effect of small panels on increased heat transfer but also the additional joints and possible air leaks caused by small panels. Despite the protecting EPS-boards, a vacuum insulation is vulnerable to strikes and breaks easily. A vacuum insulation is either broken or intact. There is no such thing as half broken vacuum insulation. Based on a bending test of vacuum panels the vacuum can tolerate a bending of 10° but breaks after that. The protecting EPS boards already break at this angle but probably don't lose their insulating properties. The breaking of a vacuum (picture 3, right picture) is difficult to notice during construction. The damage was visible when checked from the vacuum cover after many hours. Damage can be seen also from the swelling of the panel which was in the center of the panel about 10 mm.

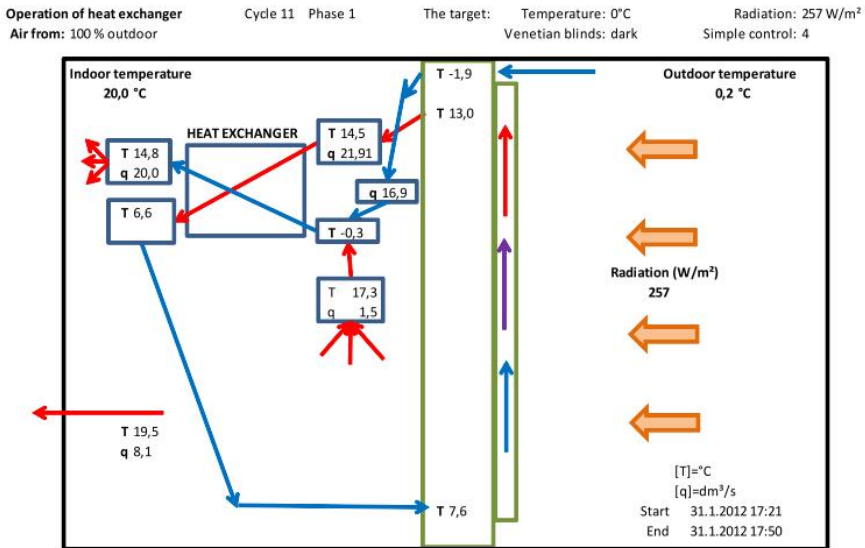
Figure 3. Test wall assembly of the Re-Solar concept, an example of temperature, air-flow rate and radiation intensity values in the test.

A full scale laboratory test was conducted to study the building physical behaviour of the Re-Solar concept. The test assembly is described in picture 3. The test wall consists of a glass façade, blinds with both white and dark surfaces, 70 mm air space, a 10.5 mm double layer of phase change material (PCM) panels, 100 mm EPS insulation and 200 mm lightweight aggregate concrete block. A heat exchanger was installed between the outdoor air and the air from the ventilation space. The outdoor climate chamber had two 1300 W infrared heaters and three 350 W halogen lamps to simulate heat radiation from the sun. Radiation intensity was approximately 210 W/m^2 from noon to early evening and $10\text{--}20 \text{ W/m}^2$ on other times. Outdoor temperature varied between $-1.5 \text{ }^\circ\text{C}$ – $10 \text{ }^\circ\text{C}$ and indoor temperature between $20\text{--}21.2 \text{ }^\circ\text{C}$. Air flow rates varied between $2\text{--}22 \text{ dm}^3/\text{s}$ in both cycles. Temperature was measured from the air space, at six depths of the wall, from the PCM-panels and from the ventilation channels. The Air flow rate was measured from the air space and ventilation channels. Pyranometer measured radiation intensity on the façade.

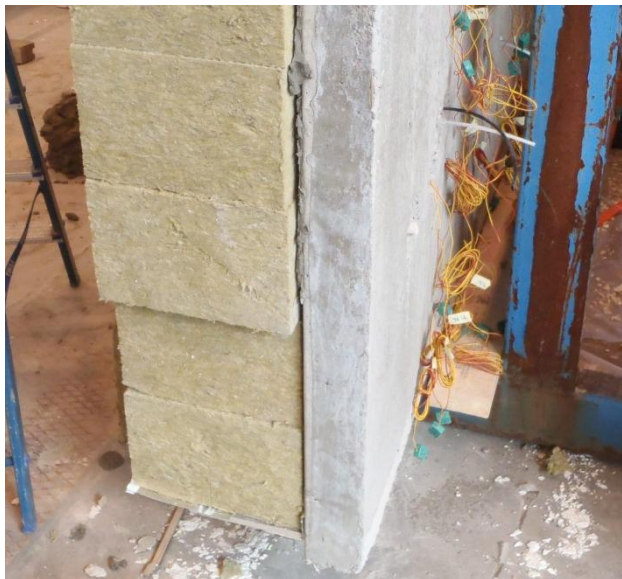
Figure 5. Concept T1b by VAHANEN, thermal plastered test wall at building phase.

pore ratio 0.21). Weaker plastering was made by adding 26% more water than was instructed by the manufacturer. Temperature and relative humidity was measured from the insulation layer. Water was added to the insulation layer directly a total of 3.6 kg in one month. Water was added indirectly with 300 x 300 x 100 mm³ wet concrete shells that were installed upon the concrete wall and heated with two halogen lamps. The final 8 day phase of the test with spraying irrigation (rain water) included temperatures cycles of +30 °C and -20 °C that lasted 2 hours each. Test assembly is similar to picture 1 but the relative humidity in the indoor air was not measured due to a probe failure. Relative humidity in the outdoor varied between 75–78%.

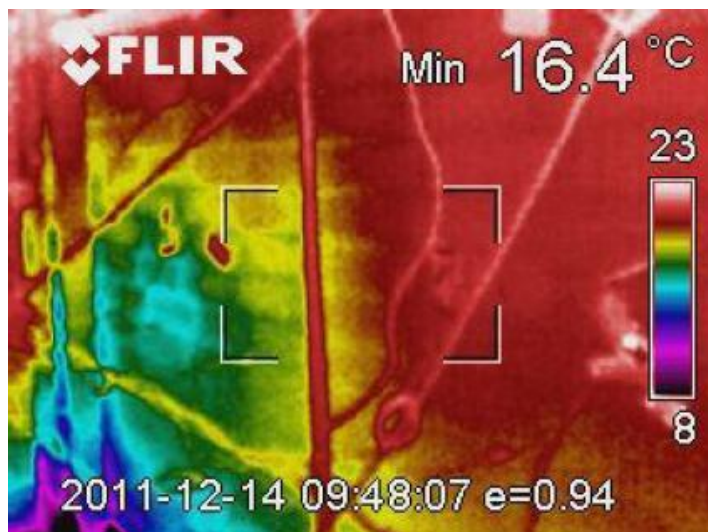
Figure 6. Thermal image from the inside points out the broken insulation in the test wall.

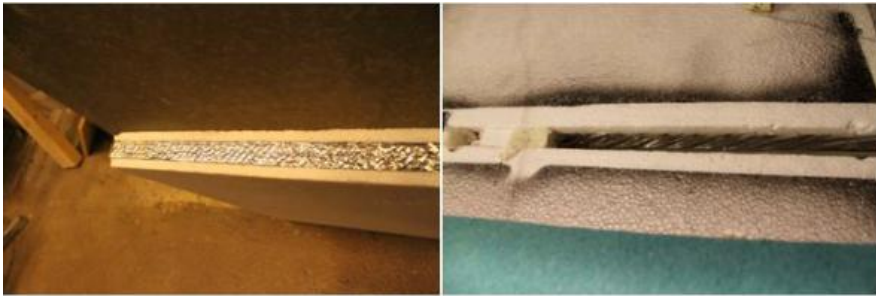
Figure 7. Intact and broken vacuum insulation panels.

A broken vacuum insulation panel has a thermal conductivity of 0.022 W/mK measured with heat flux plates. The manufacturer gives a value of ≤ 0.019 W/mK for broken insulation. Breaking of the panels causes additional heat loss but the effect is restricted to the broken panel only. The surface temperature inside the wall is lowered to 17 °C from 20 °C in the middle of the panel with outer temperature -20 °C. Risk of condensation is negligible and requires an indoor relative humidity of 80% in this case.

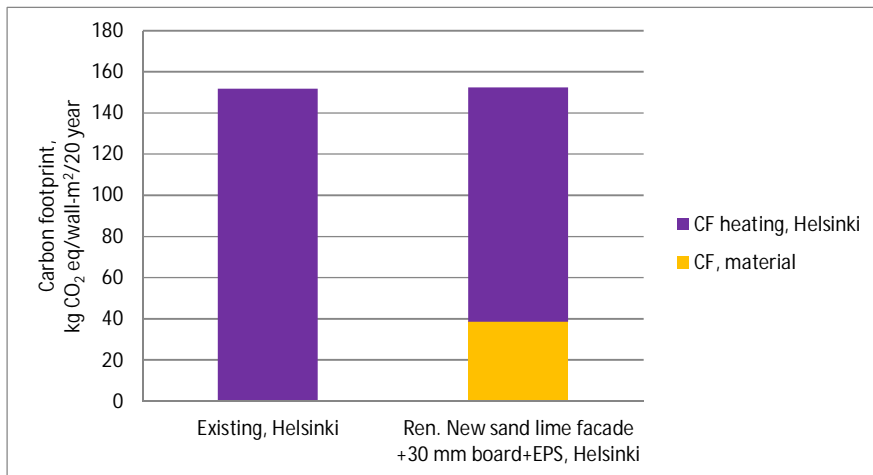
Figure 8. Carbon footprint for existing-and refurbished walls. Existing wall analysis considers only carbon footprint from heating use. Heating type for Helsinki was district heating.

- The assessment considers all materials used in the refurbishment. New external façade with sand lime brick, 30 mm rigid mineral wool and 20 mm vacuum insulation covered on both sides with EPS insulation (2 x 5 mm). No LCA data was found for vacuum insulation so this calculation assumes that all 30 mm insulation is EPS. When LCA data for vacuum insulation is available, then a new calculation should be completed.
- For the existing wall, no construction materials are considered, only the impact from heating is calculated.
- U-value used for the existing wall is 0.32 W/m²K.
- U-value used for the new concept is 0.24 W/m²K.

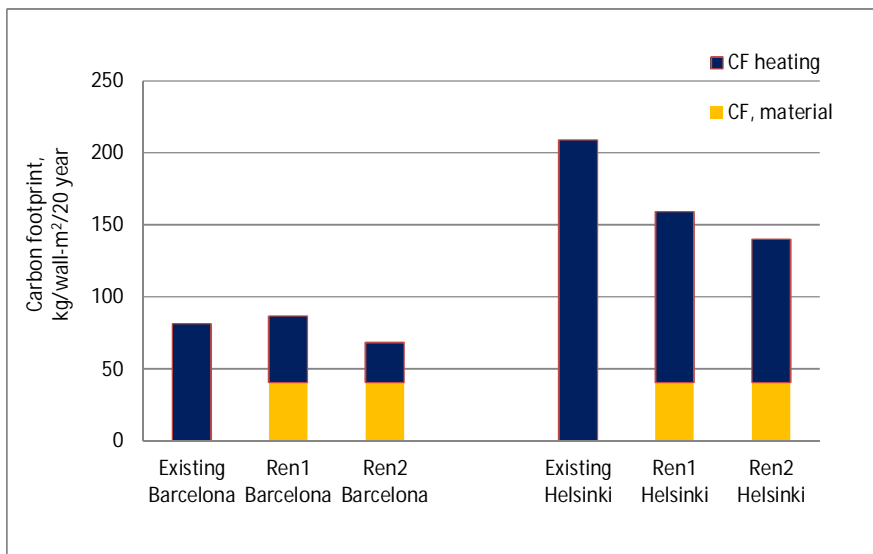
Figure 11. Carbon footprint for existing-and refurbished walls. Existing wall considers only carbon footprint from heating use. Heating type for Helsinki was district heating, and for Barcelona it was gas.

- Nevertheless, modelling was completed for two scenarios: “Ren1” is based only on the use of raw materials modelled in the LCA while “Ren2” attempts to estimate the impact of the pre-heated air.

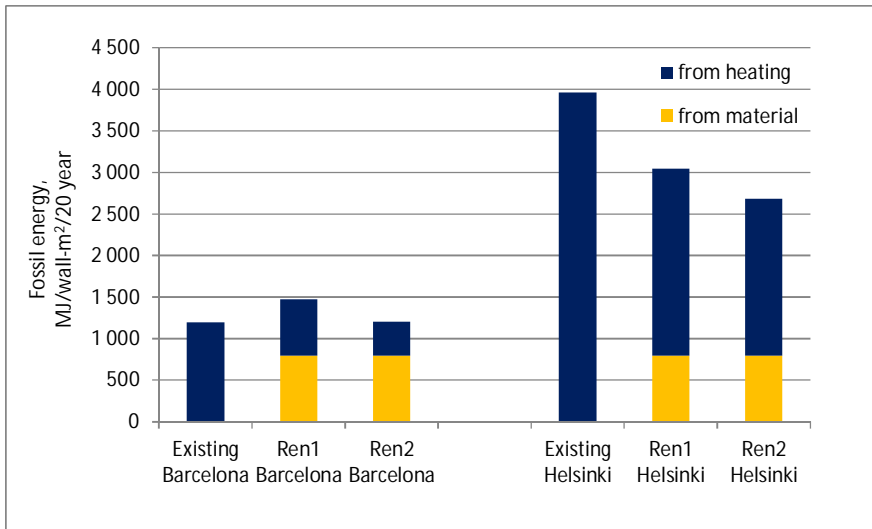
Figure 12. Fossil energy consumption for existing and refurbished walls. Heating type for Helsinki was district heating and for Barcelona it was gas.

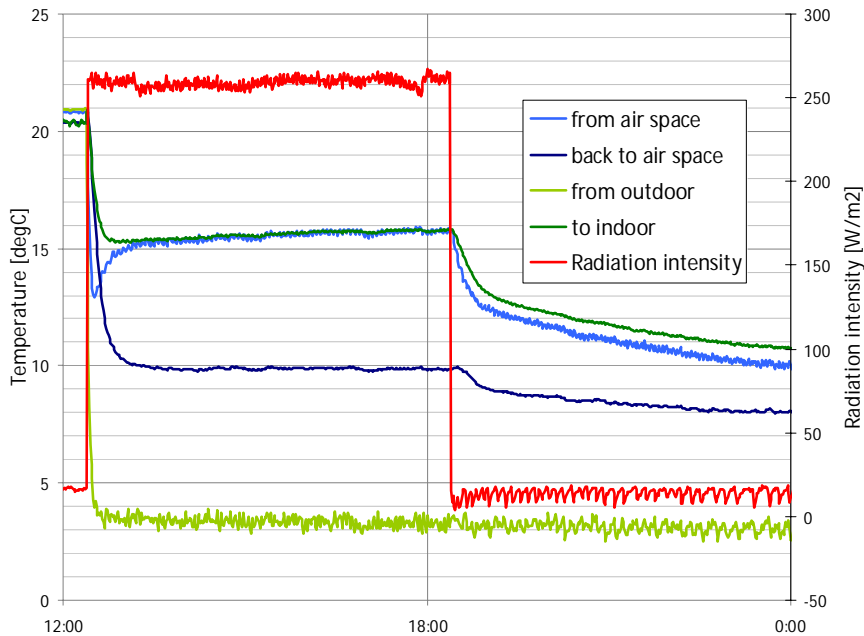
Figure 14. An example of temperatures before and after the heat exchange.

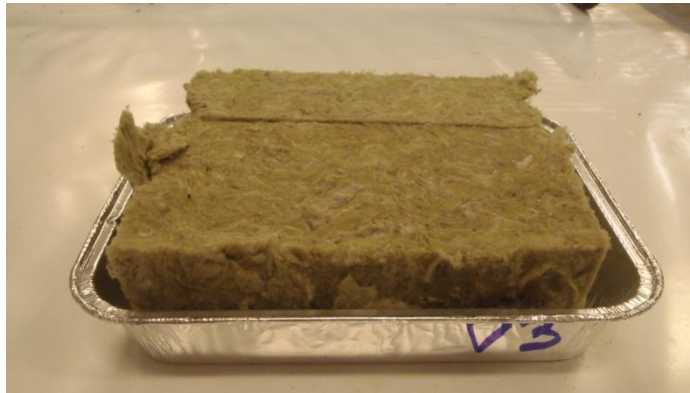
Figure 18. Insulation sample from the test wall. Samples were dried in an oven to determine moisture content as weight percent.

gradient. A total of approximately 10 kg of water was added to the wall so the structure has dried a large amount of water during the experiment. The drying ability of the thermal plastered wall is based on the low diffusion resistance of the plastering. The Sd-value of the plastering is approximately 0.1 m, whilst a 100 mm concrete wall has an Sd-value of 18 m. 300 mm rockwool has an Sd-value of 0.36 m.

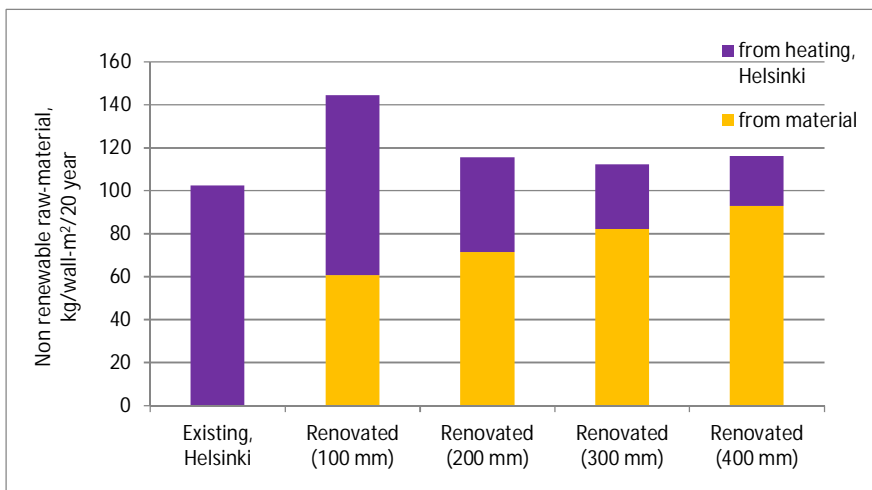
Figure 21. Non renewable raw-material consumption for existing- and refurbished walls. Heating type for Helsinki was district heating.

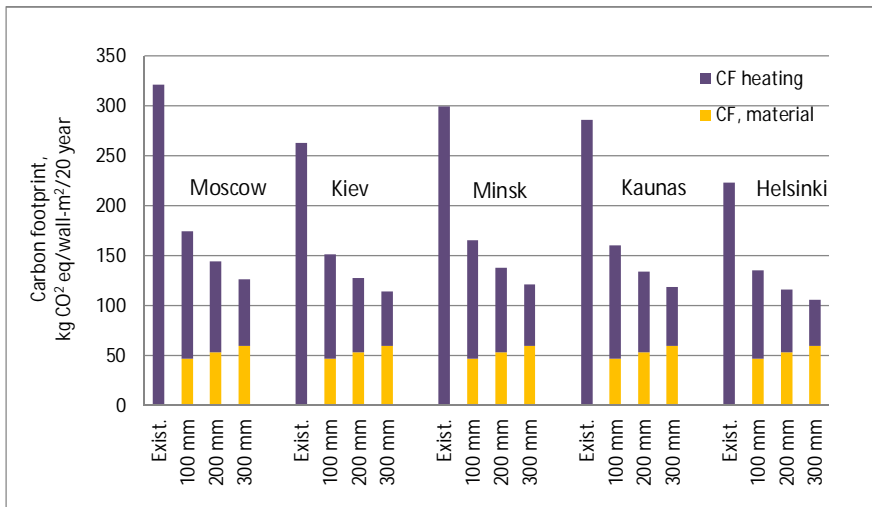
Figure 22. Carbon footprint for existing-and refurbished walls. Existing wall considers only carbon footprint from heating use. Heating type for Helsinki was district heating.

- The assessment considers all materials used and three insulation thicknesses: 100 mm, 200 mm and 300 mm additional mineral wool. For the façade render, 25 mm has been modelled.
- For the existing wall no construction materials is considered only impact from heating is calculated.
- U-value for the existing wall is 0.53 W/m²K.
- U-value for the concept with 100 mm additional insulation is 0.21 W/m²K.
- U-value for 200 mm additional insulation is 0.15 W/m²K.
- U-value for 300 mm additional insulation is 0.11 W/m²K.

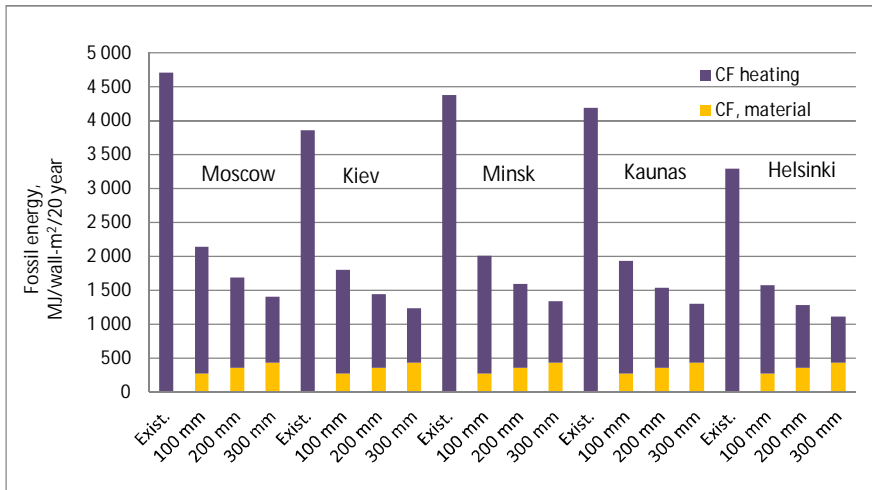
Figure 23. Fossil energy consumption for existing-and refurbished walls. Heating type for Helsinki was district heating.

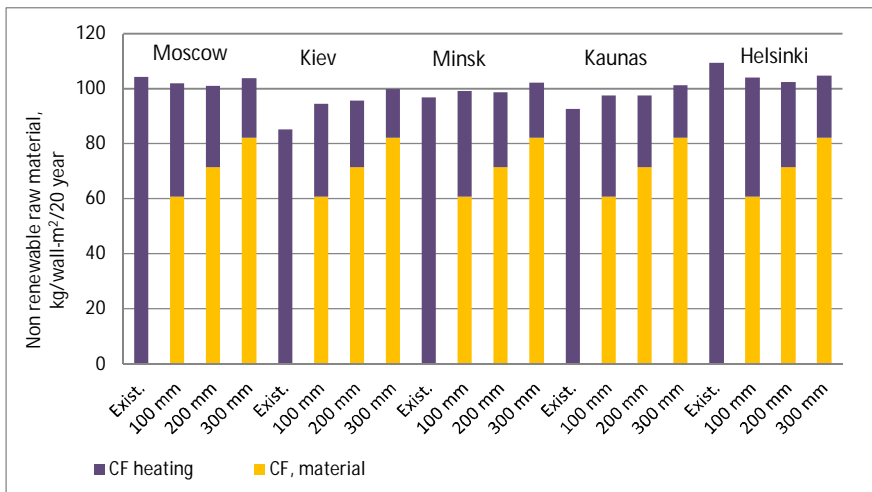
Figure 24. Non renewable raw-material consumption for existing- and refurbished walls. Heating type for Helsinki was district heating.

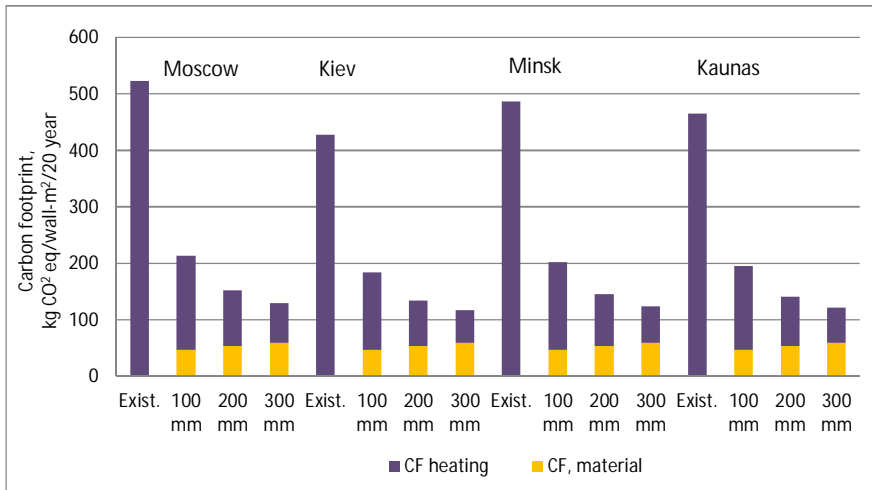
Figure 25. Carbon footprint for existing-and refurbished walls. Existing wall considers only carbon footprint from heating use. Heating type for all locations is gas.

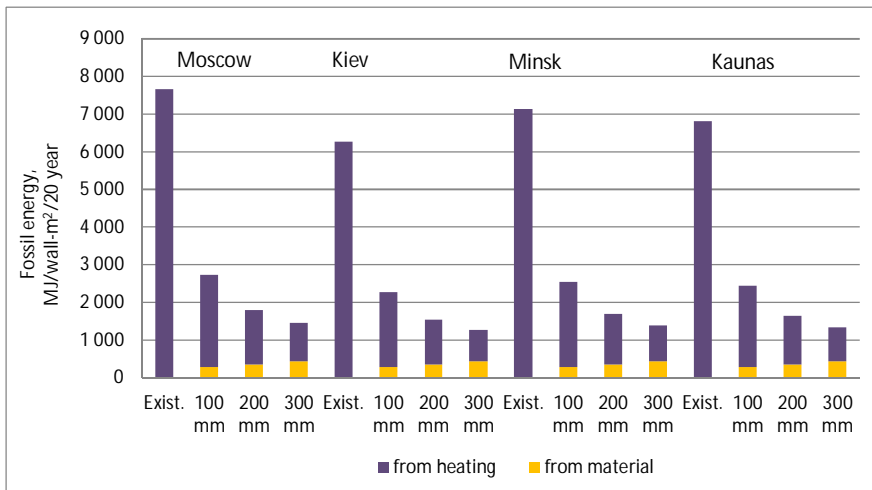
Figure 26. Fossil energy consumption for existing-and refurbished walls. Heating type for all locations is gas.

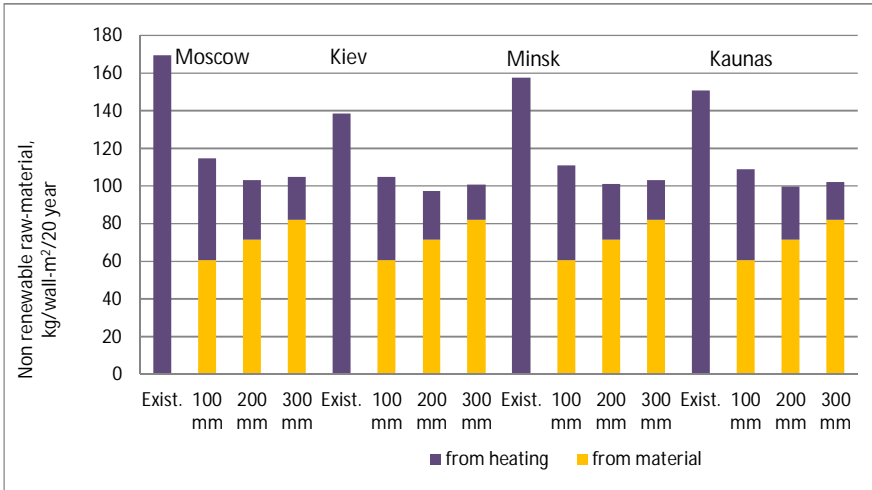
Figure 27. Non renewable raw-material consumption for existing- and refurbished walls. Heating type for all locations is gas.

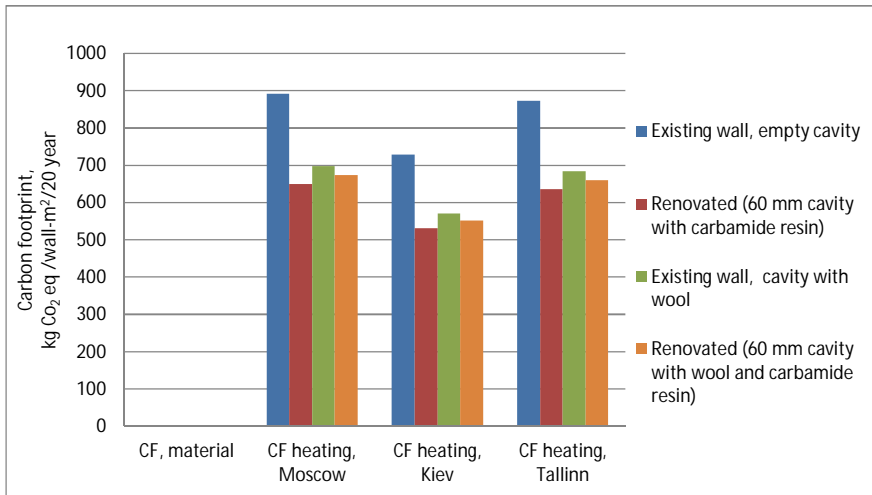
Figure 28. Carbon footprint for existing and refurbished walls. Heating type for all locations is gas.

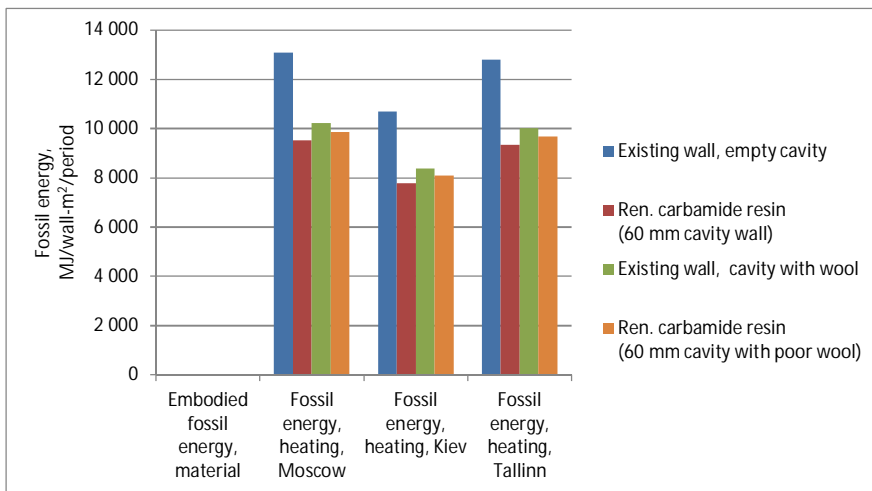
Figure 29. Fossil energy consumption for existing and refurbished walls. Heating type for all location is gas.

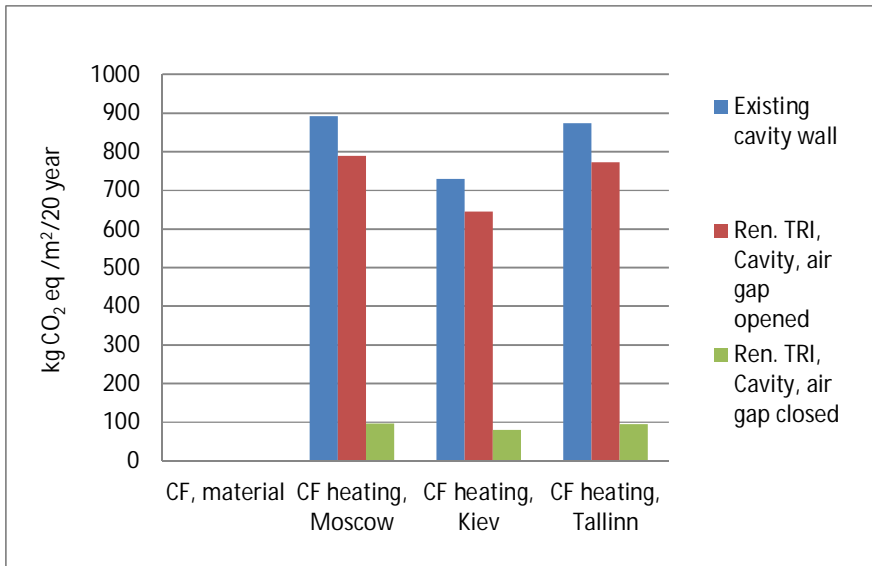
Figure 31. Carbon footprint for the existing and refurbished **cavity wall**.

- For existing and refurbished wall only impact from heating energy is considered. Concept uses thermo reflective heat insulation (TRI), which environmental impact was not known.
- U-values were used as shown above.

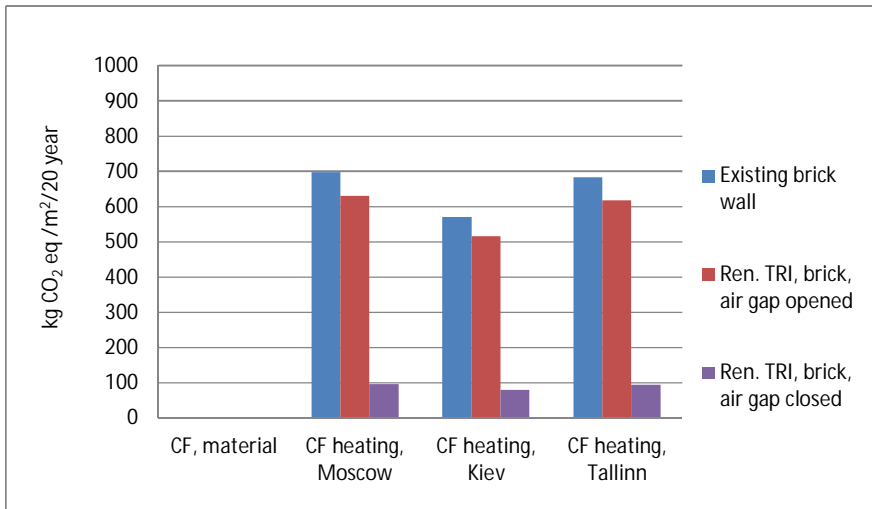
Figure 32. Carbon footprint for existing and refurbished **brick wall**.

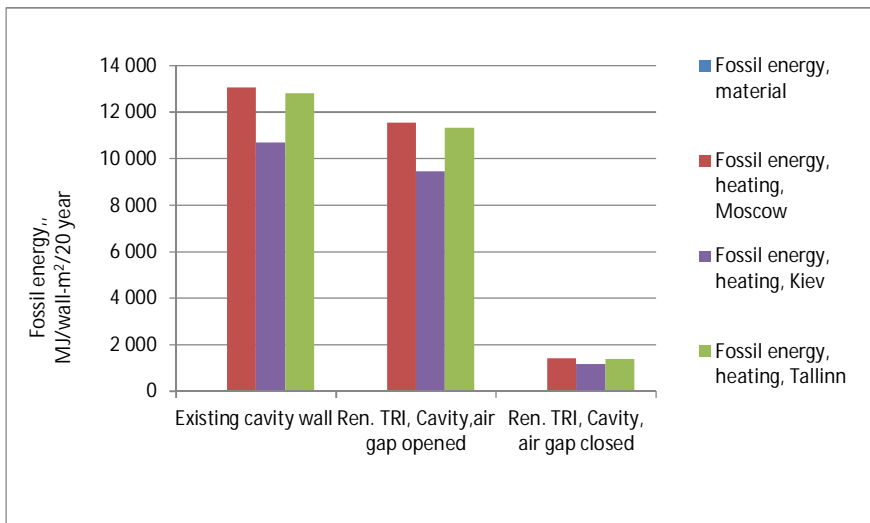
Figure 33. Fossil energy consumption for existing and refurbished **cavity** walls.

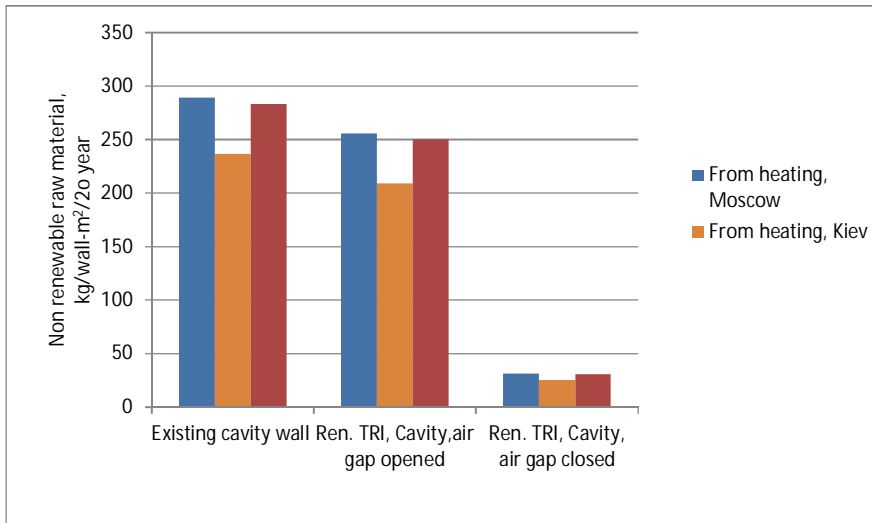
Figure 35. Non renewable raw material consumption for existing and refurbished cavity wall. TRI-thermo reflective insulation.

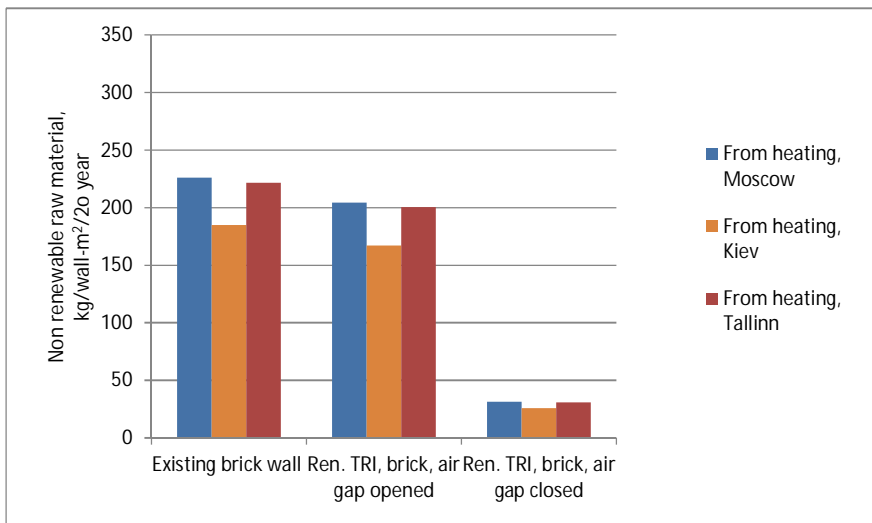
Figure 36. Non-renewable raw material consumption for existing and refurbished brick wall. TRI-thermo reflective insulation.

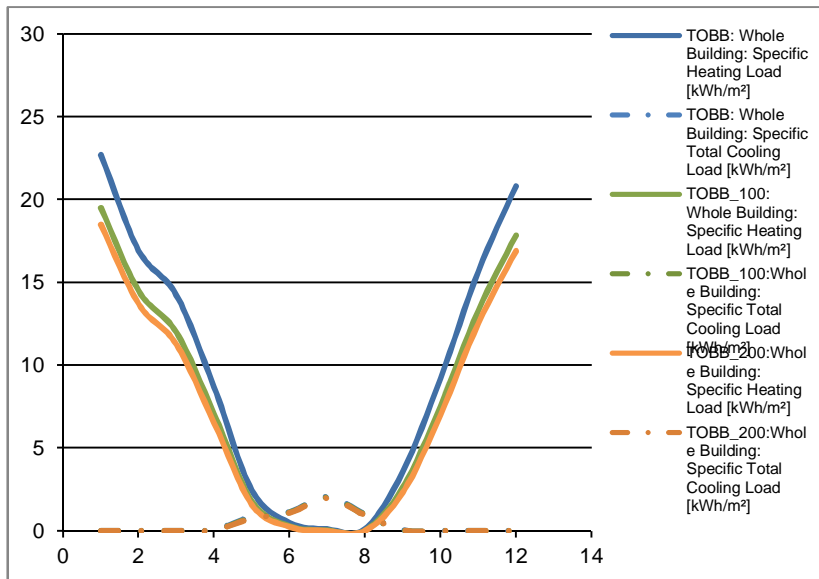
Figure 37. Monthly heating and cooling demand for modelled detached house in Oslo. 'TOBB' refers to original construction before refurbishment.

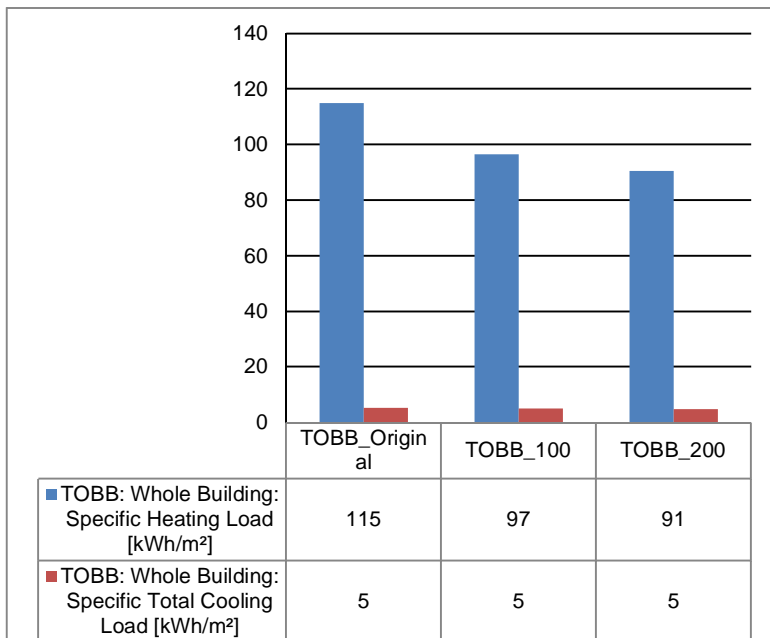
Figure 38. Total annual heating and cooling demand for modelled detached house in Oslo. TOBB' refers to original construction before refurbishment.

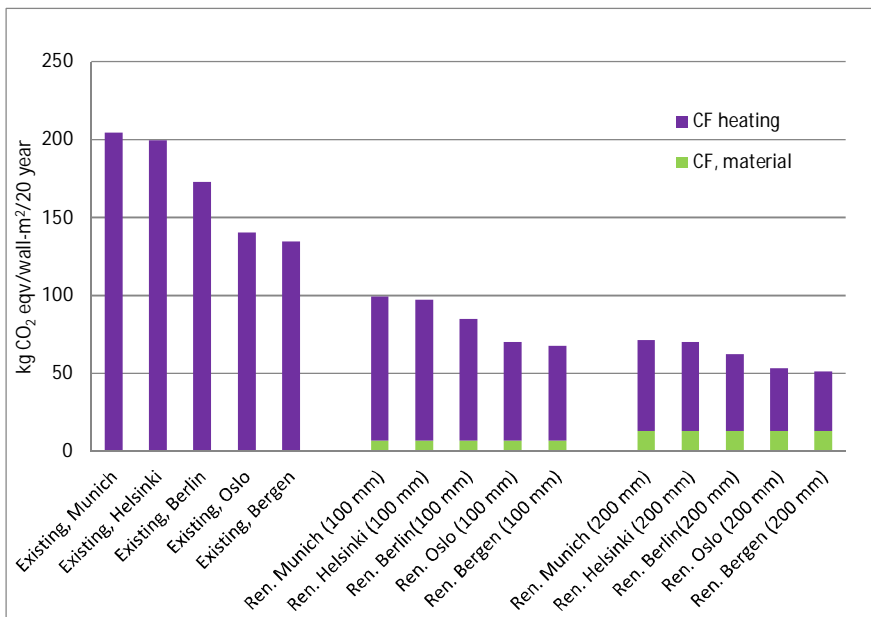
Figure 39. Carbon footprint for existing-and refurbished walls. Existing wall considers only carbon footprint from heating use. Heating type for Helsinki was district heat, for Munich and Berlin it was gas and for Oslo and Bergen it was direct electricity.

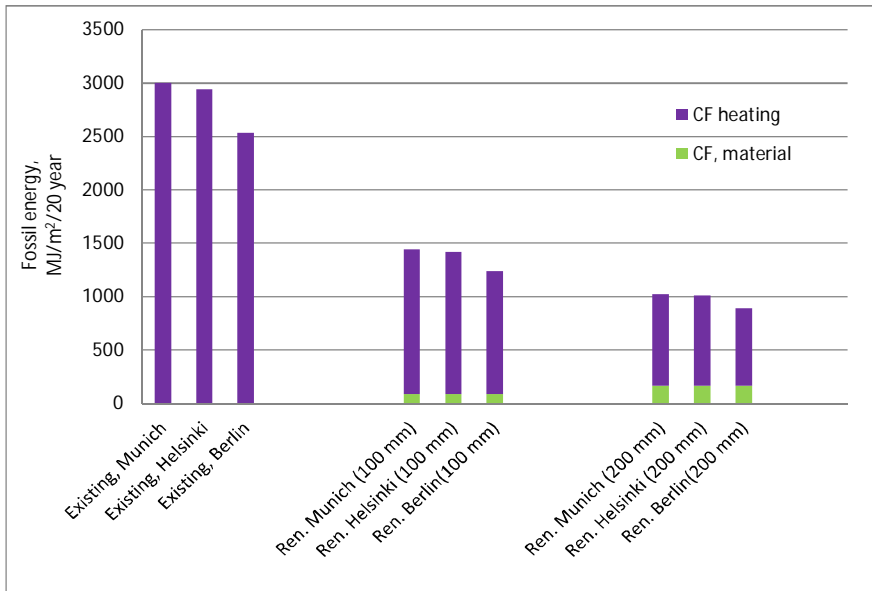
Figure 40. Fossil energy consumption for existing-and refurbished walls. Heating type for Helsinki was district heat for all other locations it was gas.

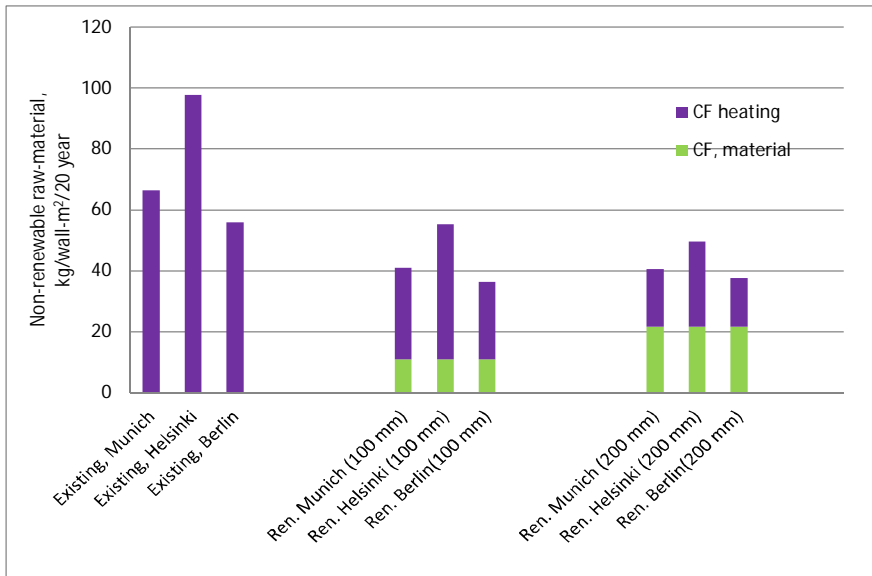
Figure 41. Non renewable raw-material consumption for existing- and refurbished walls. Information about raw-material consumption for direct electricity used in Norway was missing.

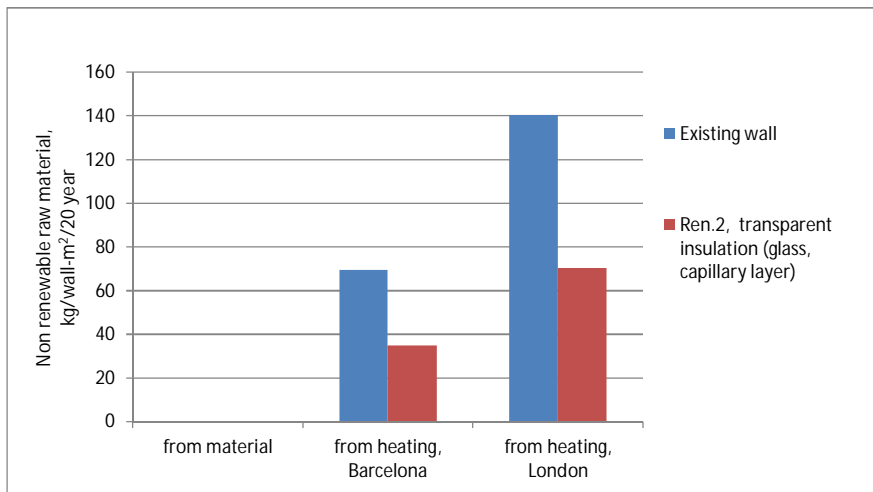
Figure 47. Non renewable raw material consumption for existing-and refurbished walls. Heating type for both cases is gas. Impact from used materials was not known.

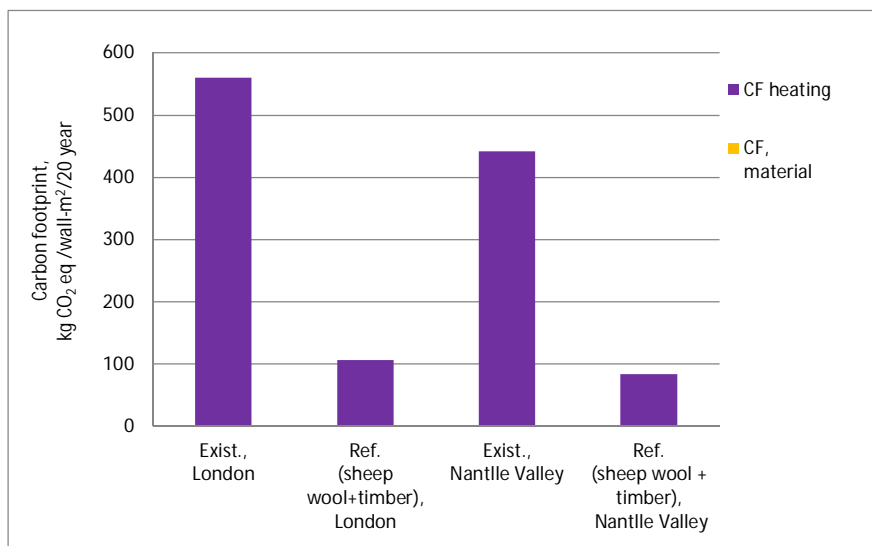
Figure 48. Carbon footprint for existing-and refurbished walls. Existing wall considers only carbon footprint from heating, renovated wall considers carbon footprint from used materials and heating, but material impact is so small and therefore not visible in the figure. Heating type for both cases is gas.

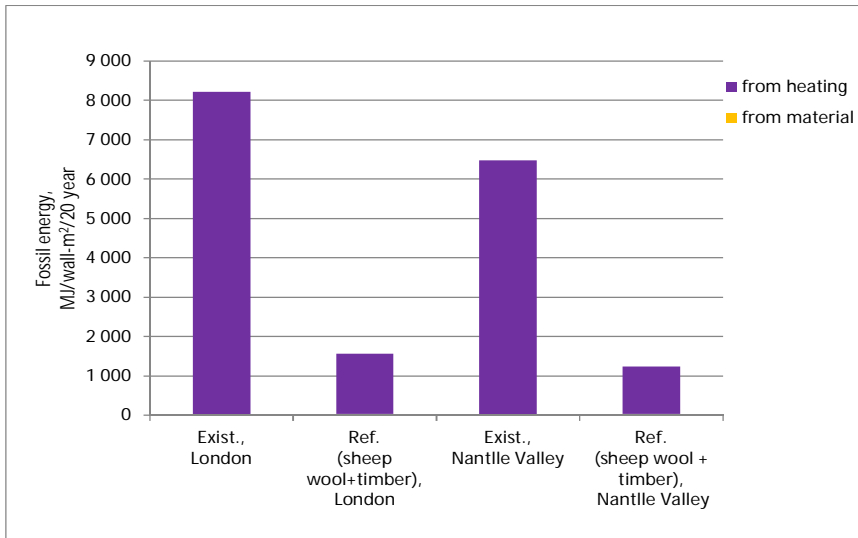
Figure 49. Fossil energy consumption for existing-and refurbished walls. Existing wall considers only fossil energy from heating, renovated wall considers fossil energy from used materials and heating, but material impact is so small and therefore not visible in the figure. Heating type for both cases is gas.

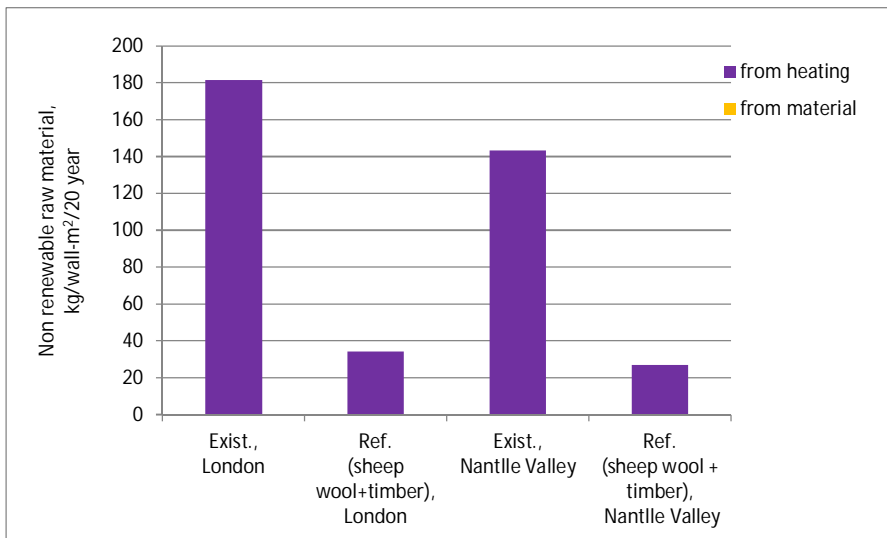
Figure 50. Non-renewable raw material consumption for existing-and refurbished walls. Existing wall considers only materials from heating use. Renovated wall considers renovation materials and materials used for heating, but material impact used in renovation is so small and therefore not visible in the figure. Heating type for both cases is gas.

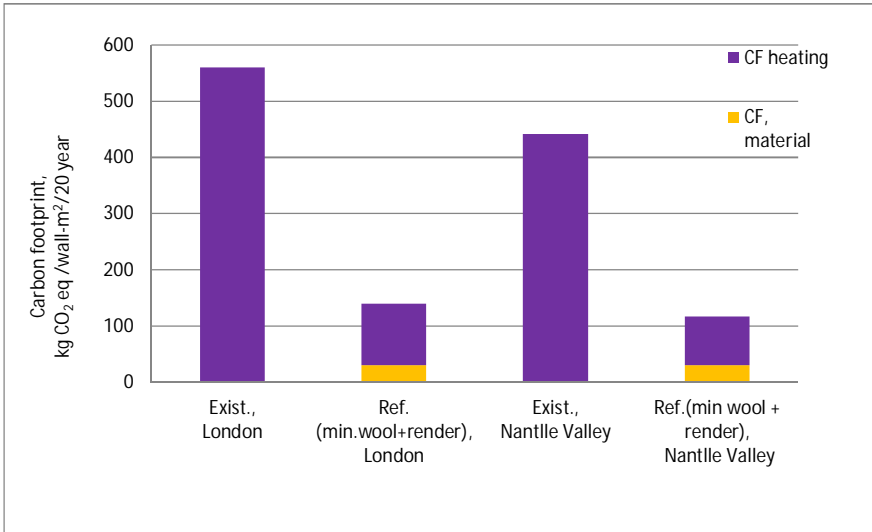
Figure 51. Carbon footprint for existing-and refurbished walls. Existing wall considers only carbon footprint from heating, renovated wall considers carbon footprint from used materials and heating, but material impact is so small and therefore not visible in the figure. Heating type for both cases is gas.

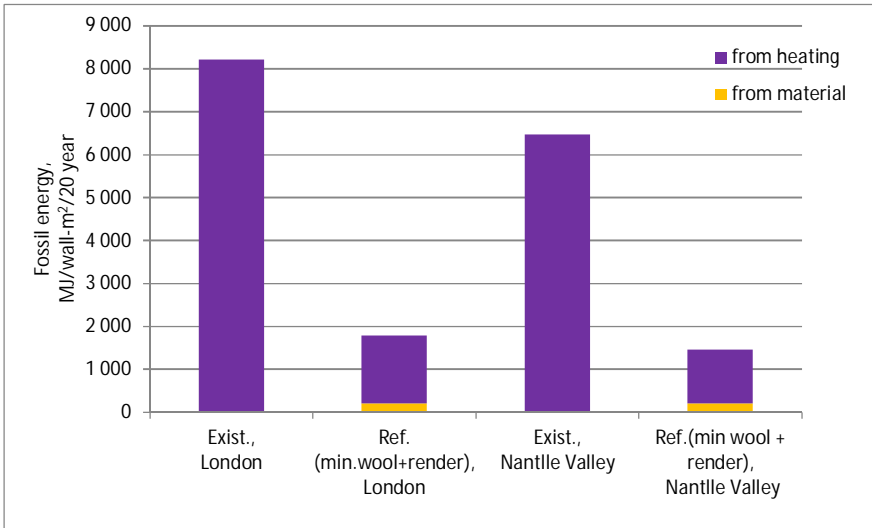
Figure 52. Fossil energy consumption for existing-and refurbished walls. Existing wall considers only fossil energy from heating, renovated wall considers fossil energy from used materials and heating, but material impact is so small and therefore not visible in the figure. Heating type for both cases is gas.

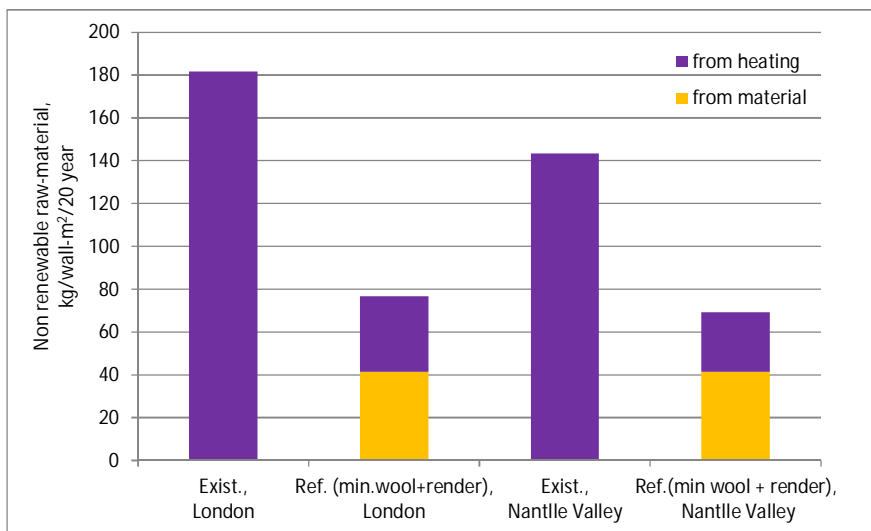
Figure 53. Non renewable raw material consumption for existing-and refurbished walls. Existing wall considers only materials from heating use. Renovated wall considers renovation materials and materials used for heating. Heating type for both cases is gas.

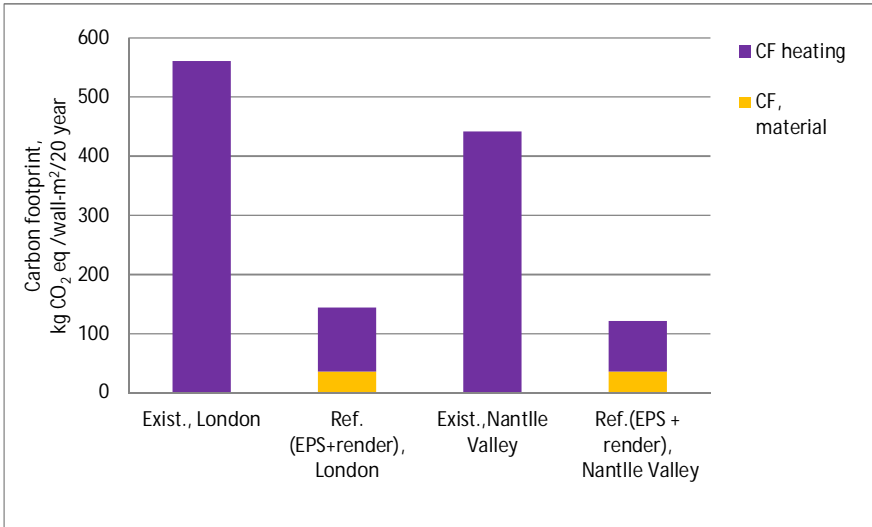
Figure 54. Carbon footprint for existing and refurbished walls. Existing wall considers only carbon footprint from heating, renovated wall considers carbon footprint from used materials and heating. Heating type for both cases is gas.

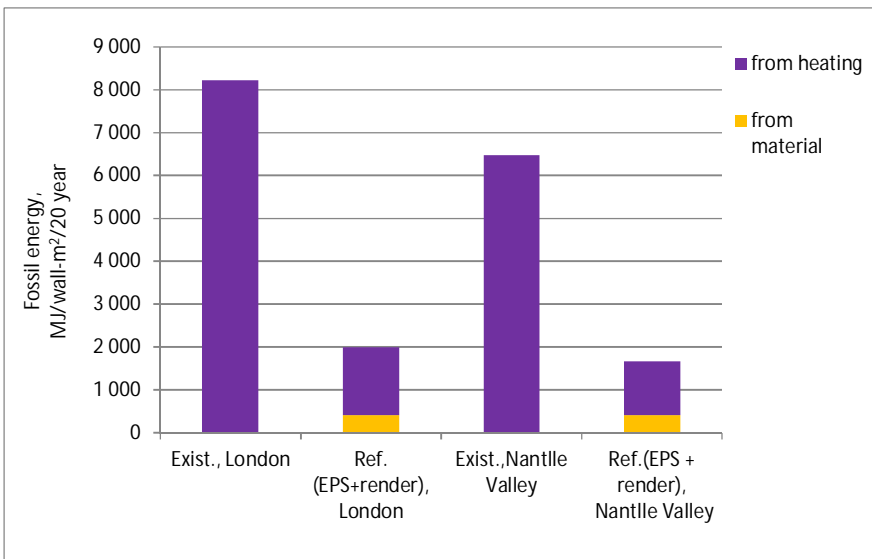
Figure 55. Fossil energy consumption for existing-and refurbished walls. Existing wall considers only fossil energy from heating, renovated wall considers fossil energy from used materials and heating. Heating type for both cases is gas.

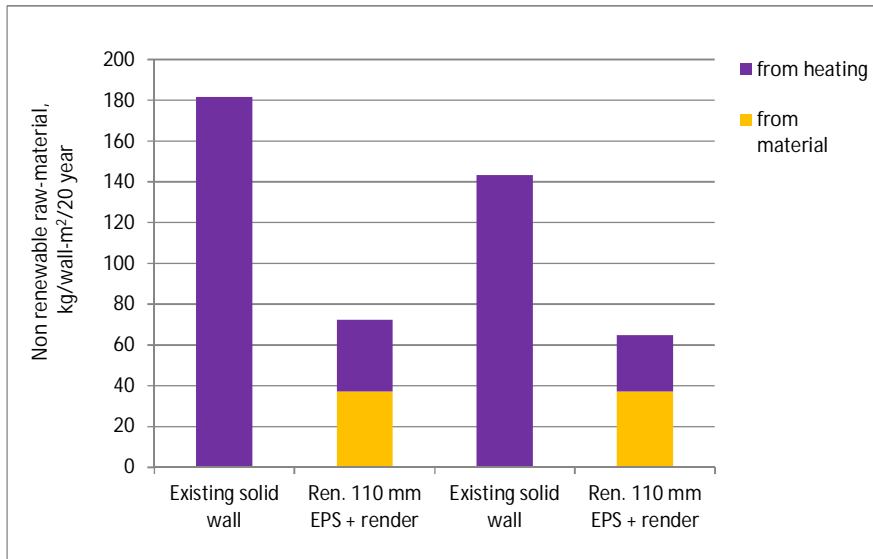
Figure 56. Non renewable raw material consumption for existing and refurbished walls. Existing wall considers only materials from heating use. Renovated wall considers renovation materials and materials used for heating. Heating type for both cases is gas.

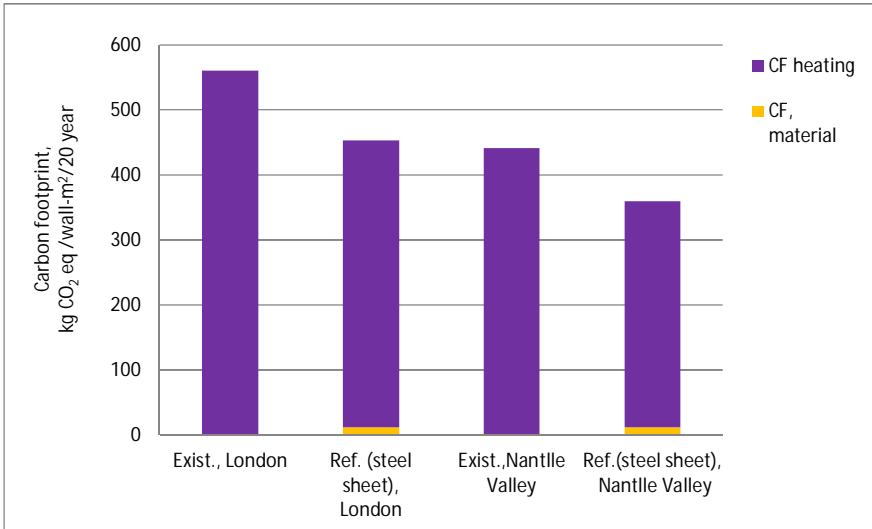
Figure 57. Carbon footprint for existing-and refurbished walls. Existing wall considers only carbon footprint from heating, renovated wall considers carbon footprint from used materials and heating. Heating type for both cases is gas.

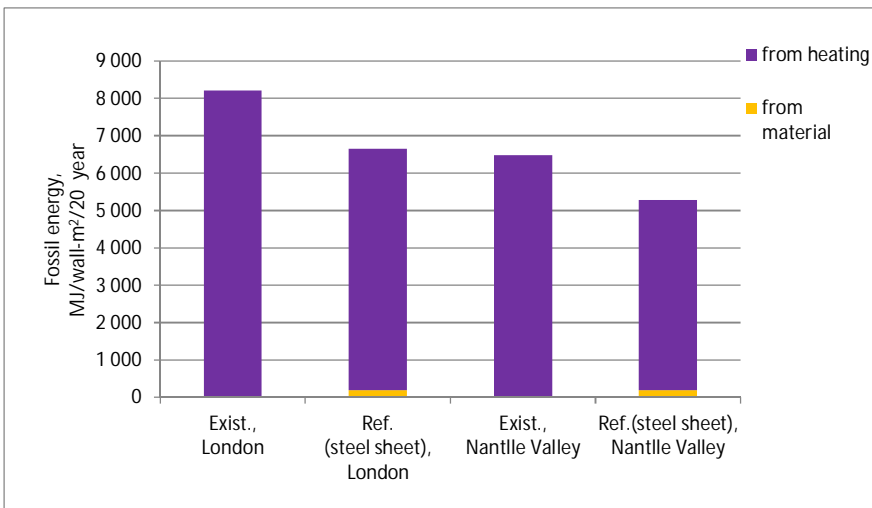
Figure 58. Fossil energy consumption for existing-and refurbished walls. Existing wall considers only fossil energy from heating, renovated wall considers fossil energy from used materials and heating. Heating type for both cases is gas.

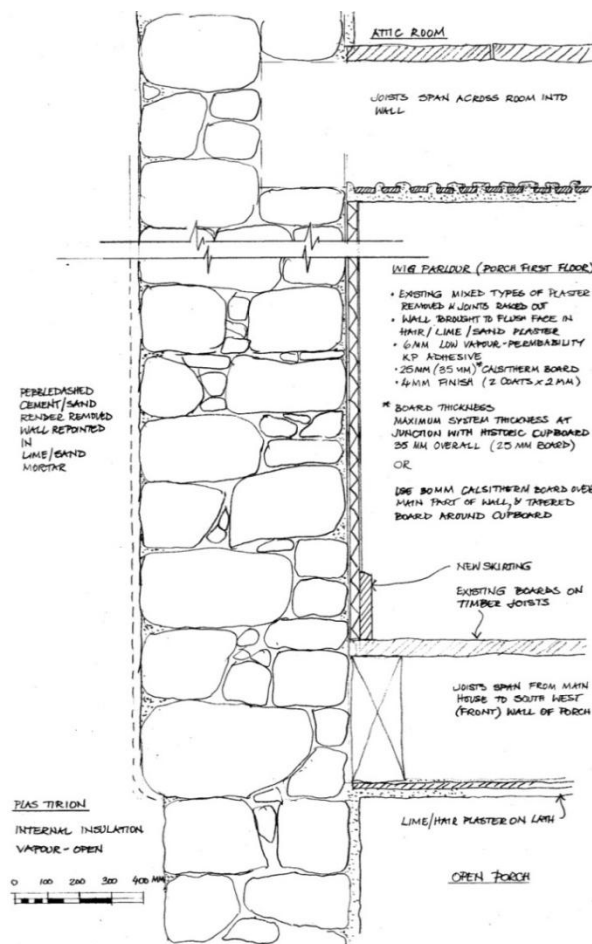
17.2 Cross section of the refurbishment concept

1. 60 0mm solid stone rubble wall, pointed with lime/sand mortar
2. Average 10 mm hair/lime/sand basecoat plaster to close face of wall and bring to flush
3. 6 mm special adhesive with limited vapour permeability
4. 25 mm (or 30 mm) Calcium Silicate board
5. 4 mm special thin-coat plaster applied in 2 coats
