## Structural integrity of Ni-base alloy welds

VTT Technology 175

The Tekes project Structural integrity of Ni-base alloy welds (SINI) was carried out at Aalto University and VTT during the period from 2010 to 2014. In nuclear industry applications, the degradation of Ni-base alloy dissimilar metal welds (DMWs), both in pressurised water reactor (PWR) and in boiling water reactor (BWR) plants, is an extensive international problem. The project participates with ongoing international cooperation in USA (Electric Power Research Institute EPRI, Alloy 690/52/152 PWSCC Research Collaboration) and in Japan (Tohoku University) for the conduction of new Ni-base alloy research. The research need is actual, especially because indications have been found in the DMWs in the reactor pressure vessel nozzle of BWRs similar to Finnish BWR designs and European pressurised water reactor (EPR PWR) -plant under construction contains a large number of varying and new types of dissimilar metal welds of which no previous experience is available.

The main focus of the project was to investigate the weldability of Alloy 690 base metal corresponding filler metal Alloy 52 and the properties of the welded

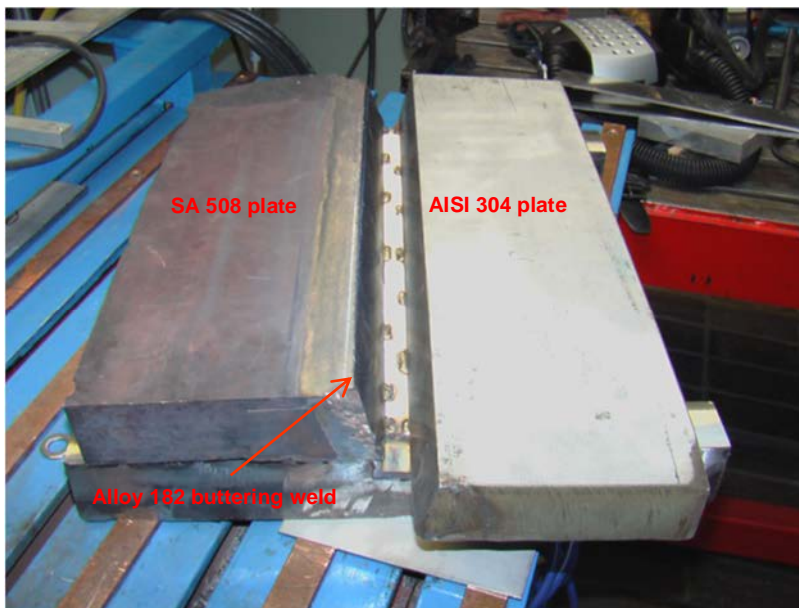
**Figure 8.** BWR safe end mock-up ready for the joint welding.

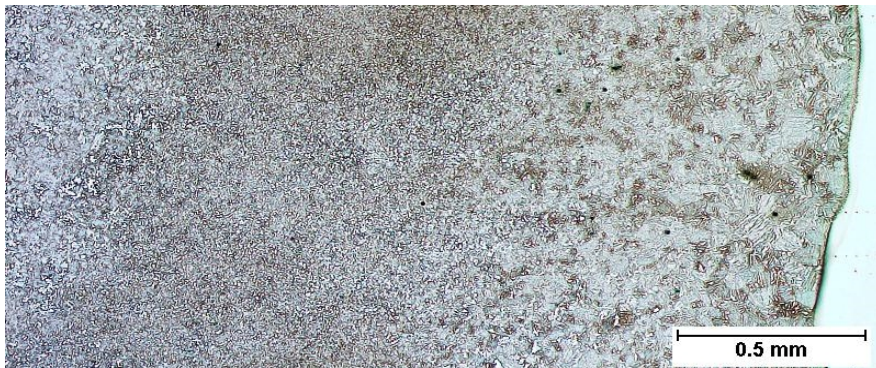
Figure 11 shows the different structural zones of the SA 508 HAZ. The HAZ consists of structural zones typical to low-alloy steel: grain coarsening, grain refining, and partial grain refining zone. The microstructure of the base metal is bainitic. Different magnification micrographs of the fusion line area between the SA 508 base metal and Alloy 182 buttering are shown in Figure 12. The base metal is over-etched due to the strong etching effect of Aqua Regia. The Type II boundary, marked with a black arrow in the images, was found at a distance of approximately 30 to 50  $\mu\text{m}$  (depending on the location) from the fusion line in the buttering side. The Type II boundary was not completely continuous along the whole weld. The presence of a martensitic zone between the fusion line and the Type II boundary can be observed in Figure 13 (marked with a red arrow). This martensitic zone was not continuous along the fusion line and its thickness varied. The microstructure of the Alloy 182 buttering was dendritic, as can be seen in Figure 14.

**Figure 11.** Microstructure of the SA 508 HAZ.

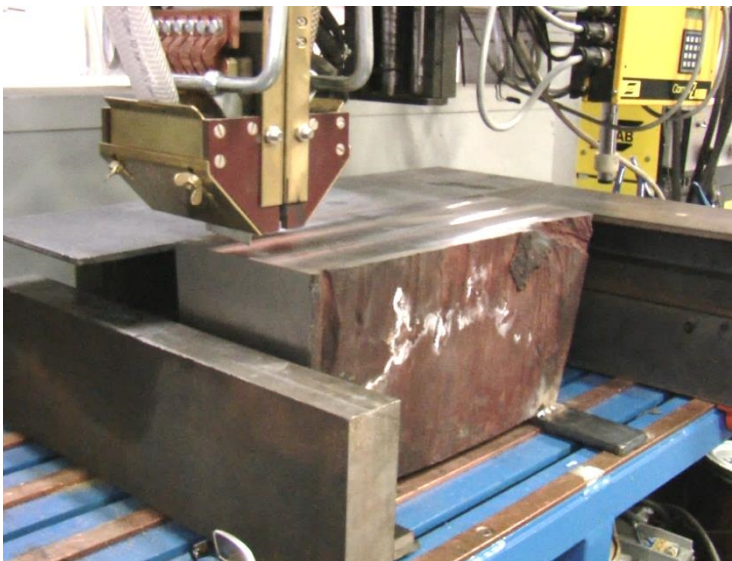
The manufacturing of the mock-up was begun by submerged arc welding (SAW) of the AISI 309L and 308L cladding layers onto a block of pressure vessel steel SA 508, Figure 54. Preheat temperature was 150 °C and interpass temperature was max. 250 °C.

**Figure 54.** Submerged arc welding (SAW) of the AISI 309L and 308L cladding layers onto a block of pressure vessel steel SA 508.

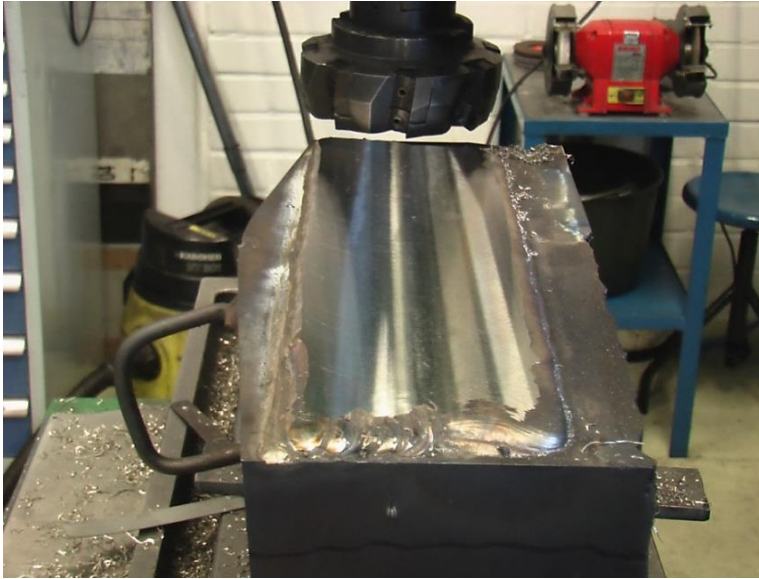
The cladding surface was machined smooth and an about 50 mm thick slice including the cladding was cut from the SA 508 steel block, Figures 55 and 56.

**Figure 55.** Machining of the cladding.

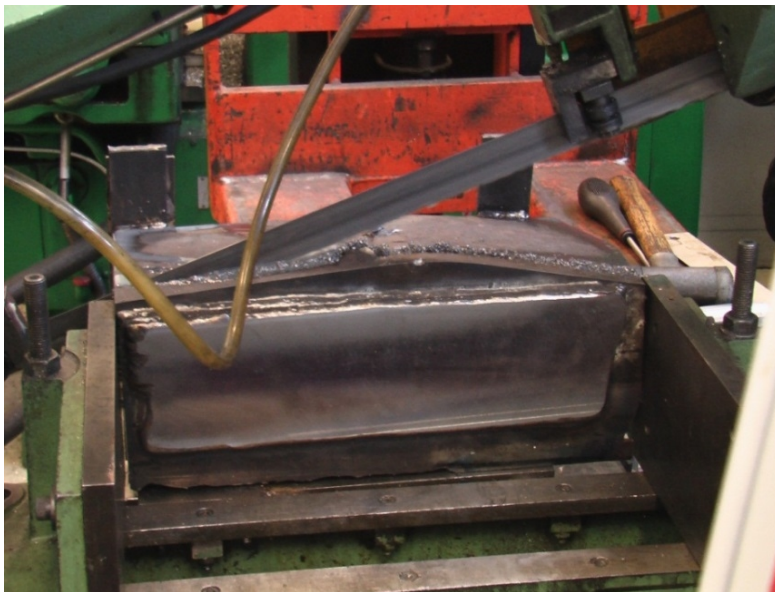
**Figure 56.** Cutting of 50 mm thick slice with the cladding from the SA 508 steel block.

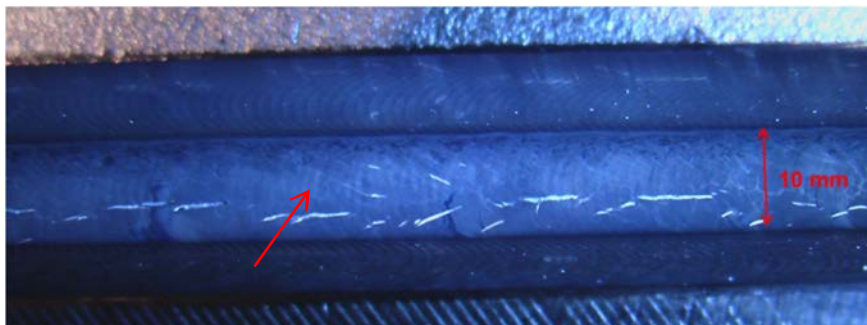
During the welding of the first seven passes, hot cracking type weld defects were observed on the weld surface, Figure 65. The cracking stopped to occur when welding reached the interface of the cladding and the SA 508 pressure vessel steel.

**Figure 65.** Hot cracking type weld defects in the surface of the first weld passes.

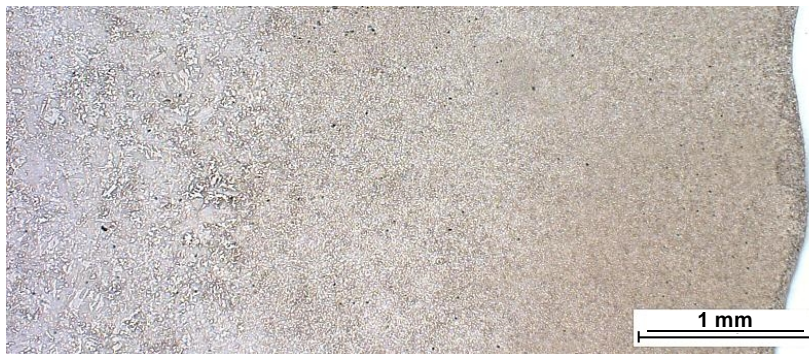
Figure 72 shows the microstructure of SA 508 HAZ of the NG-DMW in as-welded condition. The typical HAZ regions of low-alloy steel are observable. The microstructure of the base metal is bainitic. When going closer to the fusion line, the material experiences higher temperatures during welding. Thus, a higher fraction of austenite forms. After cooling, the austenite transforms into a fine distribution of ferrite grains and bainite. Along the fusion line, the temperature is at its highest. It triggers the growth of austenite grains and forms the grain coarsening zone.

**Figure 72.** Microstructure of the SA 508 – Alloy 52 interface of the as-welded state NG-DMW.

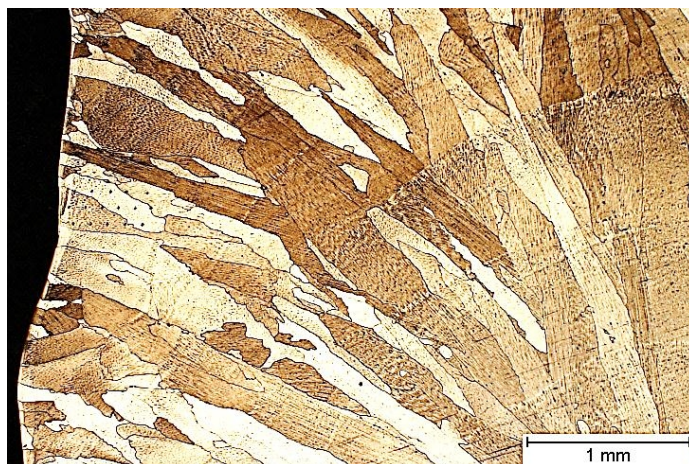
Figure 73a shows the fusion line between SA 508 and Alloy 52 etched with 2% Nital. A carbon-depleted zone (CDZ) with a width of around 0.01–0.02 mm can be observed. The CDZ has formed as a result of carbon migration at high temperature from the base metal to the weld metal due to the composition gradients. Figure 73b shows the Alloy 52 side of the fusion line. The grain boundaries seem to be mainly Type I boundaries and a zone with a width of about 0.05 mm is free of precipitates along the fusion line. The columnar dendritic structure starts after this zone. Figure 73c shows what seems to be a Type II boundary along the fusion line. It is, however, closer to the interface (about 0.01 mm) than usual Type II boundaries (0.1 mm). It is rather difficult to say if the grains are continuous across the interface since the two materials react differently to the etchants. Since the interface is ferritic/austenitic, discontinuity is to be expected. Figure 74 shows a global view of the Alloy 52 weld metal and the weld passes. Figure 75 shows the microstructure of the Alloy 52 weld metal consisting of columnar dendrites.

**Figure 74.** Microstructure of the AW Alloy 52 weld metal. The grains start to grow perpendicular to the interface and then their orientation follows the heat gradient in the weld passes.

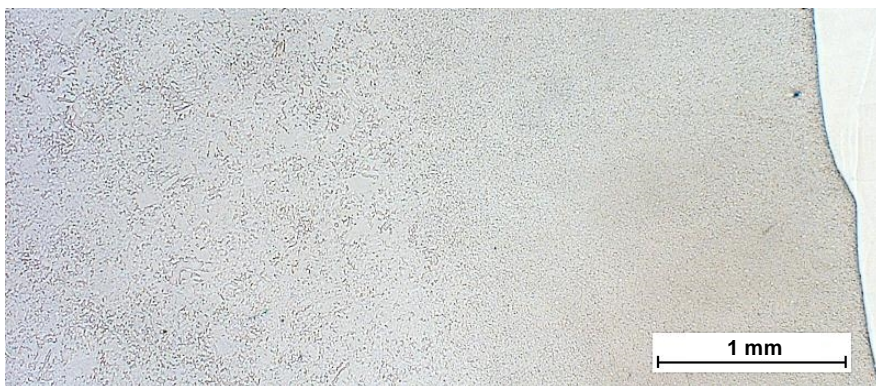
The microstructure of SA 508 HAZ of the NG-DMW in a PWHT condition is shown in Figure 76. The HAZ consists of the same distinct zones typical to the HAZ of SA 508 as in the as-welded DMW and, thus, the PWHT does not seem to have an effect on the microstructural properties of the HAZ. PWHT affects, however, on the microstructure of the interface, as shown in Figure 77. Figure 77a shows the interface etched with 2% Nital. A CDZ is clearly wider than that of the as-welded condition, with a width of about 0.1 mm. In addition, the fusion line itself is much darker etched than in the as-welded sample which suggests a higher carbon content at the fusion line. Figures 77b and c show formation of multiple precipitates in the weld metal side of the fusion line at approximately 50  $\mu\text{m}$  from the interface. Figure 77d shows what looks like a Type II boundary. It is, however, much closer to the interface (about 10  $\mu\text{m}$ ) than what is reported in the literature (about 100  $\mu\text{m}$ ).

**Figure 76.** Microstructure of the SA 508 – Alloy 52 interface of the PWHT state NG-DMW.
