Thermal ageing and mechanical performance of narrow-gap dissimilar metal welds

Matias Ahonen, Sebastian Lindqvist, Esa Leskelä, Jari Lydman, Pekka Nevasmaa, Tommi Seppänen, Pentti Arffman and Ulla Ehrnstén

VTT Technical Research Centre of Finland Ltd

VTT Technology 333

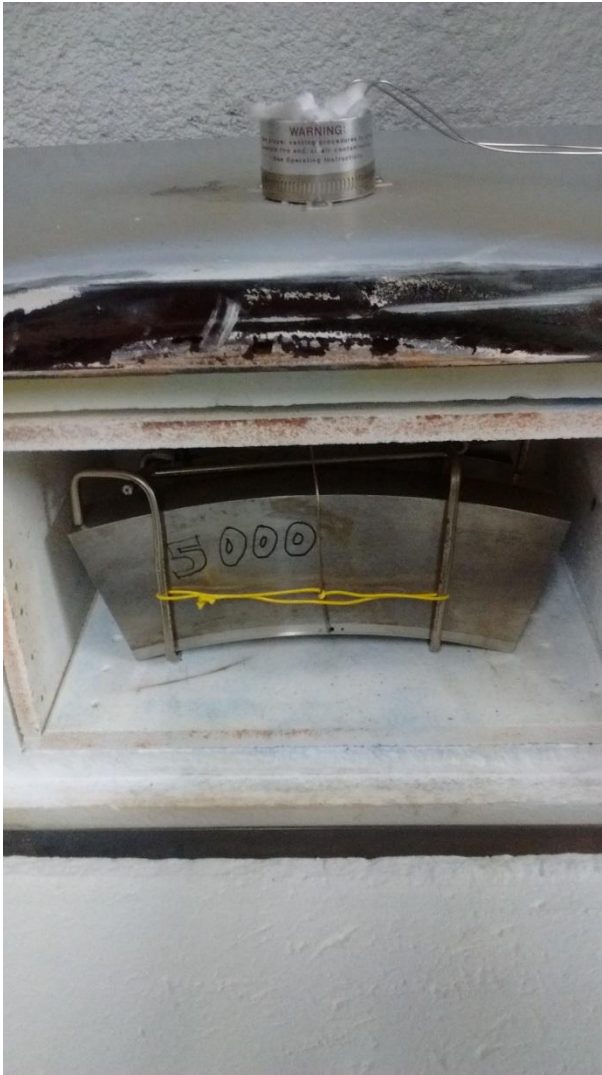
Figure 4. A photograph showing the furnace, feedthrough of the thermocouples and the mock-up block for 5000 h of ageing. The other block for 10000 h of ageing is behind the 5000 h block inside the oven.

Thermal ageing was performed on large blocks instead of the ready specimens for fracture mechanical testing, mechanical testing, hardness testing and microstructural characterization in order to avoid surface oxidation of the actual specimens.

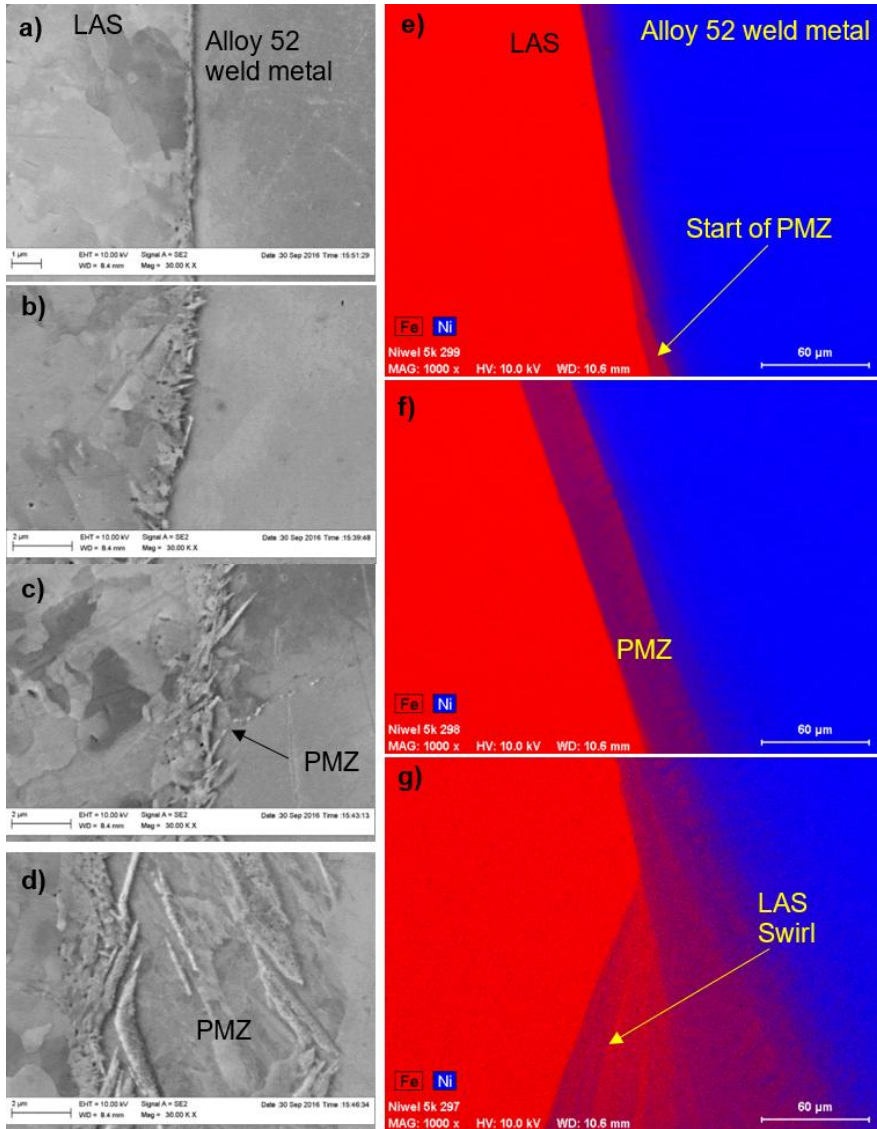
Figure 13. SEM imaging of growth of the PMZ layer from a) a straight fusion line to d) a rather large (about 10 μm) PMZ, and EDS maps showing the increase in Fe dilution into the weld metal from e) the start of PMZ to g) a LAS swirl. The beginning of the weld pass increases the width of the PMZ and the dilution of Fe (red) from the LAS to the Ni-rich (blue) weld metal.

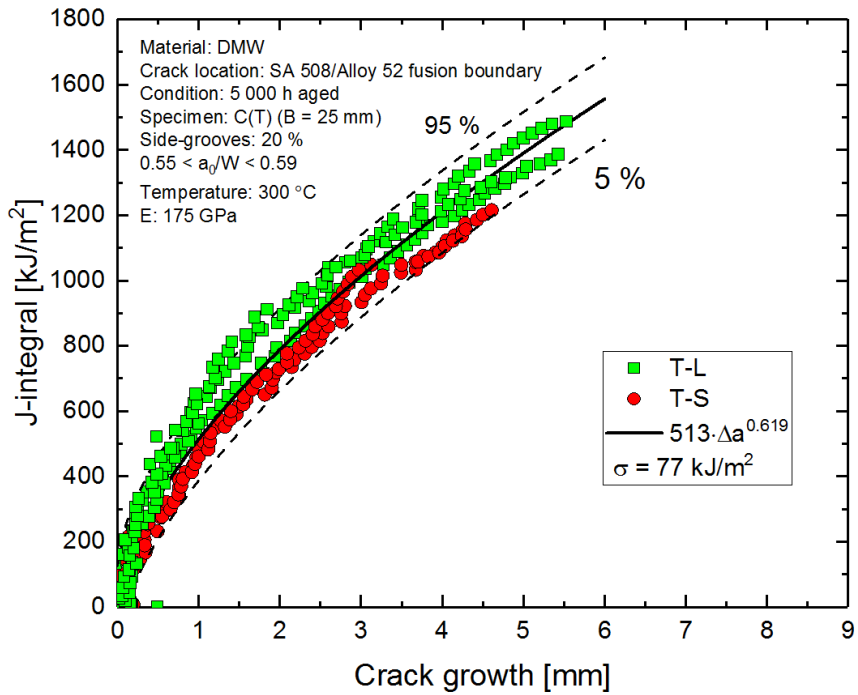
Figure 31. The J-R curves for the 5000 h aged condition.

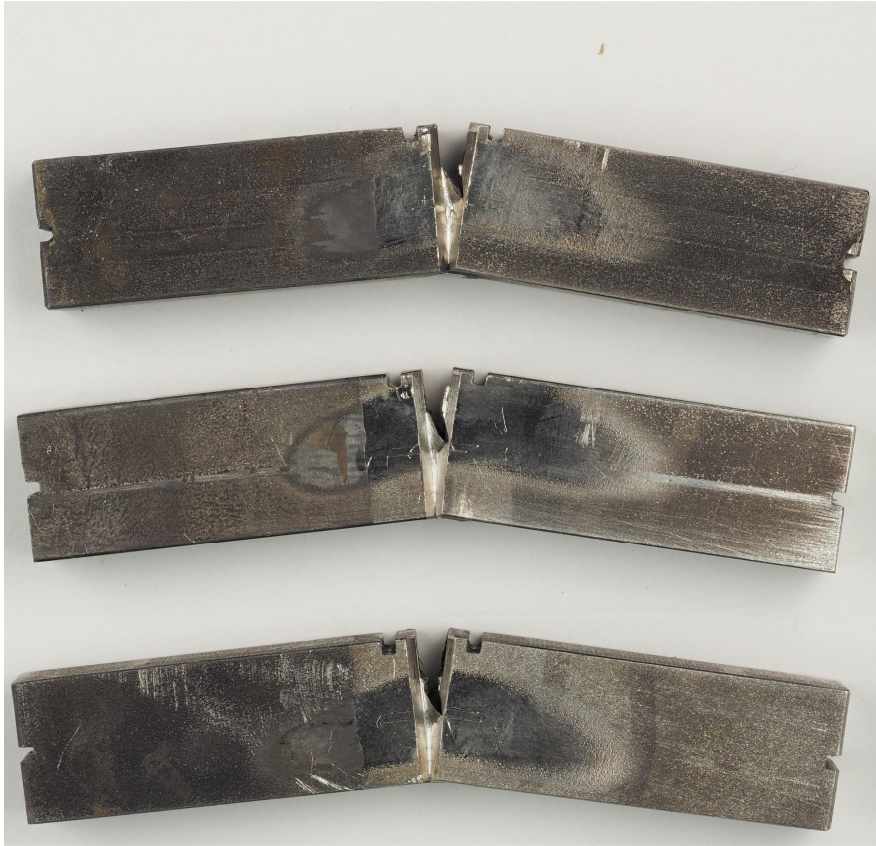
Figure 95. SE(B) specimens after J-R testing, showing crack deviation from the centerline of the specimen.

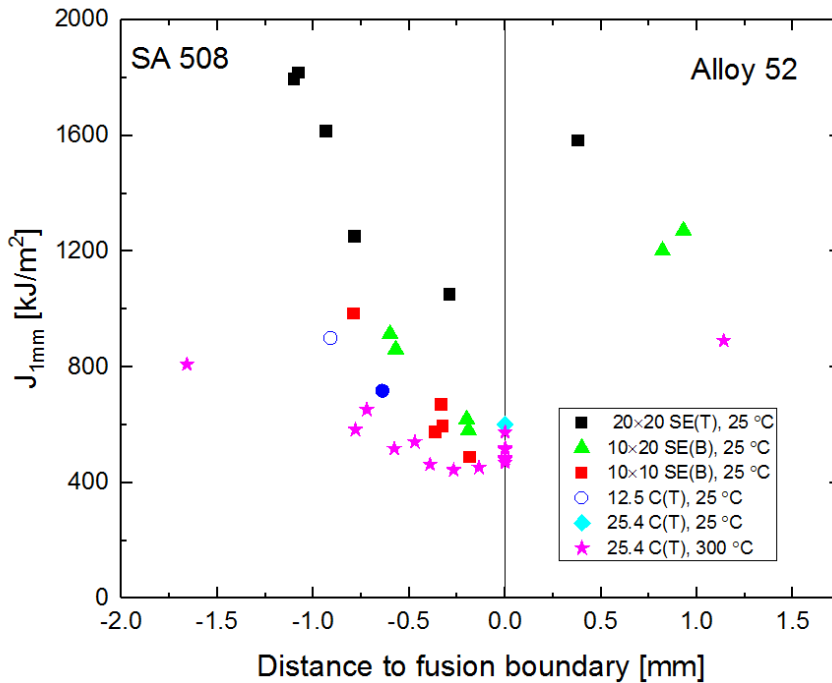
Figure 136. The effect of distance of the initial crack to the fusion boundary. The results are compared to previous investigations.
