Forum for the Effect of Thermal Aging and Microstructure on Mechanical and EAC Behaviour of Ni-base Alloy Dissimilar Metal Welds (FEMMA)

VTT Technical Research Centre of Finland

VTT Technology 420

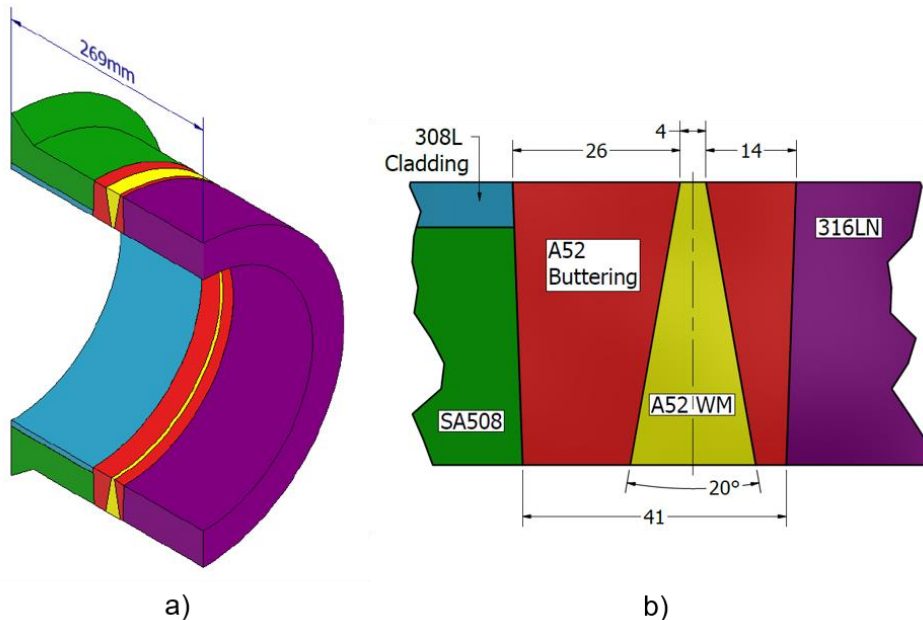
Figure 2: The illustrative figure showing (a) the location of the weld in the surge nozzle safe-end and (b) the DMW structure. All dimensions are in millimetres.

Ringhals mock-up is a DMW mock-up consisting of Alloy 52 buttering on both sides, which is representative of Ringhals pressurizer surge nozzle DMW repair solution. It consists of nozzle material SA508M Grade 2 Class 1, Ni-based Alloy 52 buttering weld, Alloy 52 V-groove weld, Alloy 52 buttering weld, joined to the austenitic stainless steel 316LN safe-end. The inner surface of the nozzle LAS is clad with stainless steel (SS) 308L. The illustrative figure of the DMW structure is shown in Figure 2. The LAS side with buttering weld was subjected to PWHT at 615 °C for 1 hour 17 minutes with heating and cooling rates of 55 °C/h from 300 °C. The V-groove weld and stainless-steel side buttering were welded at a workshop afterwards. The butterings were welded in transverse orientation and the V-groove in longitudinal orientation. The welding parameters can be found in Table 3. The chemical compositions of each material in the DMW provided by Ringhals were verified with glow-discharge optical emission spectroscopy (GD-OES) and are given in Table 4.

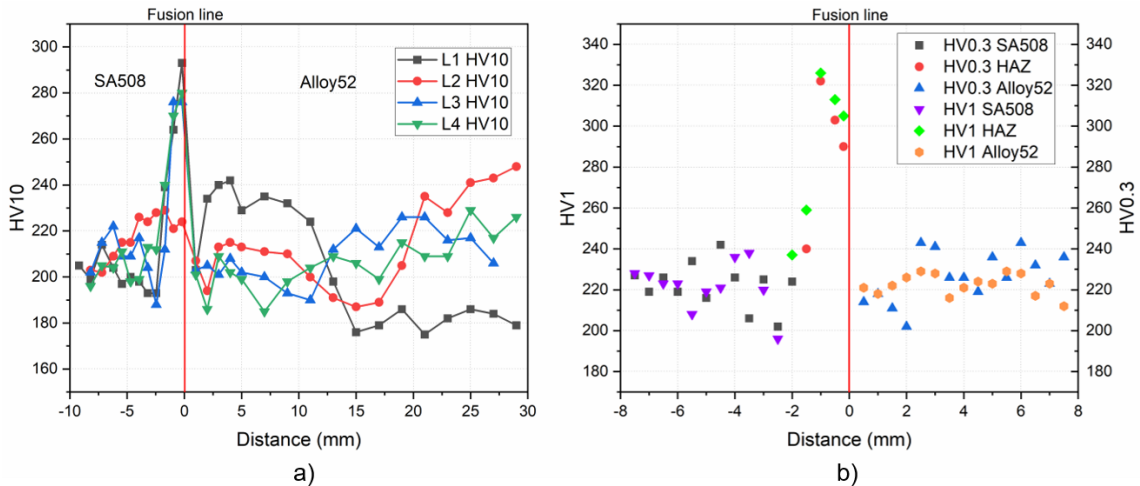
Figure 23: (a) Macro-hardness HV10 results across the FB from the measurement lines L1-L4. (b) Micro-hardness HV1 and HV0.3 results across the FB.

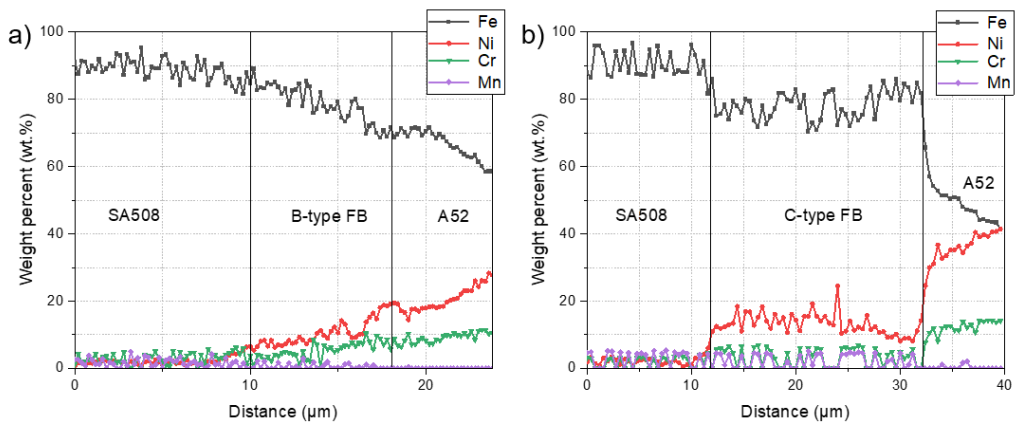
Figure 29: EDS line scans across the FBs of (a) type-B tempered martensite and (b) type-C PMZ.

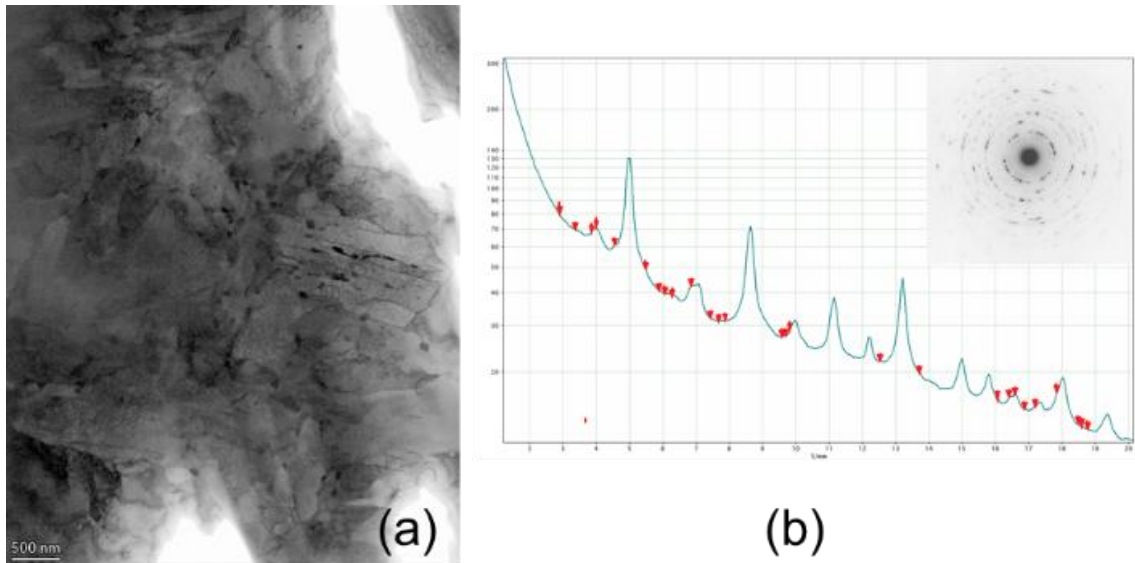
Figure 36: Buttering AR mock-up HAZ microstructure and SAED pattern. (a) STEM-BF image illustrates the ferrite grains, bainite grains and large sized carbides distribution. (b) SAED ring pattern obtained with large selected area aperture and the extracted line pattern to show M_3C peaks (marked with red arrow) and BCC reflections (peaks without mark).

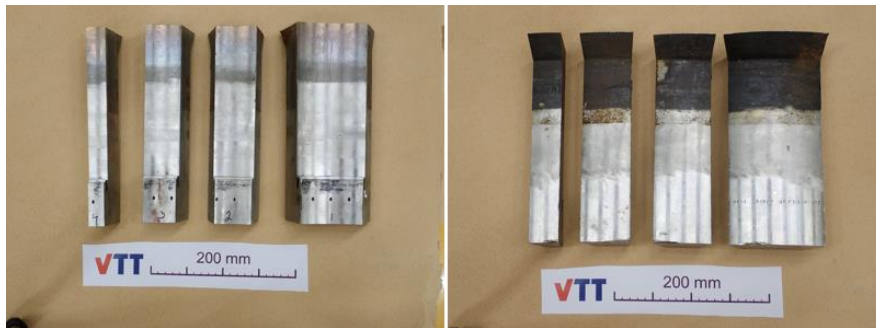
Figure 45: Ringhals mock-up (pieces 1-4 from right to left).

Figure 45 shows several thinner slices of the Ringhals buttering mock-up from which the Ringhals specimens were cut with EDM. The slices were labelled P1, P2, P3 and P4. The direction orientations are illustrated by Figure 46. The specimens were named in the way that the piece where the specimens were extracted can be tracked and the location relative to the FB was given.

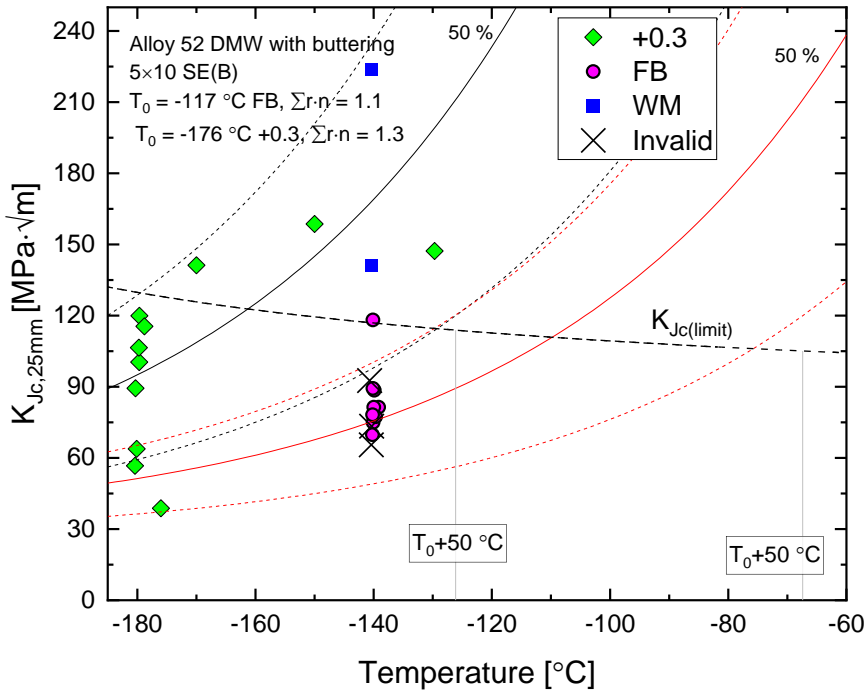
Figure 93. Fracture toughness results for (a) notch nominally at the FB and (b) notch nominally at the FB and at 0.3 mm from the FB.
