Ice action on compliant structures

| Laboratory indentation tests

VTT Building and Transport

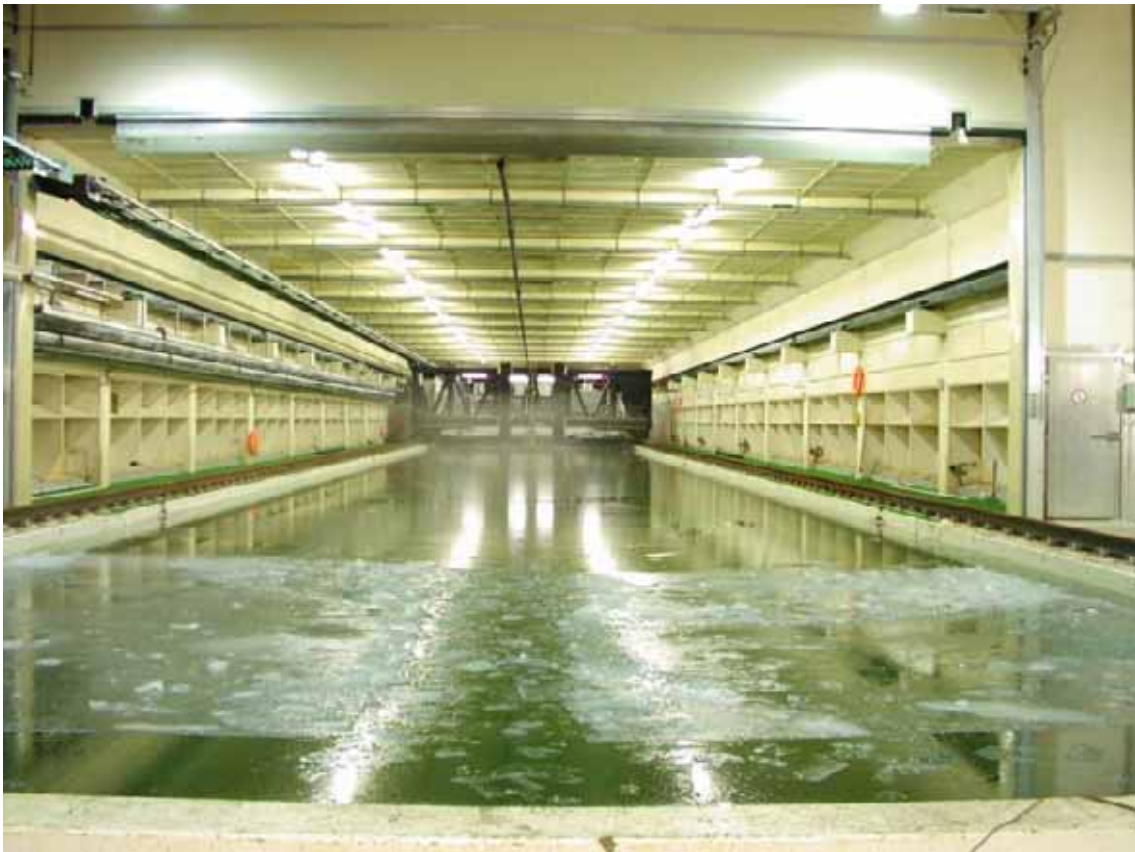
The testes were made at a Large Scale Facility of EU, known as ARCTECLAB, which is operated by the Hamburg Ship Model Basin (Hamburgische Schiffbauversuchsanstalt, HSVA). This institute has been operating ice research facilities for more than 25 years. The main facility is the 78 m long, 10 m wide and 2.5 m deep ice model tank (see Figure 1). An air forced cooling system generates air temperatures as low as -20°C . A motor-driven carriage runs at velocity that can be varied between 3 mm/s and 3 m/s, and provides a towing force up 50 kN. Service carriages above water as well as underwater are available to carry experimental equipment, measuring devices e.g. a variety of load cells, dynamometers, accelerometers, and video cameras.

Figure 1. HSVA's 78 m long, 10 m wide and 2.5 m deep ice basin.

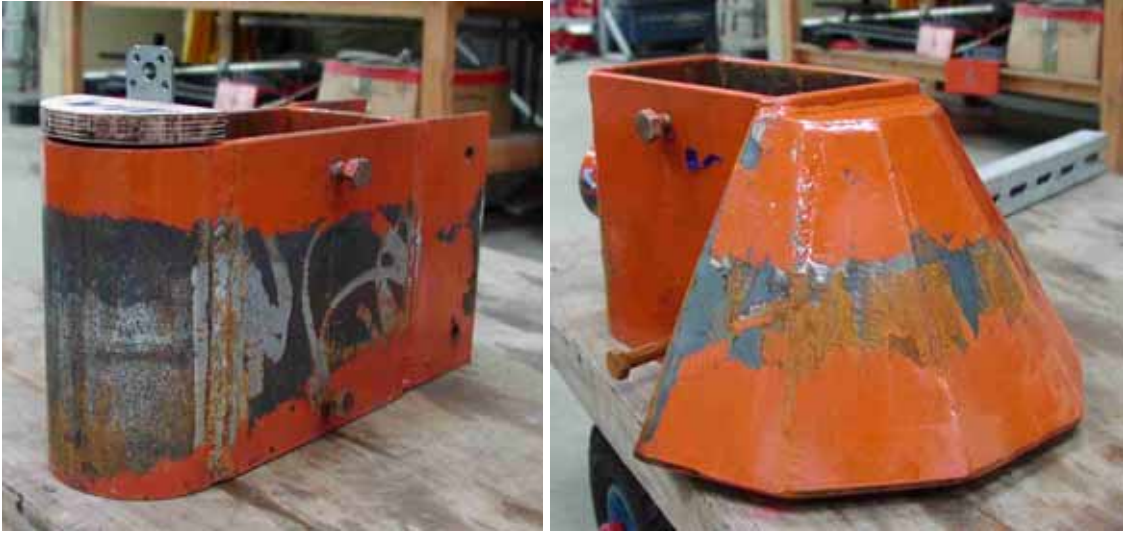
Three different types of indentors were prepared for the tests; cylindrical, conical and inclined cylindrical (Figs 14 and 15). All indentors were made of steel. Indentors were fixed to the column by M10 bolts so that the position of an indentor was adjustable (h in Figure 2). Detailed indentor drawings are shown in Figures 16–18. The diameter of cylindrical indentor was 114 m. The angle of inclination was 30 degrees for the conical indentor.

Figure 14. Cylindrical and conical indentors.

Several parameters were varied in the test. Most of the tests were done using the cylindrical indenter (Figs 14 and 16). The faceted cone depicted in Figures 14 and 17 was also used in one series of tests. The inclined cylindrical indenter (Fig. 15) was used only in preliminary tests. The main variables in these tests were the mean velocity of ice penetration and the structural variant. Table 1 provides a description of the structural variants. The height position (parameter h , Fig. 1) was also varied.

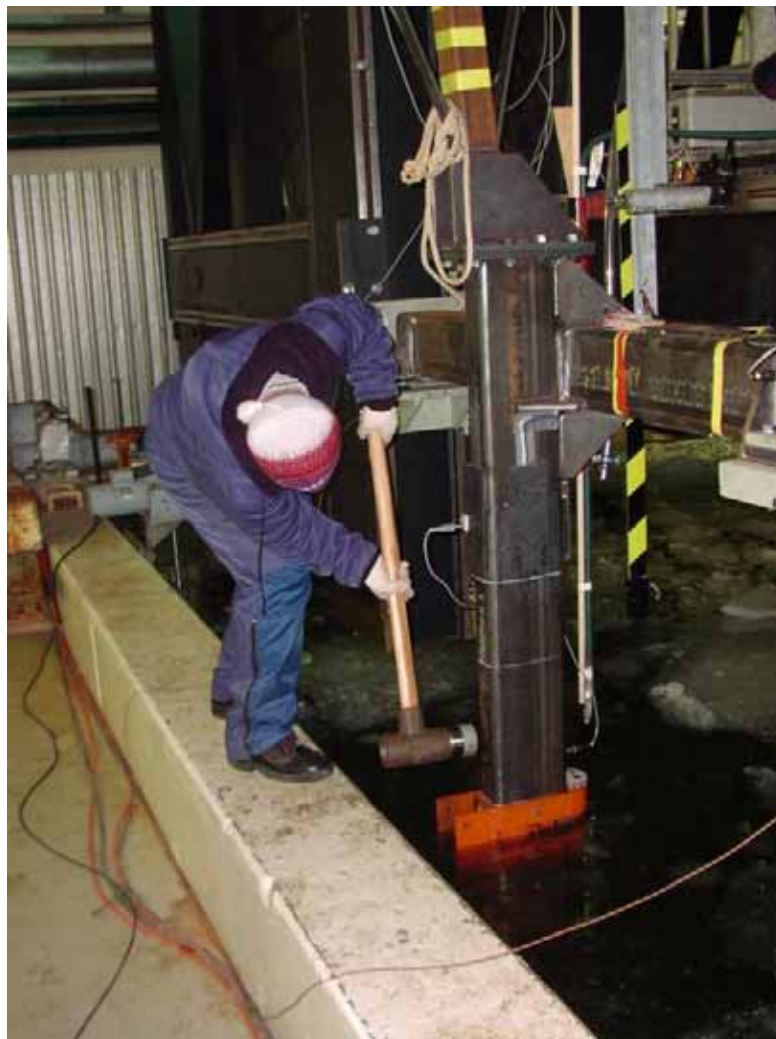
Figure 26. Hammer blow excitation in direction "a" by Bi Xiangjun.

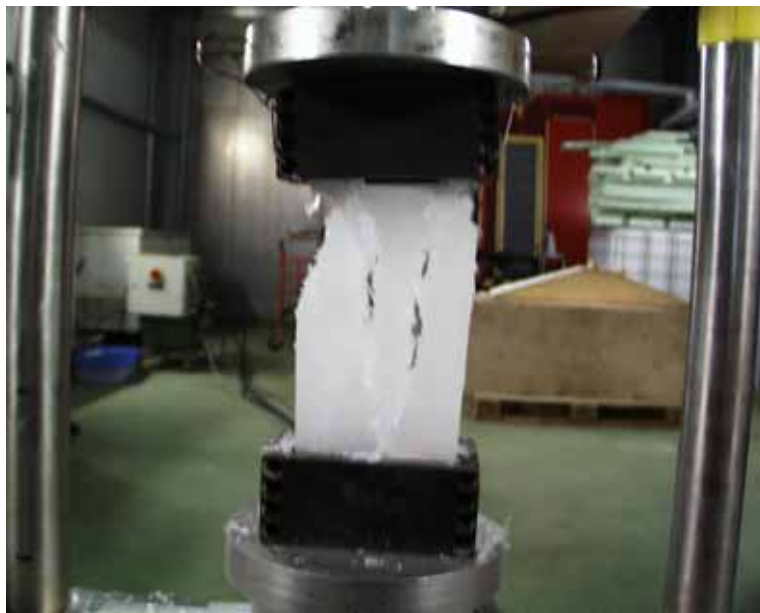
Figure 28. Uniaxial compressive test.

Three ice sheets were used in the tests. The strength of the ice sheet was studied by making uniaxial compressive tests and bending tests (Fig. 28).

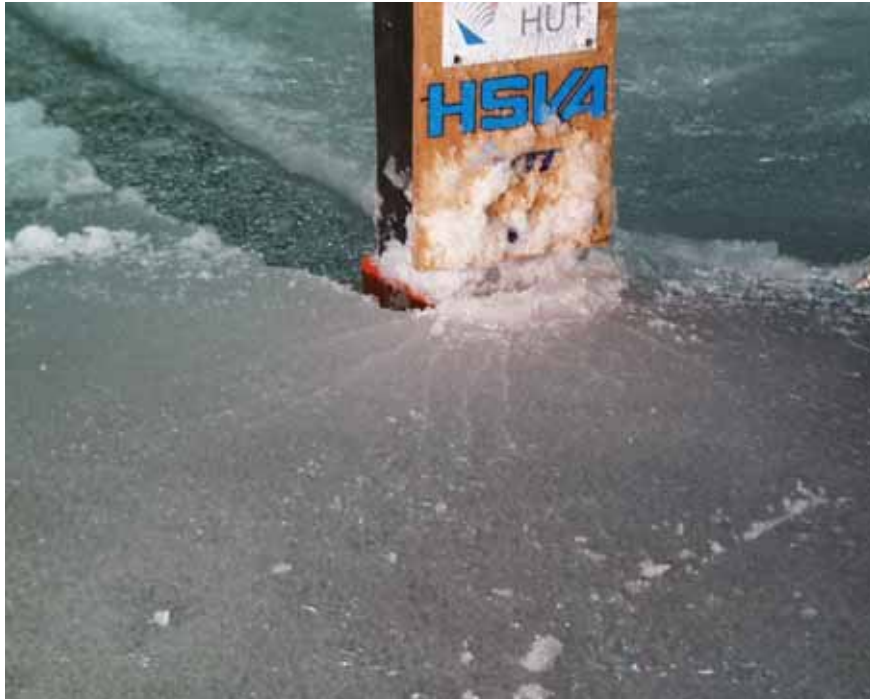
Figure 34. Ice failure in front of the inclined indenter.
