Pure torsion tests on single hollow core slabs

VTT Building and Transport

Pajari, Matti. Pure torsion tests on single hollow core slabs. Espoo 2004. VTT Tiedotteita – Research Notes 2273. 29 p. + app. 28 p.

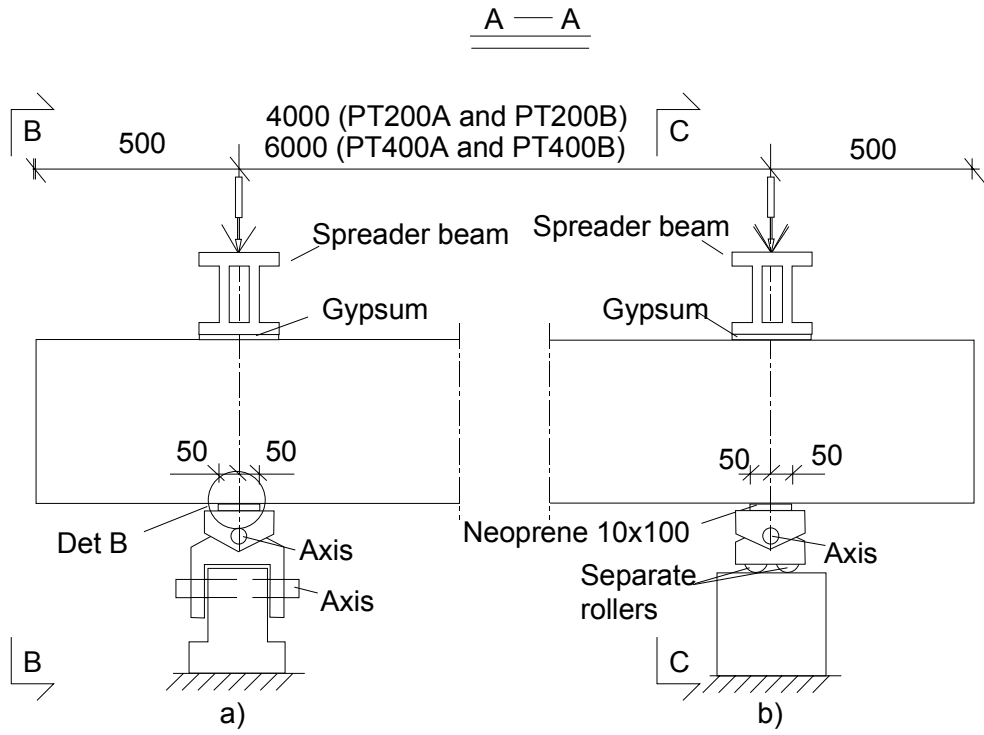
Fig. 5. Side view on test setup. For det B see Fig. 10.

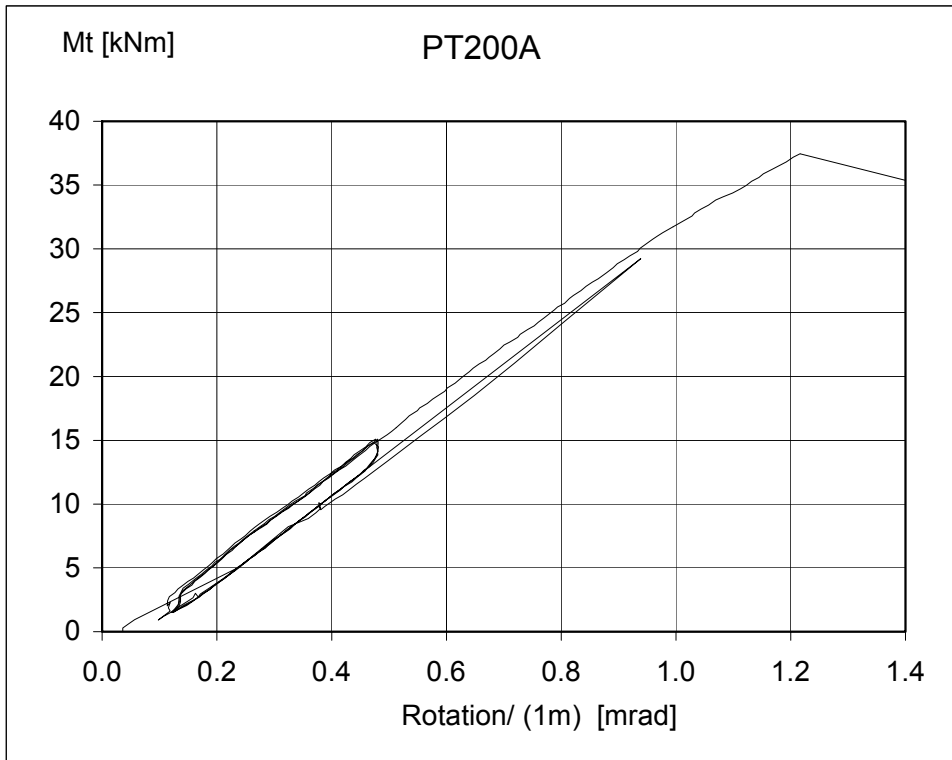
Fig. 12. PT200A. Interdependence of torque and relative angle of twist until cracking.

Figs 12–14 represent the cyclic loading phase. During the first test PT200A, at the beginning of stage 2, the load increased uncontrolled until 100 kN. To have a better control, an additional valve was installed in the hydraulic circuit and the active end was unlocked only after a small increase of load. Thanks to these arrangements, no problems in the later tests occurred in the automatic control. However, there were problems of other type during test PT200B. The hydraulic pump could not maintain the aimed pressure after the cyclic stage. Due to this, there was an unintended unloading and reloading stage after the intended cyclic stage but before cracking. This can clearly be seen in Fig. 13.

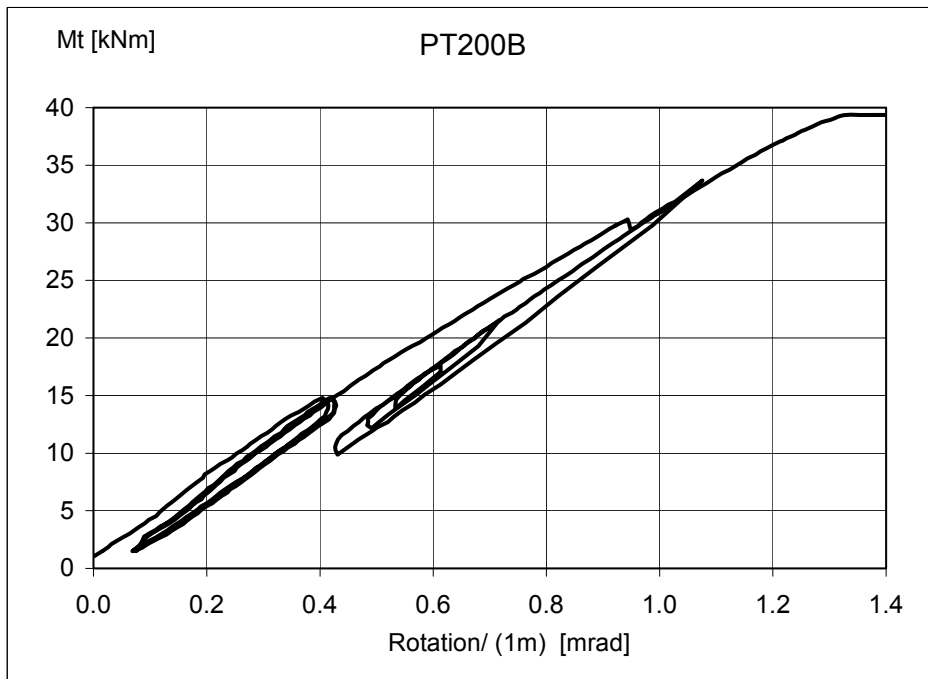
Fig. 13. PT200B. Interdependence of torque and relative angle of twist until cracking.

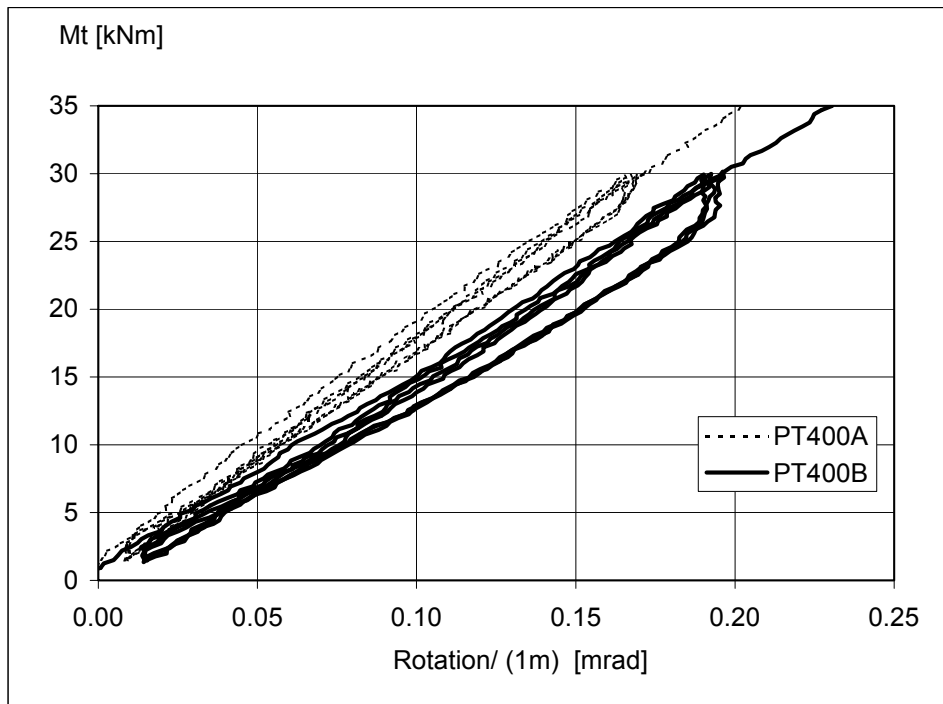
Fig. 14. PT400A and PT400B. Interdependence of torque and relative angle of twist until cracking.

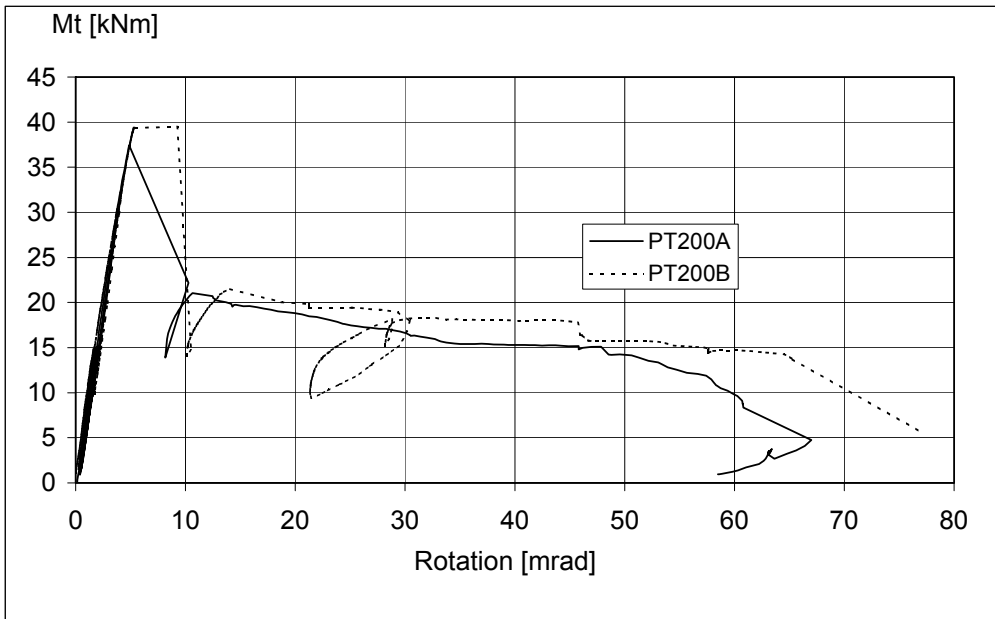
Fig. 15. Interdependence of torque and angle of twist for 200 mm slabs.

In Figs 15 and 17 the whole torque vs. rotation relationship is illustrated and in Figs 16 and 18 the initial part of these curves. The curves in Figs 15–18 indicate the difficulty involved even in a displacement controlled load test when the concrete cracks. The event is too rapid to be recorded properly.

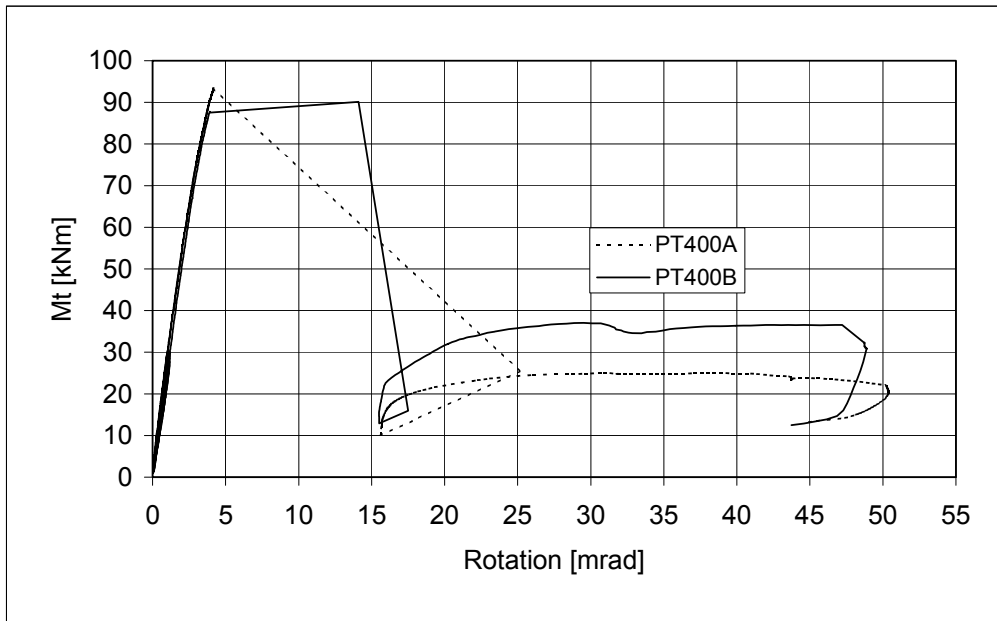
Fig. 17. Interdependence of torque and angle of twist for 400 mm slabs.

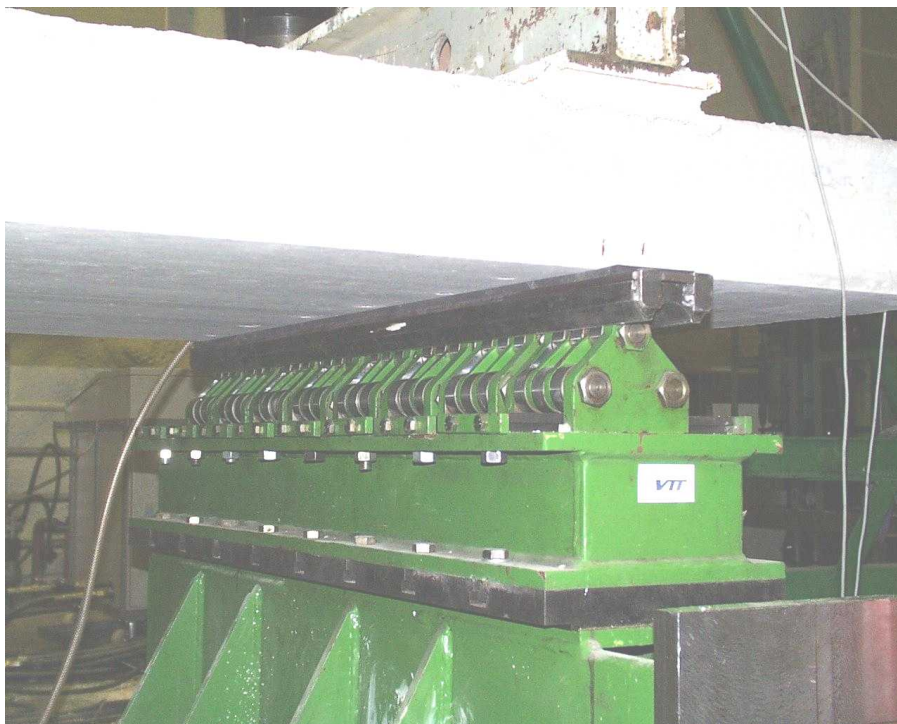
Fig. 4. PT200A. Support at passive end. Side view.

At the passive end the support was able to move longitudinally. Thanks to the separate rollers, see Figs 3 and 4 in Appendix A, the passive support was also free to rotate around a vertical axis until an angle of $50 \text{ mm} / 1200 \text{ mm}$. At the active end the restraints against rotation around a vertical axis (more exactly, axis perpendicular to the steel support) were eliminated by teflon sheets between the steel support and the neoprene strip supporting the slab end, see Figs 8–10 and Appendix A, Fig. 2. Two steel studs welded to the steel support prevented the centroid of the teflon and neoprene strip, and hence also the centroid of the slab end, from sliding relative to the centroid of the support.

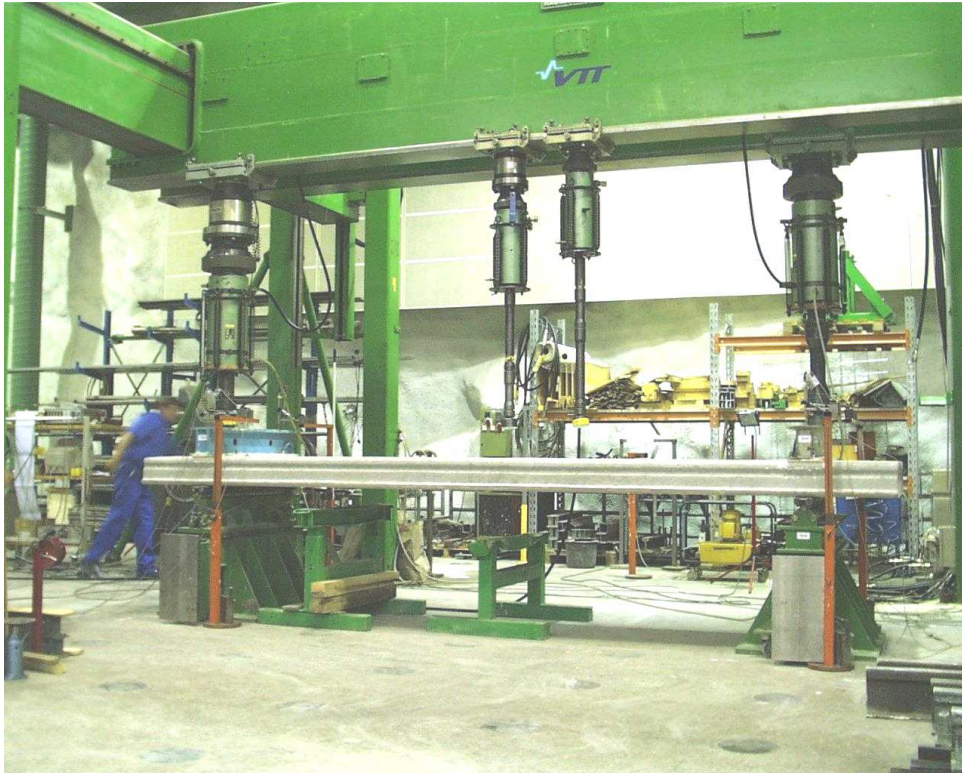
Fig. 5. PT200A. Side view on test arrangements. The two actuators in the middle were not used.

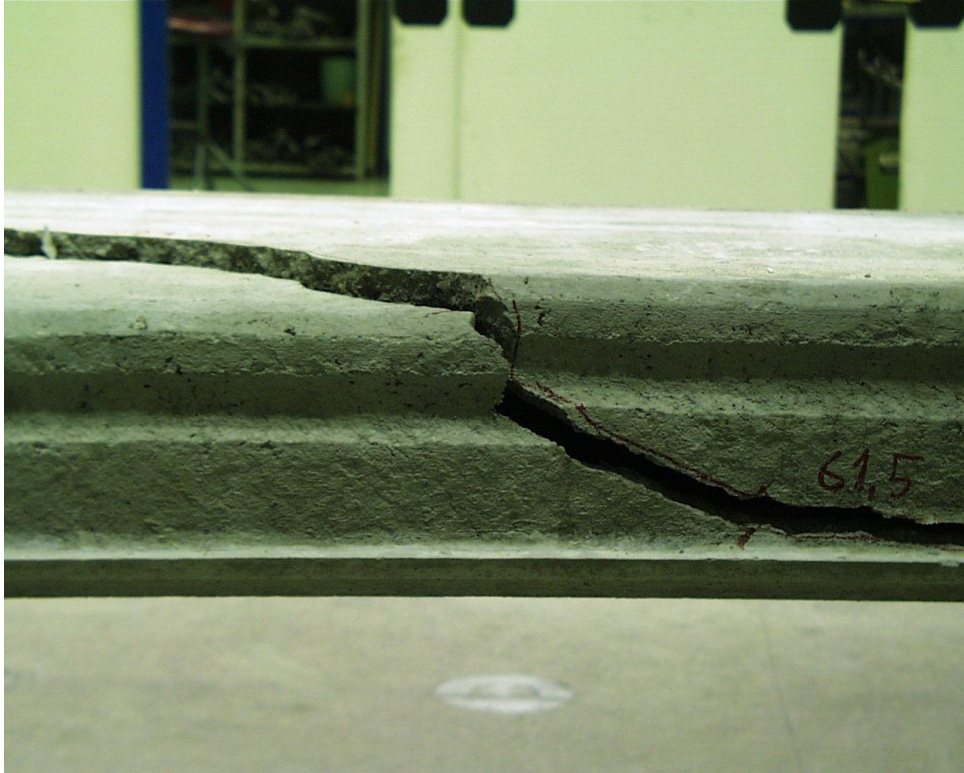
Fig. 9. PT200A. Detail of crack after failure.

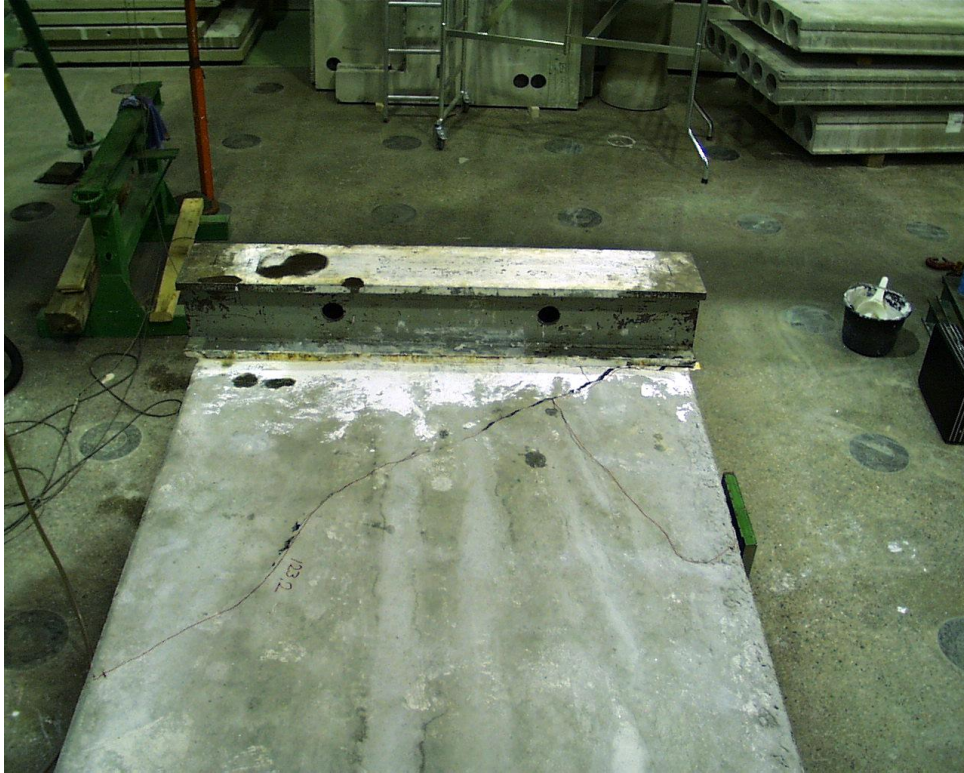
Fig. 13. PT200A. Cracks on the top of the slab after failure.

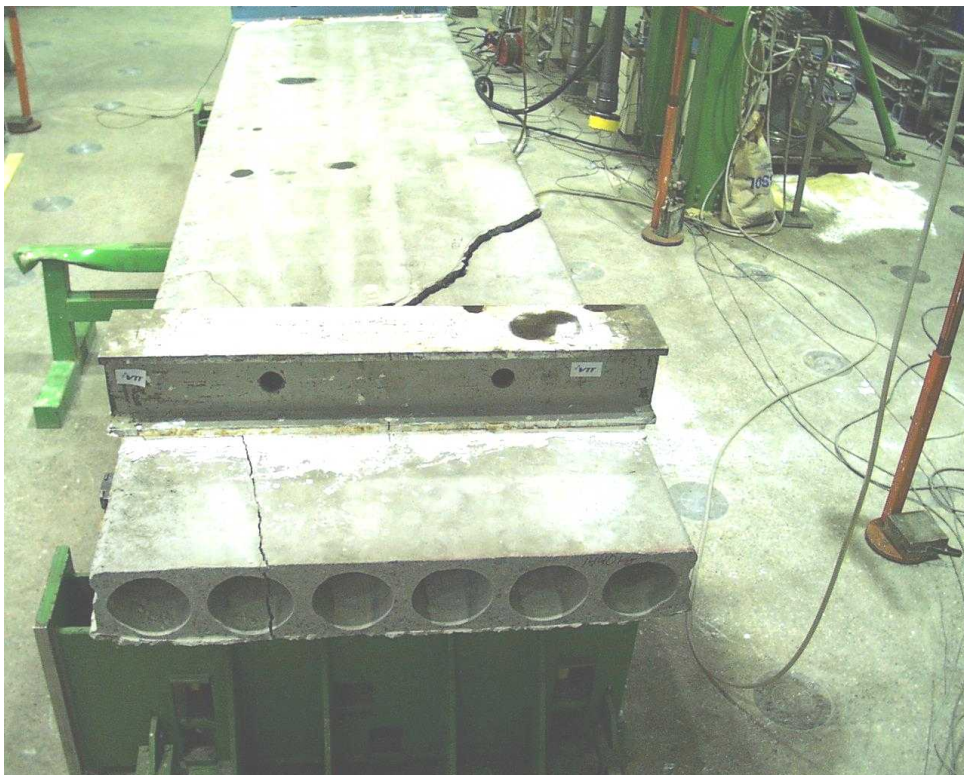
Fig. 14. PT200A. Cracking pattern at the cantilevered passive end after failure.

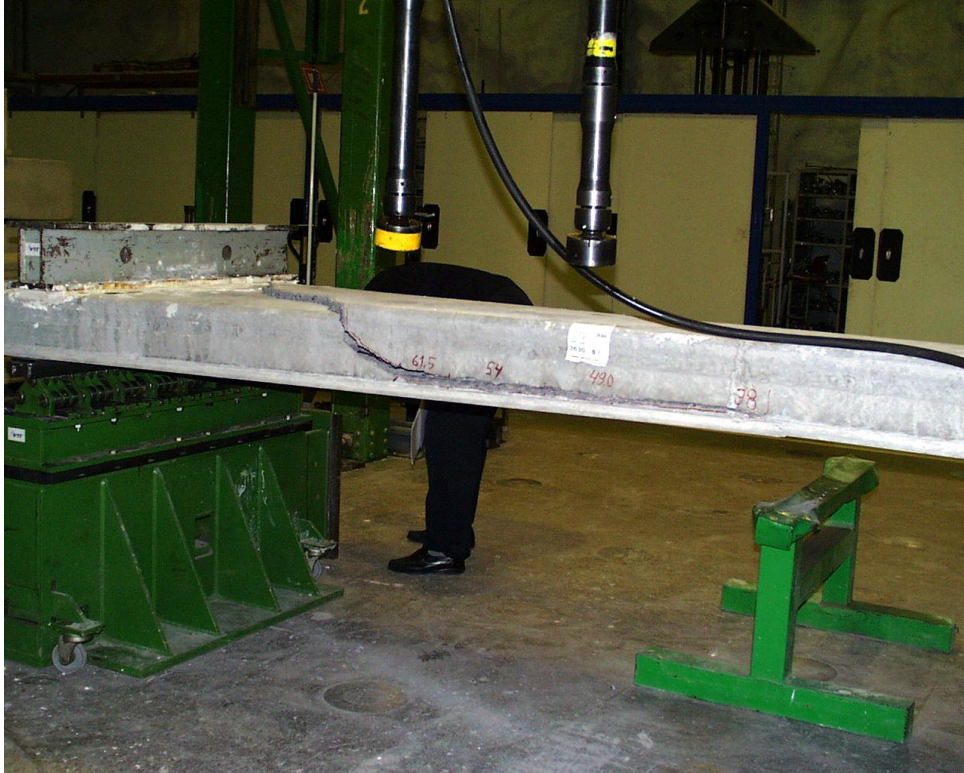
Fig. 15. PT200A. Cracking pattern after failure. The red figures refer to the applied actuator load.

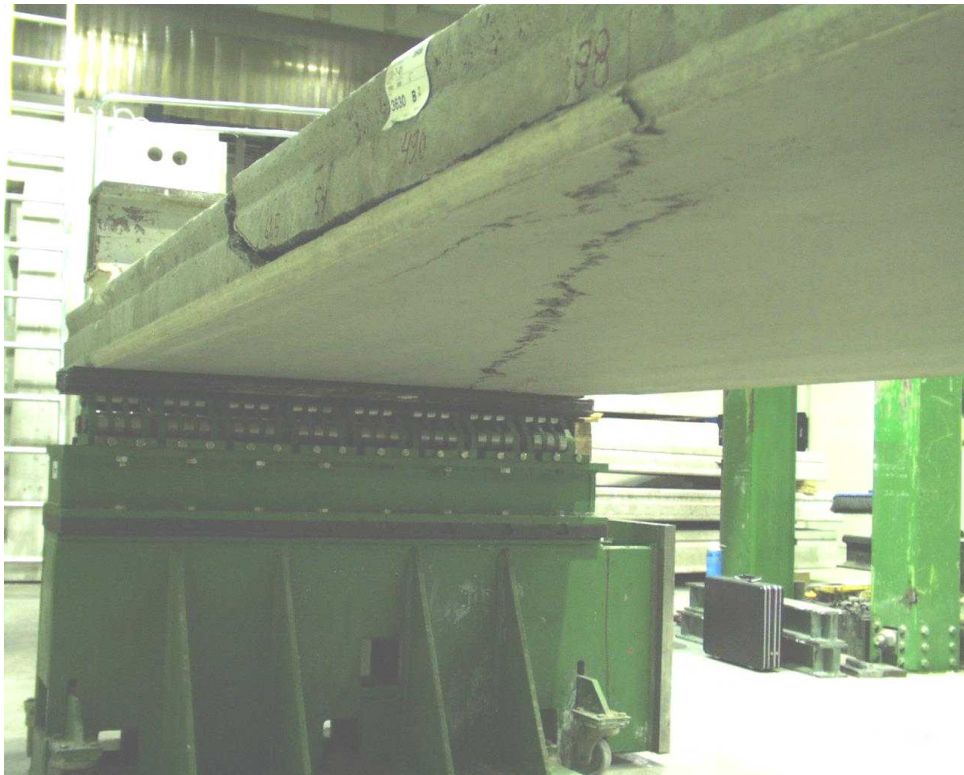
Fig. 16. PT200A. Cracking pattern at the soffit of the slab after failure.

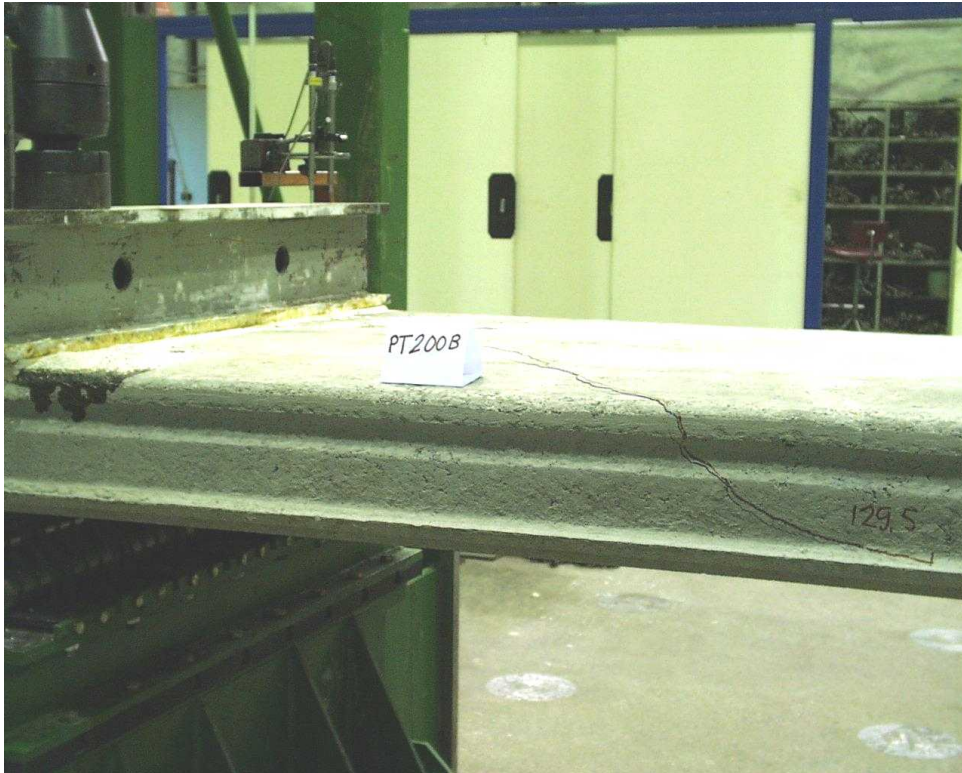
Fig. 17. PT200B. Cracking pattern at passive end.

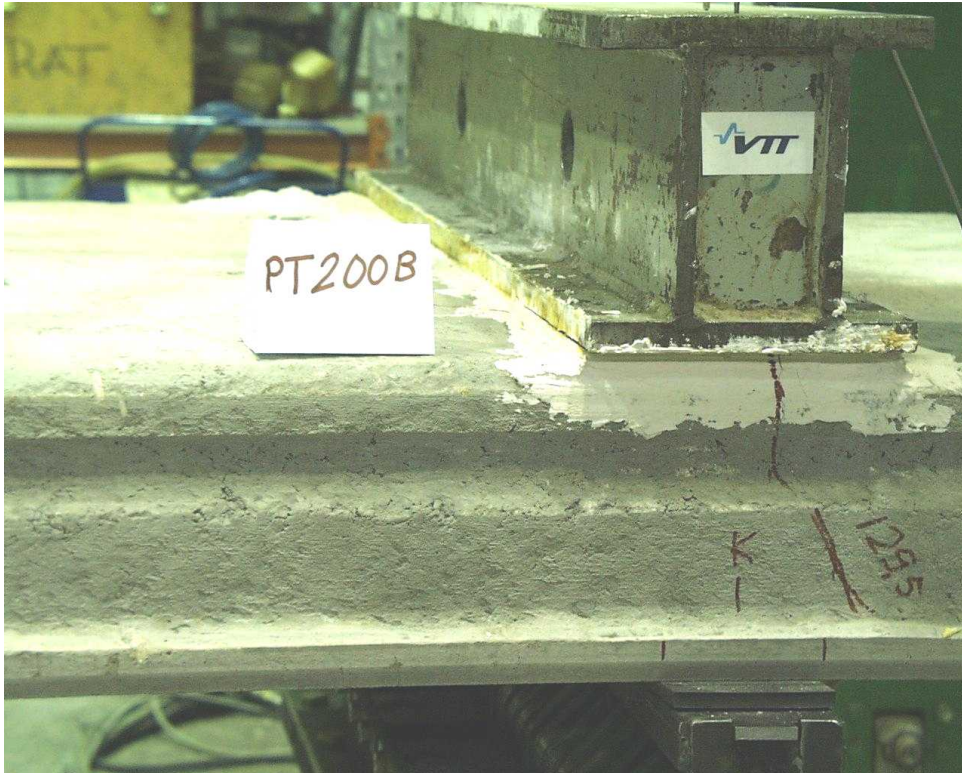
Fig. 19. PT200B. Cracking below the spreader beam at passive end.

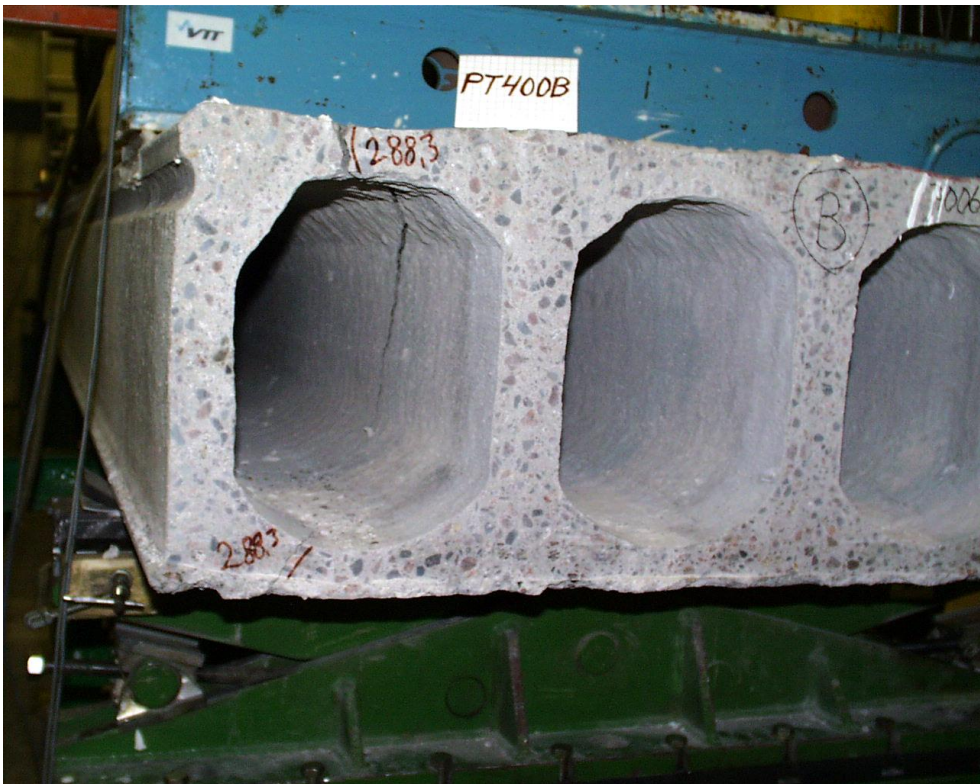
Fig. 34. PT400B. Cracking of the cantilevered end.

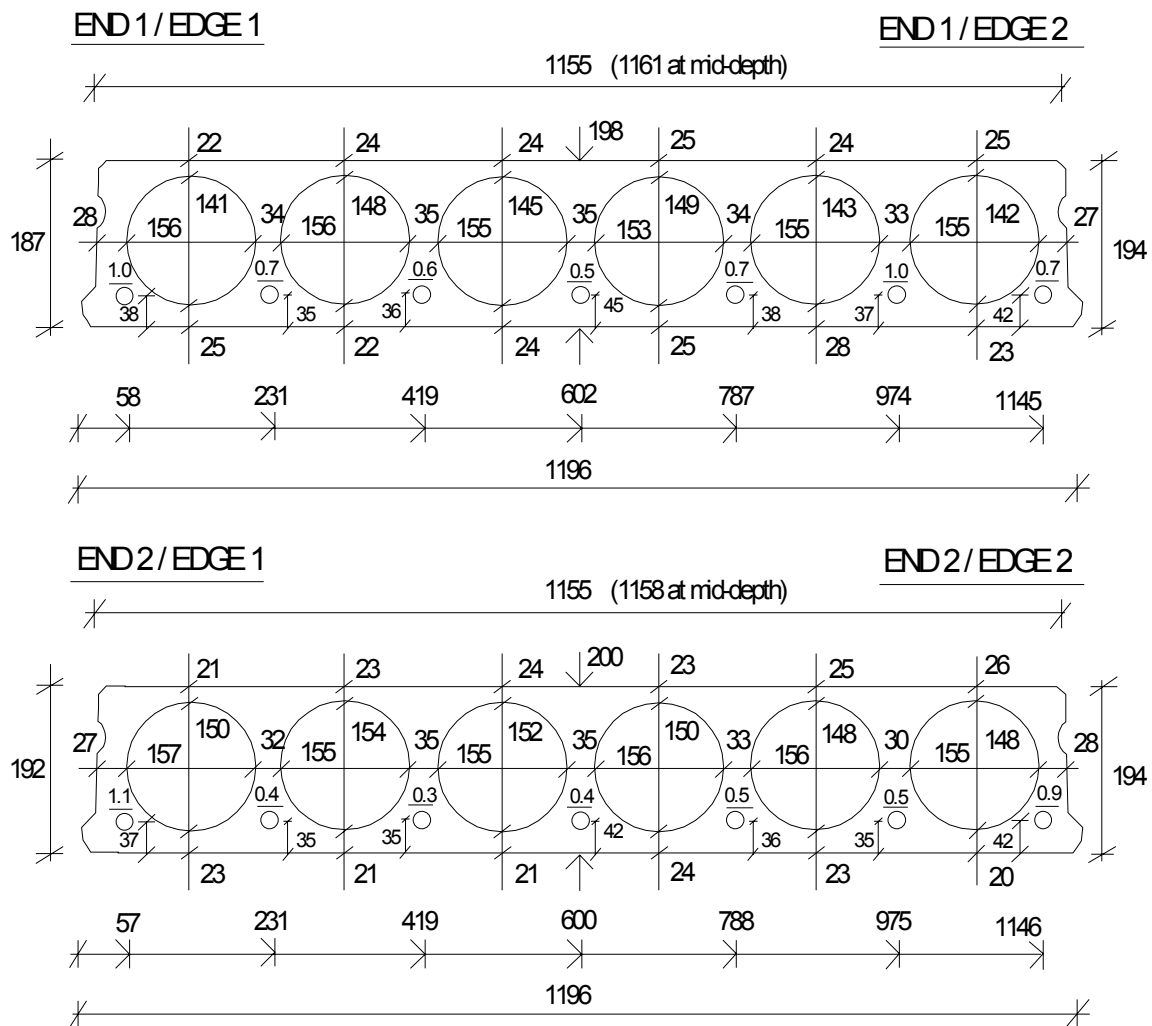
Fig. 1. PT200A.

Length : 5010 mm

Mass : 1440 kg

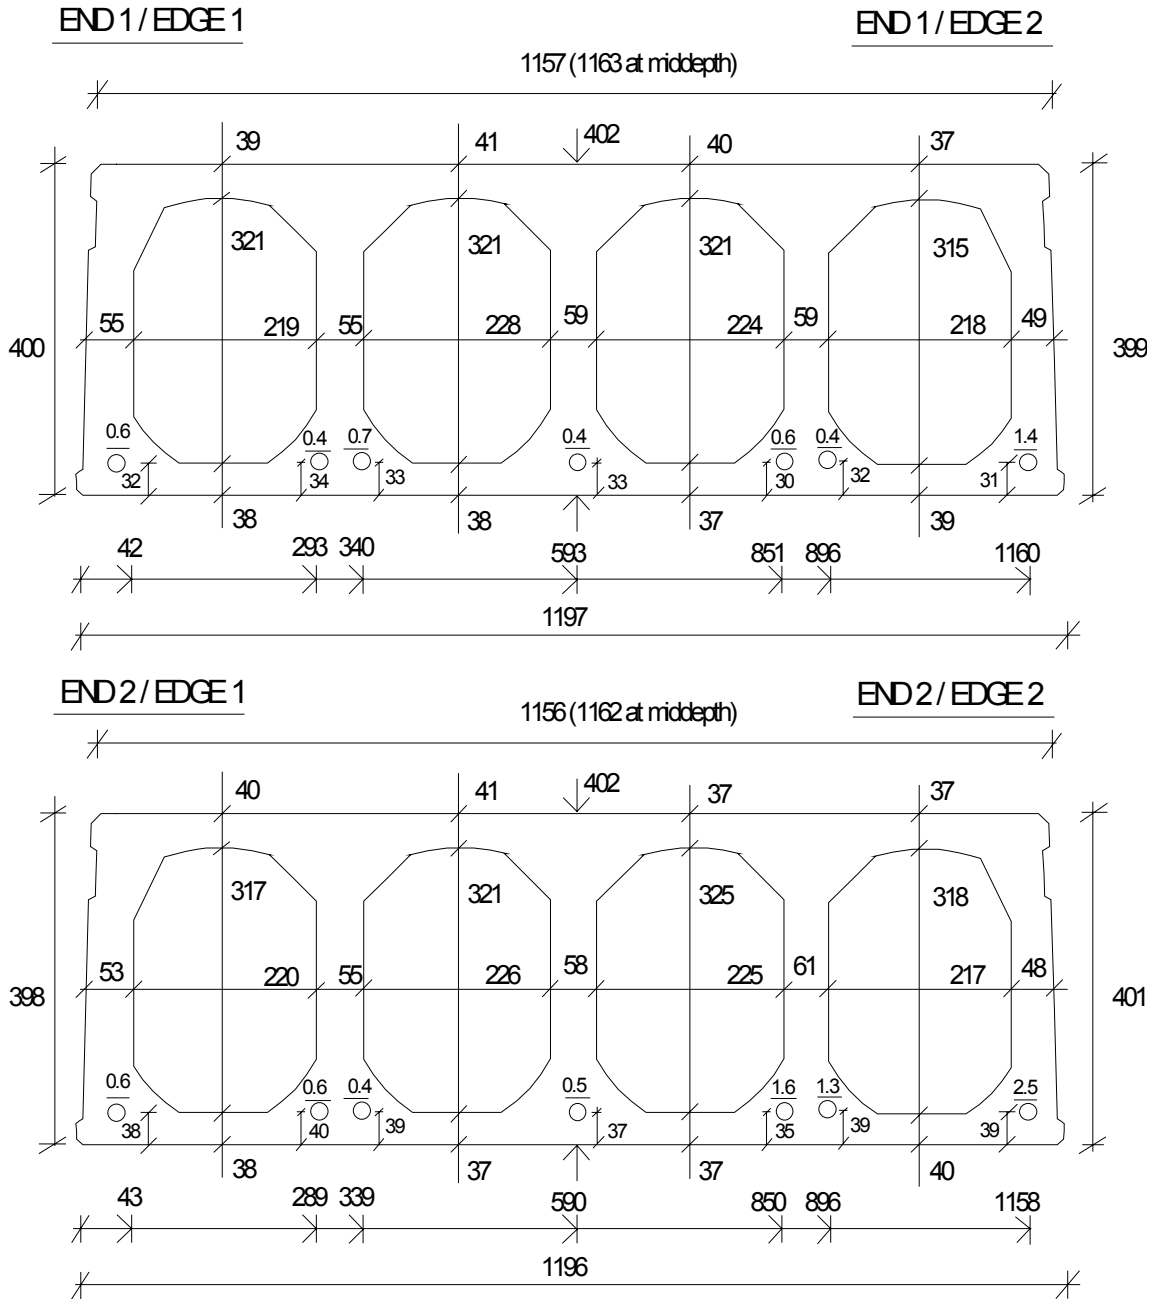
Fig. 3. PT400A.

Length : 7000 mm

Mass : 3610 kg

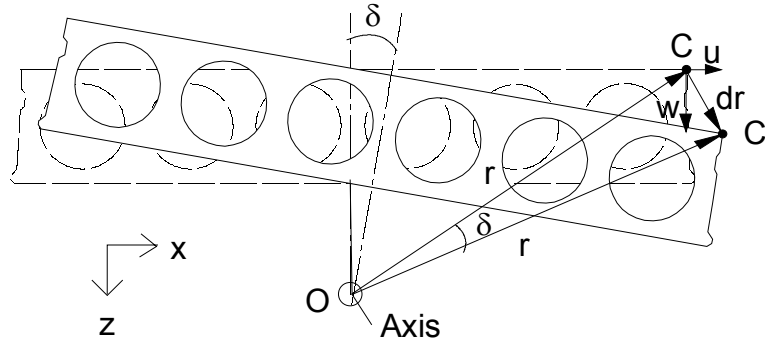
Fig. 1. Rotation of point C at corner of slab and corresponding displacements u and w .

Consider Figs 1 and 2. When the slab rotates around axis O , point C moves to point C' . If the slab is loaded by an actuator, the upper end of which is fixed to point A , see Fig. 2, both the direction and eccentricity of the load are changed. For greater rotations δ the effect of the rotation has to be taken into account when calculating the torque.

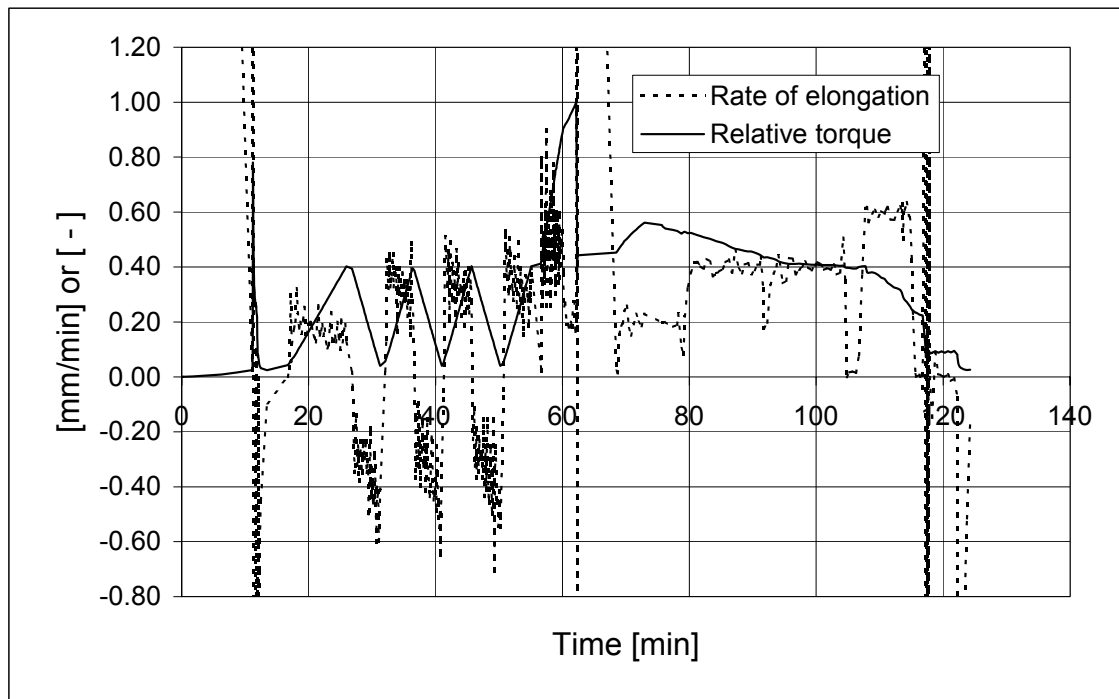
The relative torque illustrated in the following figures means the torque at the considered time step divided by the maximum torque observed during the test.

The vibration in the rate of elongation reflects not only the nonlinear response of the loading equipment and the loaded structure but also the inability of the control system to follow the response in sudden changes. On the other hand, the regularity in the behaviour of the applied torque shows that the loading history, with few exceptions, was very close to the aimed one.

The elongation of the actuator at the active end was used to control the displacements. Attempts were made to keep the rate of elongation piecewise as constant as possible. The actual loading history is illustrated in App. D.
