Shear-torsion tests on 400 mm hollow core floor

Matti Pajari

VTT Building and Transport

Pajari, Matti. Shear-torsion tests on 400 mm hollow core floor. Espoo 2004. VTT Tiedotteita – Research Notes 2274. 30 p. + app. 82 p.

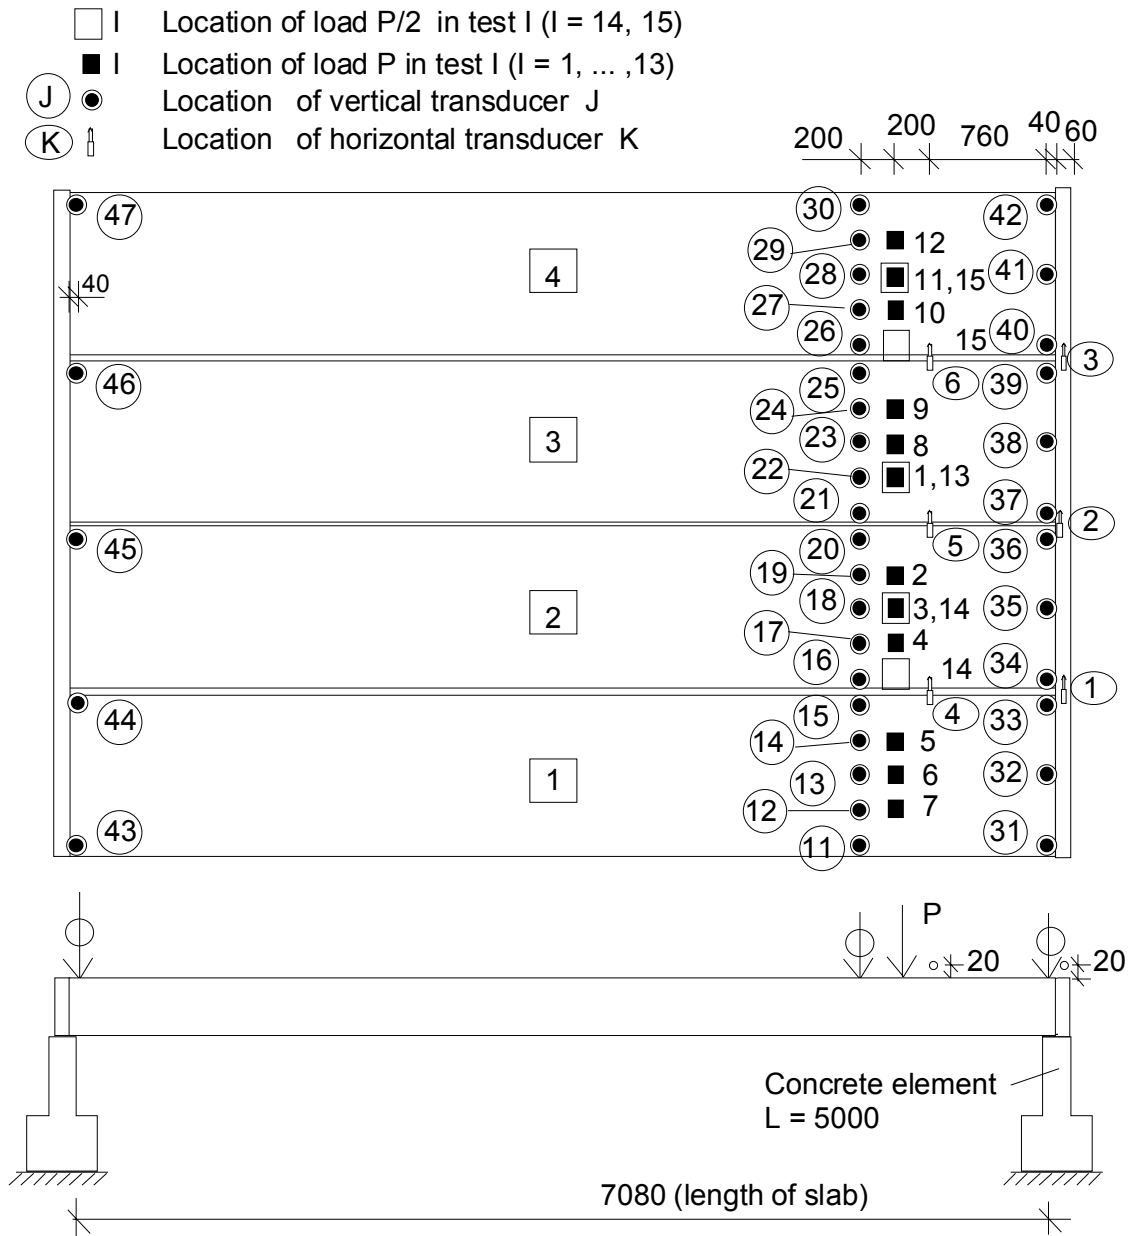
Fig. 5. Numbering and location of horizontal transducers 1–6 and vertical transducers 11–47 as well as location of loads in tests PF400:1–PF400:15.

The support conditions and test arrangements are roughly presented in Fig. 5 and in more detail in Figs 6–11.

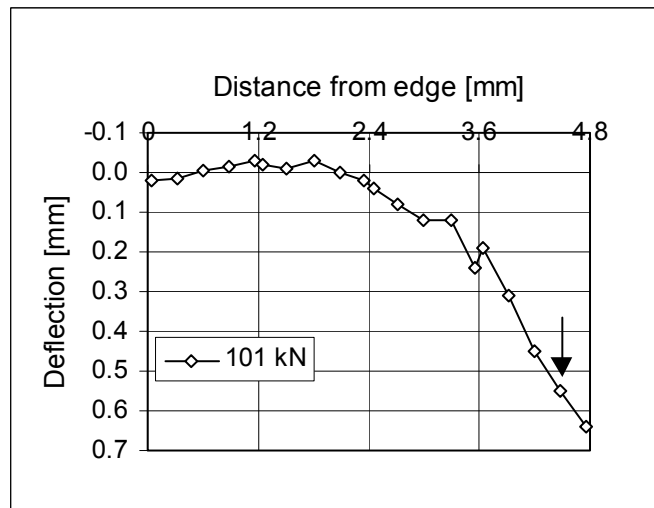
Fig. 23. PF400:12. Deflection measured by transducers 11–30 at maximum load.

Figures 12–23 illustrate the deflection of the slab along a transverse line close to the load. In many cases there is a considerable discontinuity over the joints.

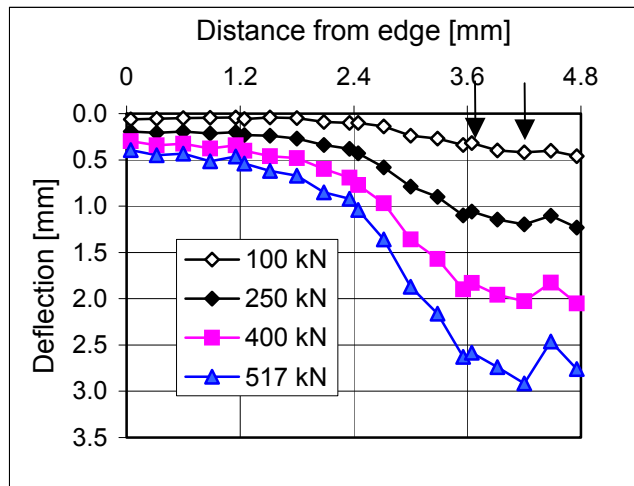
Fig. 30. PF400:15. Deflection measured by transducers 11–30 at different loads.

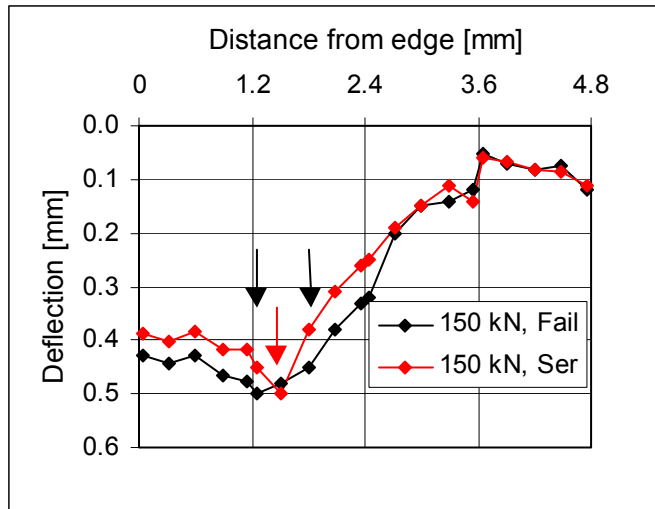
Fig. 32. Tests PF400:4 (Ser) and PF400:14 (Fail). Deflection measured by transducers 11–30 at load $P = 150$ kN.

In Figs 31–33 the deflection measured in failure test is compared with the deflection measured in service load test. The deflections coincide rather well despite the permanent deformations and cracking which had taken place before the last two tests were started.

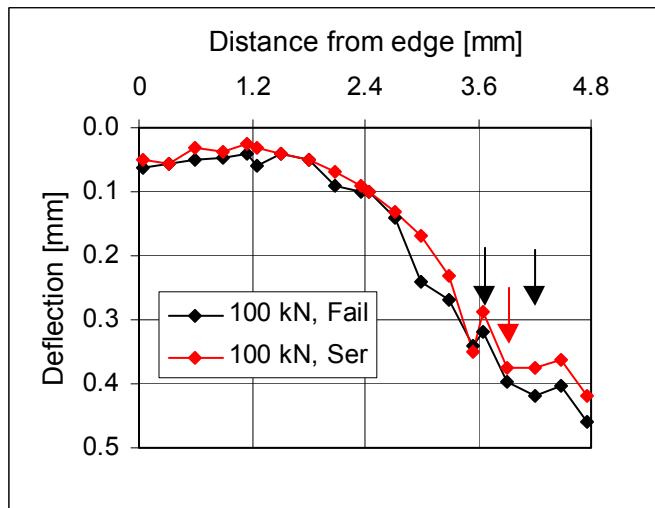
Fig. 33. Tests PF400:10 (Ser) and PF400:15 (Fail). Deflection measured by transducers 11–30 at load $P = 100$ kN.

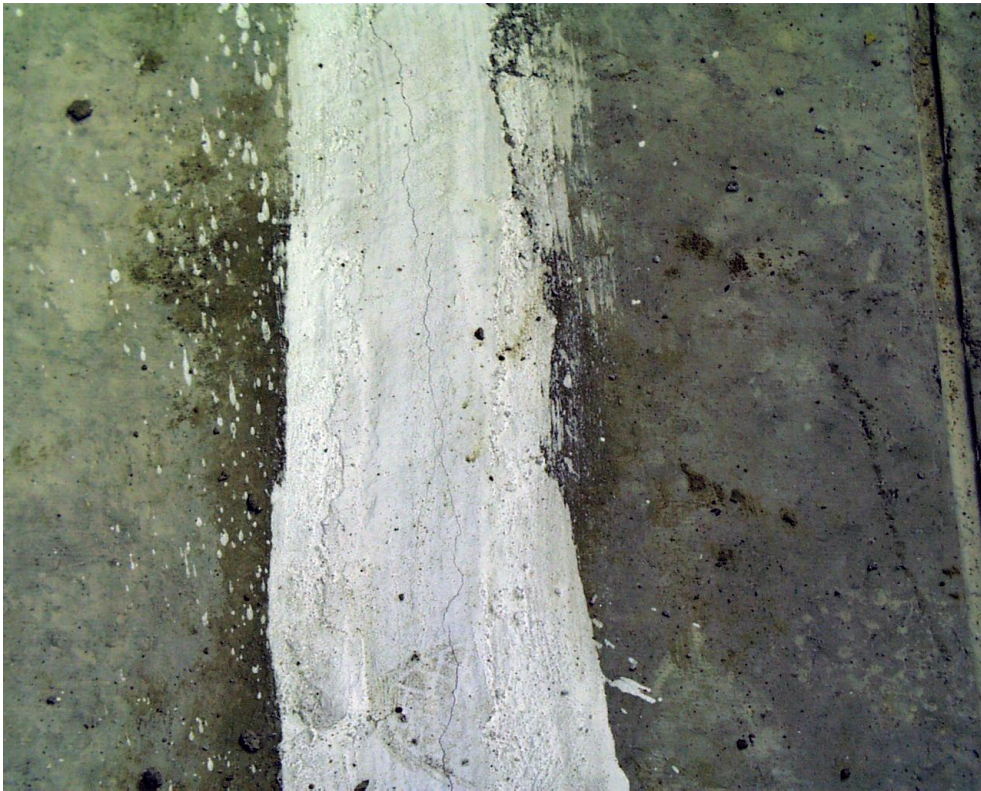
Fig. 4. Crack in joint due to wedging.

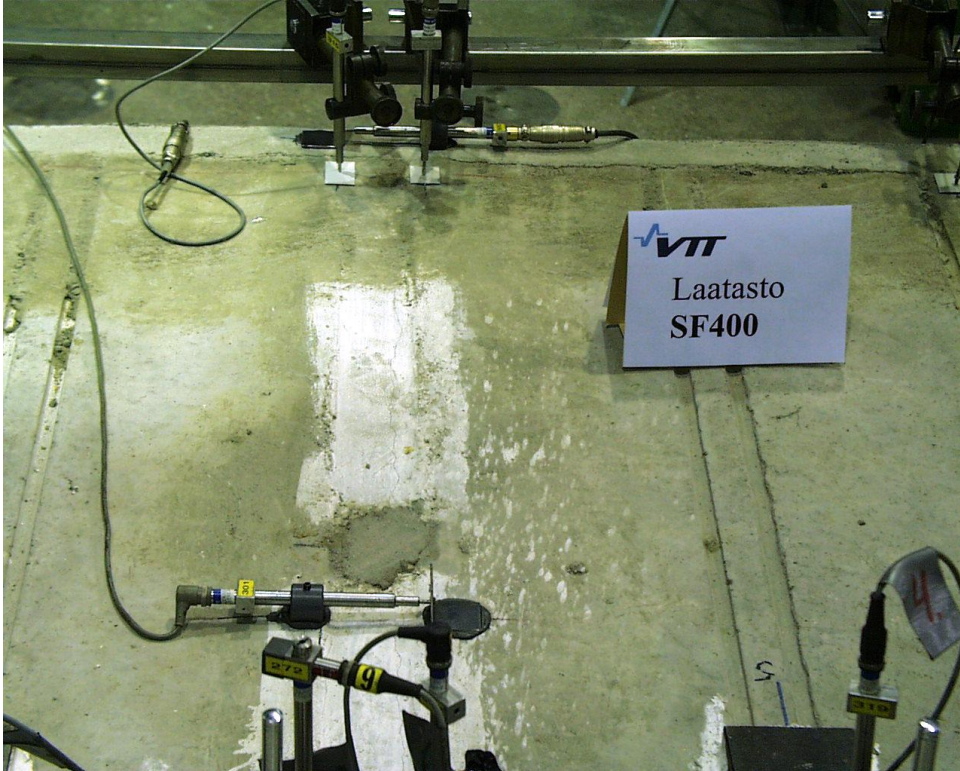
Fig. 7. Horizontal transducers for measuring crack opening.

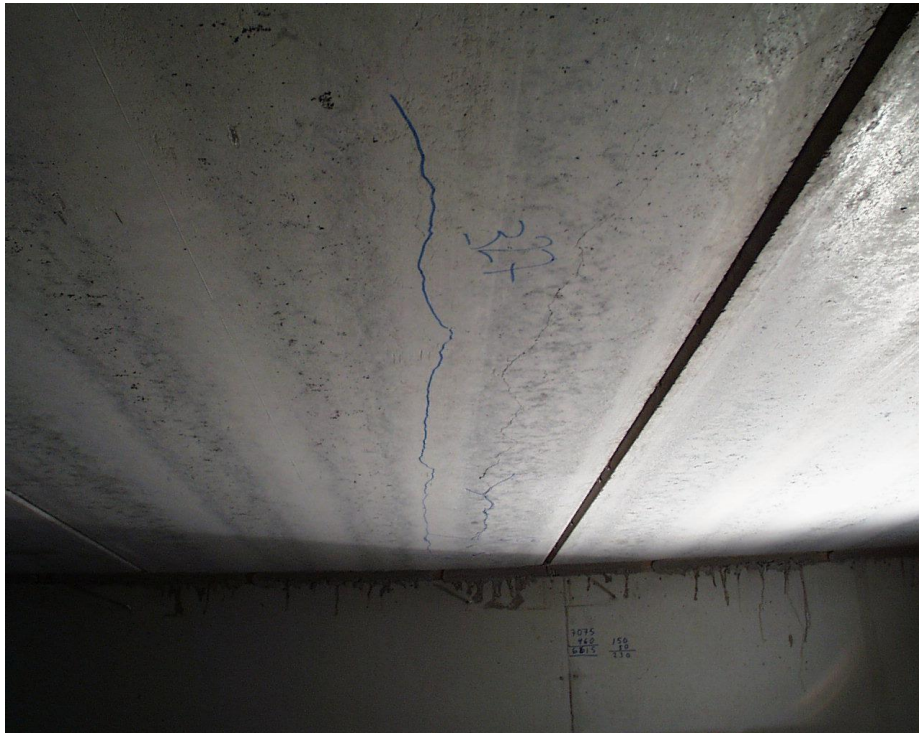
Fig. 14. PF400:13. Longitudinal cracks in soffit of slab 3 after failure.

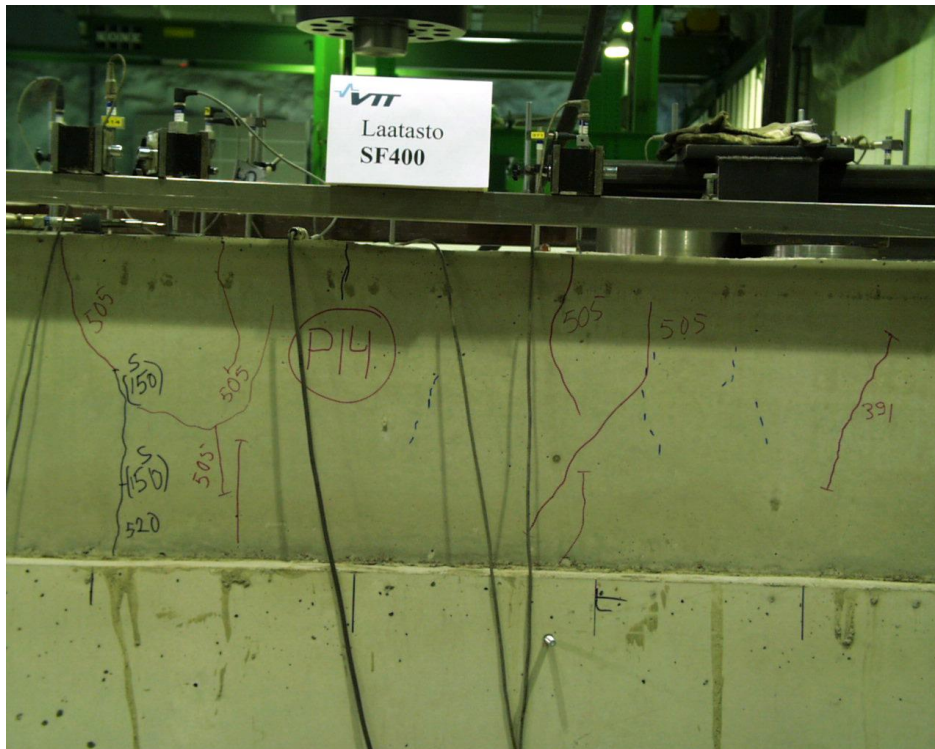
Fig. 18. PF400:14. Cracks in tie beam at the loaded end shown in red colour.

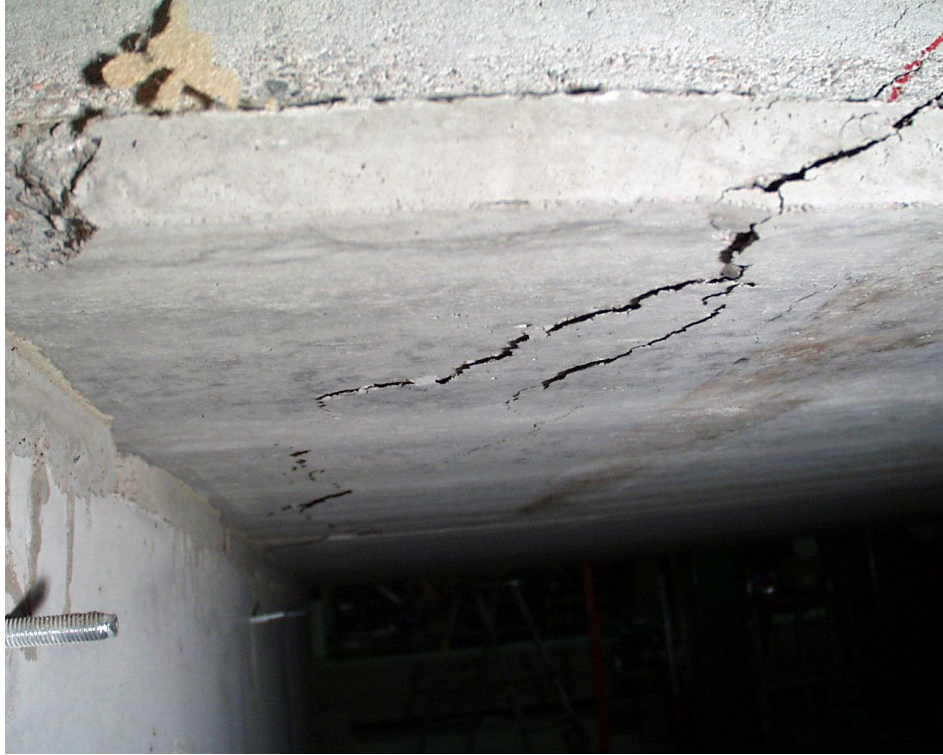
Fig. 31. PF400:15. Soffit of slab 4 after failure.
