Shear-torsion interaction tests on single hollow core slabs

VTT Building and Transport

Pajari, Matti. Shear-torsion interaction tests on single hollow core slabs. Espoo 2004. VTT Tiedotteita – Research Notes 2275. 76 p. + app. 122 p.

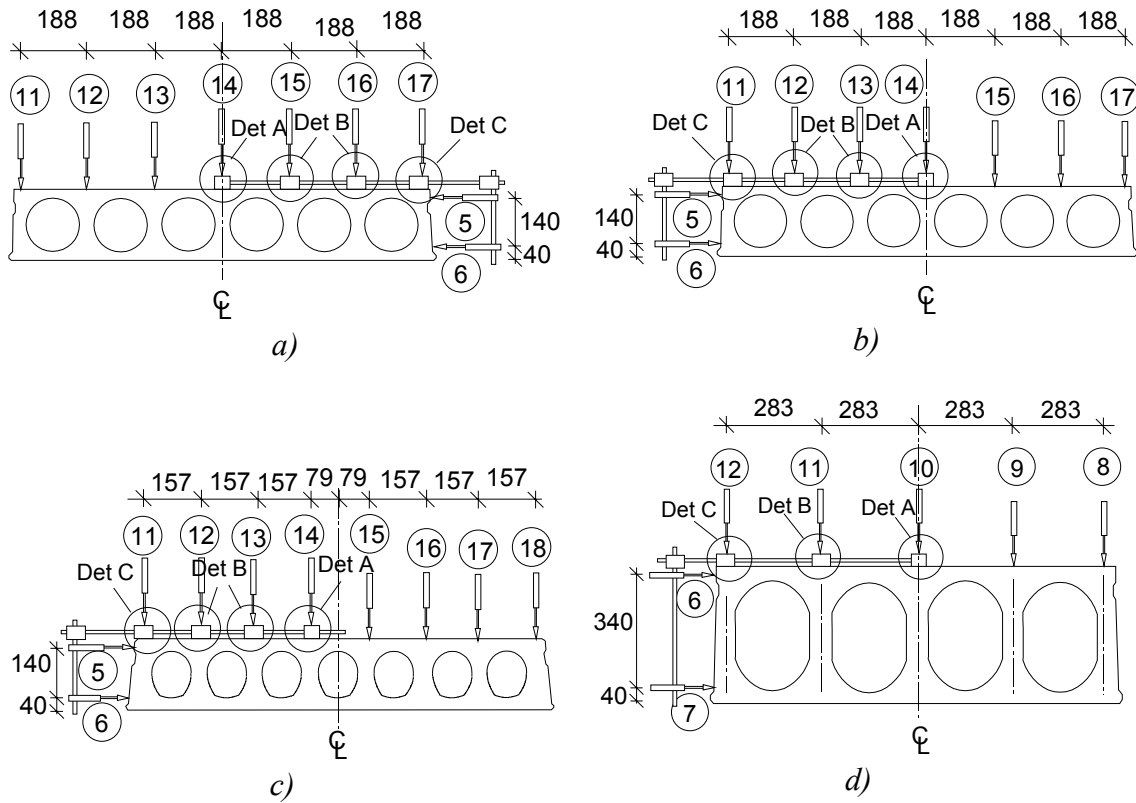
Fig. 10. Section B–B, see Fig. 5. a) Tests ST200C and ST200E1a. b) Tests ST200E1b and ST200E2. c) Tests STS200. d) Tests ST400. For Det A, B and C see Fig. 11.

Slippage of strands relative to the concrete was measured at the active end by horizontal transducers as shown in Fig. 10. Since the transducers were fixed to the concrete at the active end, they gave unreliable or misleading results after cracking of the slab end.

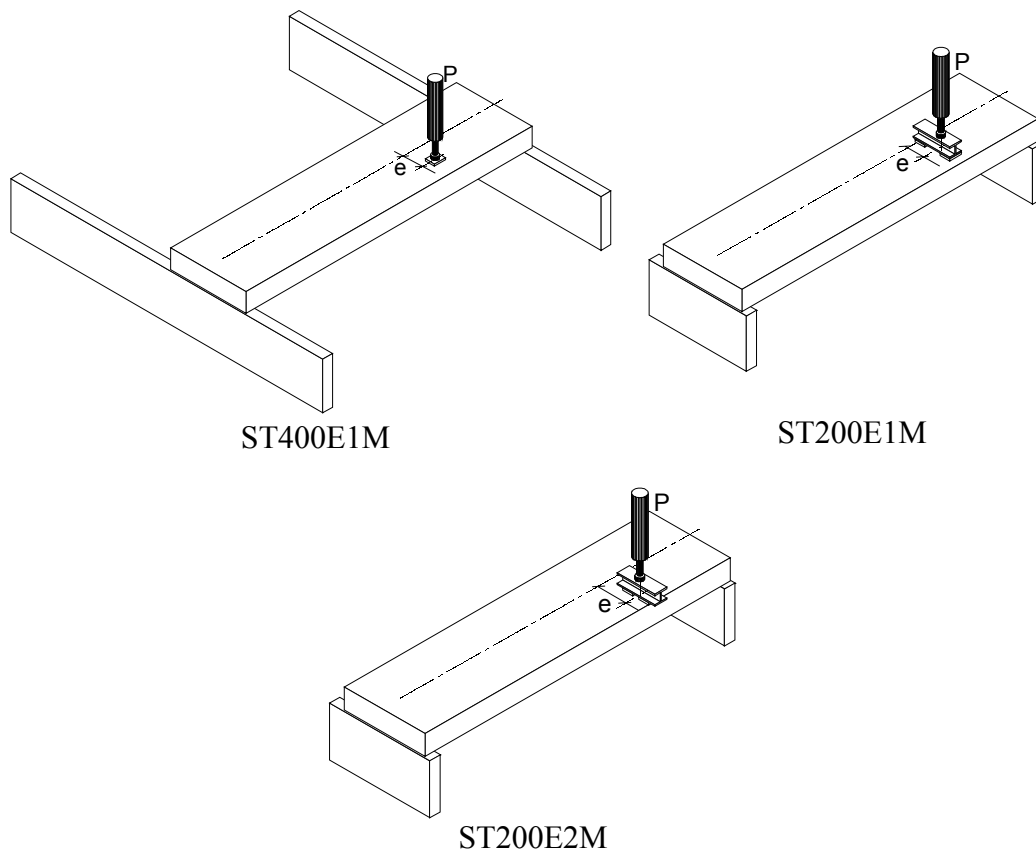
Fig. 14. Overview on arrangements.

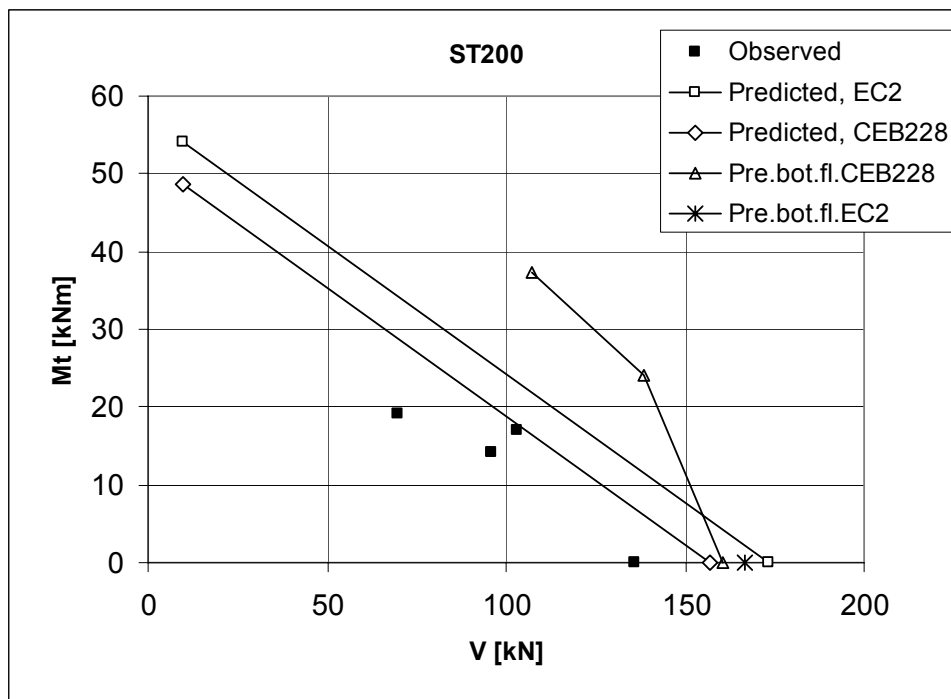
Fig. 82. Comparison of predicted and observed results for extruded 200 mm slabs on neoprene bearing.

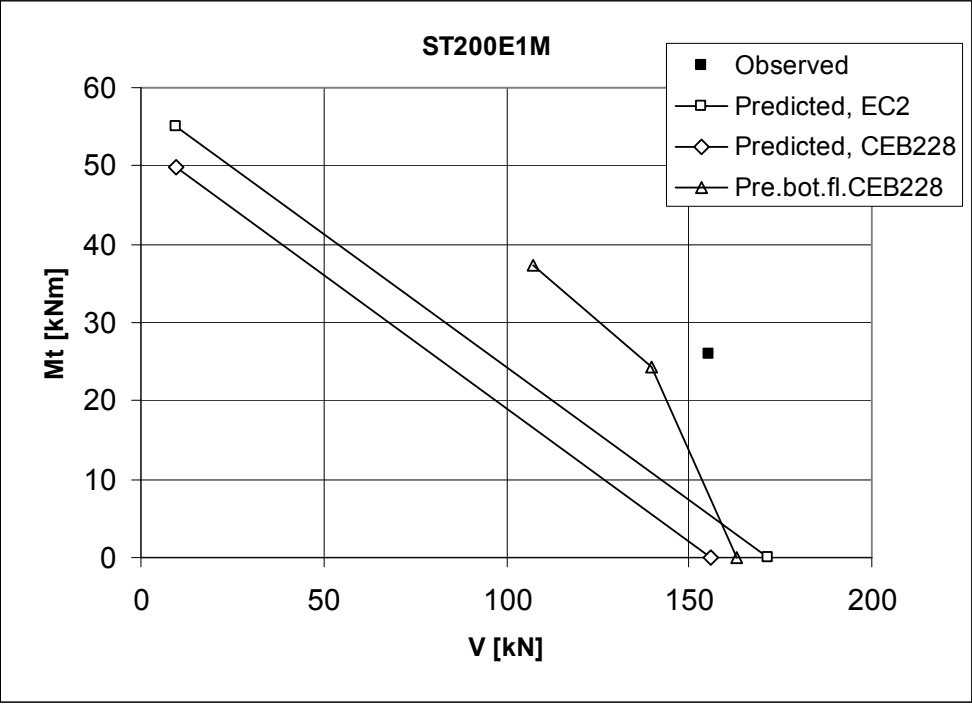
Fig. 83. Comparison of predicted and observed results for test ST200E1M.

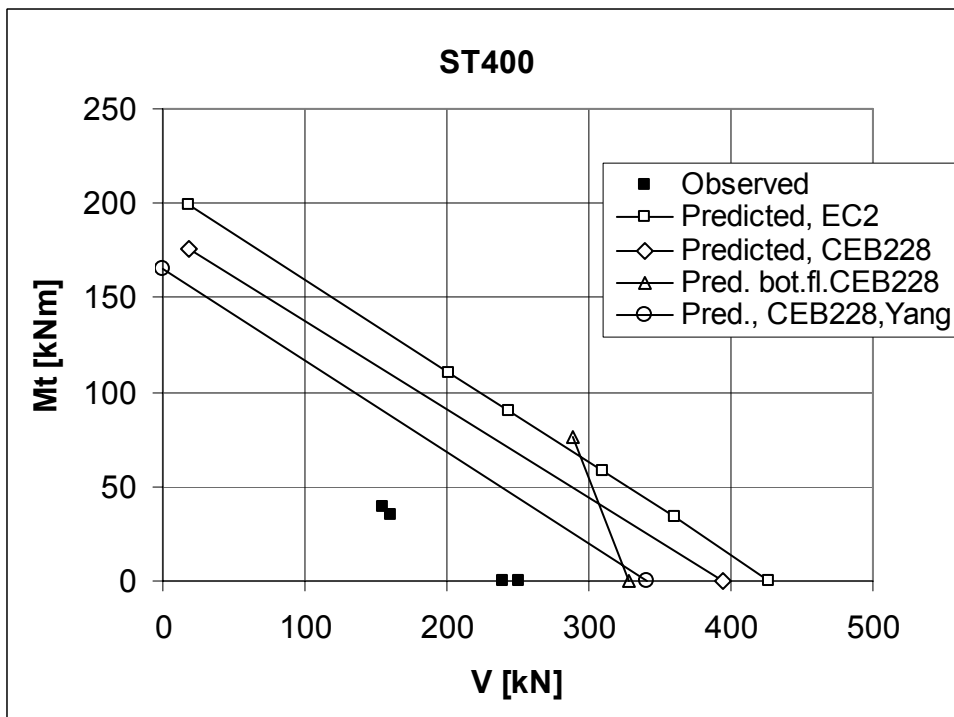
Fig. 86. Comparison of predicted and observed results for 400 mm slabs on neoprene bearing.

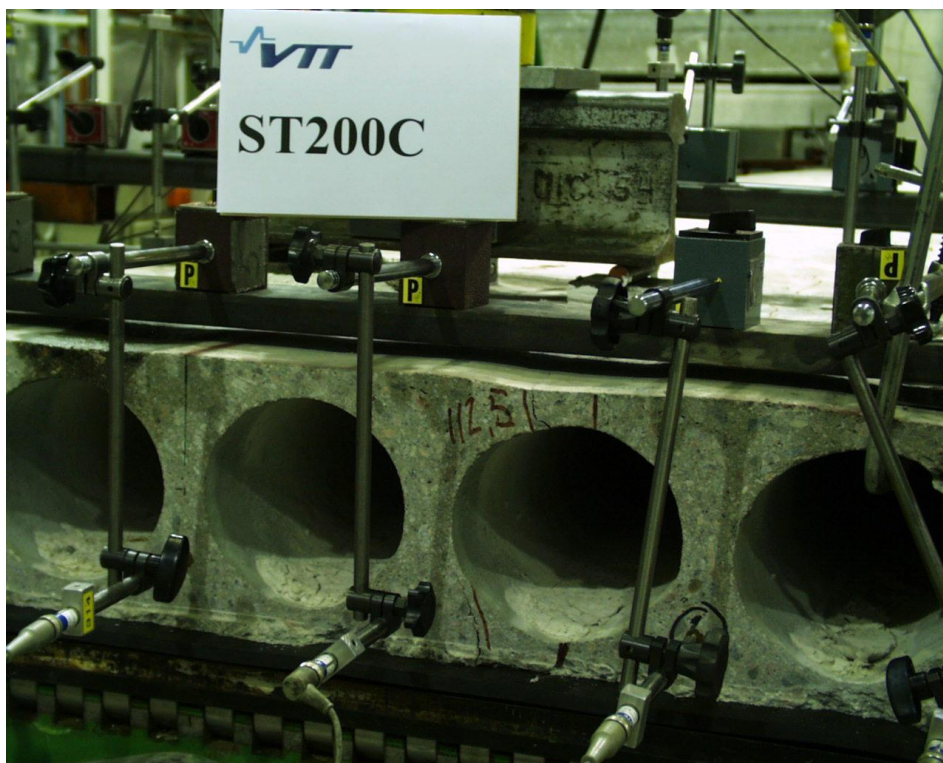
Fig. 6. ST200C. First cracks at load $P = 112.5$ kN.

135.6	0	At $P = 124$ kN: a vertical crack above and below 2nd void. These cracks increased in width and length. P came down to 112 kN. When reloading, the tips of the longitudinal cracks had passed the loads at 115 kN. At 135 kN new longitudinal cracks appeared close to the existing cracks above and below the same void. At the same time webs 3–6 failed in shear tension. Webs 1, 2 and 7 remained intact. See App. A, Figs 1–9.
ST200E1a

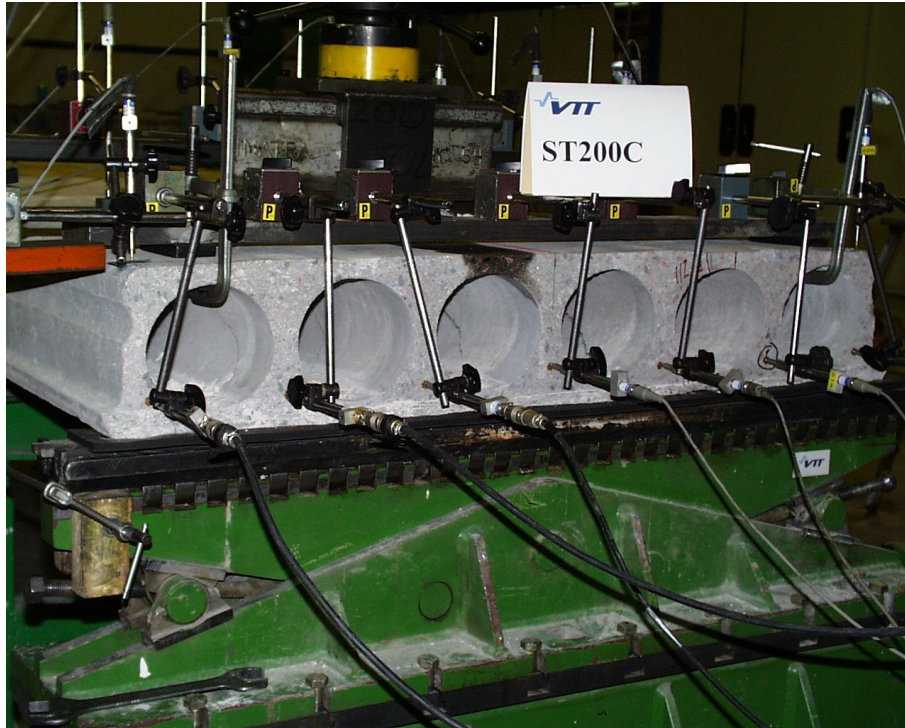
Fig. 7. ST200C. Cracks in webs after failure.

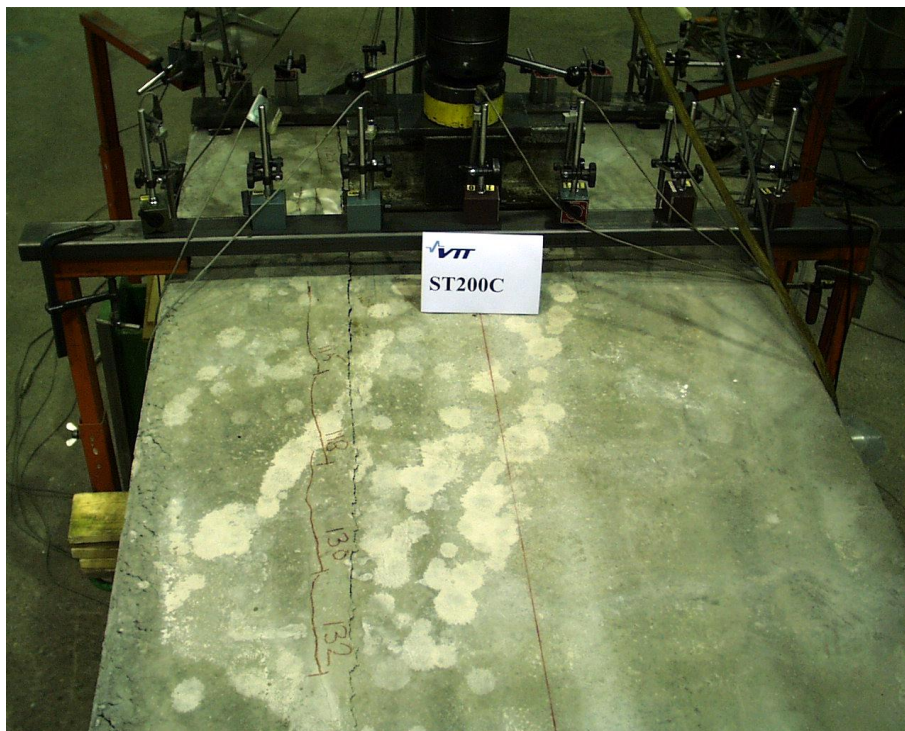
Fig. 8. ST200C. Top view. Longitudinal cracks after failure.

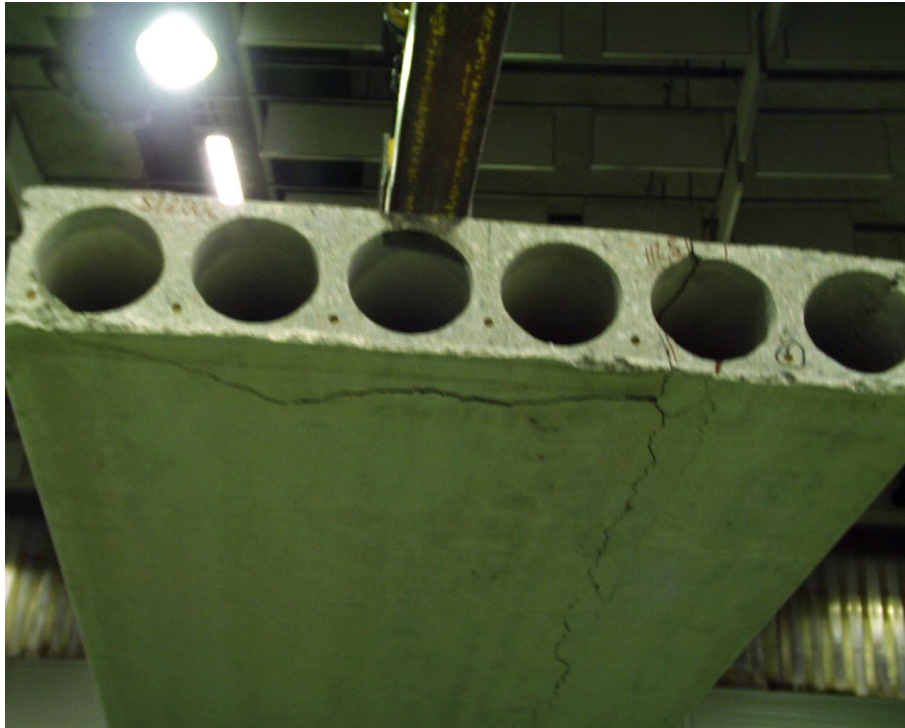
Fig. 9. ST200C. Cracking of soffit.

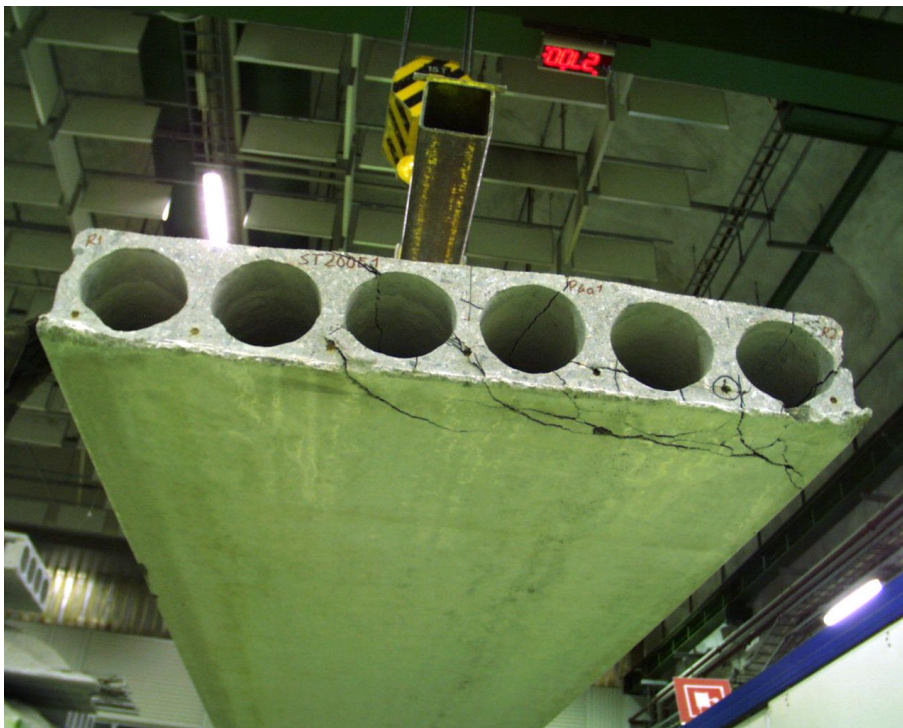
Fig. 14. ST200E1a. Soffit after failure.

100.4	187	At 100 kN: a crack in the bottom corner on the right, load to 95 kN, then load increased a bit, at 96 kN: a diagonal crack in 1st web and 2 nd –4 th web failed in shear tension. See App. A, Figs 10–14.
ST200E1b

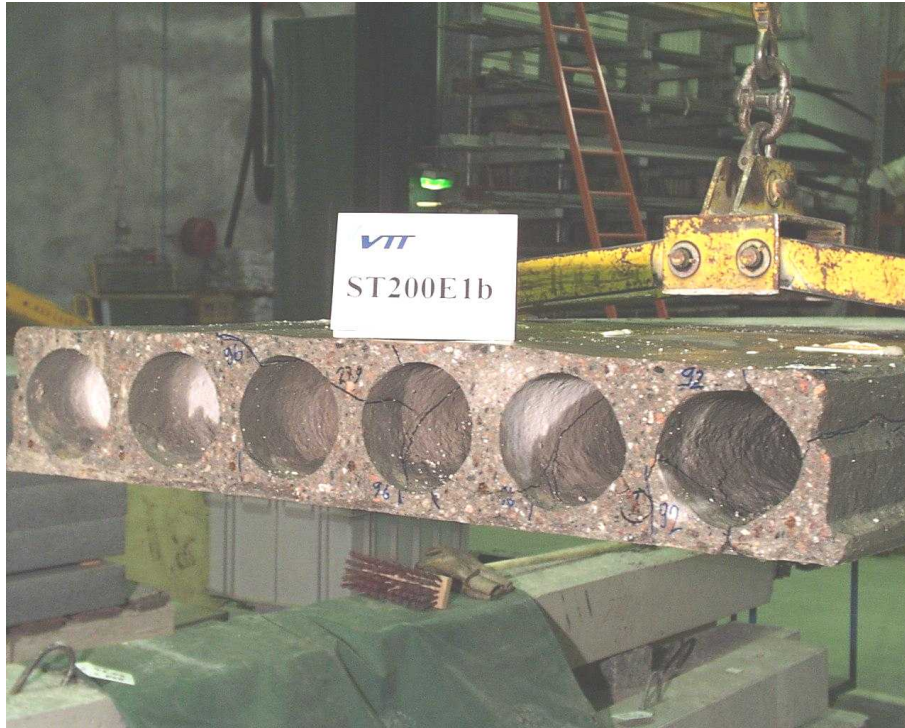
Fig. 15. ST200E1b. Cracking pattern in webs after failure.

98.4	187	At 90 kN: a longitudinal crack above the 1 st void, a diagonal crack in 1 st web, at 98 kN: a diagonal crack in the 2 nd , 3 rd and 4 th web (shear tension failure. See App. A, Figs 15–19.

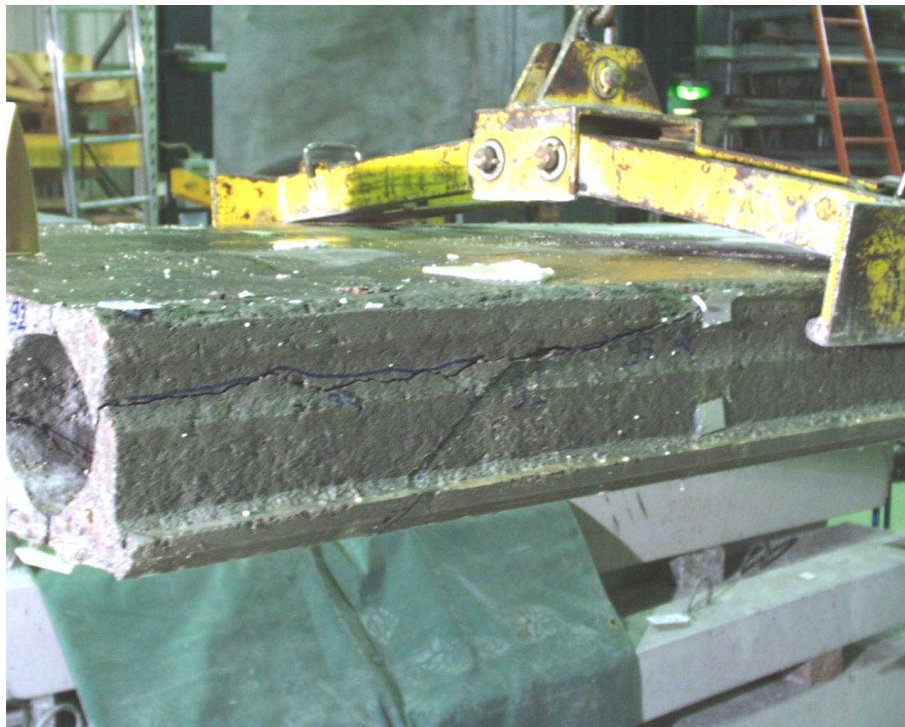
Fig. 16. ST200E1b. Northern edge after failure.

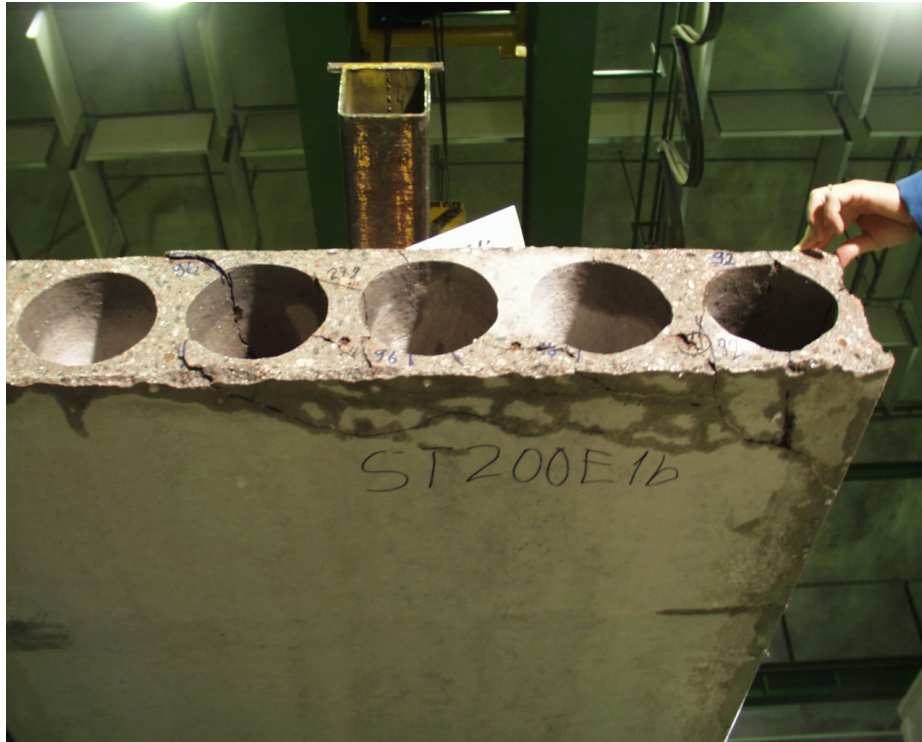
Fig. 17. ST200E1b. Cracking pattern in soffit.

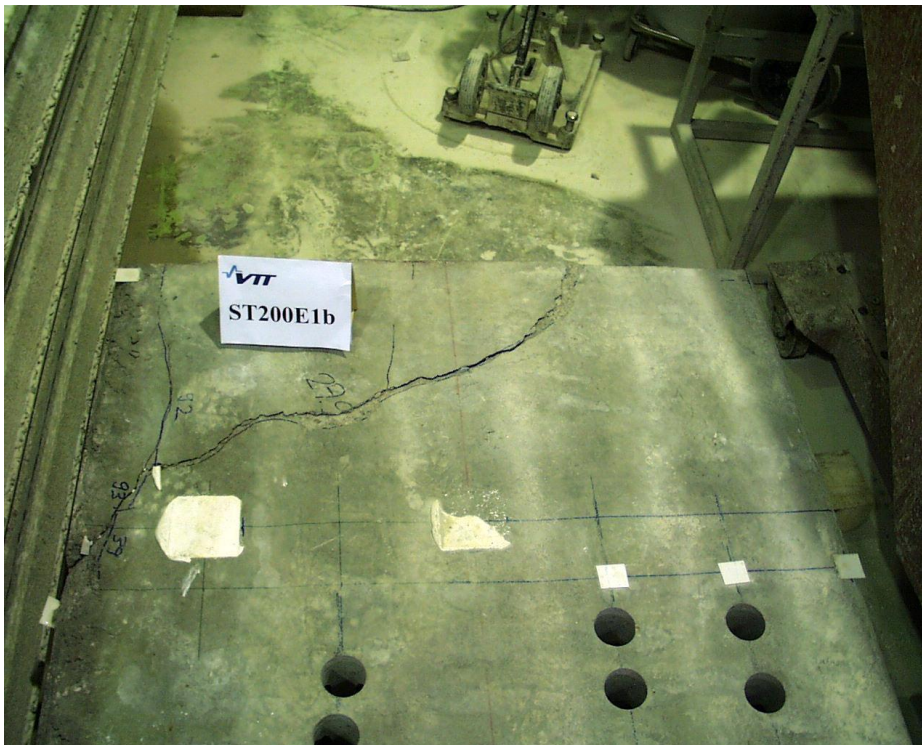
Fig. 18. ST200E1b. Cracking pattern in top flange.

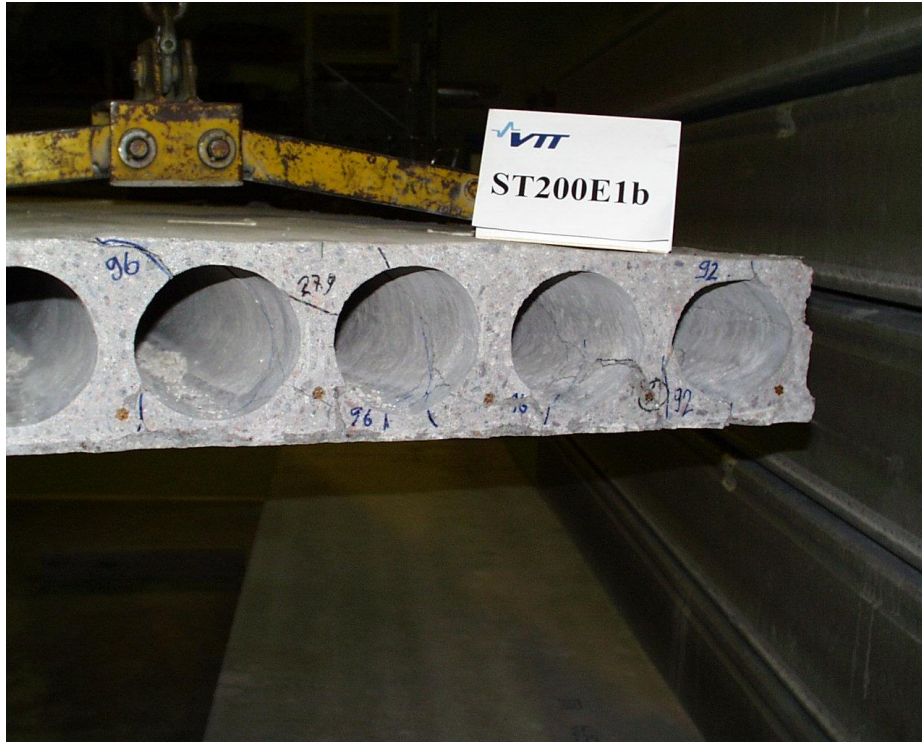
Fig. 19. ST200E1b. Cracking pattern in webs.

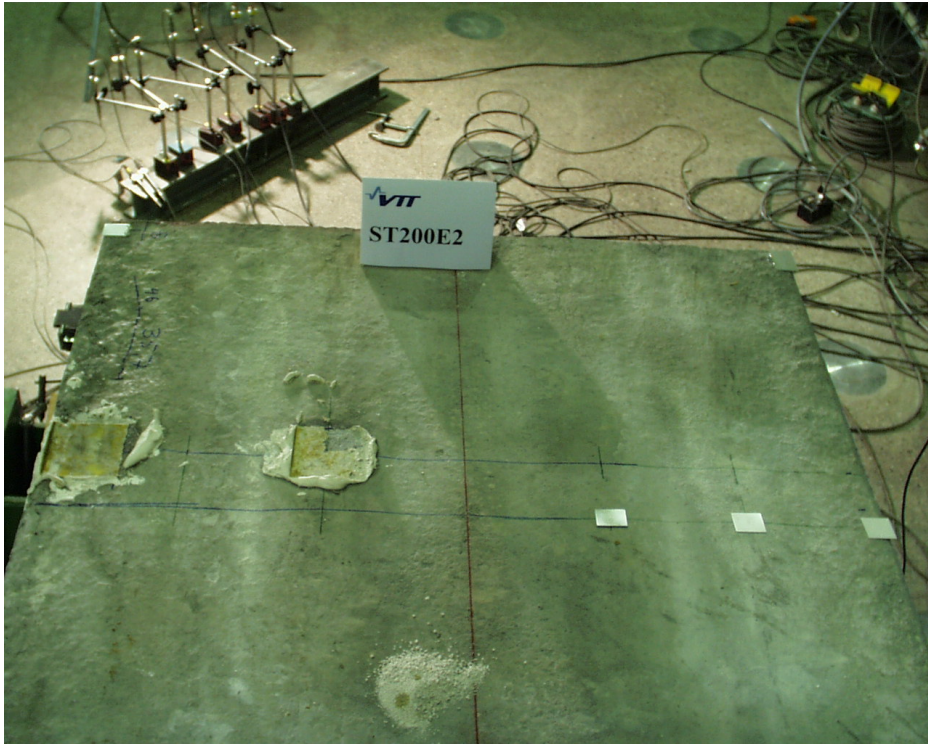
Fig. 23. ST200E2. Top view after failure.

64.4	384	At 45 kN: diagonal shear crack in 1 st web, longitudinal crack above 1 st void, the right corner was cut off, at 58 kN: a longitudinal crack in 1 st web, at 64 kN: 2 nd web failed in shear tension, the element started to rotate around the 3 rd web. See App. A, Figs 20–24.
ST200E1M

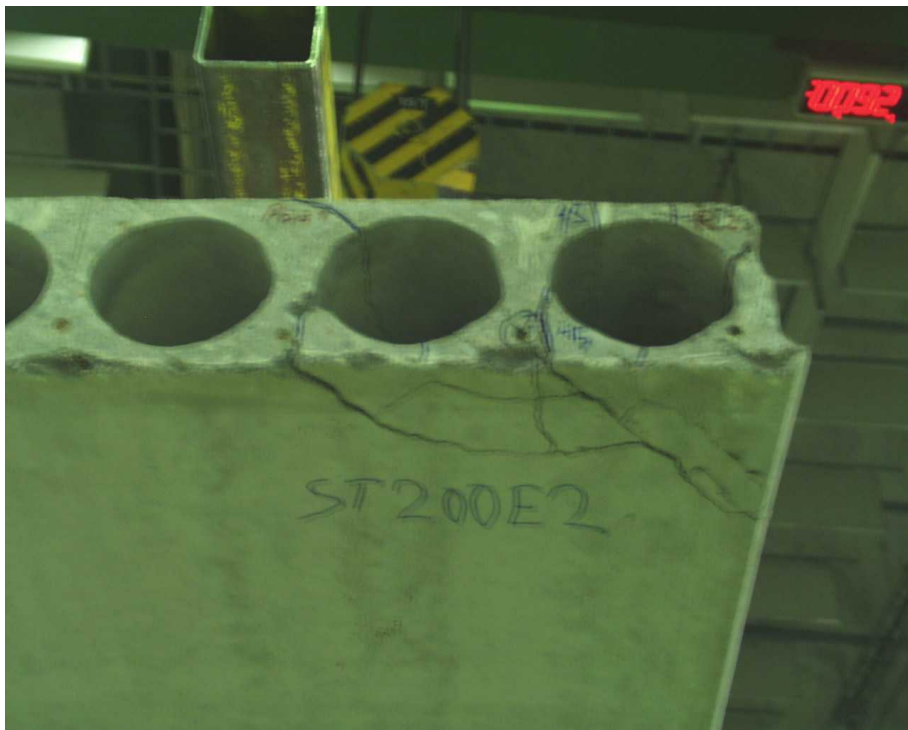
Fig. 24. ST200E2. Soffit after failure.

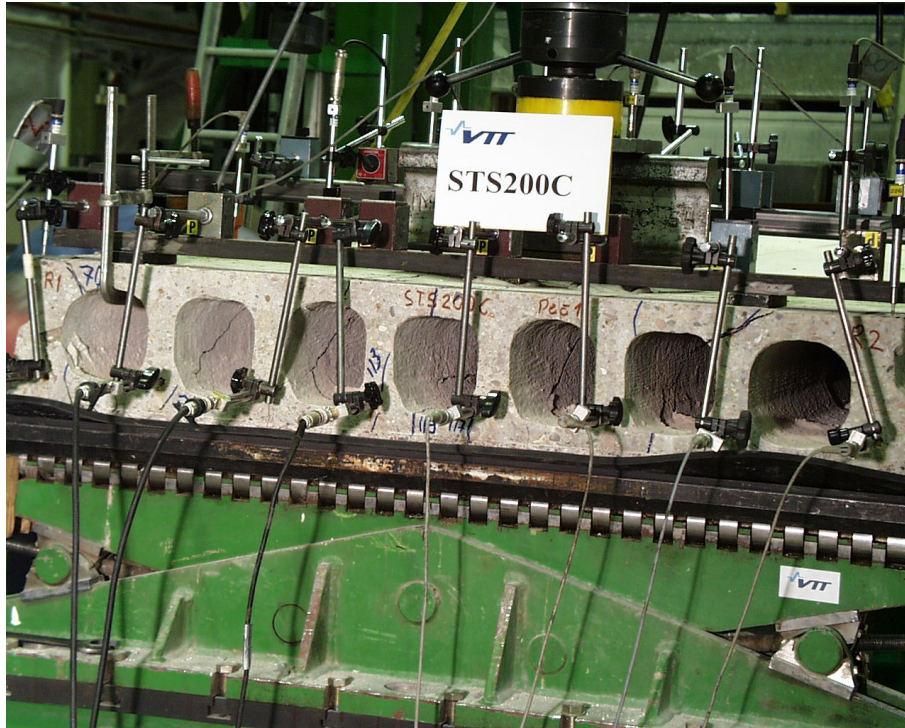
Fig. 27. STS200C. Cracking pattern in webs after failure.

125.4	0	At 125 kN: a transverse flexural crack below the load, load reduced and increased until at 117 kN: crack along strand below 7 th web and 3 rd –7 th web failed in shear tension. See App. A, Figs 25–30.

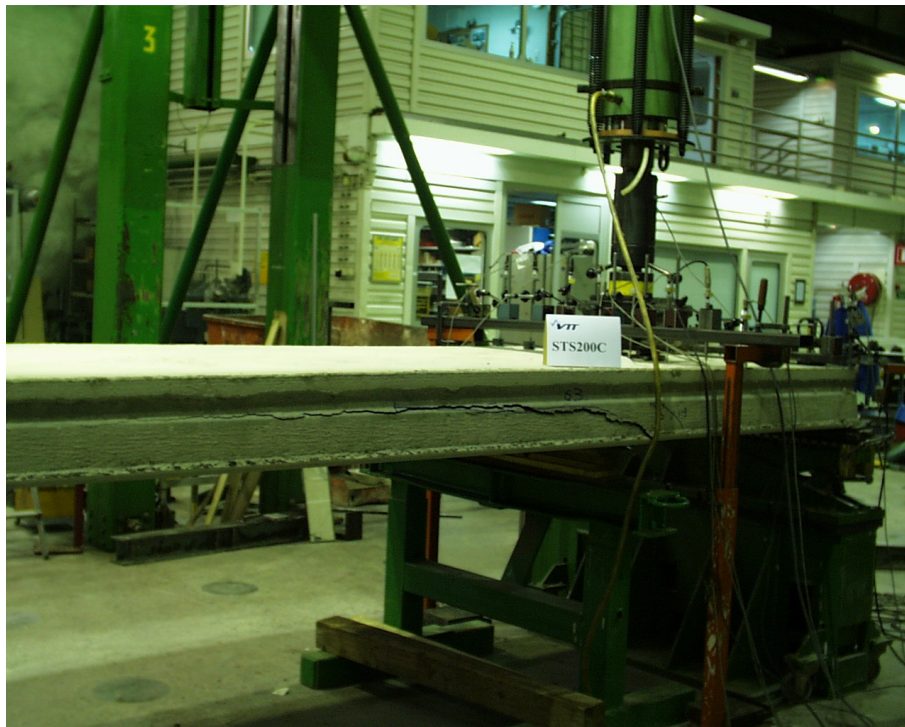
Fig. 28. STS200C. Cracking pattern after failure. Southern edge.

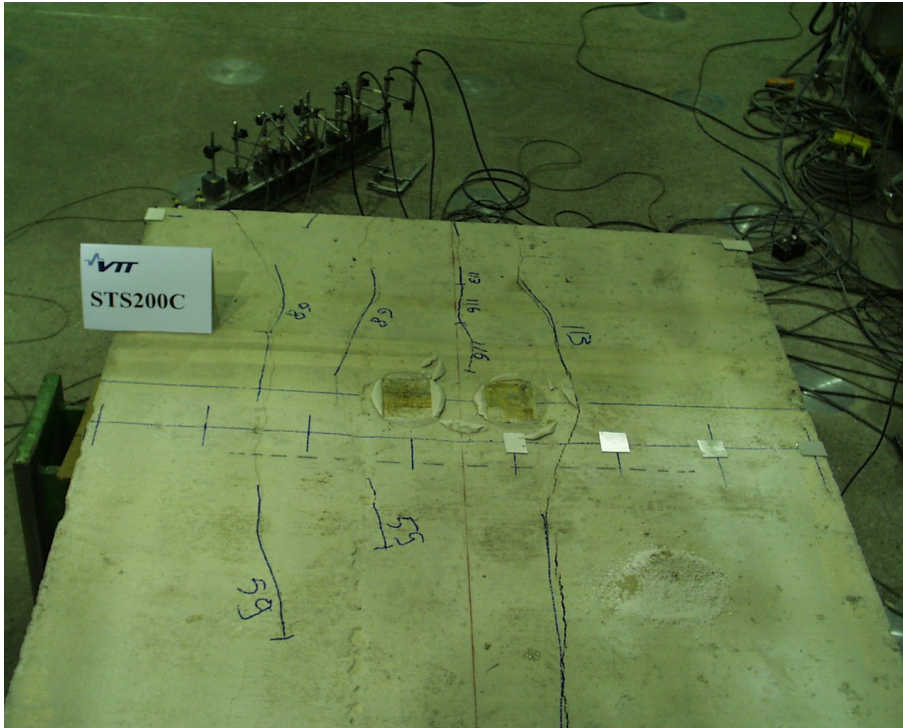
Fig. 29. STS200C. Cracking pattern after failure. Top view.

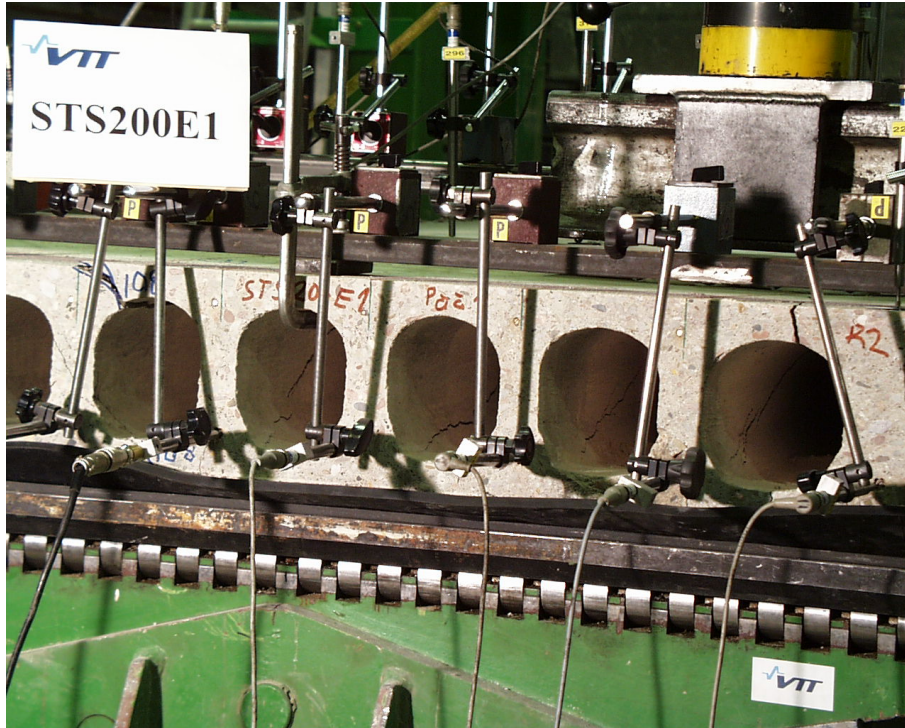
Fig. 31. STS200E1. Cracking pattern in webs after failure.

129.4	314	At 113 kN: a transverse flexural crack below the load, at 129 kN: shear cracks in 2nd and 3rd web, soffit cracked in transverse direction under these webs close to support, at 108 kN: shear crack in 1 st , 4 th and 5 th web, a longitudinal crack above 5 th void. See App. A, Figs 31–36.

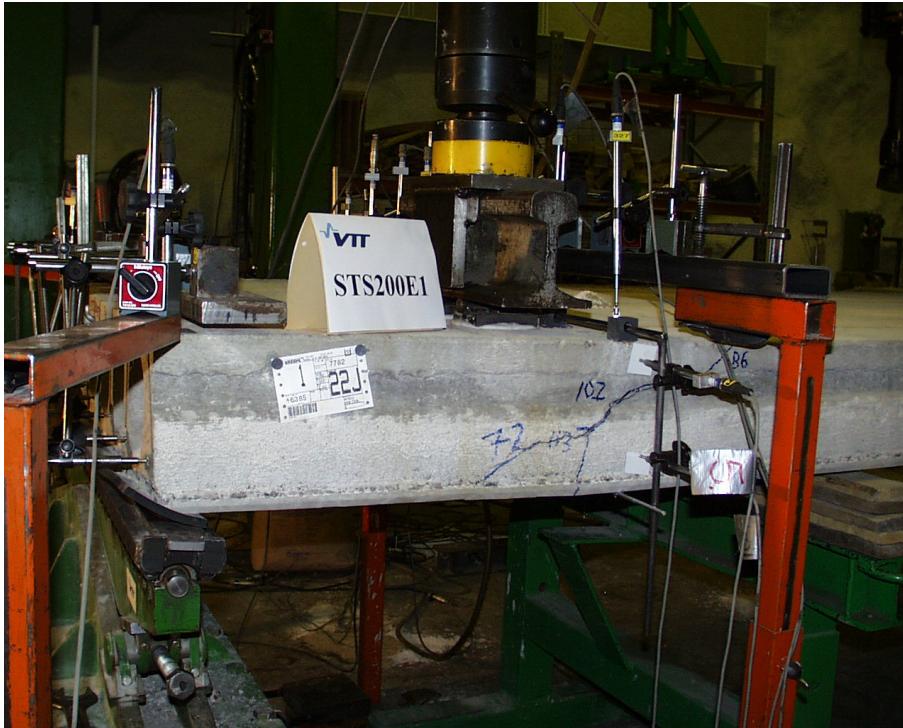
Fig. 33. STS200E1. Cracking after failure. Northern edge.

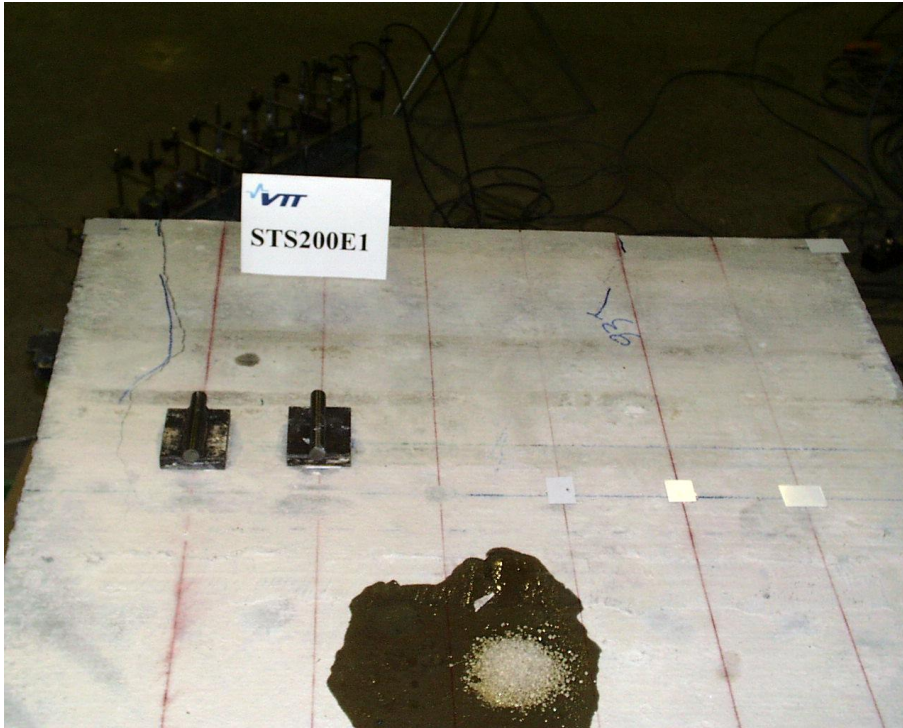
Fig. 35. STS200E1. Top surface after failure.

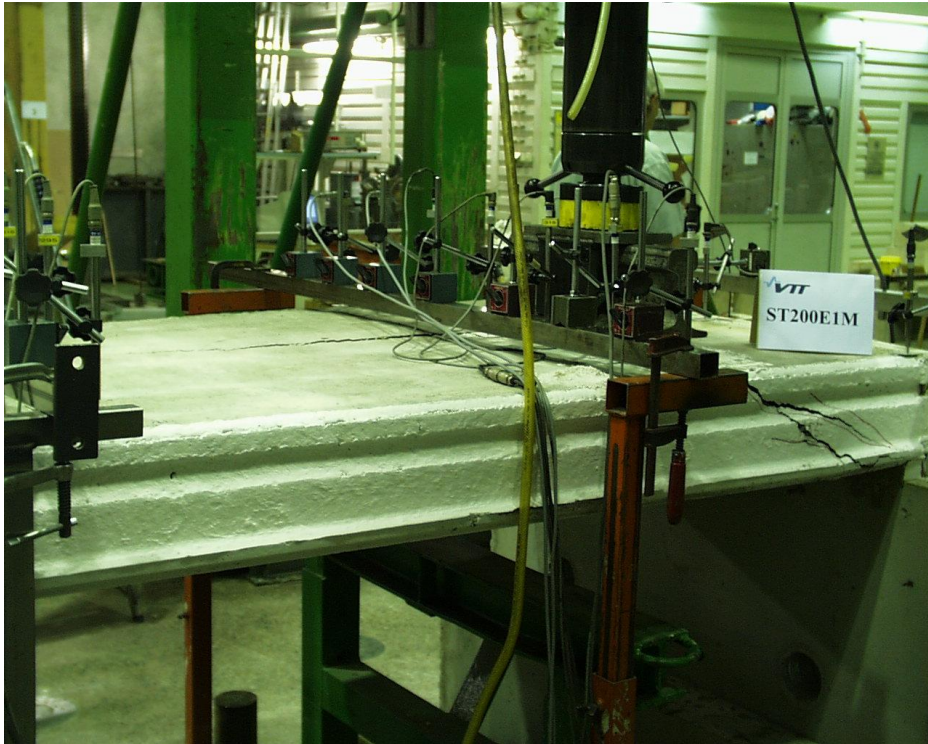
Fig. 41. ST200E1M. Cracking pattern after failure.

Cast ends	156.3	187	At $P = 155.9$: a diagonal shear crack in 1 st –4 th web and a longitudinal crack above and below 4 th void. See App. A, Figs. 37–47.
ST200E2M

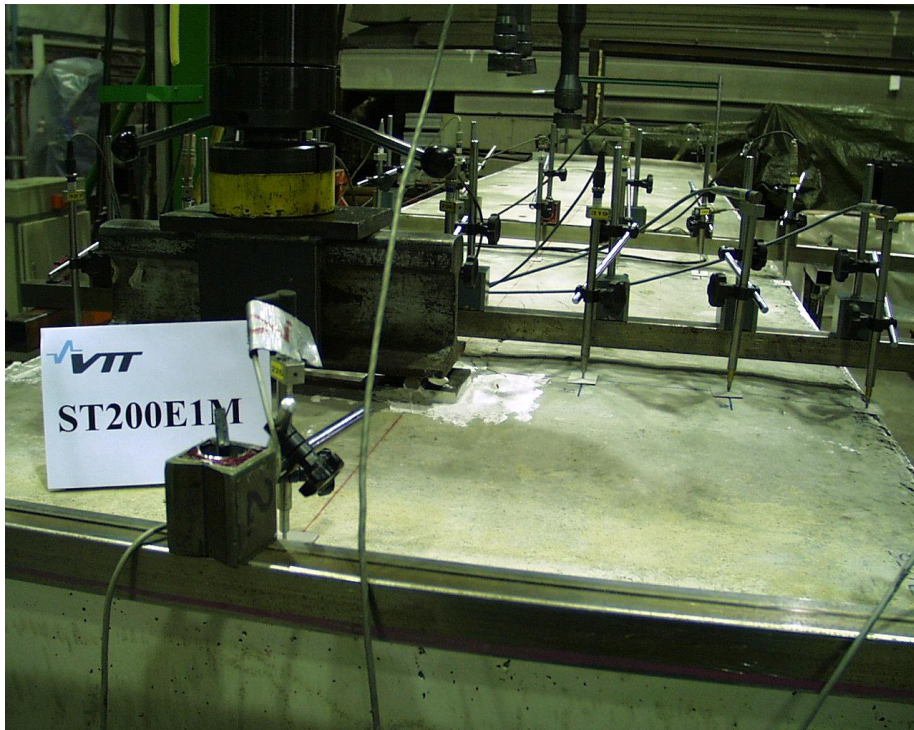
Fig. 42. ST200E1M. Longitudinal view after failure.

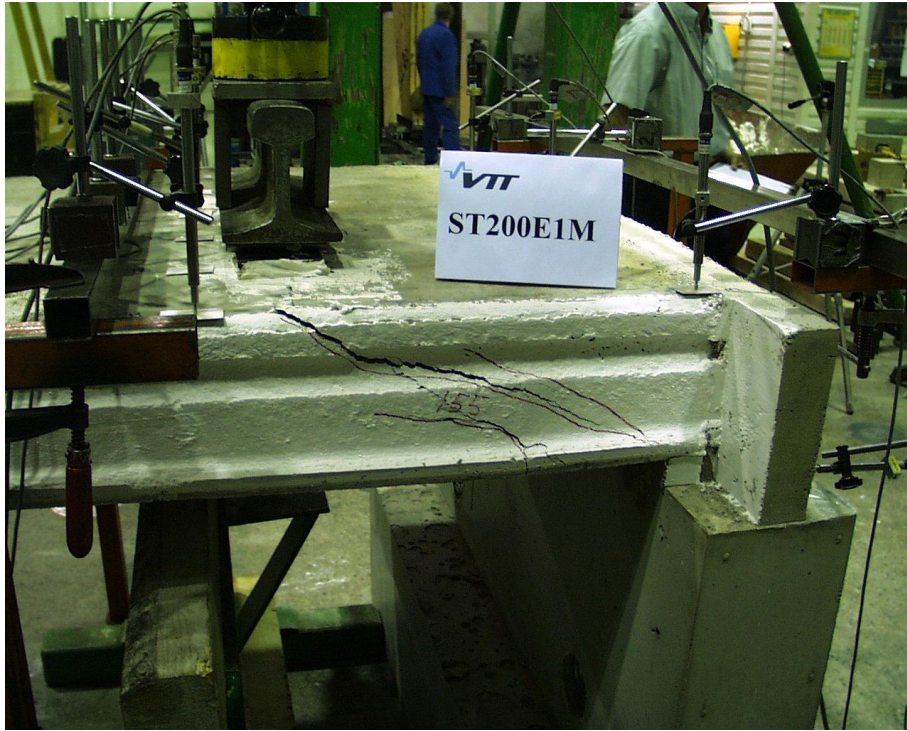
Fig. 43. ST200E1M. Cracking pattern between load and support.

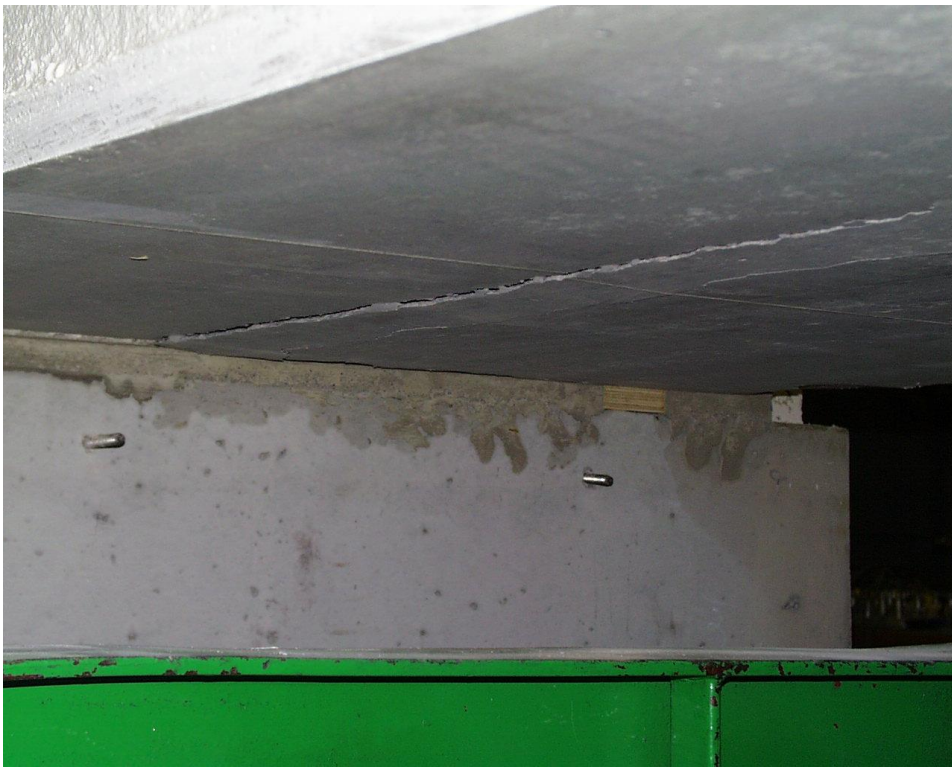
Fig. 46. ST200E1M. Soffit after failure.

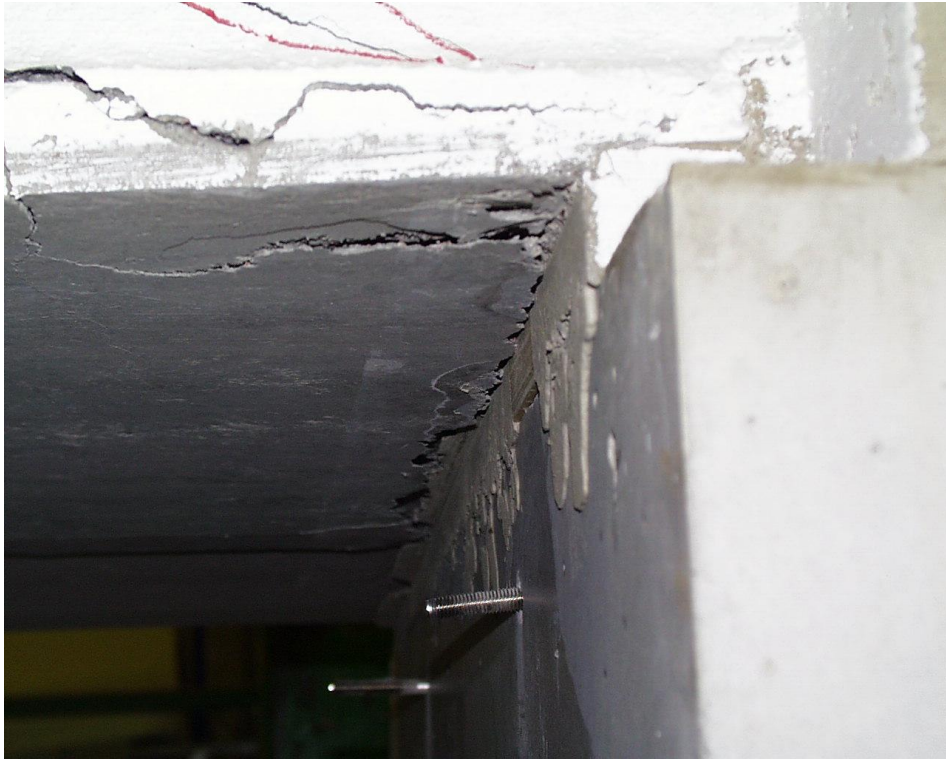
Fig. 47. ST200E1M. Transverse cracking of soffit next to support.

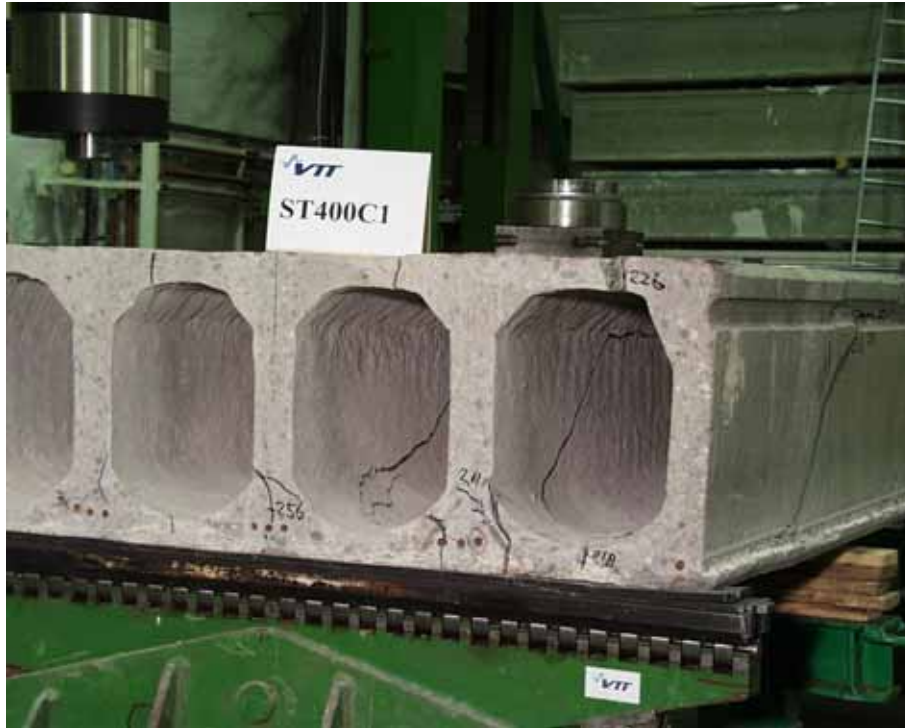
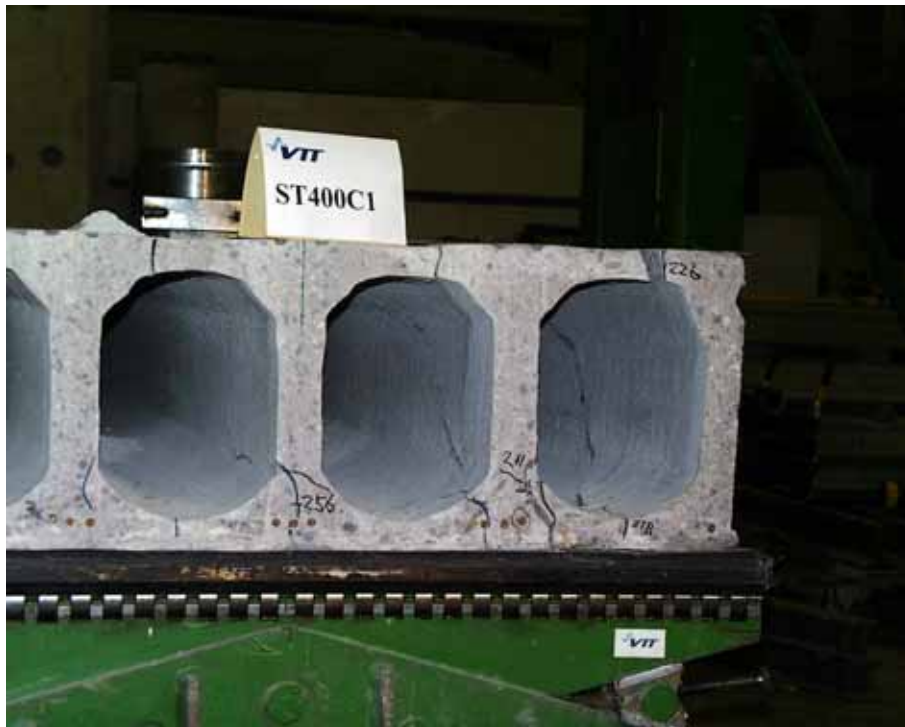
Fig. 3. ST400C1. Cracks in webs after failure.

258.3	0	At $P = 218$ kN: a longitudinal crack below 1 st void and inclined shear crack in 1 st web, at 226 kN: a longitudinal crack above 1 st void, at 247 kN: a longitudinal crack along strand below 3 rd web, at 258 kN longitudinal crack above and below 3 rd void, inclined shear crack in 2 nd and 3 rd web. See App. B, Figs 1–6.
ST400C2

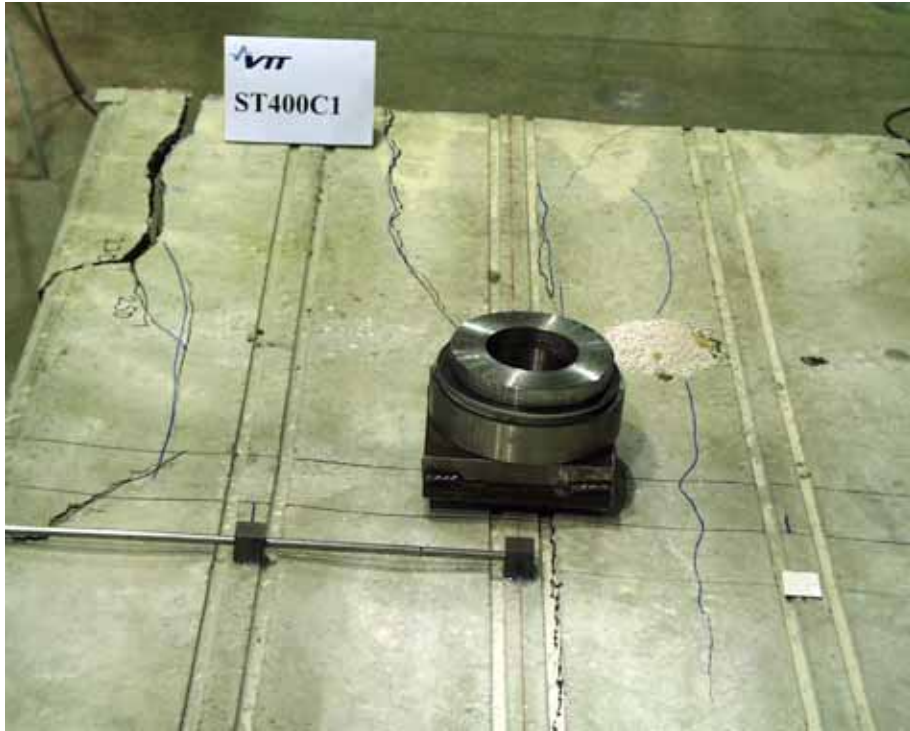
Fig. 5. ST400C1. Top surface after failure. Note the letter A on the upper left corner of the figure. Before loading there was an initial crack from the slab end to letter A.

Before loading, a longitudinal crack in the concrete was observed above one of the outermost hollow cores at each end of each 400 mm slab unit. The reasons for such a cracking are discussed in report [5], Chapter 6. These initial cracks were typically 300–500 mm in length and 0,2 mm in thickness. They can be seen in App. B, Figs 5, 14, 20, and 43. In all tests on 400 mm slabs with eccentric load the load was placed on the opposite side of the initial crack. In these tests the initial crack remained unchanged and obviously had no effect on the failure load. For centric loads such an arrangement was not possible. Consequently, in tests ST400C1 and ST400C2 the initial crack grew in
