Shear-torsion interaction tests on single hollow core slabs

VTT Building and Transport

Pajari, Matti. Shear-torsion interaction tests on single hollow core slabs. Espoo 2004. VTT Tiedotteita – Research Notes 2275. 76 p. + app. 122 p.

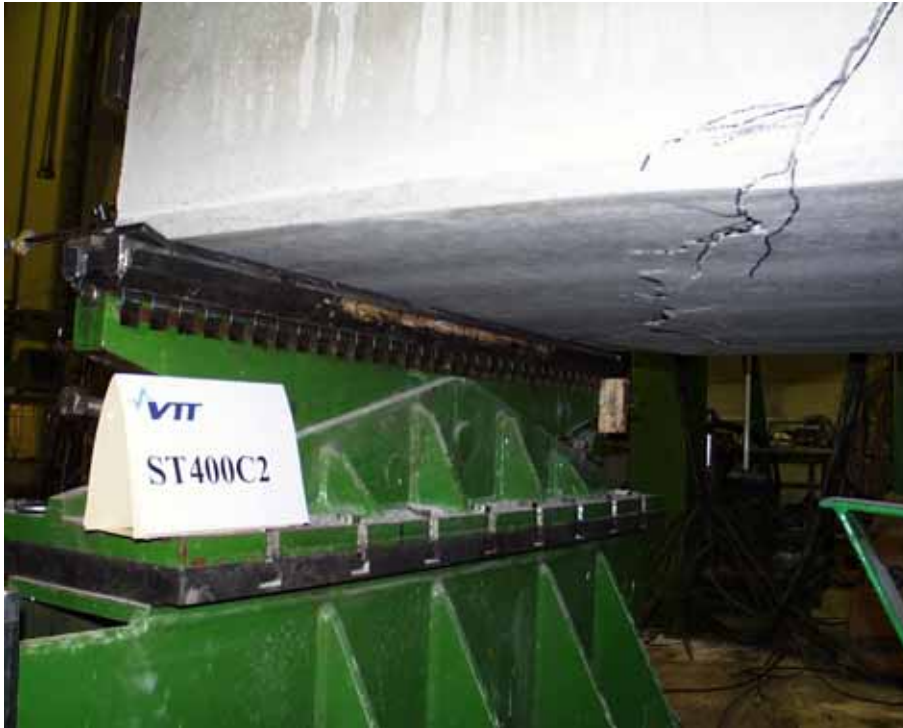
Fig. 9. ST400C2. Soffit after failure seen from the North.

272.8	0	At 195 kN: a longitudinal crack below 3 rd void and 4 th web, inclined shear crack in 5 th web, at 250 kN: a longitudinal crack above 4th void, at 272 kN: inclined shear cracks in 1 st –4 th web. See App. B, Figs 7–14.
ST400E1

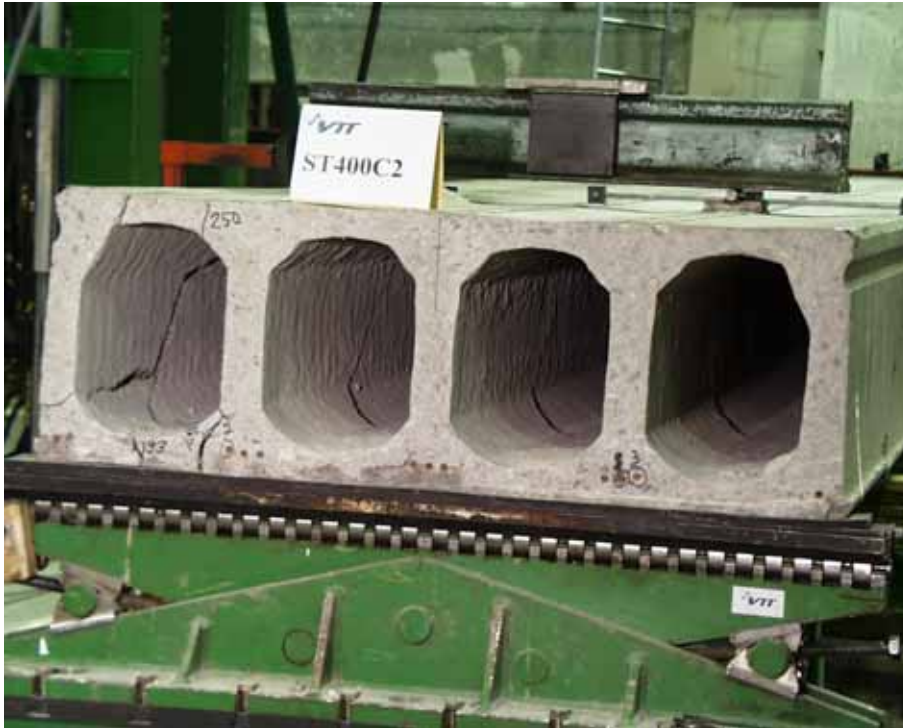
Fig. 11. ST400C2. Cracks in webs after failure.

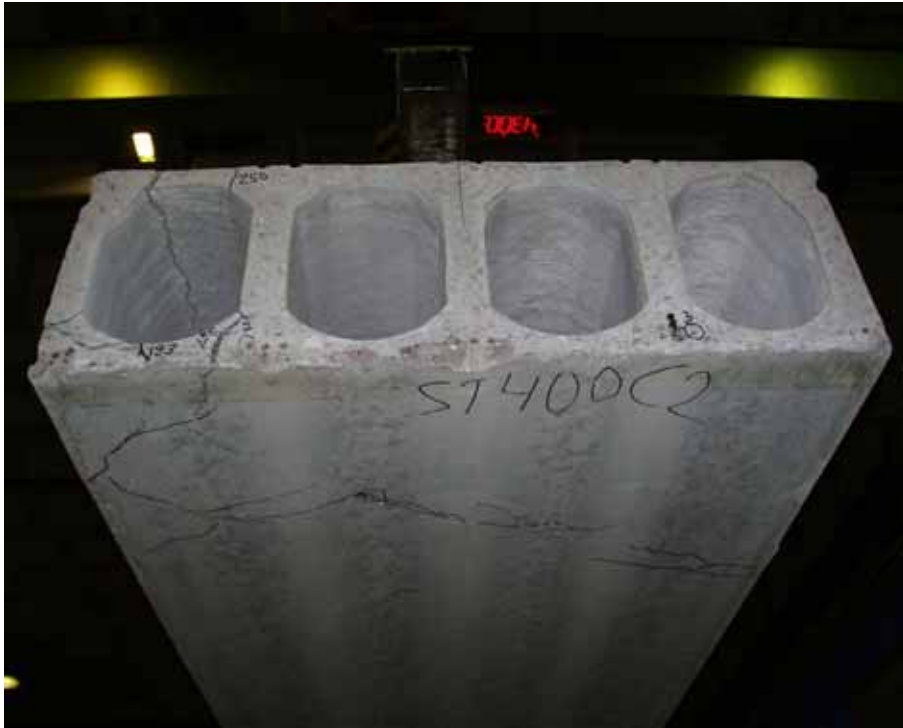
Fig. 13. ST400C2. Soffit after failure. See also Fig. 45.

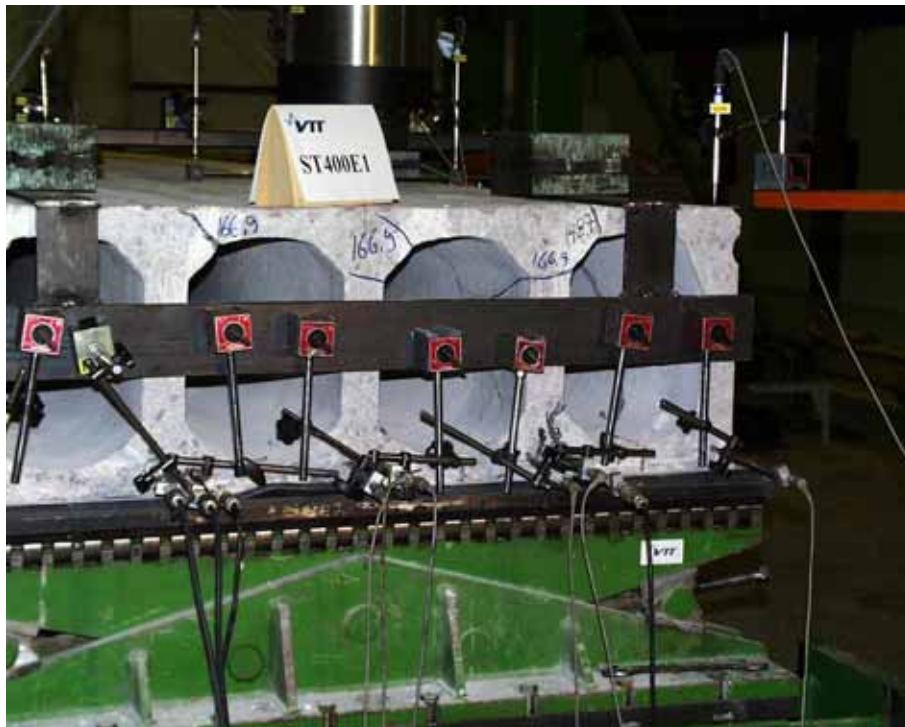
Fig. 16. ST400E1. Cracks at the end after failure.

Grouted ends	166.3	283	At 148 kN: longitudinal cracks above and below 1 st void and along a strand below 2 nd web, an inclined shear crack in 1 st web, at 166 kN: inclined shear cracks in 2 nd and 3 rd web, longitudinal cracks above 2 nd and 3 rd void, soffit cracked transversely below 1 st –3 rd web. See App. B, Figs 15–21.

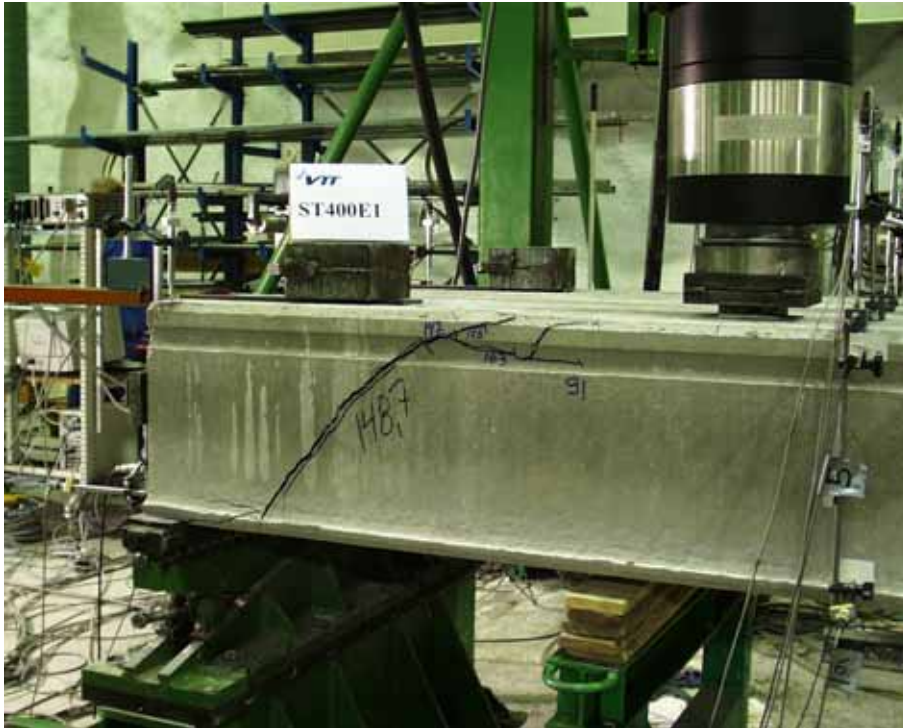
Fig. 17. ST400E1. Northern edge after failure.

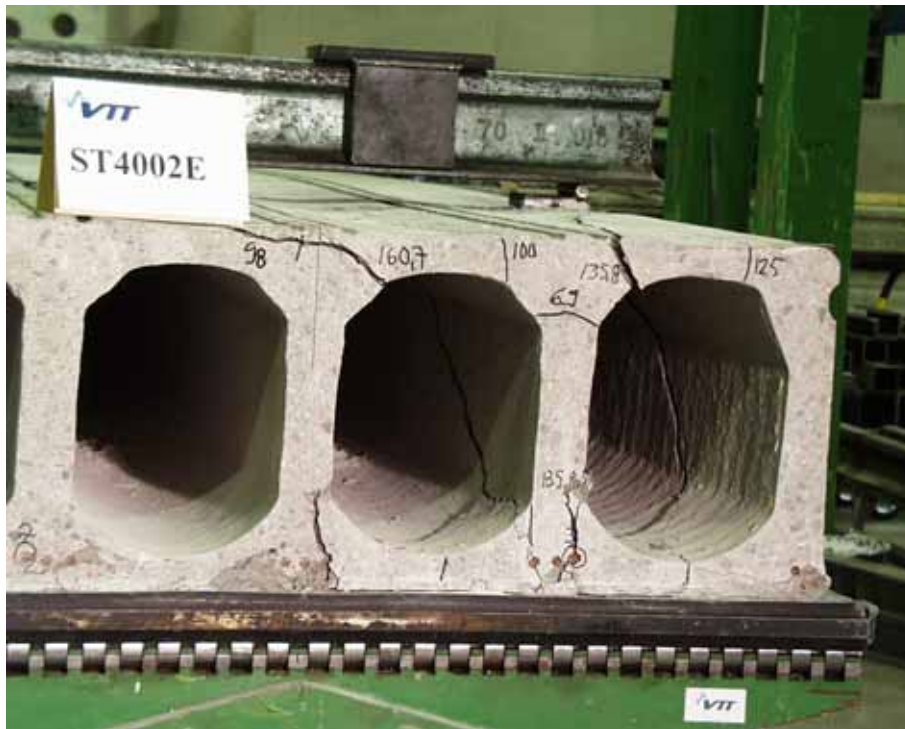
Fig. 23. ST4002E. Cracks in webs after failure.

161.0	283	At 136 kN: a longitudinal crack above and below 1 st void, inclined shear crack in 1 st web, at 128 kN: an additional longitudinal crack above 1 st void, at 160 kN: inclined shear crack in 2 nd web and longitudinal crack above 2 nd void, later strong reduction in load and rotation of the slab end around 3 rd web. See App. B, Figs 22–27.
ST400E1M

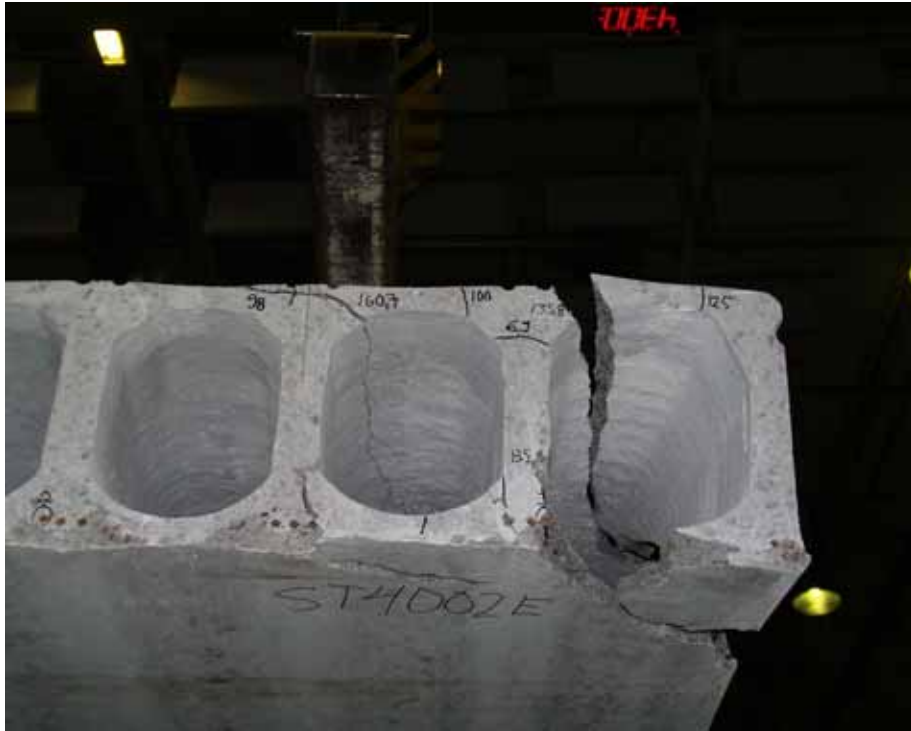
Fig. 27. ST4002E. Soffit after failure.

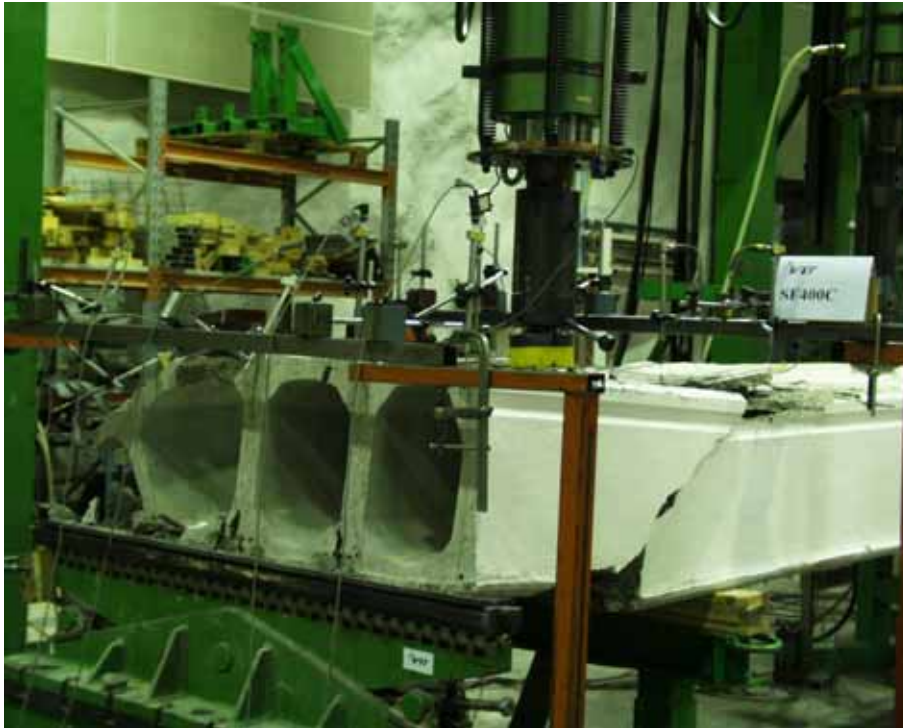
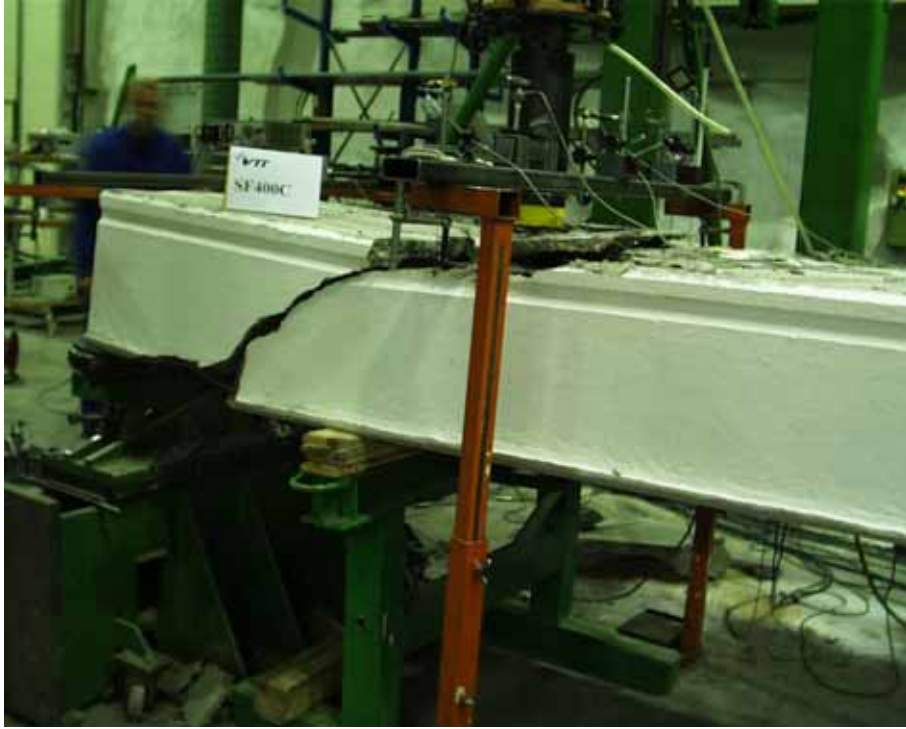
Fig. 29. SF400C. Failure mode.

In this test, the aim was to investigate flexural shear failure. However, the actual failure mode was shear tension failure. Therefore, the planned test with similar but eccentrically located loading was cancelled. Fig. 36 illustrates the test layout. More data

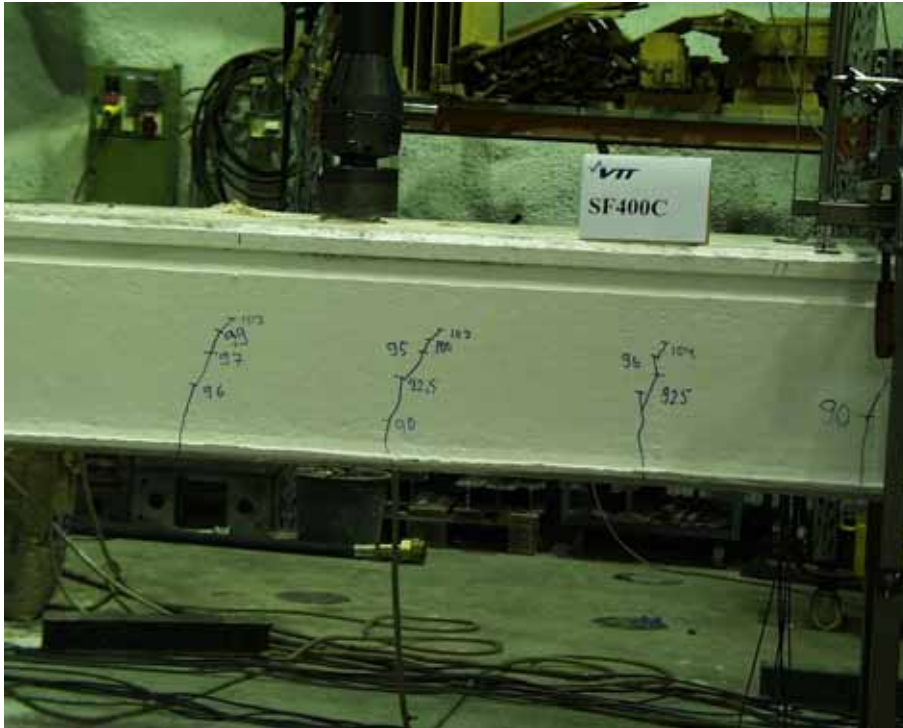
Fig. 33. SF400C. Flexural cracks in mid-span, detail of Fig. 68.

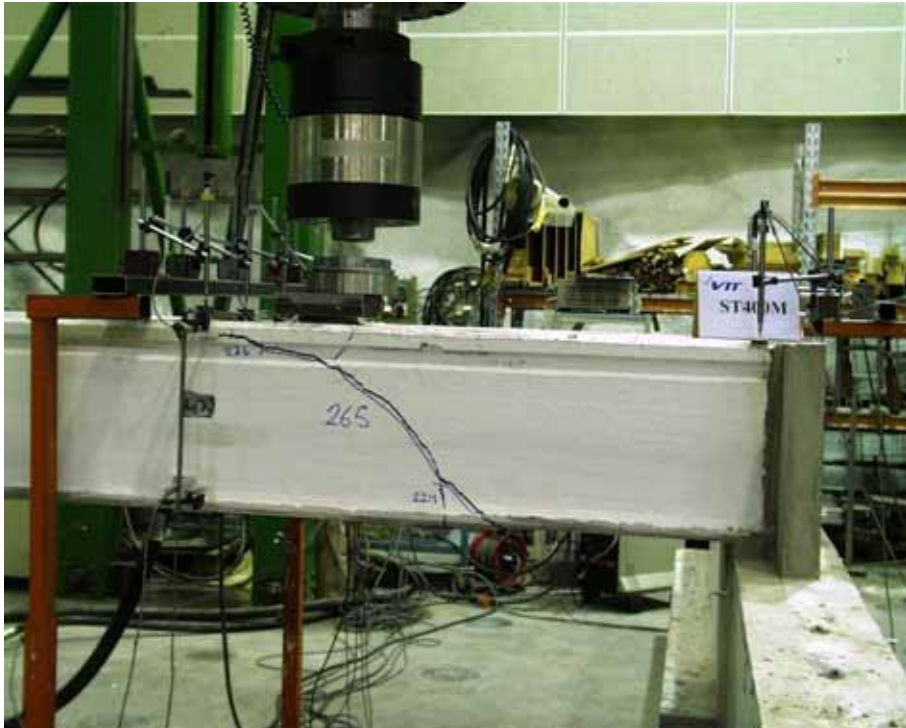
Fig. 39. ST400E1M. Shear crack after unloading.

Grouted ends	264.8	283	At 265 kN: a sudden shear failure in the webs and a longitudinal crack in the soffit below the load, a drop to 218 kN, an increase to 228 kN, followed by almost monotonous decrease of load and additional cracking. See App. B, Figs 36–43.

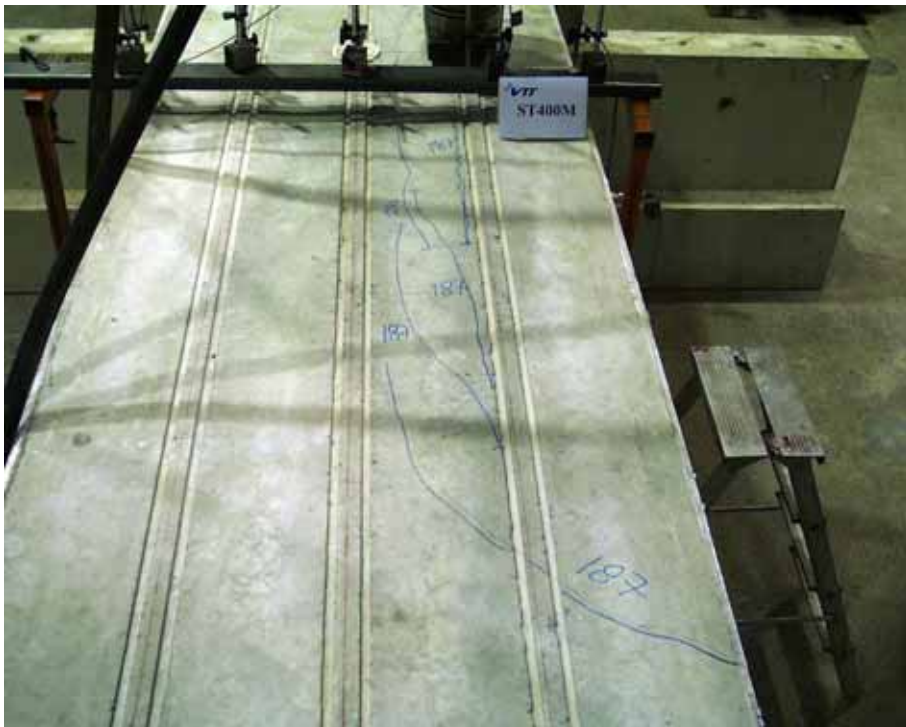
Fig. 40. ST400E1M. Cracks on the top after unloading.

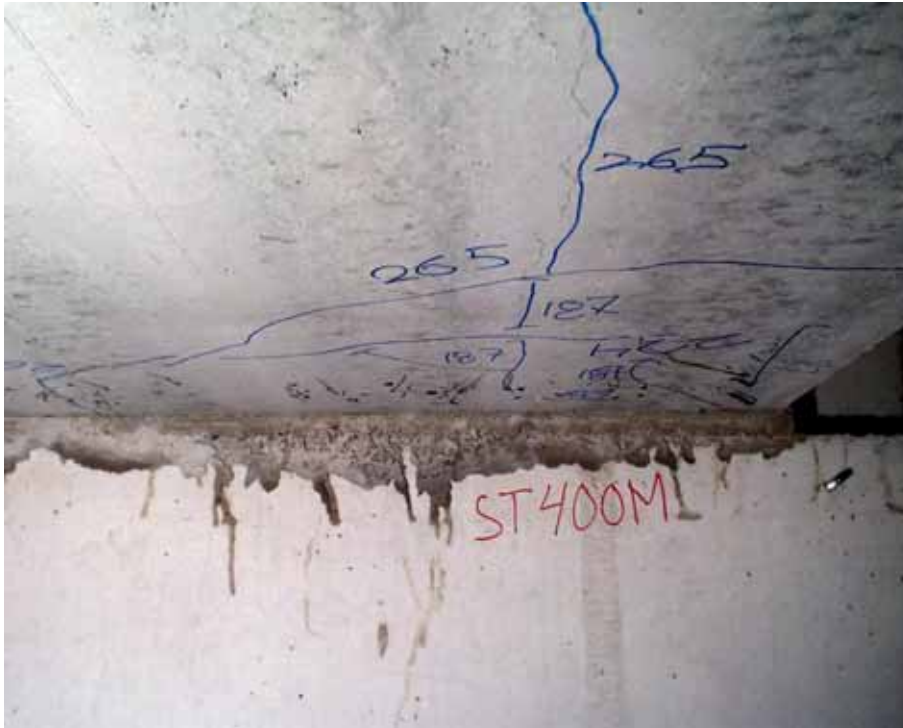
Fig. 41. ST400E1M. Cracking of soffit after unloading.

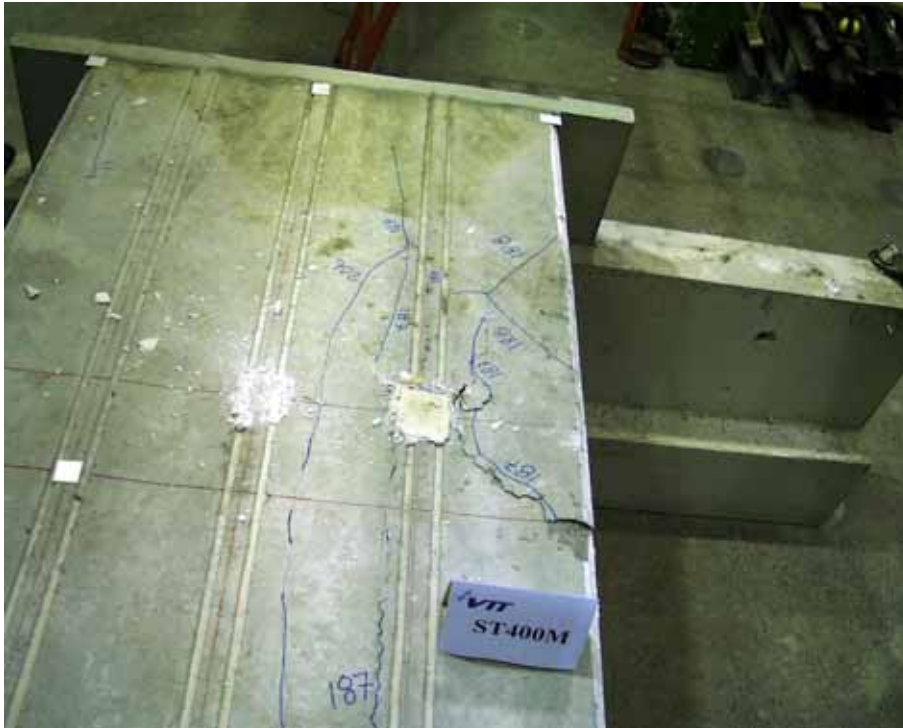
Fig. 43. ST400E1M. Cracking of the top surface after unloading. Note the letter A on the upper left corner of the figure. Before loading there was an initial crack from the slab end to letter A.

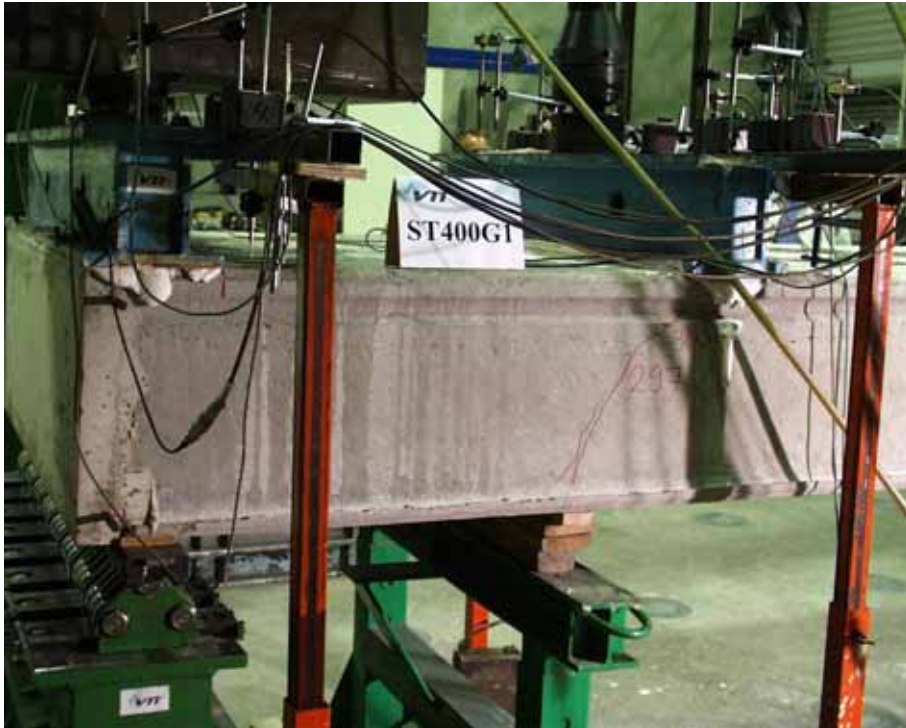
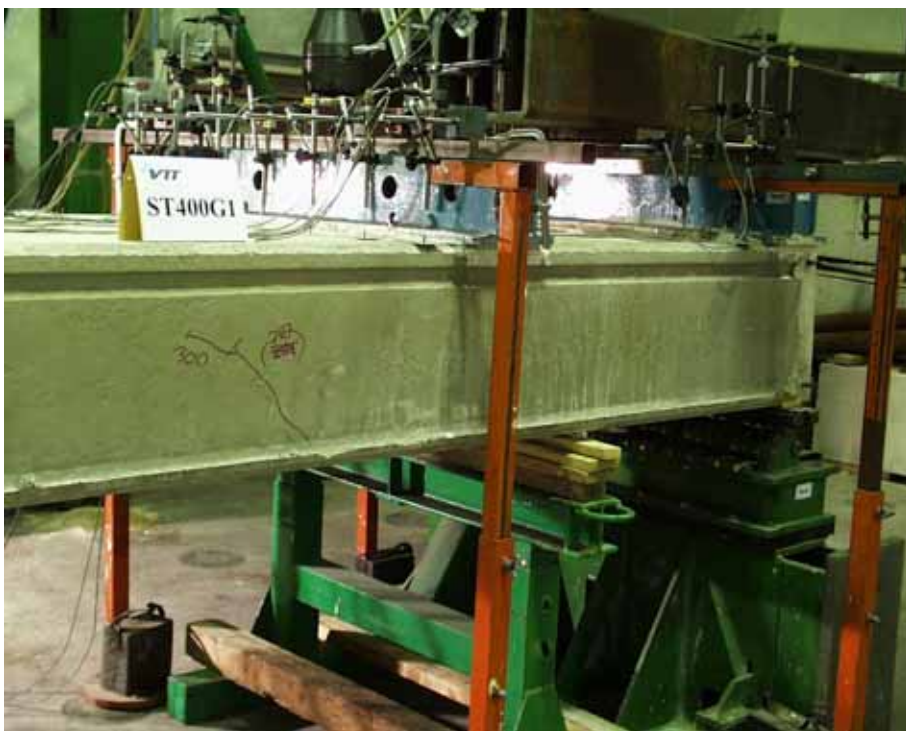
Fig. 49. ST400G1, South edge, first cracks.

Fig. 50. ST400G1, North edge, first cracks.

F_{max} kN	V_{max} kN	T_{max} mm	Description
ST400G1	336.0	305.4	67.20	At $P_l = 297$ kN: an inclined flexural-torsional crack below the load, followed by reduction of load until 273 kN. At $P_l = 334,8$ kN a sudden shear-torsion failure in the webs. See App. B, Figs 49–55.
ST400G2	360.3	326.3	72.06	At $P_l = 313$ kN: an inclined flexural-torsional crack below the load, followed by reduction of load until 284 kN. At $P_l = 357,2$ kN a shear-torsion-anchorage failure close to the central load P_l . See App. B, Figs 56–63.

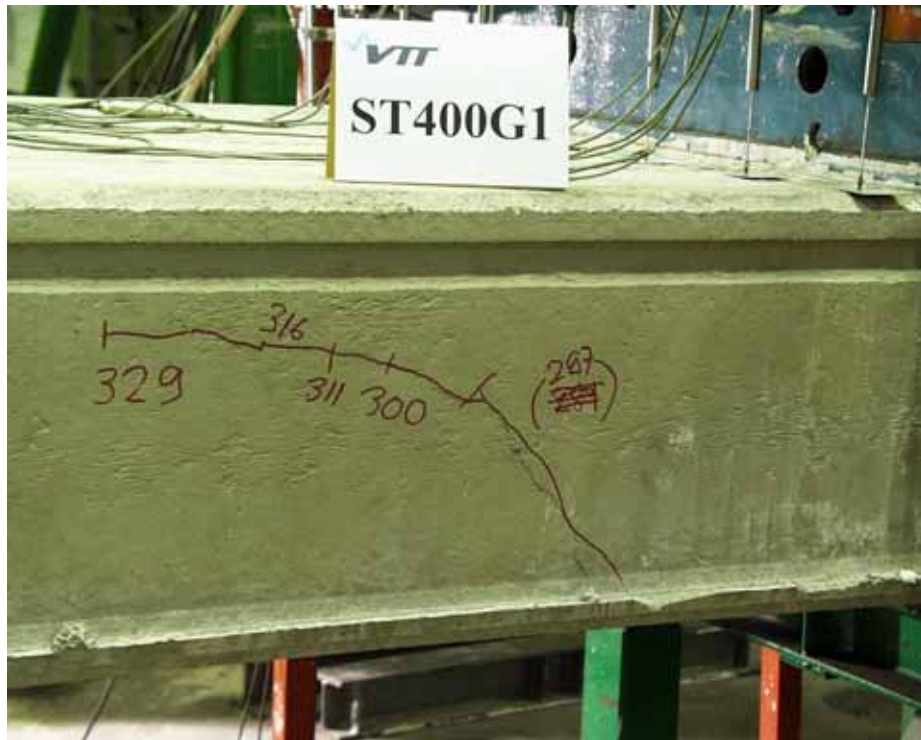
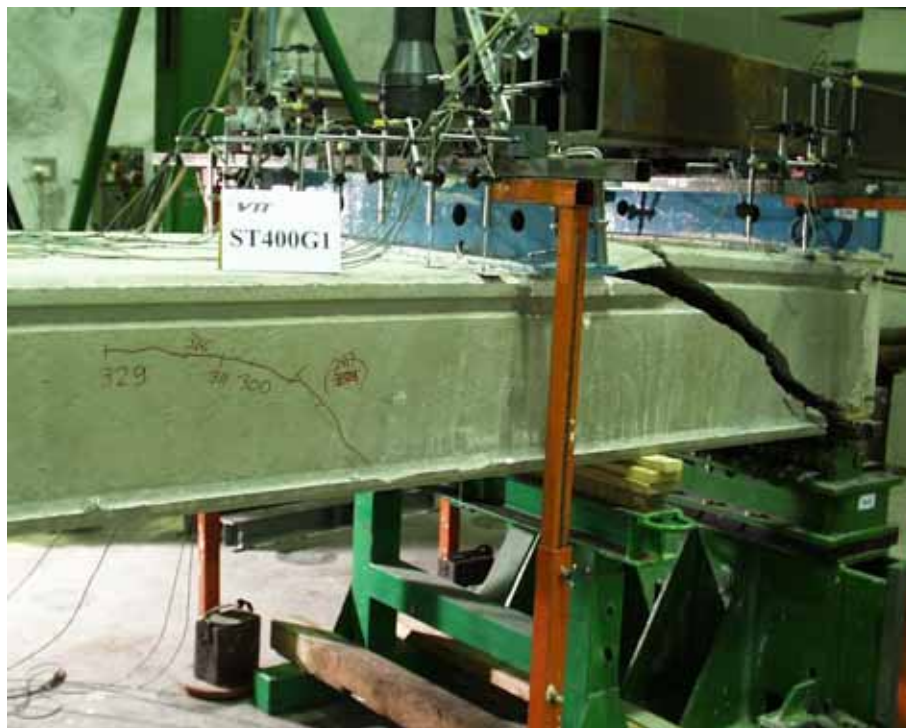
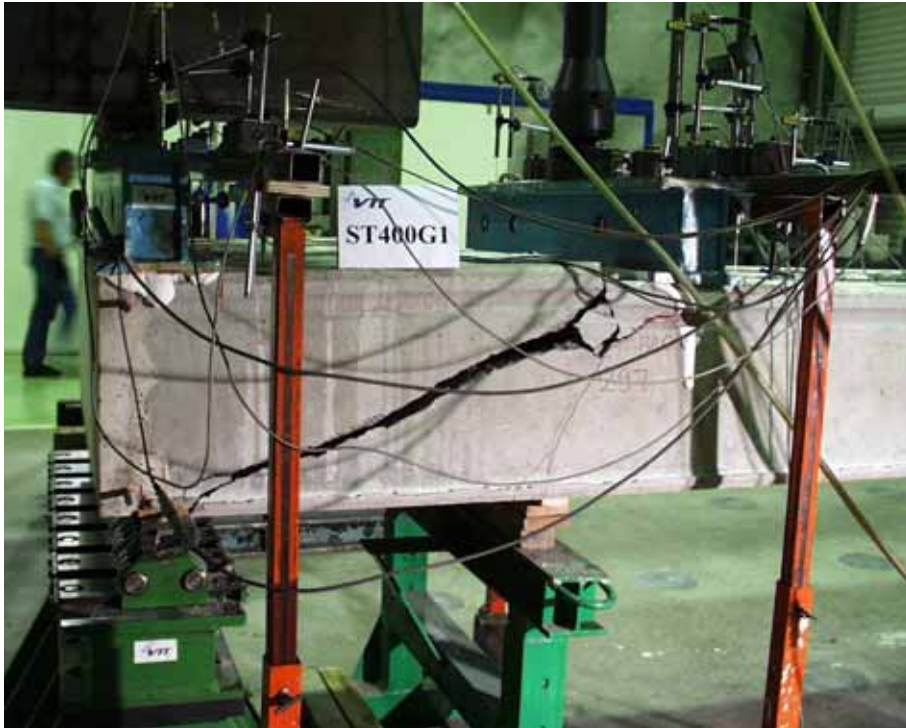
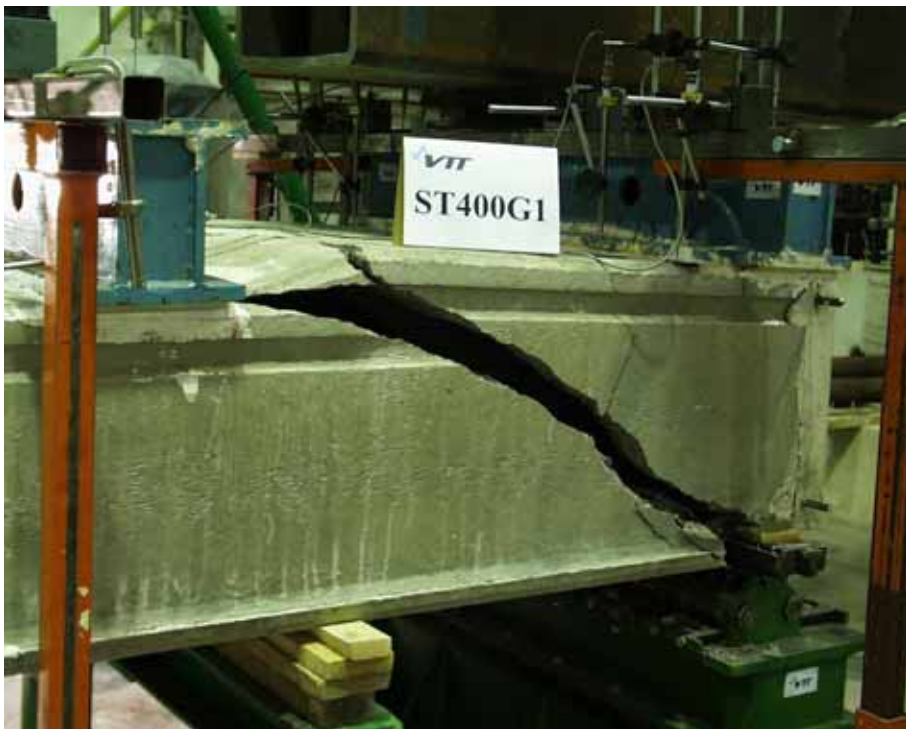
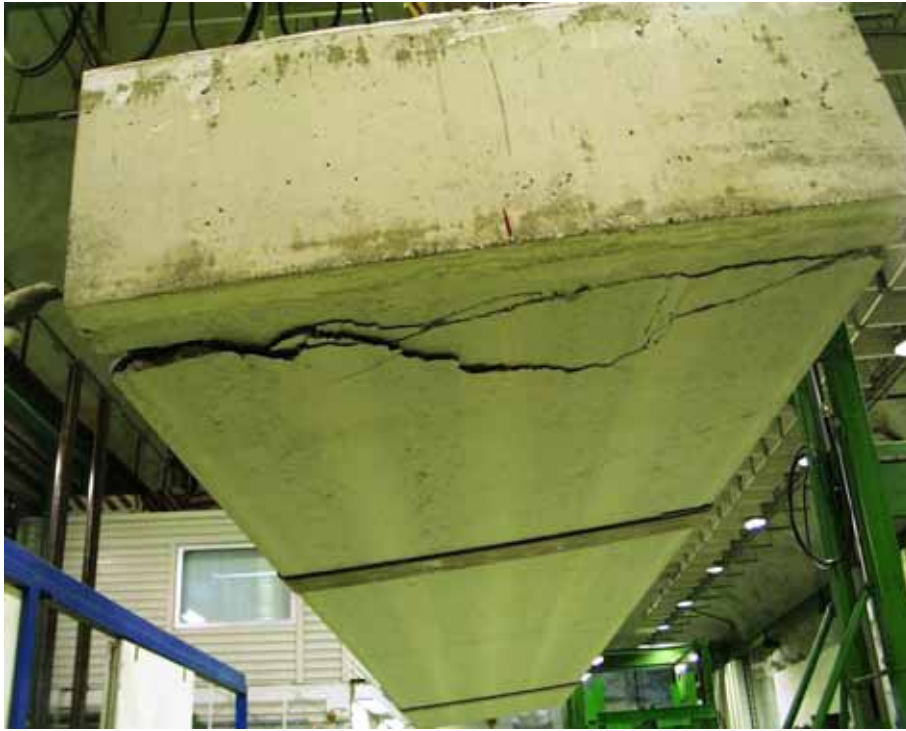
Fig. 51. ST400G1, North edge, cracks before failure.

Fig. 52. ST400G1, North edge, cracks after failure.

Fig. 53. ST400G1, South edge, cracks after failure.

Fig. 54. ST400G1, North edge, failure cracks.

Fig. 55. ST400G1, active end, soffit after failure.

In test ST400G1 the failure was a clear shear-torsion failure in the webs. On the other hand, in test ST400G2 the failure mode is more difficult to classify. As in test ST400G1, the first crack appeared in the soffit below the line load. This helical crack increased in width until failure. At $P_l = 357,2$ kN a new inclined shear crack appeared in the web between the existing crack and the support on the South end of the slab. This crack was a consequence of the failure rather than a reason to it because on this edge the increasing torsion tended to prevent such a cracking.

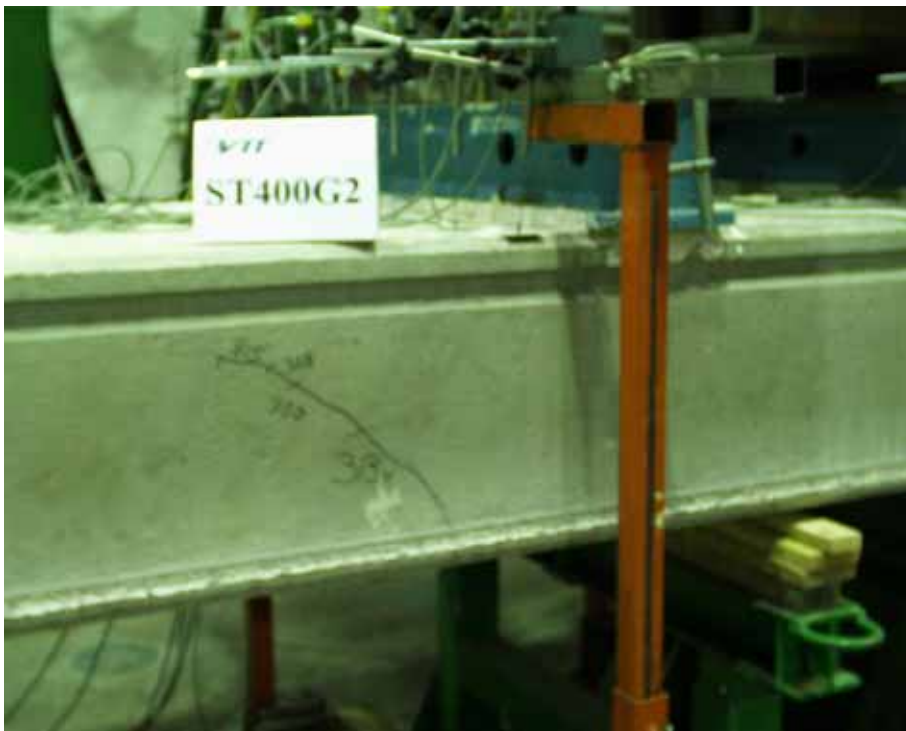
Fig. 56. ST400G2, North edge, cracks before failure.

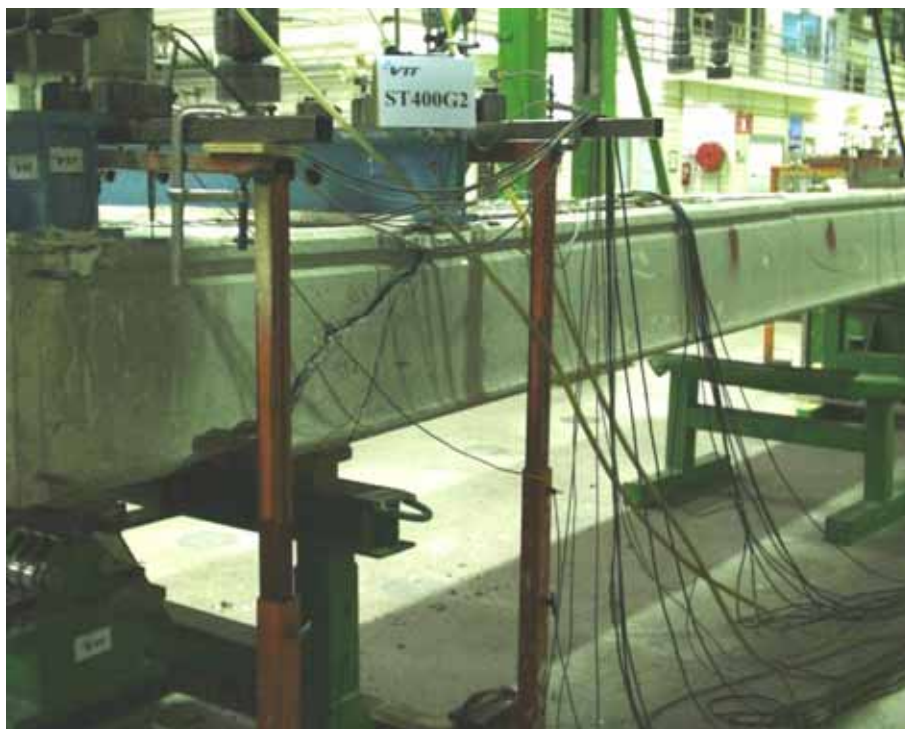
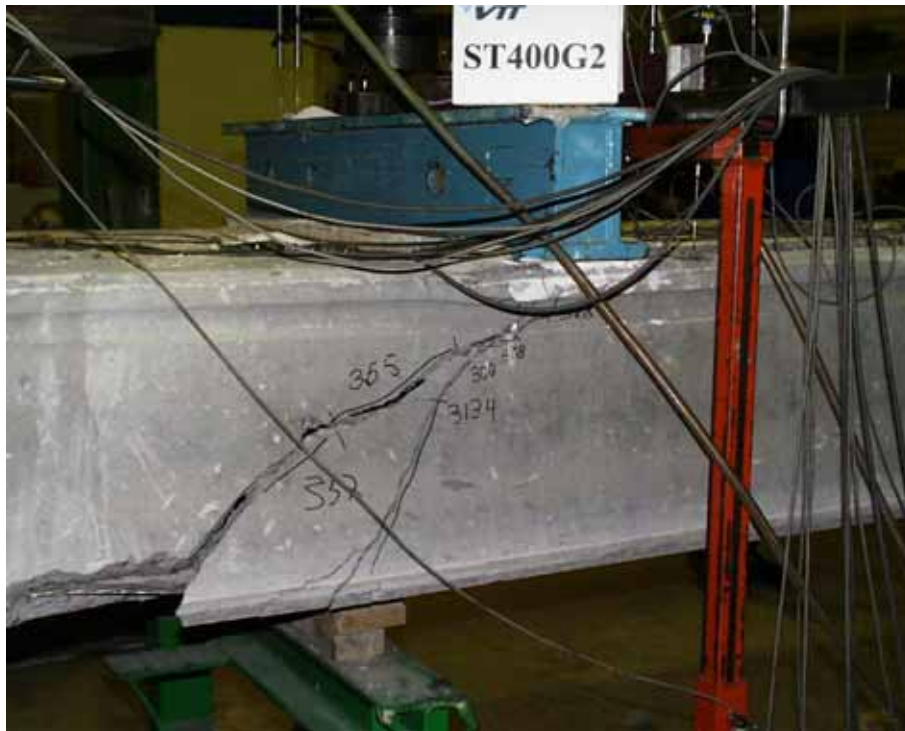
Fig. 60. ST400G2, South edge, cracks after failure.

Fig. 61. ST400G2, South edge, detail of failure cracks.

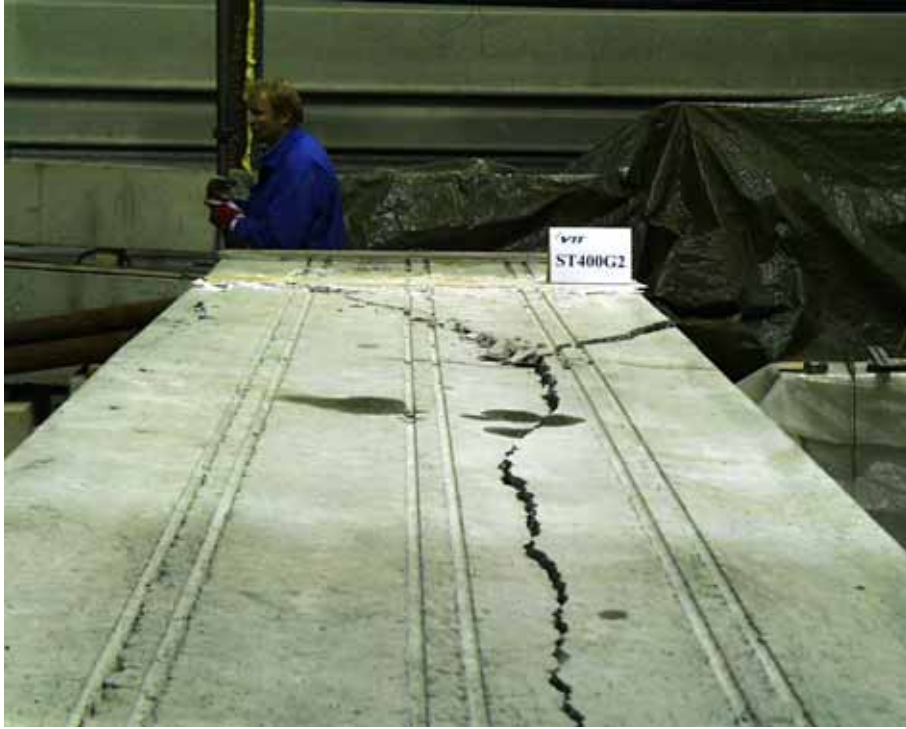
Fig. 63. ST400G2, top surface, cracks after failure.
