Hot cracking and environmentassisted cracking susceptibility of dissimilar metal welds

Hannu Hänninen¹, Anssi Brederholm¹, Tapio Saukkonen¹, Hans Gripenberg¹, Aki Toivonen², Ulla Ehrnstén² & Pertti Aaltonen²

¹ Helsinki University of Technology, Finland ² VTT Technical Research Centre of Finland

Hänninen Hannu, Brederholm, Anssi, Saukkonen, Tapio, Gripenberg, Hans, Toivonen, Aki, Ehrnstén, Ulla & Aaltonen, Pertti. Hot cracking and environment-assisted cracking susceptibility of dissimilar metal welds. Espoo 2007. VTT Tiedotteita – Research Notes 2399. 182 p.

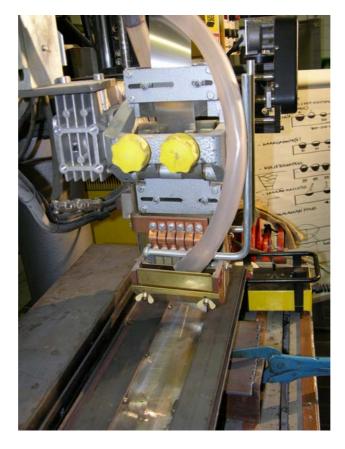
Figure 2.3. Cladding of ferritic 42CrMo4 steel bar by submerged arc welding.

The surface of a ferritic 42CrMo4 steel bar (\emptyset 80 mm and length 750 mm) was machined to the width of 70 mm (Figure 2.2). After machining, it was clad by submerged arc welding (Figure 2.3) using E 347 filler metal band (OK Band 16.11, width 60 mm and 0,5 mm thickness).

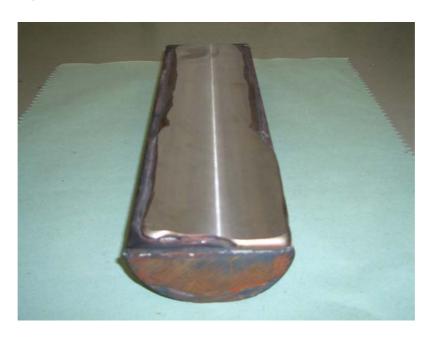
Figure 2.4. Ferritic 42CrMo4 steel bar after cladding and machining.

One layer was welded to the surface of the bar, and the thickness of the cladding was 4 mm. After welding, the surface of the weld was machined to the cladding thickness of 3 mm (Figure 2.4).

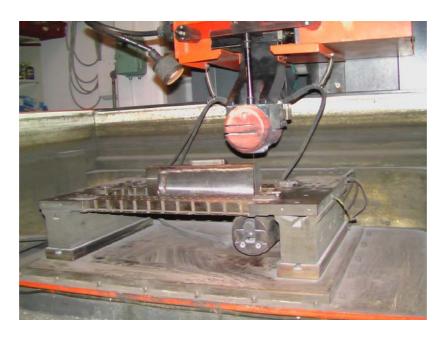
Figure 2.5. Wire Electro Discharge Machining (WEDM).

After machining, an 8 mm thick slice (Figure 2.6) was cut by Wire Electro Discharge Machining (WEDM), as shown in Figure 2.5.

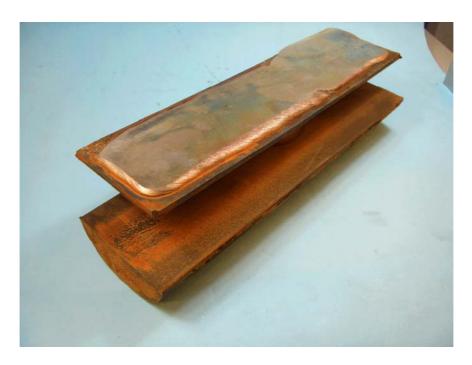
Figure 2.6. Clad, 8 mm thick slice after cutting from ferritic 42CrMo4 steel bar.

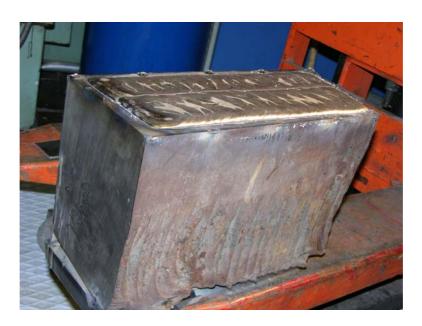
Figure 2.10. First layer of cladding on pressure vessel steel SA 508 Grade 2.

The pressure vessel steel surface was machined and then the piece was fastened to the jig for cladding. The first layer was welded by austenitic filler metal OK Band 11.65 (width 60 mm and thickness 0,5 mm) with flux OK 10.05. Two passes were welded side by side and the thickness of the cladding was 4 mm (Figure 2.10).

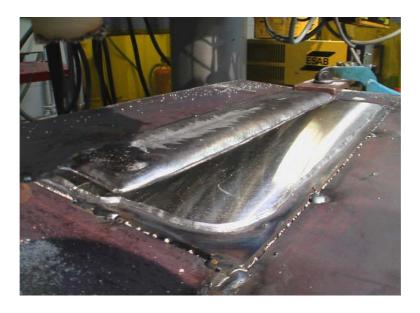
Figure 2.11. Cladding of the second layer after first pass.

After welding the first cladding layer, it was machined to the thickness of 2 mm and then the second layer of cladding was welded in the same way as the first one, using filler metal OK Band 11.61 (width 60 mm and thickness 0,5 mm). Figure 2.11 shows cladding of the second layer after the first pass.

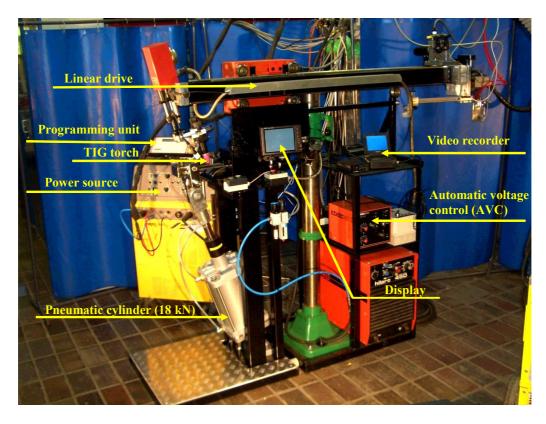
Figure 2.19. General view of Varestraint testing equipment built for hot cracking tests.

The Varestraint equipment built for the hot cracking tests is presented in Figures 2.19, 2.20 and 2.21.

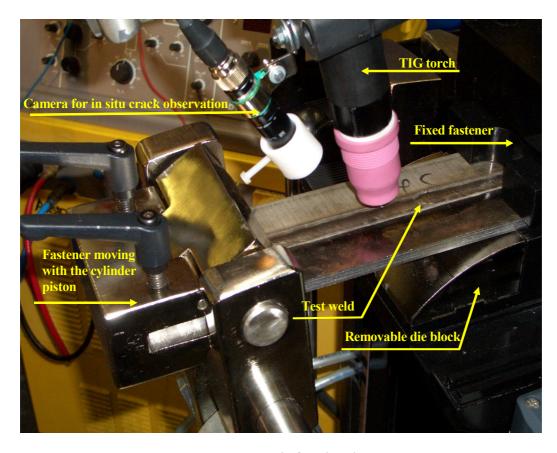
Figure 2.20. Test specimen before bending in Varestraint test.

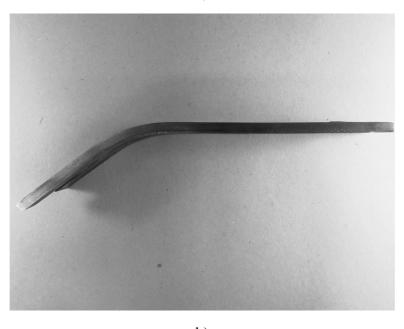
Figure 2.22 (a-b). a) Test piece after Varestraint test. b) By bending augmented strain was 4%.

In the Neste Oil case, the welding current was 250 A, voltage was 12,5 V, welding speed was 12 cm/min, heat input was 9,4 kJ/cm, welding length was 55 mm and bending speed was 16 mm/s. Bending was done so that tension was in the weld surface side. Figure 2.22 presents the test piece after Varestraint testing utilizing an augmented strain of 4%.

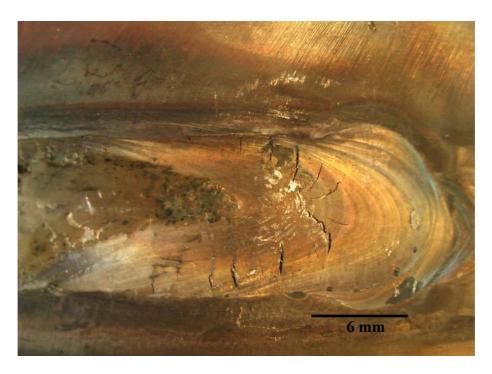
Figure 2.23. Surface of the test piece with hot cracks after Varestraint test. Augmented strain was 4%.

In Figure 2.23 is the surface of the test piece with hot cracks after Varestraint testing utilizing an augmented strain of 4%.

In Figures 2.24–2.28 are presented the calculated crack lengths from the area shown in Figure 2.23 with magnification of 25x and augmented strain of 4% (magnification is determined in standard CEN ISO/TR 17641-3, 2005).

Total crack length (TCL) of the Neste Oil case Varestraint test with 4% augmented strain was 42 mm and maximum crack length was 3,8 mm.

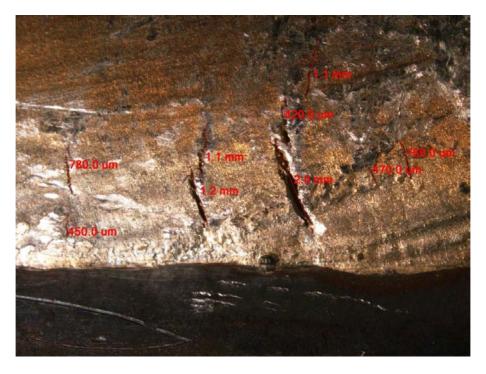
Figure 2.25. Measured crack lengths with magnification of 25x. Augmented strain was 4%.

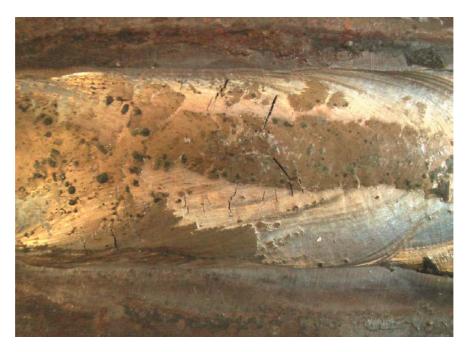
Figure 2.29. Surface of the test piece with hot cracks after Varestraint test. Augmented strain was 3%.

In Figure 2.29 is the surface of the test piece with hot cracks after Varestraint testing utilizing an augmented strain of 3%.

In Figures 2.30–2.32 are presented measured crack lengths from the area shown in Figure 2.29 with magnification of 25x and augmented strain of 3%.

Total crack length (TCL) of the Neste Oil case Varestraint test with 3% augmented strain was 28 mm and maximum crack length was 3,2 mm.

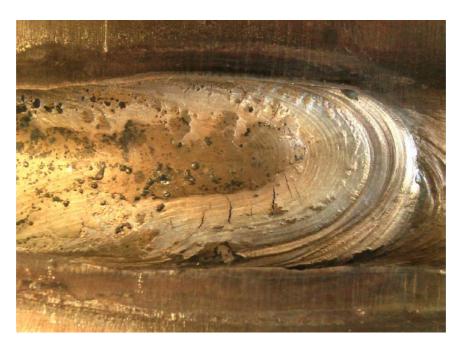
Figure 2.33. Surface of the test piece with hot cracks after Varestraint test. Augmented strain was 2%.

In Figure 2.33 is the surface of the test piece with hot cracks after Varestraint testing utilizing an augmented strain of 2%.

In Figures 2.34–2.36 are presented measured crack lengths from the area shown in Figure 2.33 with magnification of 25x and augmented strain of 2%.

Total crack length (TCL) of the Neste Oil case Varestraint test with 2% augmented strain was 27 mm and maximum crack length was 2,8 mm.

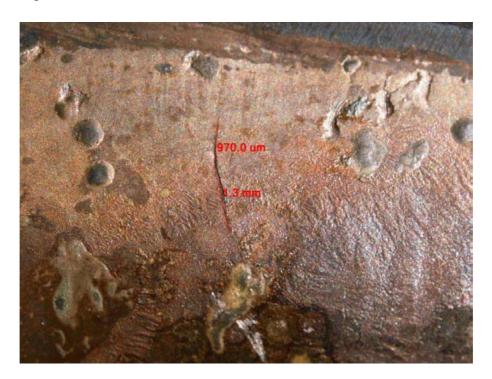
Figure 2.37. Measured crack lengths with magnification of 25x. Augmented strain was 1%.

In Figures 2.37 and 2.38 are presented measured crack lengths with magnification of 25x and augmented strain of 1%.

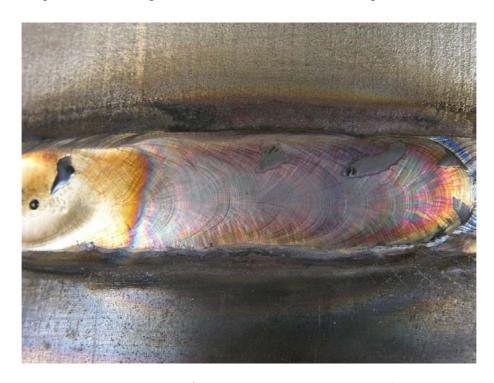
Figure 2.39. Test piece F1 after Varestraint test. Augmented strain was 4%.

In the Fortum case, the welding current was 250 A, voltage was 12,5 V, welding speed was 12 cm/min, heat input was 9,4 kJ/cm, welding length was 55 mm and bending speed was 16 mm/s. Bending was done so that tension was in the weld surface side. Figure 2.39 presents the test piece after the Varestraint test. Augmented strain was 4%.

The test was repeated with the same parameters. As seen in Figure 2.39 and also in optical microscopy examination, no cracks were observed in these specimens. It was decided that no further tests were necessary to show the low susceptibility to hot cracking of these materials.

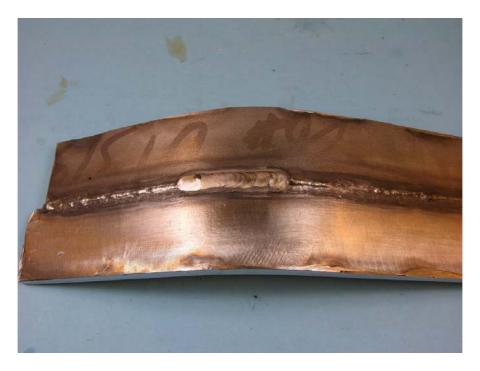
Figure 2.40. Test piece TV after Varestraint test. Augmented strain was 4%.

In the mock-up TV case, the welding current was 150 A, voltage was 10,5 V, welding speed was 12 cm/min, heat input was 4,7 kJ/cm, welding length was 45 mm and bending speed was 16 mm/s. Bending was done so that tension was in the weld root side. Figure 2.40 presents the test piece after Varestraint testing utilizing an augmented strain of 4%.

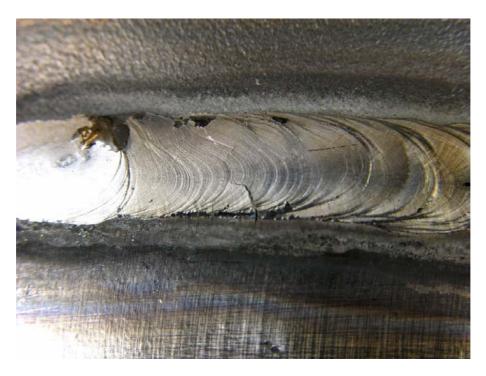
Figure 2.41. Surface of the test piece TV with hot cracks after Varestraint test. Augmented strain was 4%.

In Figure 2.41 is the surface of the test piece with hot cracks after Varestraint testing utilizing an augmented strain of 4%.

In Figures 2.42 and 2.43 are presented measured crack lengths from the area shown in Figure 2.41 with magnification of 25x and augmented strain of 4%.

Total crack length (TCL) of the mock-up TV case Varestraint test made with 4% augmented strain was 13,6 mm and maximum crack length was 4,9 mm.

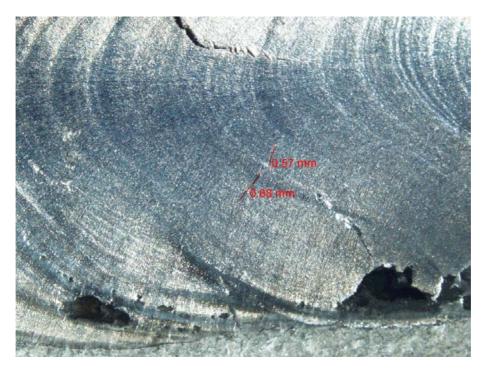
Figure 2.43. Measured crack lengths in TV test piece with magnification of 25x. Augmented strain was 4%.

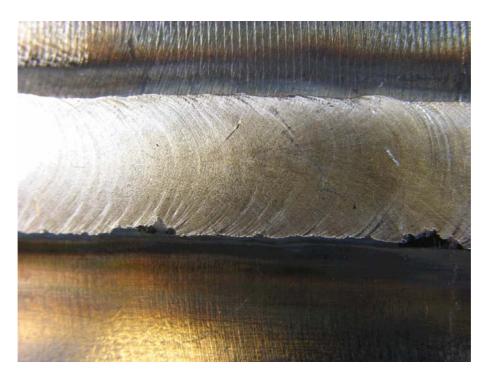
Figure 2.44. Surface of the TV test piece with hot cracks after Varestraint test. Augmented strain was 3%.

In Figure 2.44 is the surface of the TV test piece with hot cracks after Varestraint testing utilizing an augmented strain of 3%.

In Figures 2.45 and 2.46 are presented measured crack lengths in TV specimens from the area shown in Figure 2.44 with magnification of 25x and augmented strain of 3%.

Total crack length (TCL) of the mock-up TV case Varestraint test with 3% augmented strain was 4,8 mm and maximum crack length was 1,3 mm.

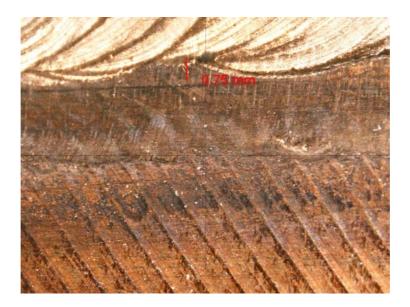
Figure 2.47. Measured crack length in TV test piece with magnification of 25x and augmented strain of 2%.

In the Varestraint test made for TV specimen using 2% augmented strain, only short crack was observed, as shown in Figure 2.47.

Total crack length (TCL) of the mock-up TV case Varestraint test with 2% augmented strain was 0,75 mm and maximum crack length was 0,75 mm.

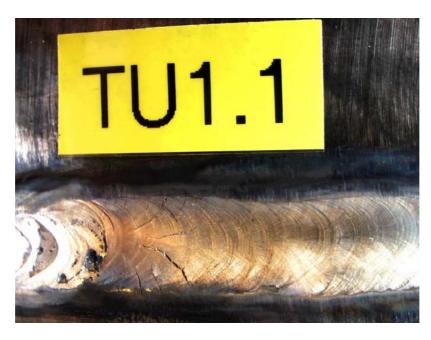
Figure 2.50. Root side surface of the test piece in mock-up 1 with hot cracks after Varestraint test. Augmented strain was 4%.

In Figure 2.50 is the surface of the test piece with hot cracks after Varestraint testing utilizing an augmented strain of 4%.

In Figures 2.51–2.54 are presented measured crack lengths from the area shown in Figure 2.50 with magnification of 25x and augmented strain of 4%.

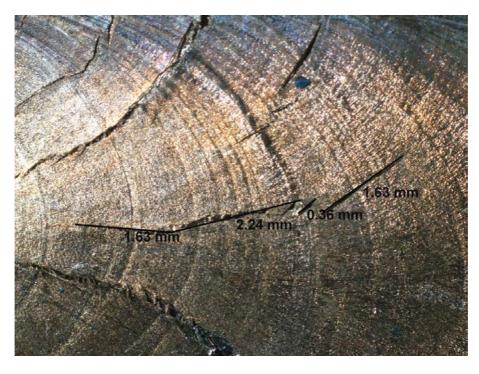
Figure 2.52. Measured crack lengths in mock-up 1 with magnification of 25x and augmented strain of 4%.

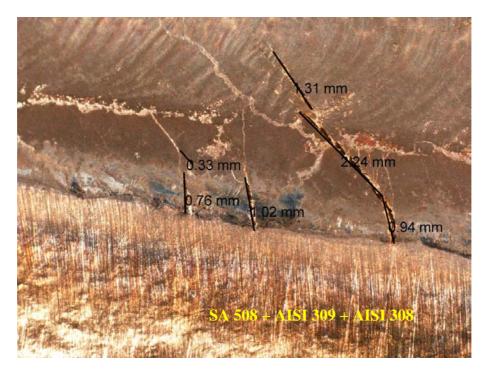
Figure 2.61. Measured crack lengths in mock-up 2 with magnification of 25x and augmented strain of 4%.

In Figures 2.60 and 2.61 are presented measured crack lengths in mock-up 2 with magnification of 25x and augmented strain of 4%.

Total crack length (TCL) of the mock-up 2 Varestraint test with 4% augmented strain was 19,5 mm and maximum crack length was 3,7 mm.

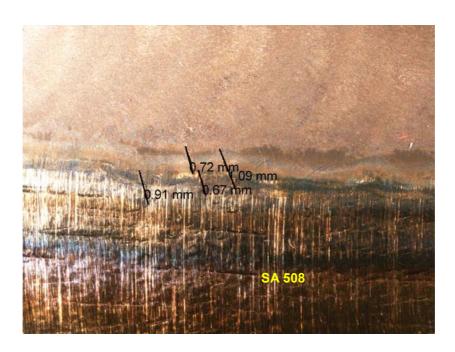
Figure 2.68. Measured crack lengths in mock-up 3 with magnification of 25x and augmented strain of 3%.

In Figure 2.68 is presented measured crack lengths in mock-up 3 with magnification of 25x and augmented strain of 3%.

Total crack length (TCL) of the mock-up 3 Varestraint test with 3% augmented strain was 3,4 mm and maximum crack length was 1,1 mm.

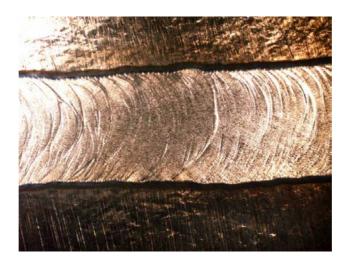
Figure 2.76. Test specimen of Inconel 82 weld after testing with 4% augmented strain.

Figure 2.76 presents the test specimen of Inconel 82 weld after testing with 4% augmented strain. No cracks were observed.

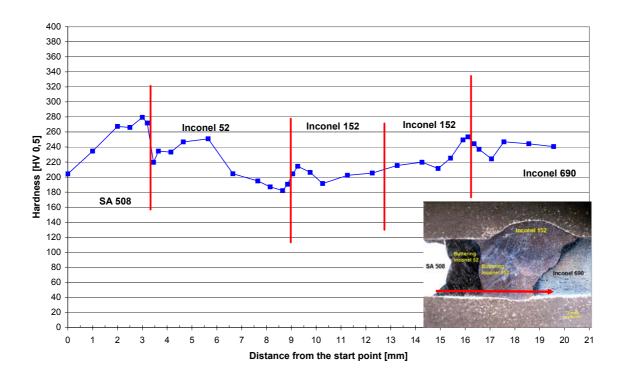
Figure 2.101. Microhardness profile of the mock-up 3 dissimilar metal weld (root side).

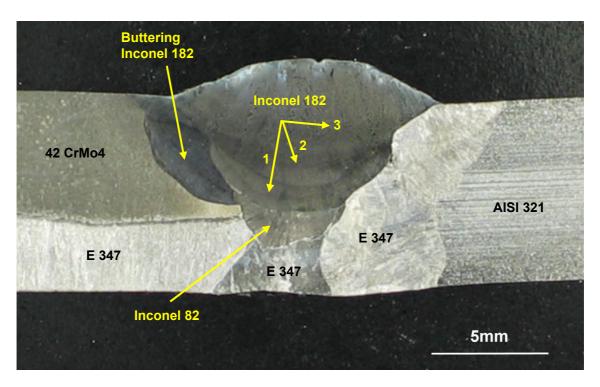
Figure 2.102. Cross-section of Neste Oil dissimilar metal weld.

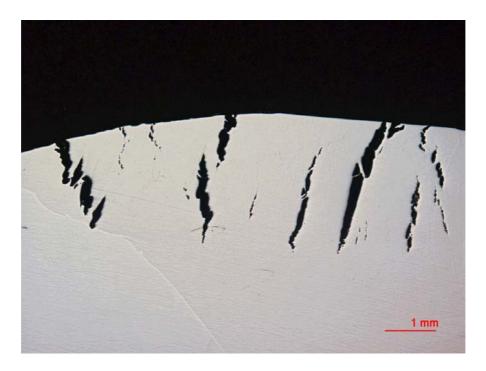
Figure 2.104. Cross-section of Neste Oil weld cracks after Varestraint test.

Figure 2.104 presents a cross-section of the Neste Oil weld cracks after Varestraint test.

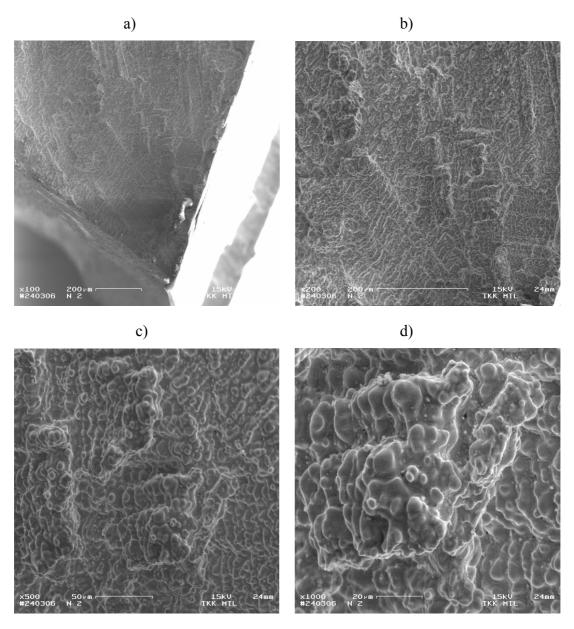
Figure 2.105 (a–d). Scanning electron microscopy (SEM) of the fracture surface of an opened Neste Oil weld crack.

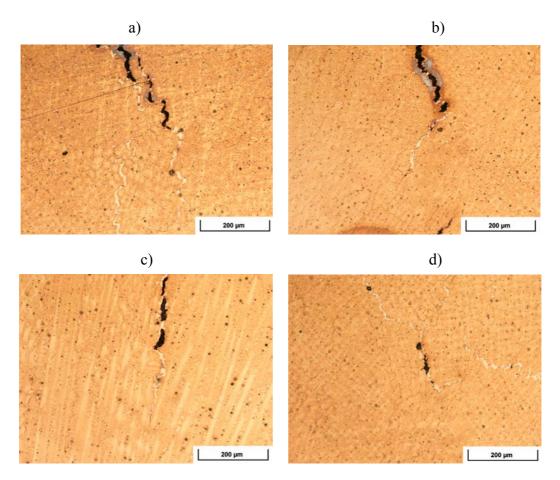
Figure 2.106 (a–d). Optical microscopy of the Neste Oil weld hot cracks (dark areas). Note the white phase ahead of the hot crack tips.

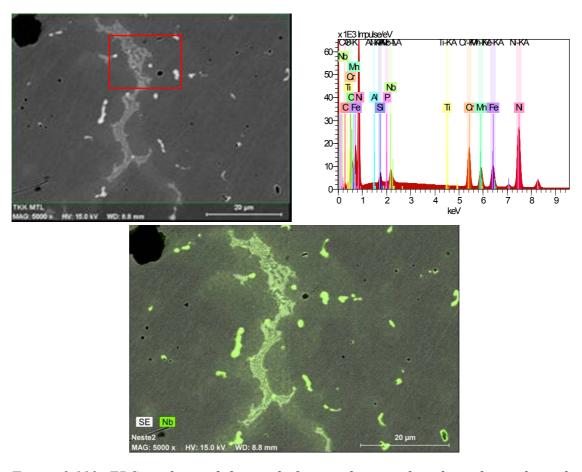
Figure 2.110. EDS analysis of the marked area showing the white phase along the dendrite boundary. Note marked Nb enrichment in the white phase and less enrichment in a wider area along the dendrite boundary.

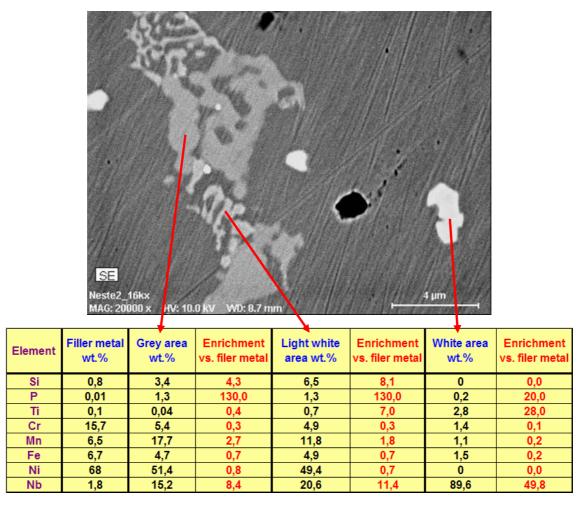
Figure 2.112. SEM image and EDS analyses of the white and grey phase showing Si, Nb, Mn and P enrichment. The spot size in EDS has an interaction diameter about l μm , and therefore the surrounding matrix also affects the result.

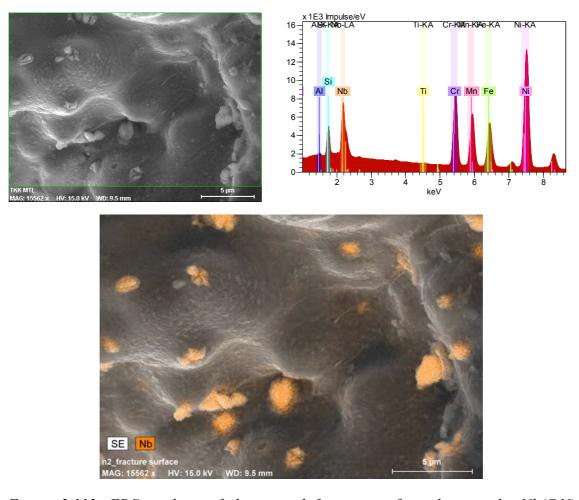
Figure 2.113. EDS analysis of the opened fracture surface showing the Nb(C,N) particles.

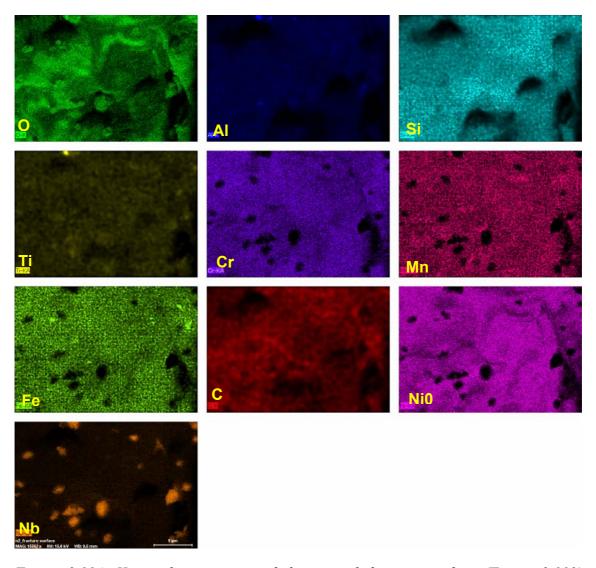
Figure 2.114. X-ray element maps of the opened fracture surface (Figure 2.113) showing element distribution.

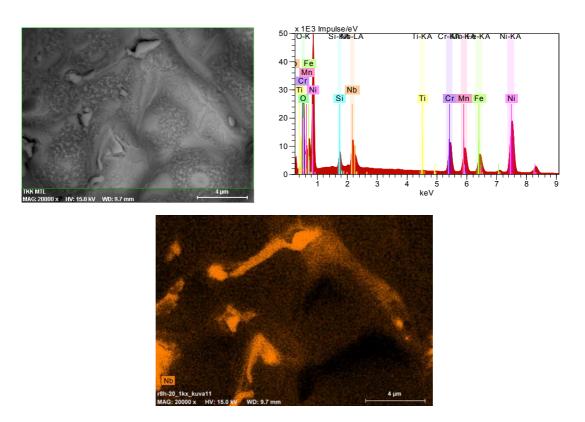
Figure 2.115. EDS analysis of the opened fracture surface with the white phase where Nb enrichment is observed.

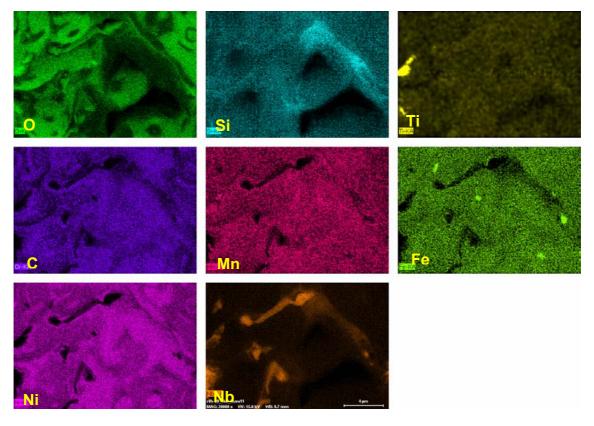
Figure 2.116. X-ray element maps of the opened fracture surface of Figure 2.115.

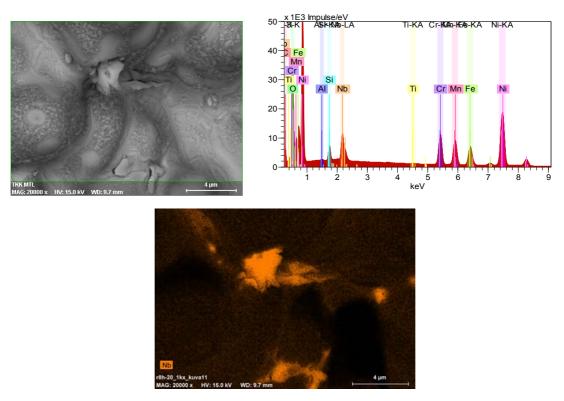
Figure 2.117. EDS analysis of the opened fracture surface with the white phase, showing Nb enrichment in it.

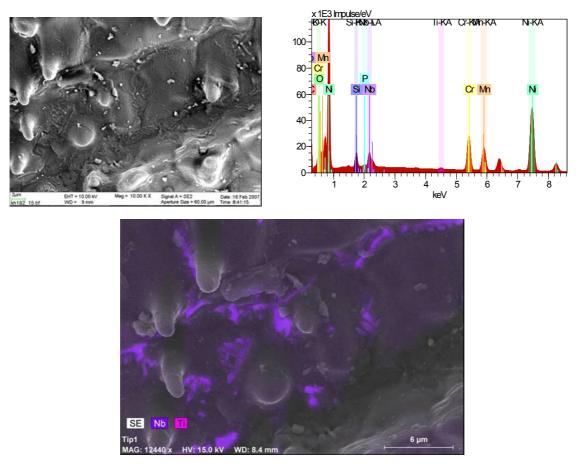
Figure 2.128. EDS analysis of the opened fracture surface showing the marked Nb enrichment of the white phase.

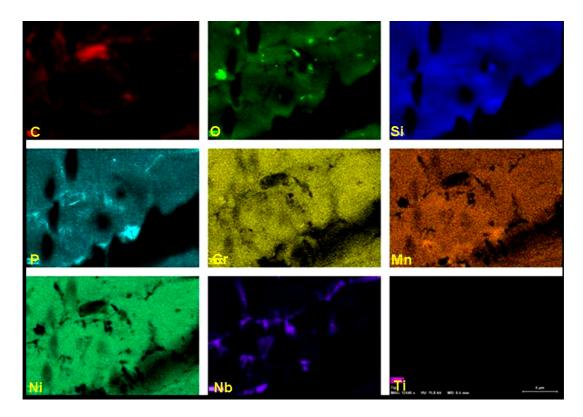
Figure 2.129. X-ray element maps of the opened fracture surface (Figure 2.128) showing the co-enrichment of Nb and Mn, Si as well as P.

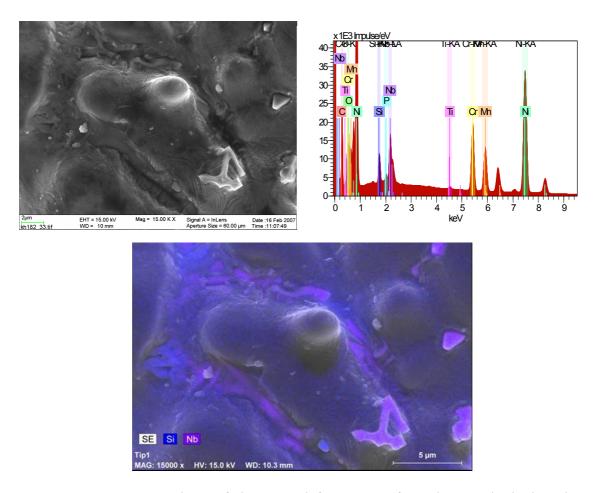
Figure 2.131. EDS analysis of the opened fracture surface showing both the white phase in the valleys between dendrites and the Nb(C,N) particles.

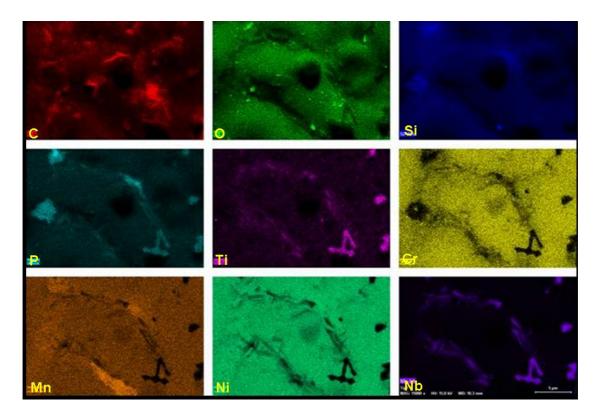
Figure 2.132. X-ray element maps of the opened fracture surface (Figure 2.131). Location marked with a square in Figure 2.130 a).

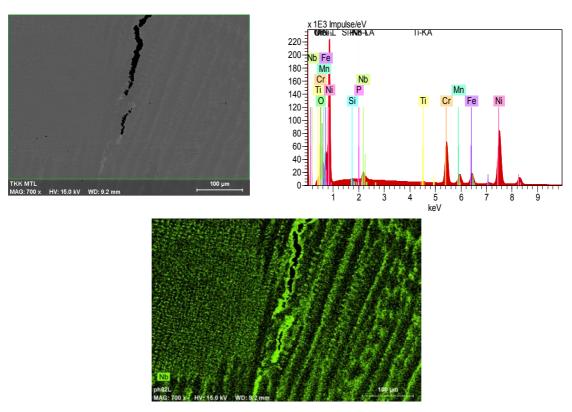
Figure 2.135. EDS analyses of a cross-section of a hot crack in alloy 82, showing strong Nb segregation.

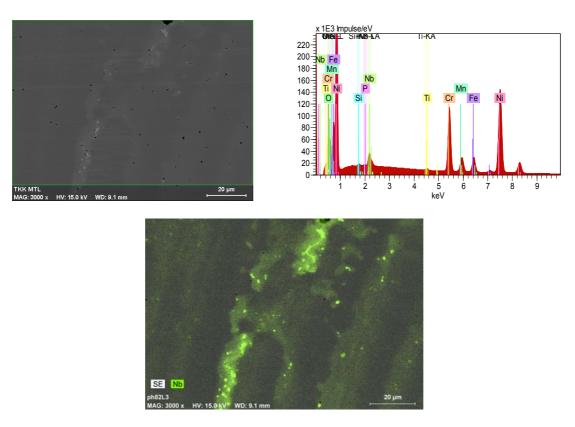
Figure 2.137. EDS analyses of a cross-section of a hot crack tip in alloy 82.

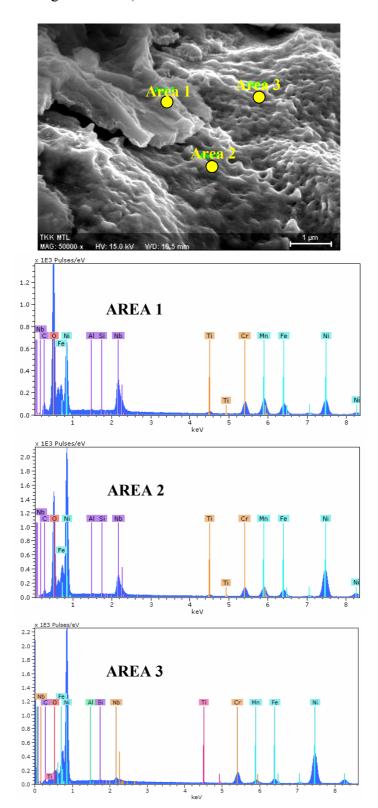
Figure 2.140. EDS analyses of three areas of the oxide layer shown in Figure 2.139 d).

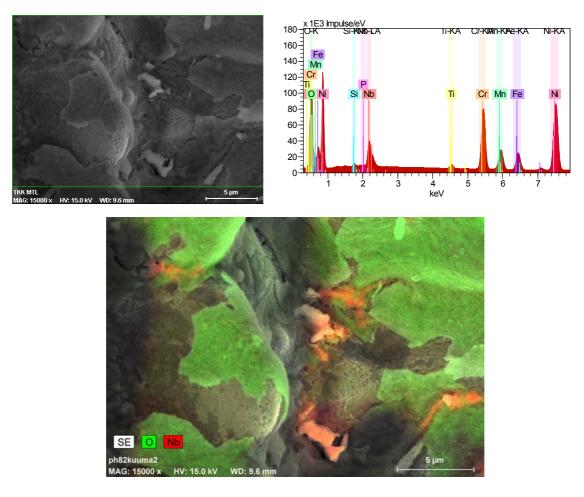
Figure 2.141. EDS analysis of the opened fracture surface of alloy 82 showing distribution of Nb and O.

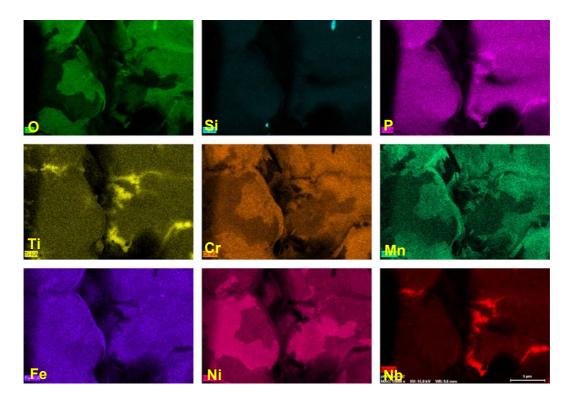
Figure 2.142. X-ray element maps of the opened fracture surface of alloy 82 (Figure 2.141) showing distribution of alloying elements on the fracture surface.

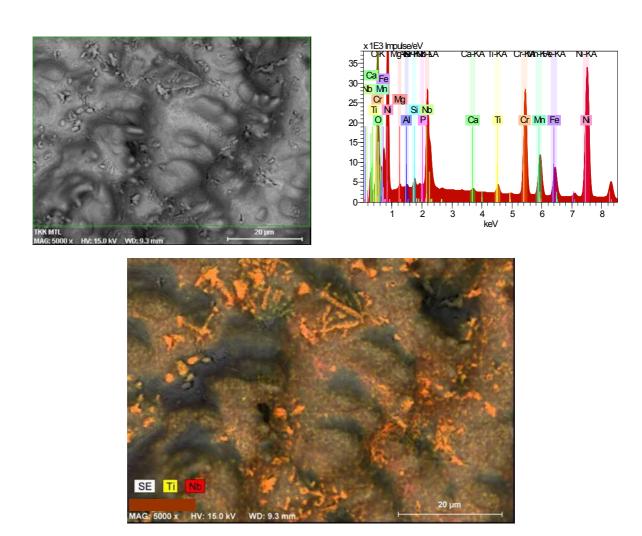
Figure 2.144. EDS analyses of the opened fracture surface of alloy 82 showing distribution of Nb and Ti.

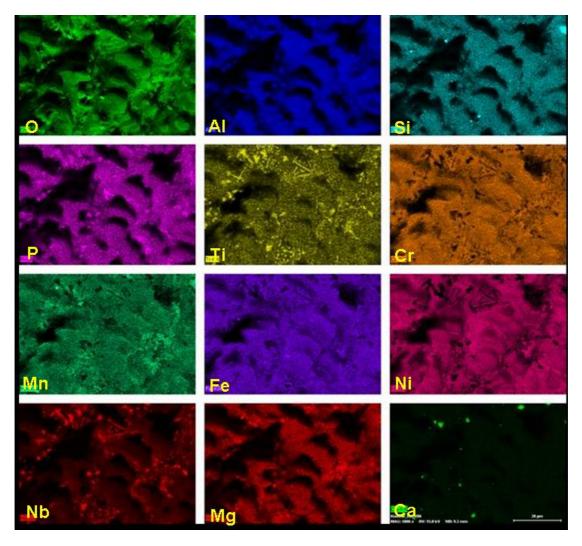
Figure 2.145. X-ray element maps of the opened fracture surface of alloy 82 (Figure 2.144) showing distribution of alloying elements.

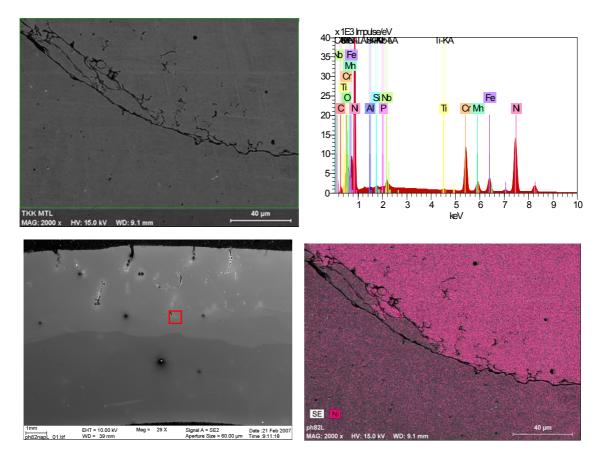
Figure 2.146. EDS analysis of a crack on weld pass boundary below the TIG re-melting pass of Inconel 82 weld metal in the Varestraint test, showing dilution of Ni in the lower pass (detail shows cracking along the boundary between passes 7 and 6 in Figure 2.73).

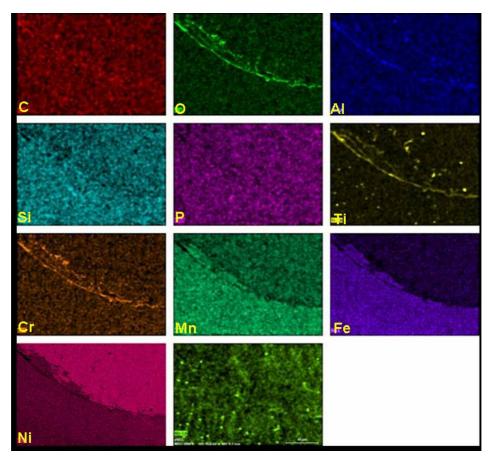
Figure 2.147. X-ray element maps of the weld pass boundary below the TIG re-melting pass of Inconel 82 weld metal in Varestraint test, showing dilution of alloying elements in the lower pass of the filled groove.

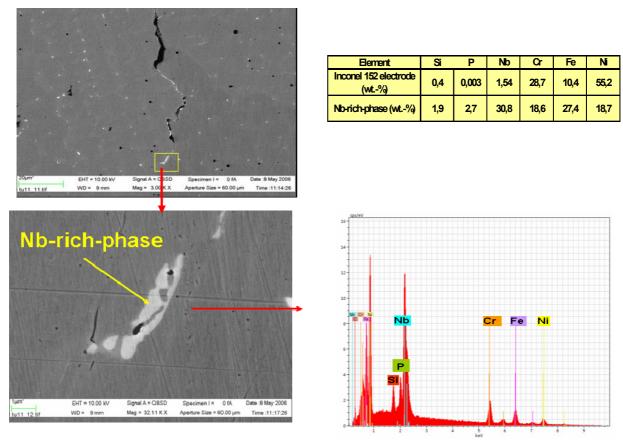
Figure 2.156. EDS analyses of the white phase ahead of a hot crack from the area marked with a square.

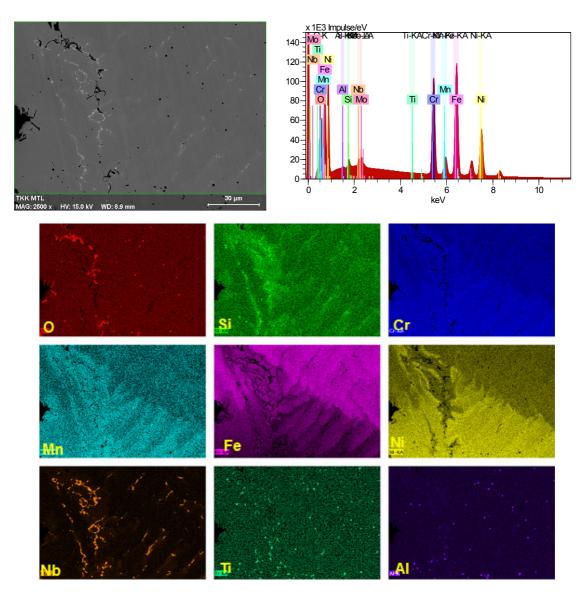
Figure 2.157. EDS analysis and X-ray element maps of the cross-section of a crack showing very high enrichment of Nb in the white phase.

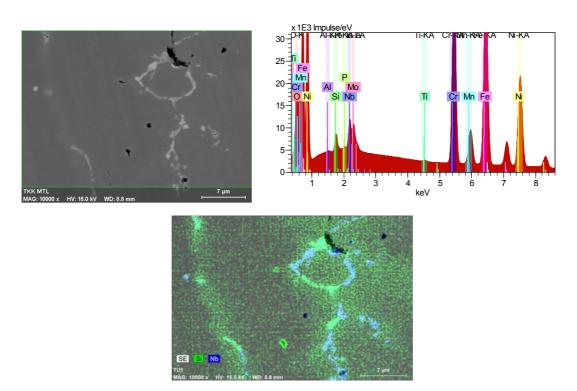
Figure 2.158. EDS analysis from the cross-section area of white phase ahead of a hot crack showing very high enrichment of Nb and Si.

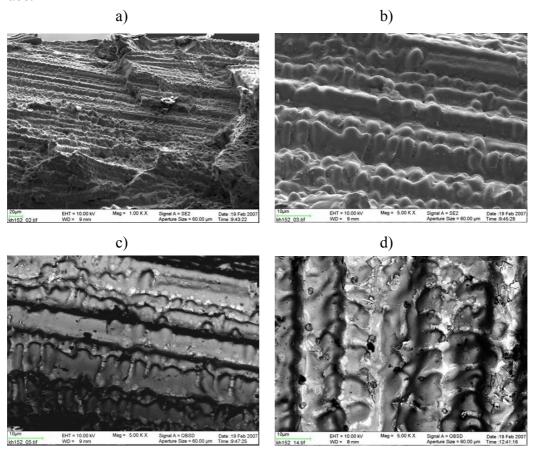
Figure 2.160 (a–d). Scanning electron microscopy (SEM) of opened fracture surface showing the presence of white phase on the fracture surface.

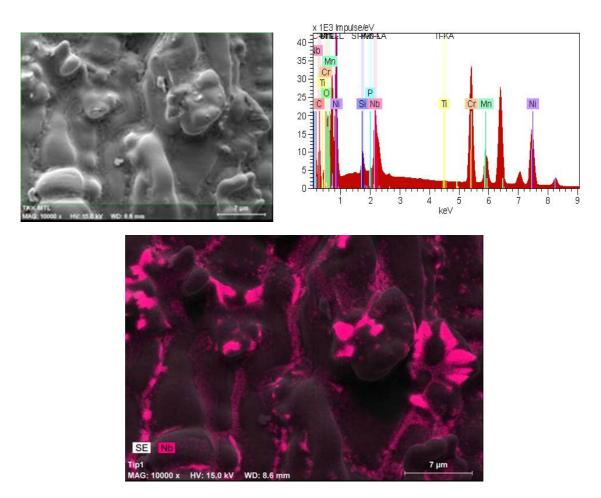
Figure 2.162. EDS analyses of the opened fracture surface showing very high enrichment of Nb.

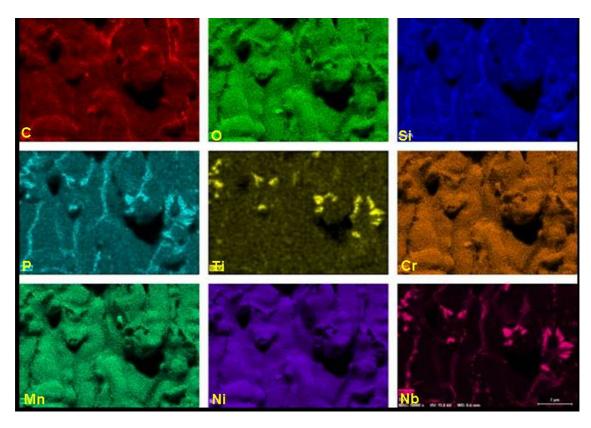
Figure 2.163. X-ray element maps of the opened fracture surface (Figure 2.162) showing that Nb is enriched together with Si, Mn and especially P to the white phase and together with Ti to the particles, Nb, Ti(C, N).

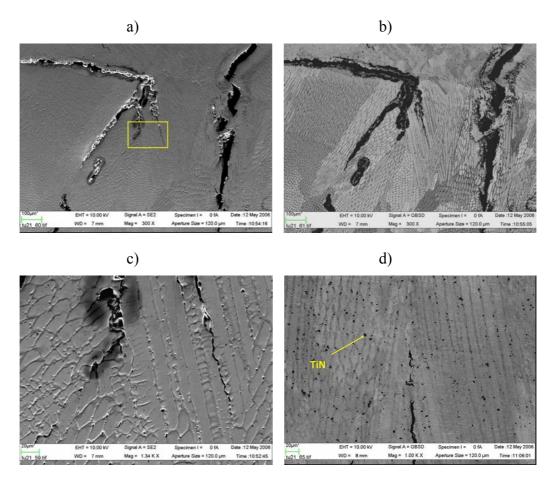
Figure 2.170 (a–d). Scanning electron microscopy (SEM) of the hot cracks.

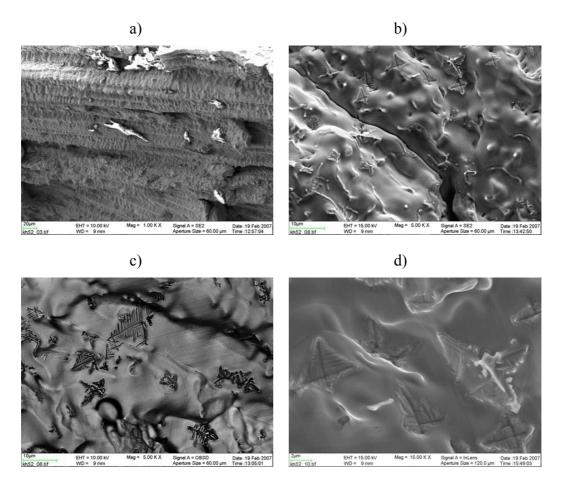
Figure 2.171 (a–d). Scanning electron microscopy (SEM) of an opened fracture surface showing large amount of precipitates.

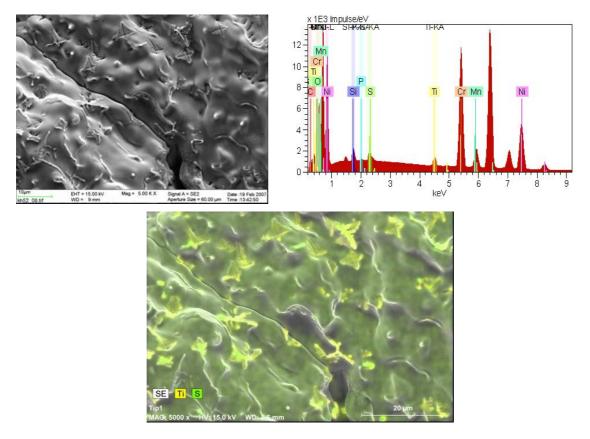
Figure 2.172. EDS analysis of the opened fracture surface shows enrichment of Ti in the precipitates on the fracture surface.

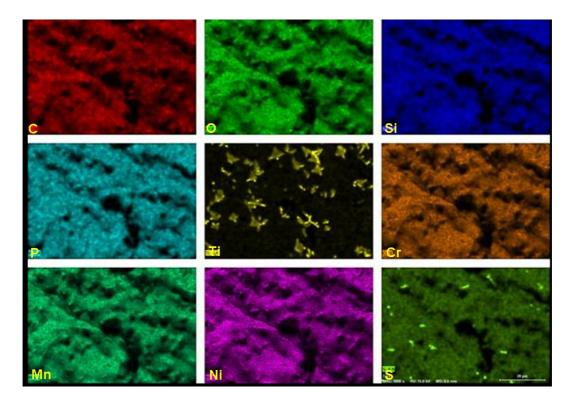
Figure 2.173. X-ray element maps of the opened fracture surface (Figure 2.172).

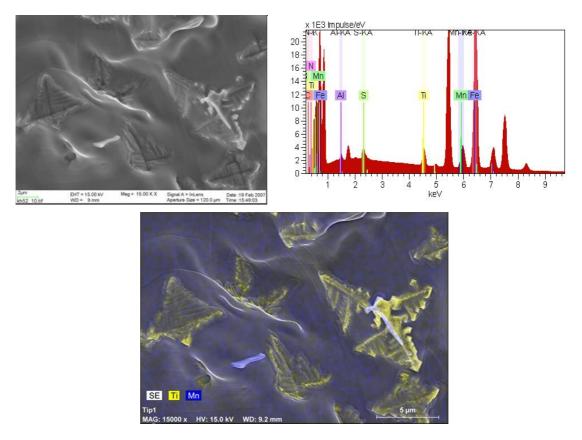
Figure 2.174. EDS analysis of the opened fracture surface.

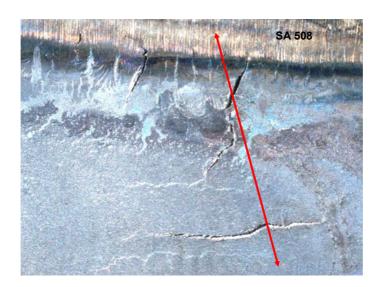
Figure 2.181. Cutting line of cross-section of mock-up 3 sample for microstructural examinations after Varestraint test.

Figure 2.181 presents the cutting line of the cross-section of mock-up 3 sample for microstructural examinations.

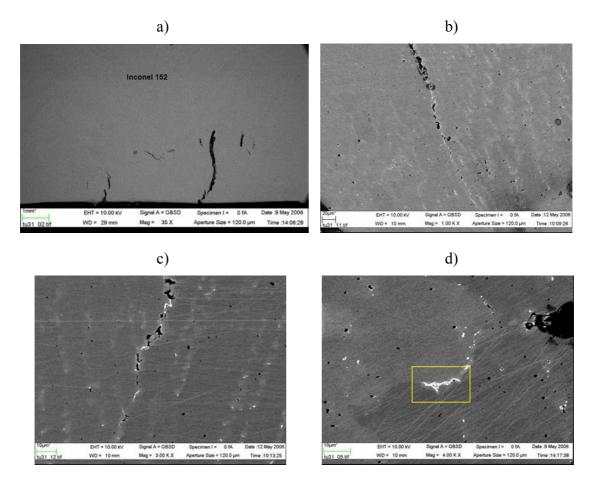
Figure 2.182 (a-d). Cross-section of mock-up 3 weld cracks after Varestraint test.

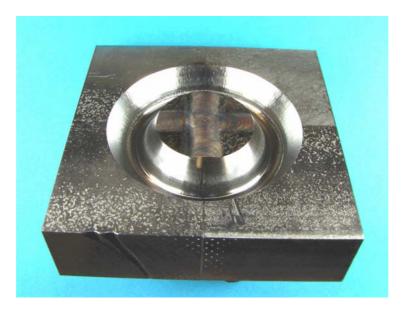
Figure 2.188. The ring segment test specimen after tack welding and machining of circumferential groove.

After tack welding of the ring segment test specimen, a circumferential groove was machined on one side of it (Figure 2.188). The dimensions of the groove are shown in Figure 2.185. No cooling liquids are allowed during machining.

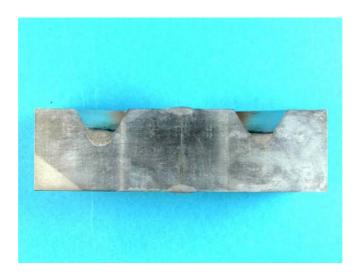
Figure 2.194. Cross-section of the Inconel 182 test specimen.

After the surface crack examination, the specimen shall be broken at separation points in order to be able to verify the root fusion. Figure 2.194 presents a cross-section of the Inconel 182 test specimen.

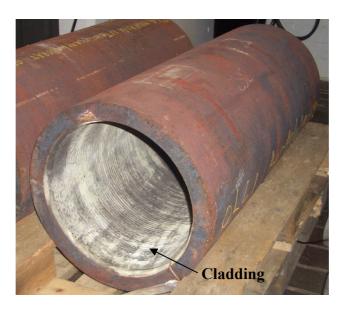
Figure 2.198. Pressure vessel steel pipe with cladding.

A full-scale dissimilar metal weld mock-up pipe was made. The pipe material was pressure vessel steel 2,25Cr1Mo0,25V, ASME code case 2098 (diameter 405 mm, wall

thickness 35 mm and length 1000 mm). The pipe was clad with AISI 309 and AISI 347 steel. The second pipe material was stainless steel AISI 347 (diameter 405 mm, wall thickness 40 mm and length 280 mm). Figure 2.198 presents the pressure vessel steel pipe with cladding.

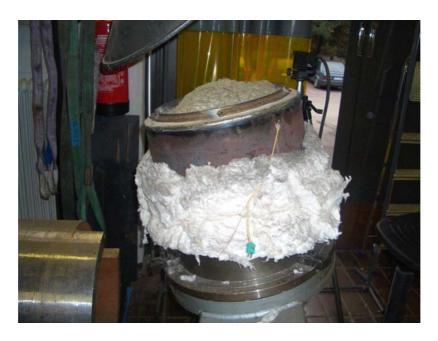
Figure 2.200. Pressure vessel steel pipe fastened to the turning table ready for buttering.

The machined pressure vessel steel side groove was buttered with welding electrode Inconel 182. Minimum requirement for the thickness of the buttering layer was 7 mm. Minimum requirement for the preheating temperature was 105 °C and maximum temperature was 250 °C. Preheating was done with a petroleum gas torch to temperature 200 °C, and the upper side of the mock-up was sealed. The preheating temperature was measured during welding by a thermocouple from the upper side of the pipe (see Figure 2.200) and from the surface of the buttering layer with a surface thermometer. Buttering was made in the flat position. Figure 2.200 presents the pressure vessel steel pipe fastened at the turning table, ready for buttering.

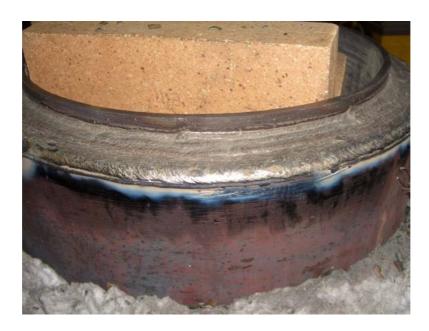
Figure 2.201 presents the pressure vessel steel pipe after the first buttering layer. Thickness of the layer was approximately 5 mm. Requirement for the layer thickness was at least 7 mm, and therefore two layers were welded to achieve a 10 mm thickness.

Figure 2.201. Pressure vessel steel pipe after first buttering layer.

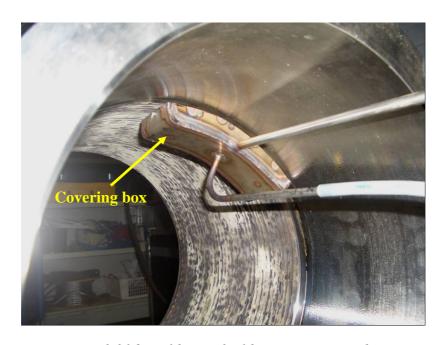
The pressure vessel steel pipe with buttering was tack welded to stainless steel AISI 347. A shielding gas covering box was used for protection of the weld root side from oxidation during the welding process (Figure 2.206).

Figure 2.206. Weld root shielding gas covering box.

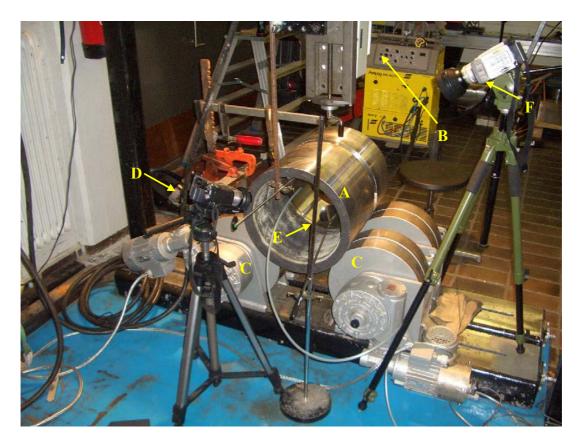
Figure 2.207 presents a general view of the welding of the mock-up. A is the mock-up to be welded. B is the welding power source. Turning rolls are marked as C. D is the video camera for monitoring the weld root via mirror E (Figure 2.208). F is the video camera for monitoring each weld bead from the surface side (Figure 2.209).

Figure 2.207. General view of the welding of the mock-up.

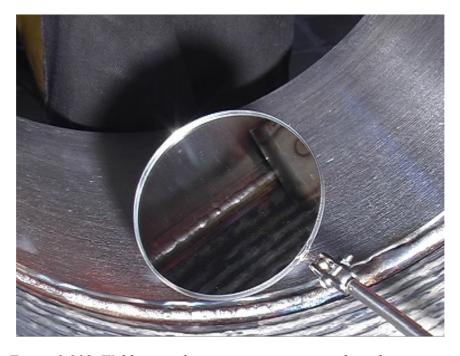
Figure~2.208.~Weld~root~side~monitoring~via~mirror~by~video~camera.

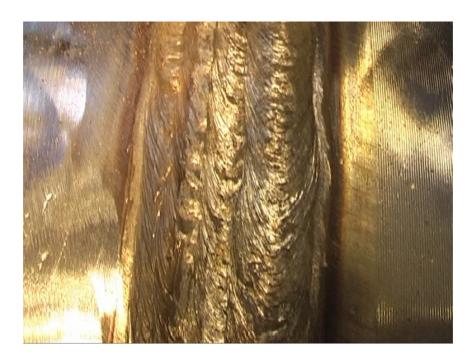
Figure 2.211 presents the finished Neste Oil dissimilar metal weld mock-up and Figure 2.212 the surface of the mock-up.

Figure 2.212. Surface of the Neste Oil dissimilar metal weld mock-up after welding.

NDE was conducted for the shop fabricated Neste Oil dissimilar metal weld mock-up for refinery applications. The requirements of the specifications for radiographic examination and liquid penetrant examination were applied. The butt-welded pipe joint of pressure vessel steel to stainless steel with Inconel 182 filler metal met the requirements set in the ASME Section 8, Div. 1 inspection procedure. However, the

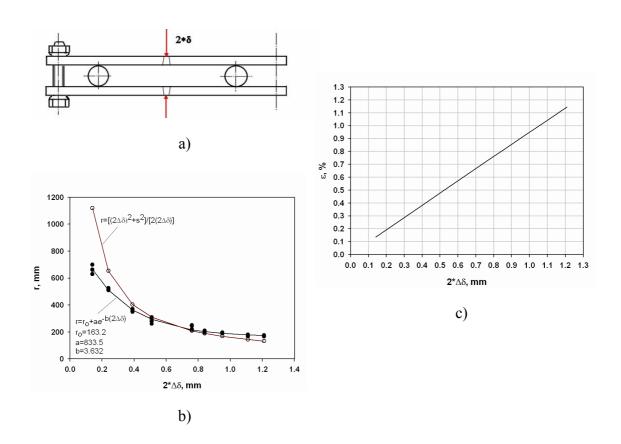
Figure 3.3 (a–c). Loading geometry with displacement measurement location indicated by two red arrows a), experimental and theoretical displacement vs. bending radius calibration curves b), and theoretical strain vs. displacement curve for a 3 mm thick plate c).

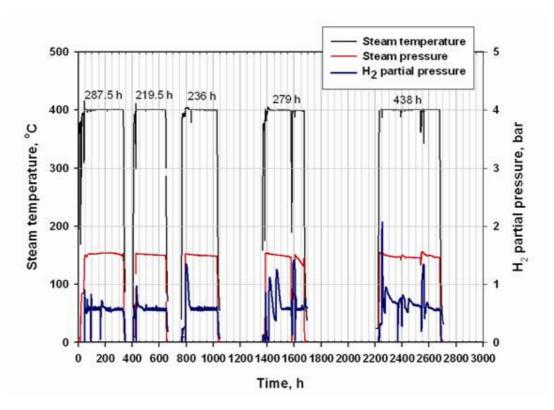
Figure 3.4. Temperature, autoclave pressure and hydrogen partial pressure during the 5 test exposures.

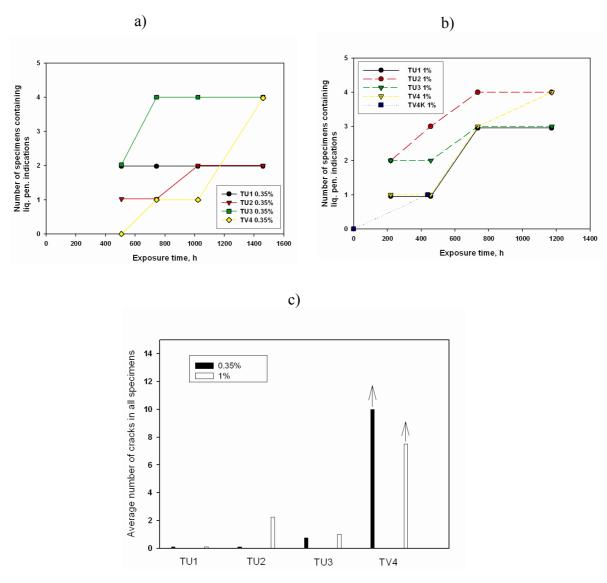
Figure 3.5 (a–c). Number of 0.35% strained specimens with a liquid penetrant indication shown as a function of exposure time a), corresponding data for specimens with 1% strain b). Liquid penetrant testing was started after 2nd or 1st exposures (0.35% and 1% strained specimens, respectively), so it is not possible to tell what was the starting level of indications in each case except for 1% strained TV4K (TV4K specimens were exposed only during the last test period and the number of specimens was 2). Figure 3.5 c) shows the average number of cracks in the specimens observed by optical microscopy or SEM.

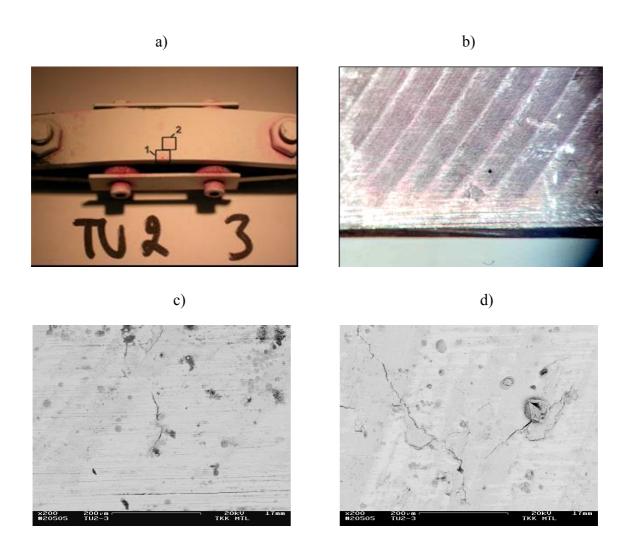
Figure 3.6 (a–d). a) Post-test liquid penetrant indications in specimen TU2-3. The locations of the subsequent photographs are shown with numbered squares. b) A photograph taken by optical microscope from location 1 in a). c)–d) SEM backscattering electron images (BEI) from locations 1 and 2 showing small crack-like features.

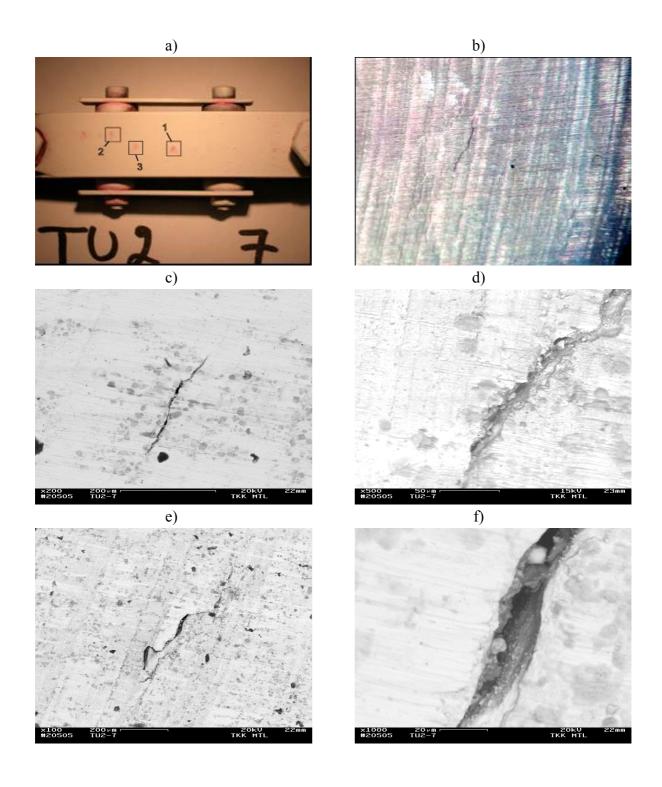
Figure 3.8 (a–f). a) Post-test liquid penetrant indications in specimen TU2-7. The locations of the subsequent photographs are shown with numbered squares. b) A photograph taken by optical microscope from location 1. c) An SEM (BEI) photograph from the same location showing a small crack. d) An SEM (BEI) photograph taken from location 2. e) An SEM (BEI) photograph taken from location 3. f) A higher magnification photograph taken from the same location as e) showing the crack-like appearance of the indication.
