Hot cracking and environmentassisted cracking susceptibility of dissimilar metal welds

Hannu Hänninen¹, Anssi Brederholm¹, Tapio Saukkonen¹, Hans Gripenberg¹, Aki Toivonen², Ulla Ehrnstén² & Pertti Aaltonen²

¹ Helsinki University of Technology, Finland ² VTT Technical Research Centre of Finland

Hänninen Hannu, Brederholm, Anssi, Saukkonen, Tapio, Gripenberg, Hans, Toivonen, Aki, Ehrnstén, Ulla & Aaltonen, Pertti. Hot cracking and environment-assisted cracking susceptibility of dissimilar metal welds. Espoo 2007. VTT Tiedotteita – Research Notes 2399. 182 p.

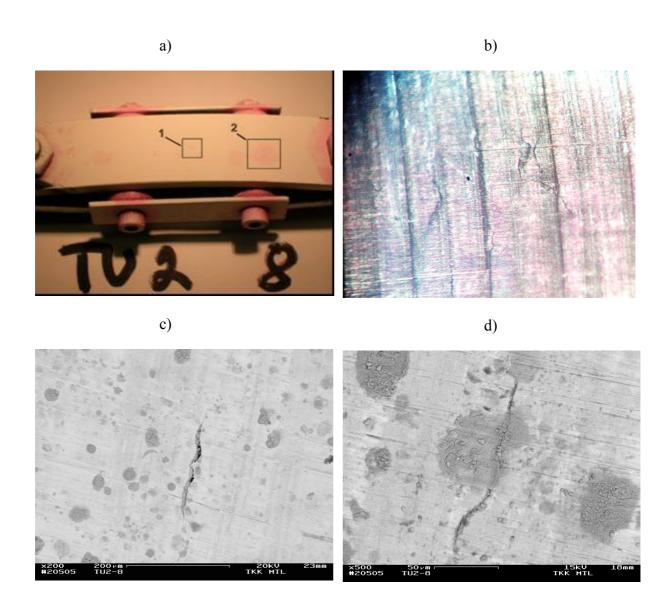
Figure 3.9 (a–d). a) Post-test liquid penetrant indications in specimen TU2-8. The locations of the subsequent photographs are shown with numbered squares. b) A photograph taken by optical microscope from location 1. c) An SEM (BEI) photograph from the same location showing a small crack. d) An SEM (BEI) photograph taken from location 2.

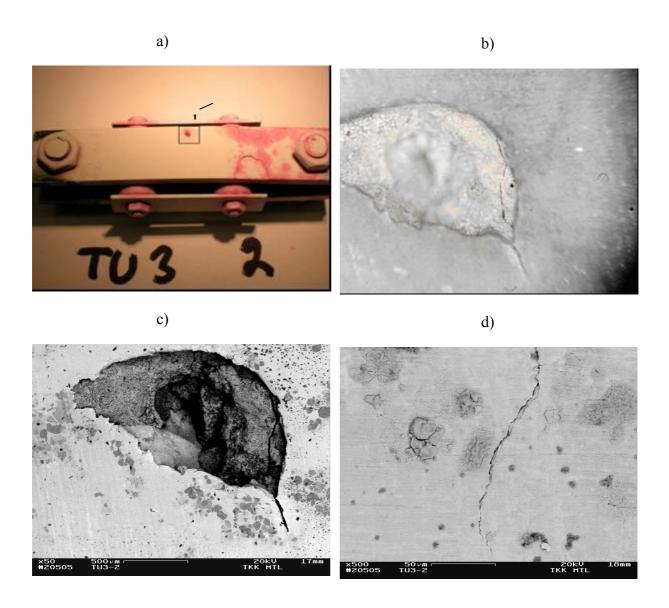
Figure 3.10 (a–d). a) Post-test liquid penetrant indications in specimen TU3-2. The location of the subsequent photographs is shown with the square. b) A photograph taken by optical microscope from location 1. A crack associated with a pit can be seen. c) An SEM (BEI) photograph from the same location showing the crack more clearly. d) An SEM (BEI) photograph taken from the tip of the same crack.

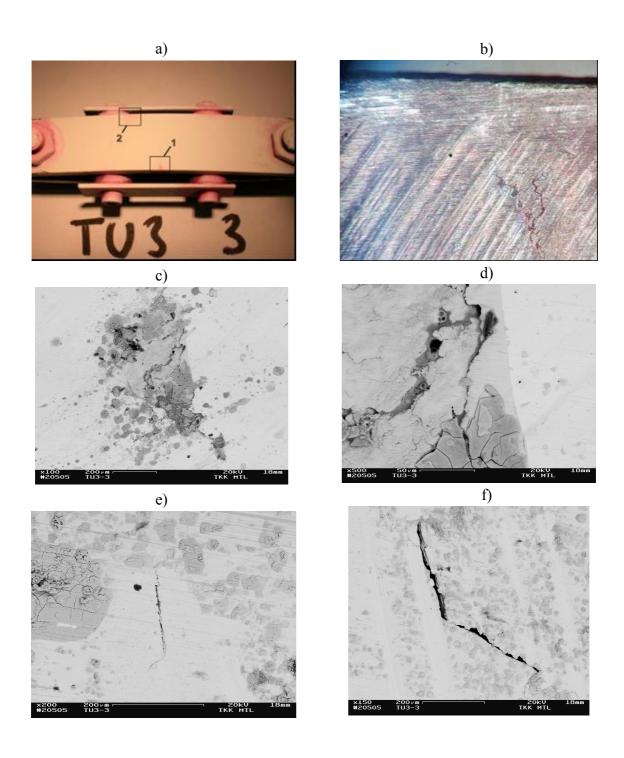
Figure 3.11 (a–f). a) Post-test liquid penetrant indications in specimen TU3-3. The locations of the subsequent photographs are shown with numbered squares. b) A photograph taken by optical microscope from location 1 (Inconel 52 buttering layer). c) An SEM (BEI) photograph from the same location showing cracked oxide layer which is different from the general surface of the specimen. d) A higher magnification SEM (BEI) photograph taken from the same location. The cracks in the oxide can be seen more clearly. e) and f) SEM (BEI) photographs taken from location 2 showing crack-like features (Inconel 152 weld).

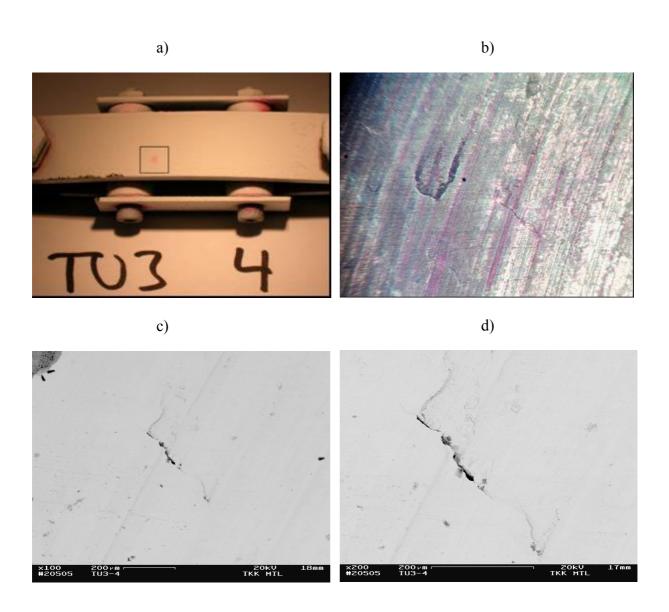
Figure 3.12 (a–d). a) Post-test liquid penetrant indication in specimen TU3-4 in Inconel 52 buttering layer. b) A photograph taken by optical microscope from the indication. c) and d) SEM (BEI) photographs from the same location showing a small crack-like feature.

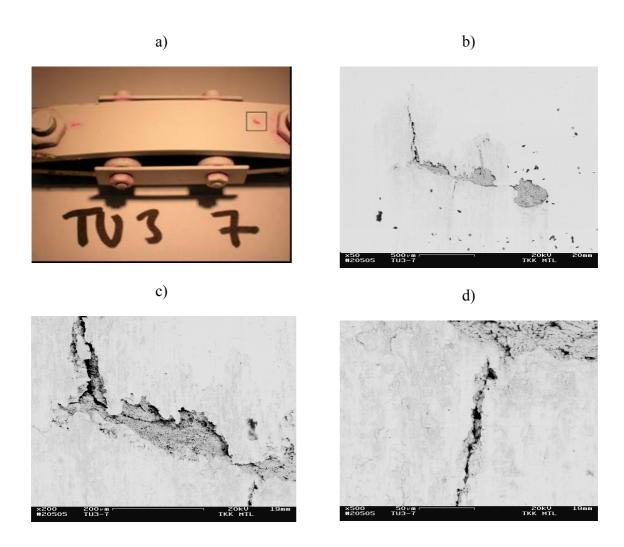
Figure 3.14 (a–d). a) Post-test liquid penetrant indications in specimen TU3-7. The location of the subsequent photographs is shown with a square. b)–d) SEM (BEI) photographs showing that the indication is a branched crack associated with a wider area where the surface layer (probably a slag inclusion) has cracked or dissolved away.

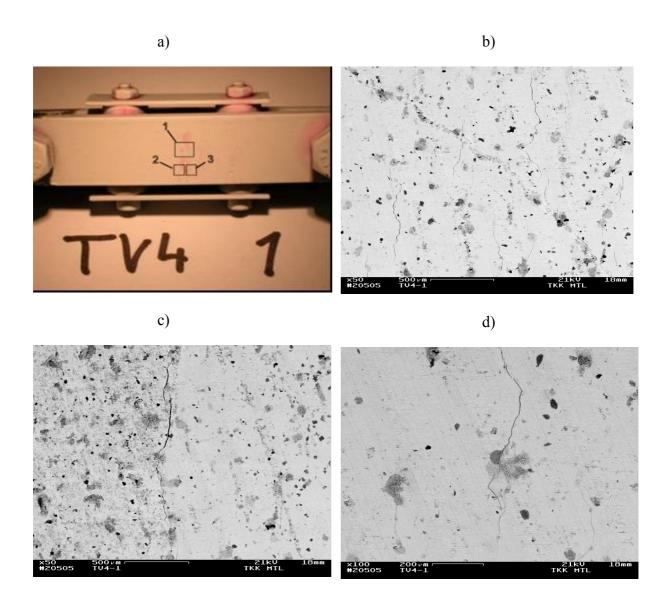
Figure 3.15 (a–d). a) Post-test liquid penetrant indications in specimen TV4-1. The locations of the subsequent photographs are shown with squares. b) An SEM (BEI) photograph taken from location 1. c) An SEM (BEI) photograph taken from location 2. d) An SEM (BEI) photograph taken from location 3. All SEM photographs show one or several long but narrow cracks. The crack in image c) is located in the weld-Inconel 600 base metal interface. Other cracks are both in weld buttering (Inconel 182) and weld joint (also Inconel 182).

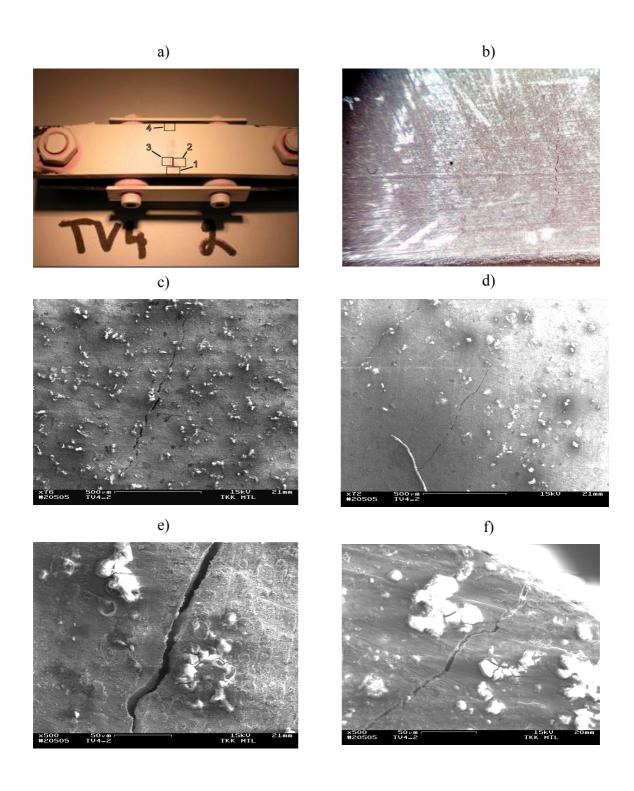
Figure 3.16 (a–f). a) Post-test liquid penetrant indications in specimen TV4-2. The locations of the subsequent photographs are shown with squares. b) A photograph taken by optical microscope from the indication in location 1 close to the specimen side surface. c) An SEM (secondary electron image, SEI) photograph taken from the same location. d)–f) SEM (SEI) photographs taken from locations 2–4, respectively. Cracks exist both in weld buttering and weld joint.

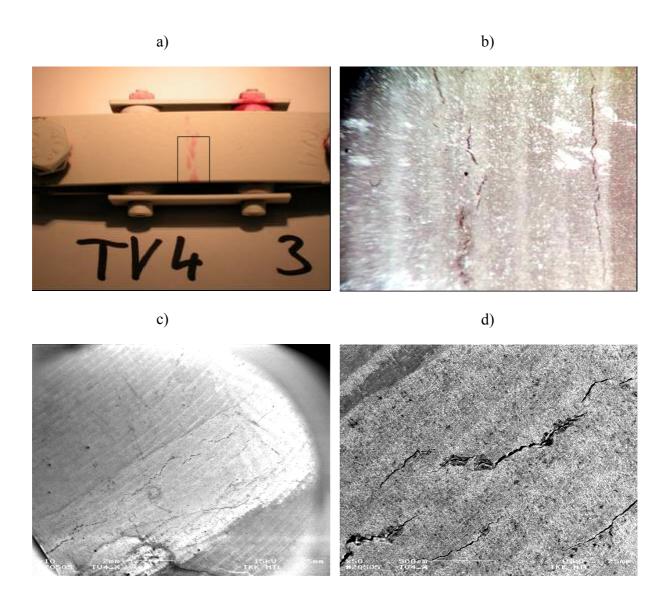
Figure 3.17 (a–d). a) Post-test liquid penetrant indications in specimen TV4-3. b) A photograph taken by optical microscope from the area marked with the square in image a). c) and d) SEM (BEI and SEI, respectively) photographs taken from the same location. Cracks are located in the weld buttering, weld joint and smaller ones also in Inconel 600 base metal.

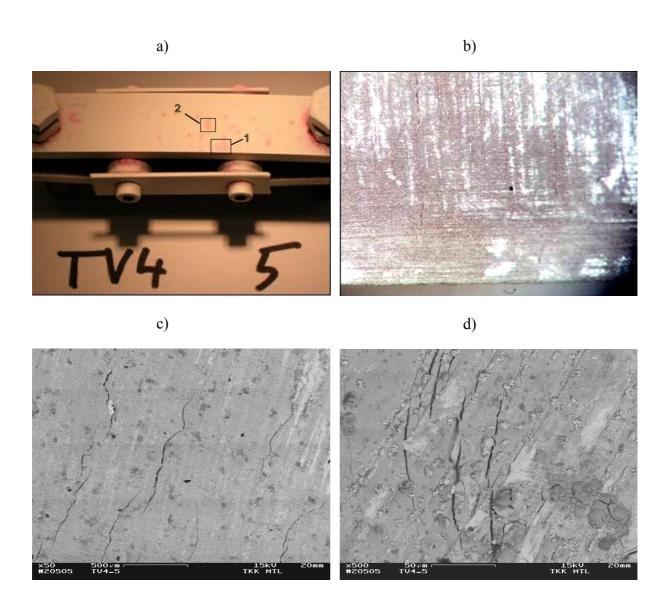
Figure 3.19 (a–d). a) Post-test liquid penetrant indications in specimen TV4-5. b) A photograph taken by optical microscope from location 1 (Inconel 600 base metal). c) An SEM (BEI) photograph taken from the same location as image b). d) An SEM (BEI) photograph taken from location 2 (Inconel 182 weld metal). The cracks were located in Inconel 182 buttering layer, weld joint and Inconel 600 base metal.

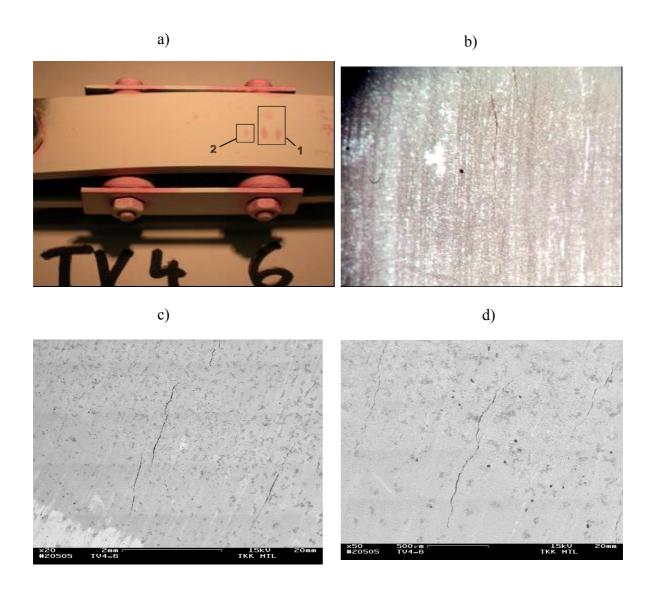
Figure 3.20 (a–d). a) Post-test liquid penetrant indications in specimen TV4-6. b) A photograph taken by optical microscope from location 1 (Inconel 182 buttering and weld joint). c) An SEM (BEI) photograph taken from the same location as image b). d) An SEM (BEI) photograph taken from location 2 (Inconel 182 weld metal). The cracks were located in Inconel 182 buttering layer and weld joint. No cracks were observed in Inconel 600 base metal.

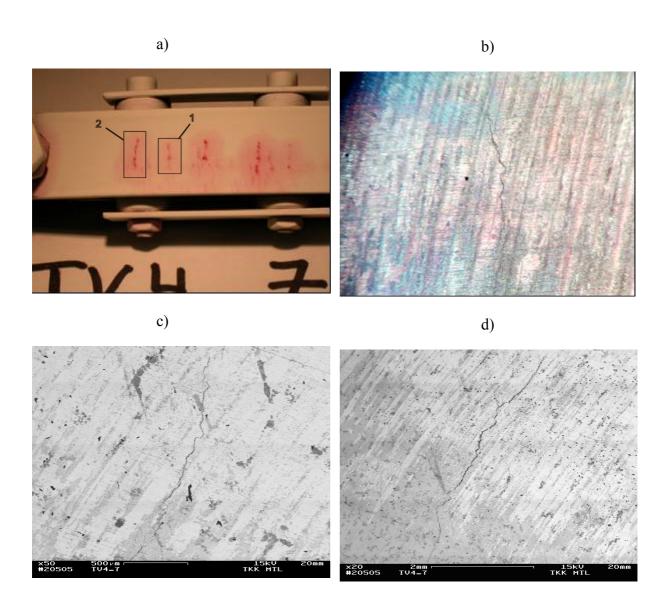
Figure 3.21 (a–d). a) Post-test liquid penetrant indications in specimen TV4-7. b) A photograph taken by optical microscope from location 1 (Inconel 182 buttering and weld joint). c) An SEM (BEI) photograph taken from the same location as image b). d) An SEM (BEI) photograph taken from location 2 (Inconel 182 buttering and weld joint). Some of the cracks extend into Inconel 600 base metal.

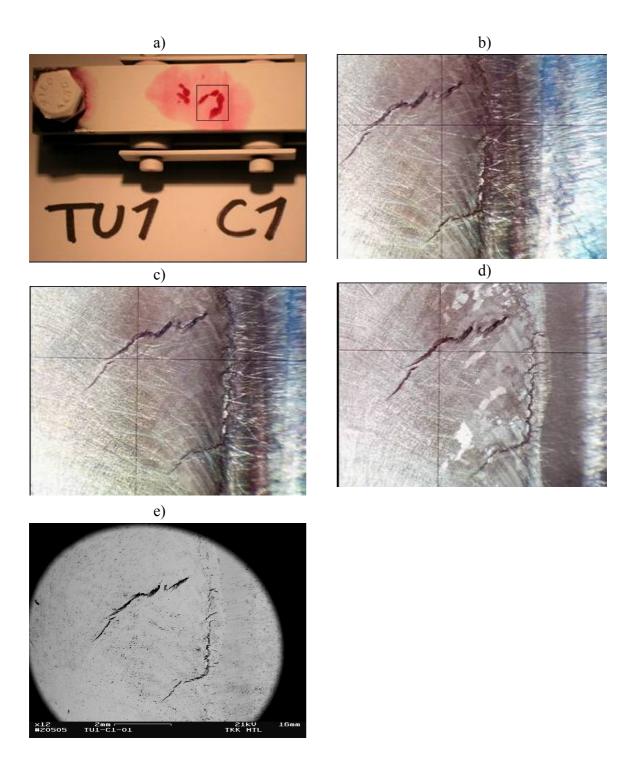
Figure 3.22 (a–e). a) Liquid penetrant indications in hot cracked specimen TU1C1. b) A photograph taken by optical microscope from the location indicated in image a) by a rectangle after Varestraint test. Image c) is the same crack as in image b) but after loading. Image d) is the same crack as in images b) and c) but after exposure to doped steam. e) Post-test SEM (BEI) photograph of the same location. The hot cracks are located in Inconel 152 weld metal and weld metal/AISI 316NG base metal interface.

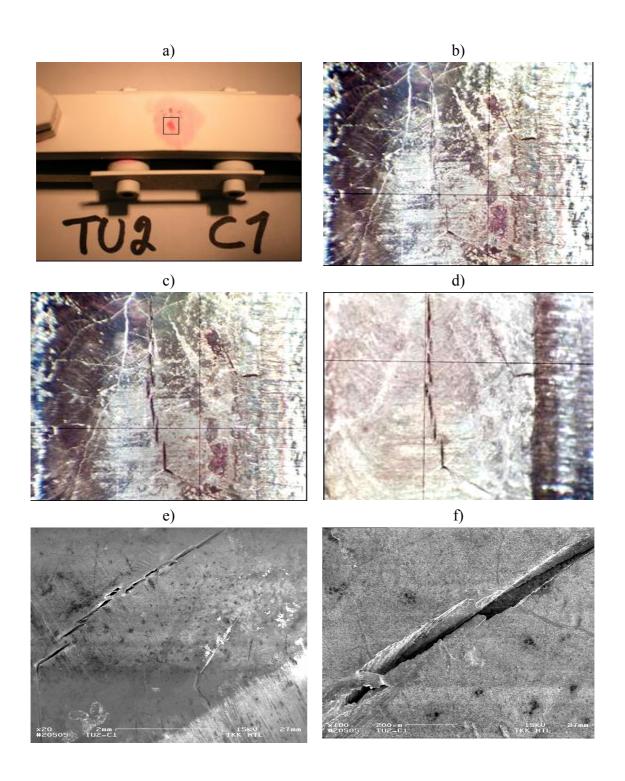
Figure 3.23 (a–f). a) Liquid penetrant indications in hot cracked specimen TU2C1. b) A photograph taken by optical microscope from the location indicated in image a) by a rectangle after Varestraint test. Image c) is the same crack as in image b) but after loading. Image d) is the same crack as in images b) and c) but after exposure to doped steam. Images e) and f) are post-test SEM (SEI) photographs of the same location. The hot cracks are located in Inconel 52 weld metal.

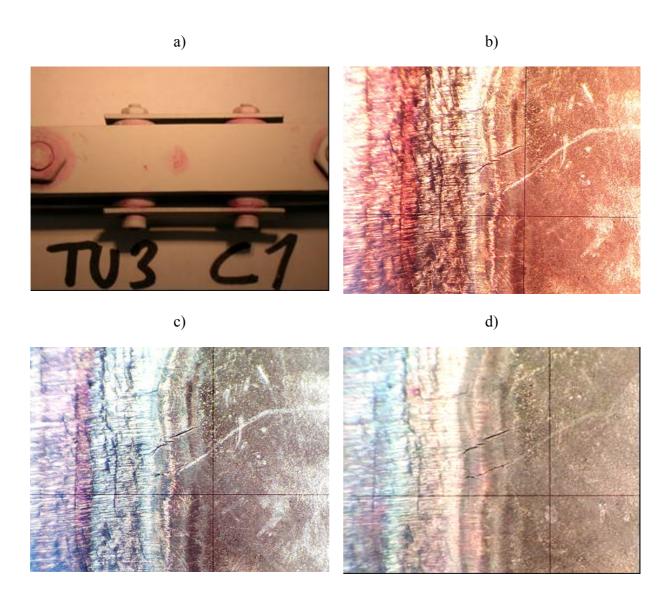
Figure 3.24 (a–d). a) Liquid penetrant indications in hot cracked specimen TU3C1. b) A photograph taken by optical microscope from the liquid penetrant indication after Varestraint test. Image c) is the same crack as in image b) but after loading. Image d) is the same crack as in images b) and c) but after exposure to doped steam. The hot cracks are located in Inconel 152 weld metal (not in alloy 152 or 52 buttering layers).

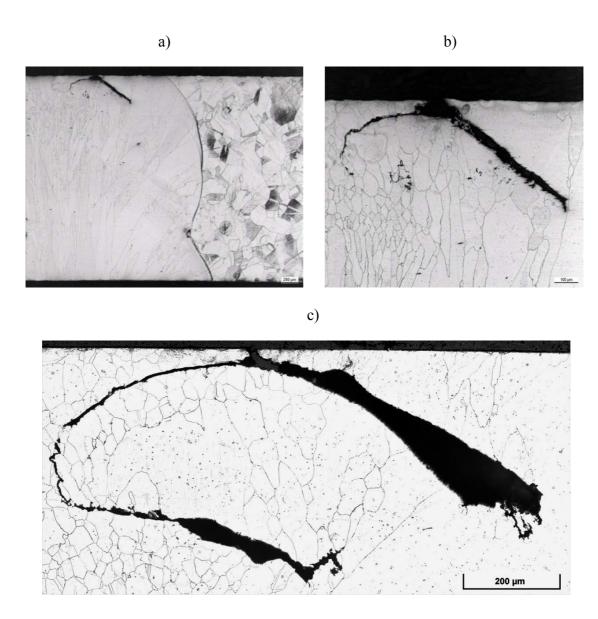
Figure 3.25 (a–c). a) A micrograph showing a part of the weld with a crack in a section cut from the weld region of specimen TU2-4. AISI 316 NG base metal is seen on the right hand side of the Inconel weld (as polished and etched). b) A higher magnification micrographs from a) (as polished and etched). c) The same location, but after \sim 0.5 mm further grinding (after etching).

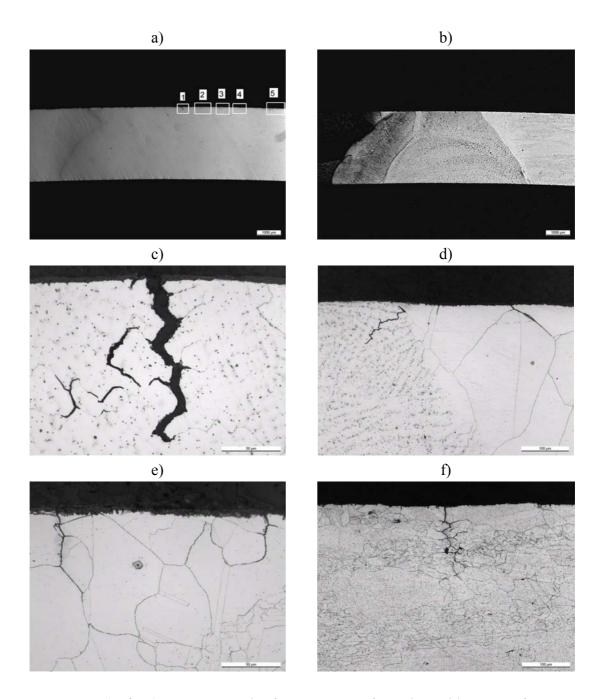
Figure 3.26 (a–f). a) A macrograph of a section cut from the weld region of specimen TV4-3. The locations of the micrographs c)–f) are shown in the photograph. b) The same section as in a) in etched condition. c) Micrograph taken from location 1 (cracks in the weld). d) Micrograph taken from location 2 (cracks in weld and Inconel 600 HAZ). e) Micrograph taken from location 3 (cracks in HAZ). f) Micrograph taken from location 4 (a branching crack in Inconel 600 base metal).

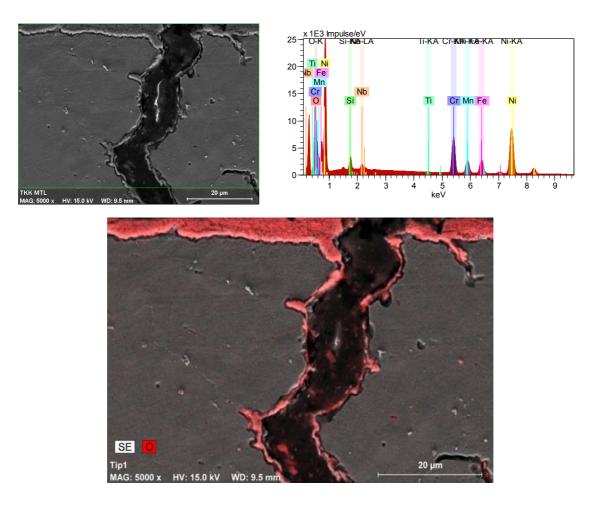
Figure 3.27. EDS analysis of cross-section of an EAC crack of specimen TV4-3 showing oxidation of the fracture surface and the outer surface of the specimen in the doped steam test.

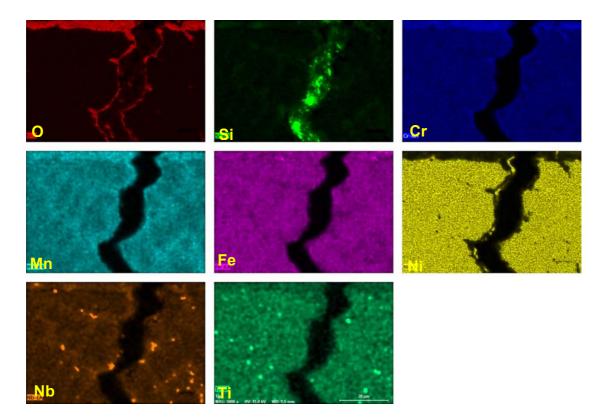
Figure 3.28. X-ray element maps of cross-section of an EAC crack of specimen TV4-3 showing element distribution in the oxide layer.

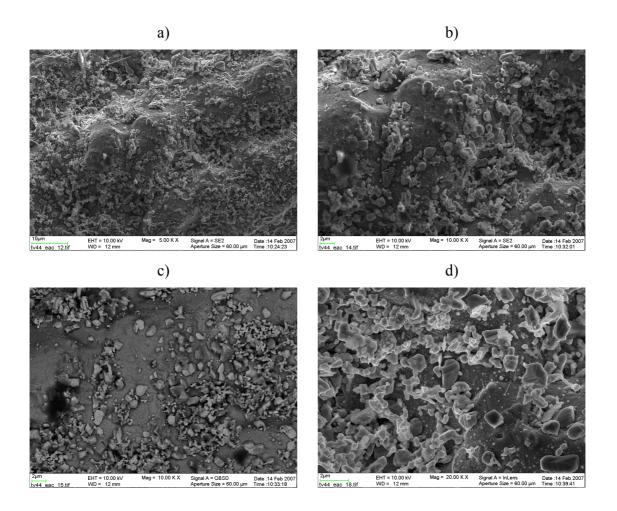
Figure 3.29 (a–d). Fracture surface of the main EAC crack of specimen TV4-4 close to the outer surface is covered by NiO particles.

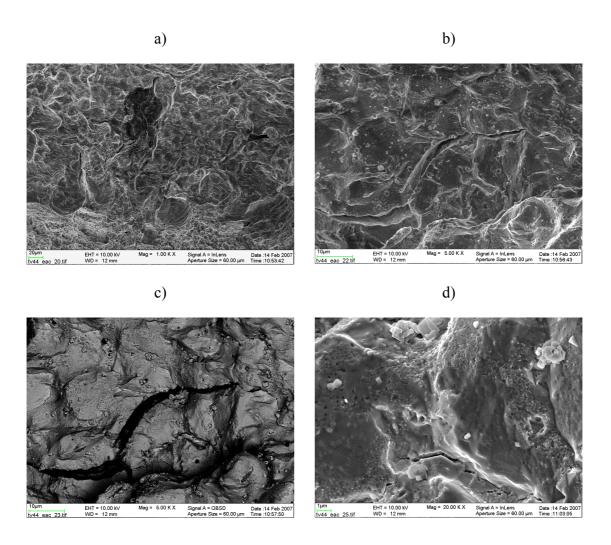
Figure 3.30 (a–d). Fracture surface of the main EAC crack of specimen TV4-4 close to the crack tip shows particles of Nb(N, C) but no NiO particles.

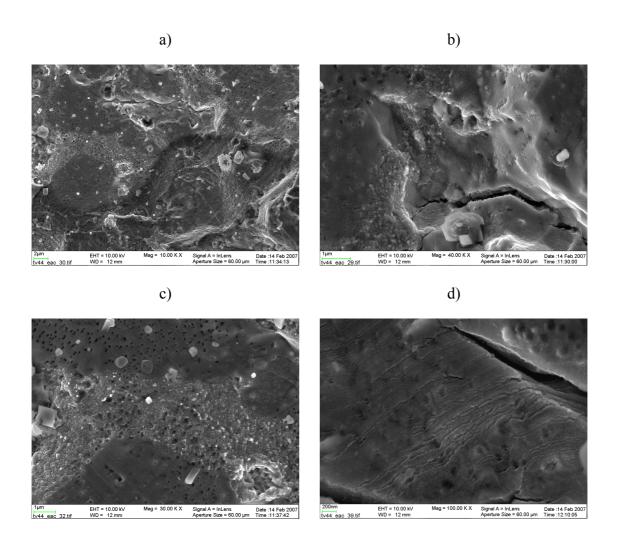
Figure 3.31 (a–d). Fracture surface of the main EAC crack of specimen TV4-4 close to the crack tip shows areas which are more rough than the otherwise smooth intergranular fracture surface. A thin oxide layer is on the fracture surface visible in d).

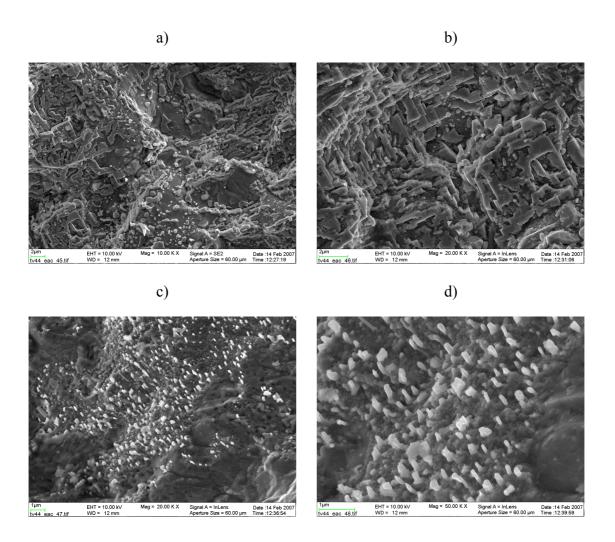
Figure 3.32 (a–d). Fracture surface of the main EAC crack of specimen TV4-4 in the middle of the fracture shows growth of NiO particles through the thin oxide layer and their subsequent lateral growth on the fracture surface.

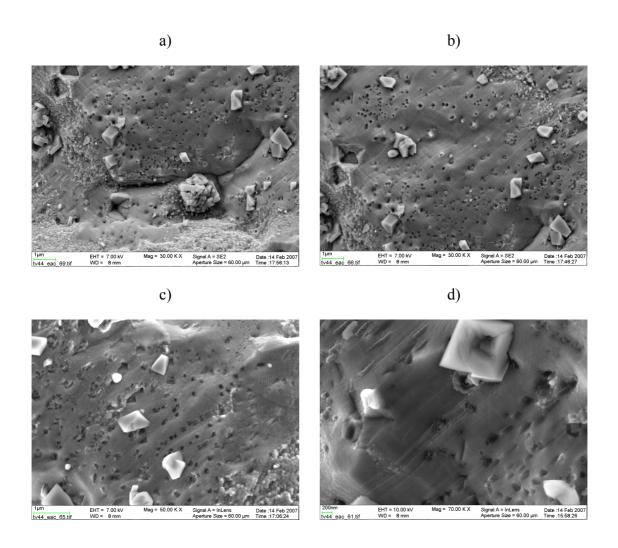
Figure 3.33 (a–d). Fracture surface of the main EAC crack of specimen TV4-4 close to the crack tip shows smooth intergranular features with large Nb(C, N) particles and a large amount of small precipitates.

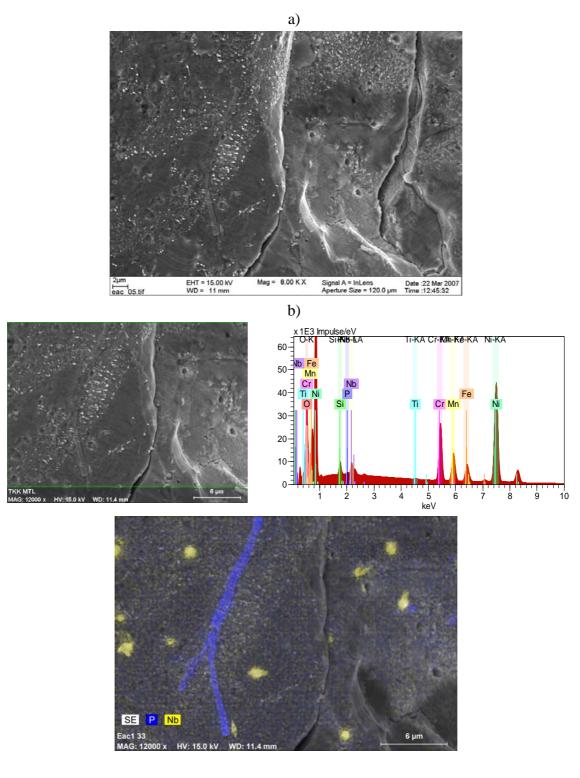
Figure 3.34 (a and b). Fracture surface of the main EAC crack of specimen TV4-4 in the area where NiO particle growth is starting shows also some lamellar features similar to the Laves phase seen on the hot cracking fracture surfaces of alloy 182. a) Fracture surface, and b) EDS analysis of the fracture surface showing P-rich lamellar phase and Nb-rich Nb(C, N) particles.

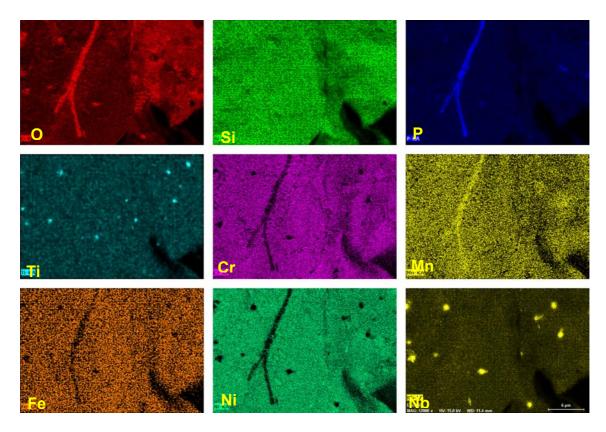
Figure 3.35. X-ray element maps of the fracture surface of the main EAC crack of specimen TV4-4 showing enrichment of P, Mn, and O as well as depletion of Ni, Cr, and Fe in the lamellar phase and Nb-rich Nb(C, N) particles.
