# **Environment-assisted cracking and hot cracking susceptibility of nickel-base alloy weld metal**

Hannu Hänninen, Anssi Brederholm, Tapio Saukkonen &  
Mykola Ivanchenko

Aki Toivonen, Wade Karlsen, Ulla Ehrnstén & Pertti Aaltonen

Hannu Hänninen, Anssi Brederholm, Tapio Saukkonen, Mykola Ivanchenko, Aki Toivonen, Wade Karlsen, Ulla Ehrnstén & Pertti Aaltonen. Environment-assisted cracking and hot cracking susceptibility of nickel-base alloy weld metals. Espoo 2011. VTT Tiedotteita – Research Notes 2582. 152 p.

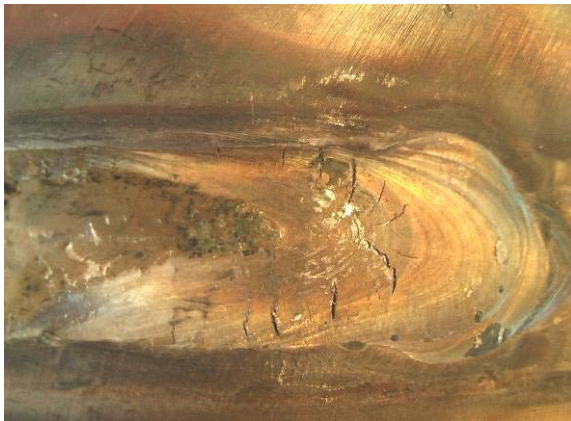
Figure 4 a) presents the surface of the Alloy 182 weld test piece with hot cracks after Varestraint testing (augmented strain 4%). Optical micrograph b) of a hot crack (dark areas) in the cross-section of the weld and FEG-SEM micrographs c) and d) of hot crack tips show details of an irregularly shaped white phase associated with the hot cracks of this alloy. The compositions of the white phase areas were examined by energy dispersive X-ray spectroscopy (EDS). Figure 5 presents X-ray element maps and Figure 6 shows a SEM image and EDS analyses of the white phase area in a dendrite boundary region. They show marked Si, Nb, Mn and P enrichment, which is compensated by depletion of Cr, Fe and Ni. Based on the high magnification backscattered electron (BSE) images and the EDS analyses, the phase appearing white in the optical micrograph of Figure 4 b) actually consists of two phases, appearing white and grey in SEM (Figure 4 d), with varying Nb, Si, Mn and Ti contents. Inside and along the dendrite/grain boundaries white Nb-rich particles, Nb(C, N), are present.

Figure 4. a) Surface of Alloy 182 weld test piece with hot cracks after Vareststraint test (augmented strain 4%). b) Optical micrograph of the hot cracks (dark areas) in a cross-section of the weld (note the white phase ahead of the hot crack tip). c) and d) SEM micrographs of weld hot crack tips showing details of the irregularly shaped white phase on the dendrite boundaries.

EBSD can be used to identify the phase structure of the weld metal. The white phase (e.g., Figure 4) presumed to be a Laves phase in Alloys 182, 152 and 82 was analysed by EBSD. Laves phase compounds  $AB_2$  are formed with A being large ion radius rare-earth or transition metal (Sc, Si, Ti, V, Zr, Nb, Mo Ta, W), while the B atoms with a small ion radius can be simple metal or transition metal (Cr, Mn, Fe, Co, Ni, Mo, Tc, Ru, Rh). The crystal structure can be the cubic C15- $MgCu_2$  type, hexagonal C14- $MgZn_2$  type or dihexagonal C36- $MgNi_2$  type [18, 19]. The size difference is necessary for the stability of a Laves phase. The ideal size ratio of A and B atoms is 1.225. In the weld metal Laves phase A and B atoms are typically not pure elements, but the mixture of several suitable elements of

Figure 50. Laves phase confirmation with EBSD for Alloy 182 hot crack tip (see Figure 4, characterization of the nickel-base alloy weld metals). a) A typical EBSD pattern of the base material. b) An EBSD pattern of the white phase. c) Another EBSD pattern of the white phase. d) The solution with the formed Laves phase simulation.

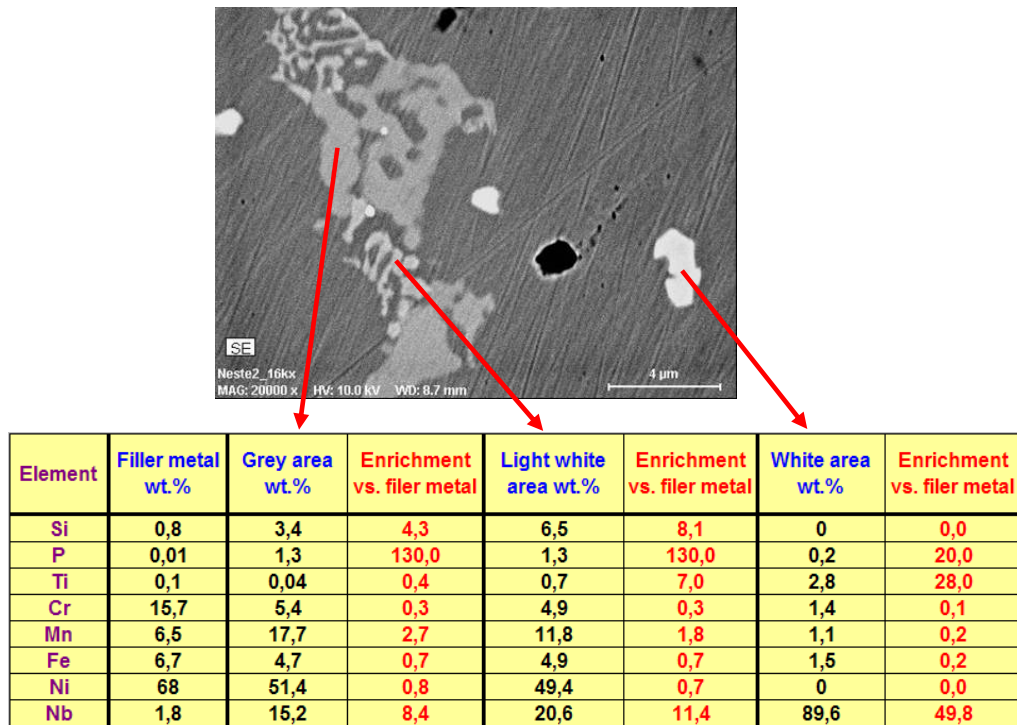
Figure 6. SEM image and EDS analyses of the white and grey phase in Alloy 182 weld showing Nb, Si, Mn and P enrichment and Nb-rich particles, Nb(C, N). The spot size in EDS analysis has an interaction diameter about 1  $\mu\text{m}$ , and therefore the surrounding matrix affects also the result.

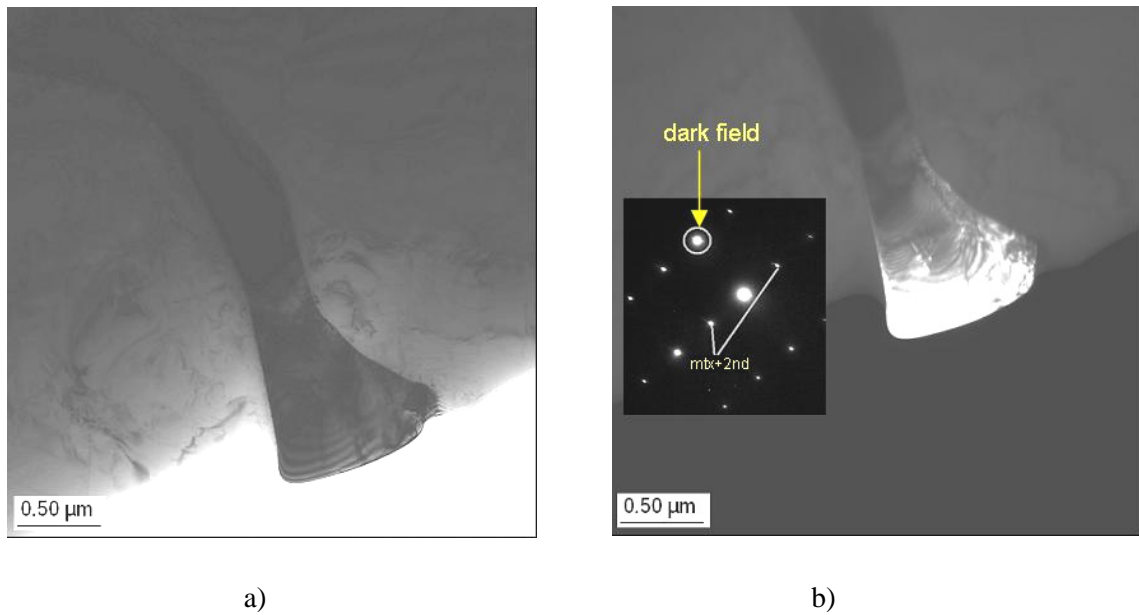
Figure 11. a) Rounded-shaped phase ahead of the hot crack tip, with a composition of 90Nb-2Ti-3Ni-3Cr-1Fe (wt.%). b) Diffraction pattern and dark field image of the phase shows that it is a distinctly different phase.

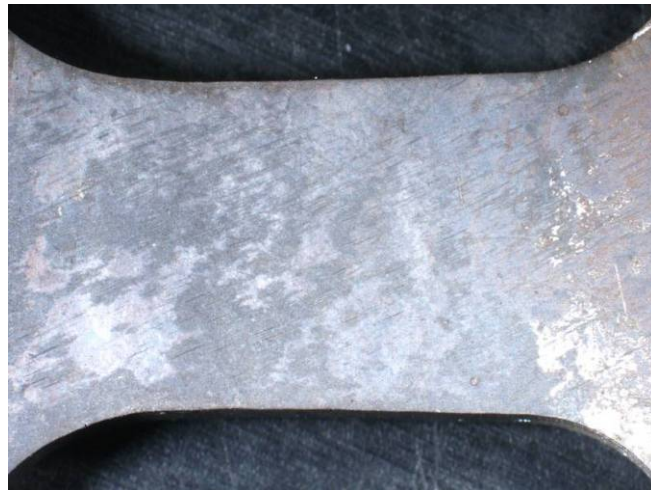
In these tests no indications of ductility-dip cracking of the test specimens were observed at the strain applied, Figure 29. The reason was that part of the strain took place in the AISI 304 steel extension material, so the true amount of strain in the gauge length was less than the desired strain. The argon gas shielding intended to prevent oxidation was also insufficient, and severe oxidation occurred on the surface of the test specimen. Tests are to be continued with revised test specimen geometry and improved gas shielding.

Figure 29. Alloy 182 test specimen surface after a DDC test at 1000°C up to 4% of plastic strain. No indications of DDC cracks are visible.

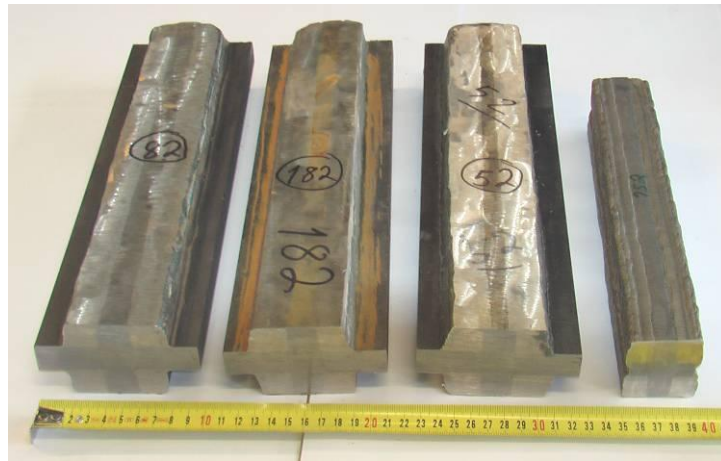
Figure 59. Four welded Ni-base alloy blocks: from the left Alloy 82, 182, 52 and 152.

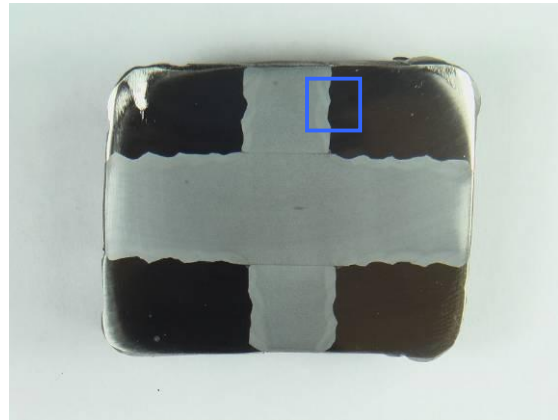
b)

The corners of the cross were filled length-wise by multi-pass welding in sequence presented in Figure 60 a. An example of a cross-section of Alloy 152 block is shown in Figure 60 b. Welding methods were shielded metal arc welding (SMAW) for filler metals of Alloy 182 and 152 and gas tungsten arc welding (GTAW) for filler metals of Alloy 82 and 52, respectively.

Figure 60. Welding sequence (a) and an example of a cross-section of Alloy 152 block (b).

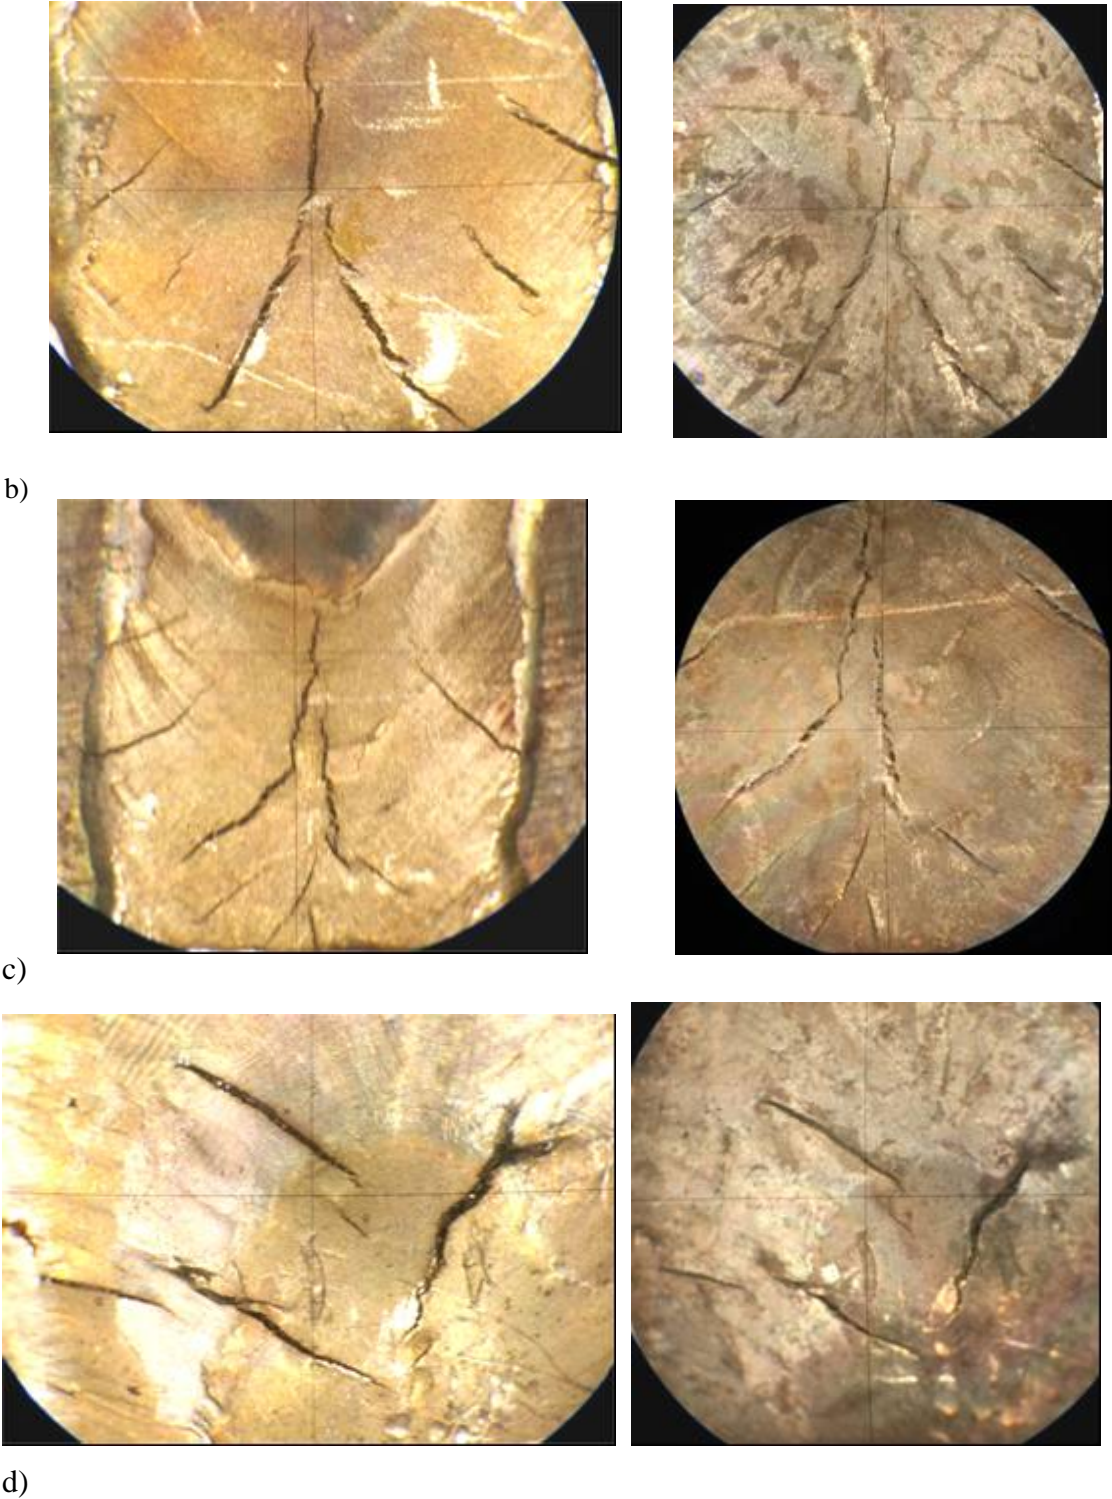
Figure 85. Pure alloy welds after hot cracking in Vareststraint test and after 750 h testing in doped steam. a) Alloy 182 (specimen No. 35), b) Alloy 82 (specimen No. 36), Alloy 152 (specimen No. 37), and d) Alloy 52 (specimen No. 38).

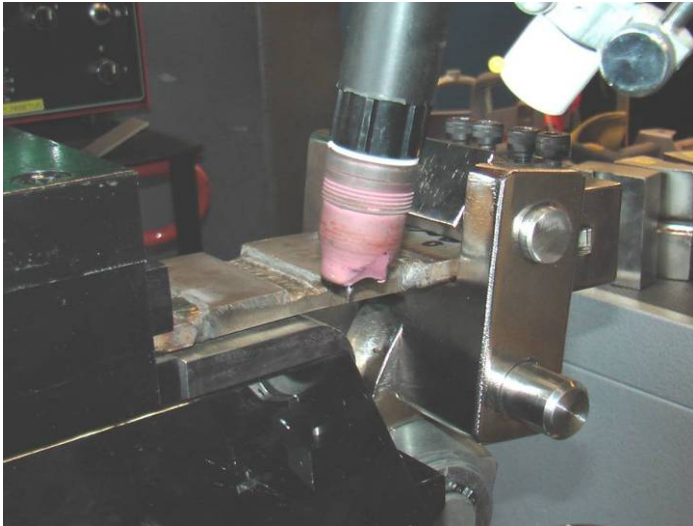
When the weld groove was almost filled, the trans-Varestraint test was performed with autogeneous gas tungsten arc (GTA) welding as shown in Figure 107. During Varestraint testing a small augmented strain (about 2%) was introduced, which was enough to produce the hot cracks in the weld bead.

Welding current:	250 A
Welding voltage:	12,5 V
Welding speed:	12 cm/min
Heat input:	9,4 kJ/cm
Bending speed:	16 mm/s
Augmented strain:	ca. 2 %

Figure 107. Trans-Varestraint testing of the test sample with almost filled weld metal. The Varestraint testing parameters are shown as an insert in the figure.
