Matti Pajari

Prestressed hollow core slabs supported on beams

| Finnish shear tests on floors in 1990–2006

VTT Working Papers 148
VTT-WORK-148

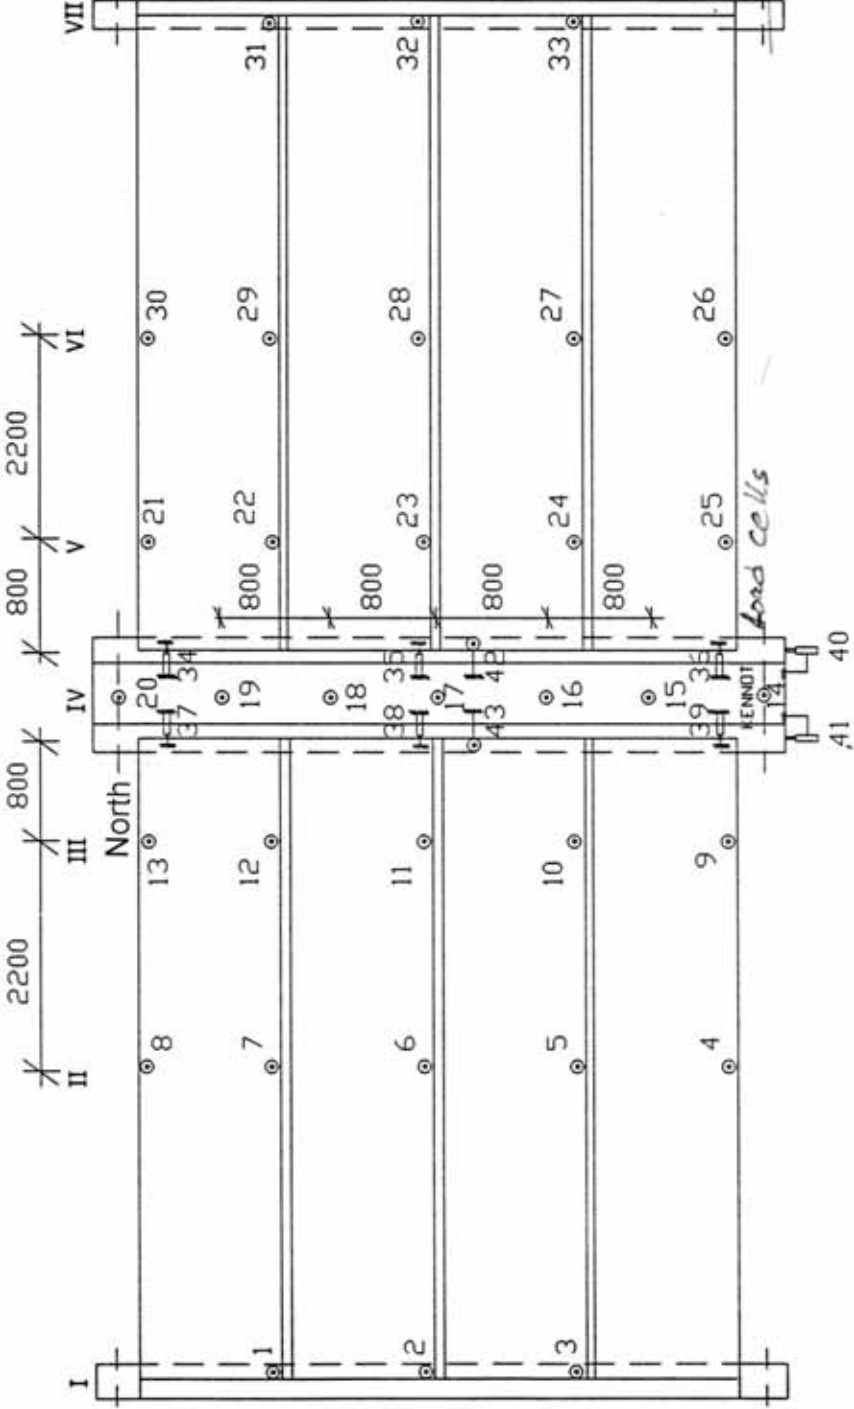
<p data-bbox="347 1848 1484 2018">Fig. 8. Location of transducers 1 ... 33 for measuring vertical deflection, 34 ... 39 for measuring the opening of cracks along the WQ-beam, 40 and 41 for measuring the differential horizontal displacement between the end of the beam and the joint concrete (see Fig. 13) and 42 & 43 for measuring differential vertical displacement between the slab end and the beam.</p>

<p>3.3 Average strain</p>	<p>-</p>
<p>3.4 Horizontal displacements</p>	<p>See Fig. 8, transducers 34 ... 41. Transducers 40 and 41 measured the sliding of the joint concrete along the WQ-beam. Fig. 13 gives an impression of the vertical position of these transducers.</p>
<p>3.5 Strain</p>

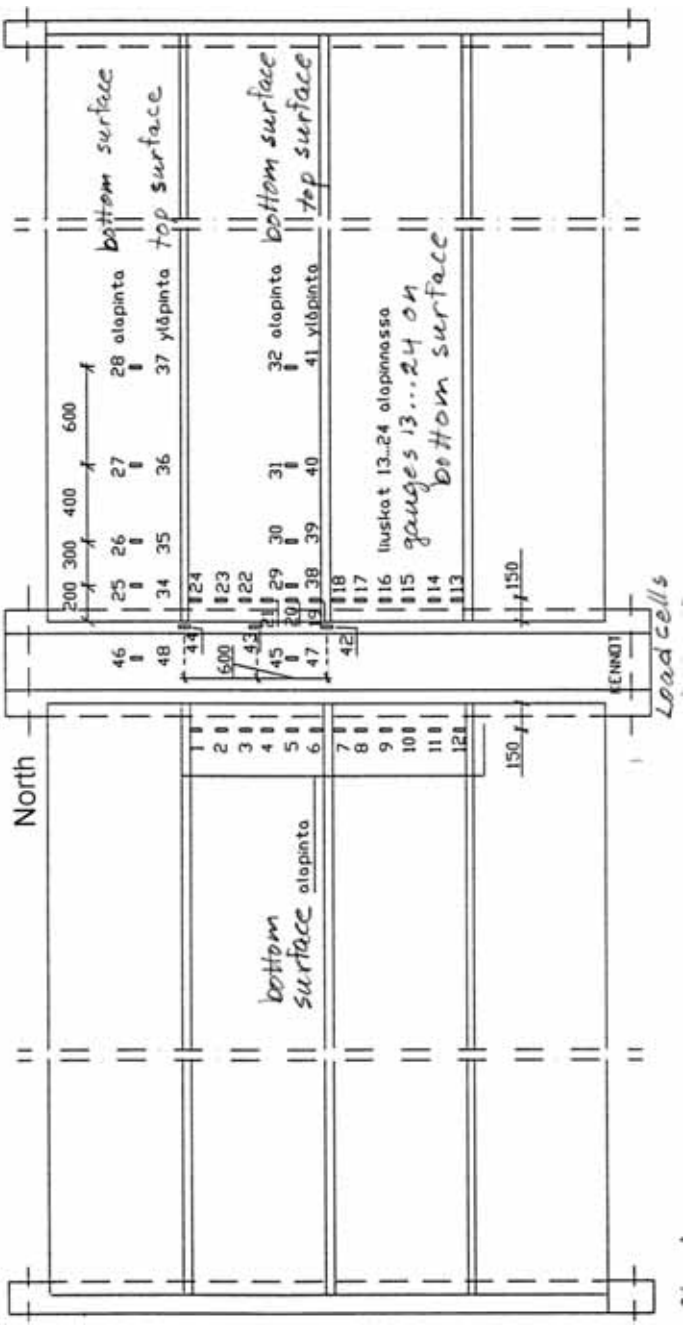
<p>Fig. 9. Position of strain gauges 1 ... 48, all parallel to the beams.</p>

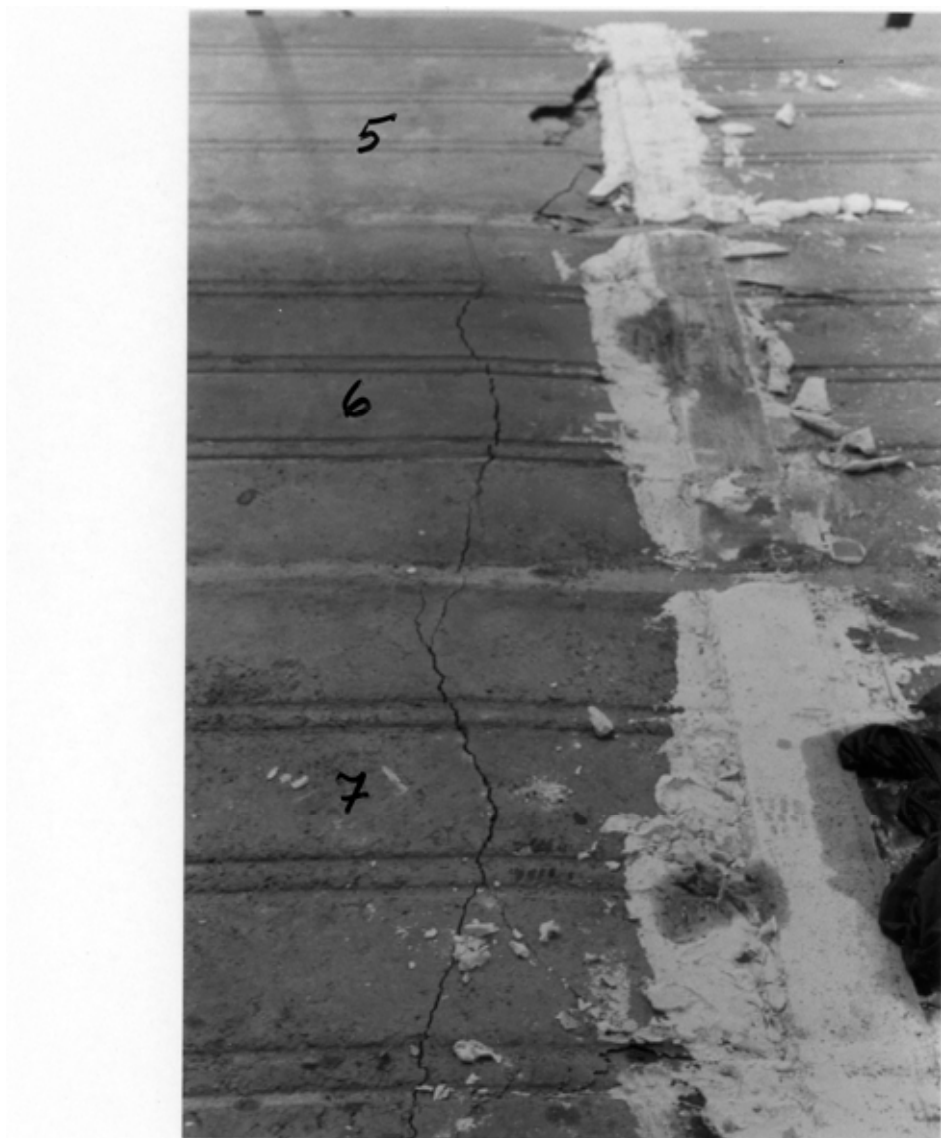
Fig. 8. Failure at stage 2 seen from above after removal of loading equipment.

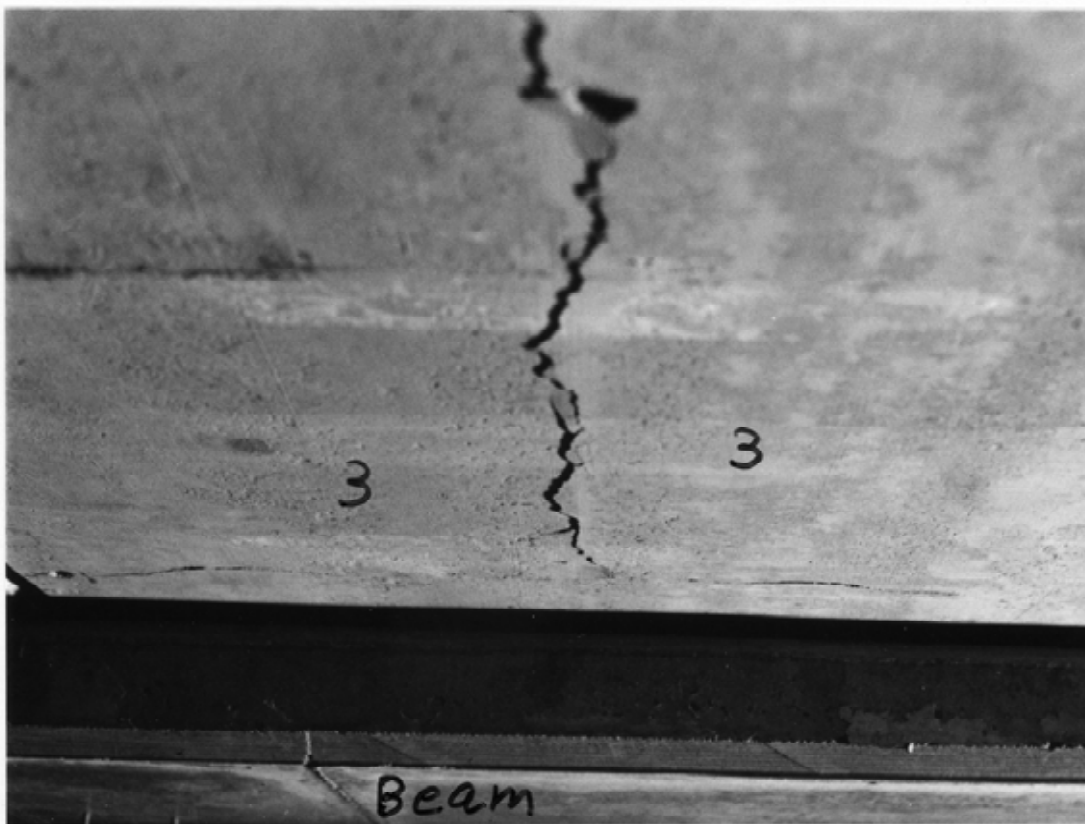
Fig. 18. Longitudinal and transverse cracking of slab unit no 3 seen from below.

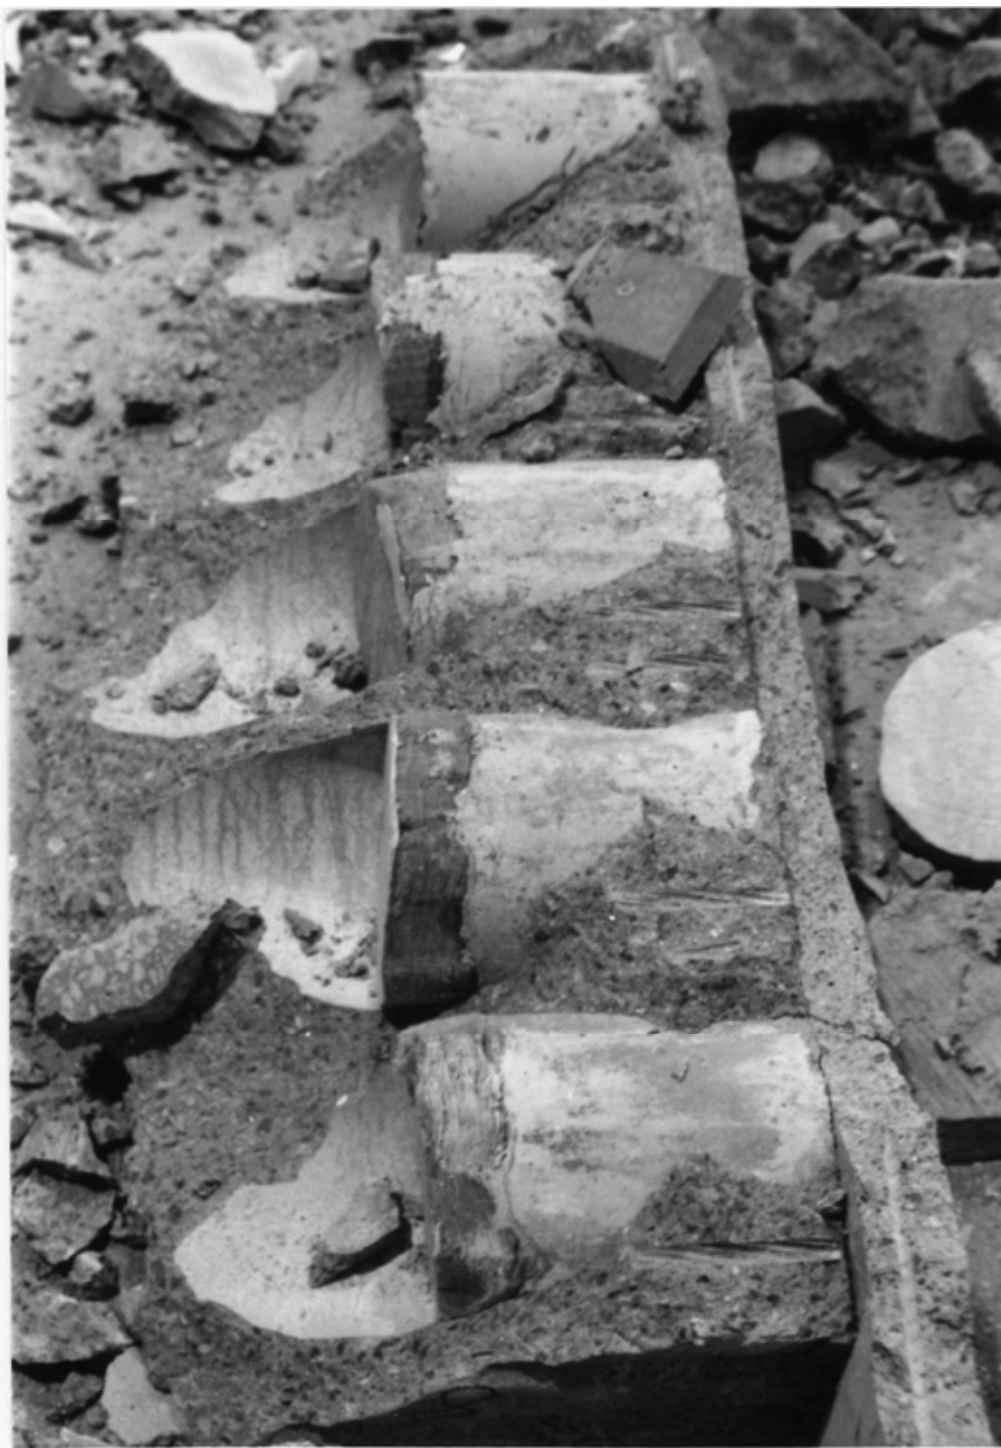
Fig. 19. Void filling at end of slab unit no 8 (upside down).

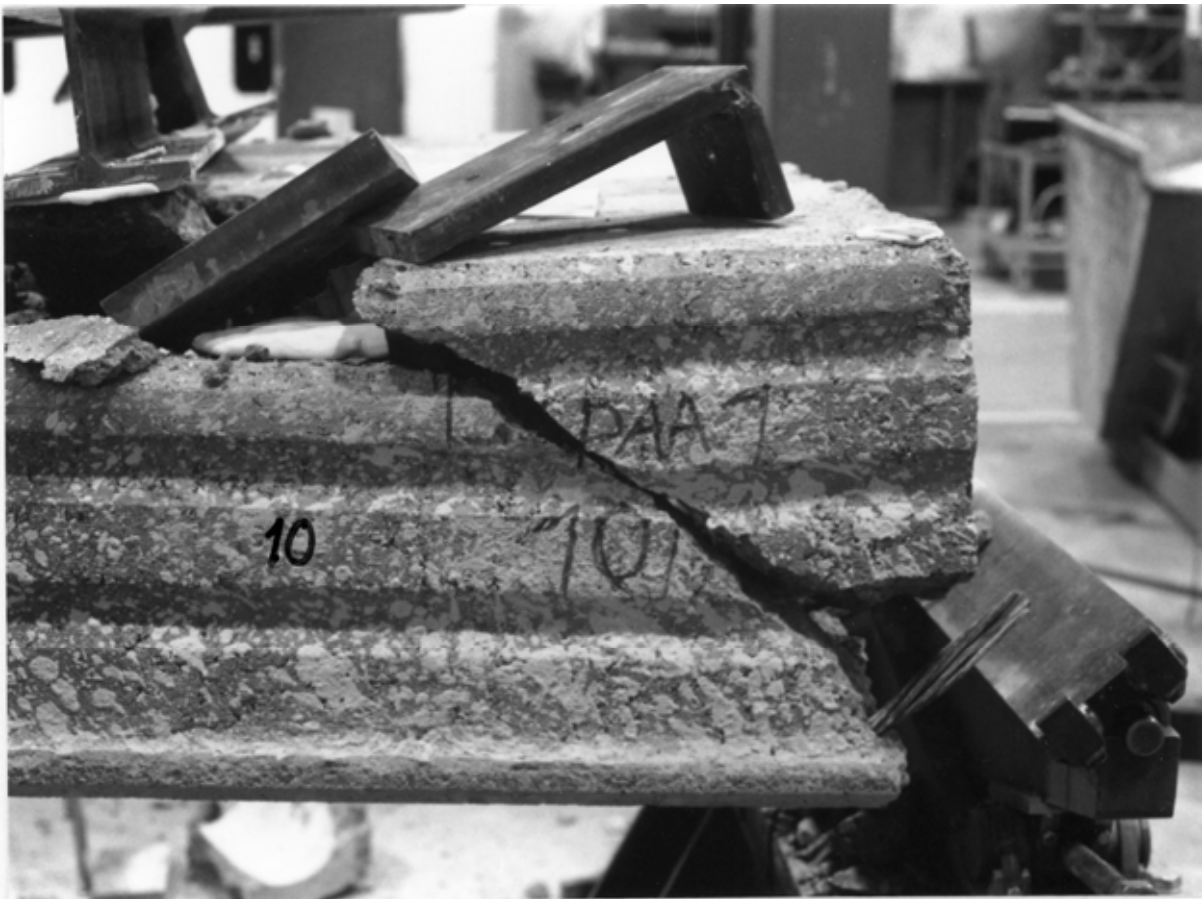
Fig. 28. Reference test R2. Failure pattern.

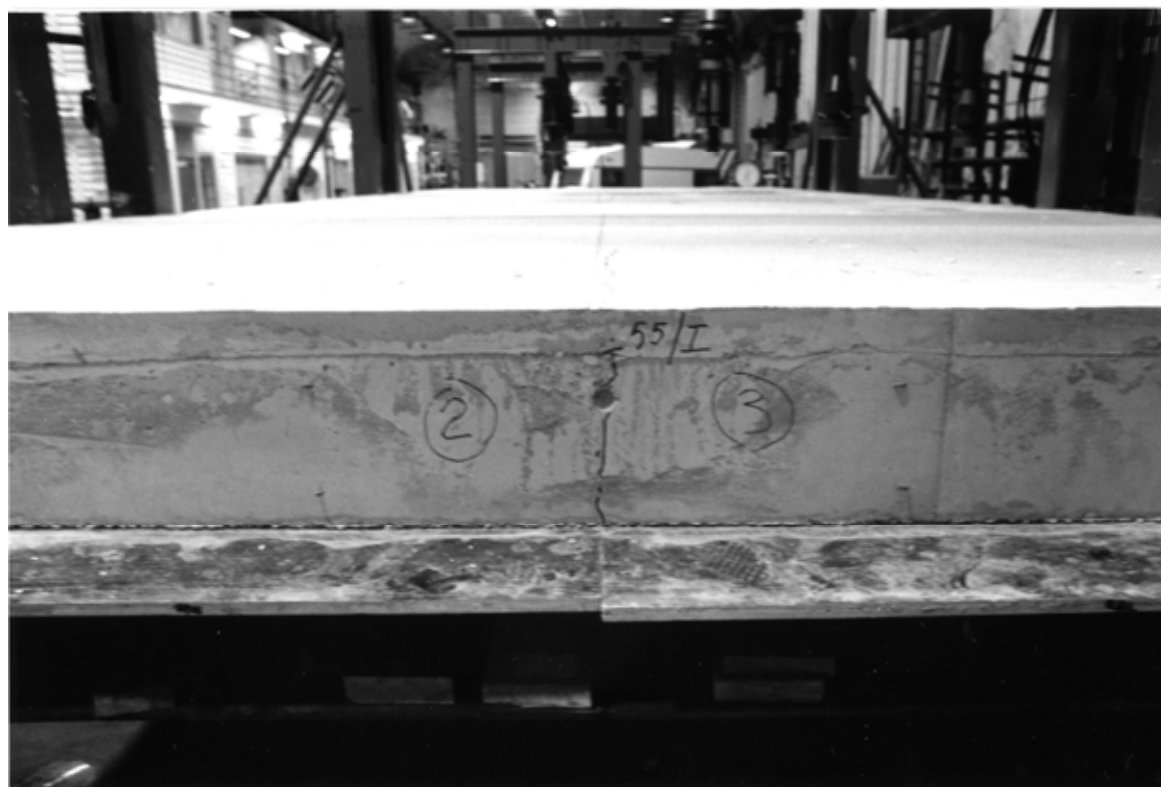
Fig. 8. A crack in the middle of the concrete tie beam, between the slab unit no 2 and 3.

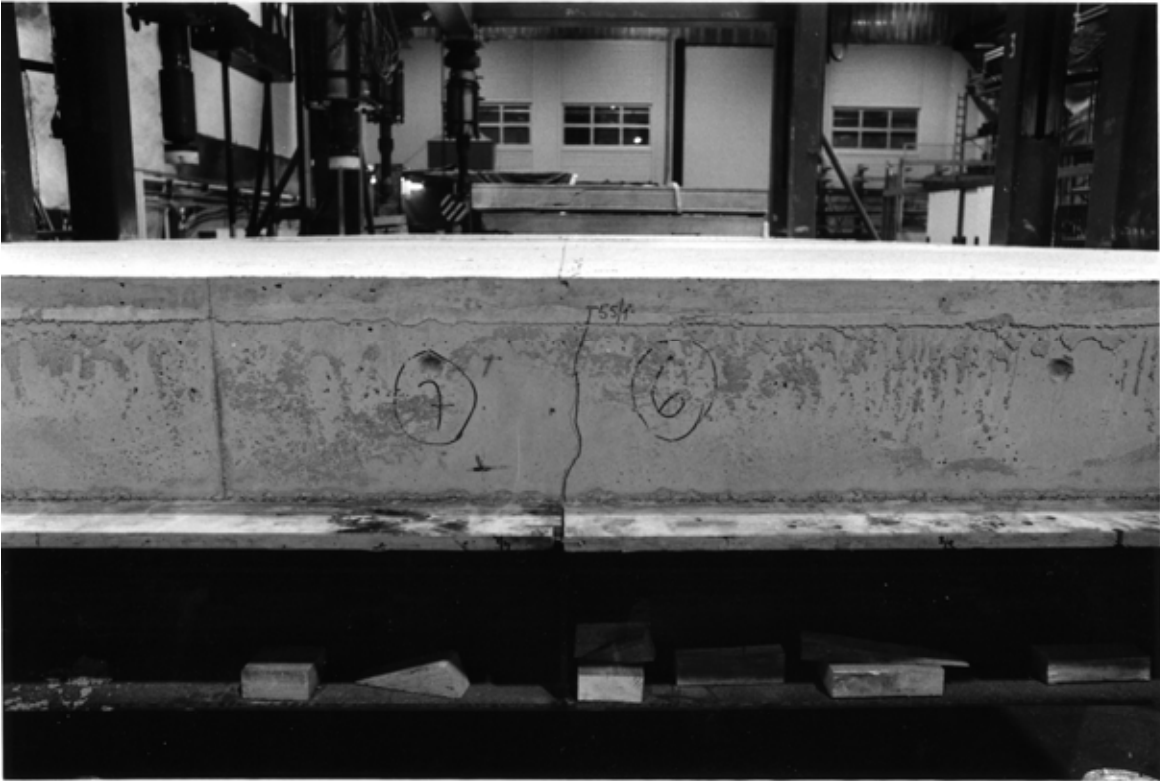
Fig. 9. A crack in the middle of the concrete tie beam, between the slab units no 6 and 7.

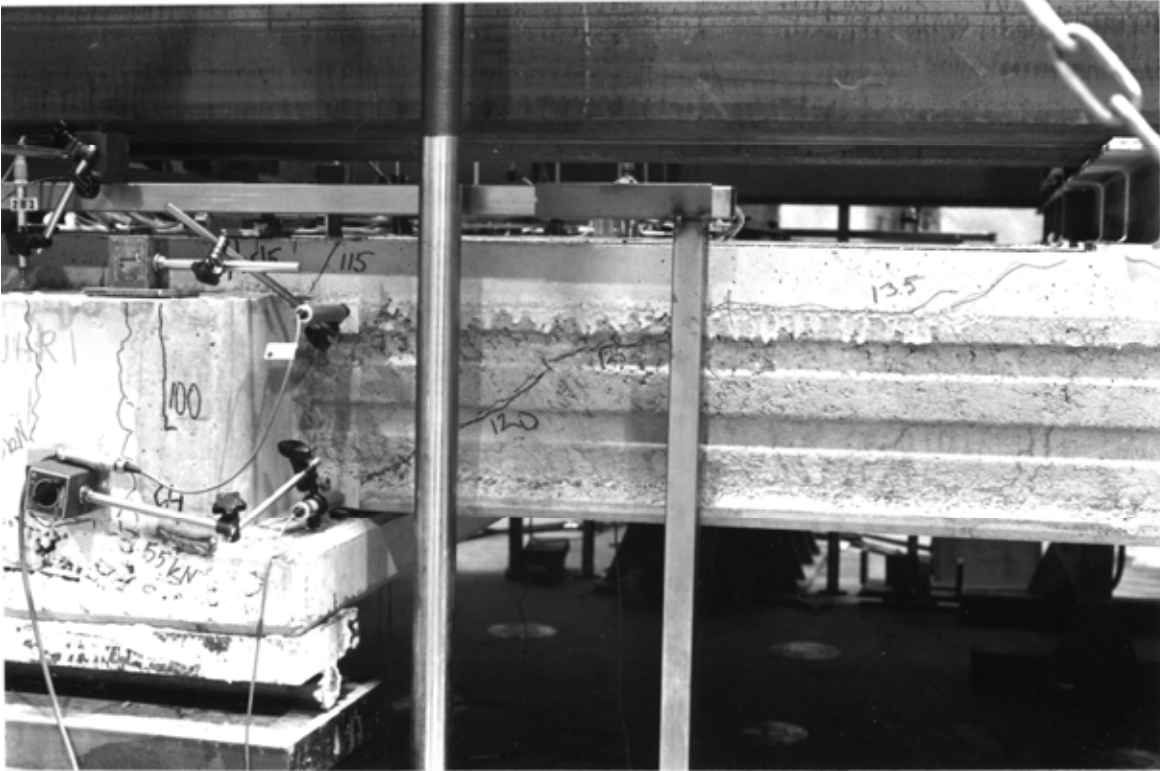
Fig. 10. The cracks in the longitudinal edge of the slab unit no 1, near the middle beam, at failure.

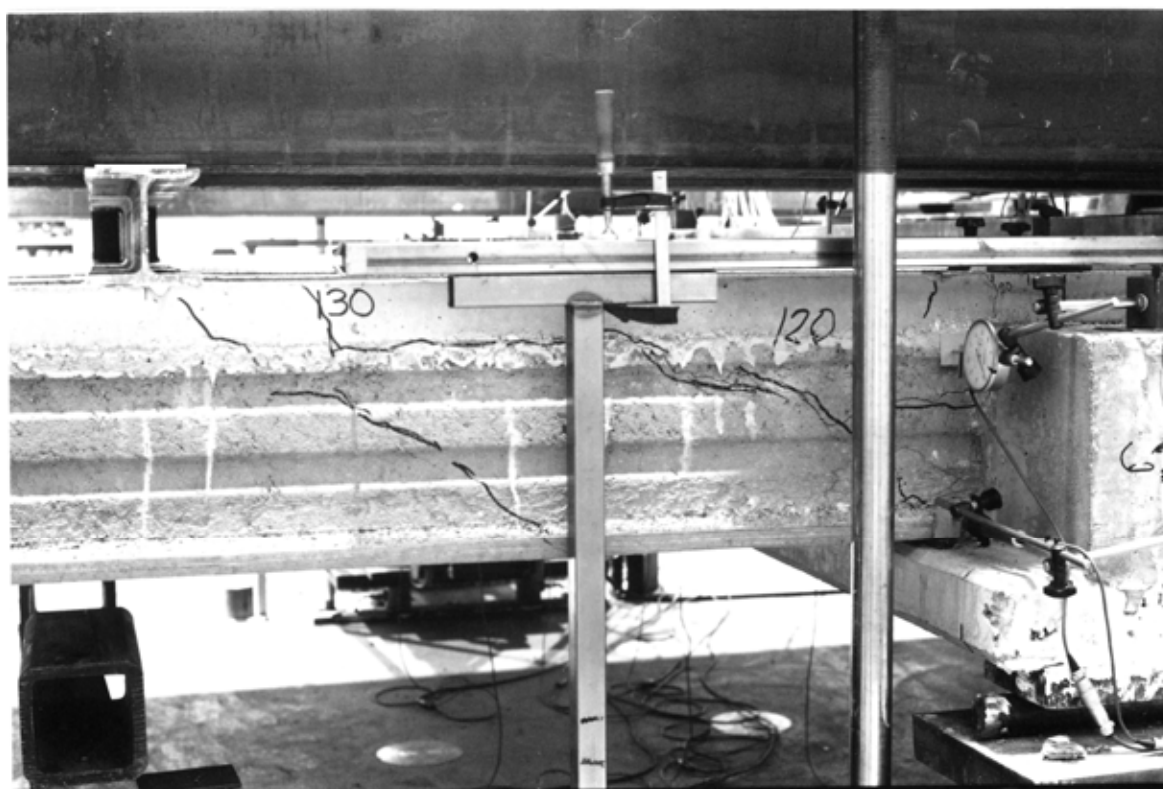
Fig. 12. The cracks in the longitudinal edge of the slab unit no 4, near the middle beam, at failure.

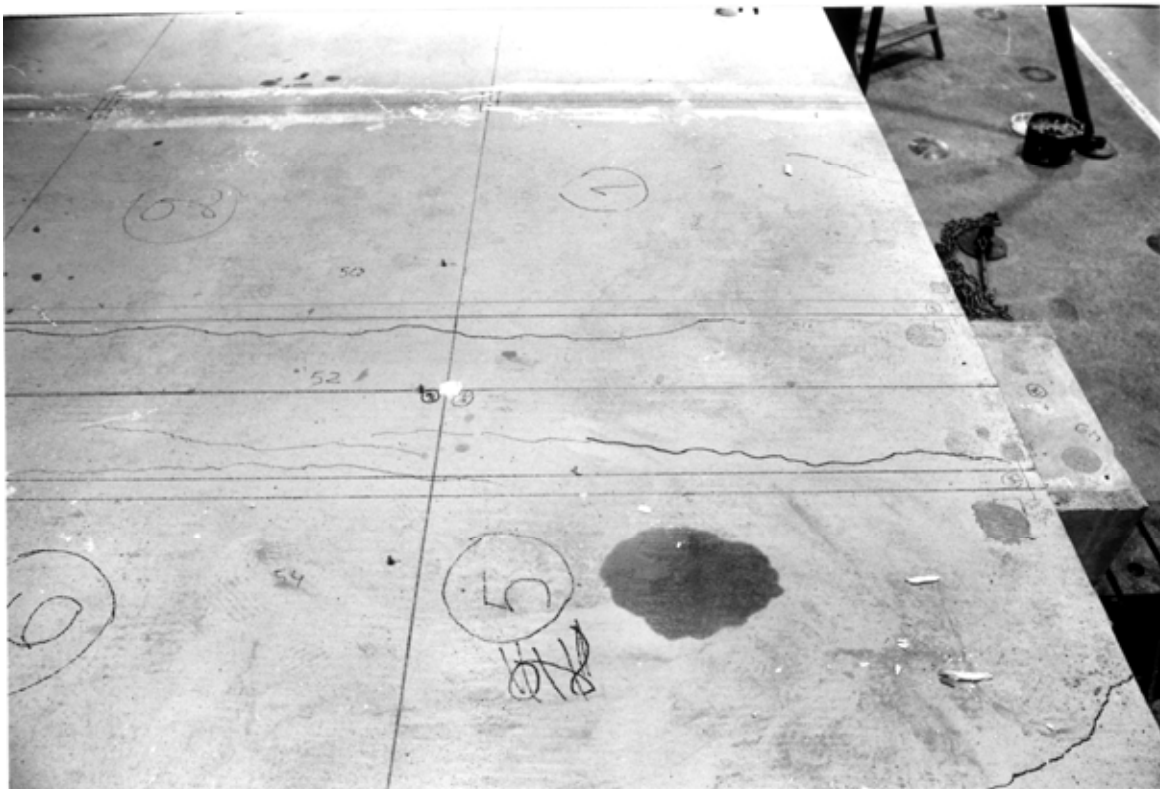
Fig. 14. The cracking of the concrete topping along the joint between the middle beam and the ends of the slab units no 1 - 2 and no 5 - 6.

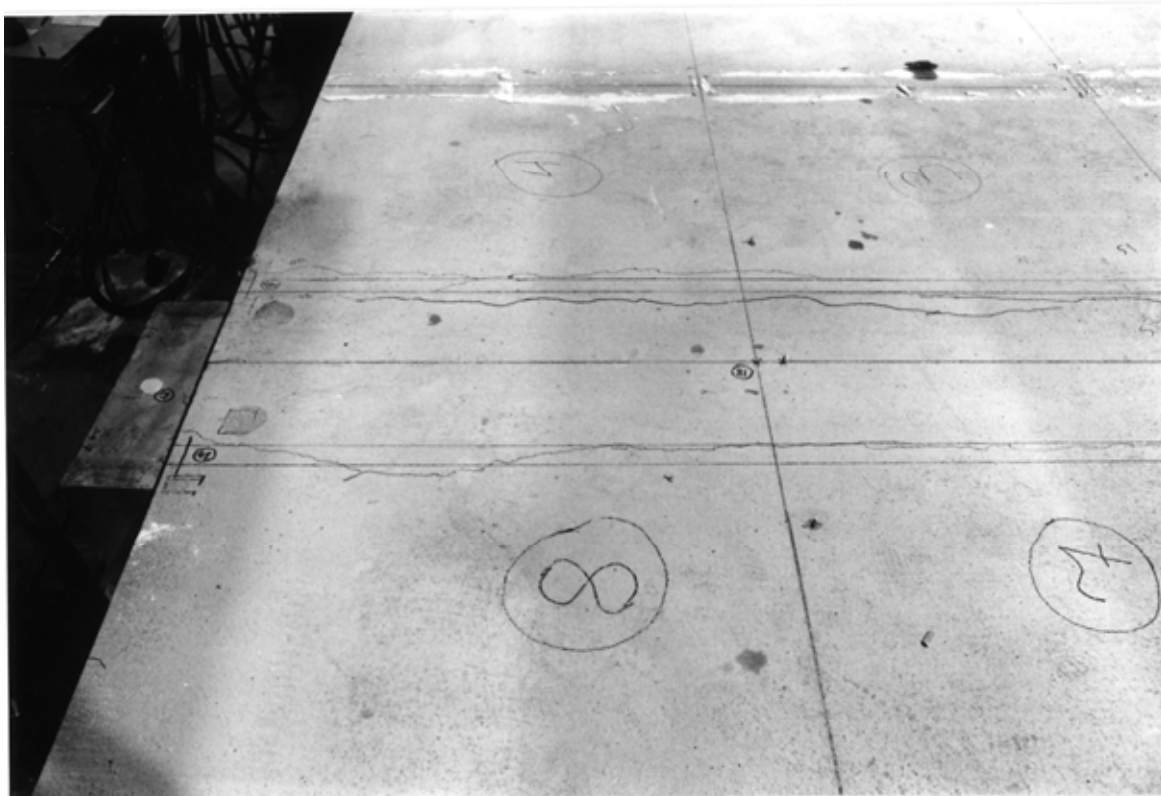
Fig. 16. The cracking of the concrete topping along the joint between the middle beam and the ends of the slab units no 3 - 4 and no 7 - 8.

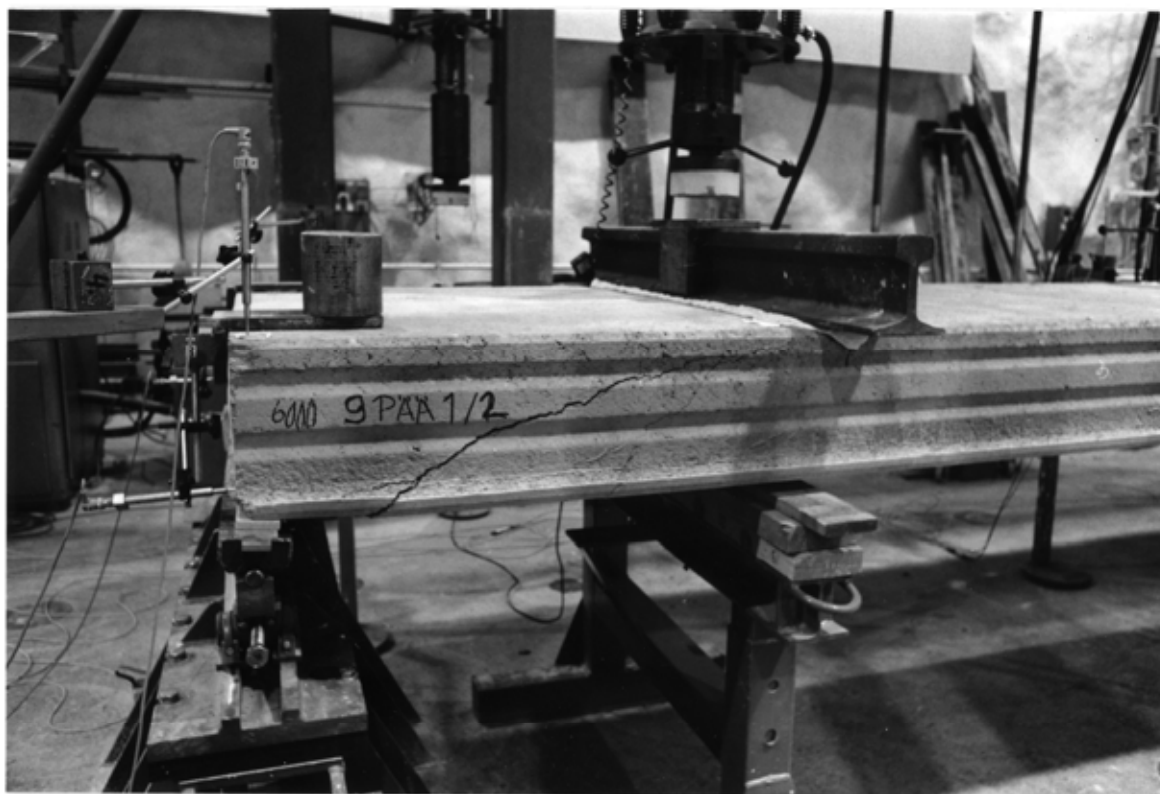
Fig. 19. The failure of the end 1 of the slab unit no 9 in the reference loading test.

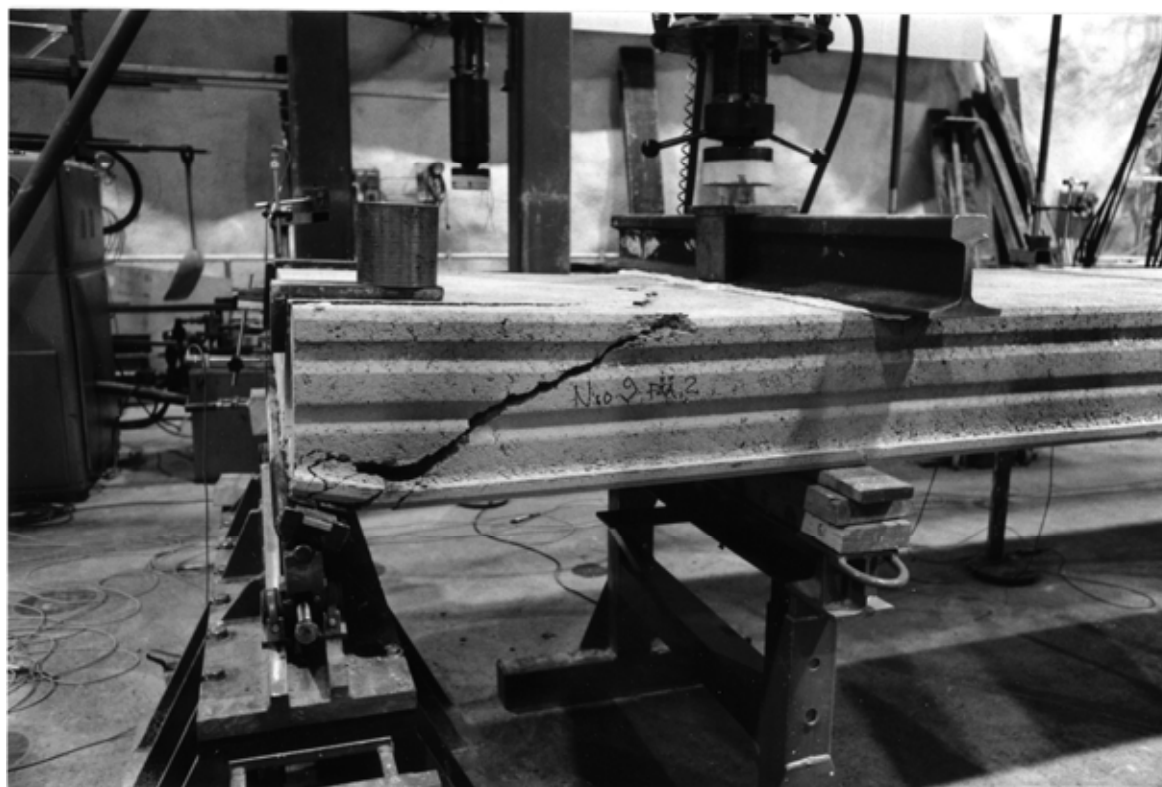
Fig. 20. The failure of the end 2 of the slab unit no 9 in the reference loading test.

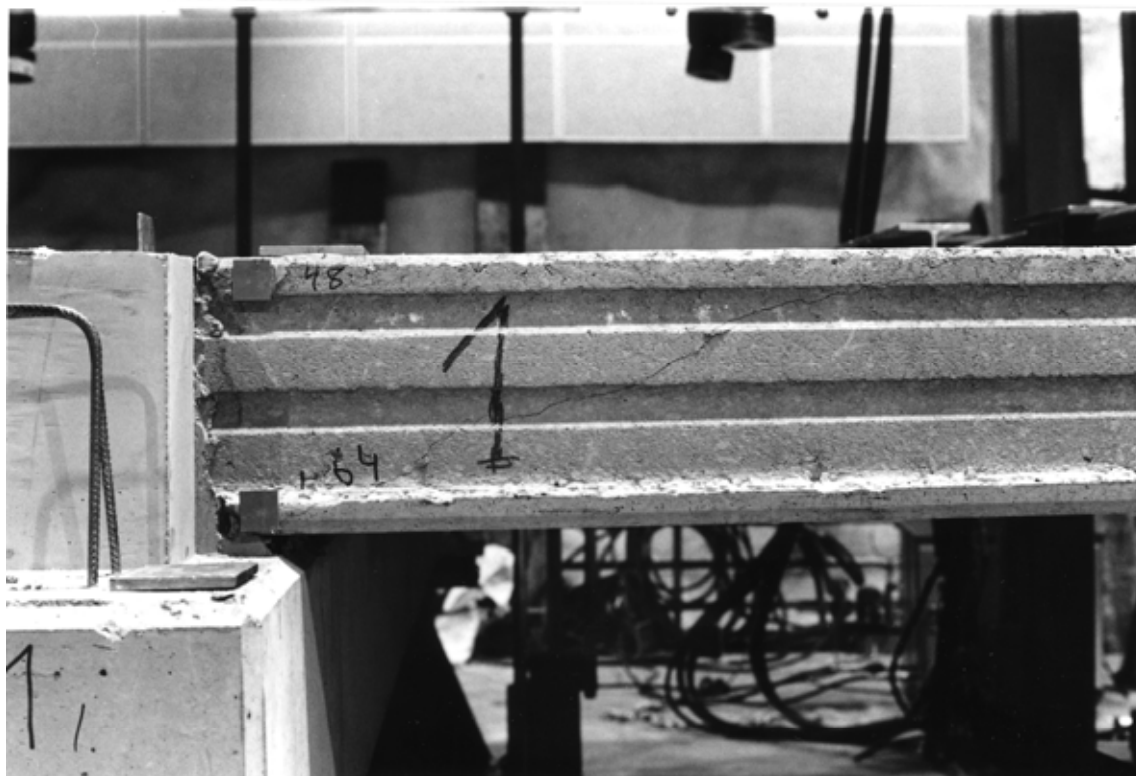
Fig. 7. The cracks in the longitudinal edge of the slab unit no 1, near the middle beam, at failure.

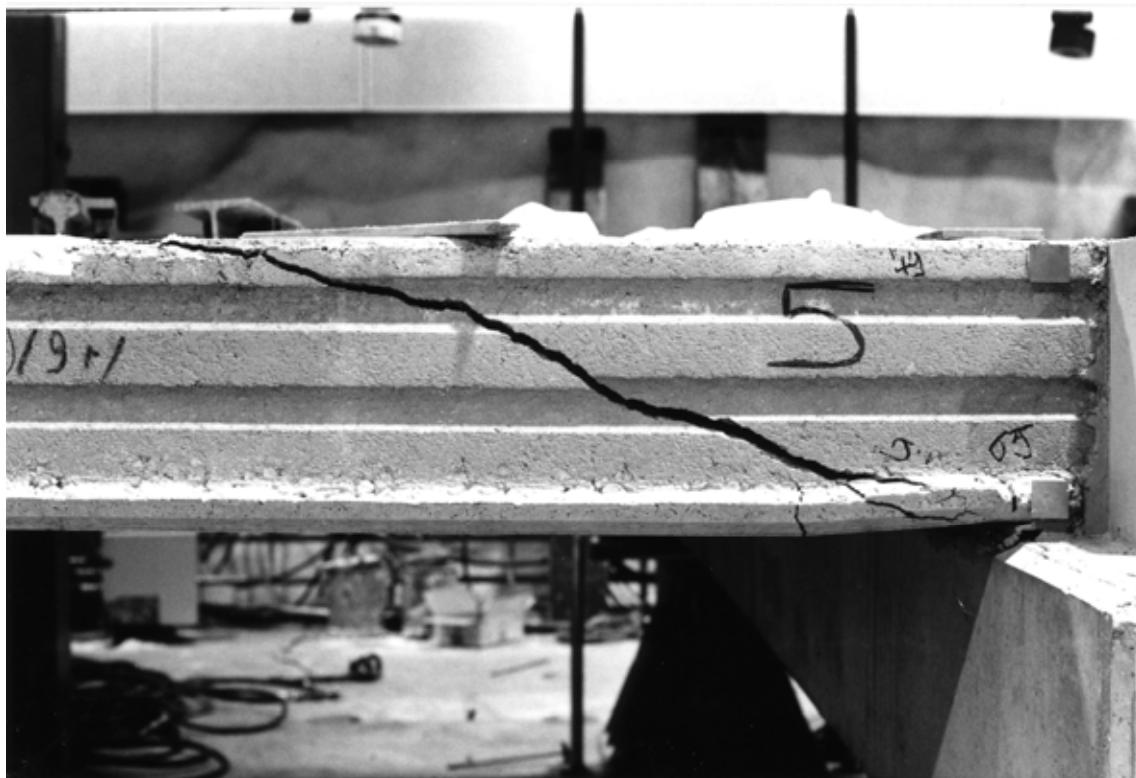
Fig. 8. The cracks in the longitudinal edge of the slab unit no 5, near the middle beam, at failure.

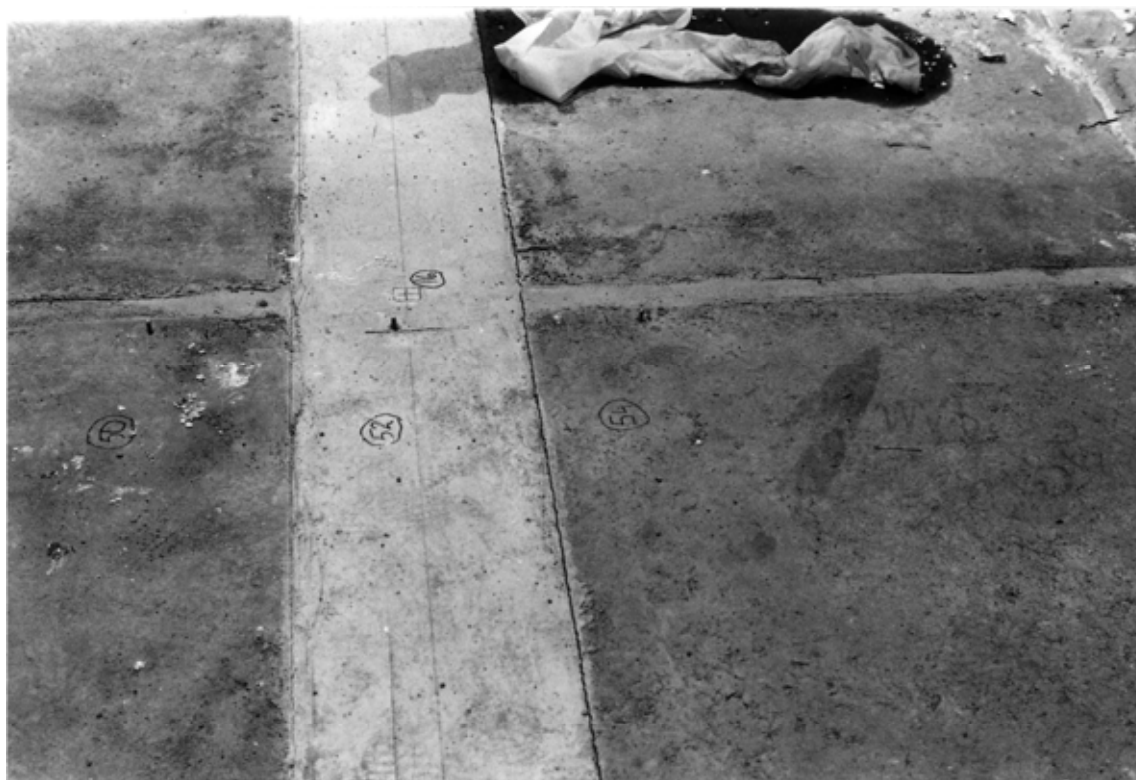
Fig. 11. Cracking of the joint between the cast in situ part of the middle beam and the ends of the slab units.

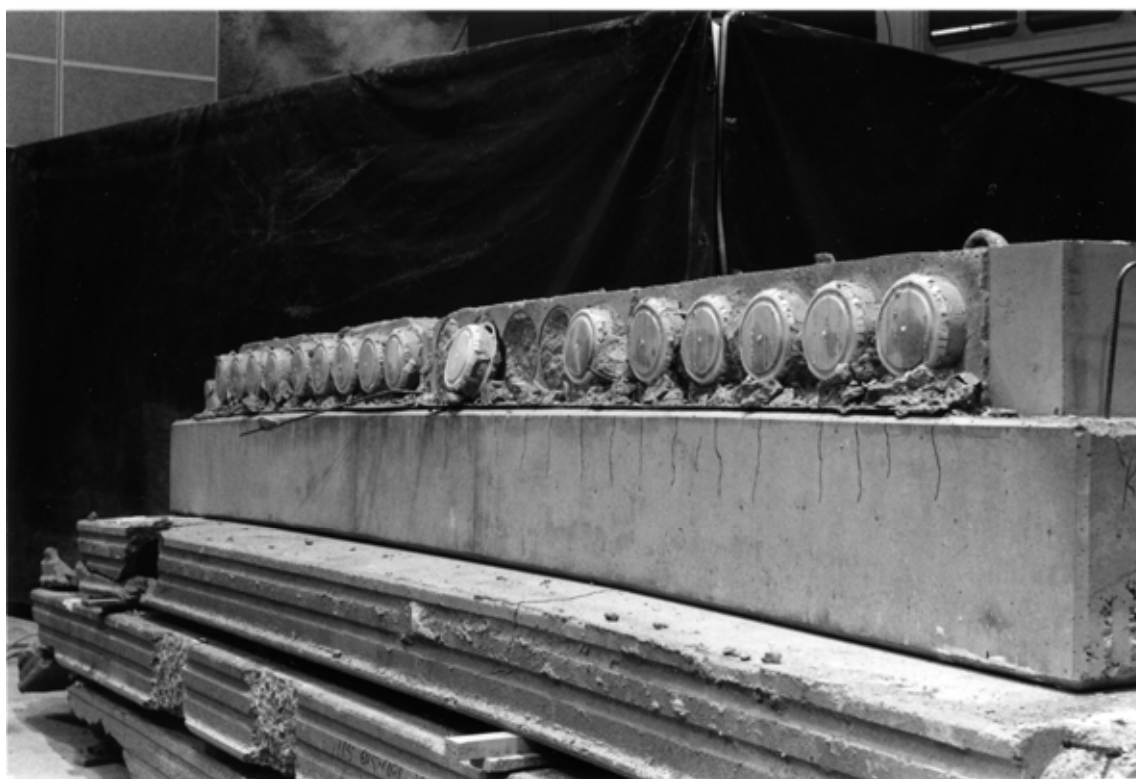
Fig. 12. The middle beam after the loading test, on the edge of the slab units no 1 - 4.

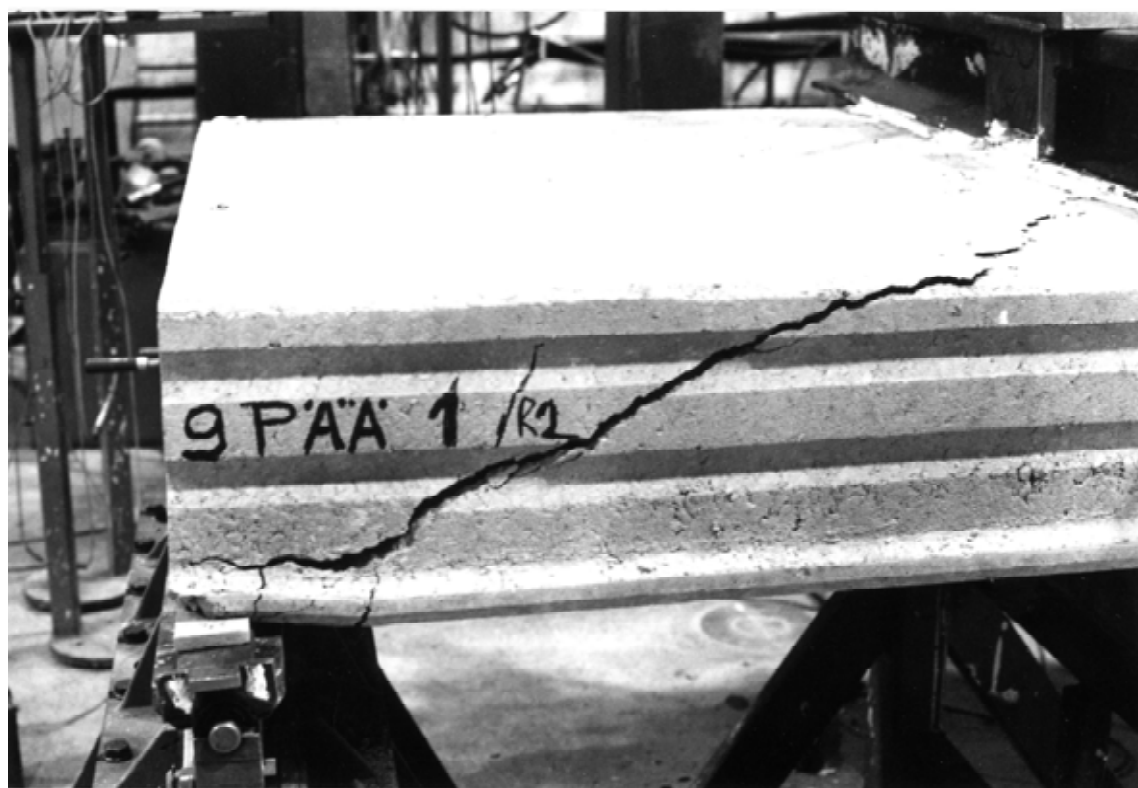
Fig. 14. The failure of the end 1 of the slab unit no 9 in the reference loading test.

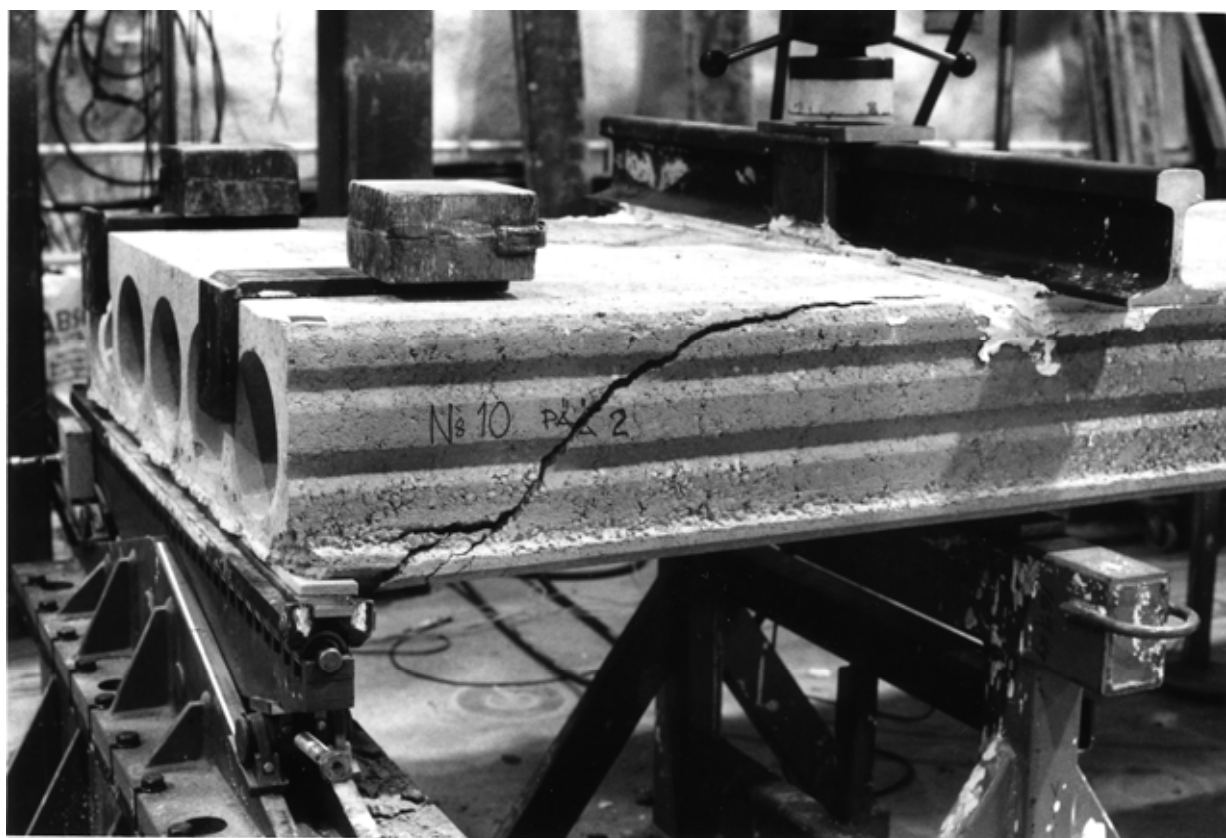
Fig. 17. The failure of the end 2 of the slab unit no 10 in the reference loading test.

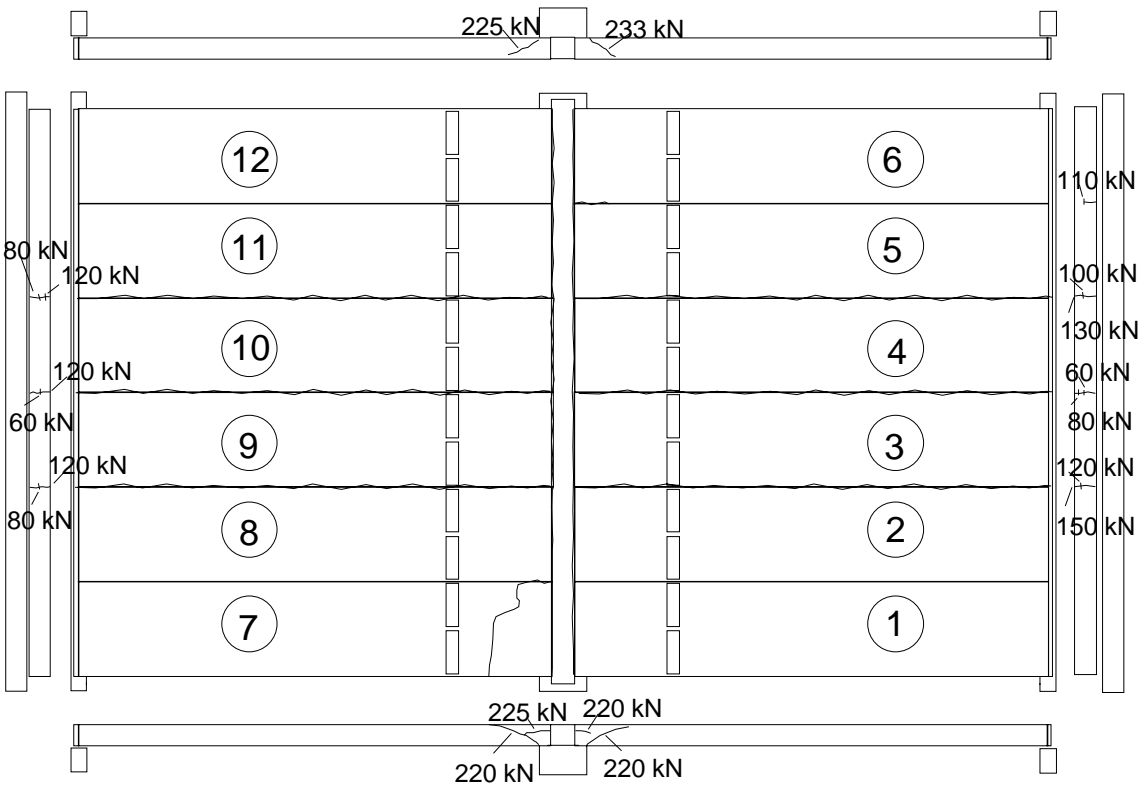
<p><i>Fig. 20. Cracks after failure on the top and in the longitudinal edges of the floor. The force values refer to the load P at which the crack was observed.</i></p>
<p>8</p>	<p>Observed shear resistance</p>
	<p>The maximum measured support reaction is regarded as the indicator of failure. The failure took place at $P = 238,2 \text{ kN}$.</p> <p>Fig. 21 shows the relationship between the measured support reaction below the South end of the middle beam and the sum of actuator loads on half floor.</p> <p>The ratio of the reaction to the load is shown in Fig. 22 and in a larger scale in Fig. 23. Based on Fig. 23 it is justified to assume that at failure the support reaction due to the line load is equal to 0,765 times the line load. Assuming simply supported slabs gives the theoretical ratio of 0,800 ... 0,801.</p>

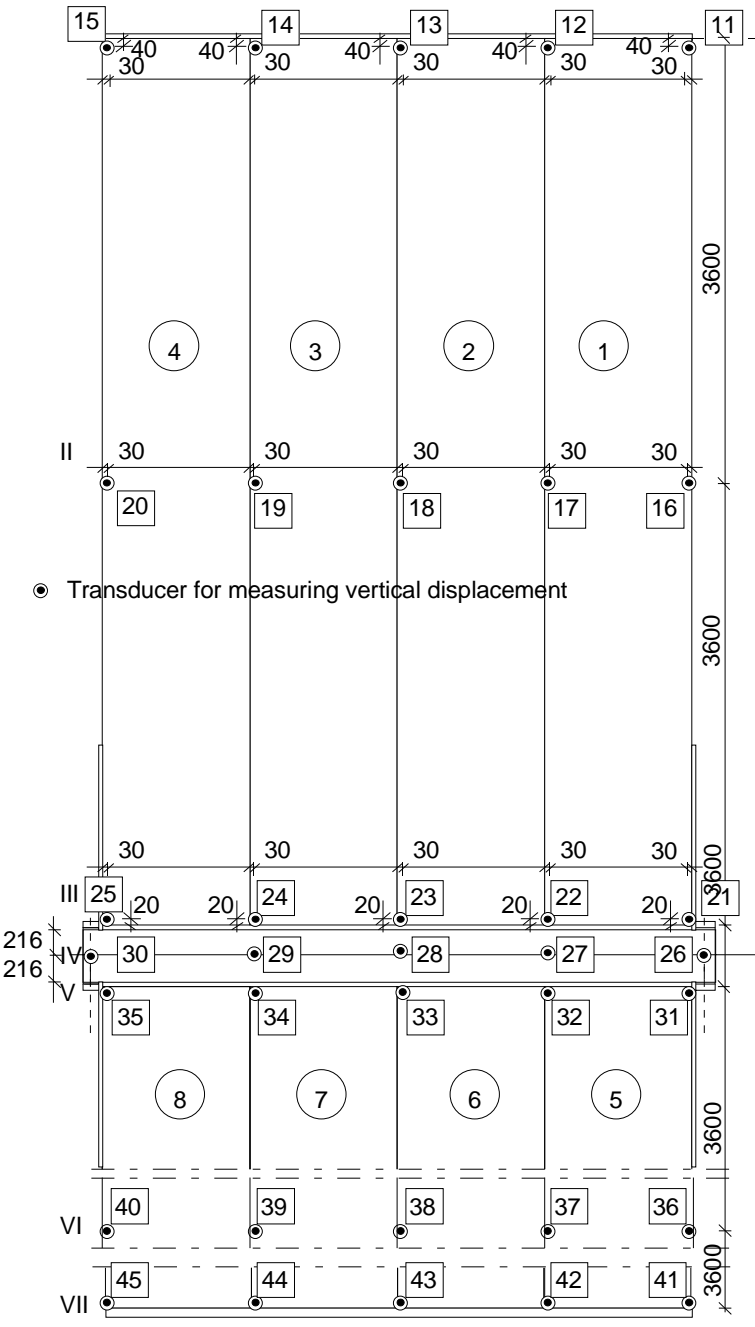
<p>● Transducer for measuring vertical displacement</p> <p><i>Fig. 13. Location of transducers 11 ... 45 for measuring vertical deflection along lines I ... VII.</i></p>
