Matti Pajari

Prestressed hollow core slabs supported on beams

| Finnish shear tests on floors in 1990–2006

VTT Working Papers 148
VTT-WORK-148

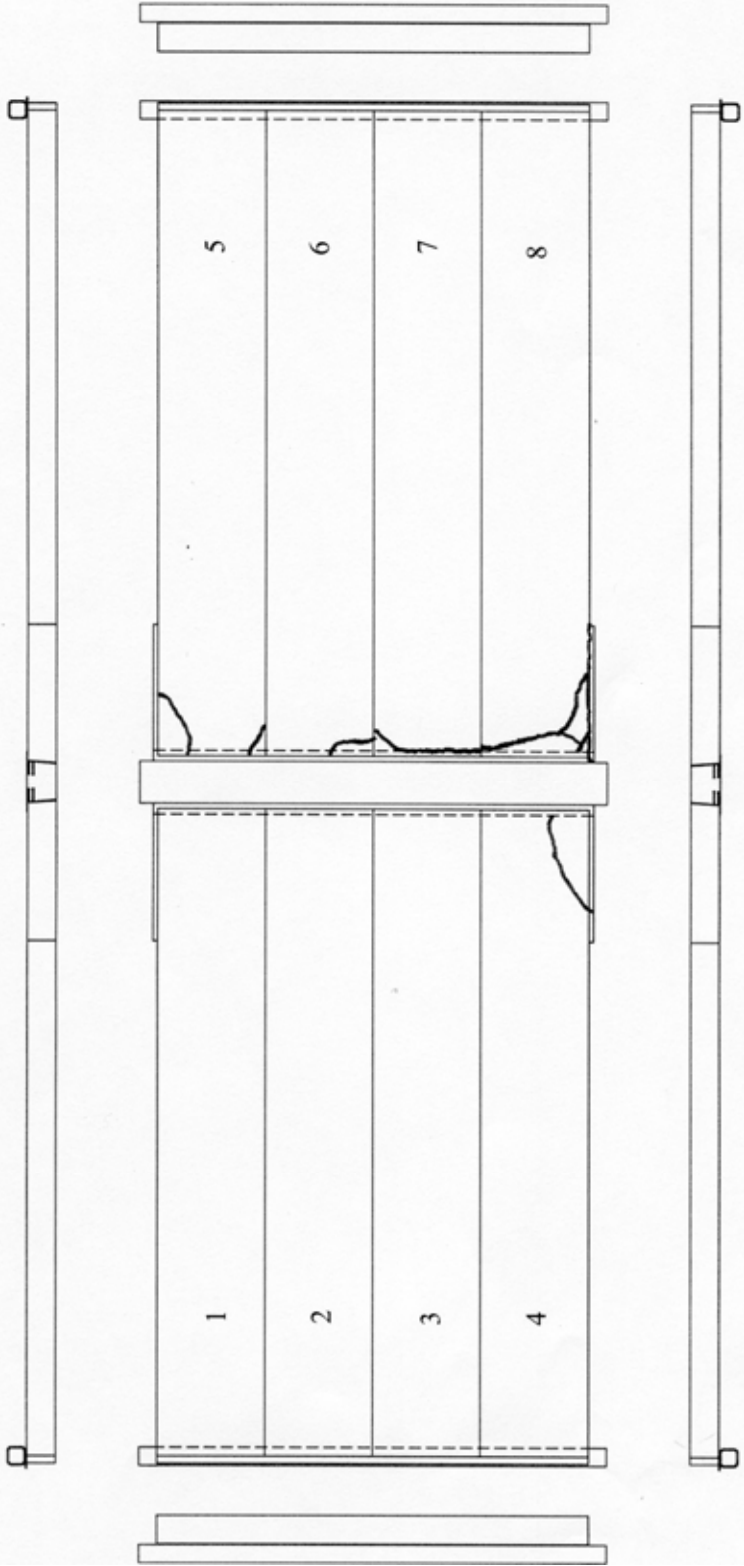
<p data-bbox="347 1989 858 2022"><i>Fig. 19. Cracks in the soffit after failure.</i></p>

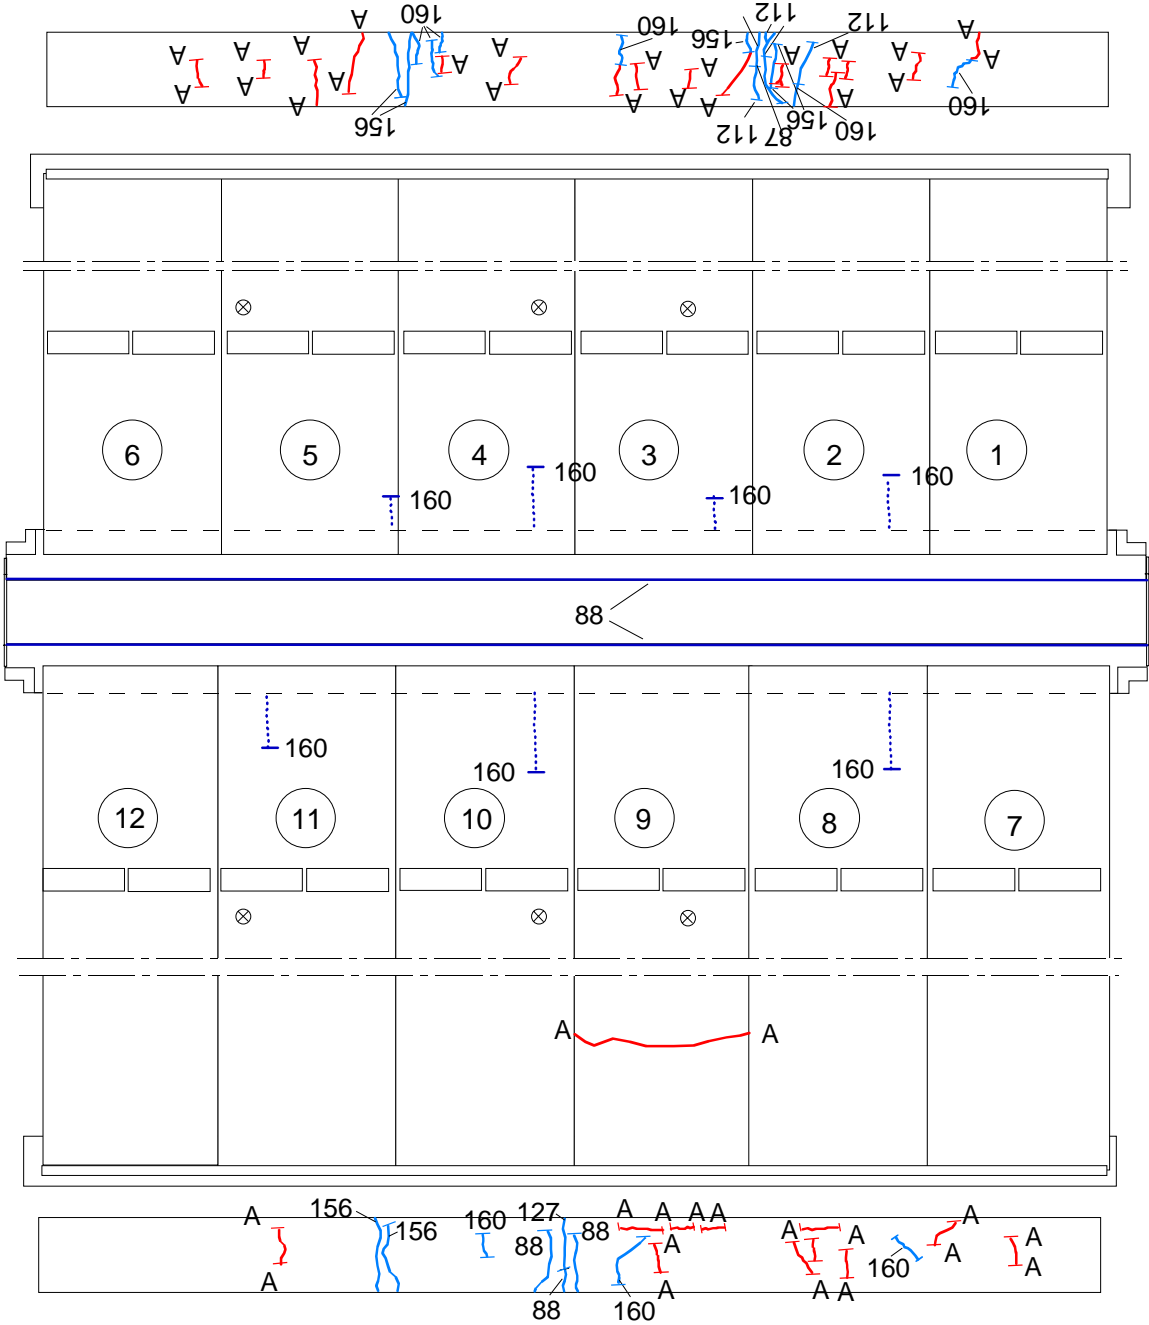
Fig. 27. Cracks at $P_a = 160$ kN. The dashed lines indicate thin ($\approx 0,1$ mm) cracks in the soffit.

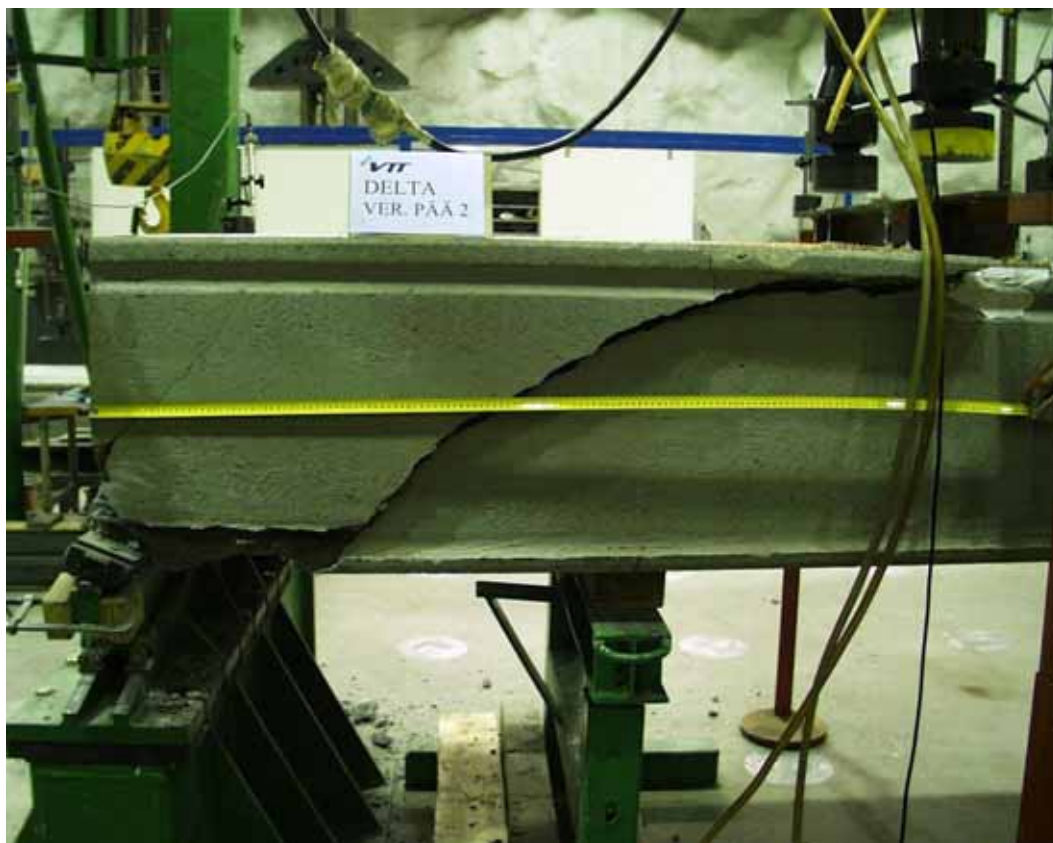
Fig. 41. Failure in reference test R2.
