## TEM microstructures of copper following three different EAC tests

Authors: Wade Karlsen, Janne Pakarinen

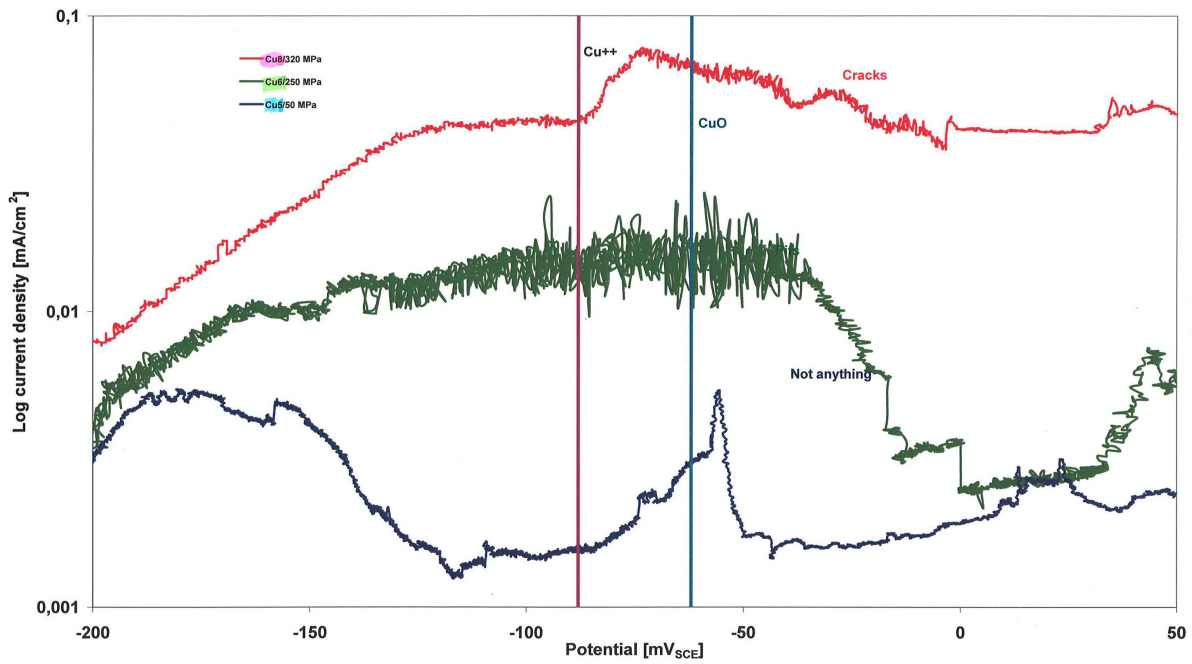
Figure 2: Current densities at different stress levels.

There were three different test bars chosen for TEM examination, each having been subjected to a slightly different combination of strain and electrochemical polarization in the corrosive solution. The polarization plots for each test are shown in Figure 2.

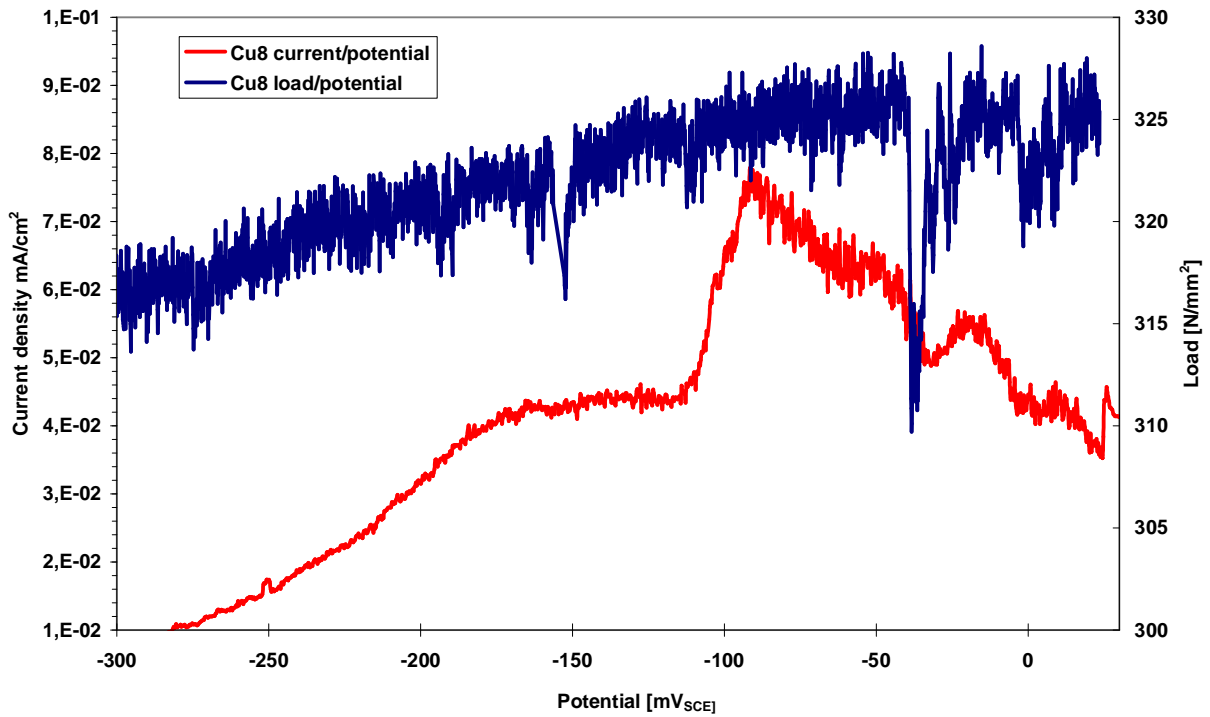
Figure 3: Load and current density at different potentials in specimen Cu8.

The stress level in this sample (320 MPa) was high enough to support dislocation mobility. As shown in Figure 3, the polarization curve indicated a transition between  $\text{Cu}_2\text{O}$  and  $\text{CuO}$ , occurring simultaneous with a detectable, abrupt load drop, suggesting a sudden, rapid strain response in the material in that regime.

One possible reason for the discrepancy between the observations and what was expected, is that the predicted vacancy injection and subsequent vacancy-dislocation interactions may have occurred only at the immediate surface of the specimen. Revisiting the load-drop plot for Cu8 (see *Figure 3*) shows that, in fact, the drop observed represents a change of less than 5 %. Assuming that the load drop is a consequence of material softening at the test bar surface, a drop of that magnitude would correspond to an equivalent reduction of load-carrying area of only about 2% (i.e. softening in the outer 2% of the material). Taking into account the dimensions of the gauge region cross-section, and assuming uniform interaction with the environment, the softening may have only occurred in the outer 10 microns of the specimen cross-section. Therefore, it is conceivable that the specimen preparation method employed in the current study simply examined re-

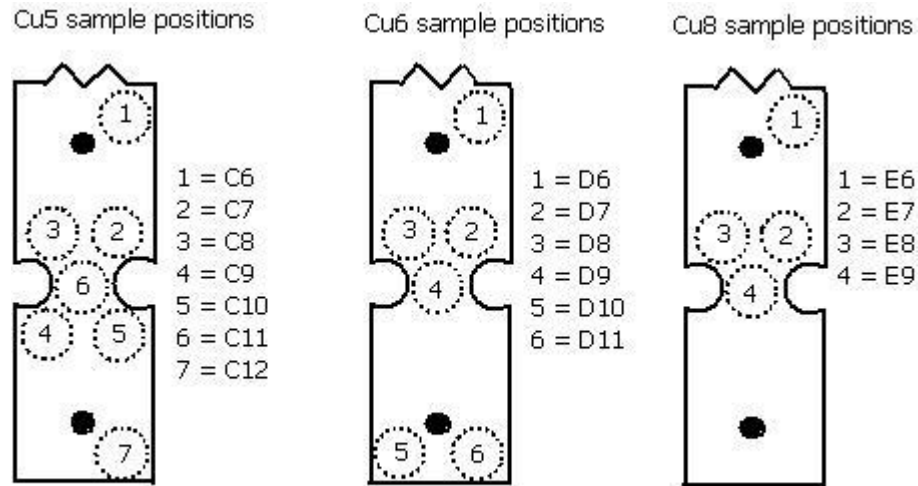
Figure 4: TEM specimen extraction locations from the three test bars.

The test bars were designed with an hourglass shape in order to promote strain localization at the narrowest region of the specimen. However, in very slow EAC tests, crack-like features sometimes also appeared in the wider portion of the bar outside of the gauge region but still exposed to the environment. Therefore, blank disks for TEM specimen productions were extracted from different regions of the test bars, to assure sampling of microstructures within the different scenarios. The particular locations are shown as dotted-line circles in Figure 4. Each location was numbered, so a particular specimen was identified with the bar number followed by disk number, as Cu5\_6, Cu6\_1, etc.
