IGSCC IN A BWR STEAM LINE AFTER 30 YEARS OF OPERATION

Ulla Ehrnstén, Juha-Matti Autio¹ and Petra Holmstrom²

ABSTRACT

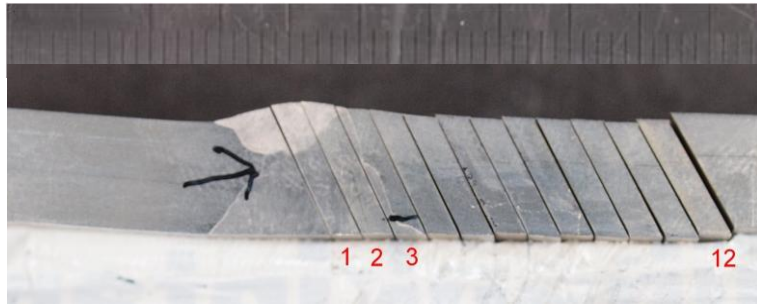
Oxalic acid etching of a cross-section close to the cracked region, but still outside it, revealed grain boundary attack, indicating sensitization, Figure 9, only between about 6 and 12 mm from the fusion line, Figure 6. The DL-EPR measurements, measured from slices cut parallel to the fusion line, Figure 10, showed a maximum degree of sensitization at a distance of 6 mm from the fusion line, Figure 11.

Figure 10. Photograph showing the cutting of the slices for DL-EPR measurements.
