Deformation microstructures of in-reactor tested copper studied by TEM

Authors: Janne Pakarinen

Preface

This report is a part of the work carried out in Associations Euratom-Tekes by VTT Materials for Power Engineering under the Task TW5-TVV-SITU2 *In-situ Investigation of the Mechanical Performance and Life Time of Copper.*

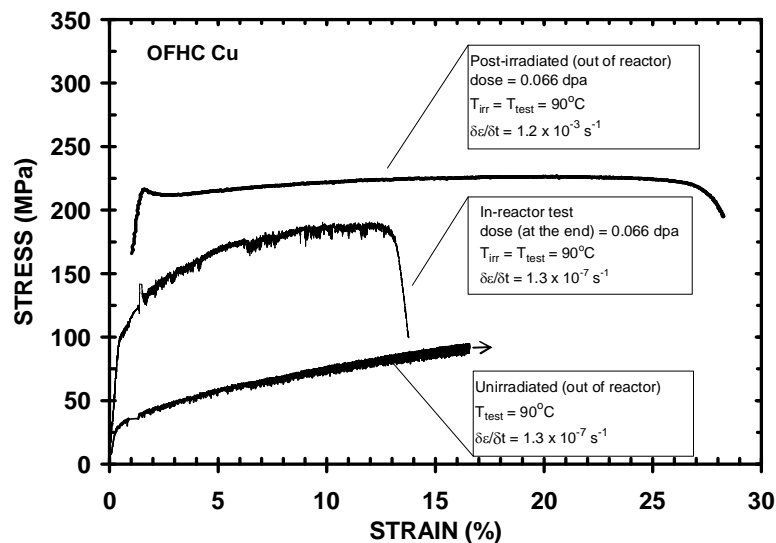
Fig. 1. Comparison of stress-strain curves of in-reactor and post-irradiation tests [3].

Only recently the development of compact and accurately controlled pneumatic in-reactor testing devices has made it possible to study the dynamic response of materials deformed during irradiation. These tensile in-reactor tests have shown that materials properties under simultaneous irradiation and tensile deformation can be different from the stress-strain behaviour of unirradiated samples and of samples tested in the post-irradiation condition. As an example, the tensile in-reactor test result in Fig. 1 (from [3]) shows that the copper sample exhibited significant hardening and a uniform deformation of only about 10 %. In comparison, the tensile tests for unirradiated copper usually show uniform deformation of well over 50 % at the same temperature.[4] The difference between in-reactor and post-irradiation experiments is also well shown in Fig. 1, namely, the post-yield hardening rate of the in-reactor tested sample is much higher than in the case of post-irradiation tests.

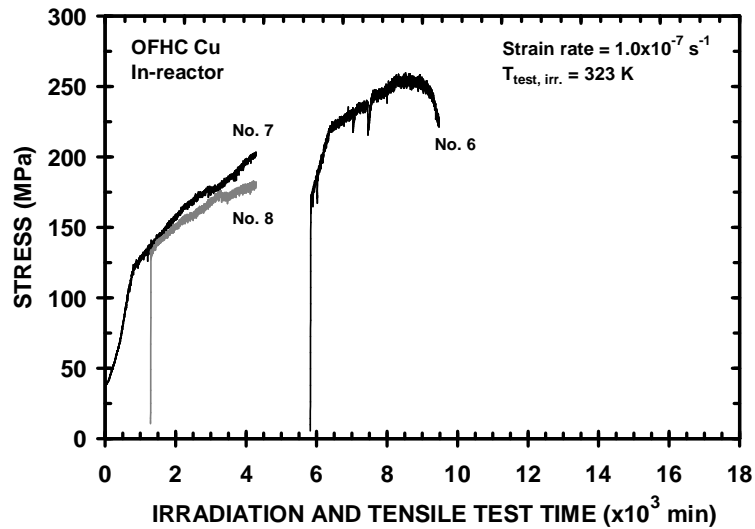
Fig. 2. In-reactor tensile curves for Bars 191 (No. 7), 193 (No. 8), and 260 (No. 6). [6]

The investigated OFHC copper samples were irradiated in the BR-2 reactor at SCK-CEN, according to Table 1. In the tensile tests, the loading of Bar 191 was begun immediately upon start of irradiation, while Bars 193 and 260 were irradiated for 1 144 and 5 822 minutes prior to initiating loading, respectively. The testing was conducted at a slow strain rate of 10^{-7} 1/s, which allows ample time for the simultaneous irradiation to induce microstructural changes. The tensile stress evolution over time for each of the samples is shown in Fig. 2. The testing details can be found from [4]. Notice that the tensile test of Bar 261 was started immediately upon irradiation, but due to computer error the exact test details are unknown.

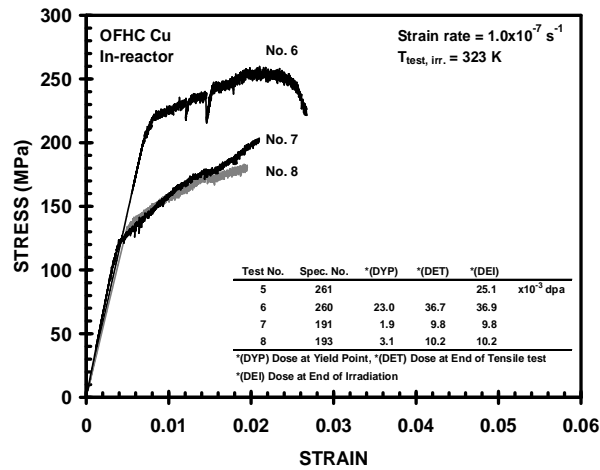
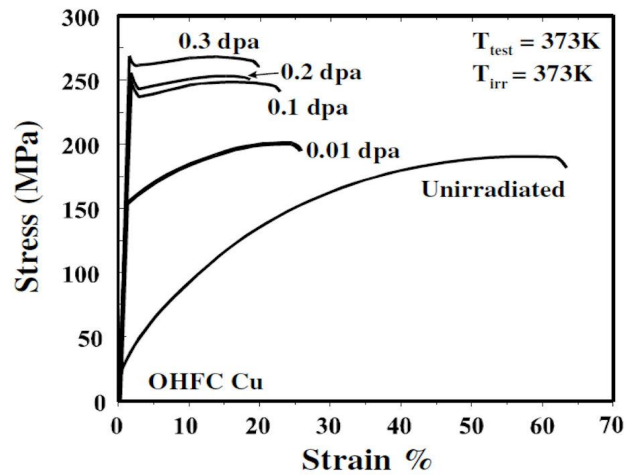
(a)

(b)

Fig. 19. Stress-strain curves for (a) in-reactor tested copper [6] and (b) post-irradiation tested copper [7].

Comparing the in-reactor stress-strain curves of Fig. 19 (a) to post-irradiation tests of [7] displayed in (b) show major differences in the post-yield hardening behaviour. Namely, the post-yield hardening rate is shown to be much higher in the in-reactor tests than in the post-irradiation tensile tests [notice the nearly tenfold difference between the strain axes of Fig. 19 (a) and (b)]. In both cases, irradiation increases the yield strength of the material as compared to unirradiated reference sample but does not induce any yield drop below dose of 0.1 dpa. The yield strengths are quite nicely in line as a function of irradiation dose [dose at yield point (DYP) values in the case of in-reactor tests], as shown in Fig. 20.

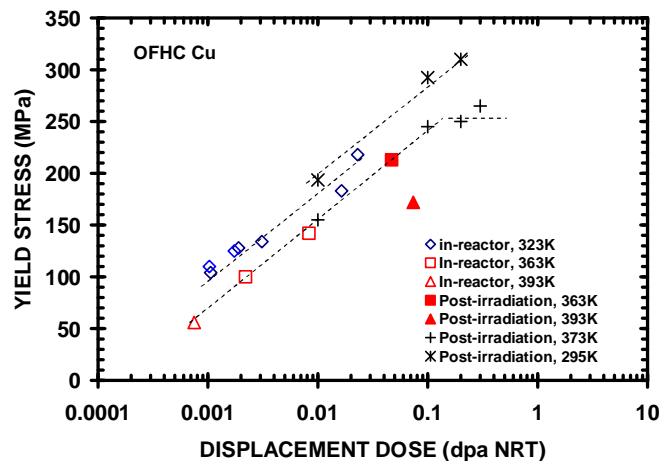
Fig. 20. Yield strengths of in-reactor (open) and post-irradiation (solid) tested copper. The studied samples are from the series labeled with open diamonds. Lines show that the yield stress – displacement dose relationship tends to be dependent of temperature. (\diamond from [6], \square , Δ , \blacksquare , and \blacktriangle from [8], + from [9] and * from [10]).
