A REVIEW OF AERONAUTICAL FATIGUE INVESTIGATIONS IN FINLAND APRIL 2011 – FEBRUARY 2013

Presented at the 33rd Conference of the
International Committee on Aeronautical Fatigue and
Structural Integrity (ICAF),
Jerusalem, Israel, 3-4 June 2013

Compiled by Aslak Siljander

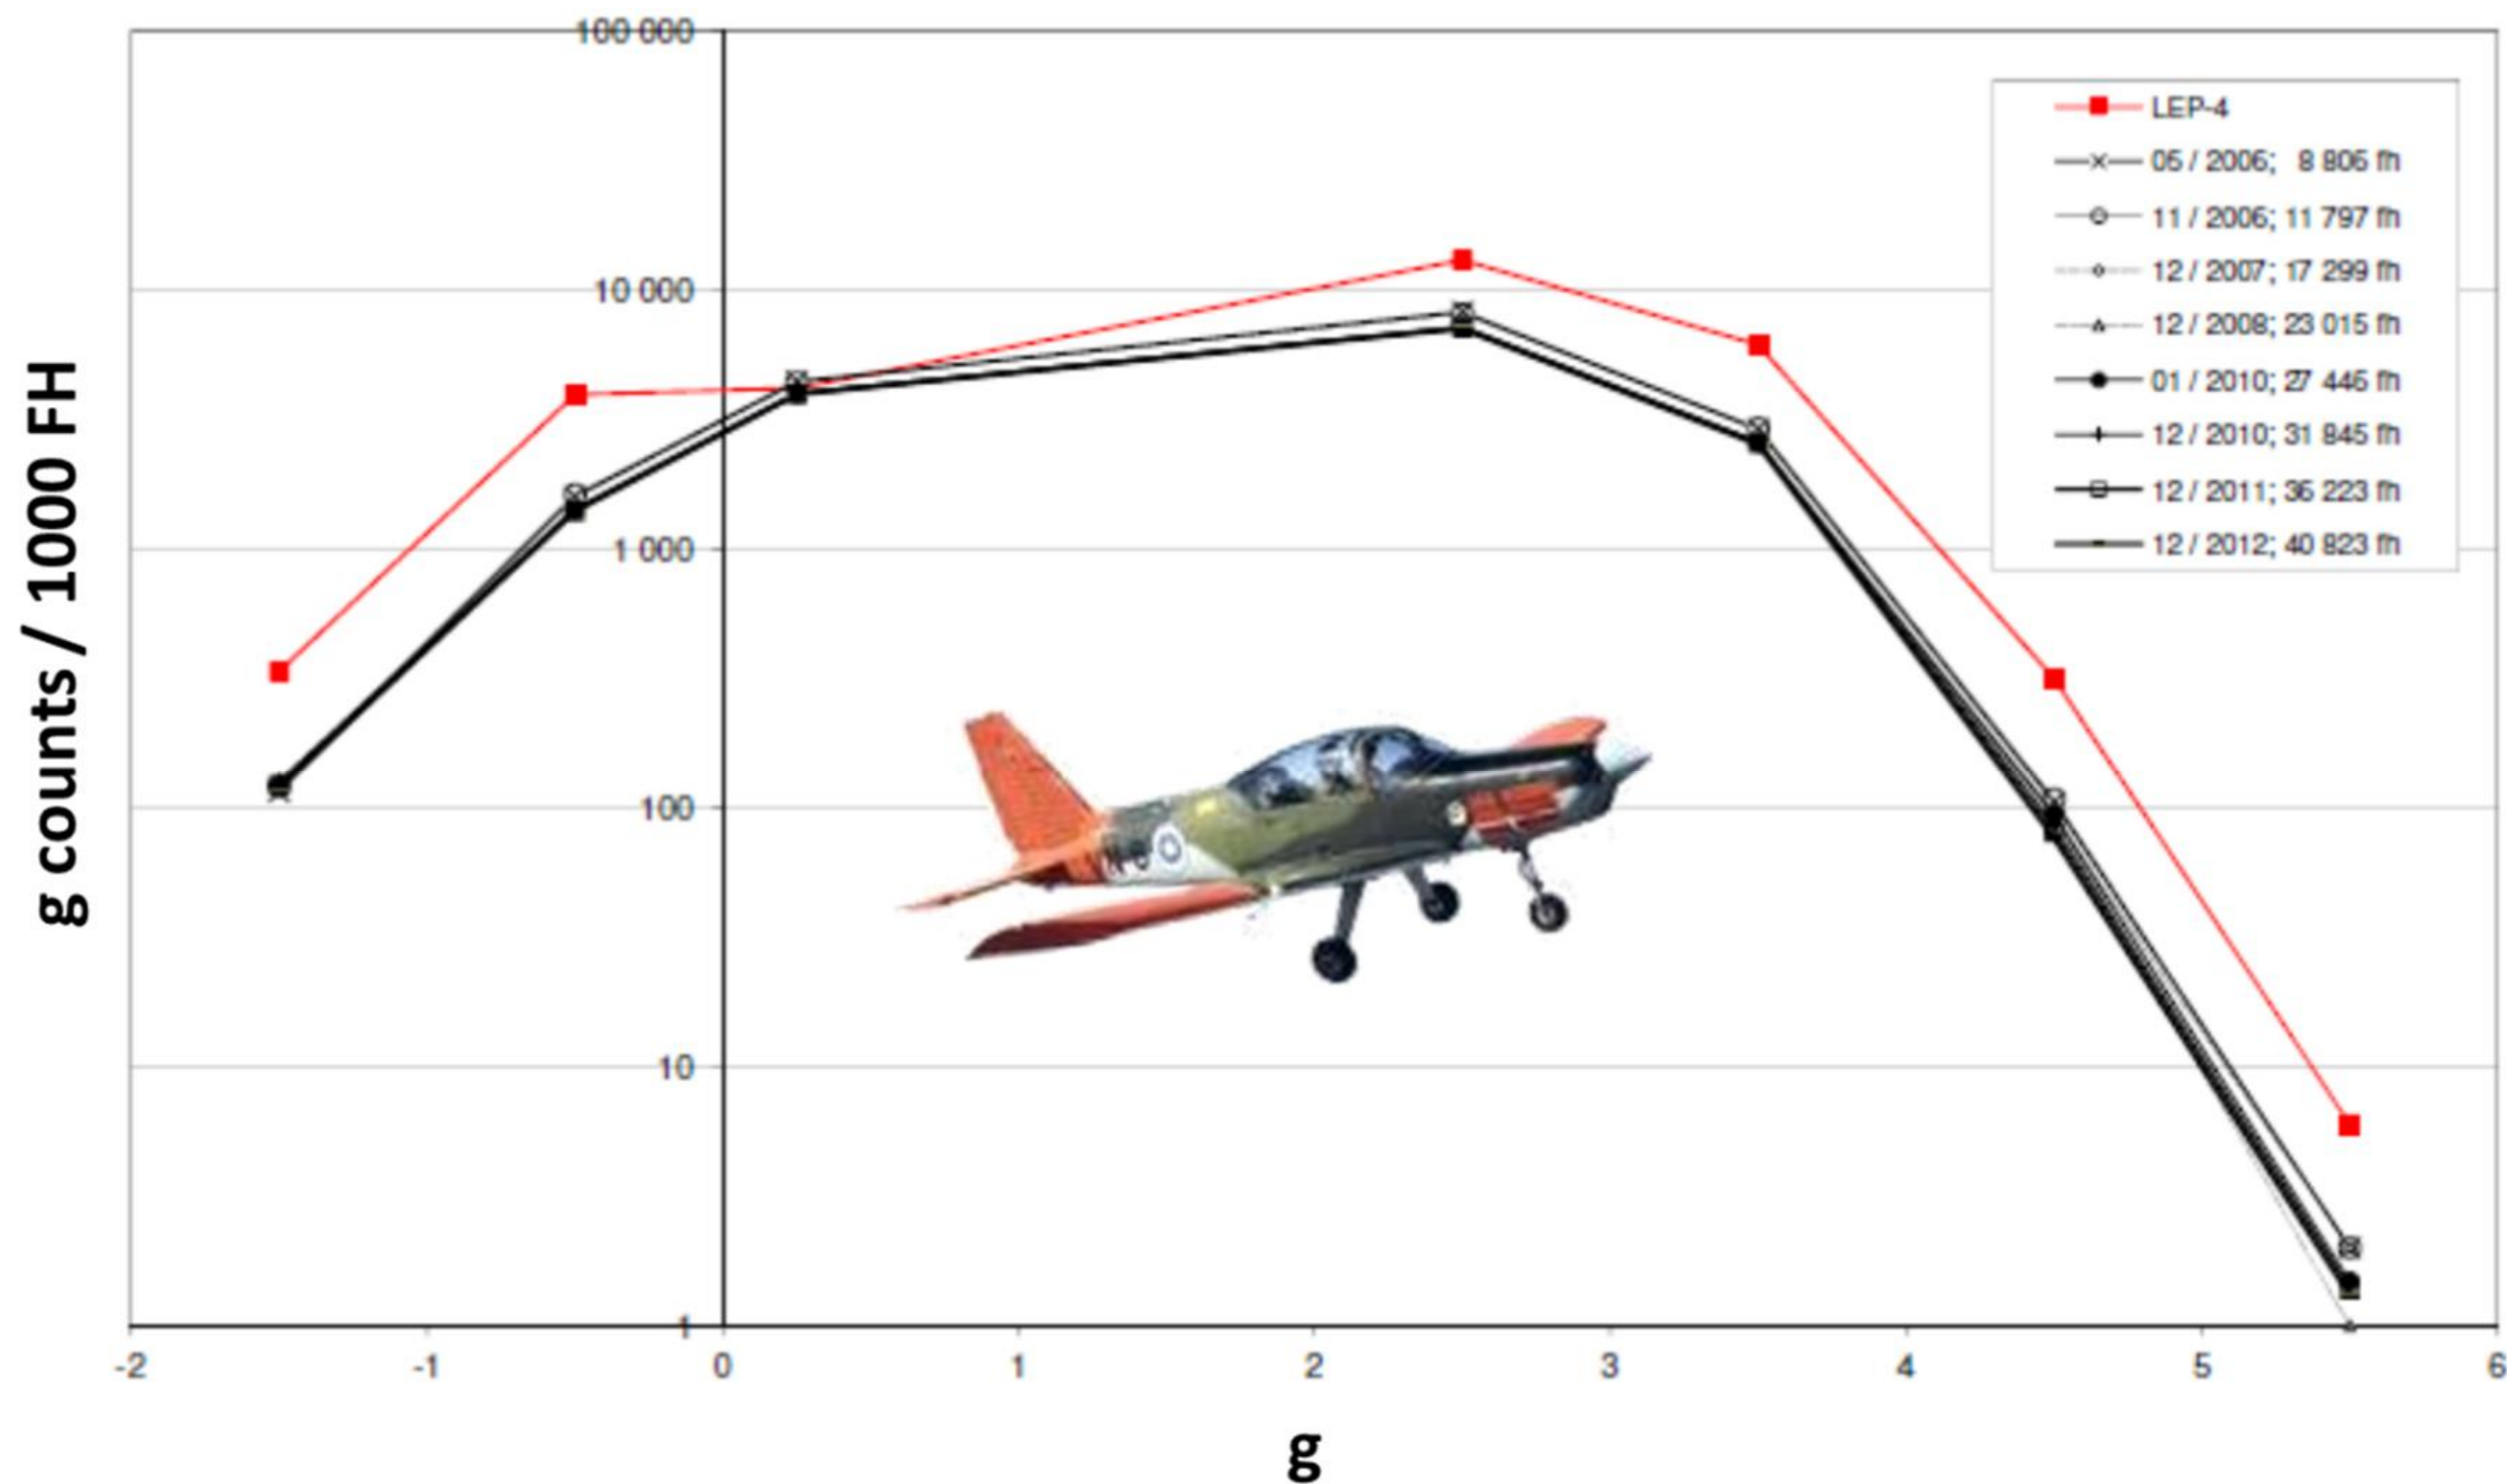
Figure 3: The g counts (x-axis) per 1000 FH (y-axis) of the Valmet Vinka. The spectrum representing the LEP design assumptions (LEP-4). The post LEP g counter spectrum as of May 2006 (- x -), as of November 2006 (- o -), as of December 2007 (- \diamond -), as of December 2008 (- Δ -), as of January 2010 (- \bullet -), as of December 2010 (- -), and the updates from the previous review: as of December 2011 (- \cdot -) and as of December 2012 (- \square -). All curves (excluding the red LEP-4) represent the fleet average from all Vinkas, as ranked according to the a/c center of gravity normal acceleration. Picture by courtesy of Patria Aviation.

Based on the g counter information, the primary trainers are in good structural condition with regard to the flight hours. The severity of usage in view of the g counter status is more benign than that on the basis of LEP assumptions, see *Fig. 3*. It is possible to operate with Vinka until 2020 under its current type certificate. If there is a need to operate beyond 2020, the Vinka fleet will require another LEP.

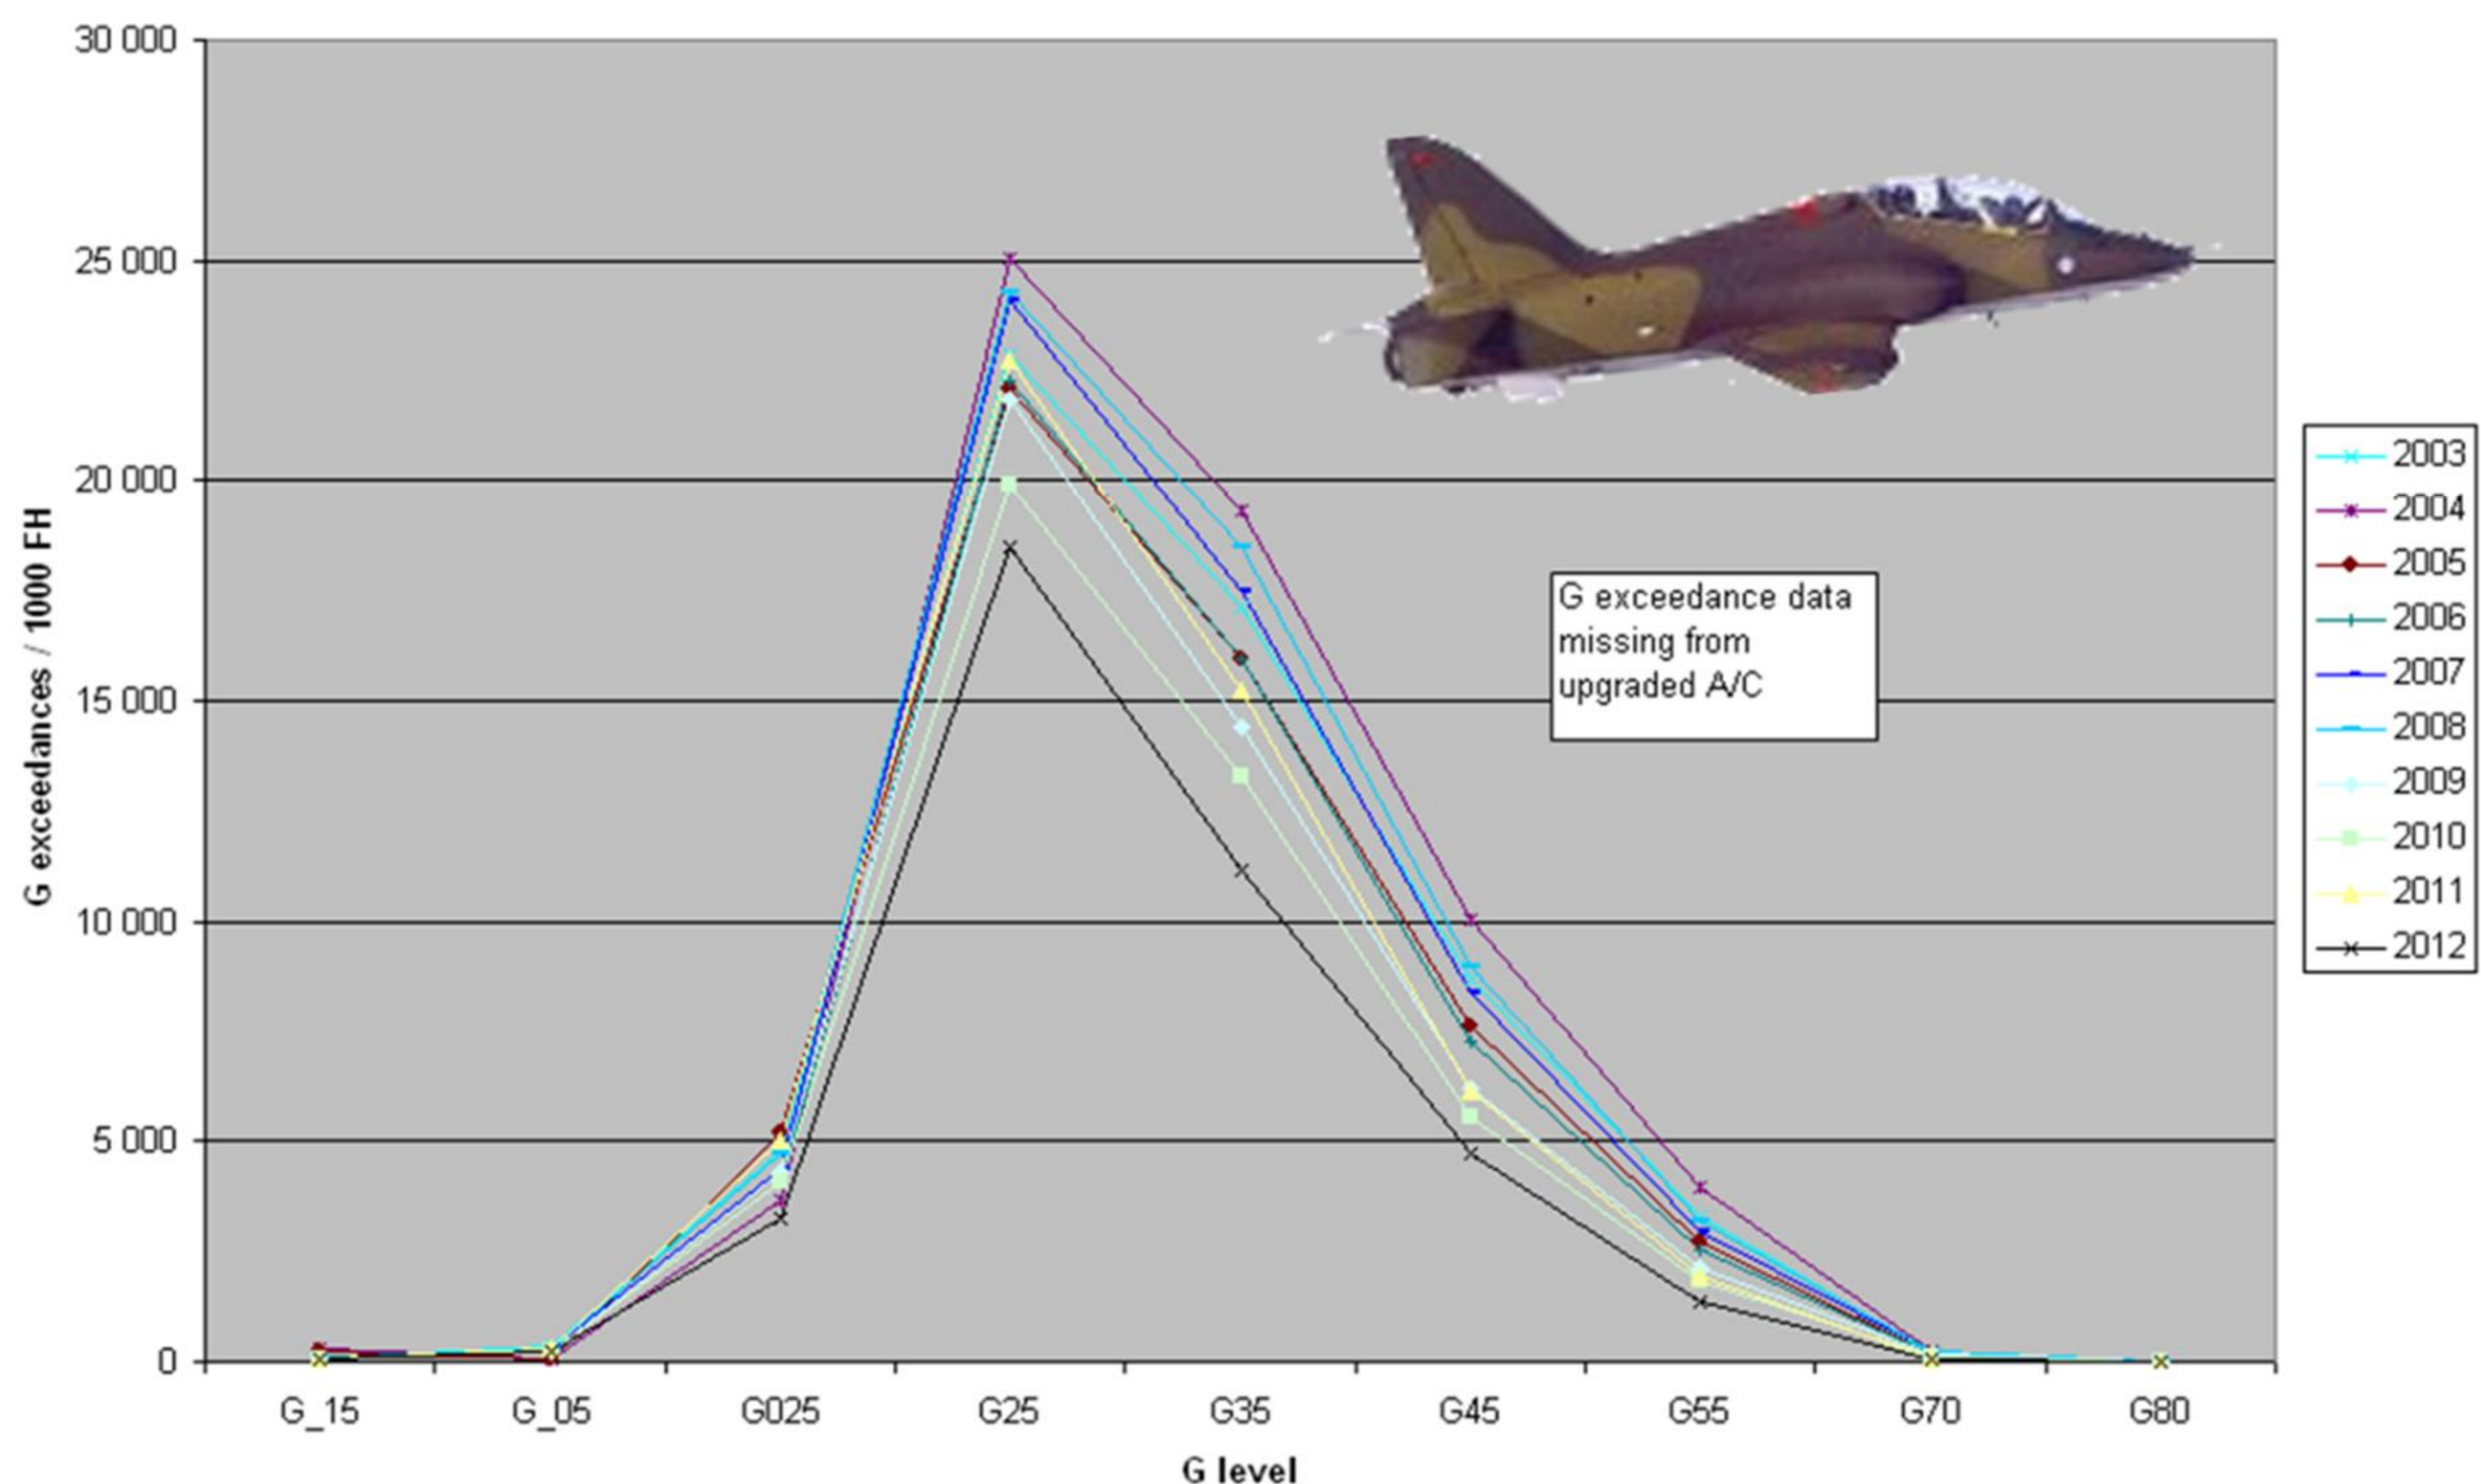
Figure 4: *G exceedance development of the FINAF Hawks (Mk.51 & Mk.51A) at the end of year 2012 (fleet average; data from all 57 aircraft included (excluding the modified Mk.66 aircraft), as ranked according to the a/c center of gravity normal acceleration. Note that all of the FINAF Hawks have been operating from the Kauhava air base since the end of 2005. Picture by courtesy of the FINAF.*

The structural fatigue consumption of the FINAF Mk.51/51A Hawks is summarized in *Fig. 4*. Further Hawk-related research efforts are provided in Chapter 13.2.2.4.

The severity of the Finnish usage in view of structural fatigue with the two jets of noteworthy maneuvering capability can be seen in *Fig. 4* (Hawk) and *Fig. 5* (Hornet). Figs. 4 and 5 clearly demonstrate the need to maintain, further develop and apply concrete and systematic efforts to cope with the structural deterioration effects of these two aircraft types.

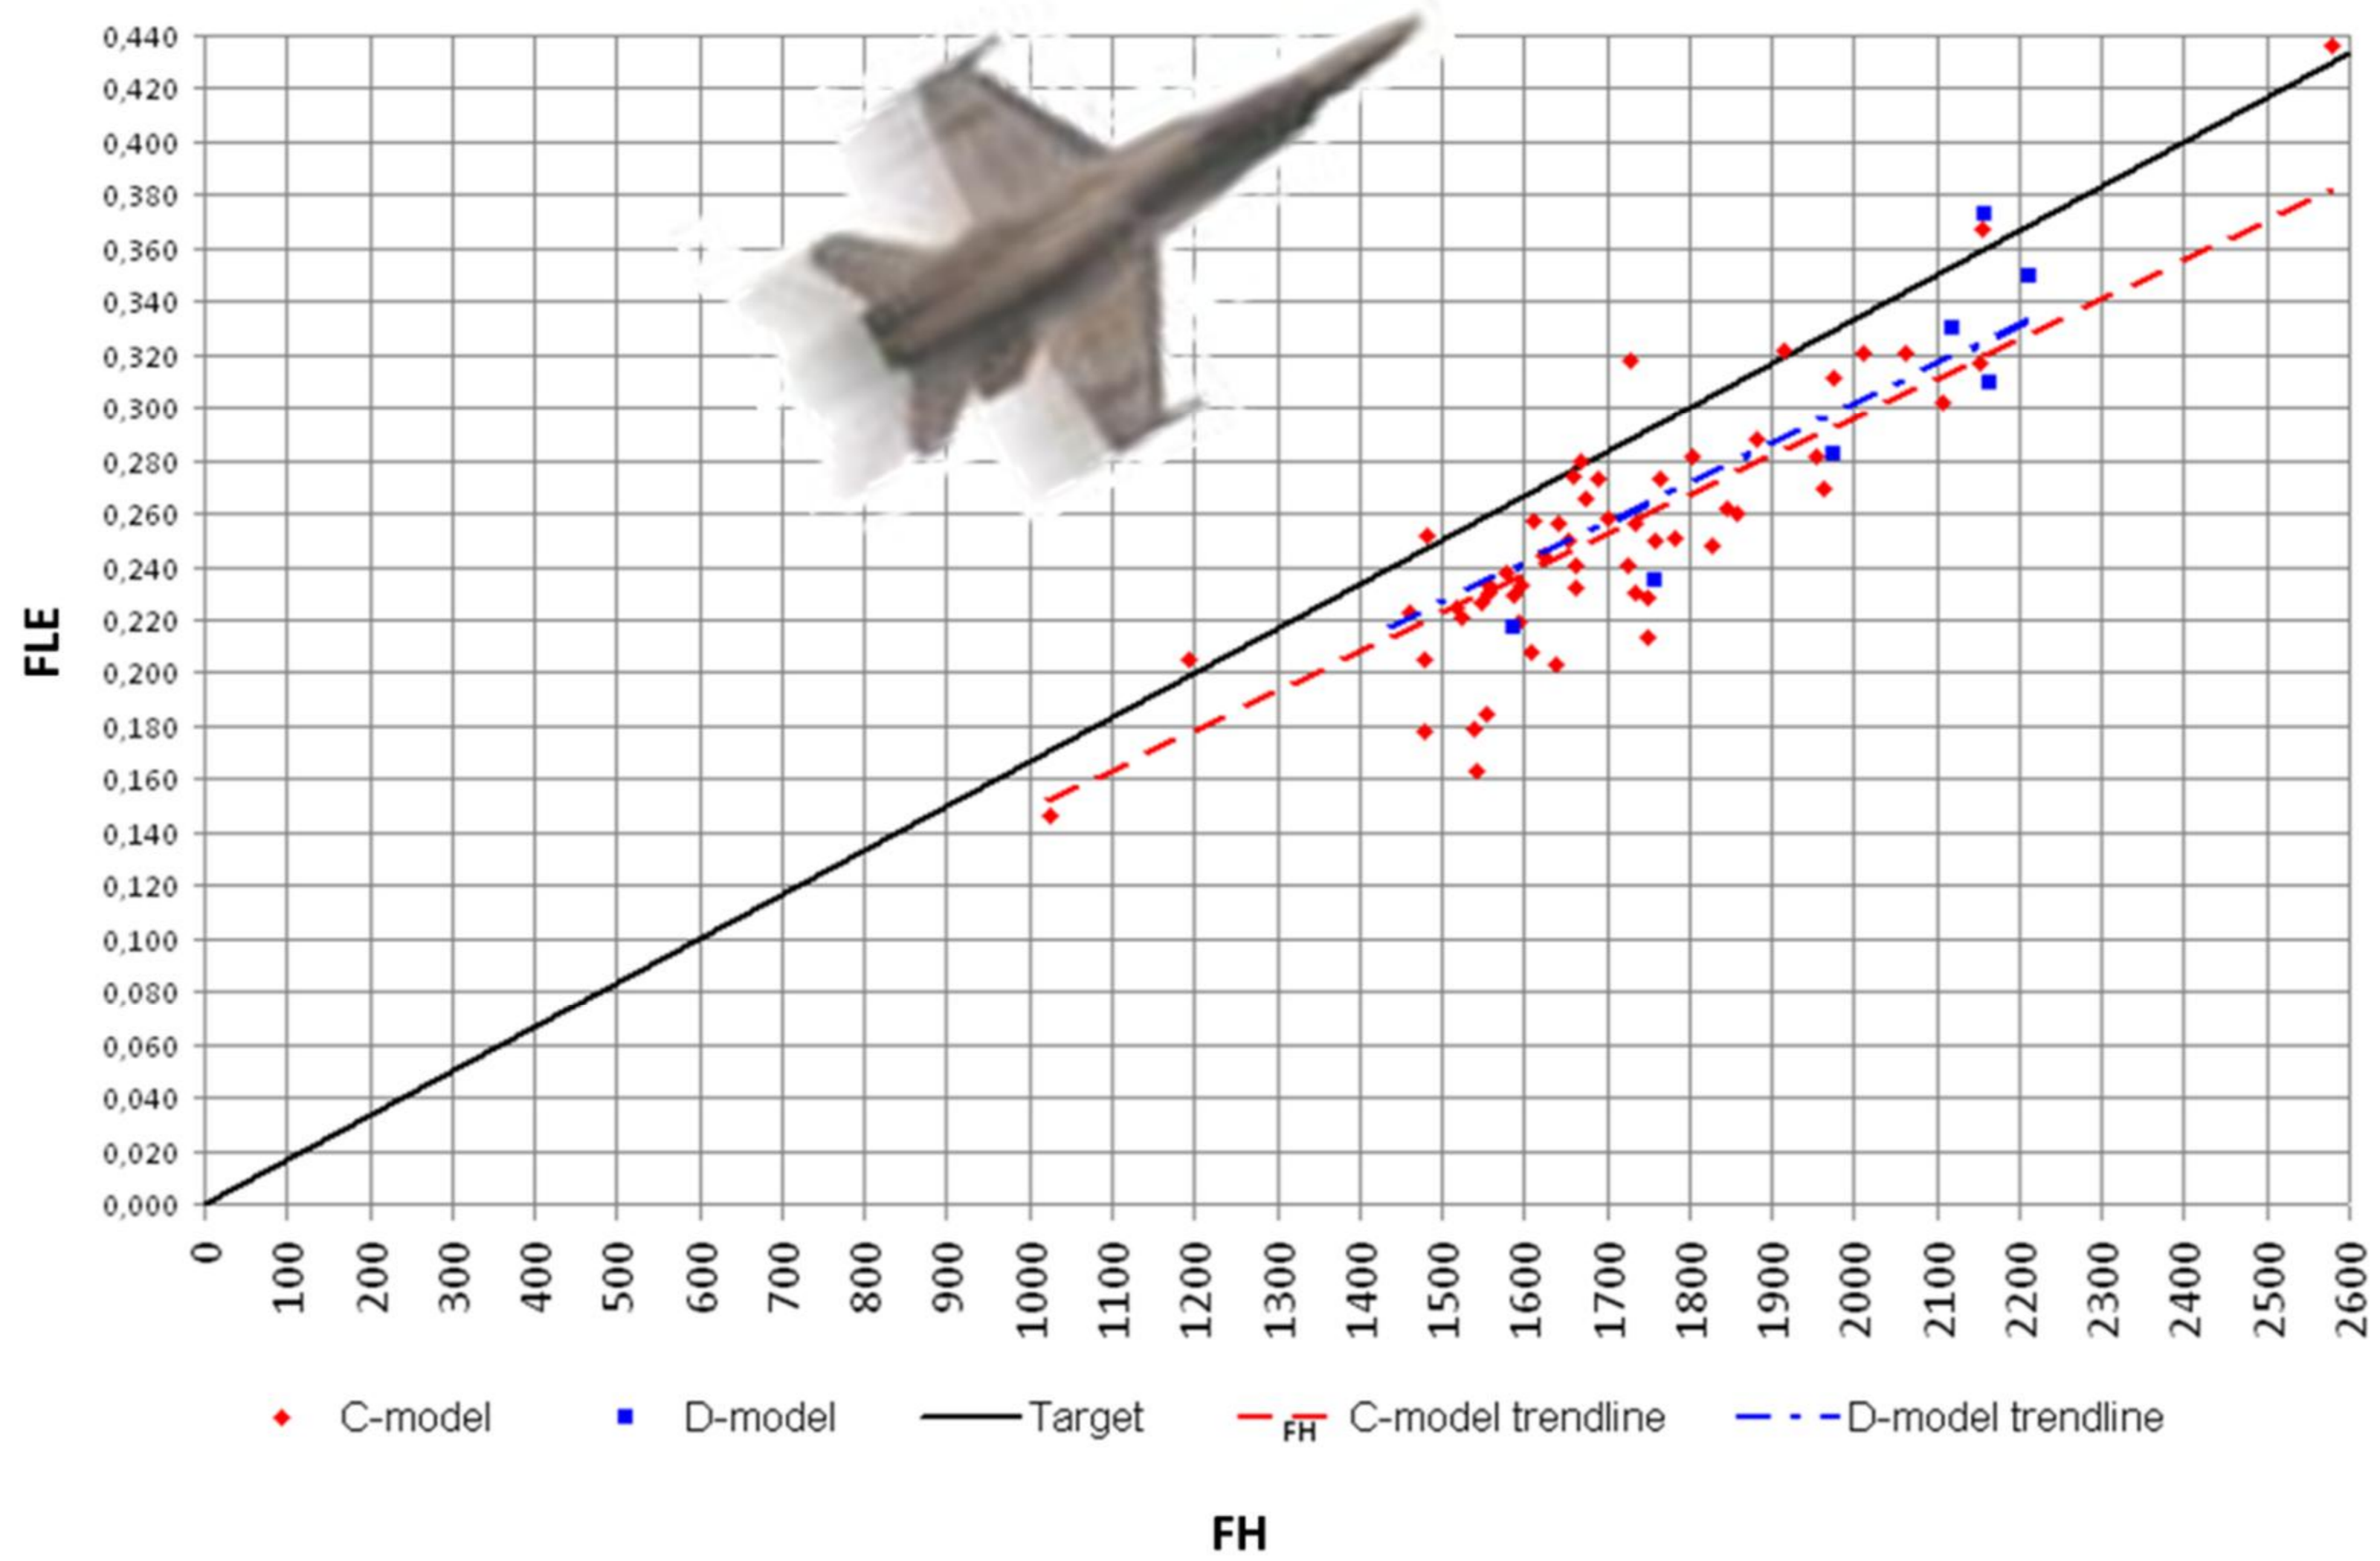
Figure 5: Summary of the wing root fatigue life expended (FLE) of the FINAF F-18C/D fleet at the end of year 2012. The data is from all 62 aircraft included. The target is 4500 FH and simultaneously 0.75 FLE. Picture by courtesy of the FINAF.

The current structural life consumption of the FINAF F-18 fleet is shown in **Fig. 5**. As presented in the figure, the aircraft usage seems less severe than the design target. However, when compared to other F-18 operators the usage is more severe. The current target for the FINAF F-18 aircraft is 4500 FH and 0.75 FLE (simultaneously).

It is worth noting that the structural life consumption (Fig. 5) is mainly decided based on a single detail of structure. The data collected from the said detail is processed by a piece of software

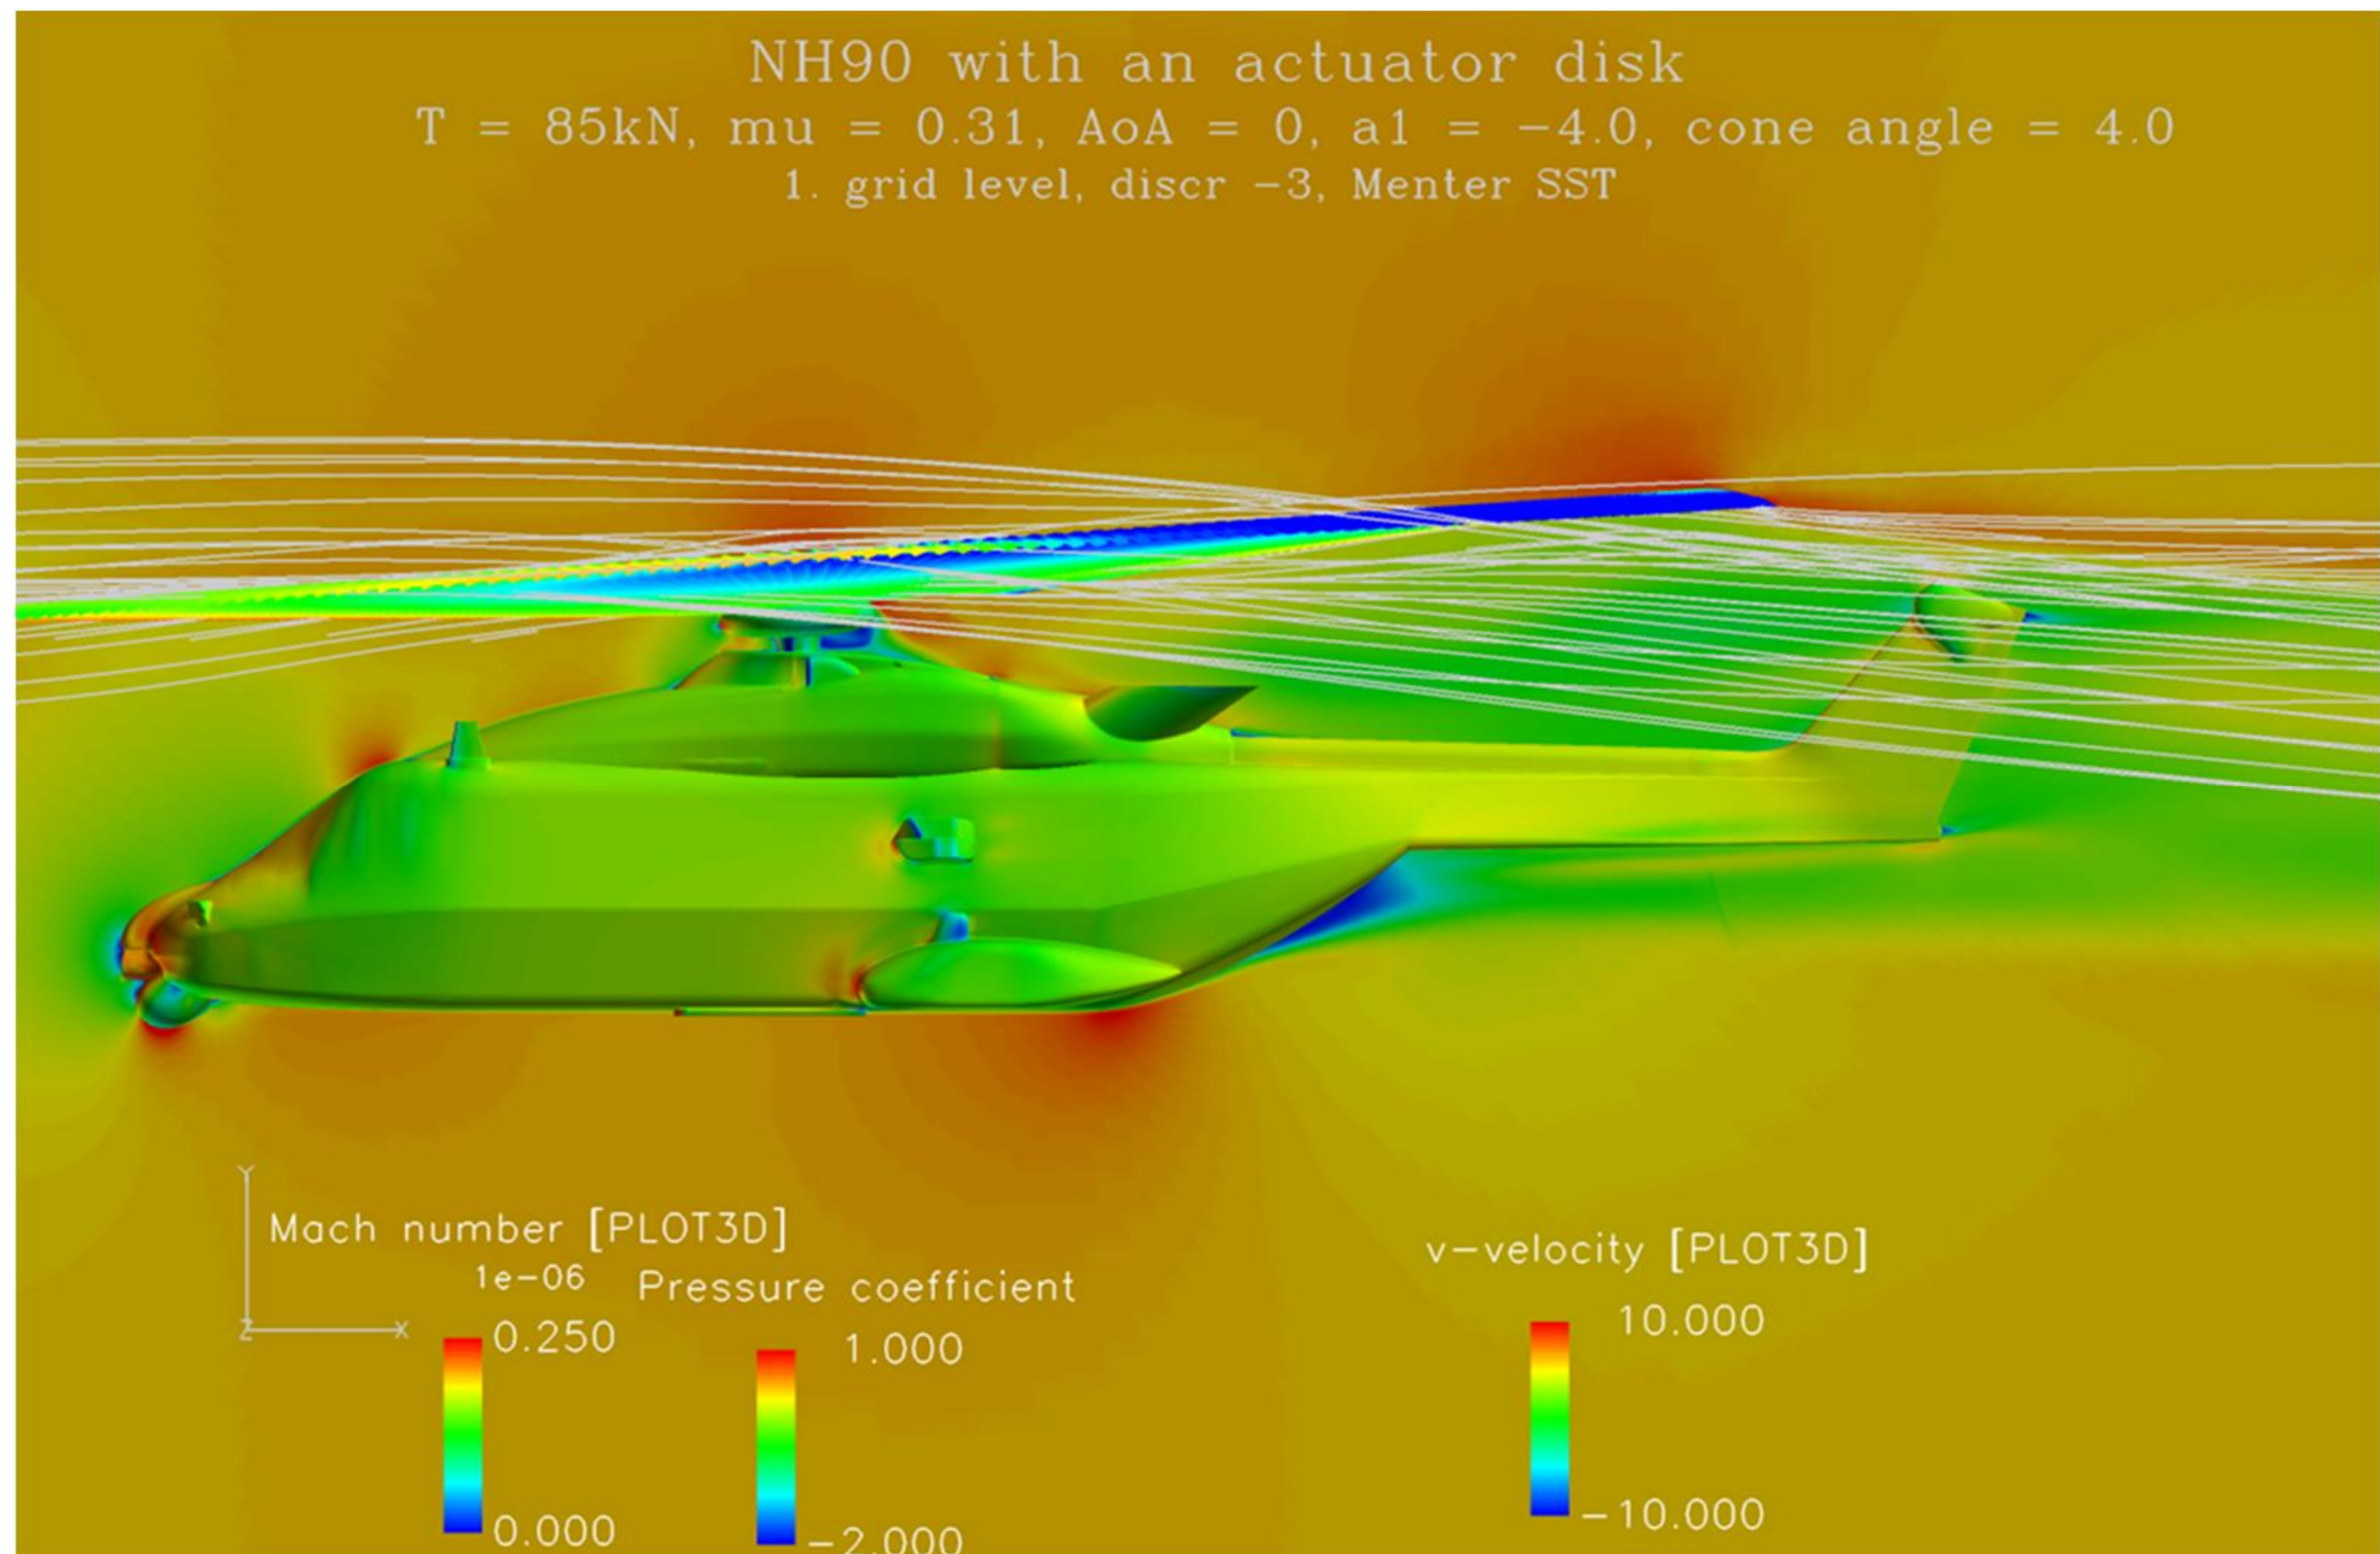
Figure 6: Computed flowfield around NH90 in cruise. Picture by courtesy of Patria Aviation.

In cruise at zero angle of attack, the lift of the fuselage is negative and is caused by its shape with little rotor influence. The computed lift magnitude corresponds to about 7 per cent of the helicopter weight. The fuselage drag is about the same as the horizontal component of the thrust vector tilted 4 degrees forward. The results conform to expectations, but there are no real data available for validation. The computed flowfield is illustrated in *Fig. 6* by the pressure distribution on the fuselage, Mach number distribution on the nominal symmetry plane, vertical velocities on the rotor plane and by some streamlines.

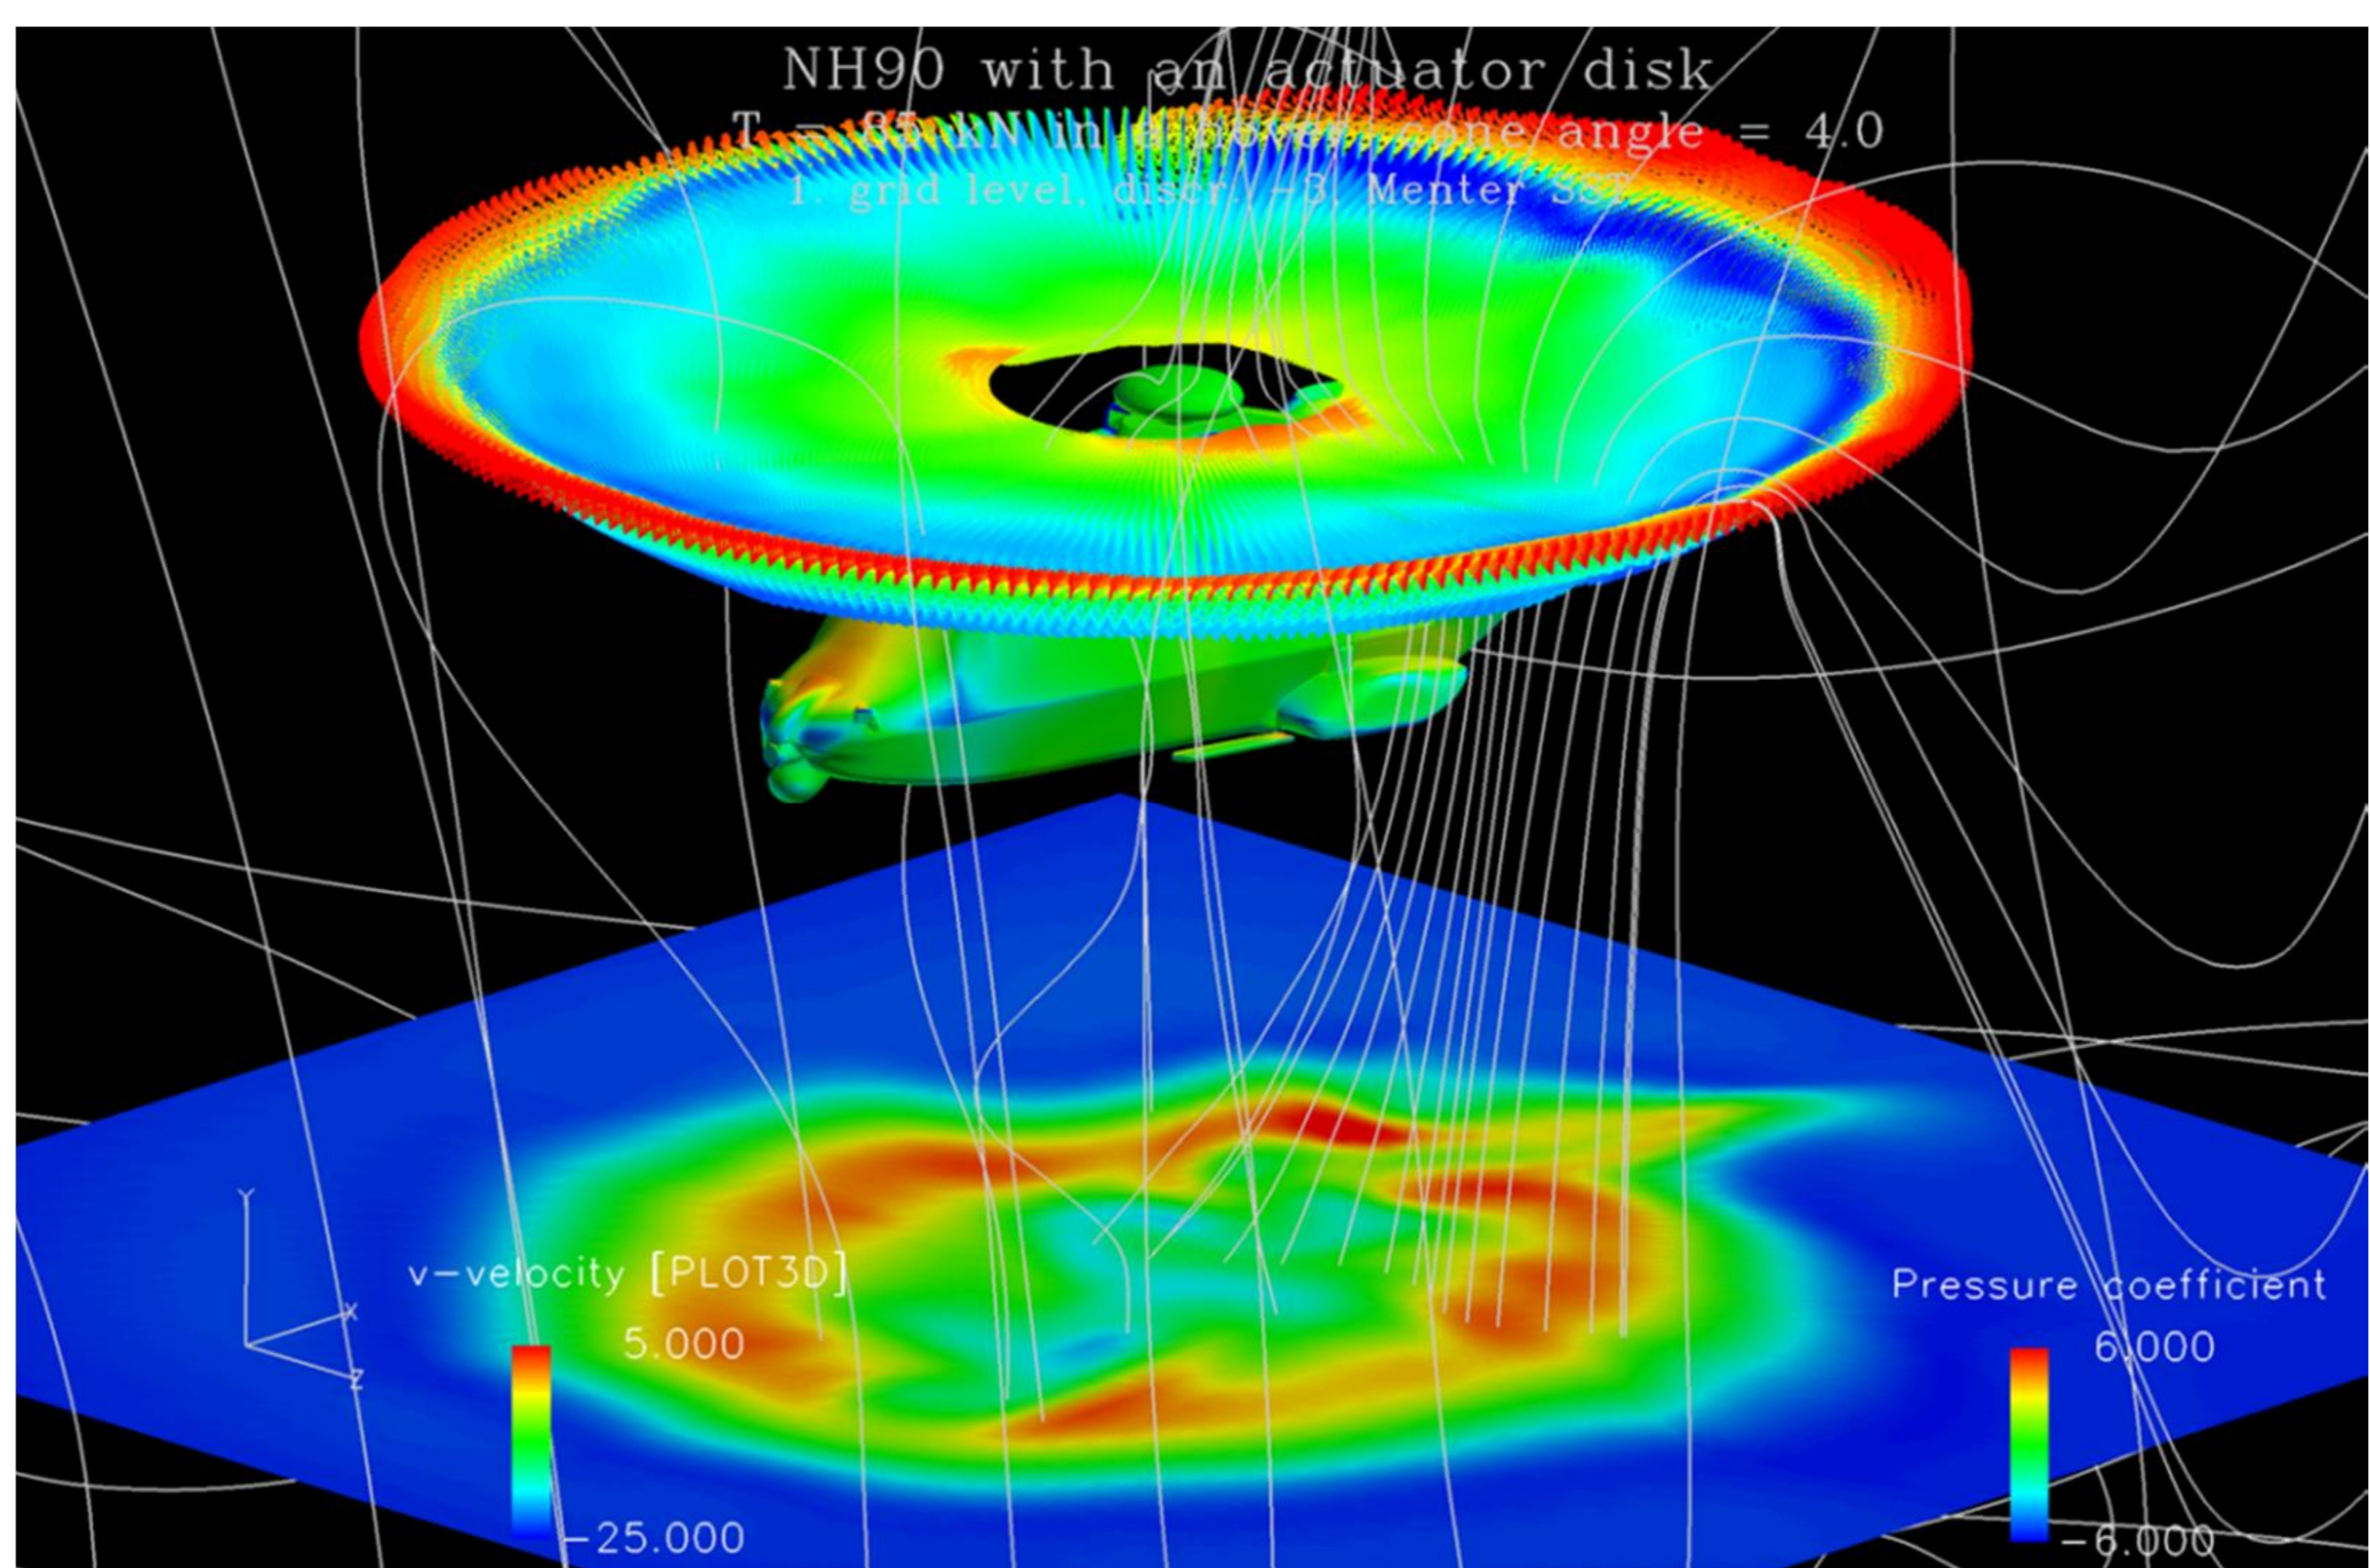
Figure 7: Computed flowfield around NH90 and on a horizontal plane below it in hover. Picture by courtesy of Patria Aviation.

In the hover case, the averaged down-force acting on the fuselage and entirely caused by the rotor blowing again represents about 7 per cent of the helicopter weight, and the horizontal forces are small. Also the moment balance is reasonably good. **Fig. 7** shows the fuselage pressure distribution and vertical velocity on the rotor plane and on a plane 6 meters below the fuselage. It is clearly seen that the fuselage disturbs the rotor outflow strongly and the pattern below the helicopter is far from axisymmetric. On the rotor disc plane, the distortion effects of the fuselage are also clearly visible
