A REVIEW OF AERONAUTICAL FATIGUE INVESTIGATIONS IN FINLAND APRIL 2011 – FEBRUARY 2013

Presented at the 33rd Conference of the
International Committee on Aeronautical Fatigue and
Structural Integrity (ICAF),
Jerusalem, Israel, 3-4 June 2013

Compiled by Aslak Siljander

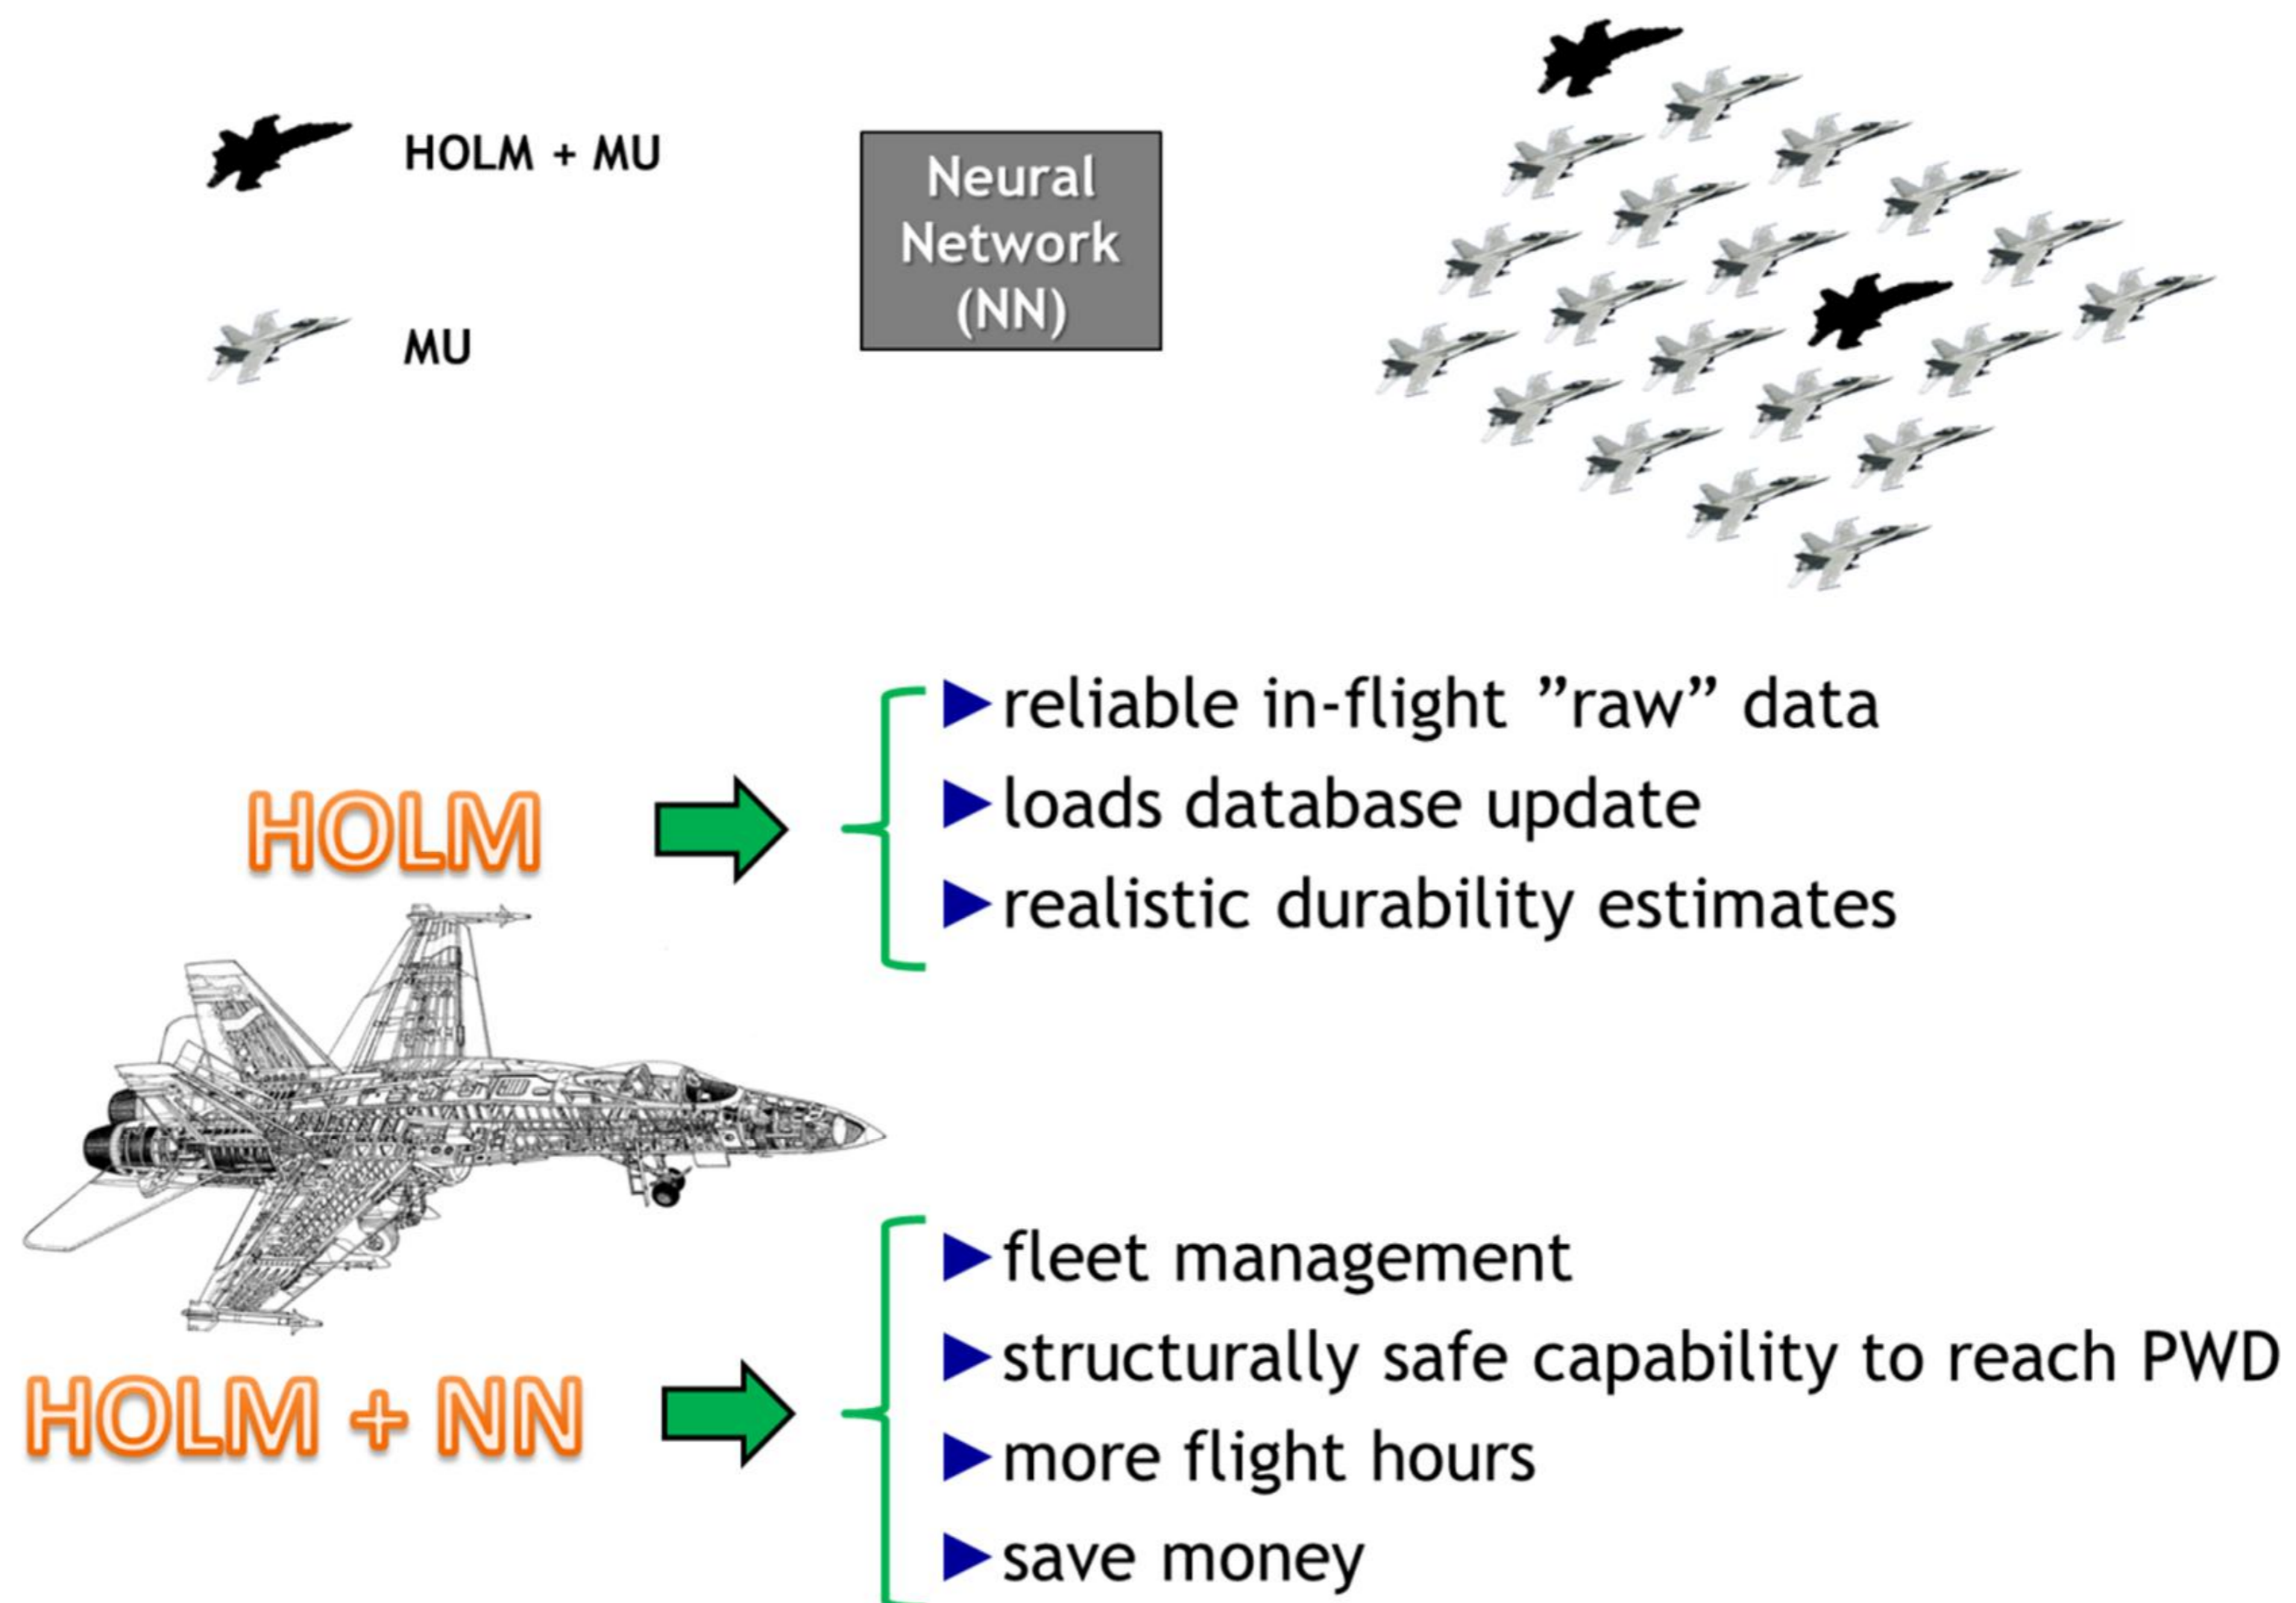
Figure 12: An overview of the Finnish “domestic fleet management system”, with which the risk associated with structural integrity can be minimized by managing the activities needed to reach the planned withdrawal date [36, 37]. Picture by courtesy of VTT and Patria Aviation Oy.

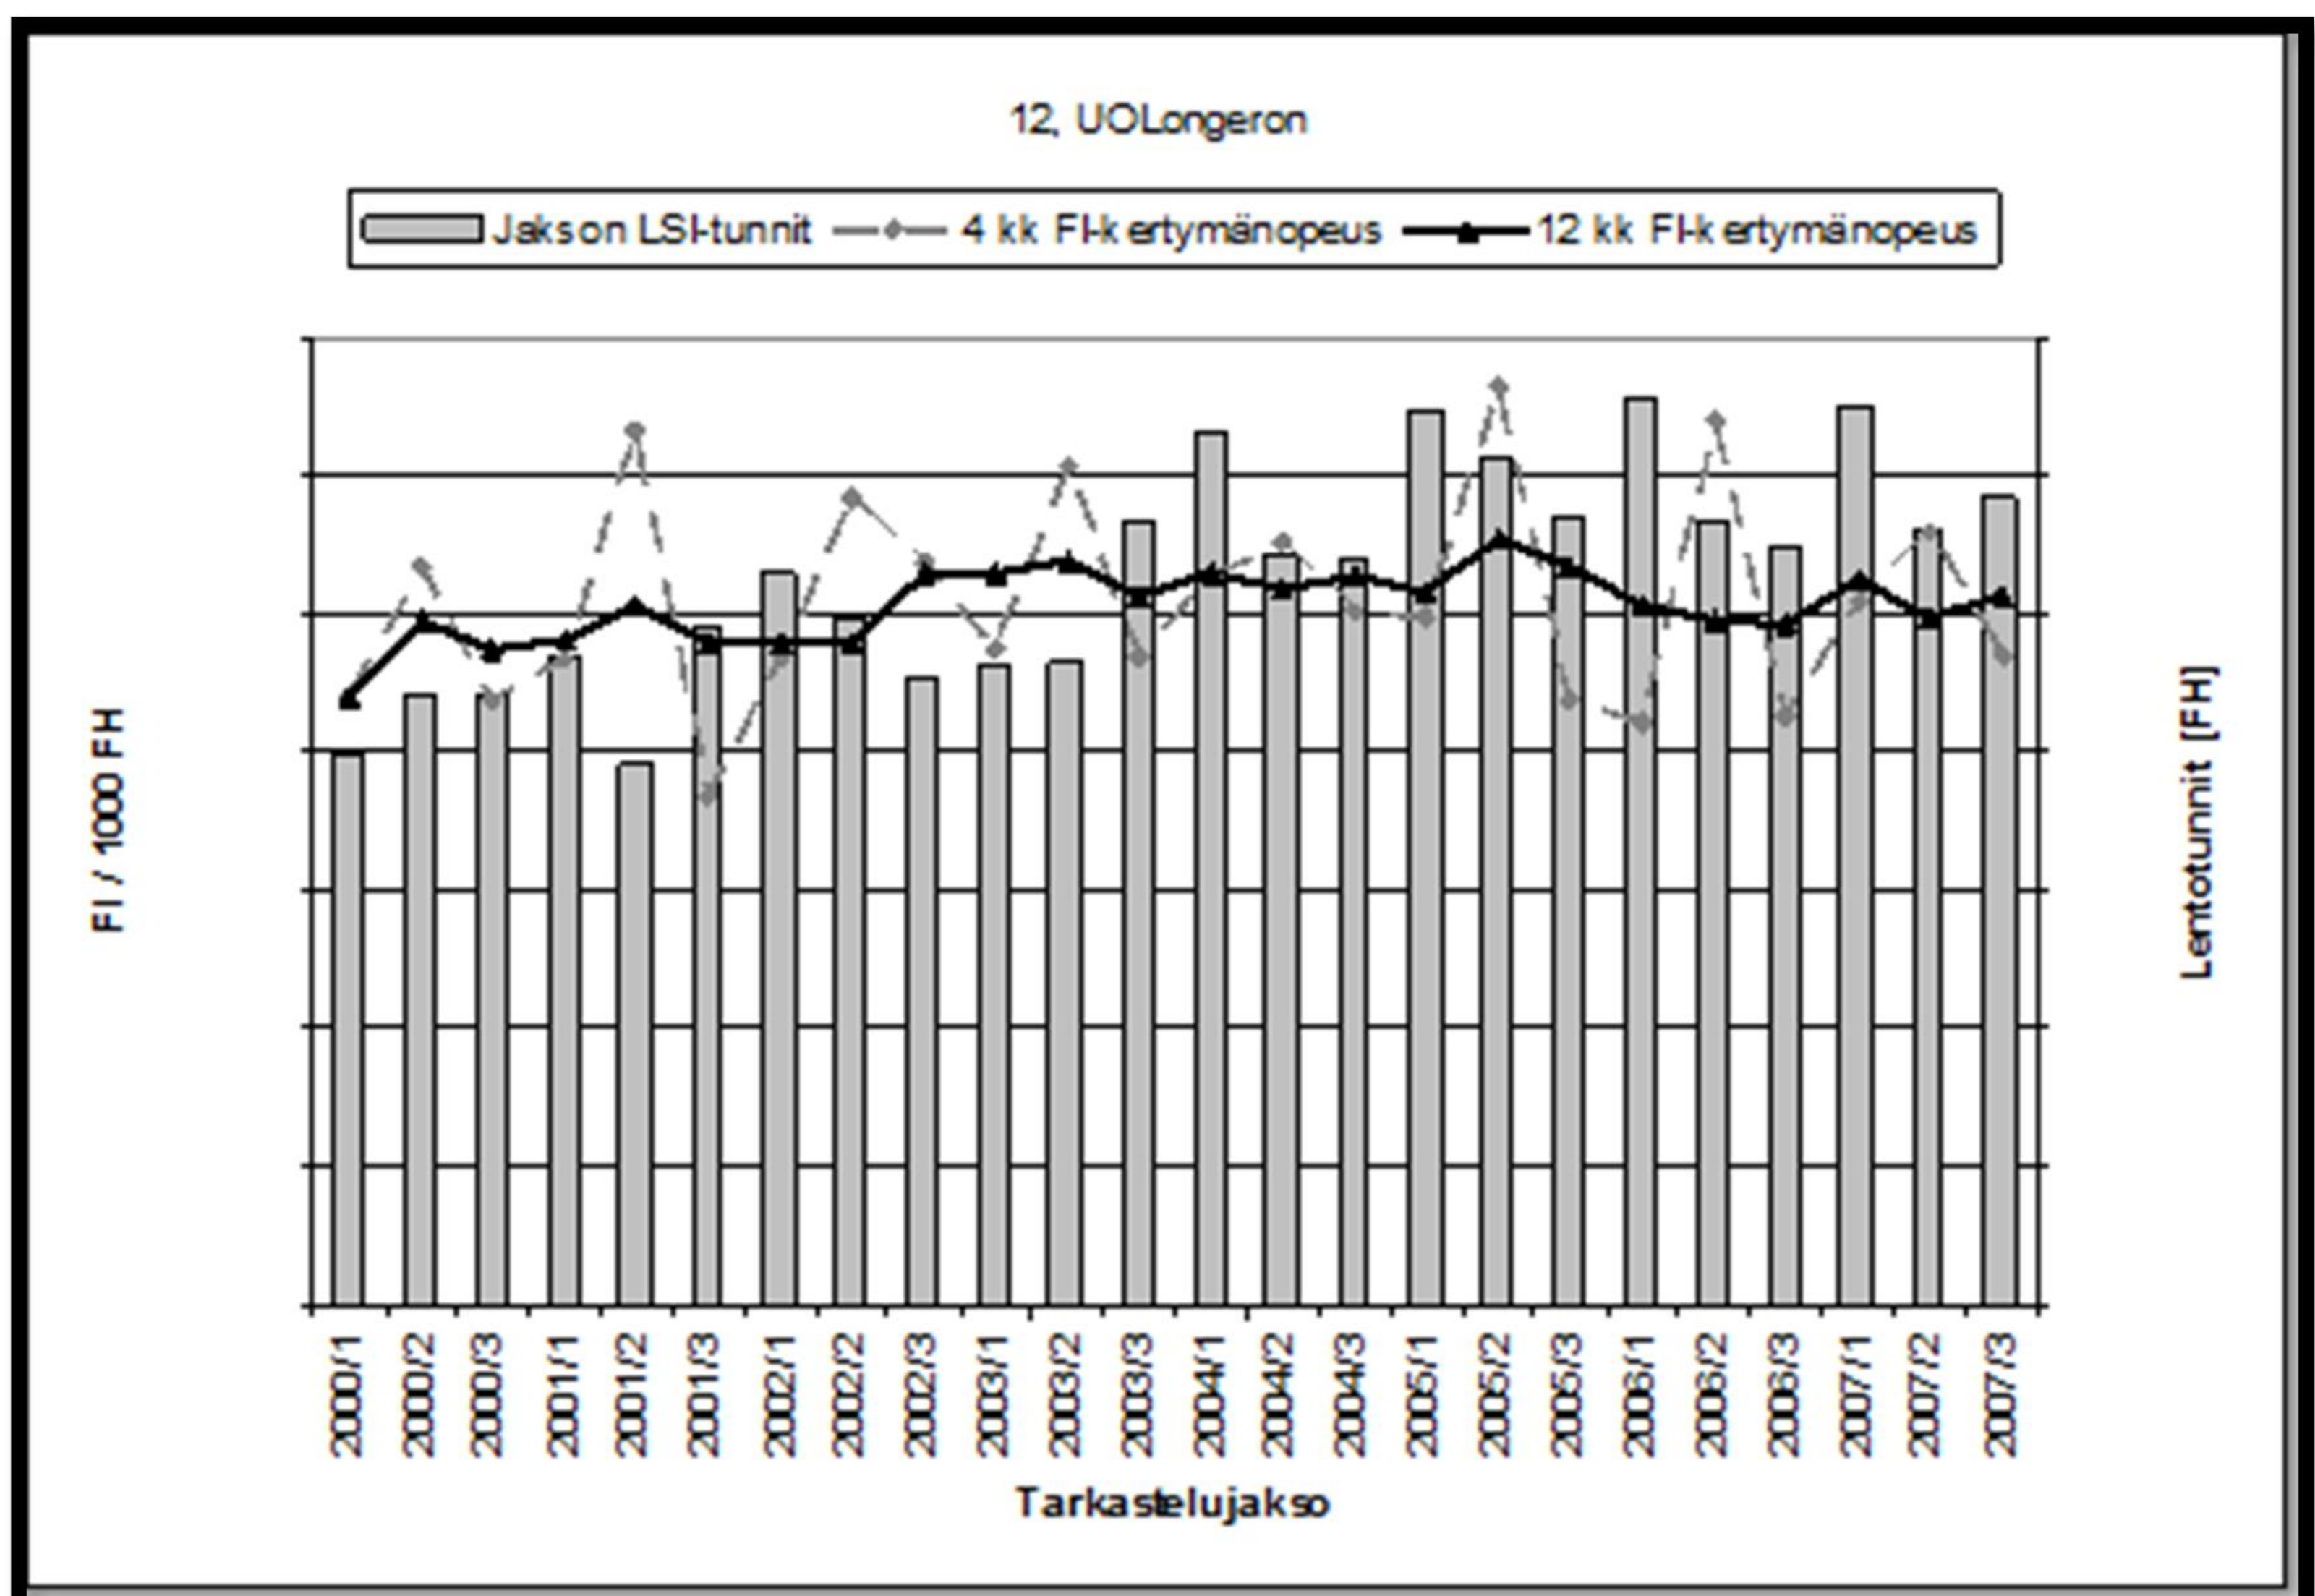
Figure 16: The whole fleet FLE accumulation rate of a fuselage longeron over period of 4 months and 12 months. The bars denote flight hours, the black line denotes 12 months accumulation rate and grey line denotes 4 months accumulation rate. Picture by courtesy of Patria Aviation.

Recently CFD and FE analysis results of the F-18 were improved causing changes in the transfer functions. Therefore the fatigue life estimations changed and the annual report delivered to the FINAF was updated. About half of the flights flown by the FINAF have been analyzed by now and the rest of the flights are in the process. An example of the results in *Fig. 15* shows FLE distribution of a structure in tail area for FINAF F-18 fleet. *Fig. 16* shows FLE accumulation rate of a fuselage longeron over period of 4 months and 12 months. It indicates how the usage of the aircrafts has been changed over the period 2000-2007.

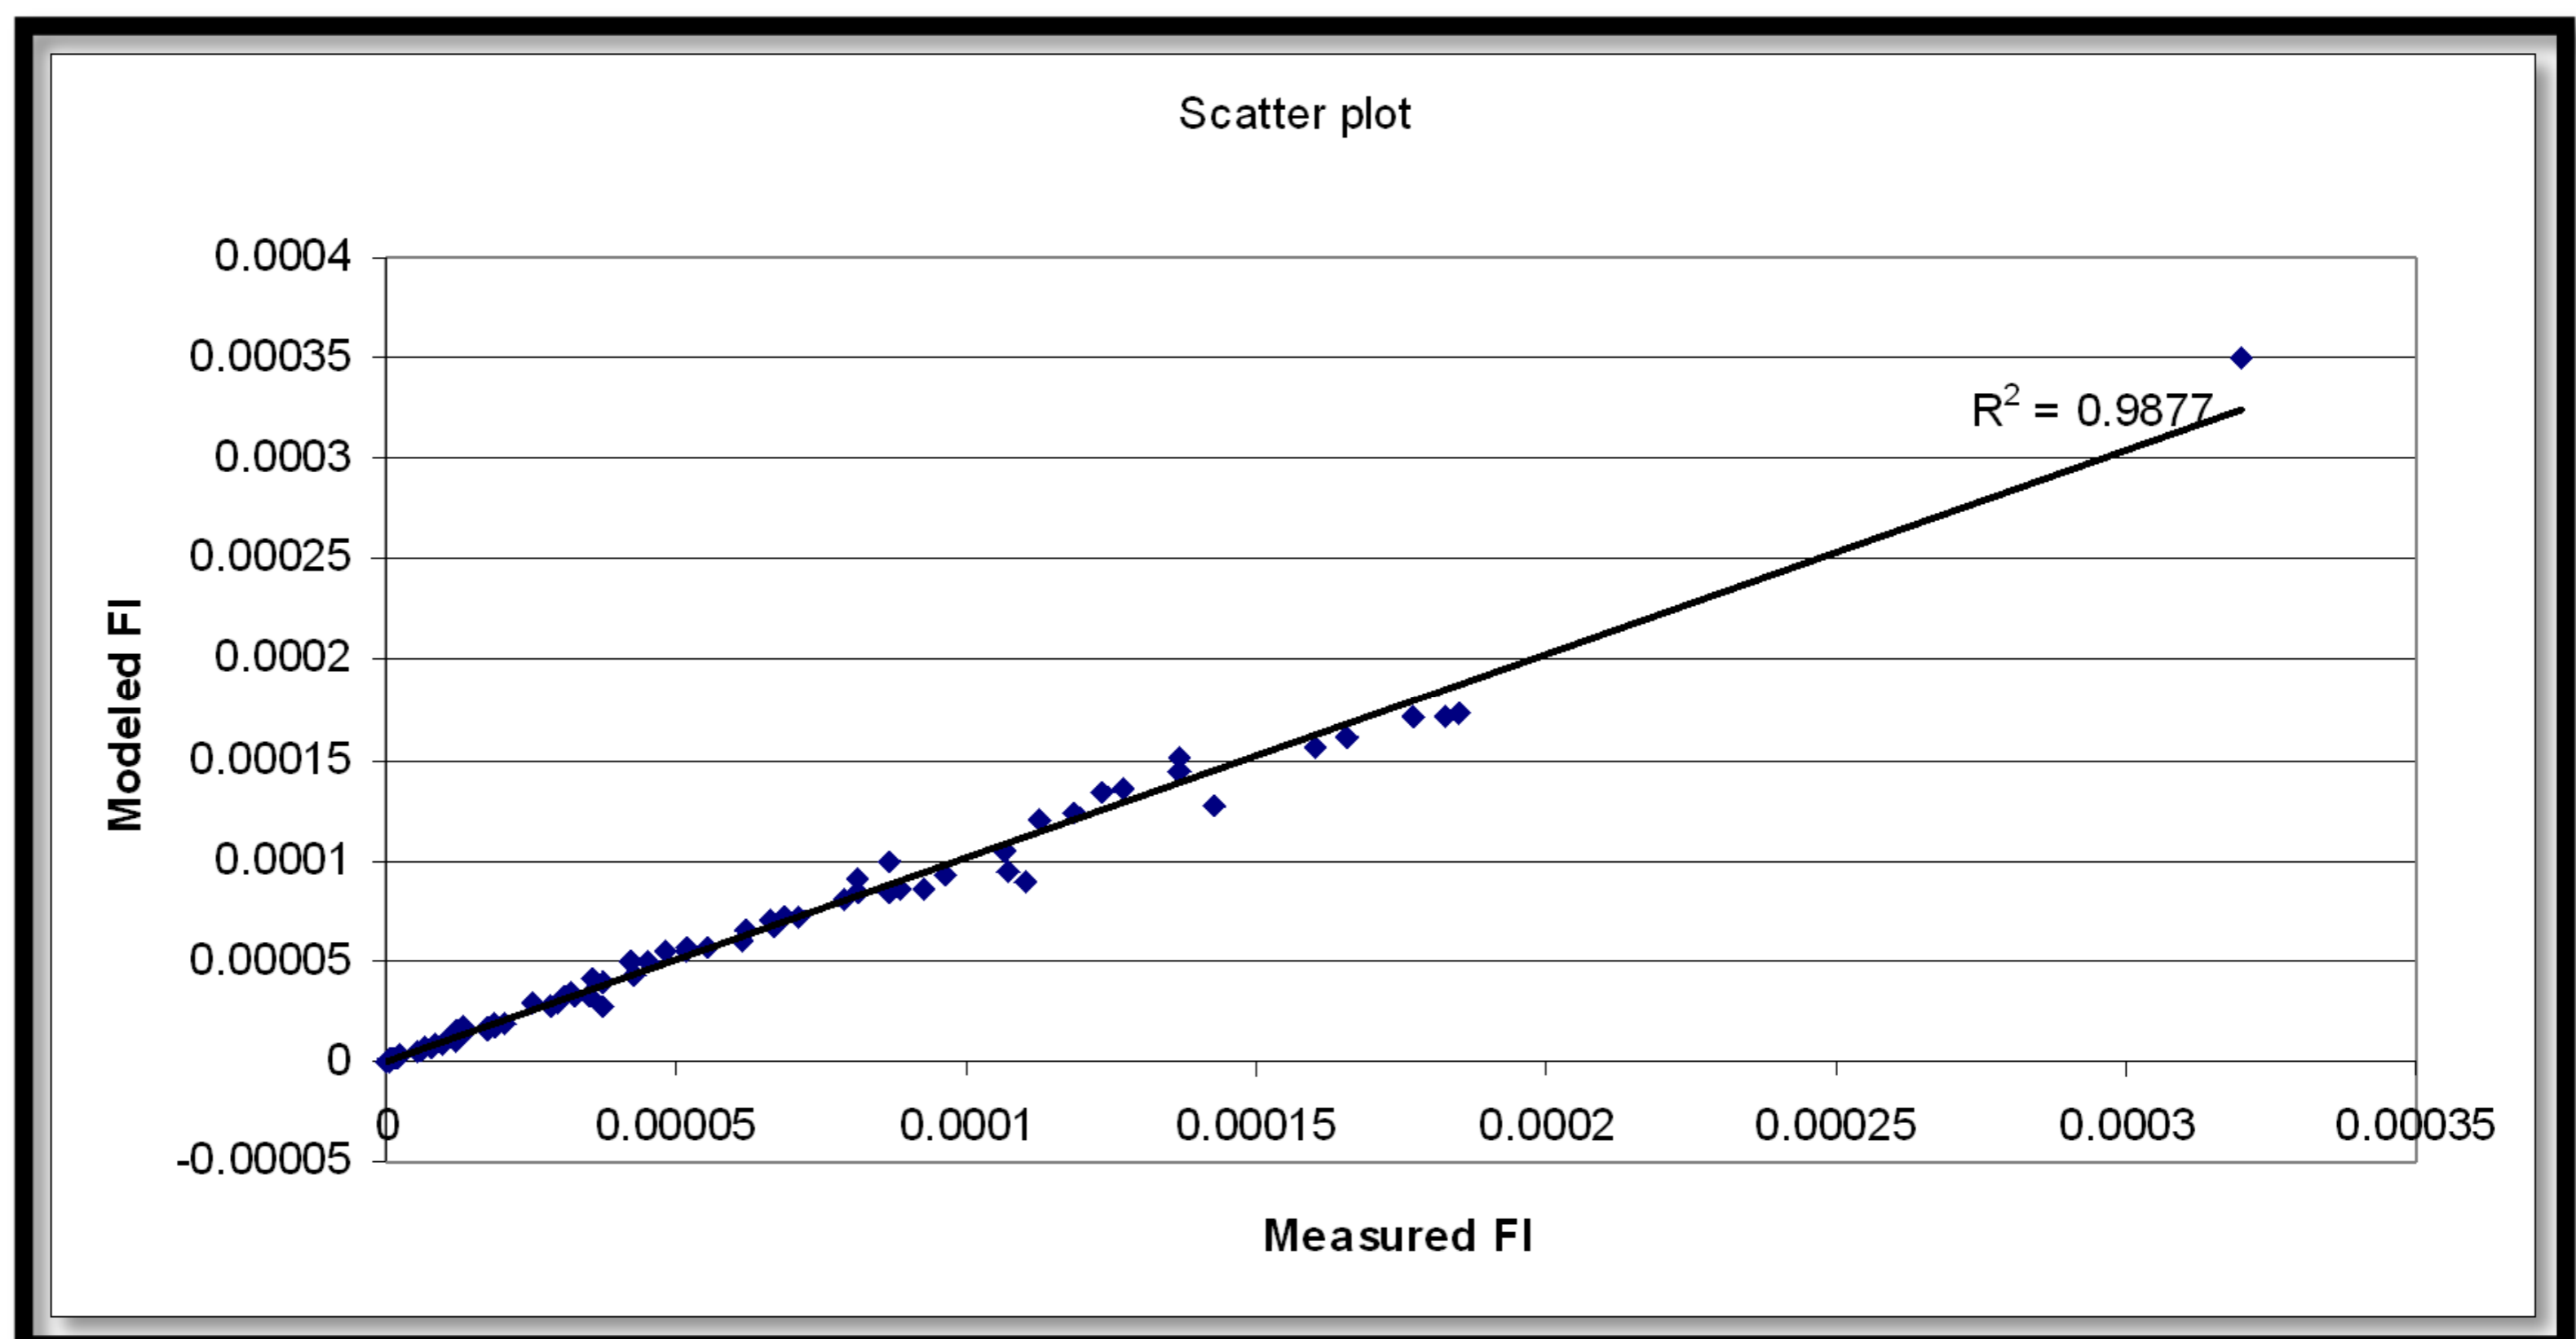
Figure 17: A proof of in-service performance of the parameter based fatigue life analysis. A scatter plot of flight specific damage from a fuselage bulkhead. Picture by courtesy of Patria Aviation.

Fig. 17 and **Fig. 18** show flight specific damage scatter and accumulation plots from the in-service performance assessment.

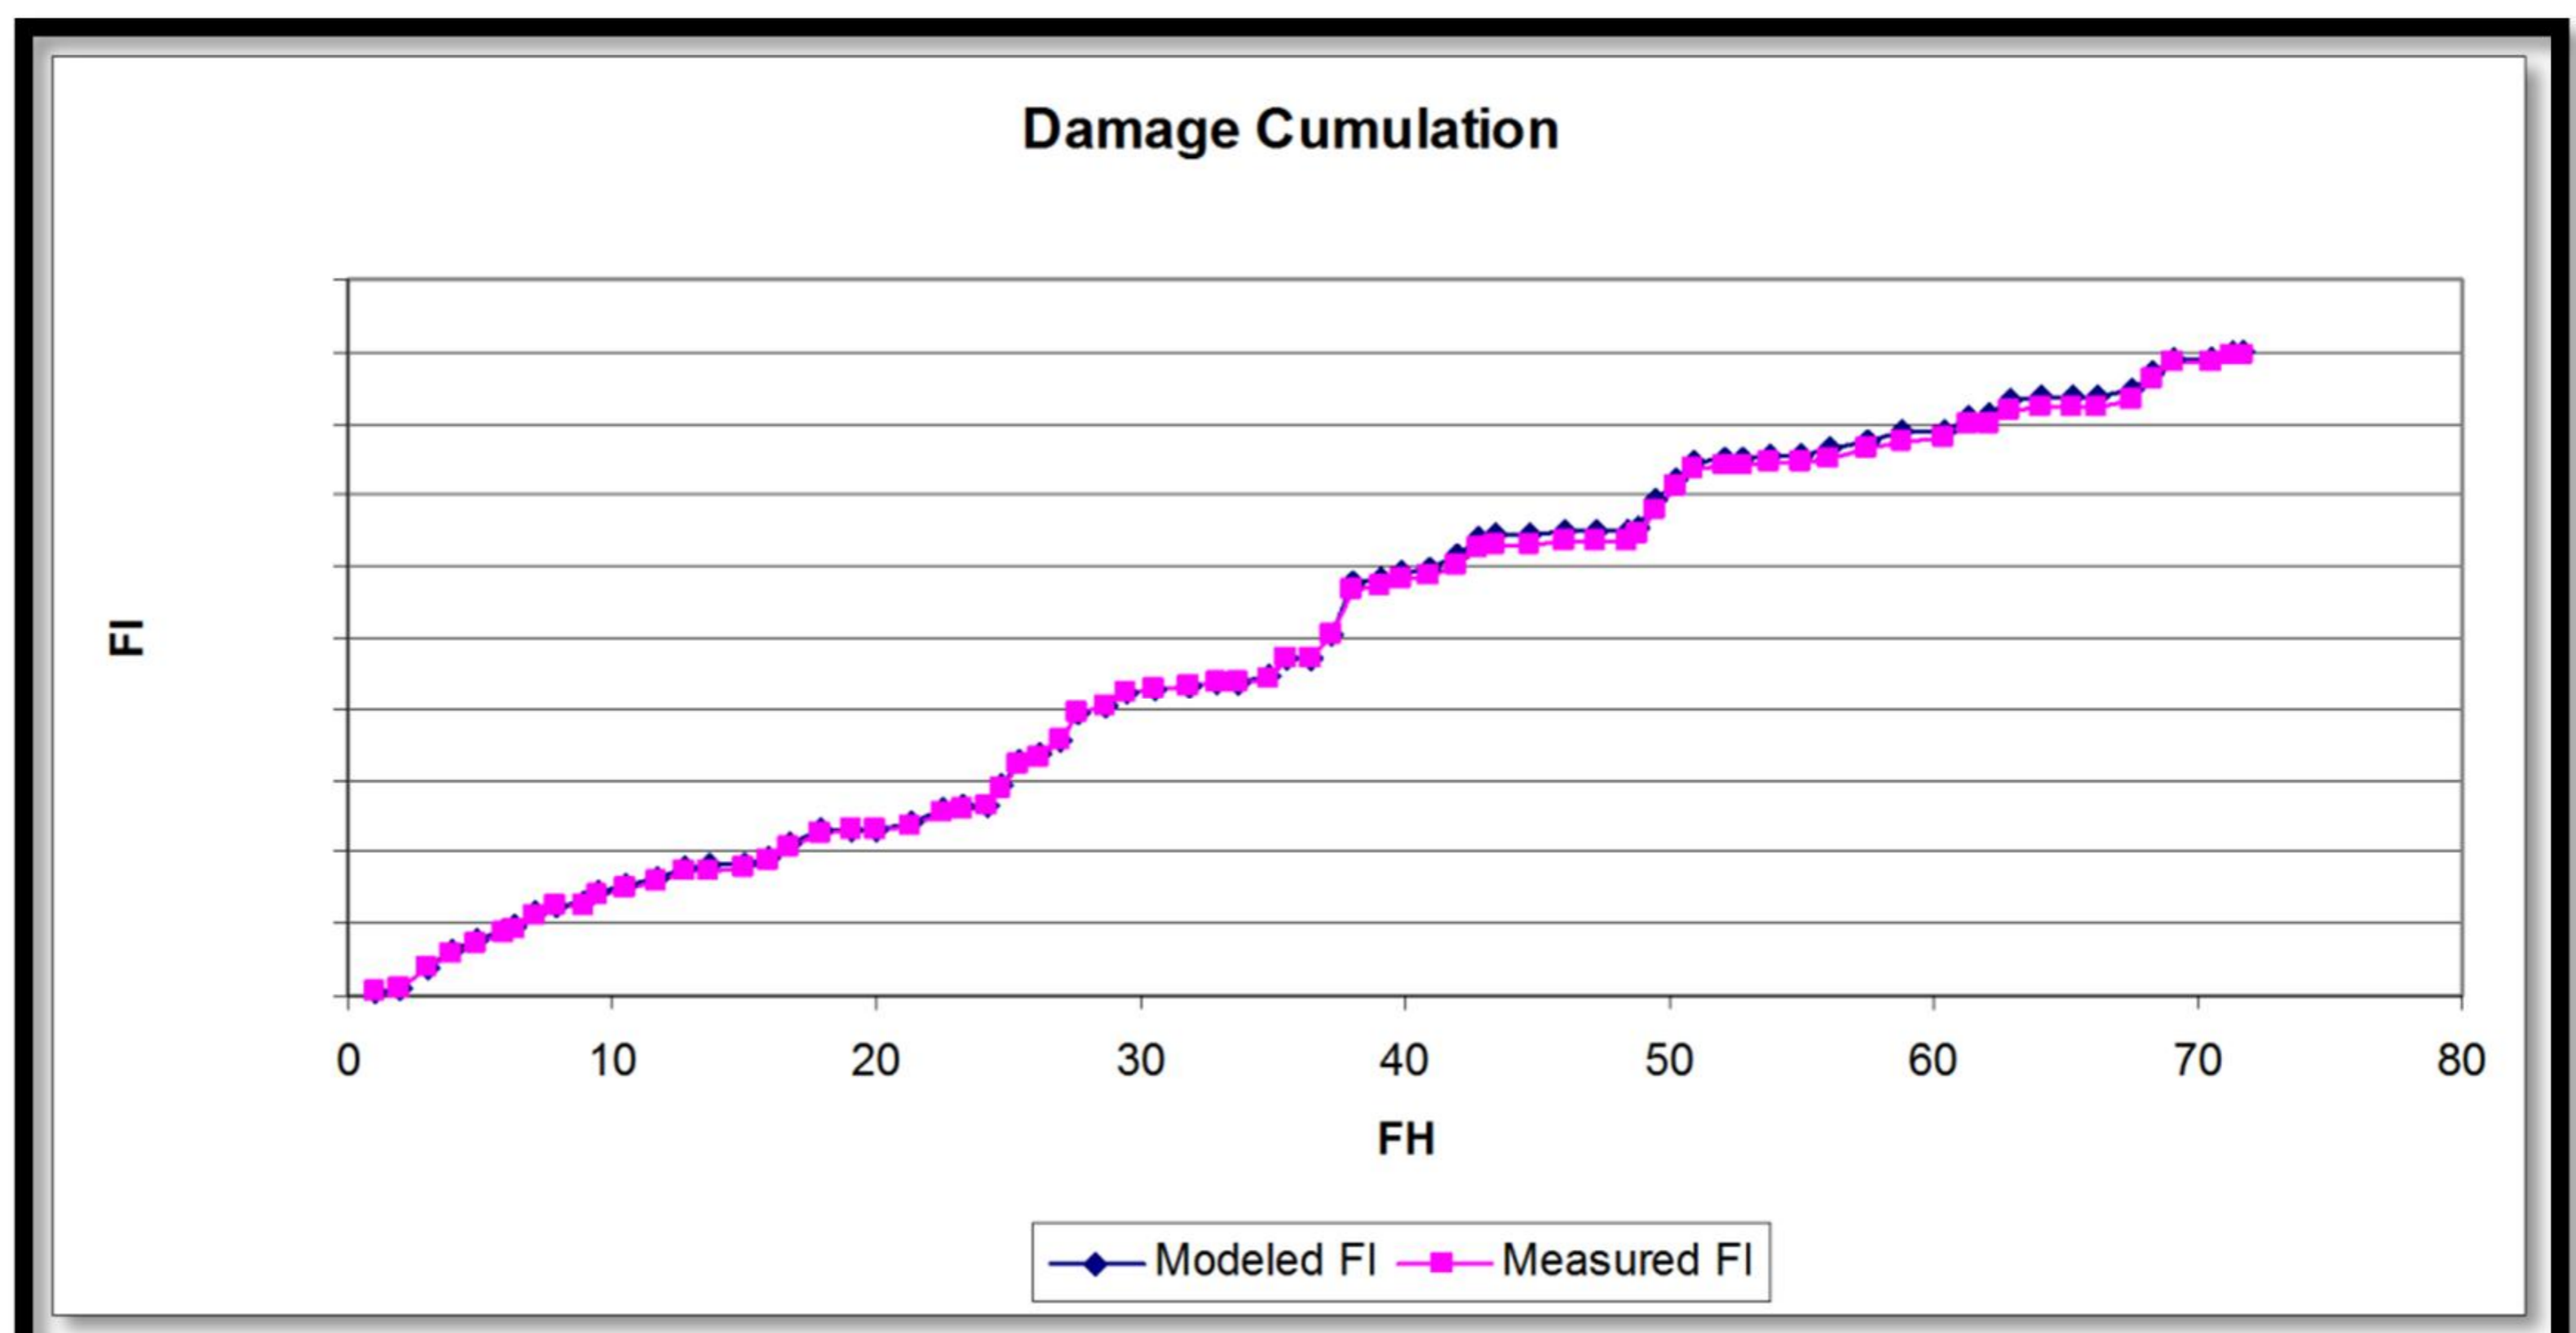
Figure 18: A proof of in-service performance of the parameter based fatigue life analysis. Modeled and measured damage accumulation over period of 70 FH. Picture by courtesy of Patria Aviation.

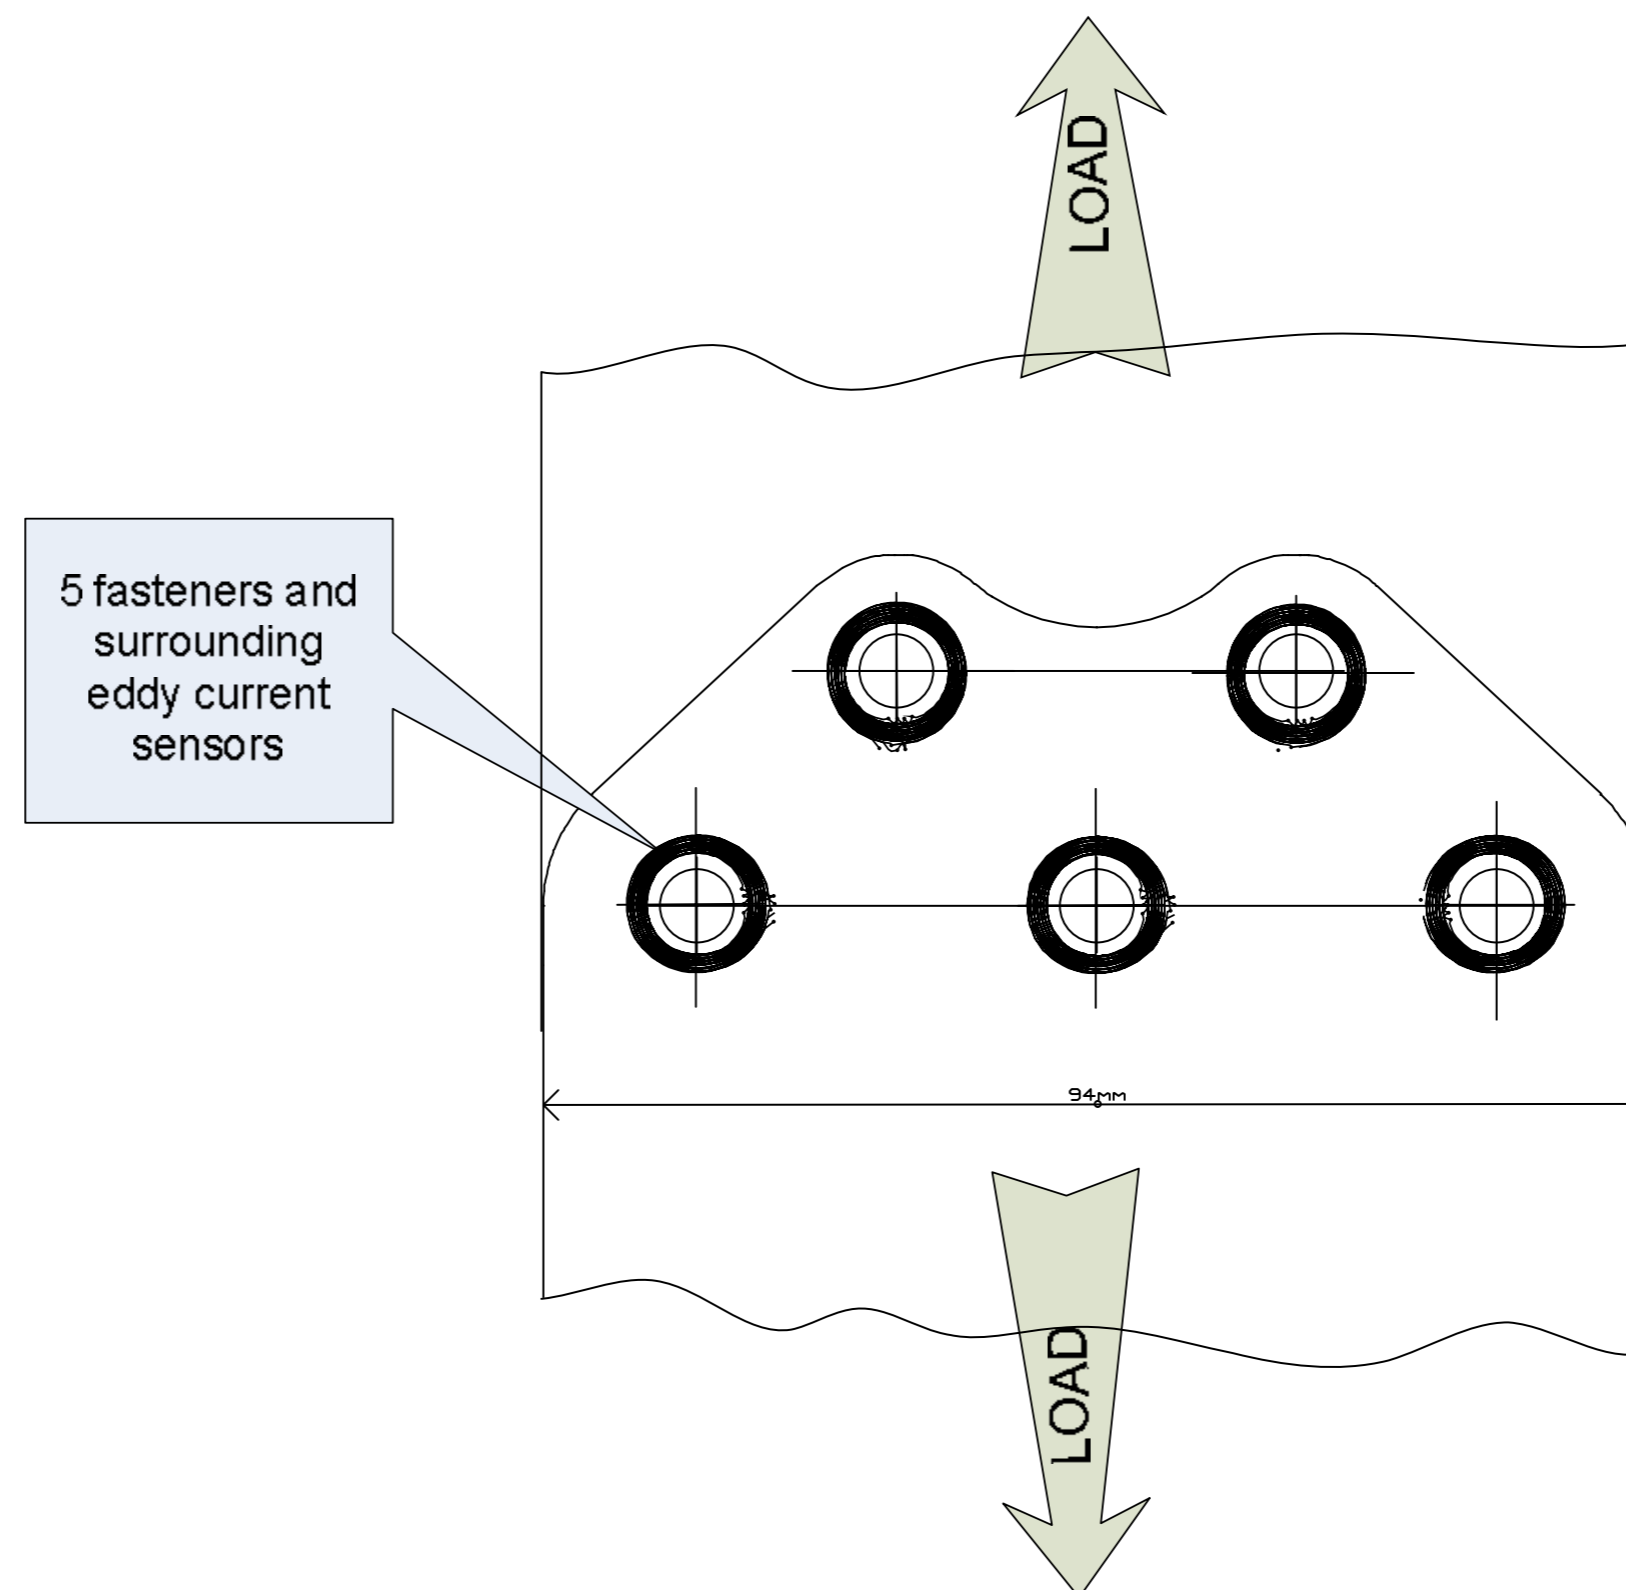
Figure 19: A specimen with five fasteners with an eddy current sensor (printed circuit board, PCB) around each fastener. Picture by courtesy of Emmecon Ltd.

Emmecon has also developed an eddy current inspection system (EDDY) which is integrated onto the structure and executes automated inspection sequence upon request or automatically. The system was tested with simplified test specimen simulating a butt strap joint in Hawk's tailplane, *Fig. 19*.

Twelve (12) specimens as sketched in **Fig. 19** were tested. In four cases the EDDY alerted from a crack, one of them was a false alarm. In three cases the specimen broke without alarm. In none of the twelve specimen crack originated from a fastener hole but a couple of millimeters outside. The reason for this is the Hi-Tigue fasteners used, which create a cold-worked area around the fastener hole. If the crack does not originate from the fastener hole it is very challenging to catch for EDDY.

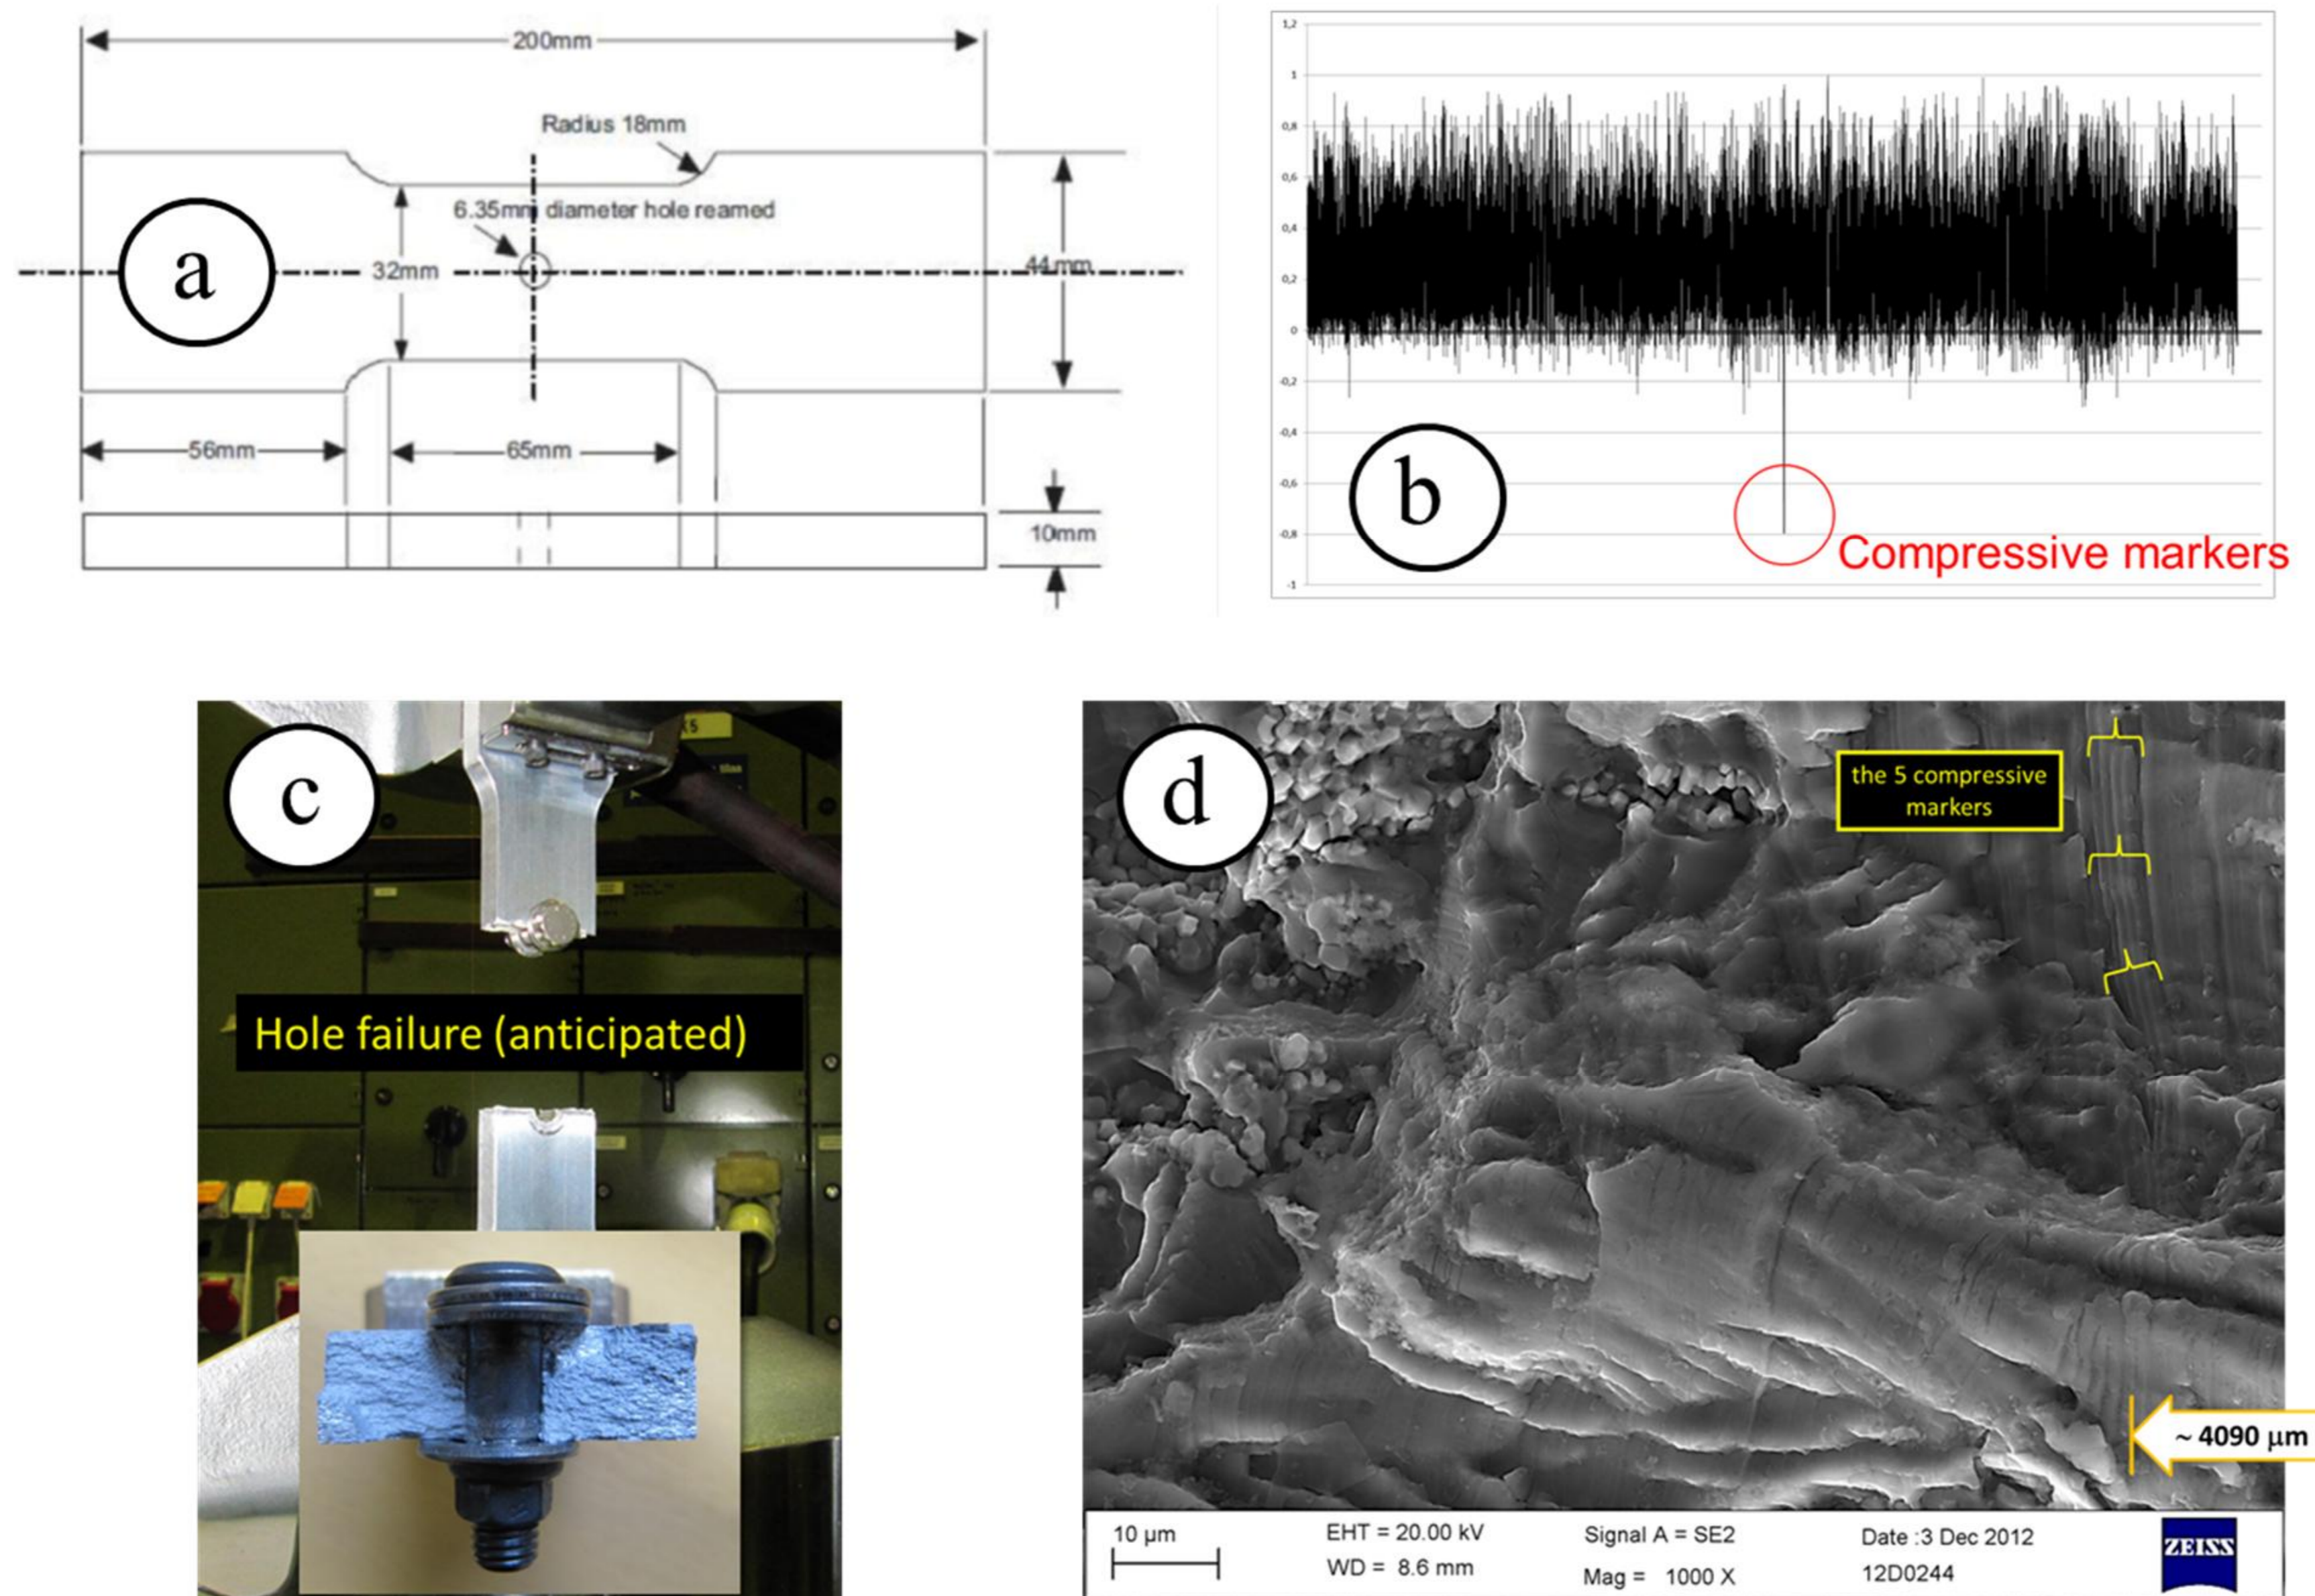
Figure 24: An overview of the project: **a)** specimen geometry; **b)** loading spectrum; **c)** failure from anticipated location (from fastener hole); **d)** scanning electron microscope picture from one of the fracture surfaces displaying the compressive markers. Picture by courtesy of VTT.

Under the auspices of the FISIF, a collaborative coupon testing program was conducted. As per the Canadian plan, the open-hole coupons were etched (by Australia), then pre-cycled (by Switzerland), after which the specimens were shipped to Patria, Finland, where the coupons' hole was first reamed (oversized), then cold worked (split sleeve) followed by interference fit or clearance fit fastener installation in order to have the coupons represent in-service usage. Patria then provided the coupons to VTT who conducted spectrum fatigue tests on the coupons and investigated the fracture surface characteristics using quantitative fractography on coupons with a hole with either clearance fit or interference fit, *Fig 24* [58]. Detailed analysis of the results is being done within the FISIF community.
