A REVIEW OF AERONAUTICAL FATIGUE INVESTIGATIONS IN FINLAND APRIL 2011 – FEBRUARY 2013

Presented at the 33rd Conference of the
International Committee on Aeronautical Fatigue and
Structural Integrity (ICAF),
Jerusalem, Israel, 3-4 June 2013

Compiled by Aslak Siljander

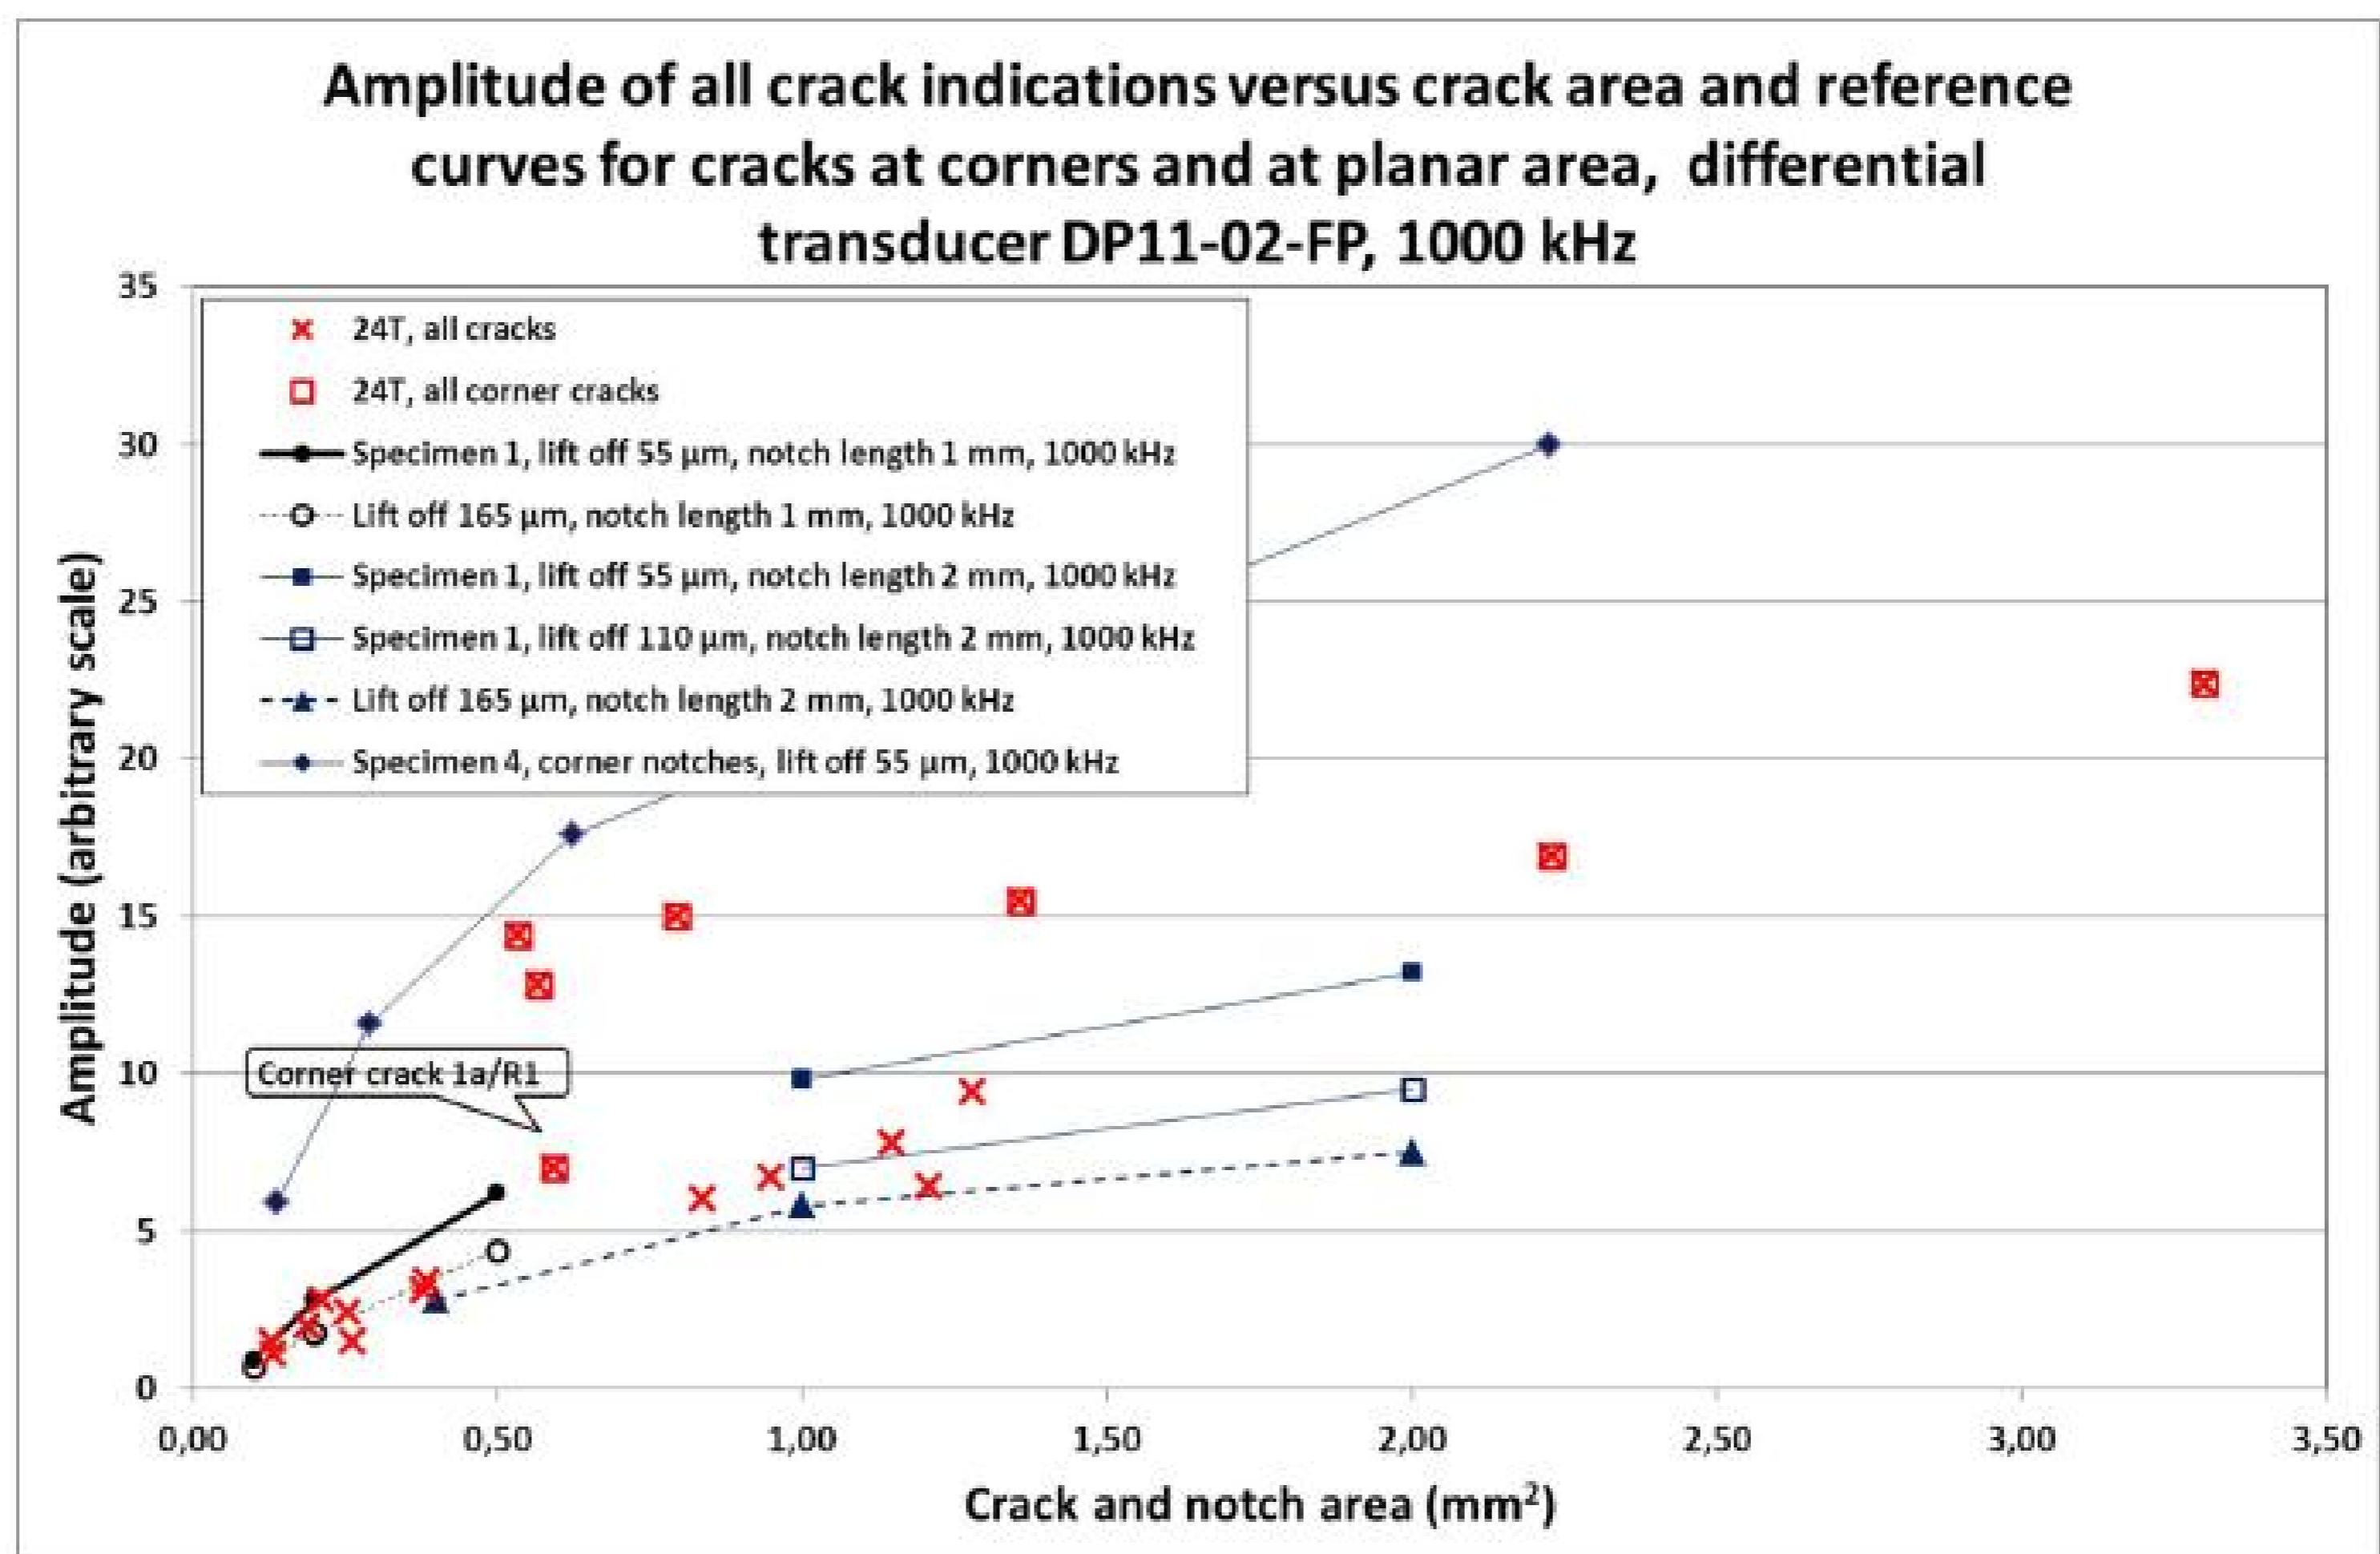
Figure 25: The specimen 24T, the amplitudes of all detected single fatigue crack indications black reference graphs for shorter and blue for longer indications. The small diameter transducer DP11-02-F4 was applied. The ET frequency was 1000 kHz. Picture by courtesy of VTT.

The best UT results were achieved before painting with the 12 MHz material transducer. Altogether 16 fatigue cracks were detected. The size of the smallest detected crack was 0.63 mm x 0.26 mm. Defect depths were strongly undersized. The accuracy of the defect length sizing was quite good. After painting, only few defects were detected with this technique. With the lower frequency UT techniques more defects were detected after painting. However the defect depth sizing accuracy was poor. After painting the best results were achieved by ET. Differential and absolute probes were used. Sensitivity differences between the probes were surprisingly small. Altogether 16 cracks were detected. The accuracy of length sizing was good. The accuracy of defect depth sizing was reasonable if the defect length and thickness of painting are taken into account. The size of the smallest fatigue crack detected with ET after painting was 0.63 mm x 0.26 mm (length x depth). **Fig. 25** summarizes some of the ET results obtained. **Table 1** summarizes the recommendations concerning the high sensitivity ET and UT techniques applicable for sub-millimeter defect detection and sizing [59].

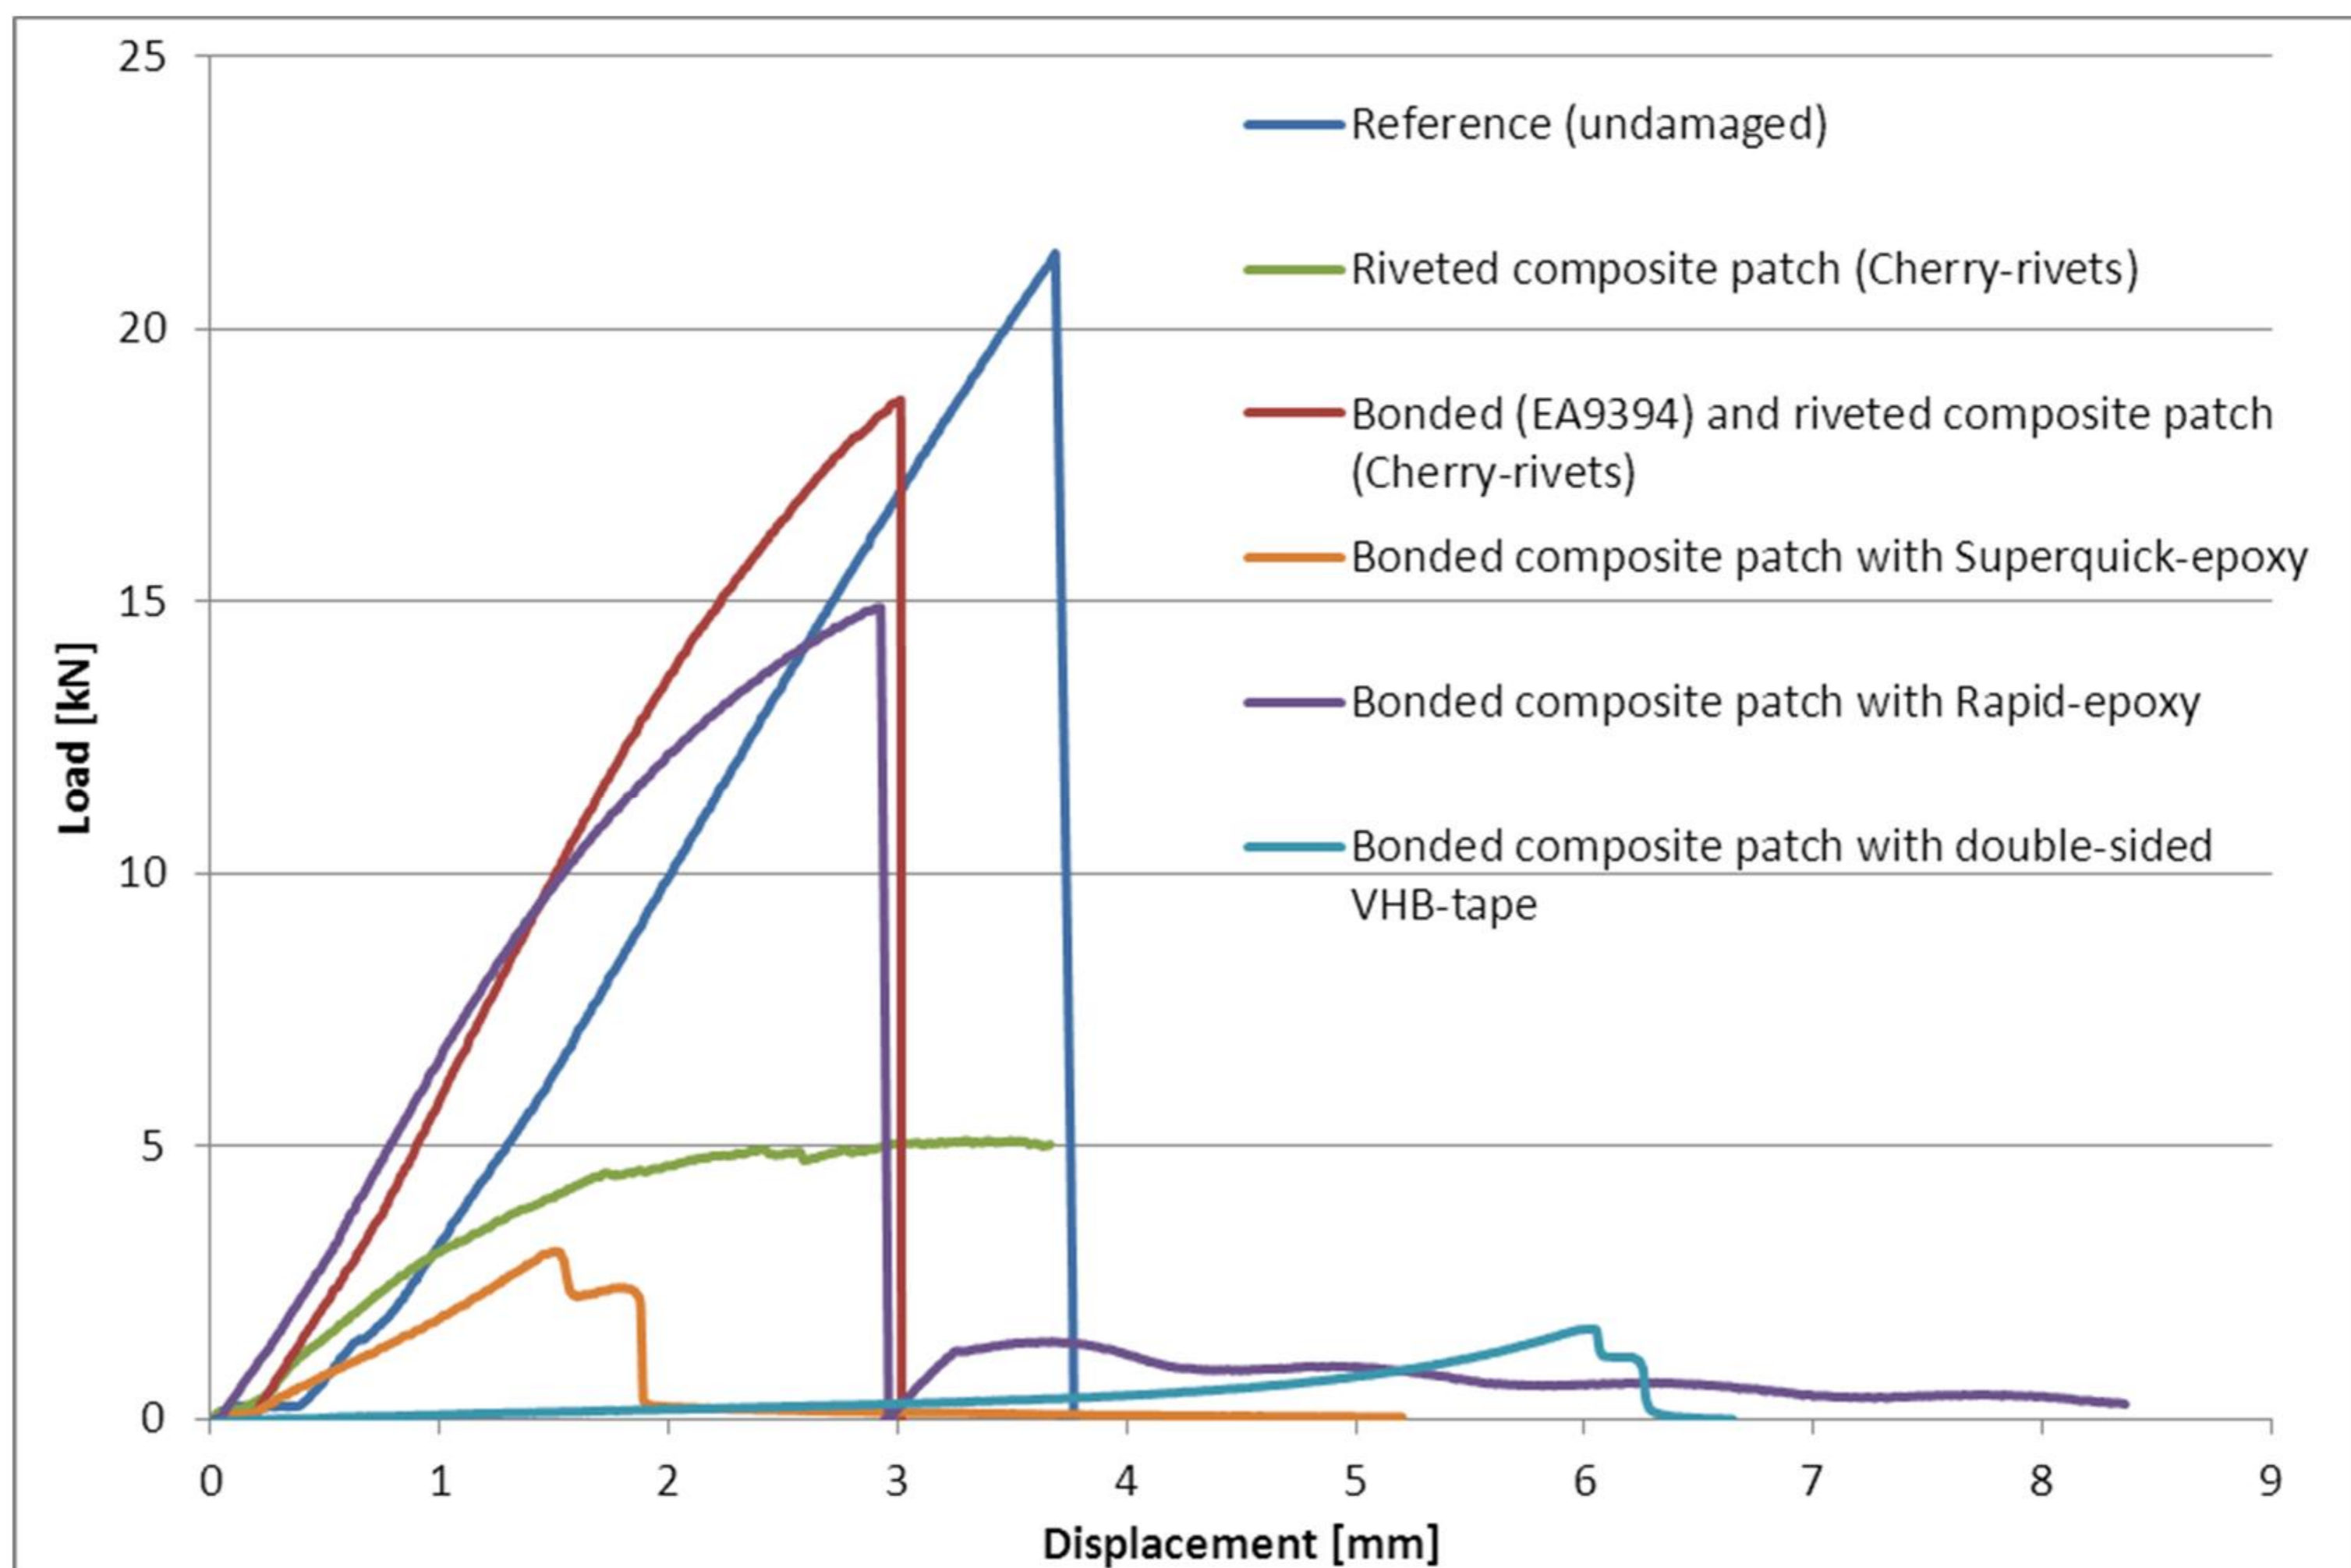
Figure 27: Graphical representation of the experimental results obtained. Picture by courtesy of Aalto University.

The test results showed that riveted and adhesively bonded and only adhesively bonded procured composite patch repair methods could be applied within two hours. They restored 90 % and 75% of the static strength respectively. The riveted repair restored only 29 % of the strength. According to test results, first two repair methods restore moderately mechanical properties and have ability to be processed rapidly in the field using minimum equipment, *Fig. 26* and *Fig. 27* [60].

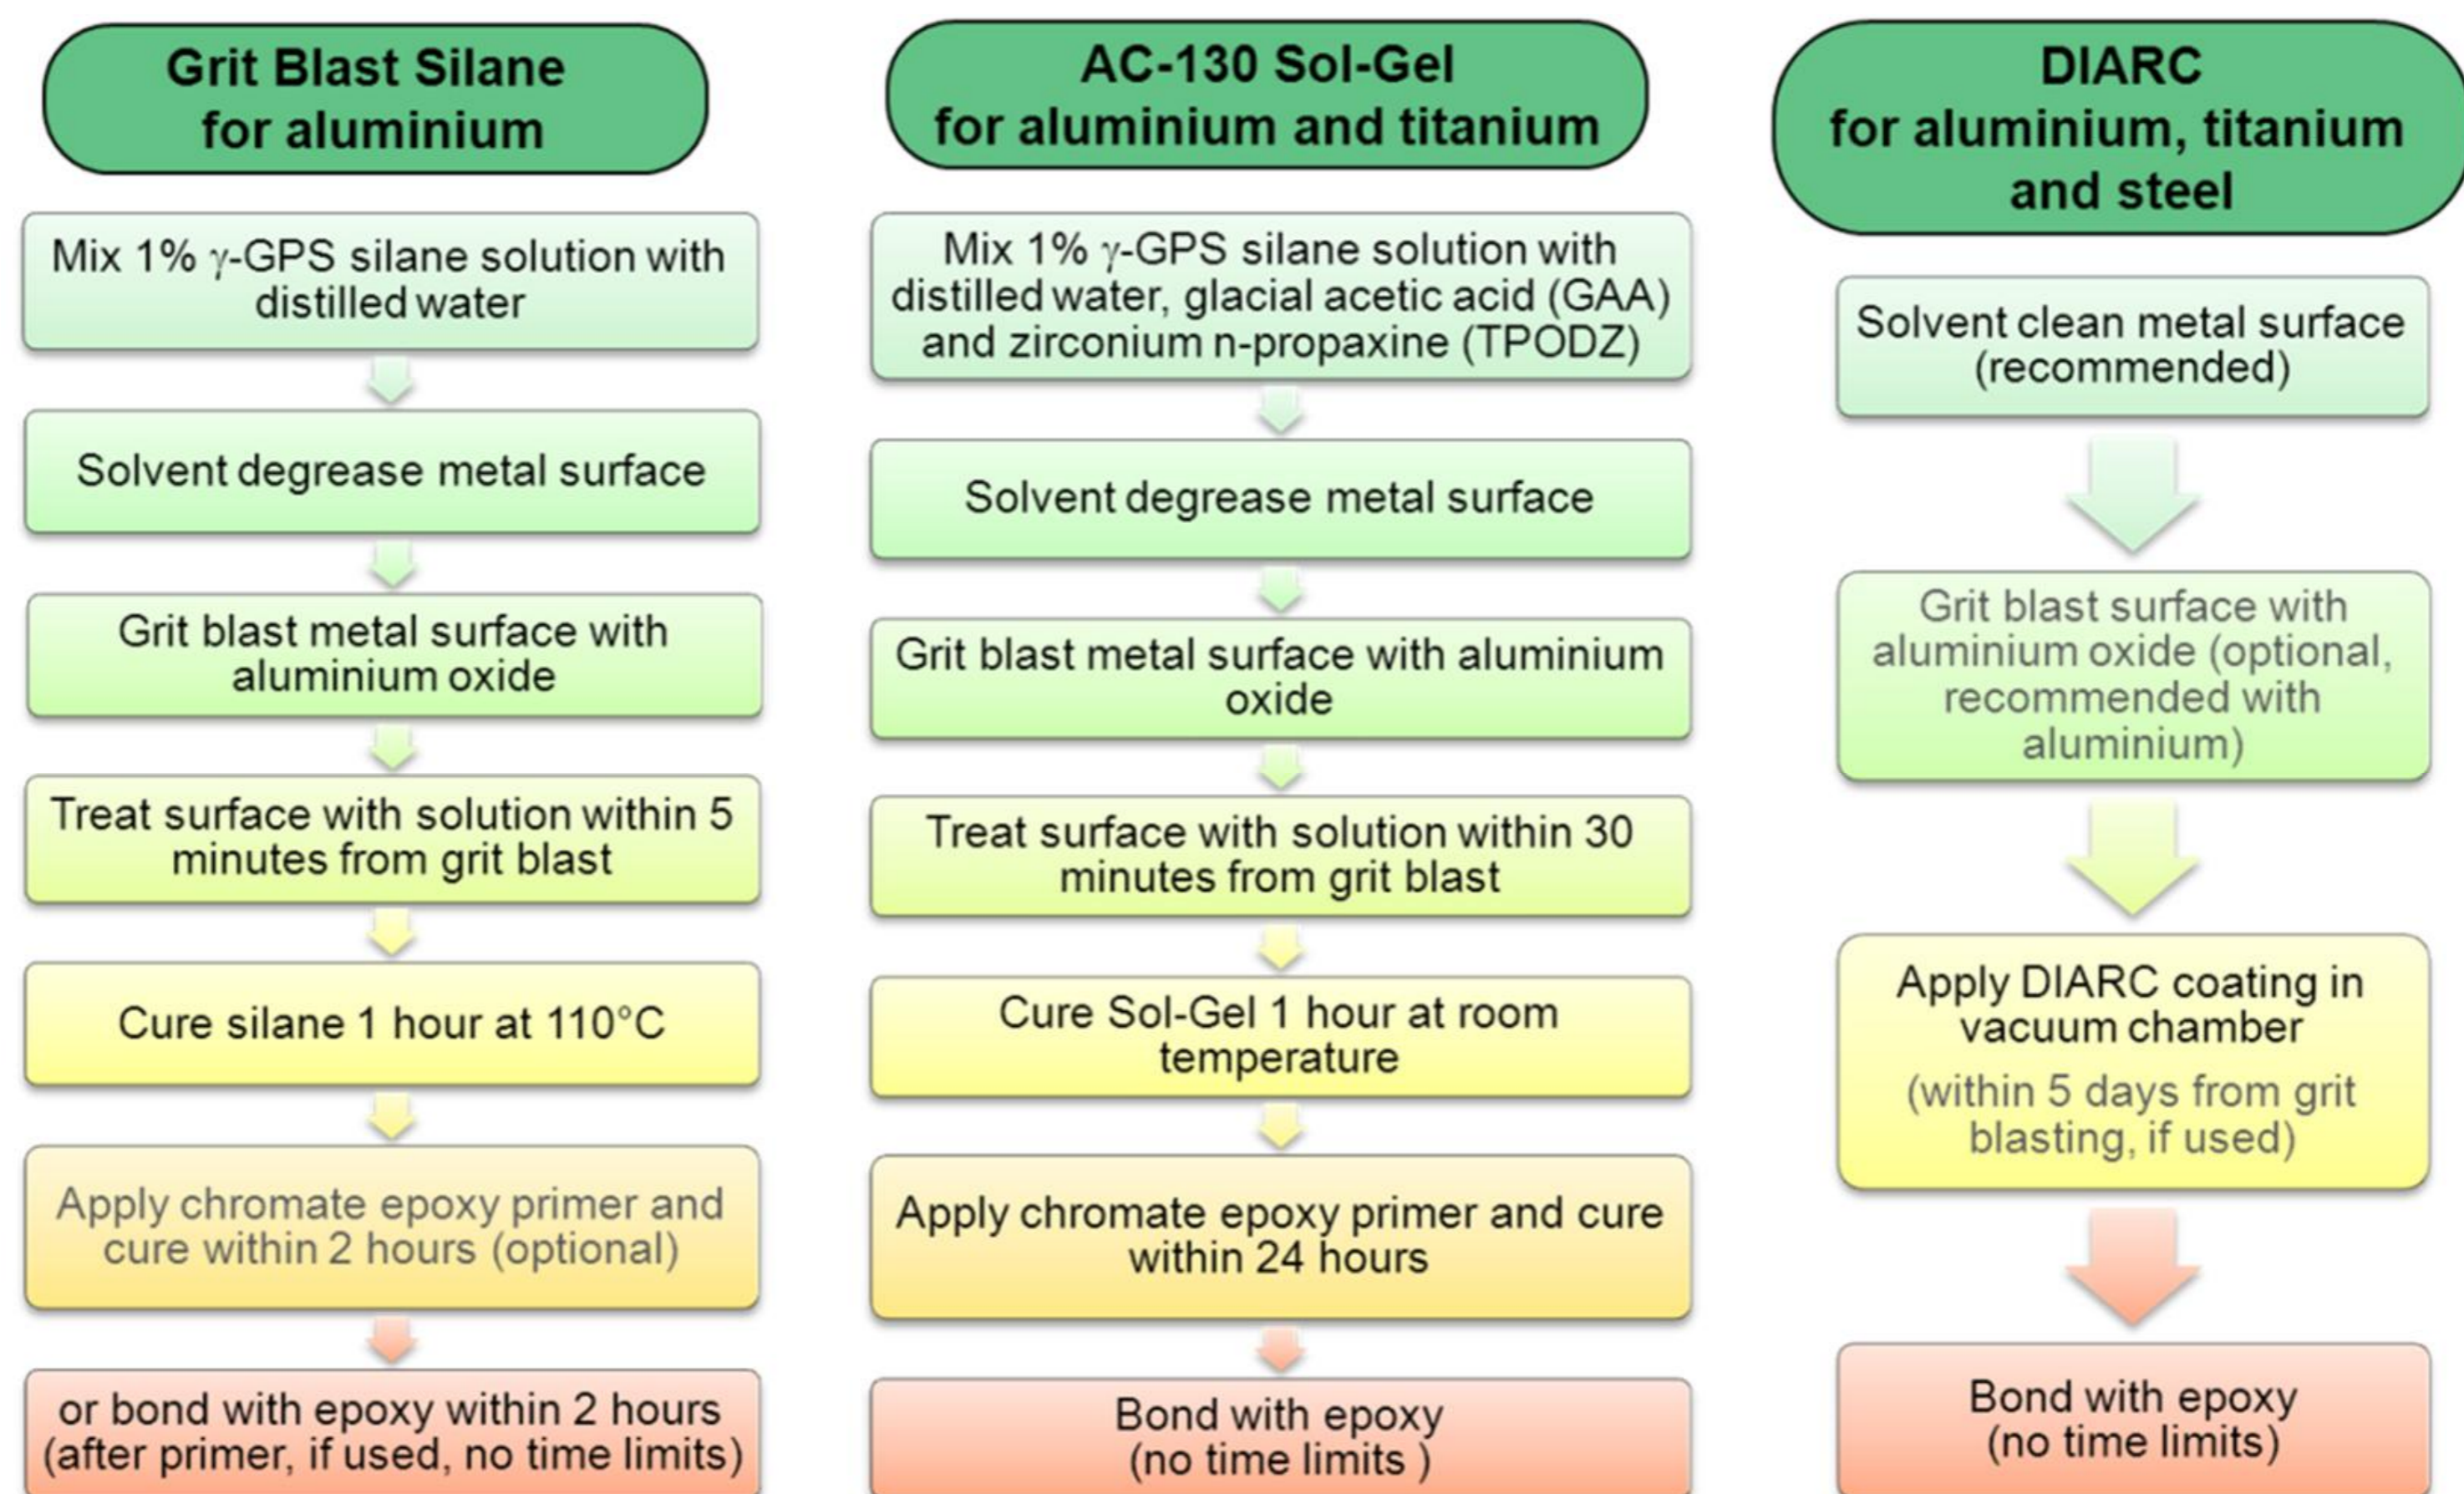
Figure 28: Surface treatment comparisons. Picture by courtesy of Aalto University.

The objective of this study [61] was to investigate the performance of new DIARC coating method for metal bonding. The results were compared to grit blast silane (GBS) and grit blast AC-130 Sol-Gel (SG) testing. **Fig. 28** summarizes the surface treatment comparisons.

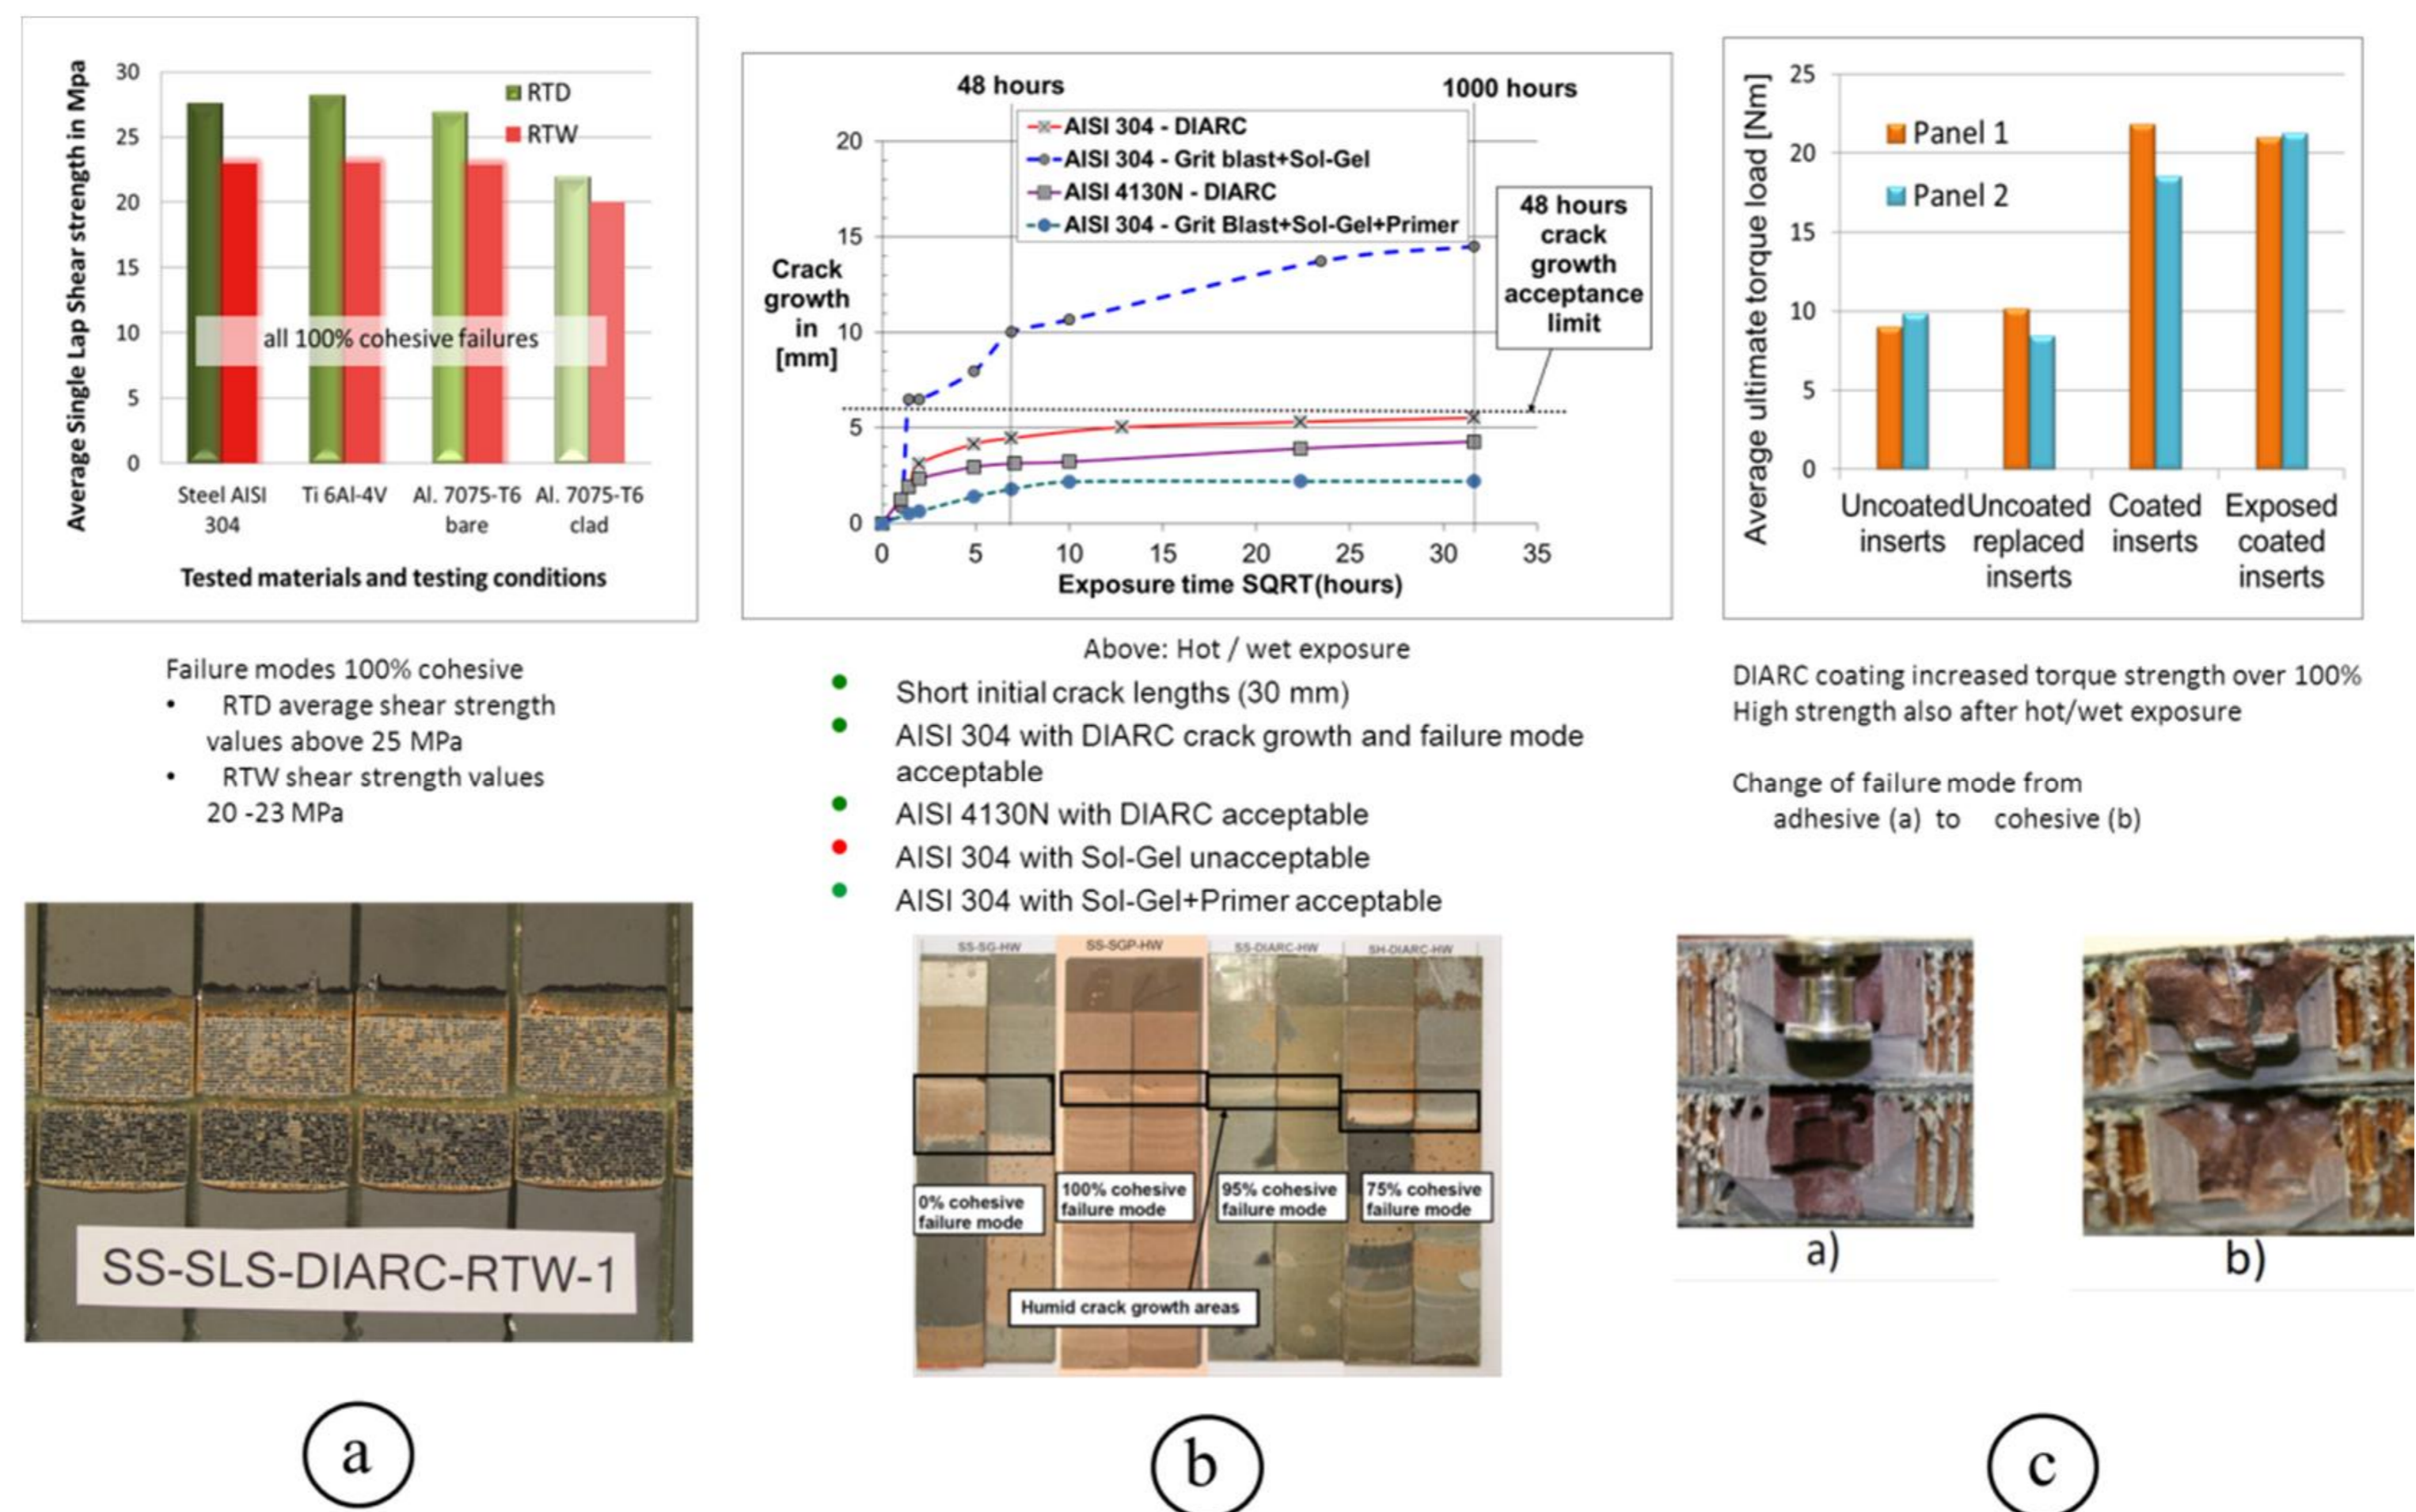
Figure 29: DIARC® (www.diacr.fi) vacuum plasma surface treatment was tested for comparing its performance in aluminium, titanium and steel structural epoxy bonding with existing methods. Static single lap shear and static double lap shear specimens were tested at room temperature as dry and wet. Wedge tests were also performed in different environments. DIARC coating provided good results with all metals in all testing. In a case study the coating applied to sandwich honeycomb steel inserts improved their torque strength over 100 %. Results: a) Single Lap Shear, DIARC Coating; b) Wedge Tests, AISI Specimens; c) Case study: Potted Steel Inserts. Picture by courtesy of Aalto University.

DIARC coating provided good results with all metals in all testing. In a case study the coating applied to sandwich honeycomb steel inserts improved their torque strength over 100 %, **Fig. 29**.

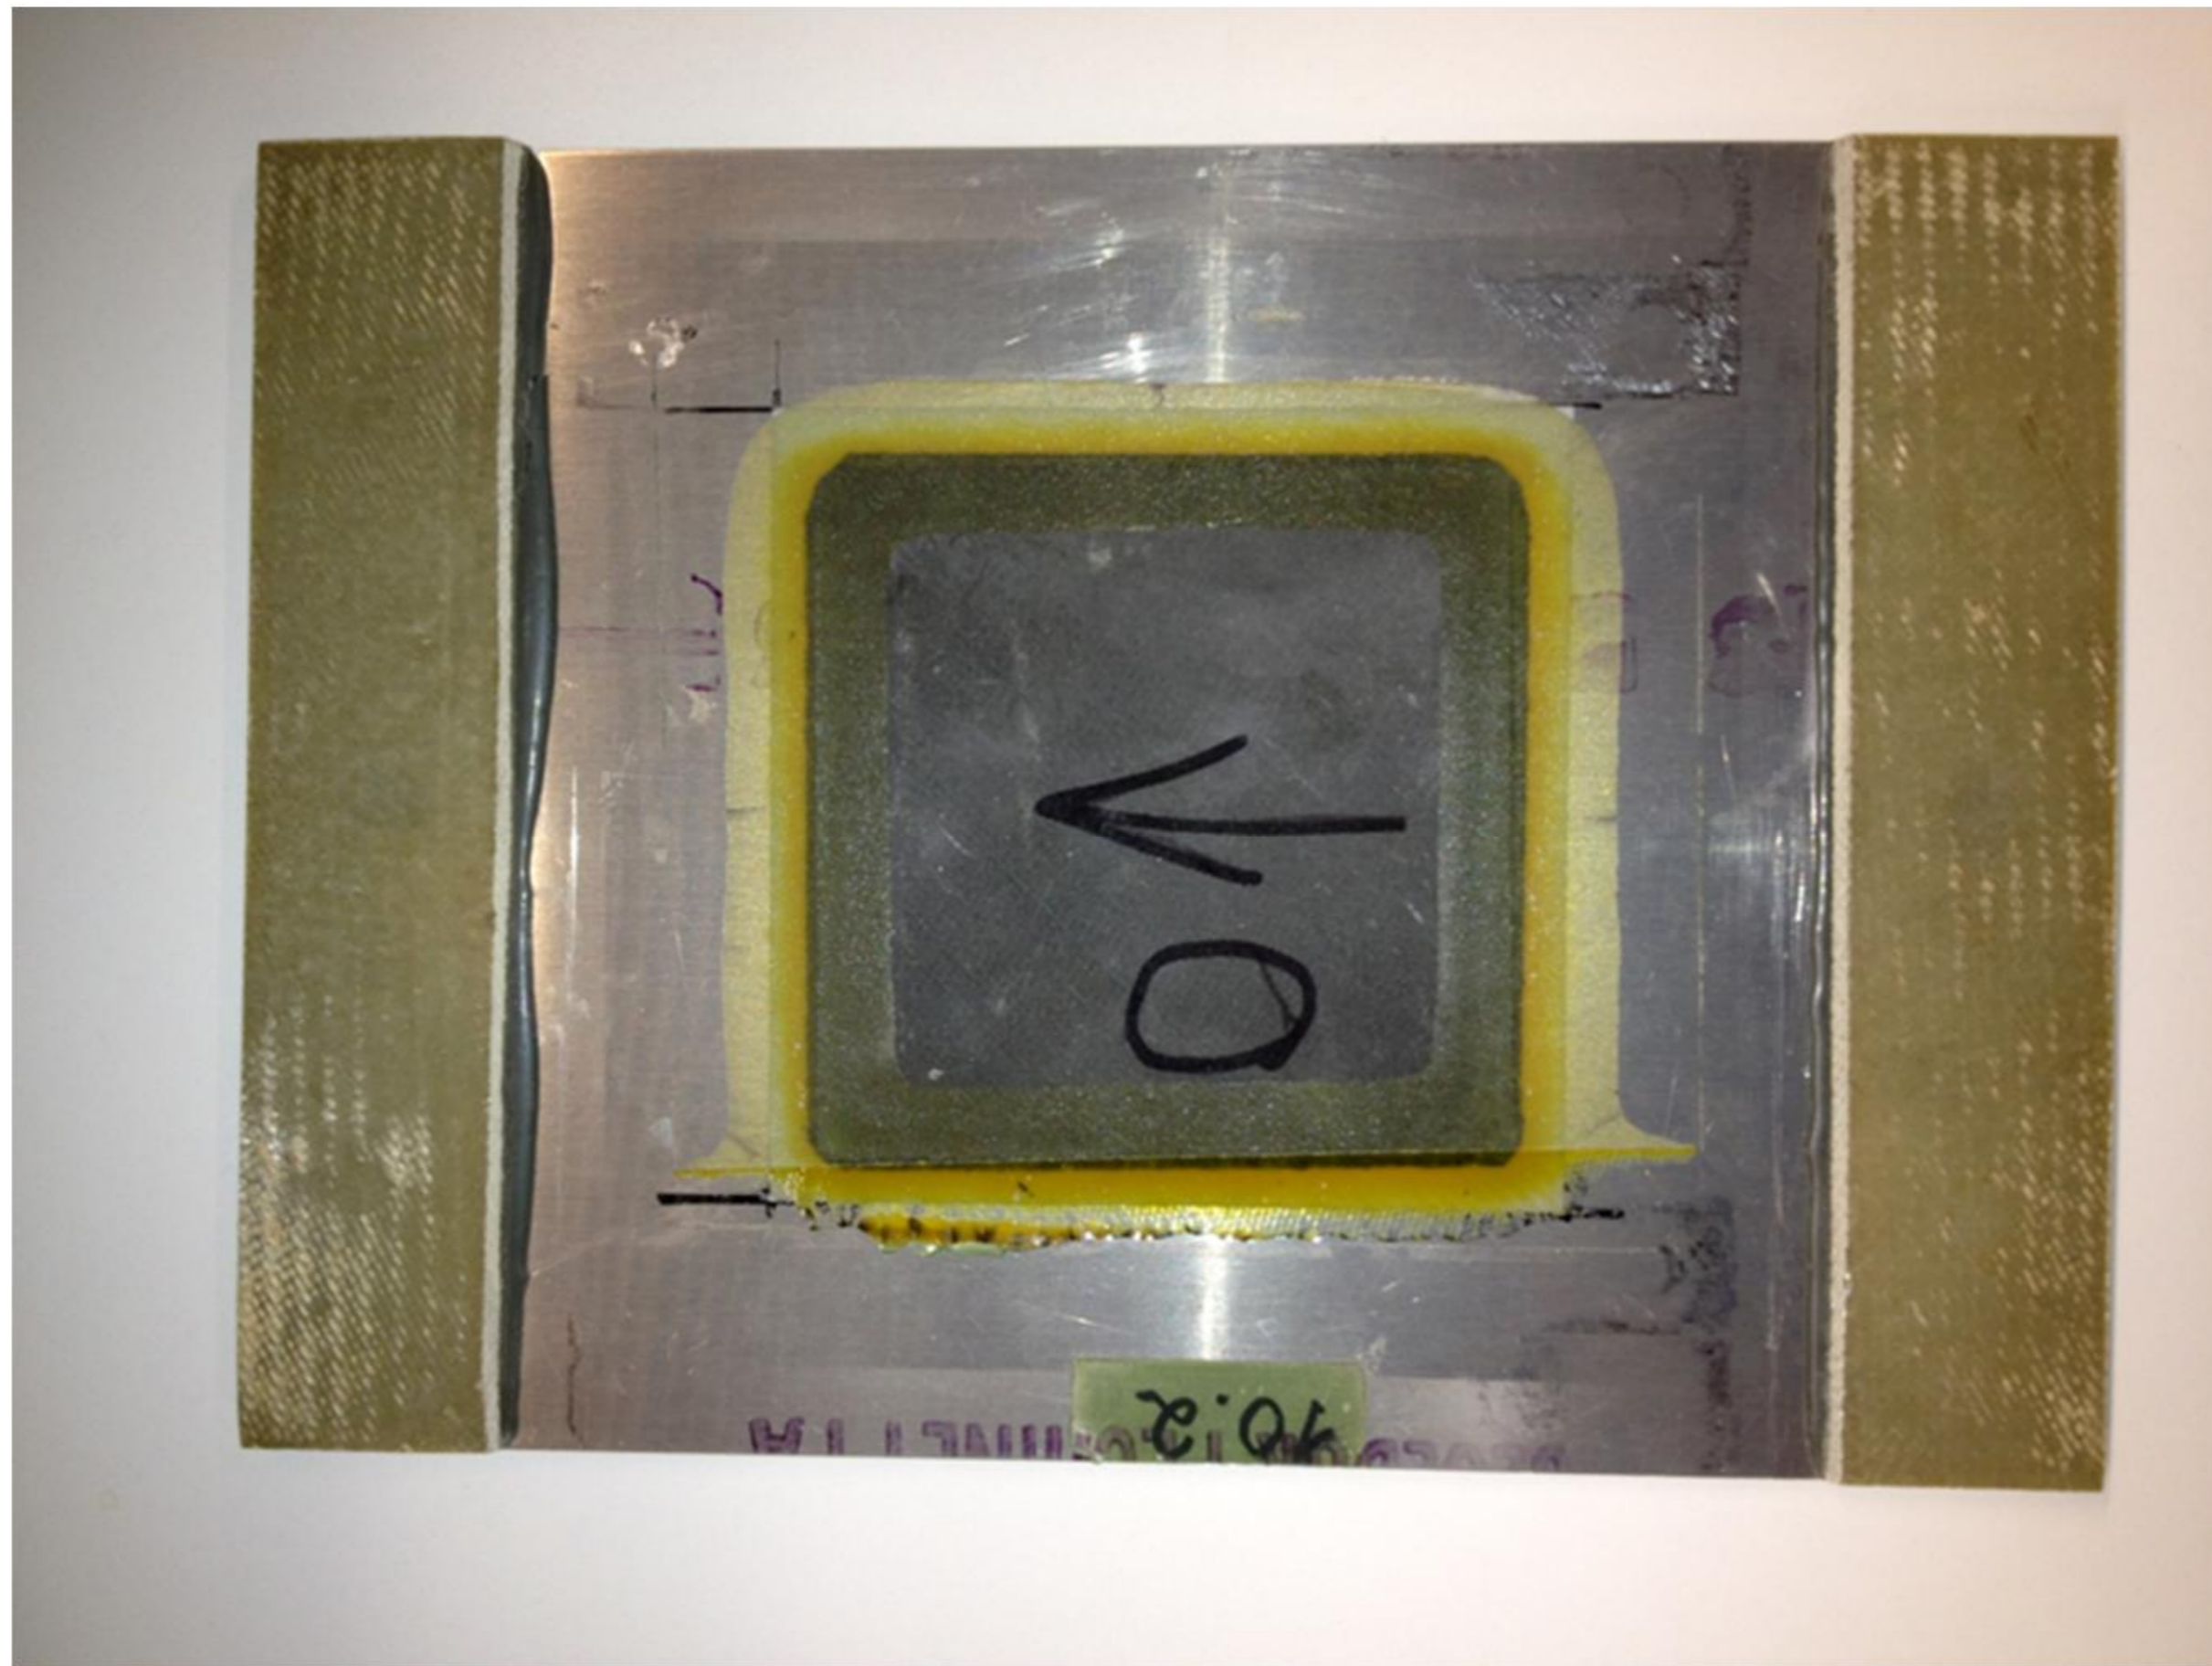
Figure 30: The examined structure; a 2024-T3 aluminum plate and a carbon/epoxy prepreg patch bonded with FM73M epoxy adhesive. Picture by courtesy of Aalto University.

limitations, which is why the results varied considerably [62]. An overview of the work is provided in *Fig. 30* and *Fig. 31*.
