A REVIEW OF AERONAUTICAL FATIGUE INVESTIGATIONS IN FINLAND MARCH 2013 – FEBRUARY 2015

Presented at the 34th Conference of the International Committee on Aeronautical Fatigue and Structural Integrity (ICAF), Helsinki, Finland, 1-2 June 2015

Compiled by Aslak Siljander, Piritta Varis

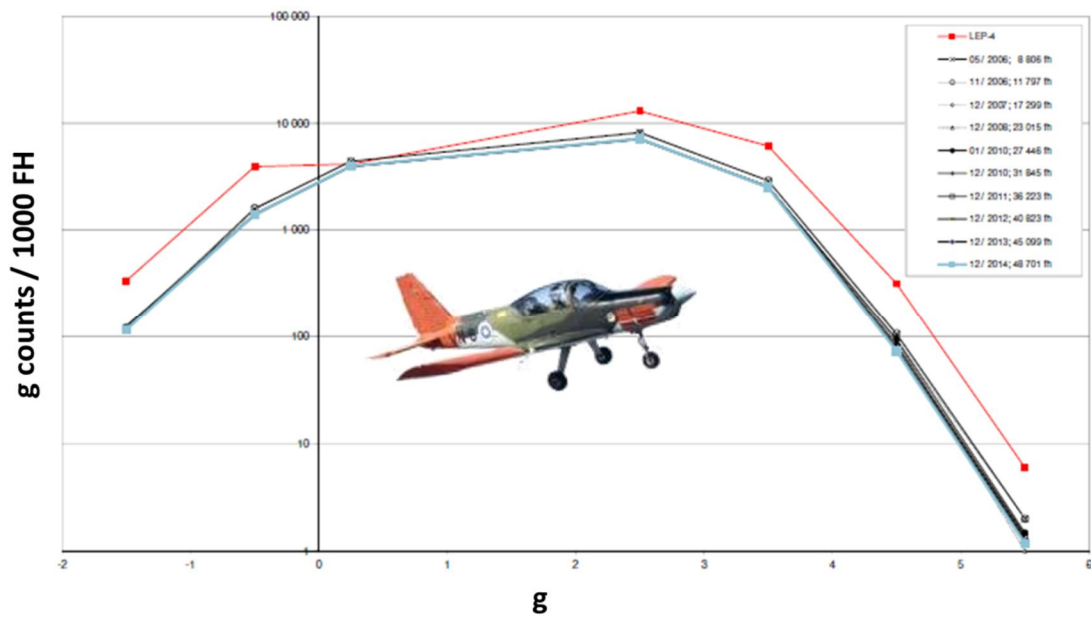
Figure 3: The g counts per 1000 FH of the Valmet Vinka. From top to bottom: The spectrum representing the LEP design assumptions (LEP-4); the post LEP g counter spectrum as of May 2006; as of November 2006; as of December 2007; as of December 2008; as of January 2010; as of December 2010; as of December 2011; as of December 2012; and the updates from the previous review: as of December 2013; as of December 2014. All curves (excluding the red LEP-4) represent the fleet average from all Vinkas, as ranked according to the a/c center of gravity normal acceleration. Picture by courtesy of Patria Aviation.

Based on the g counter information, the primary trainers are in good structural condition with regard to the flight hours. The severity of usage in view of the g counter status is more benign than that on the basis of LEP assumptions, see **Fig. 3**. It is possible to operate with Vinka until 2020 under its current type certificate. According to the FINAF's current plans the Vinkas planned withdrawal date is 2018. If there is a need to operate beyond 2020, the Vinka fleet will require another LEP.

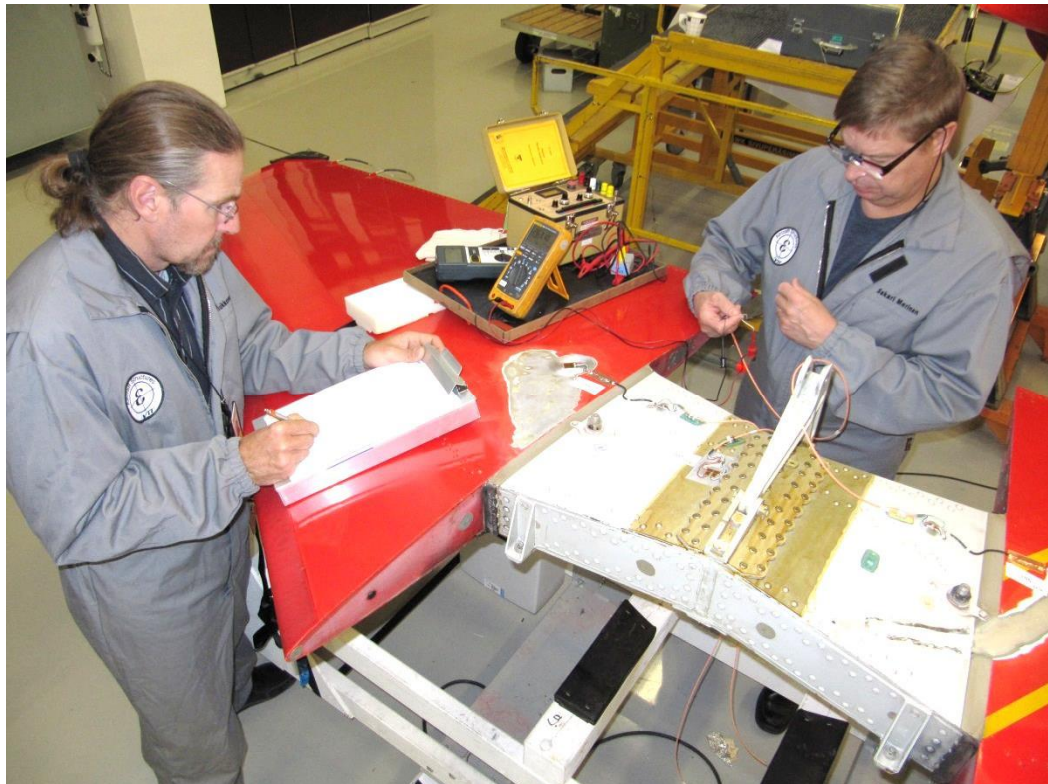
Figure 12: An overview of Mk66 tailplane mini OLM instrumentation. Picture by courtesy of VTT Ltd.

A decision has been made within the FINAF to instrument one Mk66 jet trainer with a mini OLM system capable of collecting enough in-flight data from dedicated test flights as well as from normal squadron service, to come up with an average spectrum for the most important structural assemblies. The aircraft is being instrumented at the writing of this review (*Fig. 12*) and the flights (tens of flights rather than hundreds of flights) will be flown during 2015.

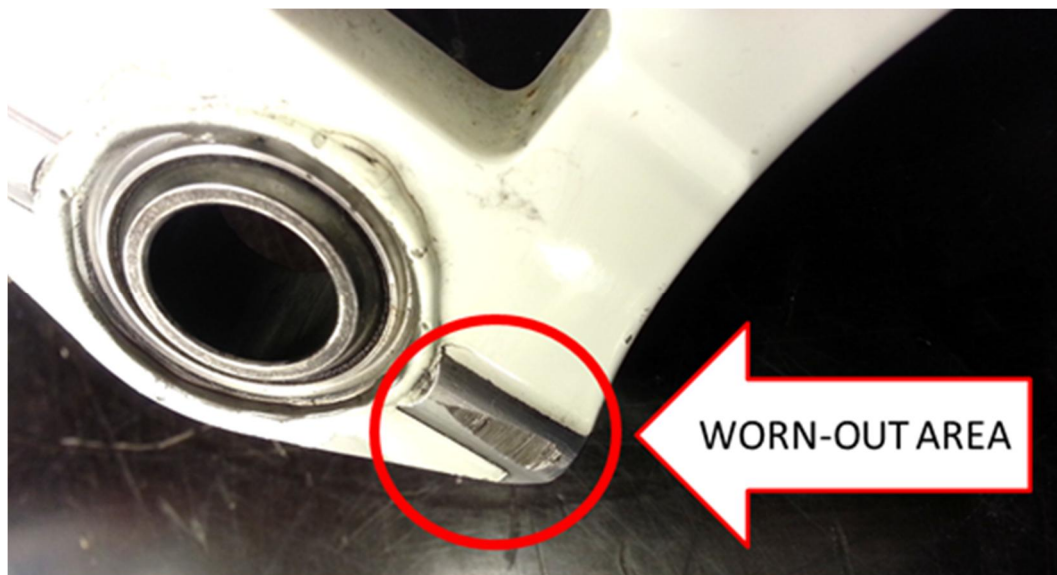
Figure 20: An overview of the Aileron's hydraulic cylinder's worn flange. Picture by courtesy of the FINAF.

As there are several on-aircraft parts and subsystem components (e.g. hydraulics, flight controls etc.) that wear out during normal service, the FINAF initiated a study with VTT to investigate possibilities to develop in-country capabilities related to restoring the structural integrity of the worn parts thus supporting maintenance, repair and overhaul (MRO) activities and improving the management and sustainment of spares and component life cycle. One such subsystem component wearing out in normal service is the FINAF F-18 Aileron's hydraulic cylinder's flange, *Fig. 20*.
